DATE: November 4, 2014

SUBJECT: ET-Plus Beam Guard End Terminals Maintenance Guidance

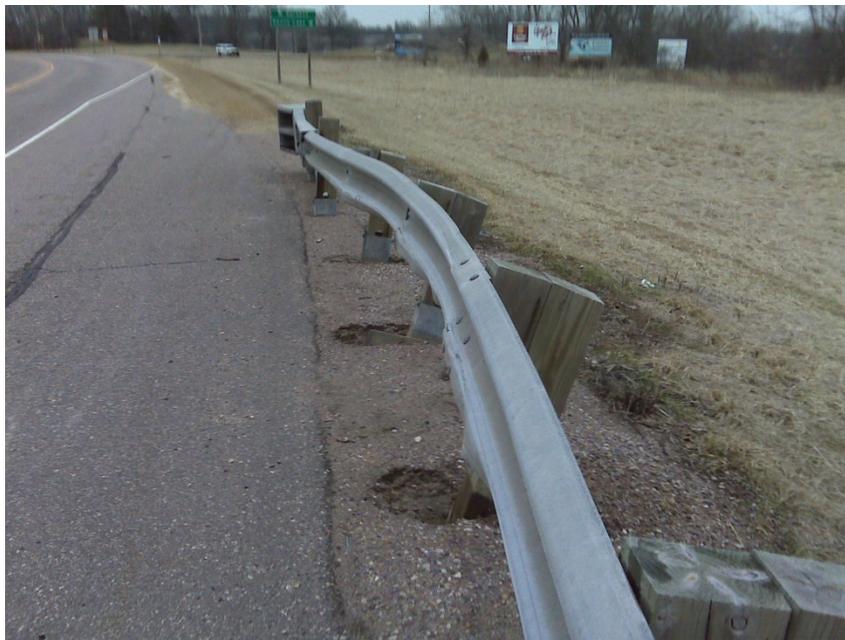
Damage leading to partial replacement of ET-Plus hardware:

- Head is not damaged or shows no signs of contact.
- Head can be removed, if needed, from rail by the use of limited force or by the use of hand tools.
- Some rails may be flattened or bent (see below)
- Post may be shifted/leaning away from roadway (see below)
- One or two post may be damaged

Partial Repair
