Optimizing Bridge Abutment Slope Protection at Stream Crossings

This brief summarizes Project 0092-21-02,
“Optimizing Bridge Abutment Slope Protection at Stream Crossings”
Wisconsin Highway Research Program

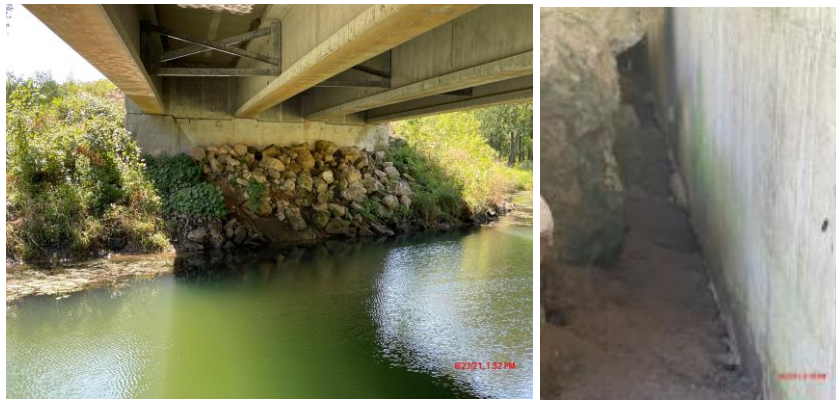
Photos of an abutment and a close-up of erosion along the abutment
