**Wisconsin Highway Research Program**

Project No. 0092-04-15

**Bridge Integrated Analysis and Decision Support:  
Case Histories**

**Final Report**

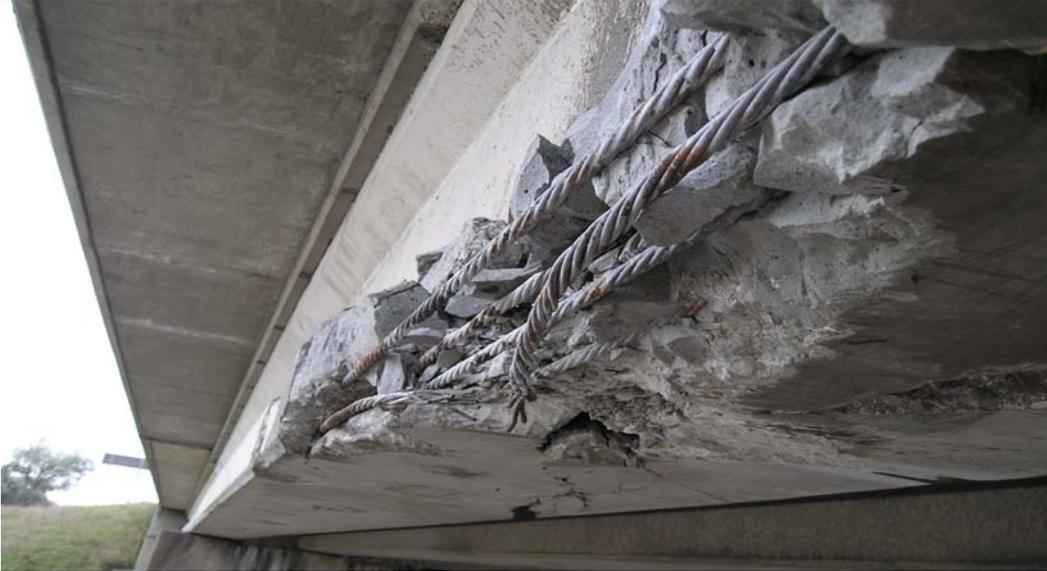
Mr. Weber noted severe damage to girder 1 with six exposed reinforcing steel strands and one severed strand. (See Figure 2.) The bottom flange of girder 1 has severe cracking that extended into the web. It was recommended that because of the extensive cracking the girder be replaced. Furthermore, the impact caused patches placed over previously damaged areas on girders 6 and 7 to fall off. (See Figure 3.) It was recommended that both of these girders be repaired. Although the damage, especially to girder 1, was extensive it was decided that the bridge was still structurally sound and no restrictions were placed on its use. In an effort to repair these damages before another impact occurred it was decided to use an outside contractor to complete the repairs as quickly as possible.

**Figure 2: Detailed View of Severely Damaged Girder #1.**

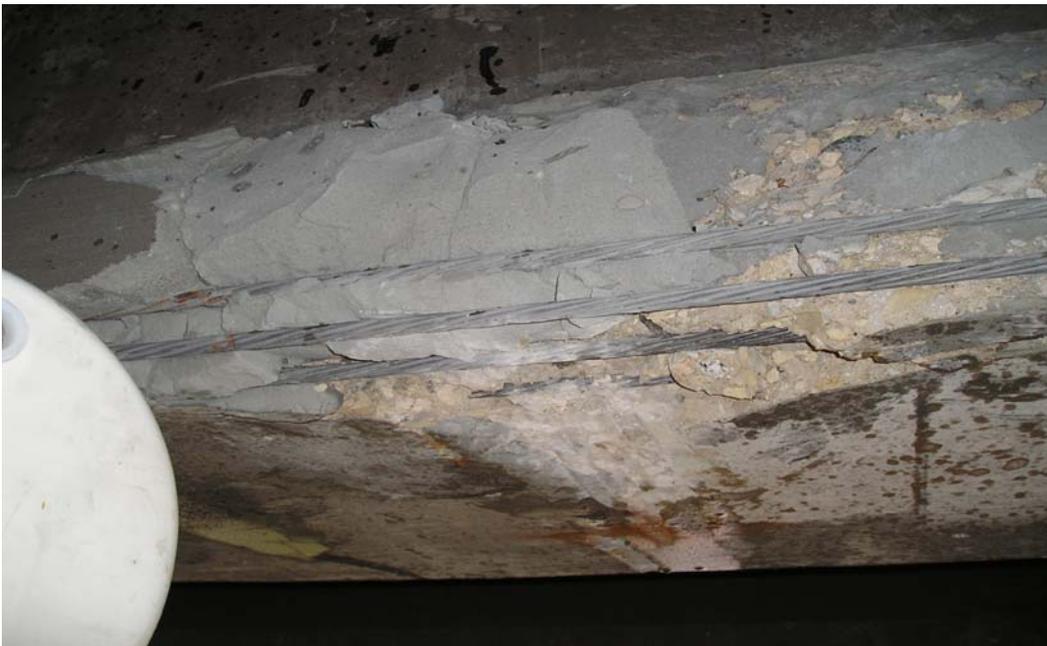
**Figure 3: Detailed View of Damaged Area with Lost Patch in Girder #7.**

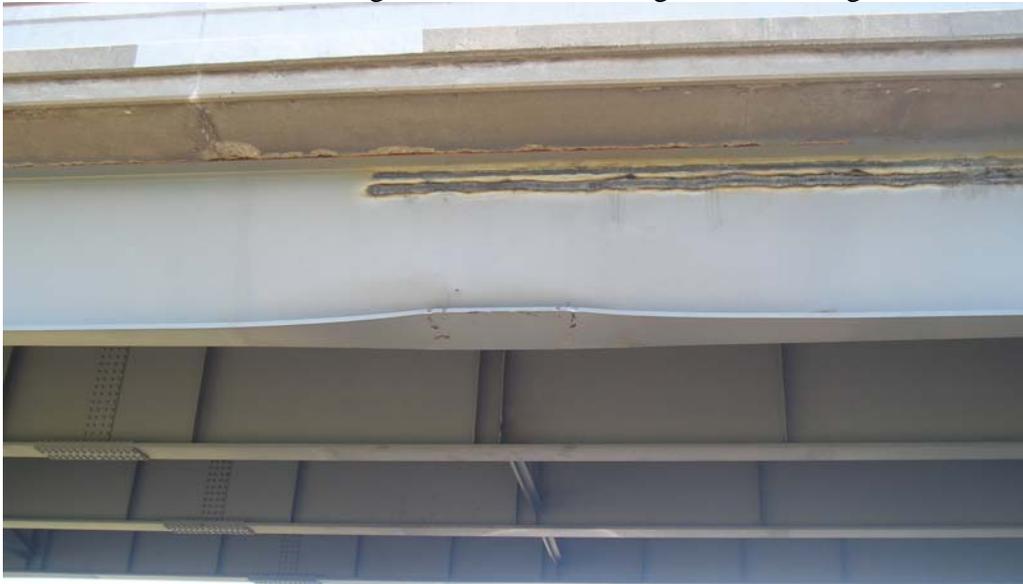
Although the steel girder was significantly bent by the impact (See Figure 2) it was decided that the structural integrity of the bridge had not been significantly compromised. Thus, it was recommended that the girder be heat straightened and repainted. The heat straightening was performed by County and State employees on August 27, 2005. (See Figure 3.) An outside contractor repainted the girder from August 29, 2005 till September 1, 2005. The total cost of all operations was \$96,647.73. No restrictions remain on the use of the bridge and it retains its original load ratings.

**Figure 2: Detailed View of Severely Bent Northernmost Exterior Girder.**

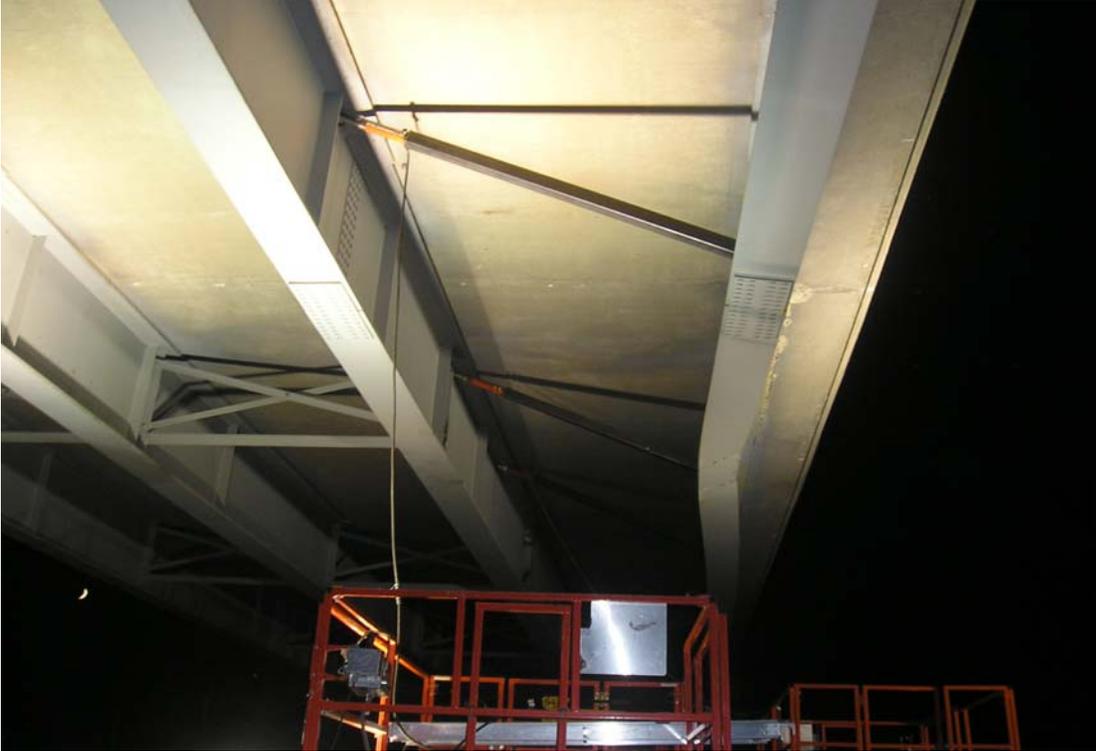
**Figure 3: Heat Straightening of Bent Girder.**

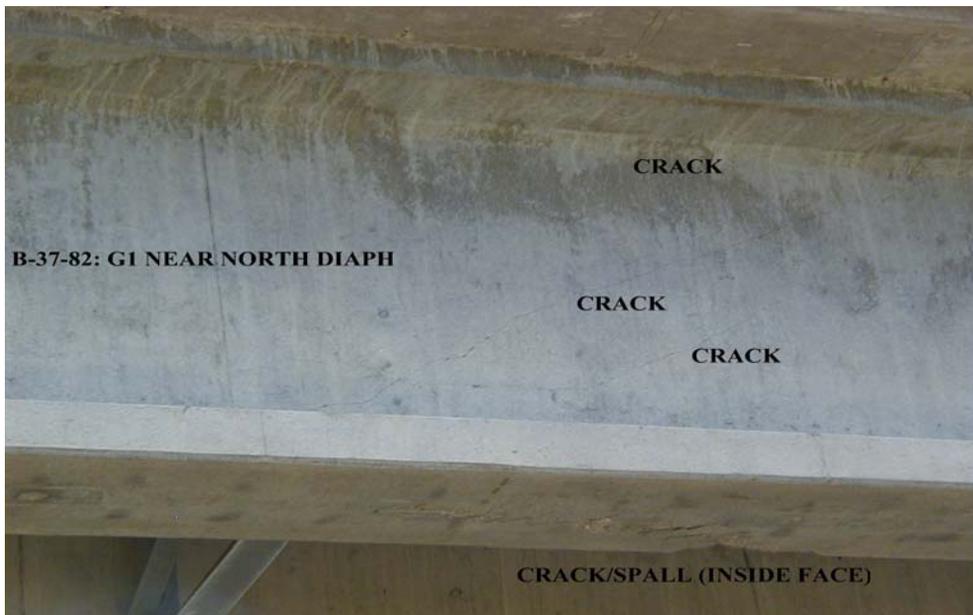
**Figure 1: Detailed View of Severely Cracked Girder #1.**

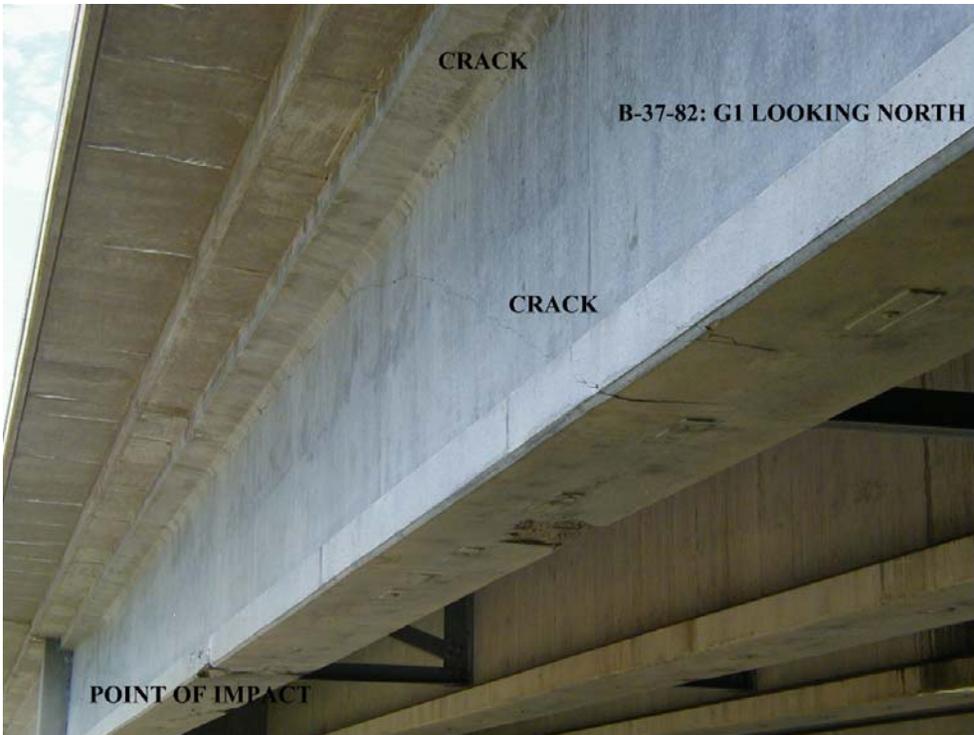
**Figure 2: Detailed View of Severely Cracked Girder #1 (Looking North).**

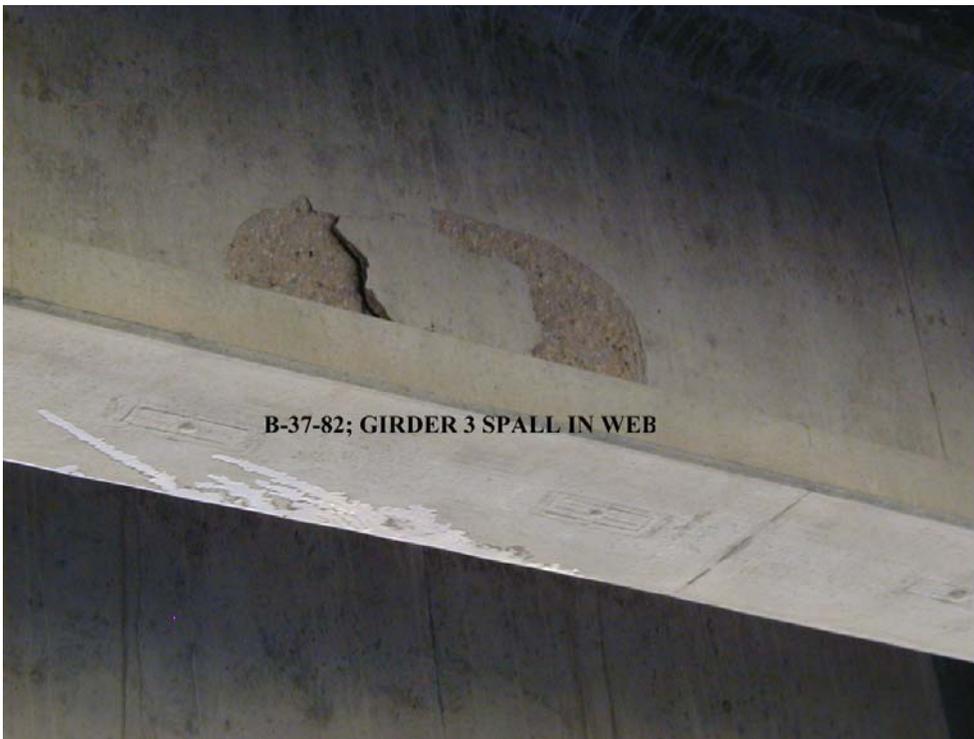
**Figure 3: Detailed View of Severely Spalled Web in Girder #3.**

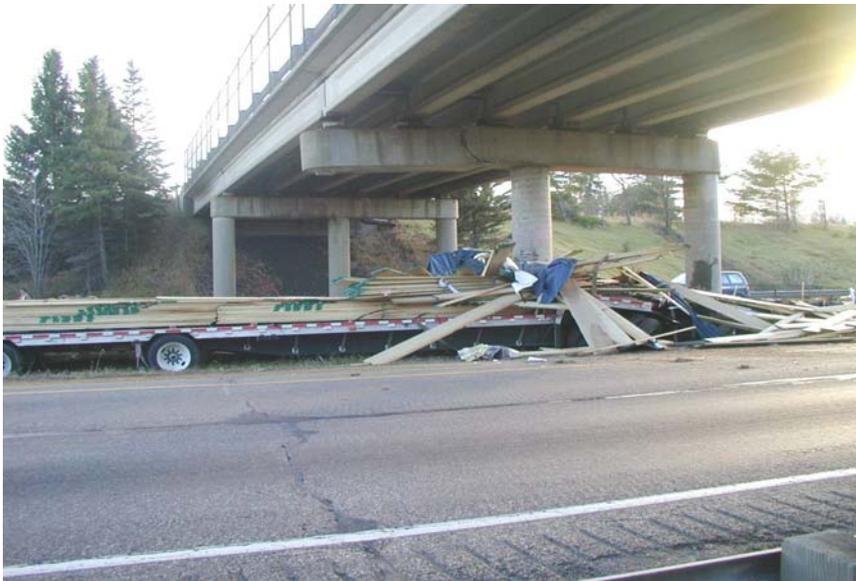
No major repairs to the structure were documented until the incident which occurred in November of 2001. On Thursday, November 15, 2001, the Wilson Street Bridge was struck by a semi-trailer truck carrying a load of lumber. The truck was traveling in the westbound lanes of I-94 and struck the center pier separating the eastbound and westbound lanes. The east pier column was completely demolished and the pier cap was severely cracked at the center column. (See Figure 1.) The truck cab was also demolished and the driver was found dead at the scene.

**Figure 1: General View of Severely Damaged Central Pier.**

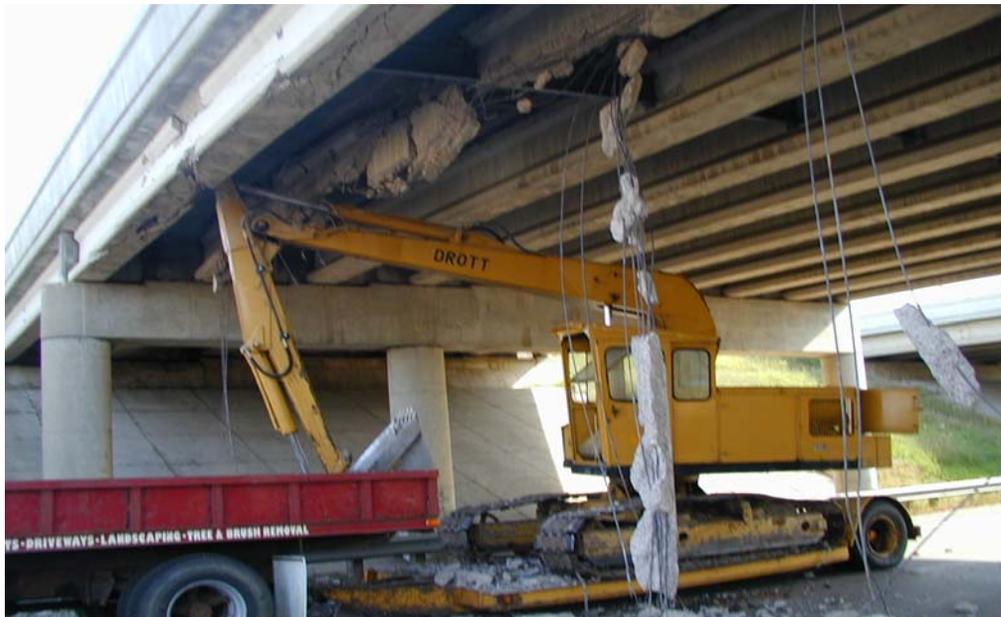
The bridge superstructure was repaired in 1980 and no further records of damages are available till October of 2001. On Tuesday, October 2, 2001, the westbound I-94 bridge was struck by the boom of an excavating shovel loaded on a flatbed truck trailer. The truck was traveling in the northbound lanes of STH 37/85. In this incident four concrete girders were struck with girders #18 and 19 in span 3 being severely damaged. (See Figure 1.)

**Figure 1: General View of Severely Damaged Concrete Girders.**

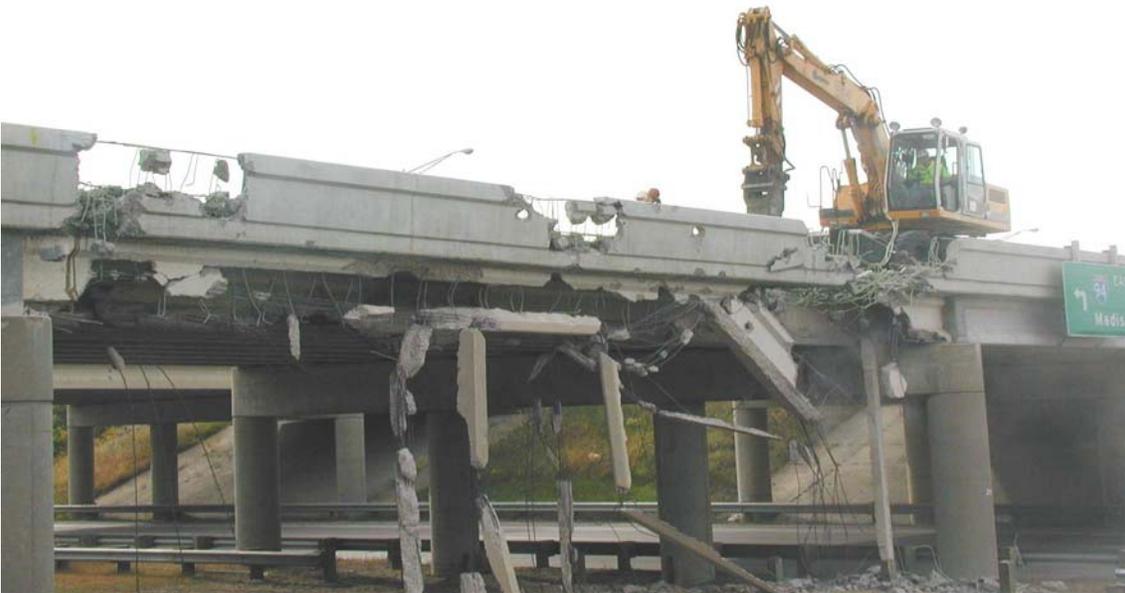
**Figure 4: Demolition of Severely Damaged Girders.**

The emergency status of the westbound I-94 bridge allowed for immediate repairs to be performed by an outside contractor (Lunda Construction Company). The extent of the damage required removal and replacement of the severely damaged girders. To accomplish this, barriers were erected on westbound I-94 at 11:00 a.m. on Thursday, October 4. Sawing began on the afternoon of October 5 and was completed on the morning of October 5. (See Figure 3.) On October 5 debris from the sawing operation was removed and the northbound lanes of STH 37/85 were reopened to traffic at 4:00 p.m. Only the westbound I-94 entrance ramp remained closed. On Monday, October 8, traffic on one lane of northbound STH 37/85 was restricted to allow working space for the contractor to perform the demolition operation. (See Figure 4.)

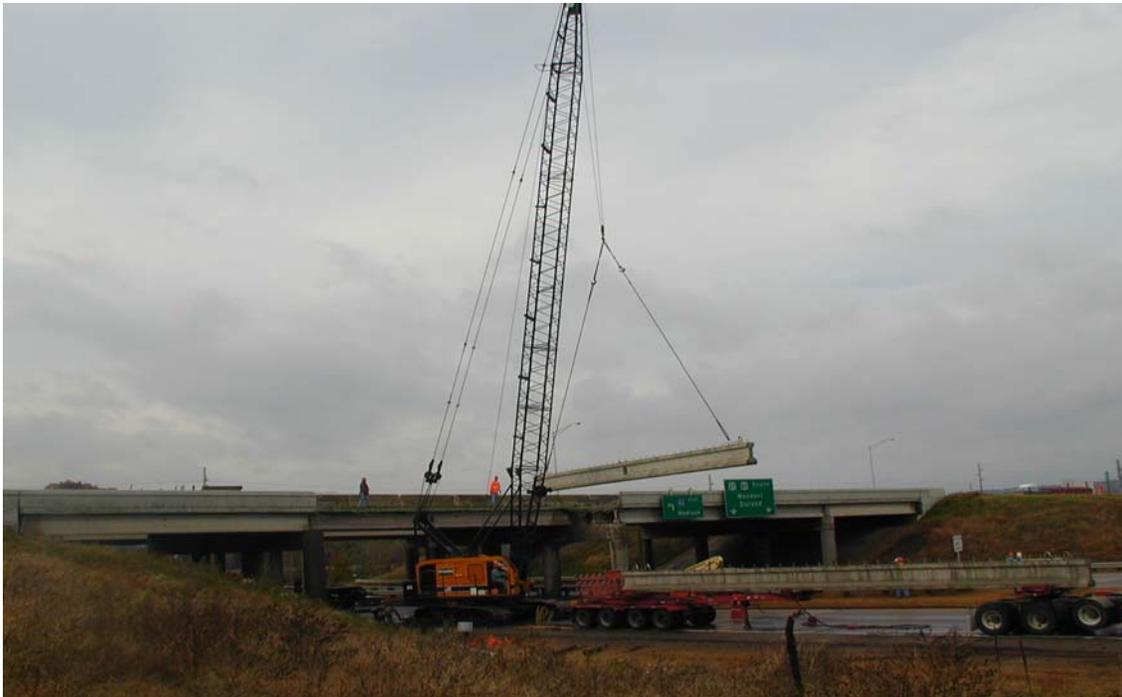
**Figure 5: Installation of Replacement Girders.**

This restriction remained in place until the end of the project. The replacement girders were received and erected on Wednesday, October 7. (See Figure 5.) Forming of the deck was initiated on October 11 and setting of the iron began on October 12. The diaphragms were poured on October 16, the deck pour began on October 17 (see Figure 6), and curing of the deck continued until October 19. All remaining repair work was completed by October 25 and traffic was restored to normal conditions on October 26 at 4:00 p.m.

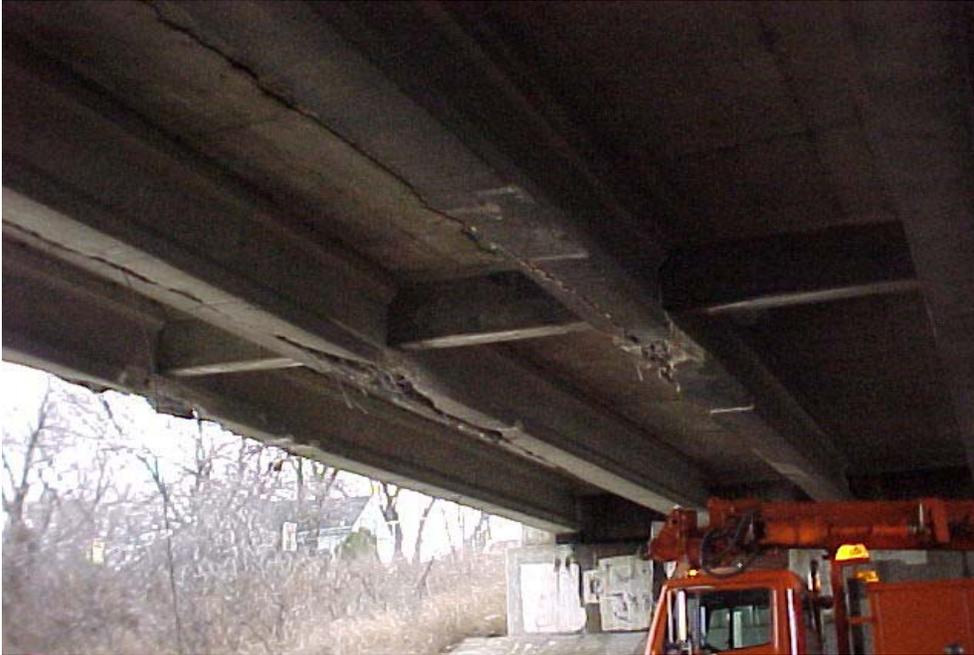
On Friday, January 13, 2006 the Seminole Highway Bridge was struck by an oversize load mounted on a flatbed semi truck trailer. The truck was traveling in the westbound lanes of U.S. Highways 12/14/18/151. In this incident (1/13/2006), the three westerly girders (5, 6, and 7) were damaged beyond repair. (See Figures 1 & 2.)

**Figure 1: Girders #5, 6, and 7 after impact.**

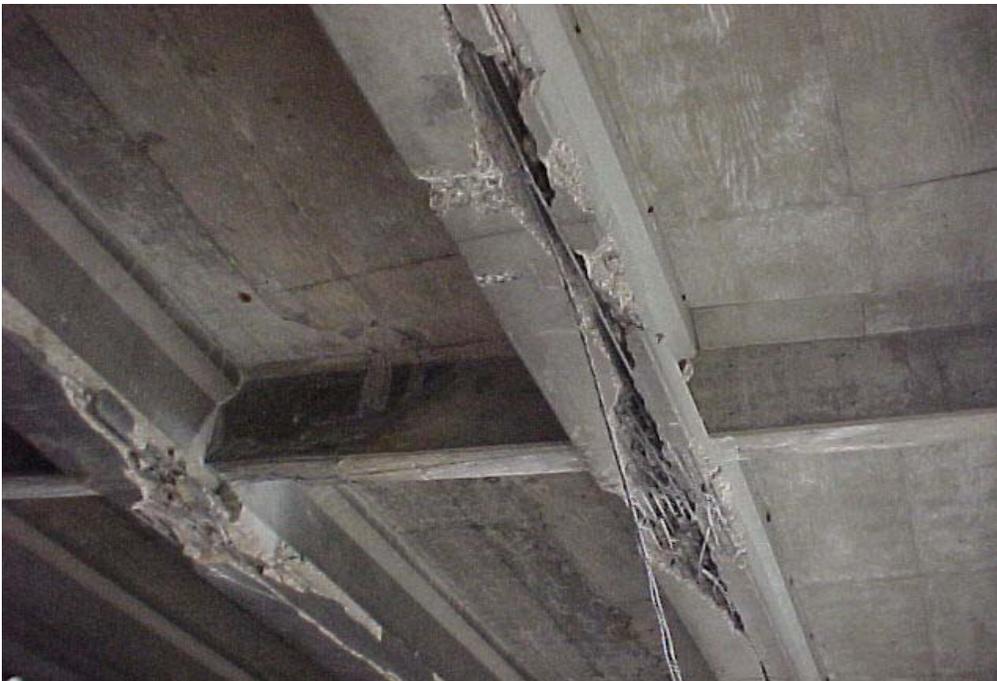
**Figure 2: Detailed View of Girder Damage.**

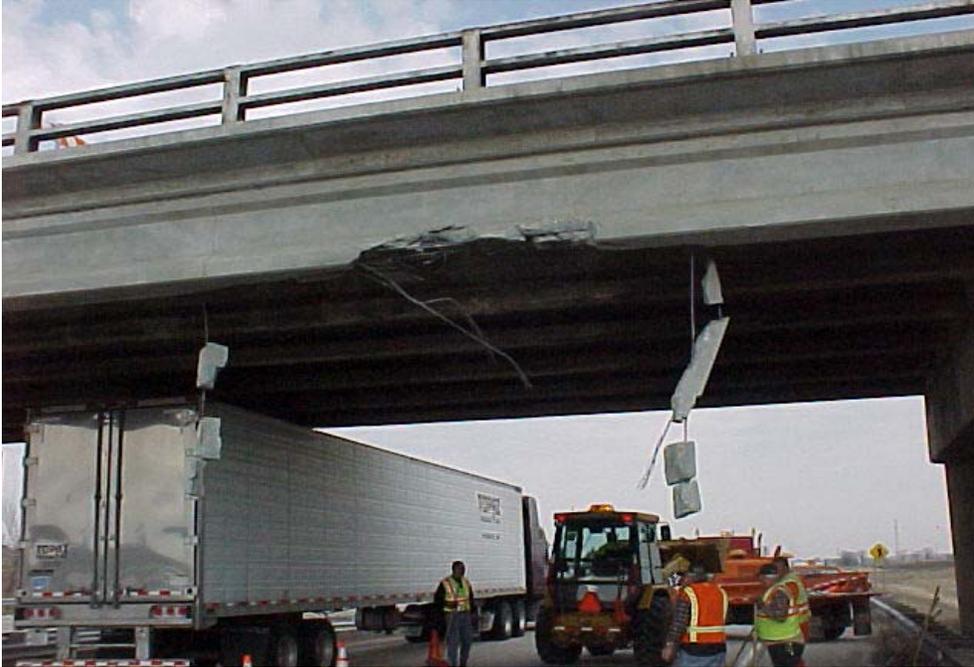
**Figure 1: Impact Damage to Bridge # B-14-0028.**

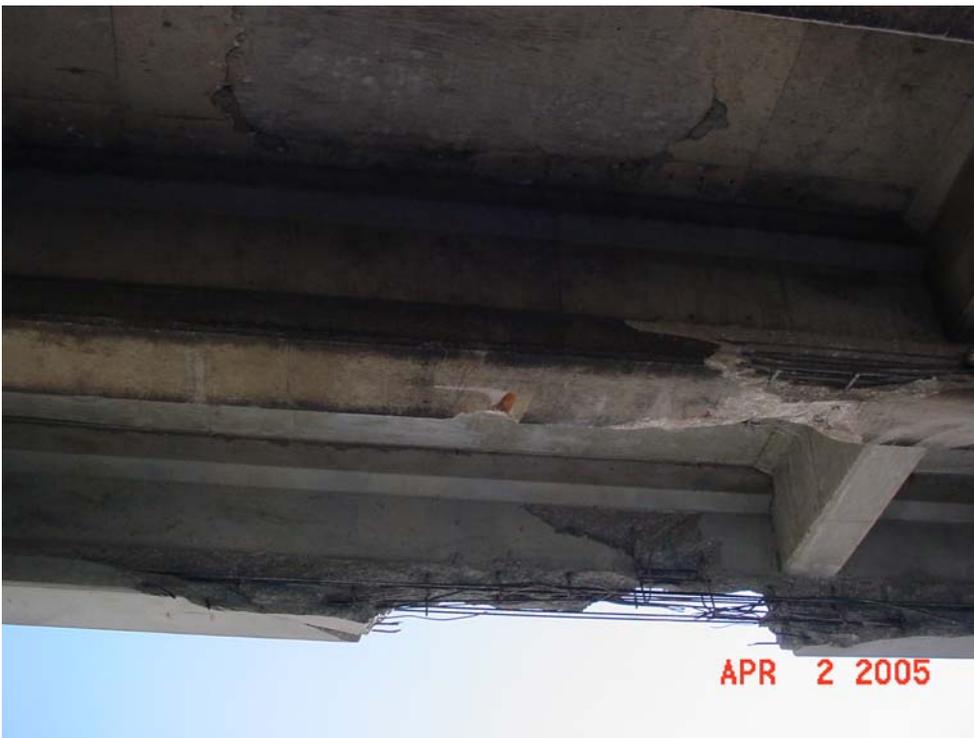
**Figure 2: Detail of Damage to Girder #1.**

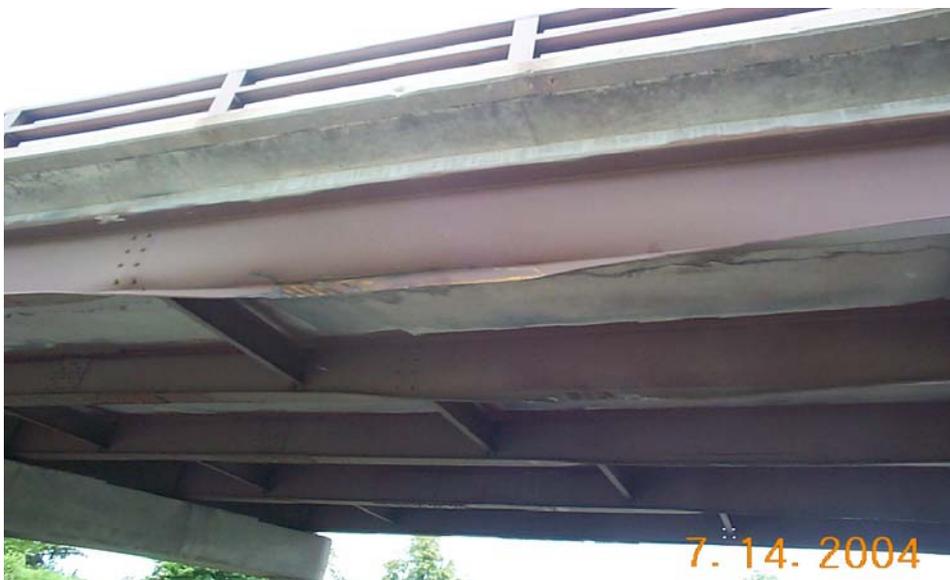
The first reported incident for this structure was a vehicular impact to span 2 (girders 2 and 5) on 7/10/2003 by a truck traveling westbound on State Highway 16. The 2003 incident resulted in bending and gouging of the girders and a tear in the bottom flange of girder 2. The damaged girders were repaired by 9/18/2003. On Wednesday, July 14, 2004 the County Highway M Bridge was struck in span 2 by an oversize semi truck trailer traveling eastbound on State Highway 16. In this second incident, all five girders in span 2 were damaged beyond repair. (See Figures 1 & 2.)

**Figure 1: Impact Damage to Bridge # B-14-0044.**

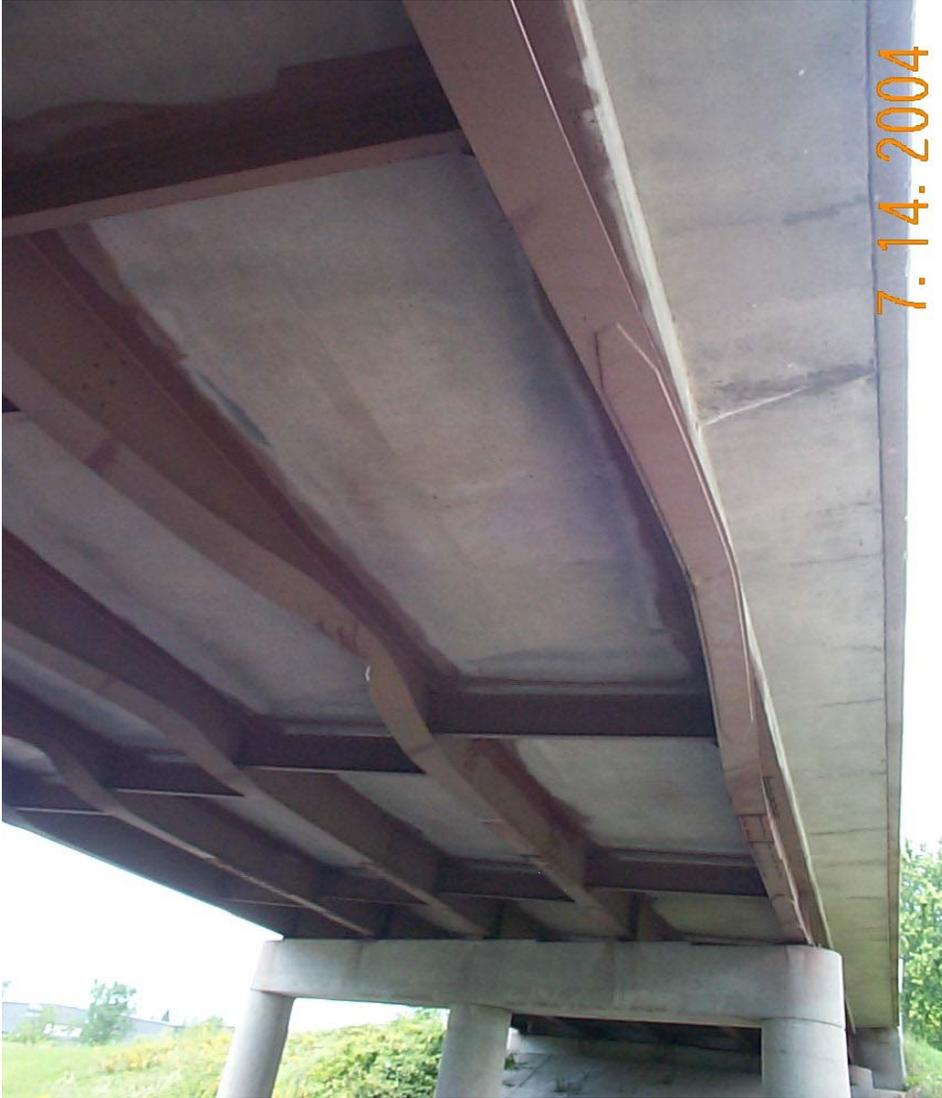
**Figure 2: Impact Damage to Bridge Girders.**

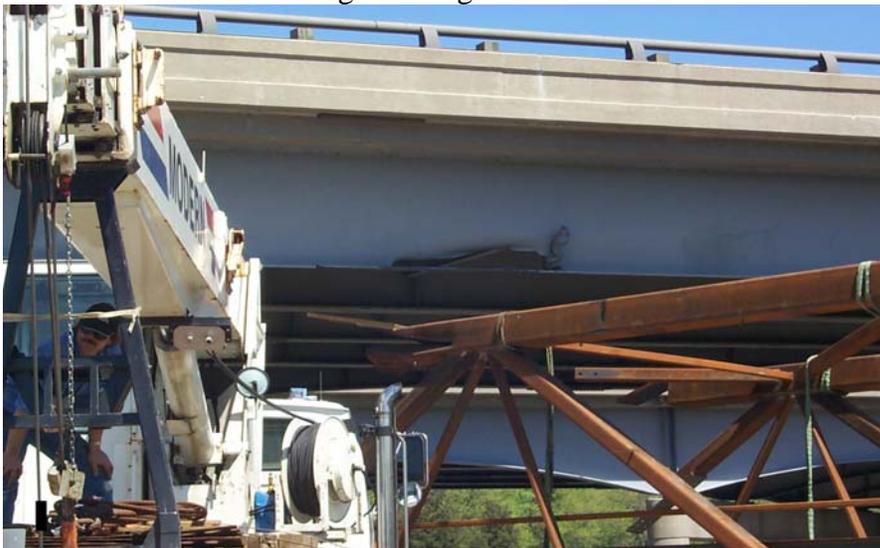
The first reported incident for this structure occurred on Tuesday, May 4, 2004 when span three of bridge B-32-0036 was damaged by a truck carrying a pedestrian bridge that struck the south fascia girder with the top chord of the pedestrian bridge. The truck was traveling in the northbound lanes of STH 35. This impact caused a hole to be torn in the web of the girder and bending of approximately 8 in out of plane. (See Figures 1 & 2.) Furthermore, six stiffeners were buckled in the impact and a 3/16 in long crack was formed on the bottom flange of the girder.

**Figure 1: Span #3 External Girder After Impact.**

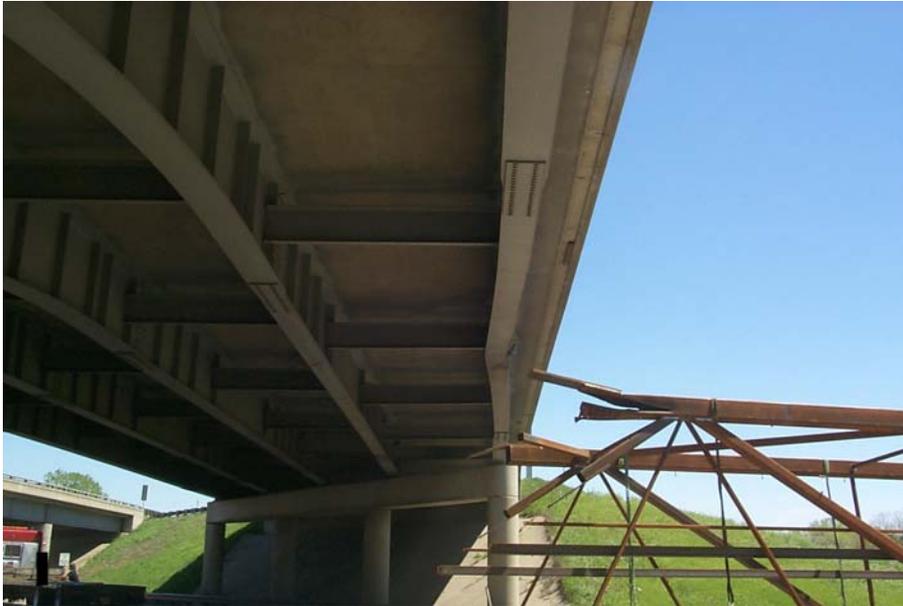
**Figure 2: Out of Plane Deformation After Impact.**

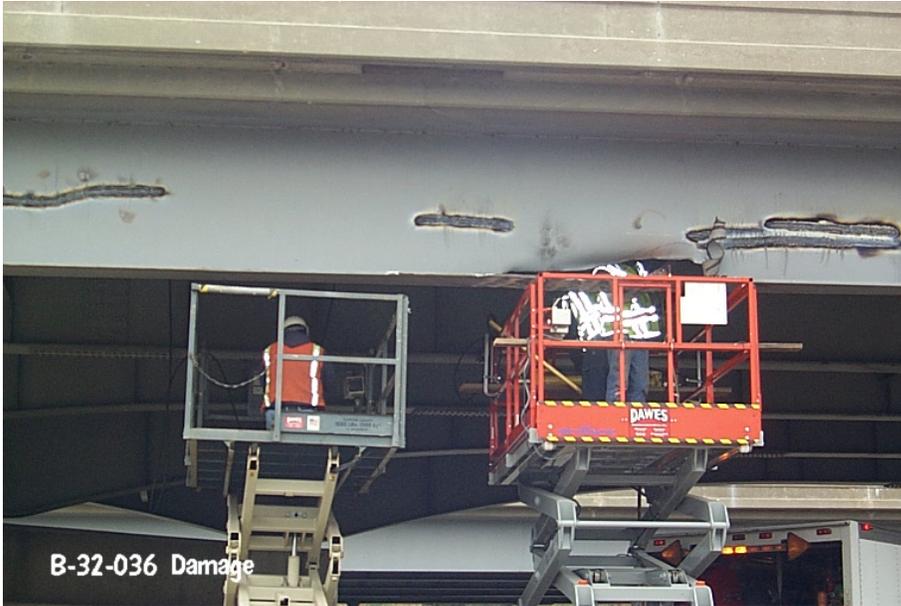
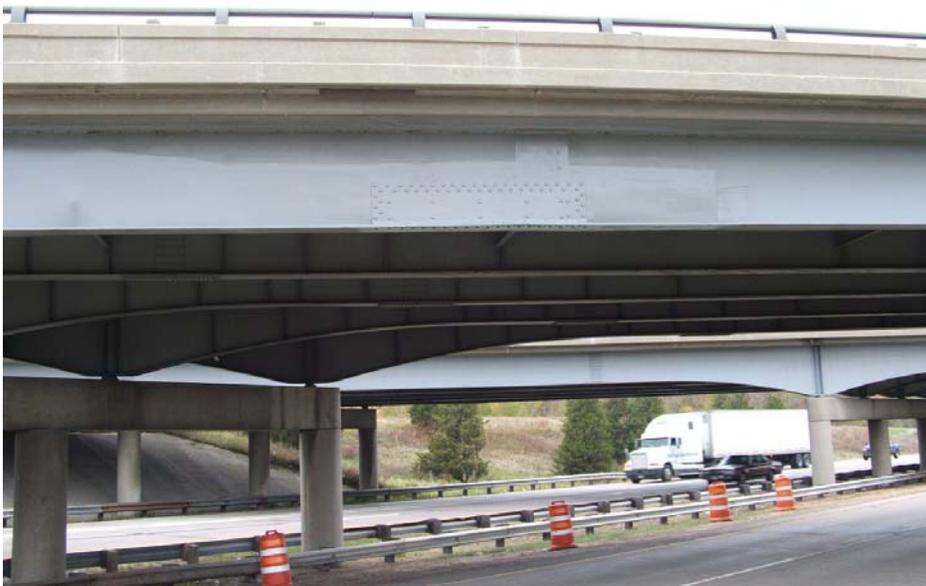
**Figure 3: Repair Activities.**

**Figure 4: Repaired Girder.**

The repairs to bridge number B-32-0036 were performed by a bridge repair crew from the WisDOT central office located in Madison, Wisconsin. (See Figure 3 & 4.) The repairs were completed on October 4, 2004. During the repairs one lane of STH 35 northbound was closed to vehicular traffic. The steel girder deflection was removed by means of a heat straightening process, a plate was bolted over the hole in the fascia girder web, one diaphragm was replaced and another was heat straightened. A post repair interim inspection was performed on October 29, 2004, and the remaining barriers and signage for closing the shoulder of eastbound I-90 were removed. The repairs were judged to be successfully completed and the bridge retains all of its original load ratings.

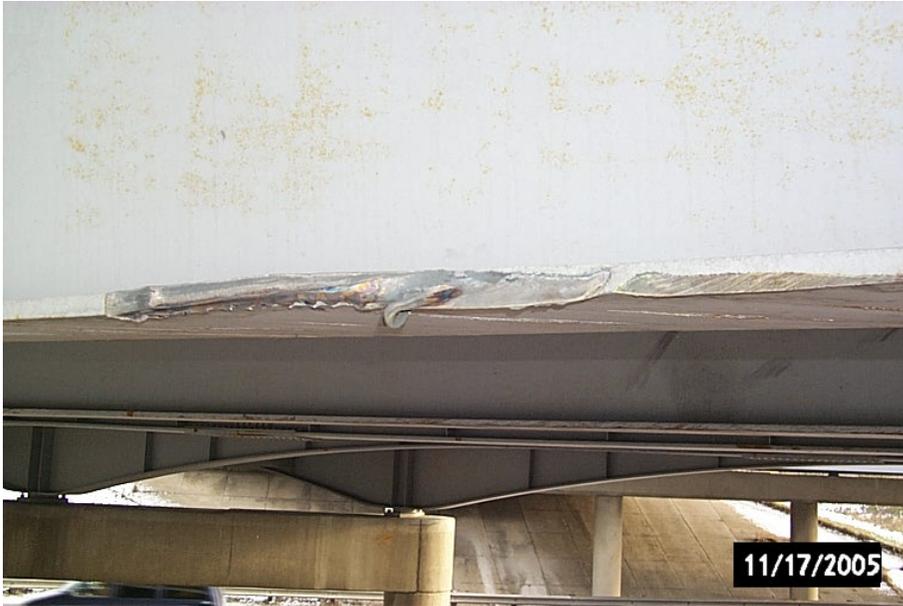
On Thursday, November 17, 2005 span three of bridge B-32-0037 was damaged when a truck carrying a quarry loader struck the north exterior girder while merging onto southbound STH 35. In this incident the exterior girder was bent 5.5 inches out-of-plumb and several stiffeners in the inside of the girder were bent, broken, or separated from the girder. (See Figures 1 & 2). Furthermore, two other girders were struck resulting in small amounts of out-of-plumb deformation and several bent stiffeners.

**Figure 1: Damage to Exterior Girder.**

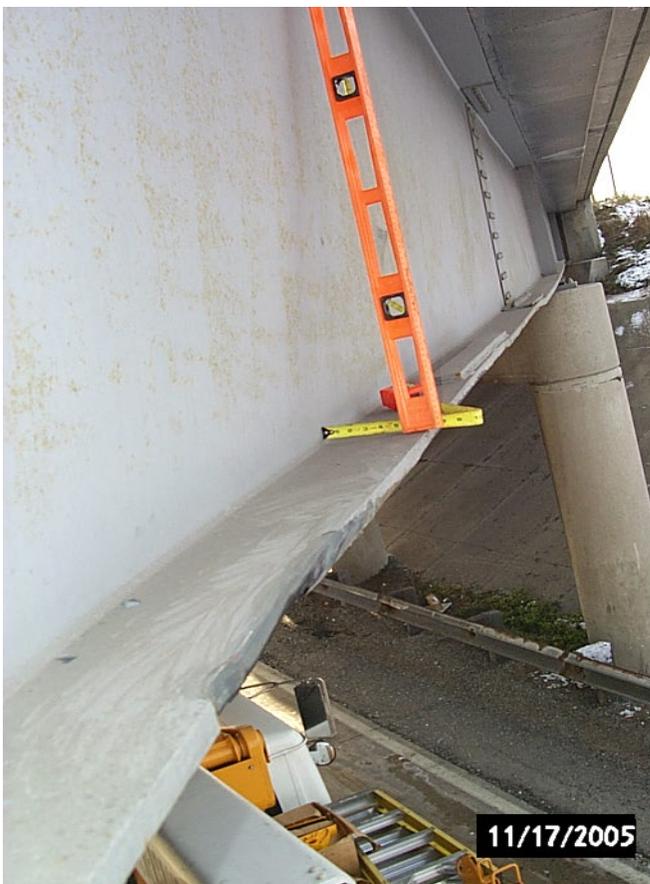
**Figure 2: Damage to Exterior Girder (out-of-plumb).**

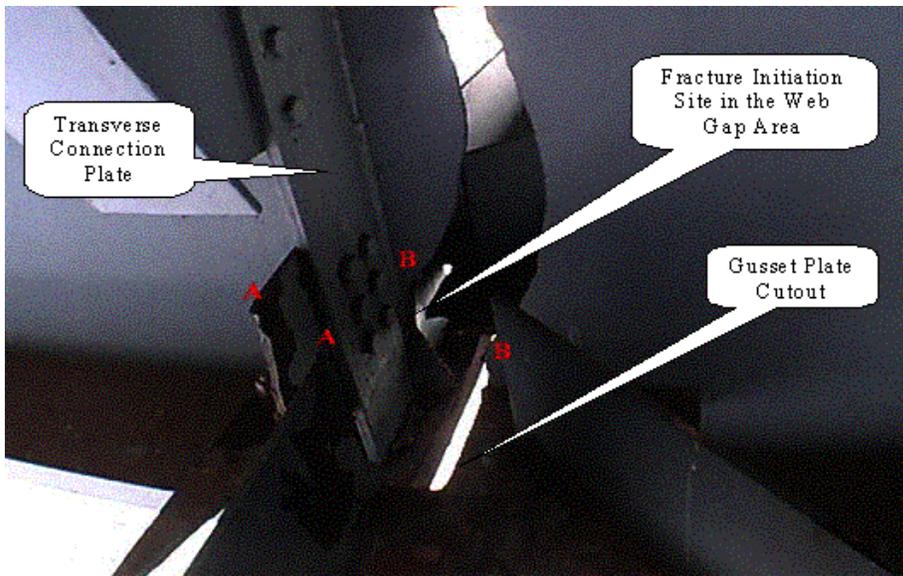
As construction progressed on the bridge a forensic investigation of various structural members was performed. This investigation was a joint effort of Lichtenstein Consulting Engineers, the Center for Advanced Structural Systems at Lehigh University, Northwestern University, and the Turner-Fairbank Research Center of the Federal Highway Administration. The results of the investigation and subsequent analysis indicated that the fractures initiated in the web plate, most likely the interior girder, at the joint where the lower lateral bracing system framed into the web. The initiation site was located in the gap between the gusset (shelf) plate and the transverse connection/stiffener plate. Figure 1 shows the fracture initiation site in the web gap area.

**Figure 1. Fracture initiation site in the web gap area.**

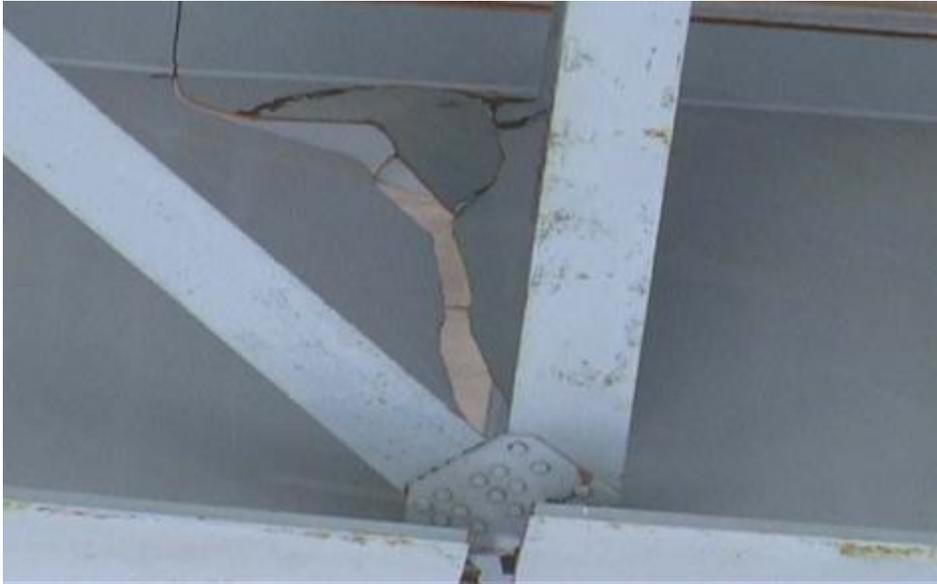
was detailed with a narrow web gap that caused local high constraint, increased stiffness, and reduced the apparent fracture resistance. As ideally detailed, the joint has only 1/8 inch separating the welds on the two plates. The fabrication tolerance resulted in reduced gaps as well as intersecting welds in many locations throughout the structure. This local triaxial constraint condition prevented yielding and redistribution of the local stress concentrations occurring in this region. As a result, the local stress state in the web gap was forced well beyond the yield strength of the material. Stress analysis showed that the intersecting welds increased the rigidity of the joint and made the constraint problem even worse. Figure 2 shows a view of the joint assembly where the fracture initiated.

**Figure 2. Joint assembly where the lateral brace system frames into the girder web.**

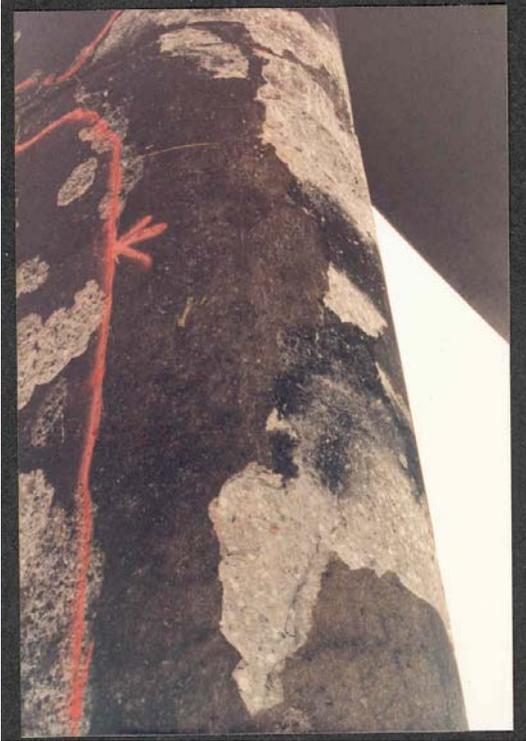
The inspection was performed by the WisDOT region Bridge Maintenance and Inspection Specialist, Mr. Herb Szatmary. His summary report (issued on December 10, 1992) indicated damage to several units of the Marquette Interchange, especially units 4B, 4C, 4E, and 5D. On unit 5D the east pier shaft suffered heavy scaling with delamination to a depth of 2 – 3.5 in. over an area of approximately 160 sq. ft. (See Fig. 2).

**Figure 2: Unit 5D Column with Scaling and Delamination.**

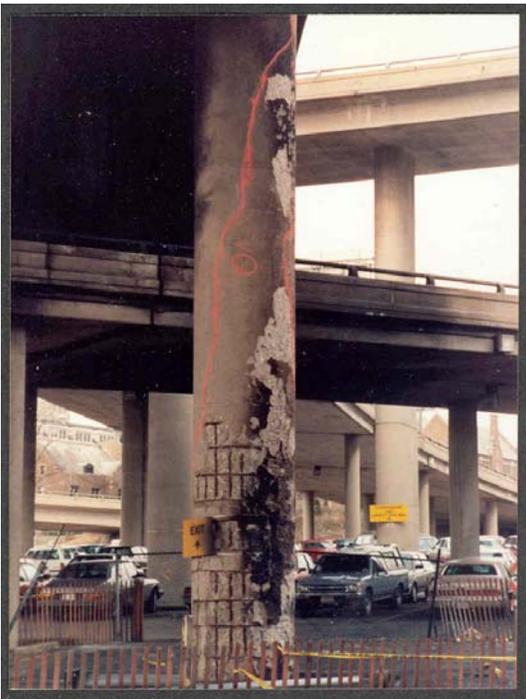
The east column of the south pier of unit 4C suffered similar damage (See Fig. 3).

**Figure 3: Unit 4C Column with Scaling and Delamination.**

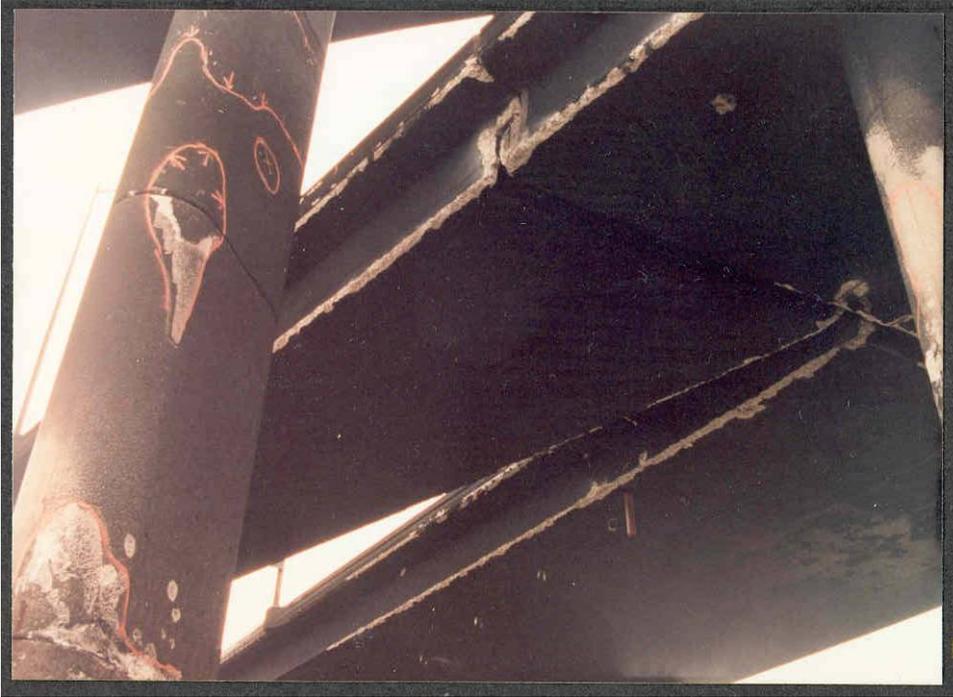
On units 4B, 4C, and 4E some of the edges of the bottom floor of the concrete box girders were spalled during the fire. Other edges were cracked and knocked off during the inspection. Similar damage was observed on the edges at the expansion joint openings, the bottom edges of the deck overlays, and some edges in the exterior face of the parapets. In general, little or no delamination from the reinforcing steel occurred in these areas. The following figure shows an example of edge damage for units 4B and 4C.

**Figure 4: Units 4B and 4C Box Girders with Scaling.**

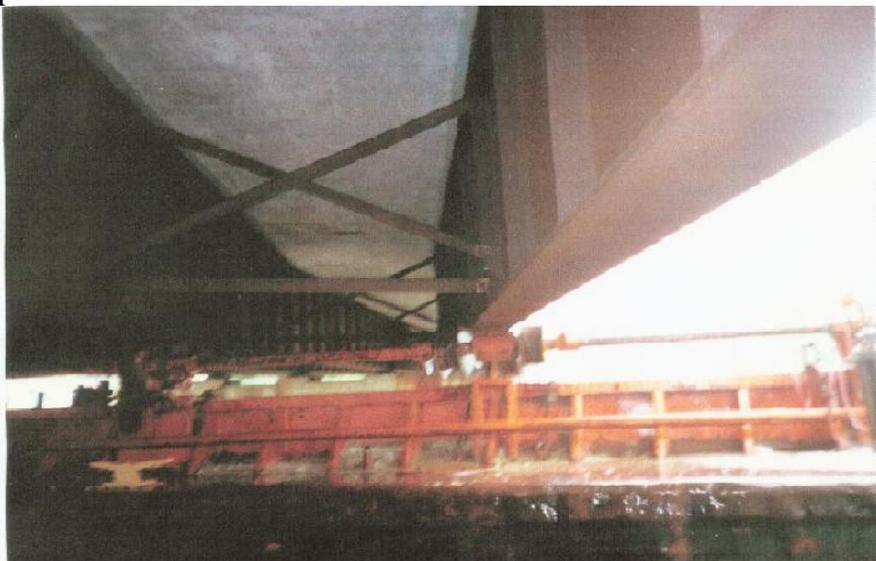
On Monday, June 17, 1996, the 25<sup>th</sup> Street Bridge was struck by equipment loaded on a river barge. The barge had been moored on the river but broke its lines during a period of heavy rainfall which raised the river height and increased the river current velocity. Prior to this date, there was no serious damage to the bridge reported. In the present incident the easternmost girder of the south span was struck by the barge. (See Figure 1.) The impact resulted in a deflection of 3.25 inches of the bottom flange of the plate girder. (See Figure 2.) Also, the stiffener at the intermediate diaphragm failed at its connection to the bottom horizontal angle, and the bolt hole in the bottom horizontal angle was elongated where the angle connects to the stiffener. Some minor damage to a concrete pier was sustained.

**Figure 1: Equipment on Barge Impacted Easternmost Girder of South Span.**

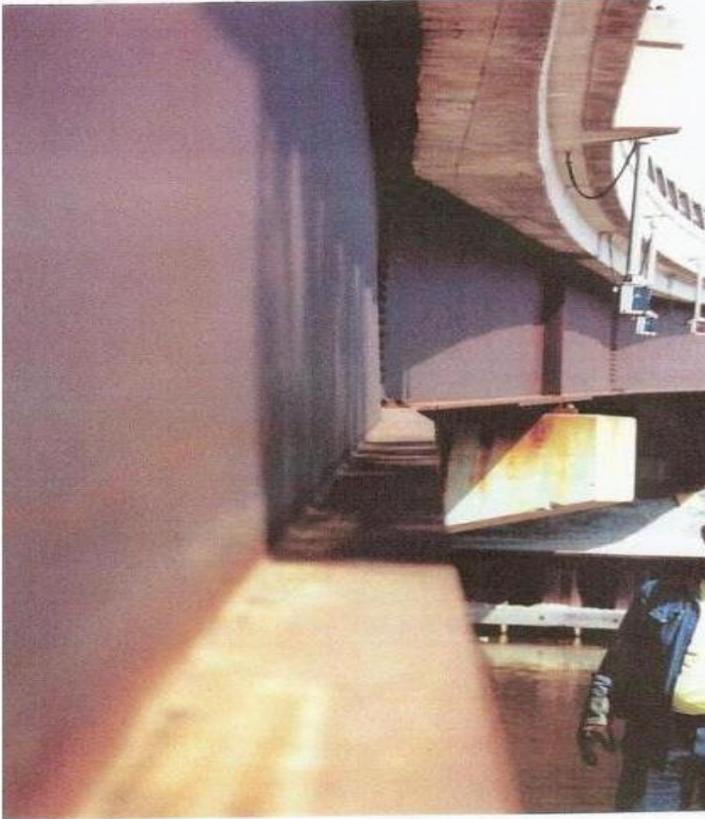
**Figure 2: Looking North along Easternmost Girder: Max Deflection.**

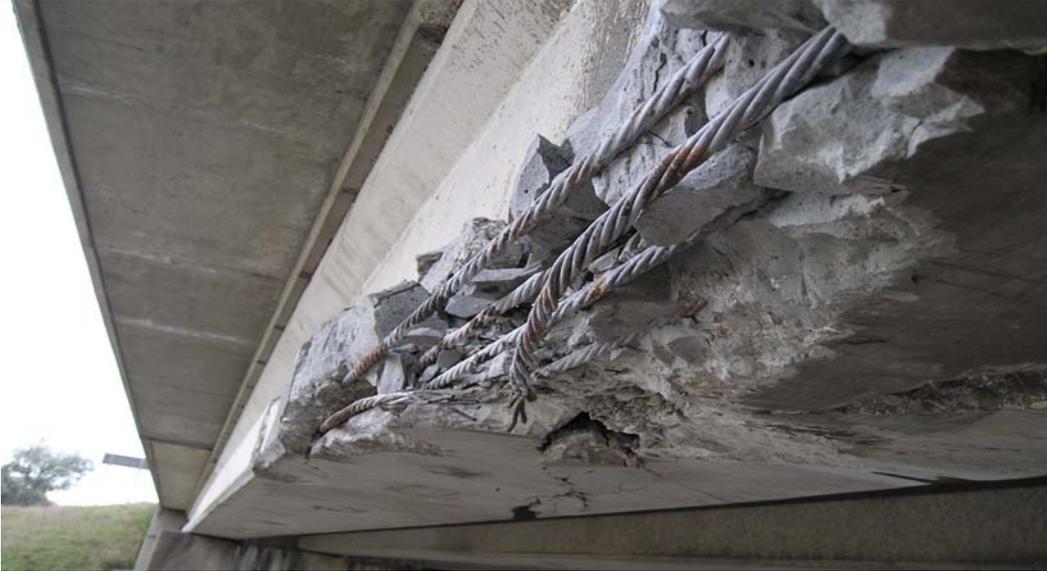
**Figure 2: Detailed View of Severely Damaged Girder #1.**

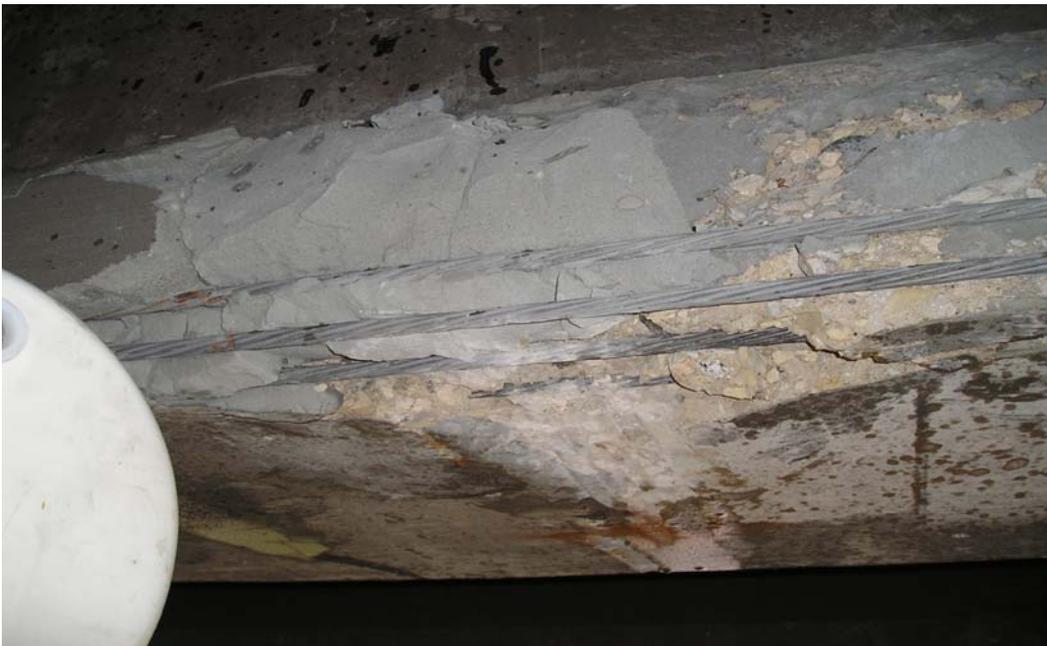
**Figure 3: Detailed View of Damaged Area with Lost Patch in Girder #7.**
