AN ASSET MANAGEMENT APPROACH FOR DRAINAGE INFRASTRUCTURE AND CULVERTS

Project 06-08
June 2008

Midwest Regional University Transportation Center
College of Engineering
Department of Civil and Environmental Engineering
University of Wisconsin, Madison
Wisconsin, Madison

17. Key Words Culverts, Asset Management, Condition Assessment, Inventory Inspection, Decision Support System (DSS)		18. Distribution Statement No restrictions. This report is available through the Transportation Research Information Services of the National Transportation Library.

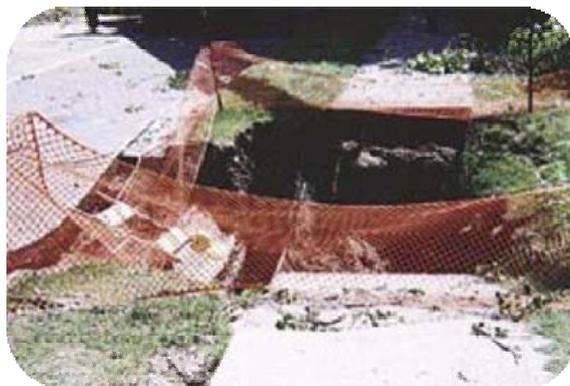
Figure 1.2: Culvert Failure in Muskegon, Michigan

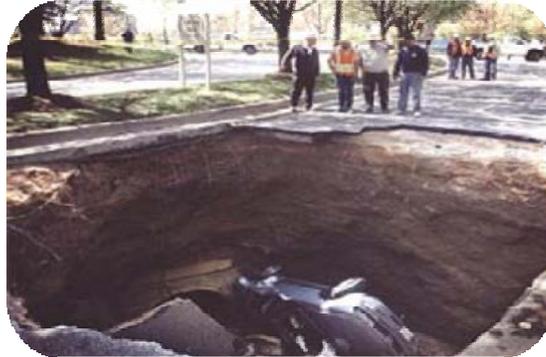
Figure 1.3: 84” Diameter CMP Failure in Maryland

- The failure of a 17 year old 84” diameter CMP culvert in Maryland resulted in the injury of two people, when their car fell into a 20’ long by 30’ wide by 20’ deep sinkhole as shown in the Figure 1.3.

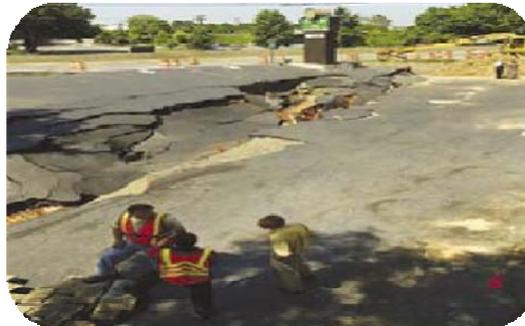
Figure 1.4: Failure of 126” diameter CMP in Charlotte, North Carolina

- The failure of a 20 year old, 126” diameter CMP in Charlotte, North Carolina resulted in a massive sinkhole as shown in Figure 1.4. The cost of replacement was approximately \$300,000.

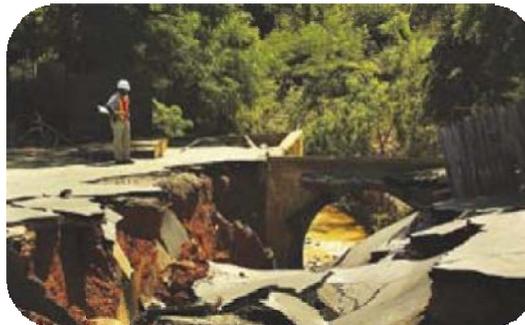
Figure 1.5: Failure of a 30 year old, 96” diameter CMP in Hickory, North Carolina

- The Failure of a 30 year old, 96” diameter CMP in Hickory, North Carolina resulted in the formation of a massive sinkhole as shown in Figure 1.5. The sinkhole affected the safety of US highway 70 and caused conflicts between property owner, city and NCDOT as a liability and responsibility for damages. The cost of repair was \$ 1.5 Million.

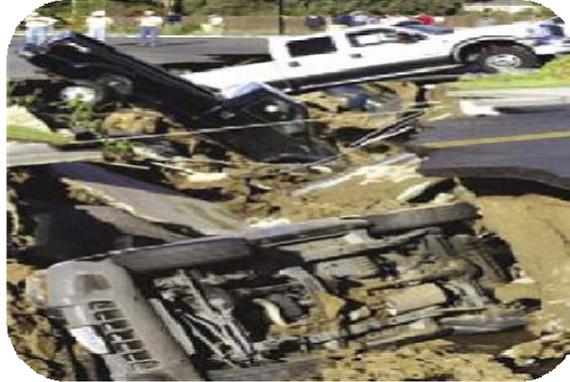
Figure 1.6: Failure of 30-Year Old CMP in Bakersfield, California

- The failure of a 30 year old CMP in Downtown, Bakersfield, California as shown in Figure 1.6, created lot of problems and precipitated the road crossings by the city. As a result of the following incident, CMP is no longer permitted in California.

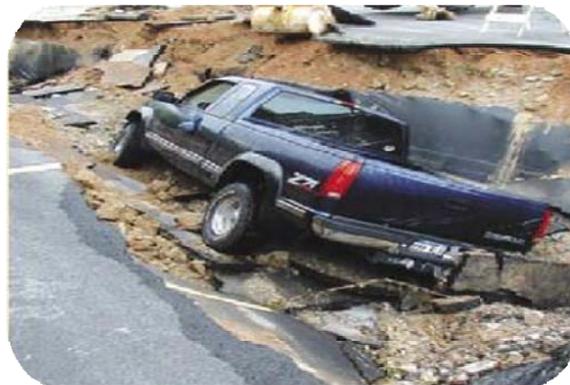
Figure 1.7: Failure of a 30-Year Old, 96” CMP in West Bountiful, Utah

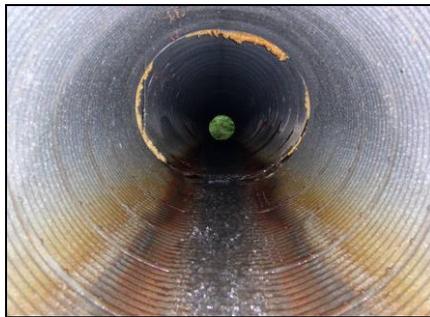
Corrosion – Corrosion is the destruction of pipe materials by chemical action. Metal culverts or reinforcements in concrete pipes are attacked by corrosion as the process of returning metals to their native state of oxides or salts. Figure 2.12 shows corrosion in metal culvert. *Chemical corrosion* of culverts may occur in the presence of soils and water containing acids, alkalis, dissolved salts, and organic industrial wastes. Sulfates, carbonates, and chlorides degrade concrete which is a process often accelerated in regions where freeze-thaw cycles leave the material open to deeper penetration by the offending elements. *Electrochemical corrosion* of metal culverts may occur due to the presence of water or some other liquid to act as an electrolyte, as well as materials acting as an anode, cathode, and conductor. As electrons move from anode to cathode, metal ions are released into solution, with characteristic pitting at the anode. The culvert will act as both anode and cathode forming an electrolytic cell around the material. Figure 2.12 shows a similar type of corrosion in culvert.

Figure 2.12: Corrosion in Culverts

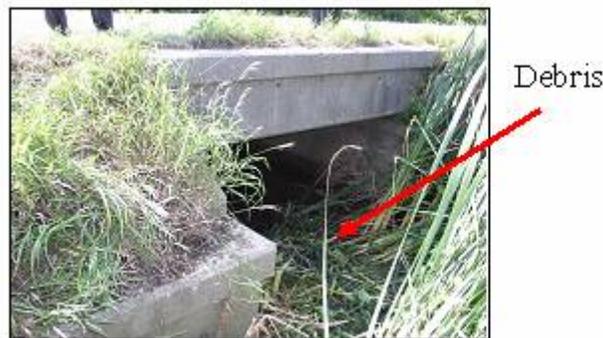
Figure 2.13: Debris at the Opening of the Culvert

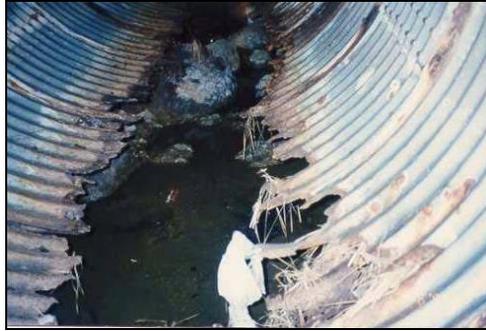
Bed load – Bed load is the main cause for abrasion. Figure 2.14 shows abrasion in culvert. Critical factors in evaluating bed load potential are the size, shape, and hardness of the bed load material, and the velocity and frequency of flow in the culvert. Flow velocities greater than 4.5 m/sec that carry a bed load are considered very abrasive. Steel culverts are most susceptible to the dual action of abrasion and corrosion when they are exposed to low resistivity and/or low pH environments, which shorten their service life.

Figure 2.14: Deterioration due to Abrasion (Caltrans, 2003)

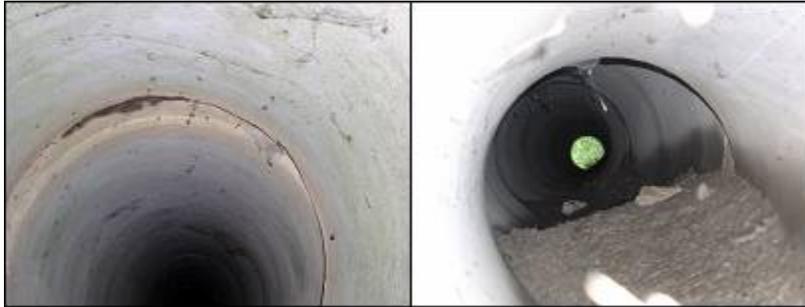
Figure 2.15: Culvert Pipe showing Cracks and Joint Separation

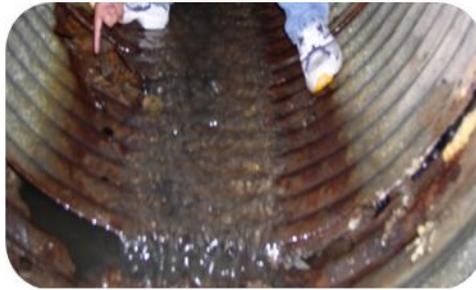
Figure 9.1: Big Hole and Corrosion in the Invert of the Culvert 25001273A01

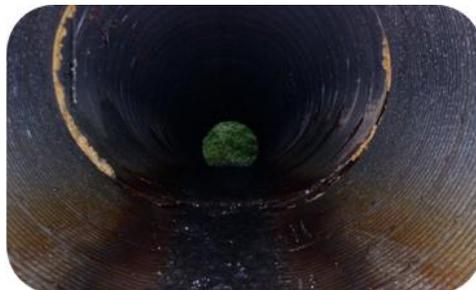
Figure 9.2: Misalignment of the Culvert 25001273A01

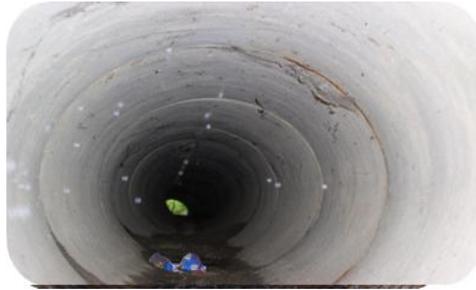
Figure 9.3: Misalignment of the Culvert

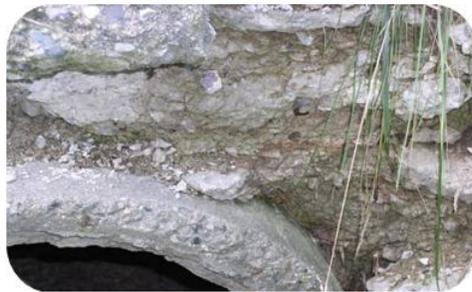
Figure 9.4: Failure of the Headwall due to Heavy Spalling

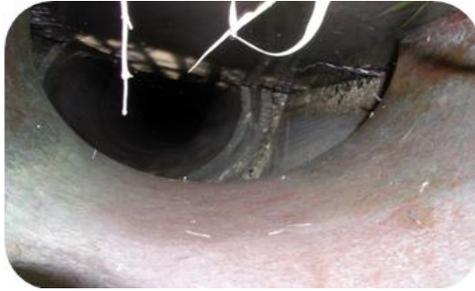
Figure 9.5: Significant Misalignment of the Culvert Structure

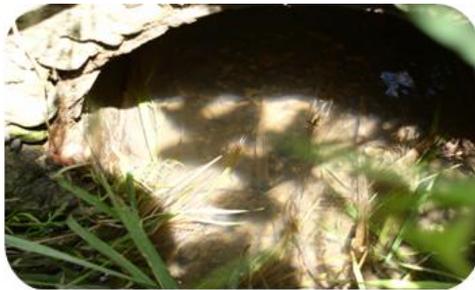
Figure 9.6: Vegetation and Heavy Spalling in the Headwall

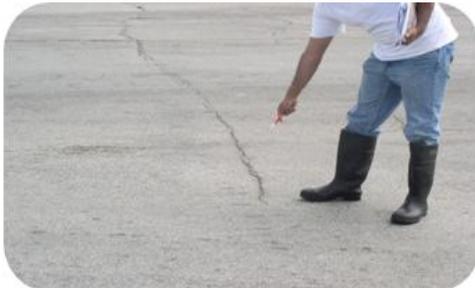
Figure 9.7: Cracks on the Roadway Surface

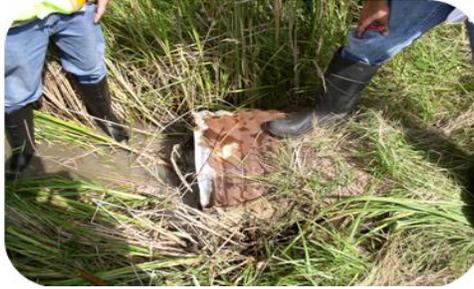
Figure 9.9: Corrosion on the Outside Surface of the CMP

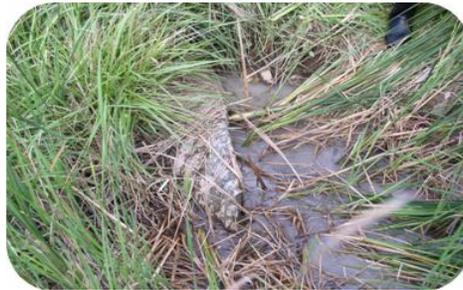
Figure 9.10: Total Failure of the Culvert End
