CONDITION ASSESSMENT OF TREATED-TIMBER GUARDRAIL POSTS

Final Report
October 2010

Sponsored by:
Wisconsin Department of Transportation

Sponsored by
Wisconsin Department of Transportation
(Project No. 0092-43-03)

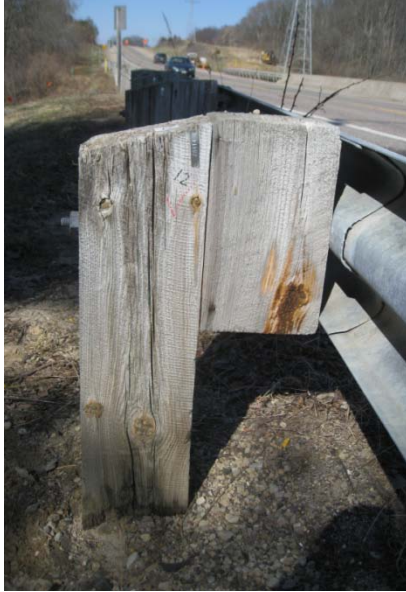
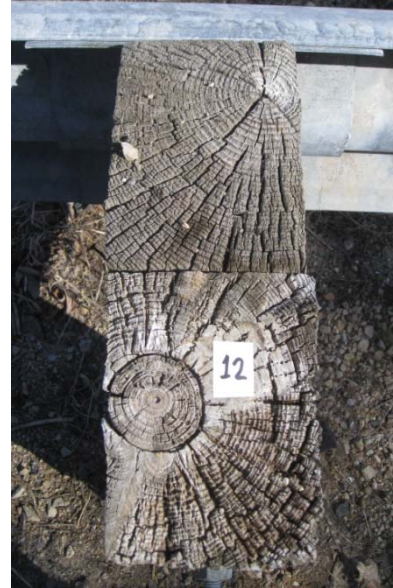
Figure 7 – Condition of old guardrail posts after several years of service near Merrimac, Wisconsin.

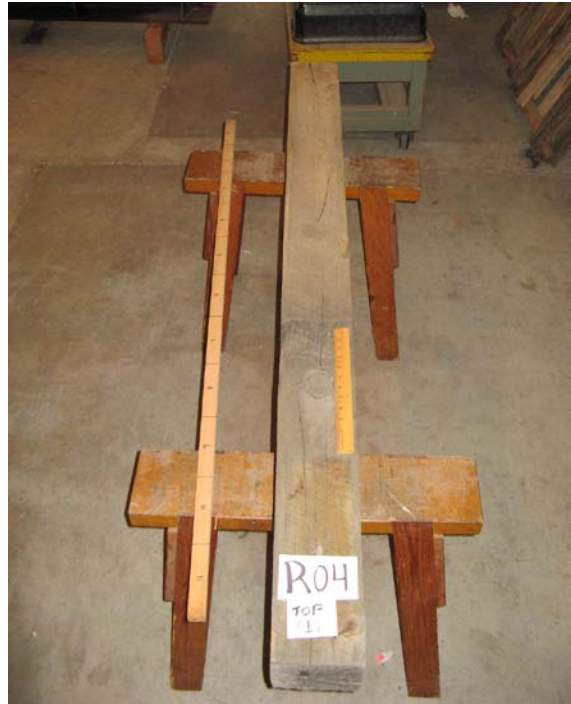
Figure 13 – Physical condition of each salvaged post was photographed and physical defects mapped.

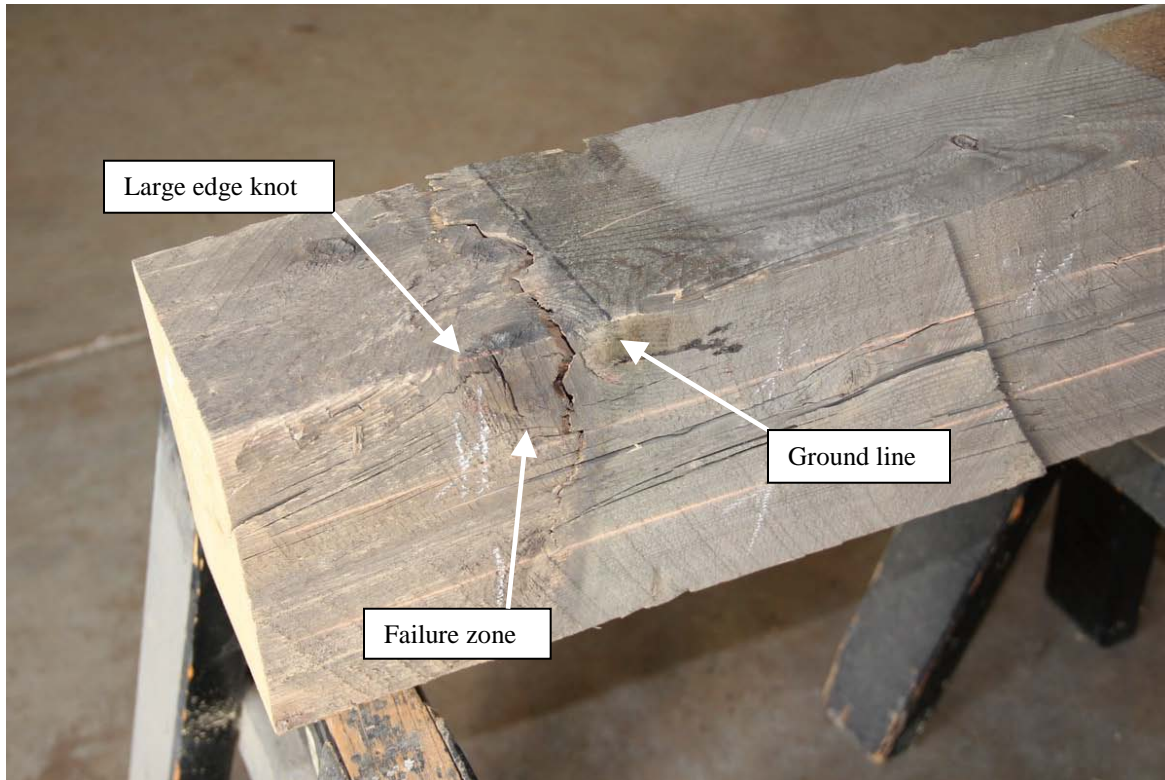
A cantilevered-bending failure for Royalton post specimen number 19 is shown in Figure 26. The failure zone typically occurred near the ground line of the post. In this case, however, the presence of a large edge-knot caused the post to fail prematurely. More stringent visual grading of the posts near the ground line zone could help to achieve more consistent residual post strengths. Figure 27 shows a typical load-displacement curve from Merrimac post specimen number 13. This post failed at a load higher than 12 Kips and with more 0.60 inches of deflection at the cantilevered end. The MOR values are summarized in the following figures: Merrimac posts (Figure 28) and Royalton posts (Figure 29). The

Figure 26 – Failed cantilever bending specimen R19 from the Royalton test site. Note the edge knots at the failure zone near the ground line.
