Partial Depth Repair of Concrete Pavements in Wisconsin

FINAL REPORT

Partial Depth Repair of
Concrete Pavements in Wisconsin
Research Study # 98-03

Report # WI-05-12

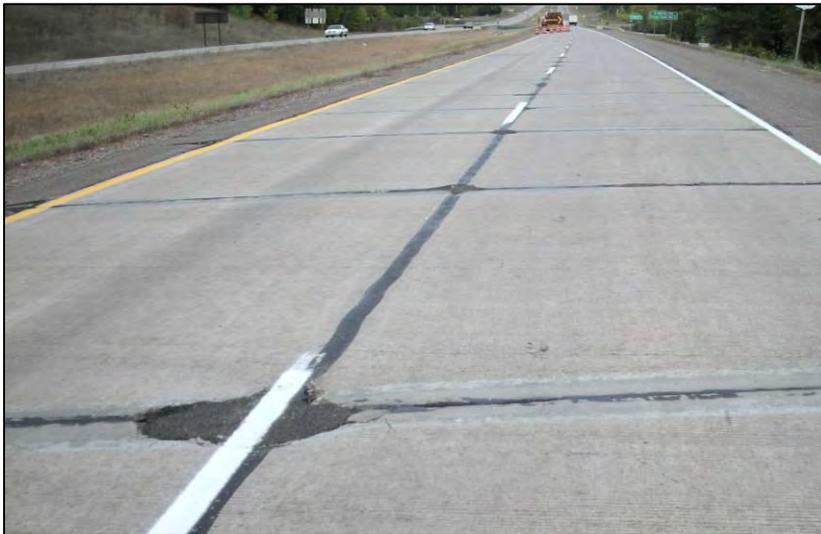
The third and final review of Test Section 1 took place in October 2009, after the test sections had been in service for 9 years. The condition of the PDR in Test Section 1 had worsened, particularly at the transverse and centerline joint intersections. Asphalt patches were present at all transverse and centerline joint intersections, where pieces of the PDR patch material had spalled away (see Figure 4).

Figure 4. Asphalt patches at intersection of transverse and centerline joints, Test Section 1, 2009.

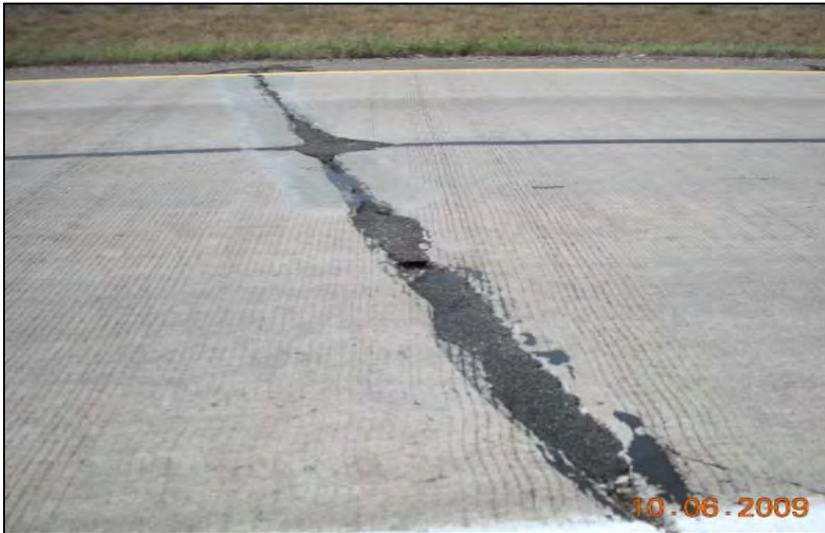
At least four joints also had pieces of PDR material missing from the passing lane transverse joint; asphalt patches had been placed here, as well. The date of asphalt patching is unknown. Slight spalling was present in the intact PDR material, similar to what was observed during the 2001 and 2002 surveys. In some locations, the PDR material was still in good condition. The overall pavement condition was poor, however. Along with the spalled PDR patch material, additional spalling had occurred at joint locations that did not receive PDR in 2000. These areas had also been patched with asphalt (see Figure 5).

Figure 5. Additional spalling at joint locations that were not repaired with PDR, Test Section 1, 2009.

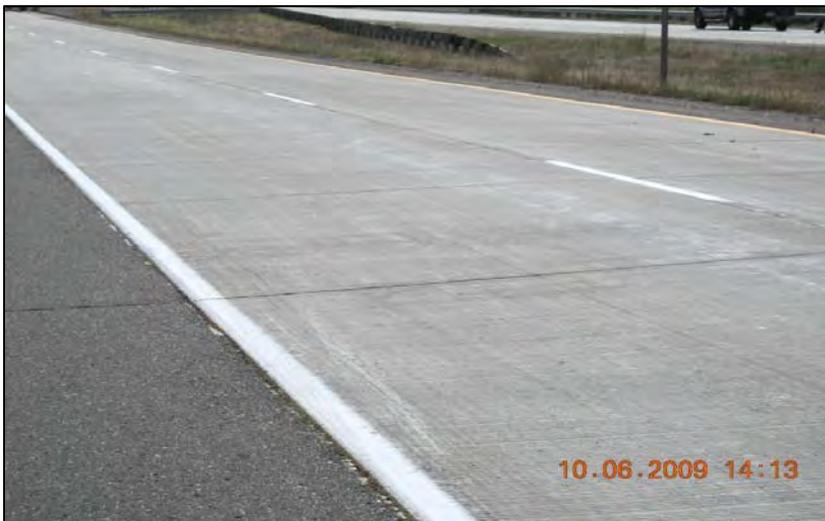
The bonded concrete overlay (Control Section 1) had excellent performance during all field reviews (2001, 2002 and 2009). In September 2002, one transverse crack was noted. The overlay is shown in Figure 6; this picture was taken during the 2009 field review.

Figure 6. Bonded concrete overlay, 2009.

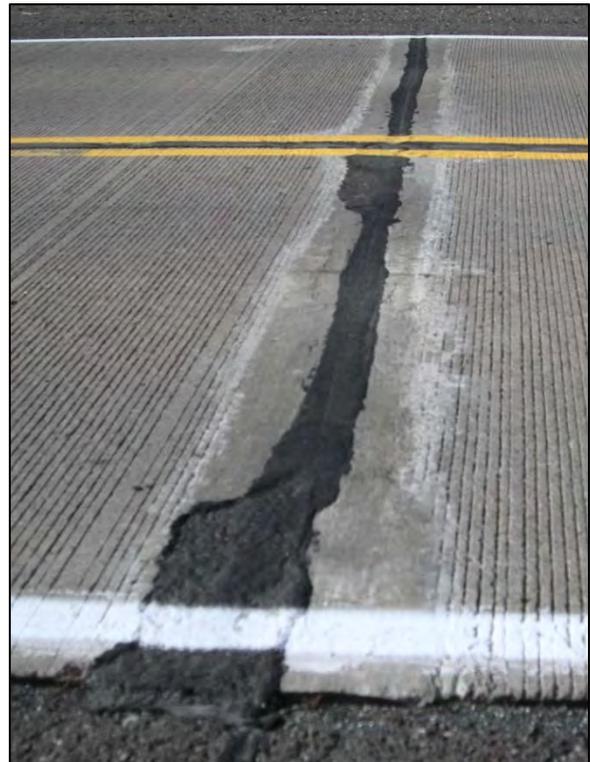
In 2009, Test Sections 2 and 3 were performing adequately, but the PDR was showing early signs of failure at several joints. Several significantly spalled portions had been patched with asphalt, as shown in Figure 7.

Figure 7. Asphalt patches in spalled PDR, Test Section 3, 2009.

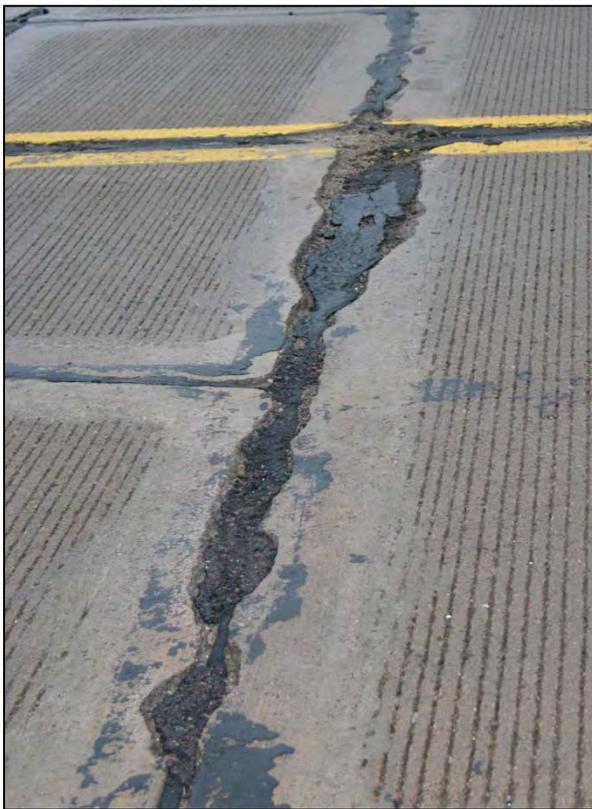
During the 2012 field review, it was noted that in the southern portion of the project, the PDR lengths ranged from 1' in width to full pavement width and exhibited a failure rate of approximately 70%. While in the northern section of the project, the majority of the PDR lengths were full width and exhibited a failure rate of approximately 95%. Overall, PDR failures were noted at an average of approximately 75 percent of the joints. Spalls that had previously been patched with asphalt had lost material (see Figure 8). Additional PDR locations were noted where patch material had cracked, leaving pieces that would soon spall away (see Figure 9). Some of the joints that received PDR that were not full width exhibited signs of deterioration in the concrete that was not repaired. However, some of the pavement joints that had not required repair were still performing very well. All of the joints had been sealed, essentially eliminating Test Section 2. Prior to that point, it does not appear that sealing the concrete joints had improved the performance of the PDR.

Figure 8. Deteriorated asphalt patch in PDR, USH 63, 2012.

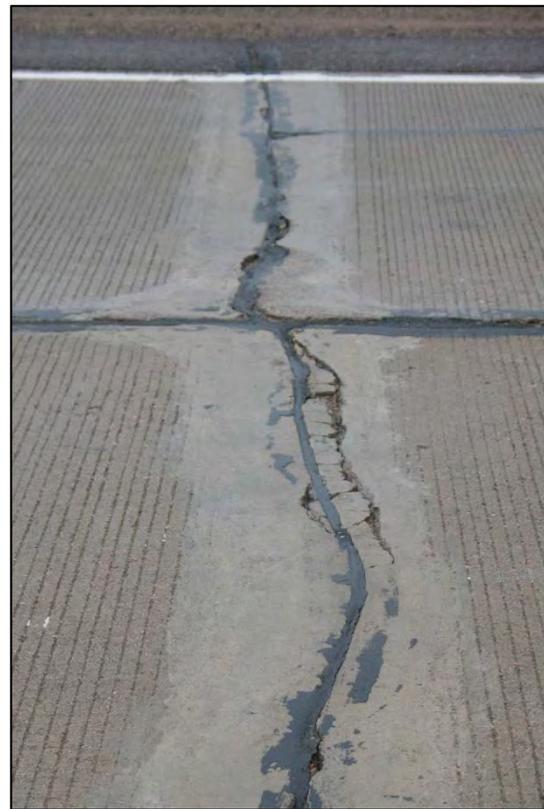
Figure 9. Cracked PDR, USH 63, 2012.

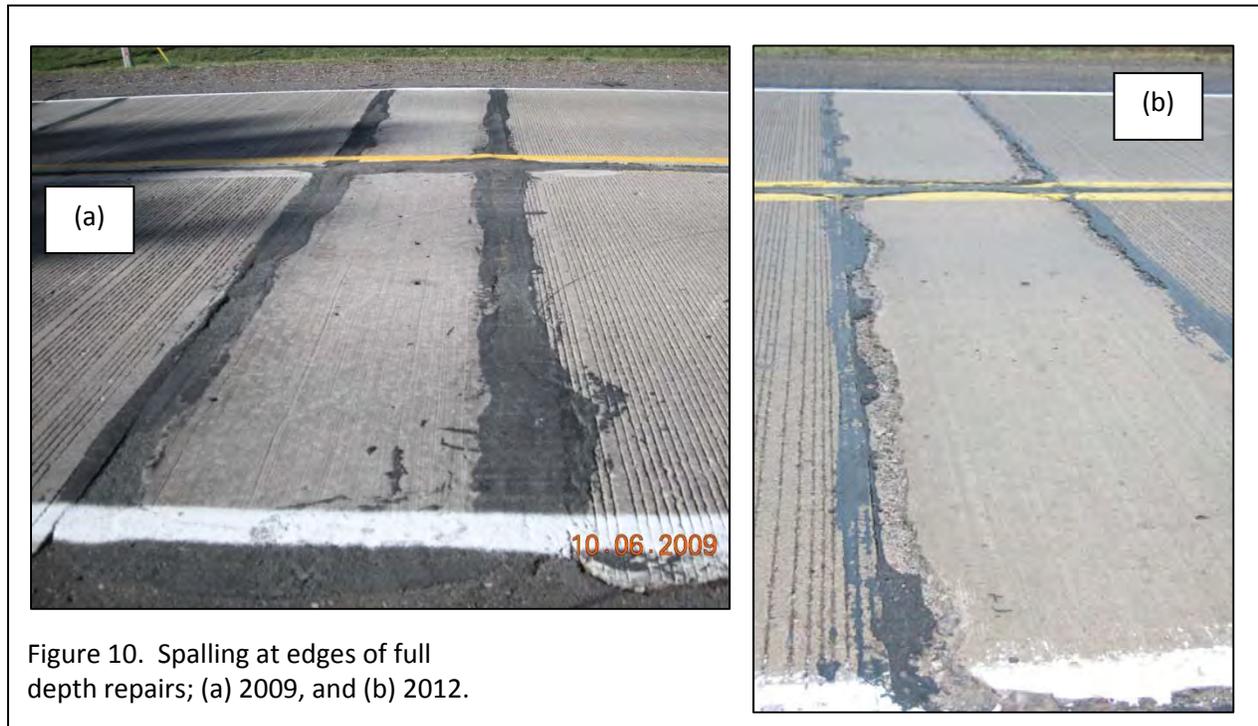
3 were exhibiting significant distress. Based on the observations and as can be seen in Figures 10-a and 10-b, the distress was limited to the full depth repair concrete and appeared to be a material issue. It was also noted that by the 2012 review most of the asphalt patching and sealant had worn away (see Figure 10-b).

Figure 10. Spalling at edges of full depth repairs; (a) 2009, and (b) 2012.

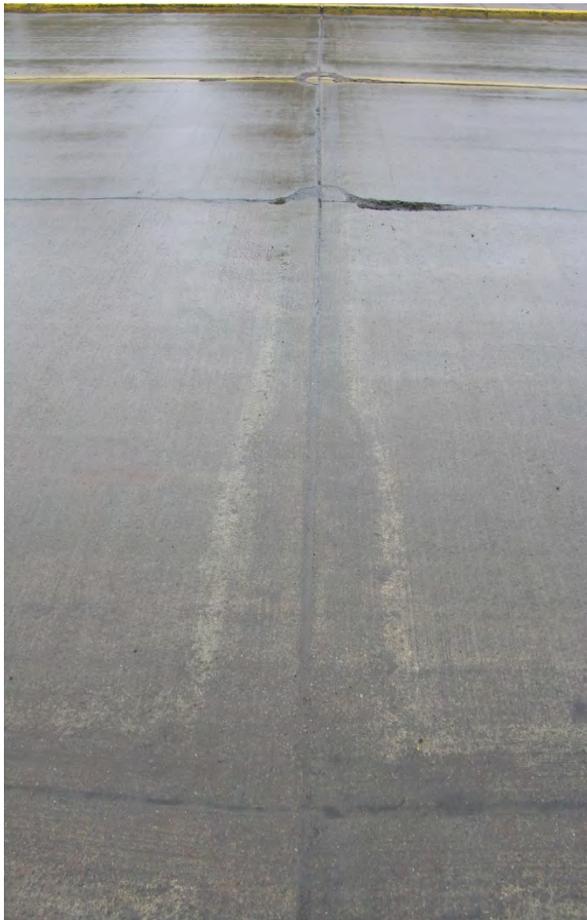
The PDR on this project had been in service for 9 years at the time of the field review in 2012. Although some of the joints are in great condition, as shown in Figure 12, overall the project performance is poor and further rehabilitation is necessary to restore the deteriorated joints. Many of the repaired joints had spalled and lost PDR patch material at the joint (Figure 13). Additional PDR patch material was breaking up and would soon spall out of the joint (Figure 14). Asphalt patches were located at some joints where existing concrete had spalled away (Figure 15). These locations had not received PDR.

Figure 12. Good PDR joint (USH 8, 2003 construction)

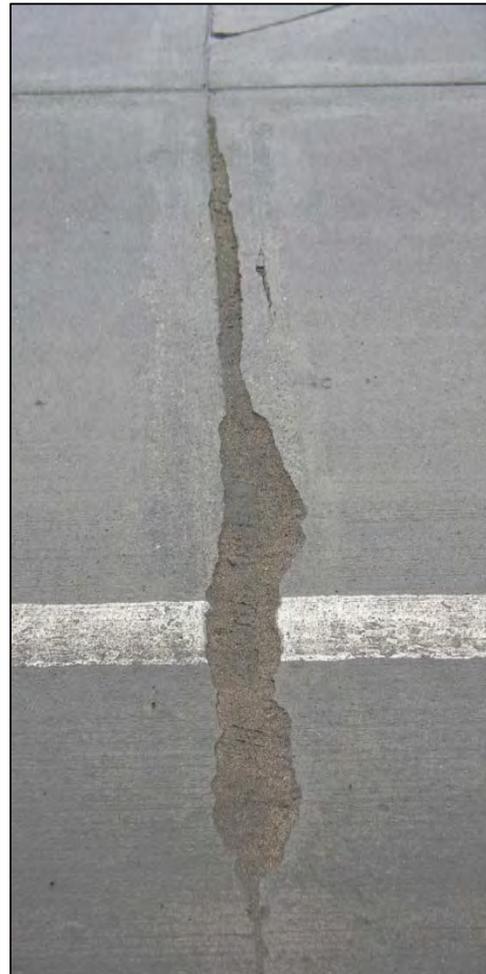
Figure 13. Spalled PDR patch material (USH 8, 2003 construction)

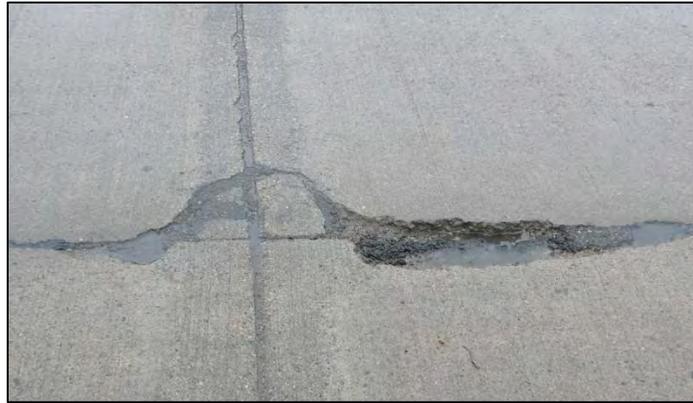
Figure 14. Broken PDR patch material and distress along longitudinal joint of original concrete (USH 8, 2003 construction).

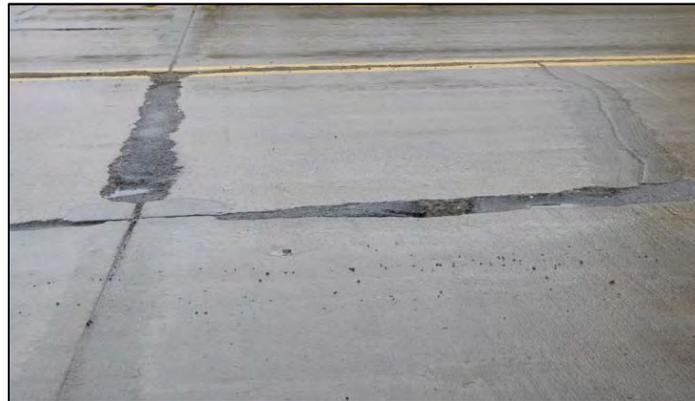
Figure 15. Asphalt patches in existing concrete (USH 8, 2003 construction).

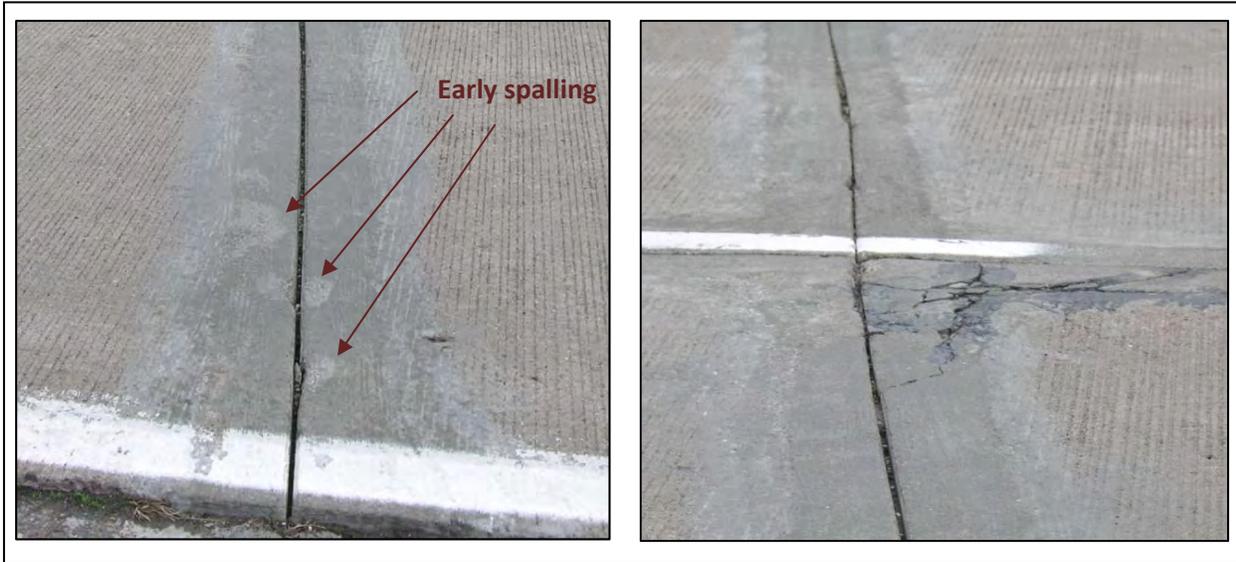
These PDR rehabilitations were performed on USH 53 for the 19 miles directly south of the formal test project evaluated in this study. The PDR in the southern portion of the project had been in service for 5 years when the project was reviewed in 2012. Overall, the PDR performed well with early signs of spalling and deterioration noted at localized joints (Figure 16). The PDR in the northern portion of this project had been in service for 7 years when the project was reviewed in 2012. Overall, it was in worse condition than the southern portion. This may be attributable to the fact that the northern portion of the project has been in service an additional two years. The PDR at some joints was performing fairly well, while advanced spalling had occurred at other locations (Figure 17).

Figure 16. Early spalling and deterioration (USH 53, 2005 construction).

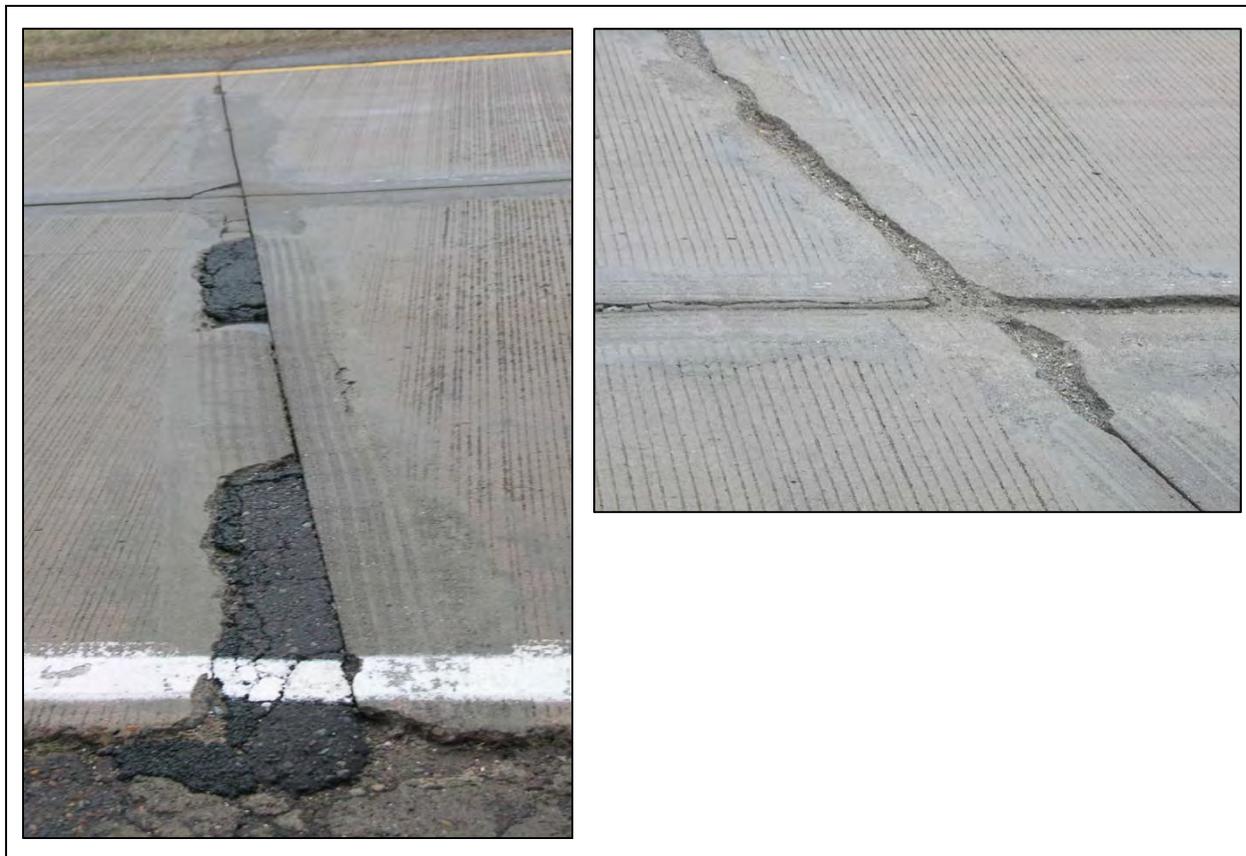
Figure 17. Spalling of PDR material (USH 53, 2007 construction).

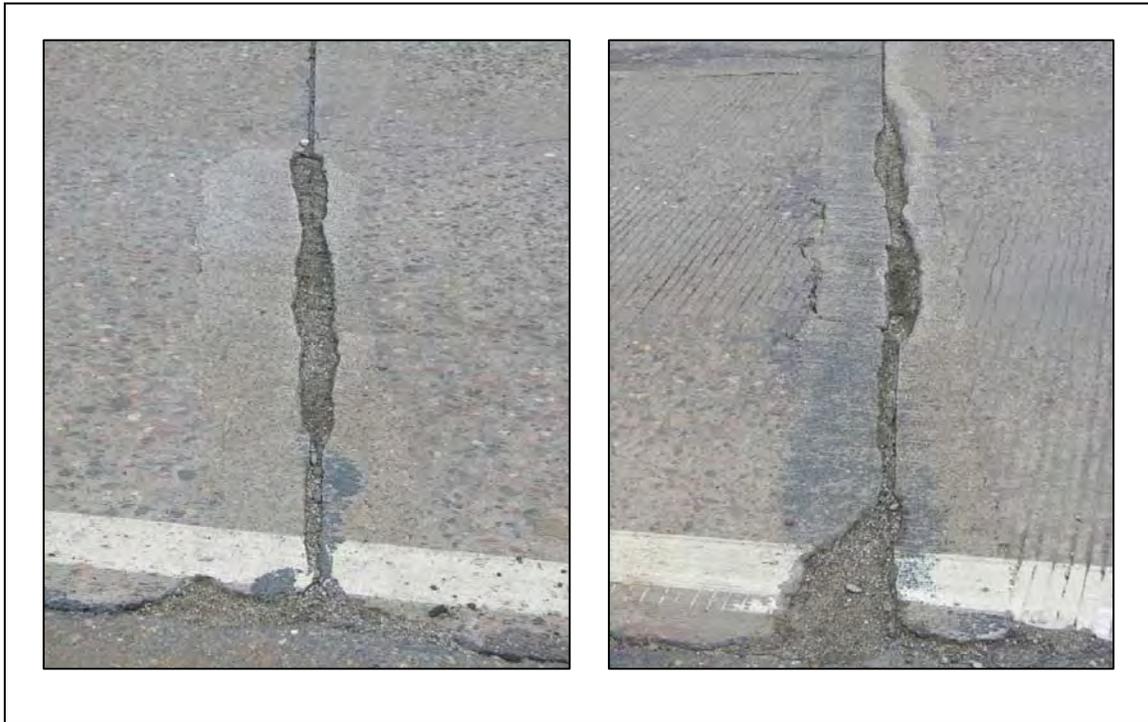
PDR was performed on this concrete ramp section as part of a larger reconstruction project on mainline USH 53. The PDR was 6 years old at the time of evaluation. Early signs of deterioration and loss of PDR patch material were noted at 100% of the repaired joints at this location during a March 2012 review (Figure 18). A second review was completed in July 2012, at which time all of the PDR locations had received asphalt patching.

Figure 18. Early deterioration and loss of PDR patch material (USH 53 ramp, 2006 construction).

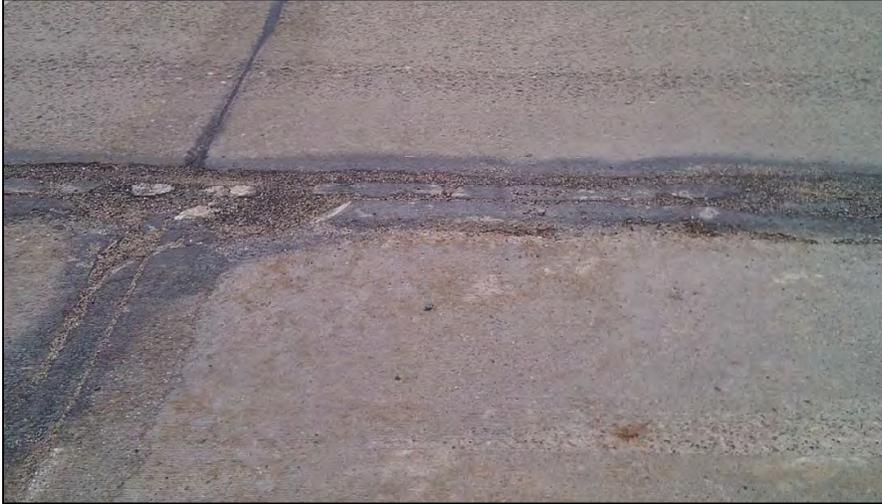
PDR was performed at joints and cracks on USH 12 and STH 37 in 2007. The PDR was 5 years old when it was reviewed in 2012. Cracking and spalling of the PDR patch material was observed at numerous repair locations (Figure 19, 20), at a rate of approximately 63% and 81% for USH 12 and STH 37 respectively. In several locations on STH 37, existing concrete had continued to deteriorate at a distance of 1 to 2 feet from the joint or crack. Spalling of the existing concrete appeared to be affecting the performance of adjacent PDR (Figure 21).

Figure 19. Spalling of PDR patch material (USH 12, 2007 construction).

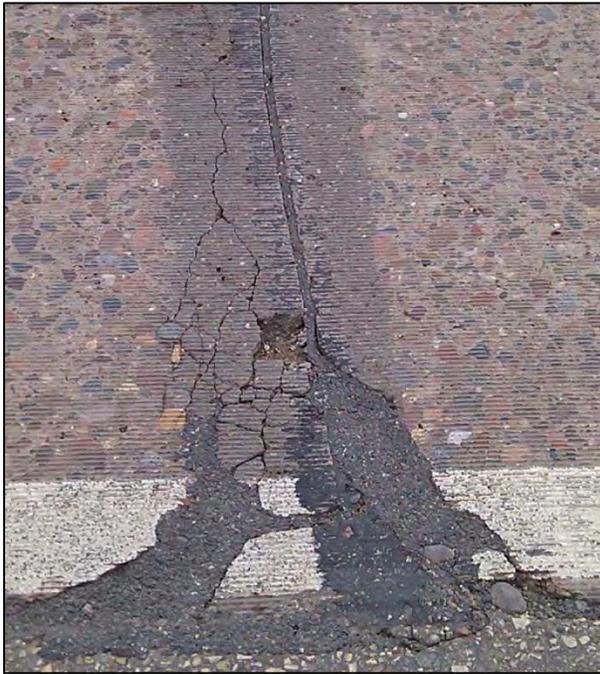
Figure 20. Cracking of PDR patch material (STH 37, 2007 construction).

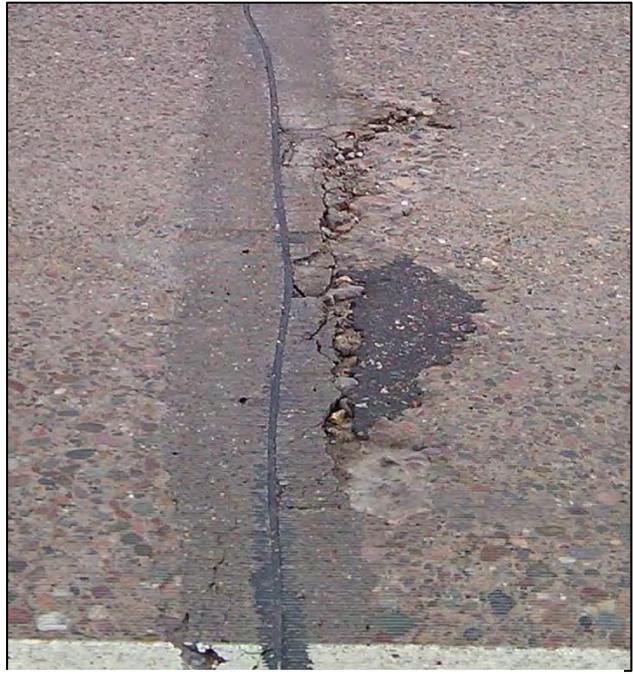
Figure 21. Deterioration of existing concrete adjacent to PDR (STH 37, 2007 construction).

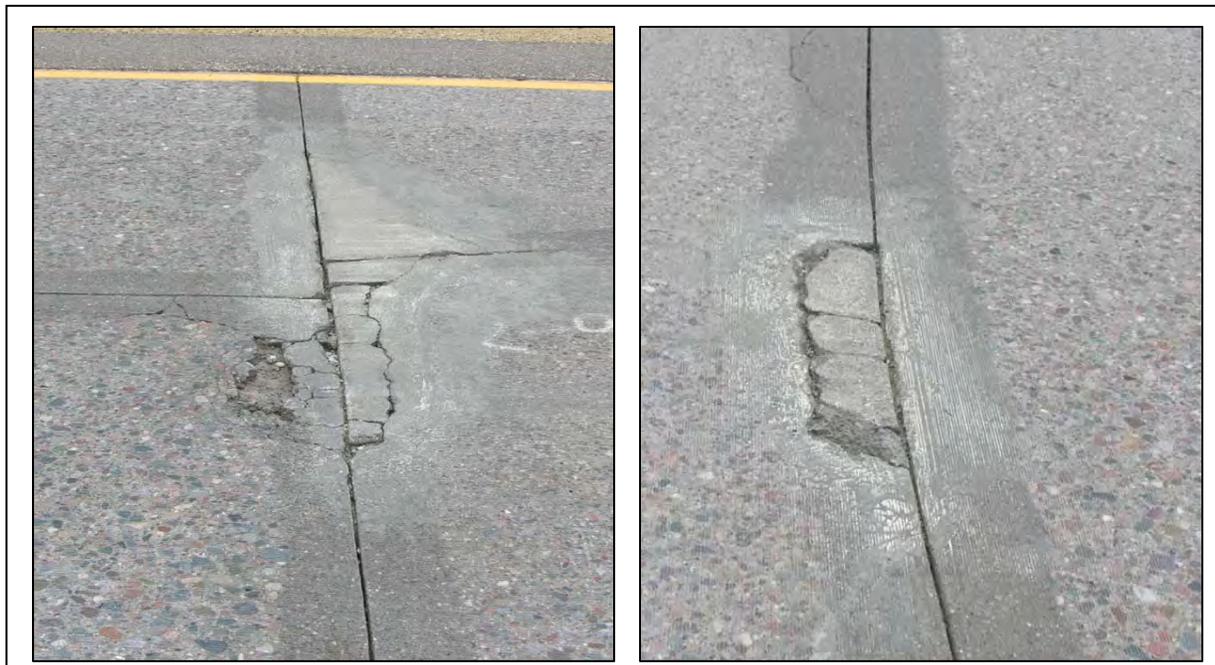
In 2008, rest area improvements were conducted at Wisconsin rest area locations 61 and 62 on I-94, eastbound (EB) and westbound (WB) respectively, near Menomonie and rest area locations 33 and 34 on USH 53, southbound (SB) and northbound (NB) respectively, near Chetek. PDR was performed at joints and cracks on the ramps and in parking lots, by the same contractor, at all four locations. The joints and cracks were diamond ground after PDR. After 4 years in service, cracks and spalling were present in many of the PDR locations. It also appears as though some of the failed PDR locations had been patched with concrete (Figure). The I-94 rest areas were determined to have a distress rate of 42% (WB) and 57% (EB) during a 2012 site review.

Figure 22. Cracks and spalling in PDR patch material (I-94 rest area, 2008 construction).

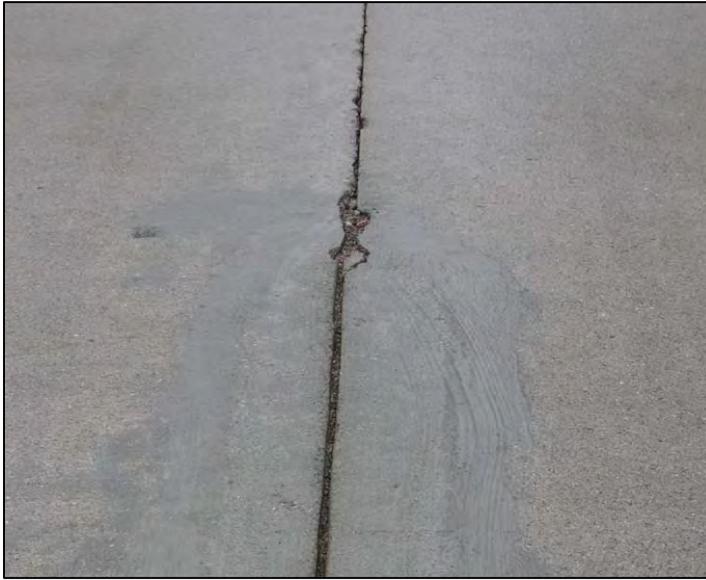
The PDR was in relatively good condition at the USH 53 SB rest stop location. A site review in 2012 determined that at the USH 53 rest areas, the PDR locations experienced a distress rate of approximately 24% (SB) and 63% (NB). However, some existing concrete that did not receive PDR was beginning to spall at the joints. If deterioration continues, performance of adjacent PDR could be affected (Figure).

Figure 23. Spalling at existing concrete joint (USH 53 rest area, 2008 construction).
