REPORT NUMBER: WI-02-07

EVALUATION OF THE URETEK METHOD[®] OF PAVEMENT LIFTING

FINAL REPORT

WisDOT Research Study # WI-01-07

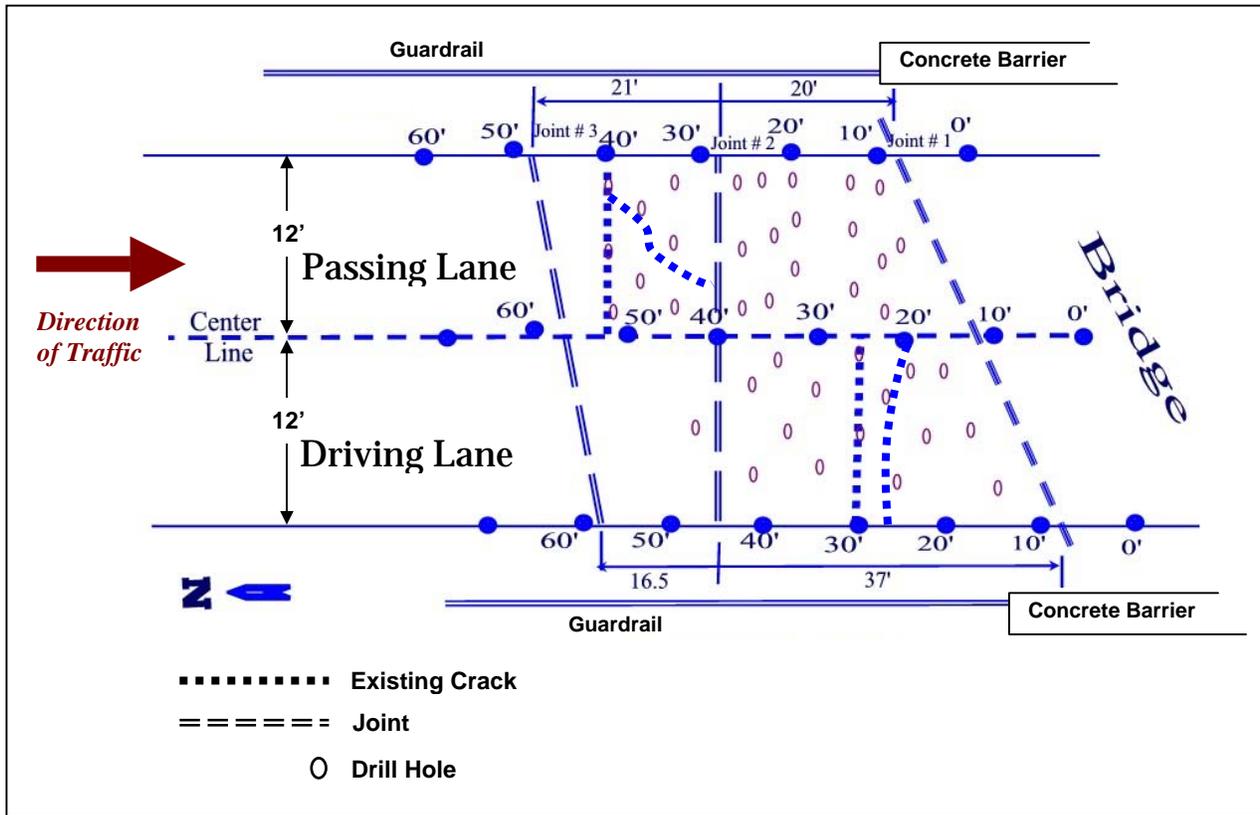
Figure 1 Station and Drill Hole Layout, I-39 Southbound (Figure not to scale)

of the lanes and were used to monitor the slab rise as material was injected. One end of the line was secured before Station 0, and the other end was secured after Joint 3 (Figure 1).

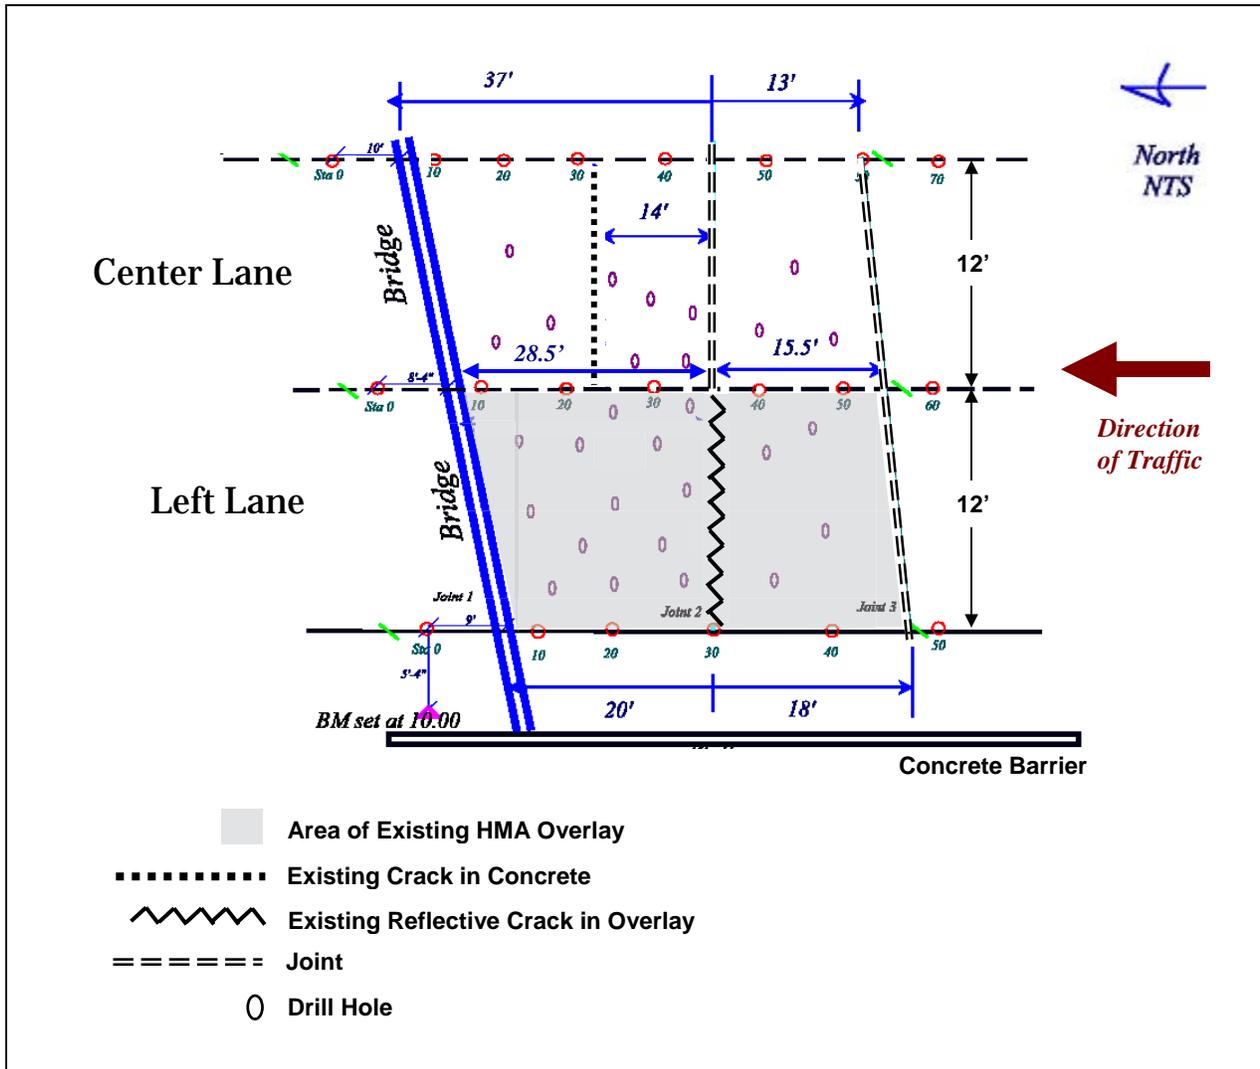
Figure 2 Station and Drill Hole Layout, USH 12 Westbound
(Figure not to scale)

performed, because vertical gaps between the pavement and string lines were visible at several locations. The largest vertical gaps were located at Station 30 at the far left string line location, at Station 20 at the center string line location, and at Station 10 at the right string line location. These vertical gaps indicated that the highest level of pavement lifting was required at these locations.

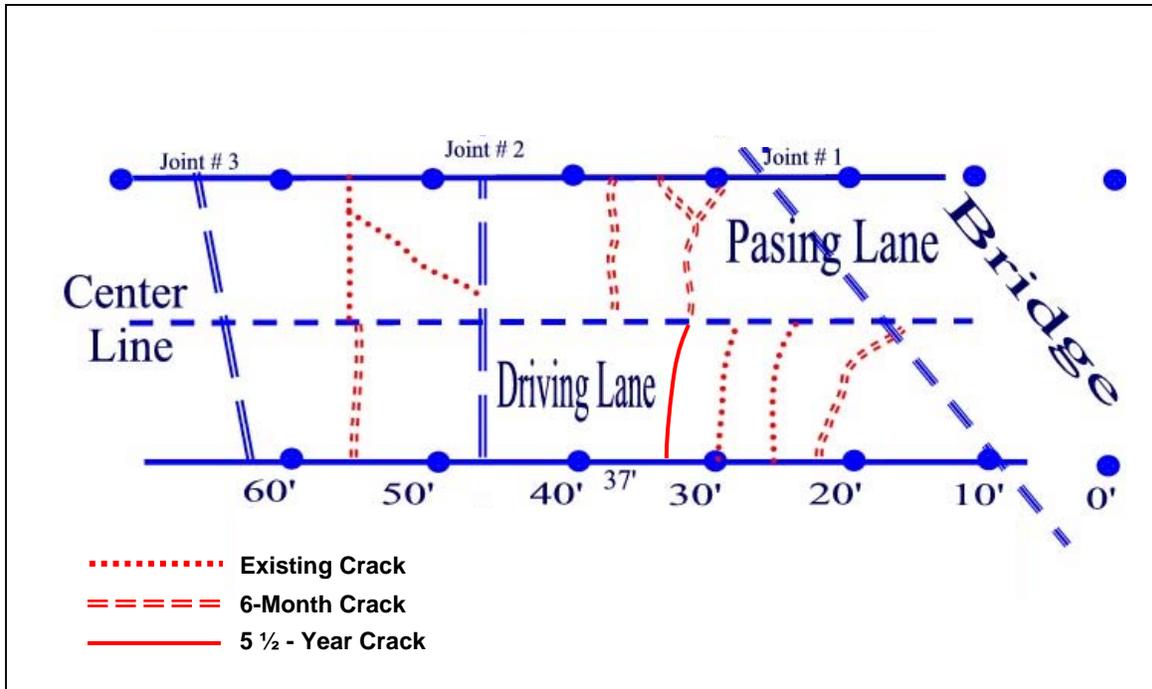
Figure 3. Location of Existing and New Cracks, I-39 Southbound

After six months, four fine transverse cracks had developed in the test slabs. Two of the cracks were in the driving lane (one in each slab), and two were in the passing lane (both in the first slab). At five and one half years after lifting, an additional crack had formed in the first slab of the driving lane (Figure 3).

It is likely that the new cracks induced in the test slabs were a result of the pavement lifting process. The cracks tended to occur between injection hole locations, and cracks occasionally spread through drill holes as well. (See Figures B-5 through B-7 in Appendix B) It is hypothesized that injection and expansion of the foam material exerted additional stresses in the slab, which resulted in the transverse cracking noted during the visual inspections.

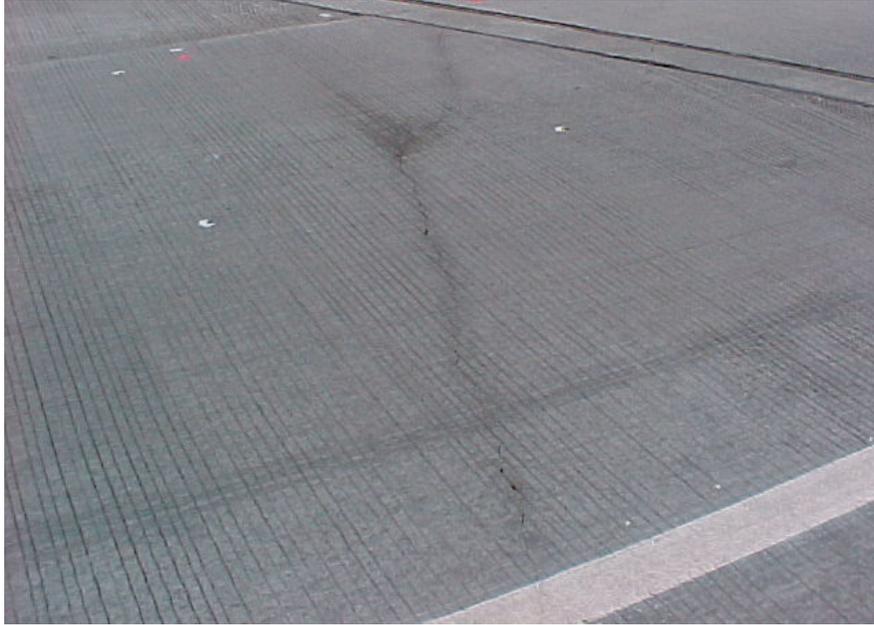
5. The slabs at Test Site #1 developed fine cracks within six months of pavement lifting. These cracks, which are likely due to stresses induced by pavement lifting, may reduce the service life of the slabs. Fine cracks were also noted in pavement tested in other states' research studies.^{2,3}

Figure B-5. Crack that developed at Test Site #1
(Photo taken at 6-month crack survey)

1. It is recommended that The URETEK Method[®] be used only for the lifting of an approach slab and not for void filling. Void filling should be performed using other methods such as concrete slurry. A large amount of fill material is potentially required when voids are present, and use of the URETEK material is not cost effective in that case.
2. The URETEK Method[®] is practical for use on high traffic volume highways where lane closure time is critical.
3. It is not recommended that this method be used to lift a slab that is sagging in the middle. This could lead to cracking of the slab, and consequently reduction of the slab service life. In this situation, slab replacement or and HMA overlay may be better solutions.
4. Use of ground penetrating radar (GPR) is recommended for an accurate estimate of material required for lifting.

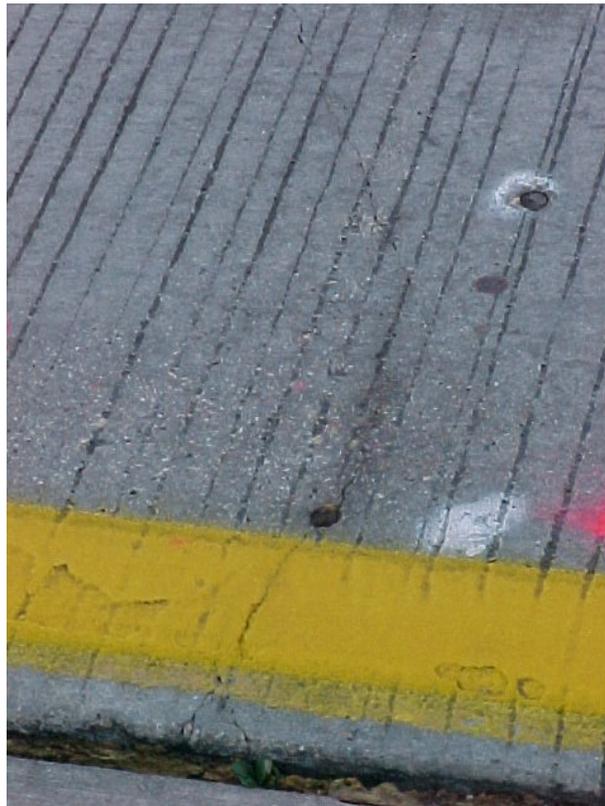
Figure B-6. Crack that developed through a drilled hole at Test Site #1
(Photo taken at 6-month crack survey)

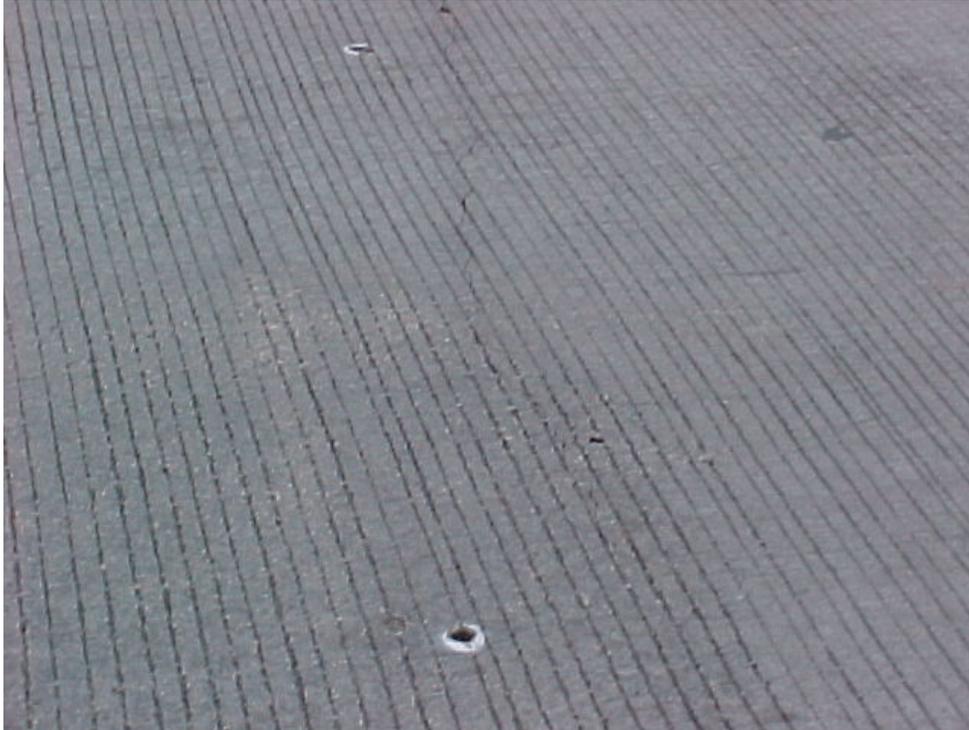
Figure B-7. Crack that developed between drilled holes at Test Site #1
(Photo taken at 6-month crack survey)
