Bridge Asbestos Inspection Report

WisDOT Project ID: 1196-04-02
 Structure Number: B-03-020
 Structure Name: USH 53 SB over Chetek River
 City/County: Town of Chetek, Barron County, Wisconsin
 GEI project Number: 1901822
 Date Inspected: April 4, 2019
 Inspected by: Kyle C. Sandmire
 Asbestos Inspector License Number: All- 217616
 Consultant Company: GEI Consultants, Inc.

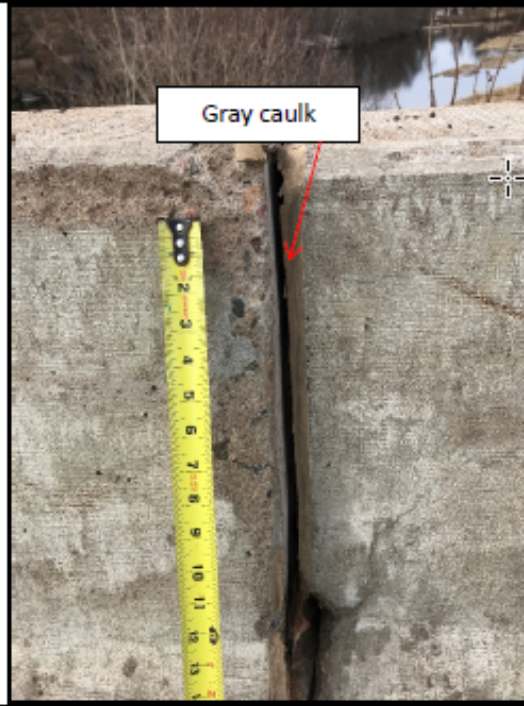
PHOTOGRAPH NO: 4	
DIRECTION: SW

View of the gray caulk on the bridge wall joints and abutment joints. The gray caulk is not ACM.

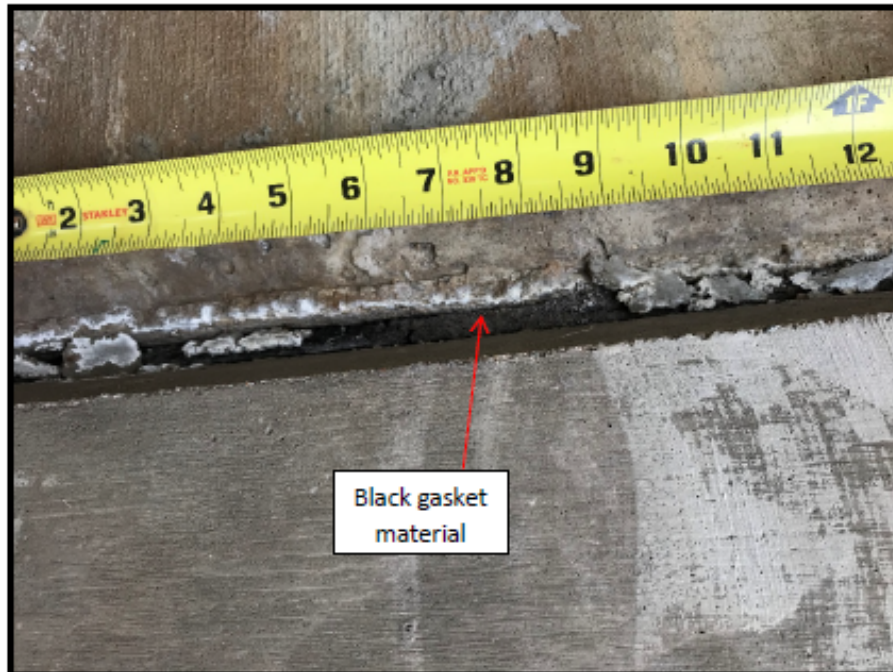
PHOTOGRAPH NO: 5

View of the black gasket material between the bridge deck and abutment. The black gasket material is not ACM.

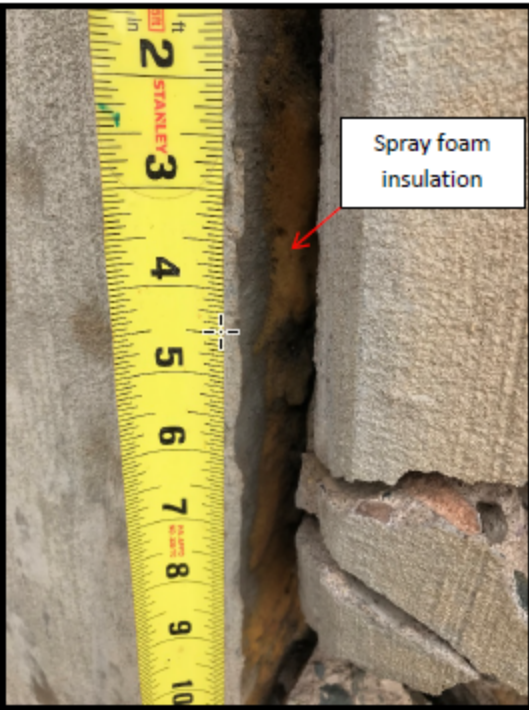
PHOTOGRAPH NO: 6

<p>DESCRIPTION:</p> <p>View of the spray foam insulation between the bridge deck and abutment. The spray foam insulation is not ACM.</p>
