Road Safety Audit REPORT

WIS 441 Tri-County Project

Date: Apr 25-26, 2012

Realignment of WIS 441 and reconstruction of five interchanges.

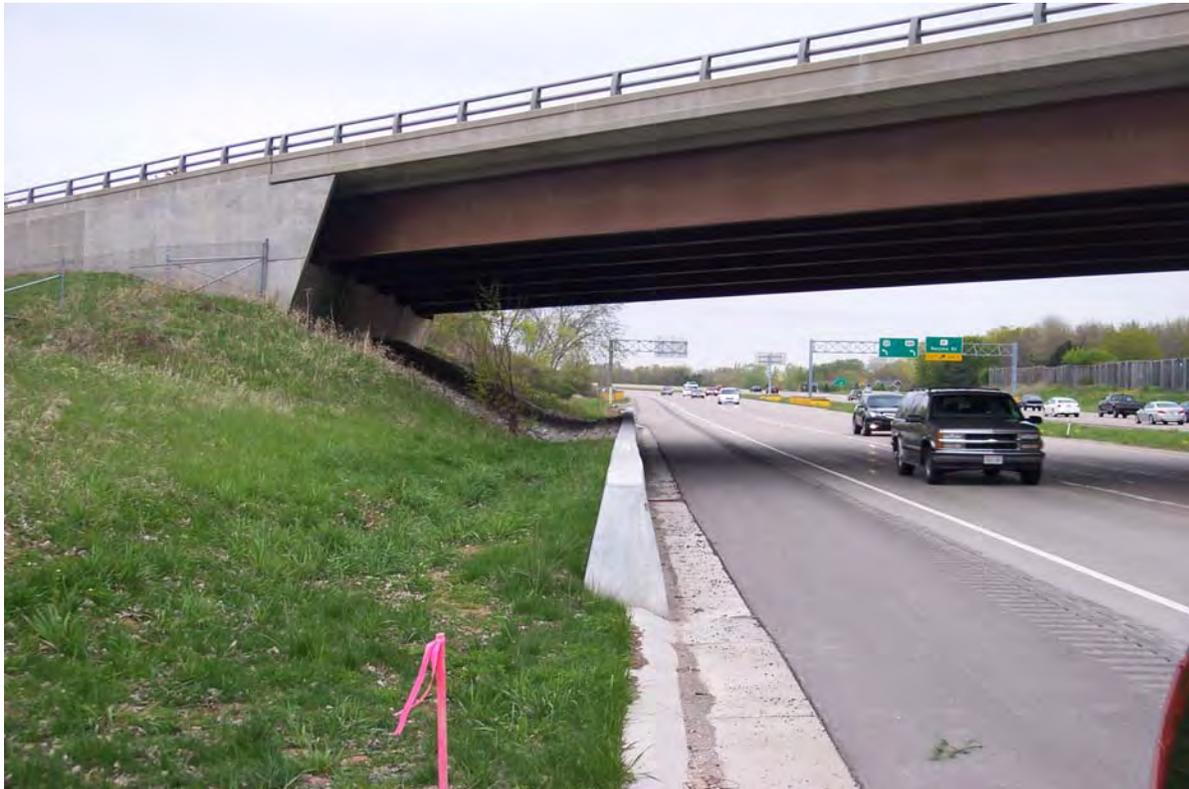
Issue 1: Barrier wall in clear zone

There are concrete barrier walls shielding the abutments on both sides of WIS 441 under the County P Bridge that are close to the outside travel lanes and within the clear zone. The concrete barrier walls are used for protection for the abutments, but can become a hazard themselves.

Resulting Road Safety Risk: Medium

Shorten the length of the bridge abutments on both sides to locate them further away from the travel lanes, preferably outside the clear zone.

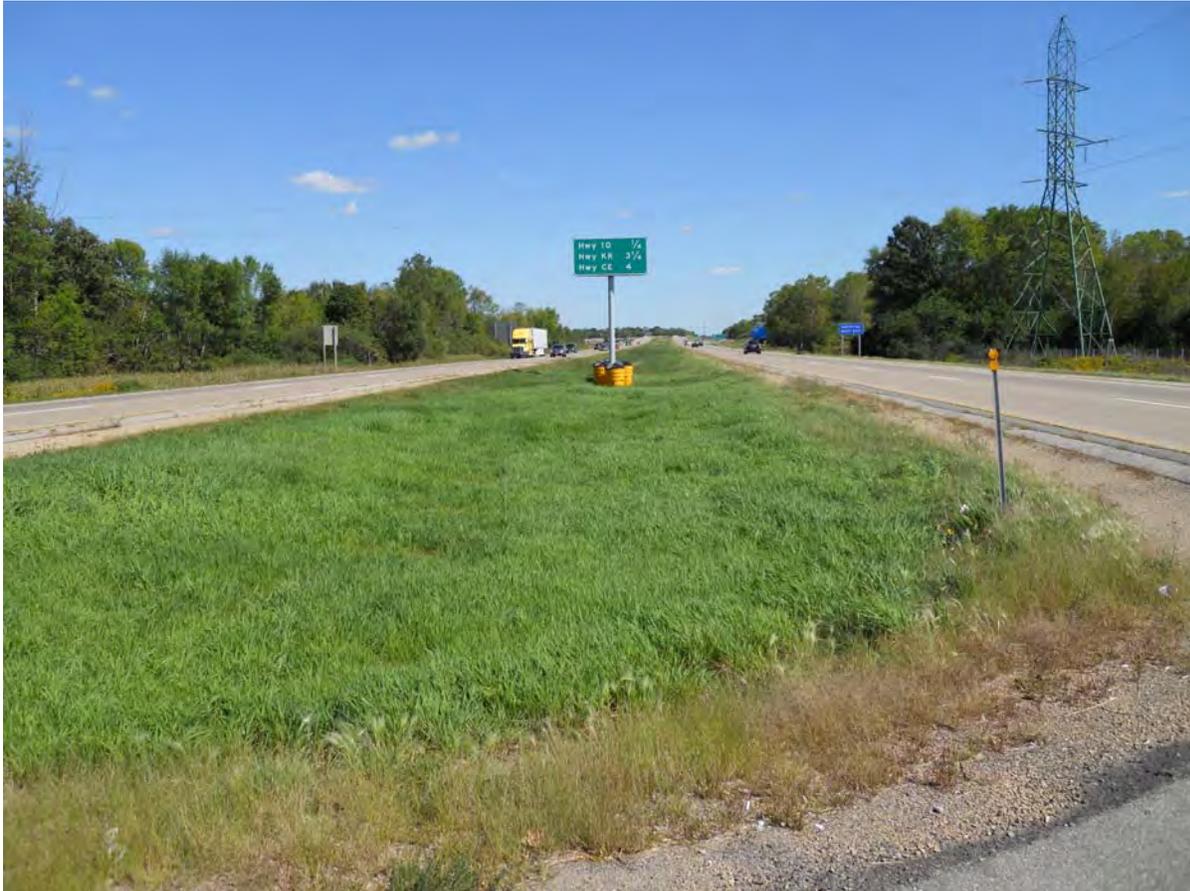
Issue 2: Crossover protection

There are several segments with no crossover protection in the median on WIS 441. Vehicles that run off the road into the median do not have guardrail or other crossover protection to prevent them from traveling into the opposite lanes.

Resulting Road Safety Risk: Medium

Add guardrail, barrier wall, cable barrier, or other crossover protection in the median on WIS 441.

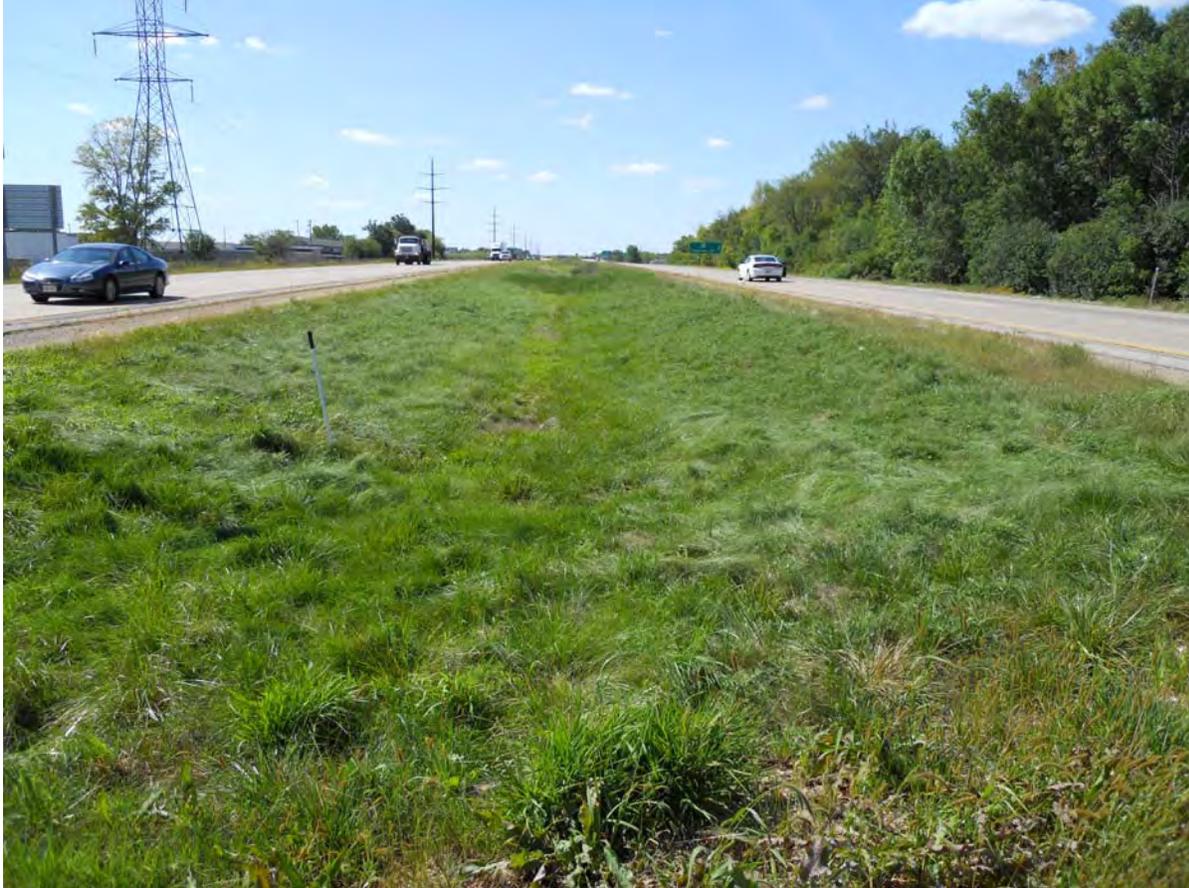
Issue 7: Depressed median

The median is depressed in several sections along WIS 441 which could be a potential hazard. A depressed median may cause a vehicle that enters the median area to overturn.

Remove depression in median area to eliminate the potential hazard. The proposed reconstruction with double barrier wall in the median removes this as an issue.

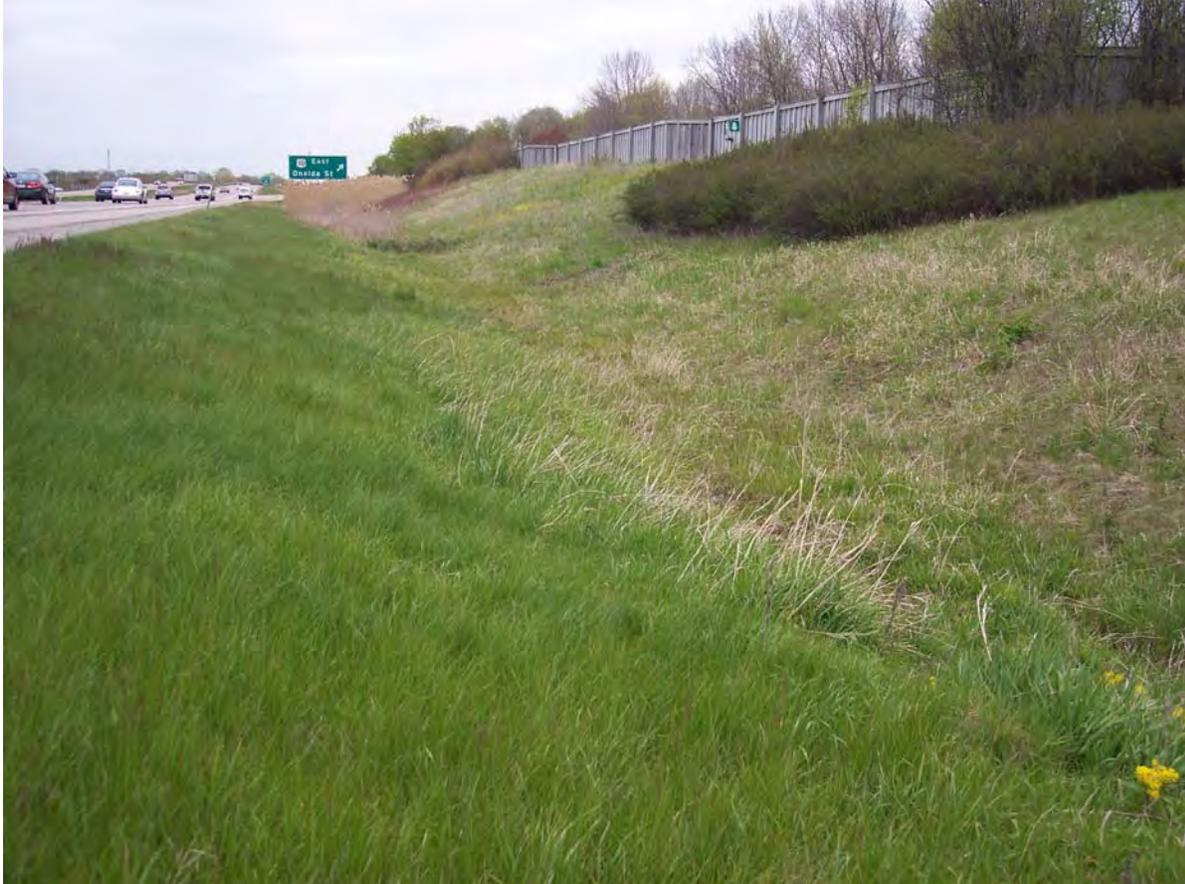
The front slope on the right side of WIS 441 eastbound, east of the Appleton Road interchange, is 40% that slopes down into a ditch. This slope is not considered to be recoverable.

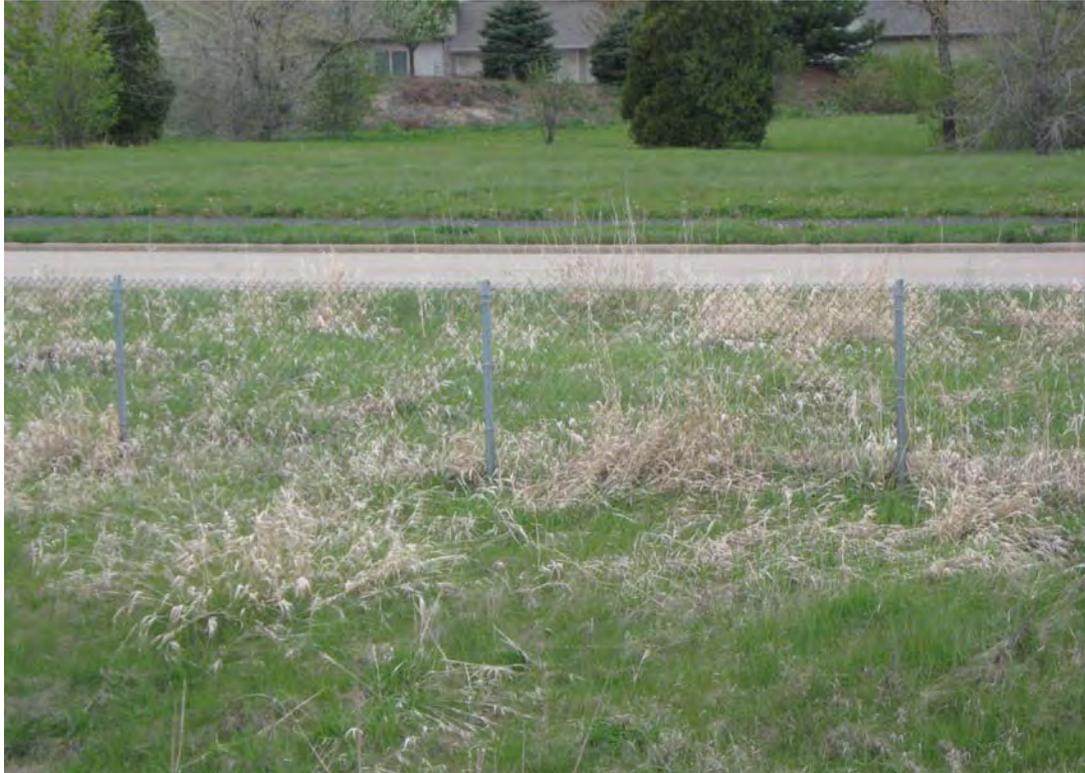
Several struck deer were observed throughout the area. Several deer crashes have occurred in the area.

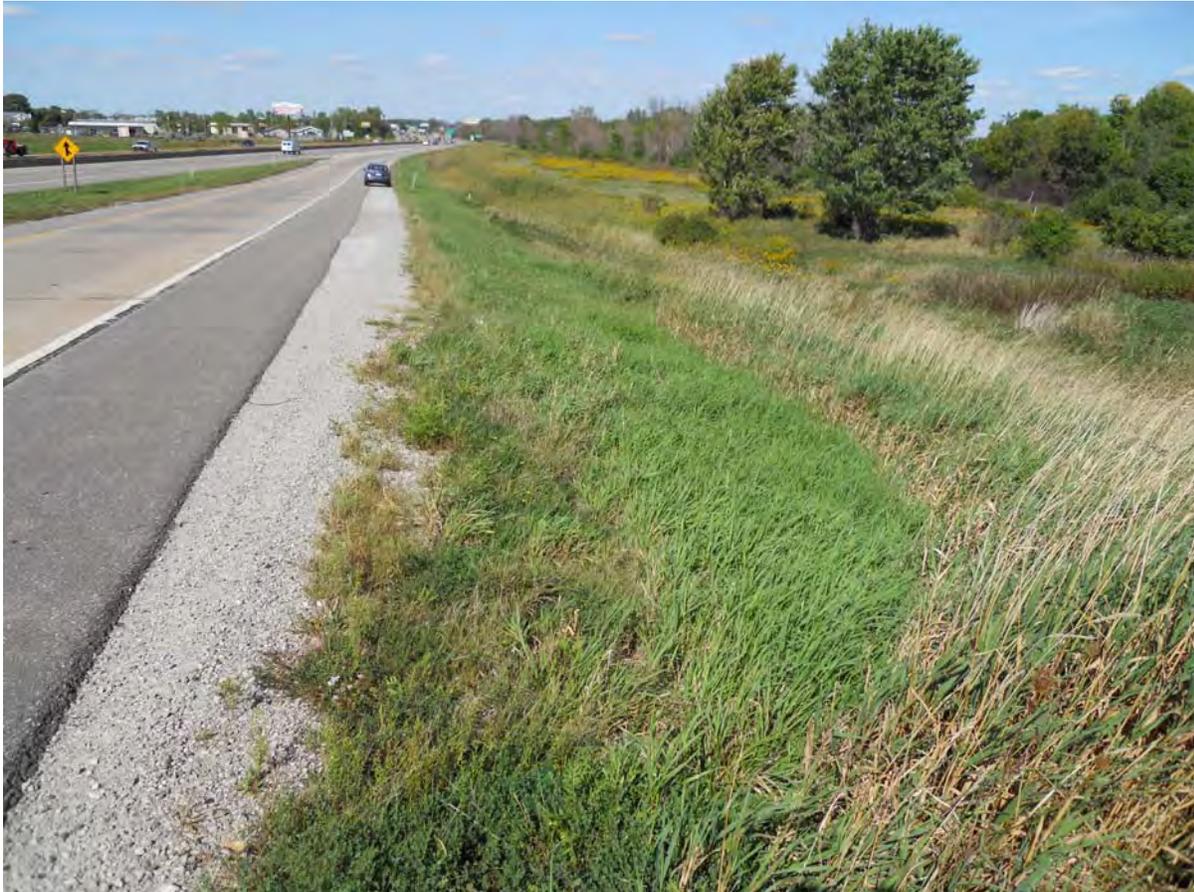
There is no recovery area at the bottom of the 3:1 slope on the ramp for WIS 441 westbound to US 41 northbound. This could be a safety issue for vehicles that run off the road in this area.

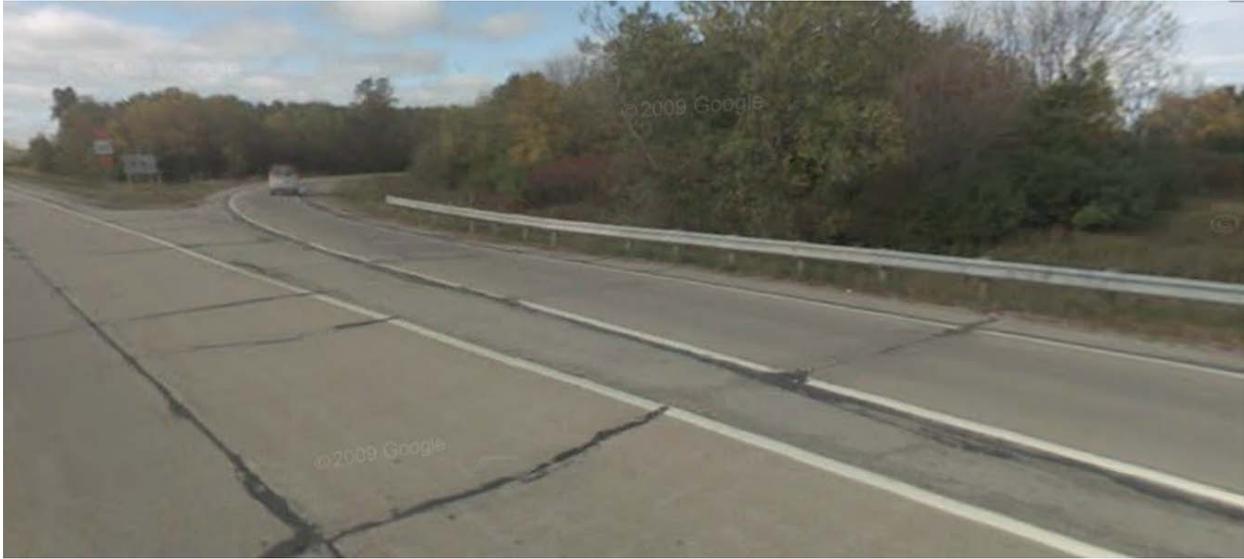
The deflection spacing behind guardrail on the loop ramp from southbound US 41 to eastbound WIS 441 is not sufficient. Insufficient deflection spacing does not allow adequate area between the guardrail and the hazard it is shielding to absorb an impact without reaching the hazard.

Relocate the guardrail to increase the deflection spacing between the guardrail and the hazard.

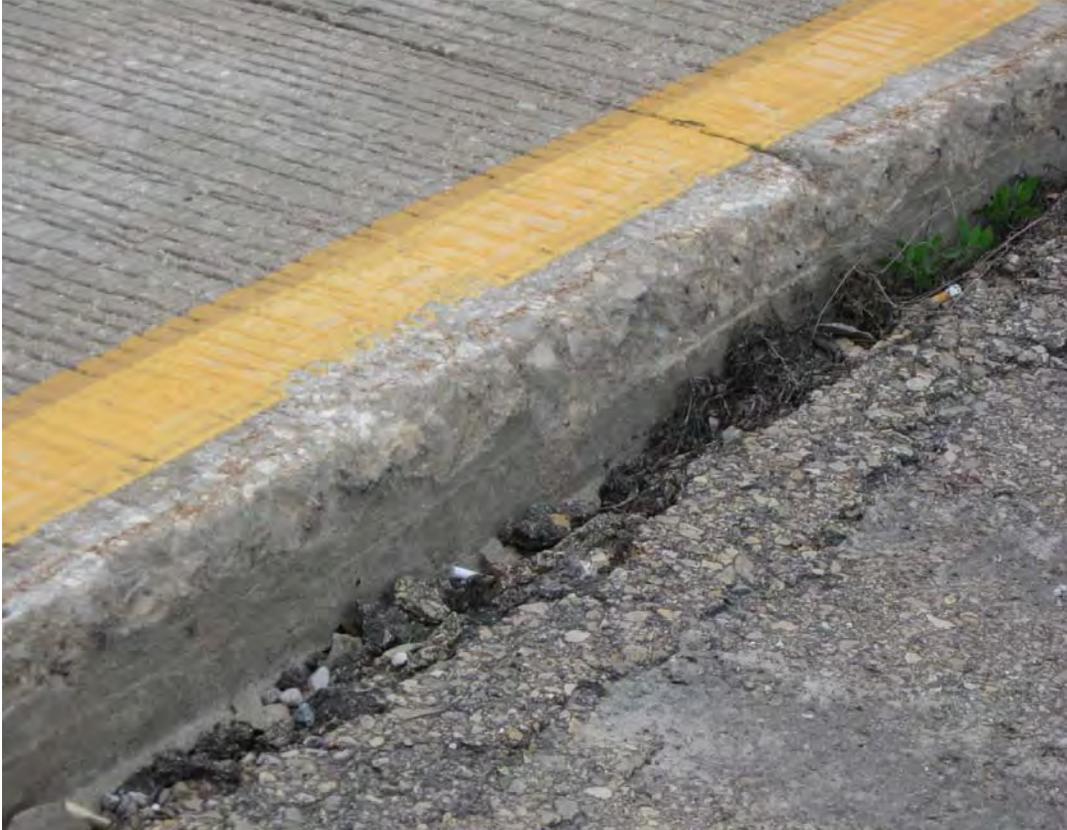
The asphalt shoulder has settled away from the concrete roadway ramp in some areas. This causes a difference in elevation at the edge of travel that may be a safety concern if a vehicle overtracks into this area.

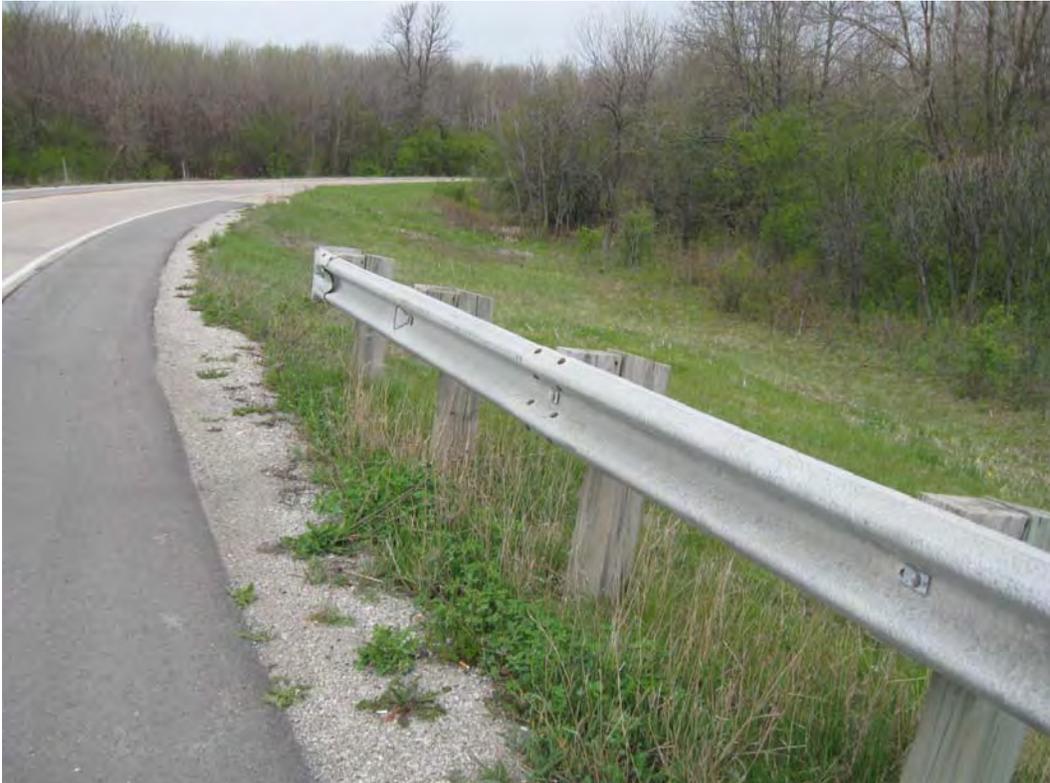
The loop ramp for southbound US 41 to eastbound WIS 441 has guardrail that is mounted higher than 24 inches. This is higher than recommended.

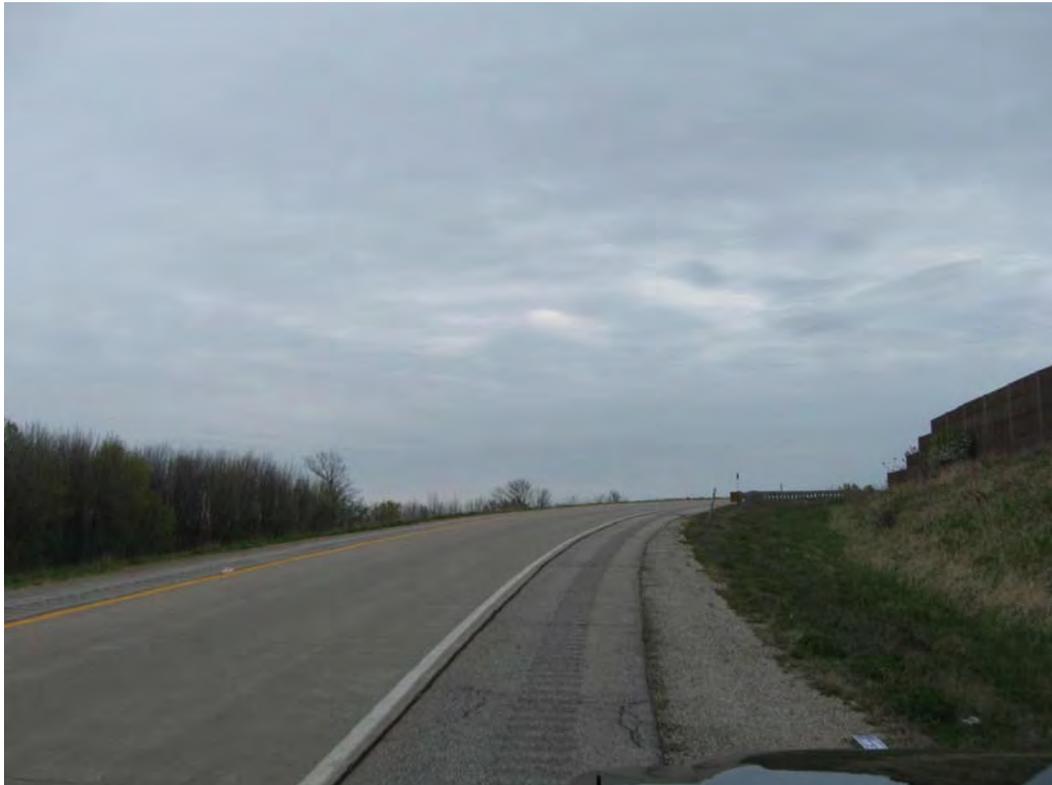
The ramp from eastbound WIS 441 to southbound US 41 has horizontal and vertical sight distance issues. Low sight distance may contribute to a vehicle not detecting a hazard in time to react and avoid a collision.

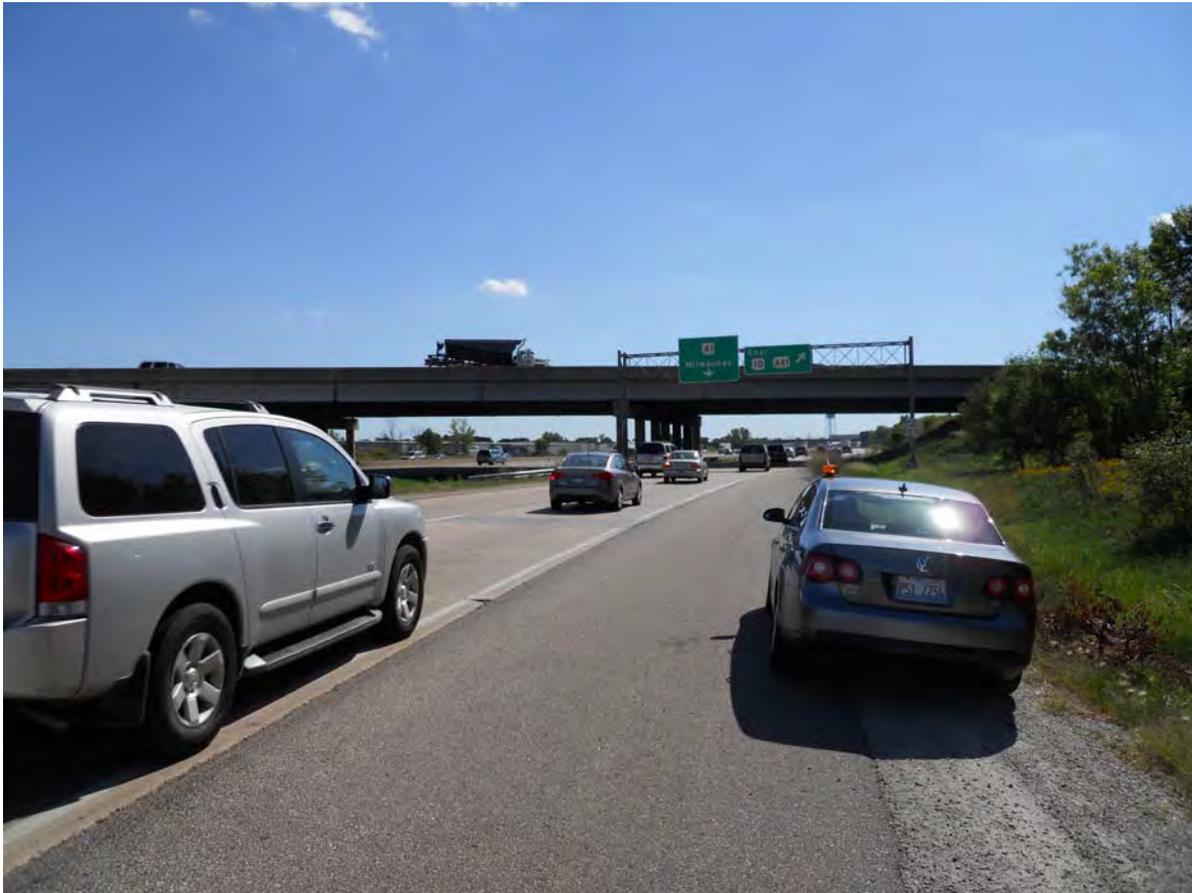
On the loop ramp for westbound WIS 441 to southbound US 41, the traffic movement is heavy and there are merge/weave issues. This can cause operational and safety issues.

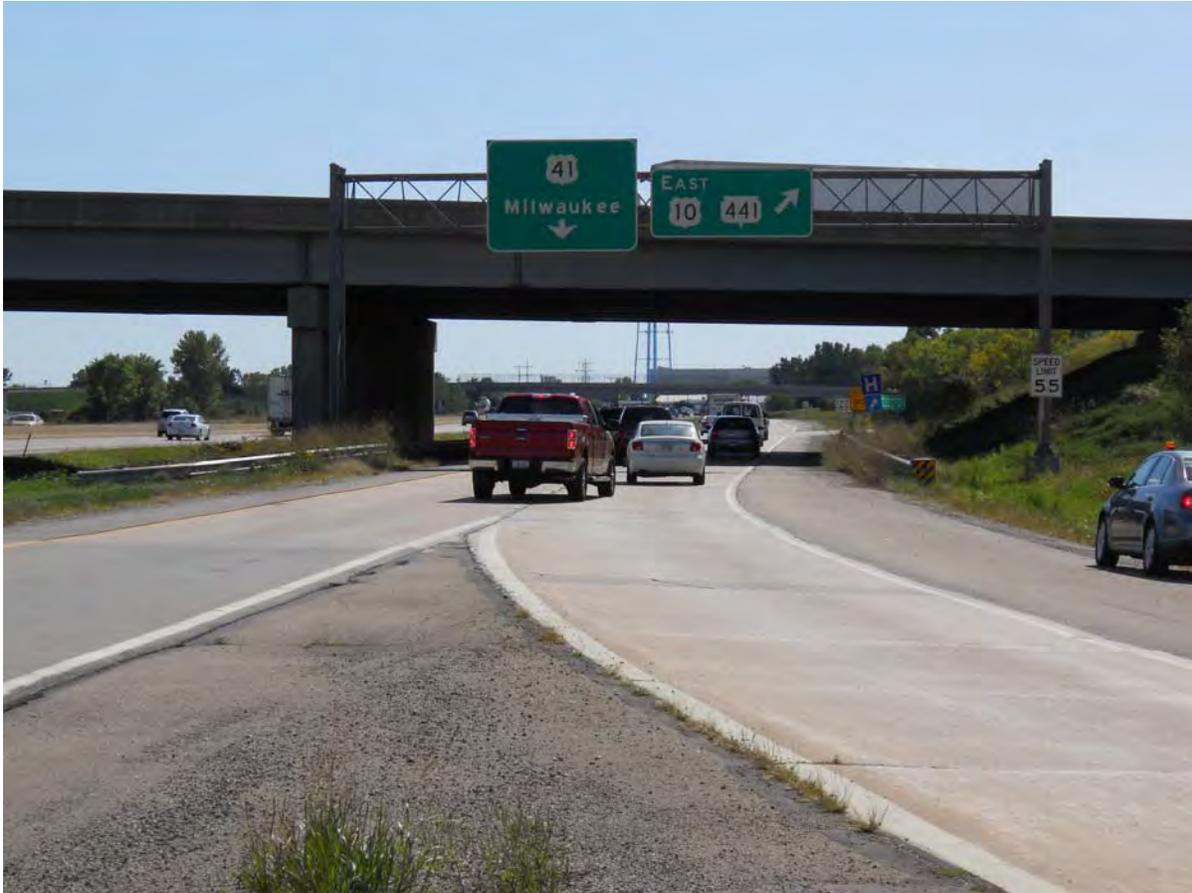
There is a potential weave issue on the southbound CD road. This can cause operational and safety issues.

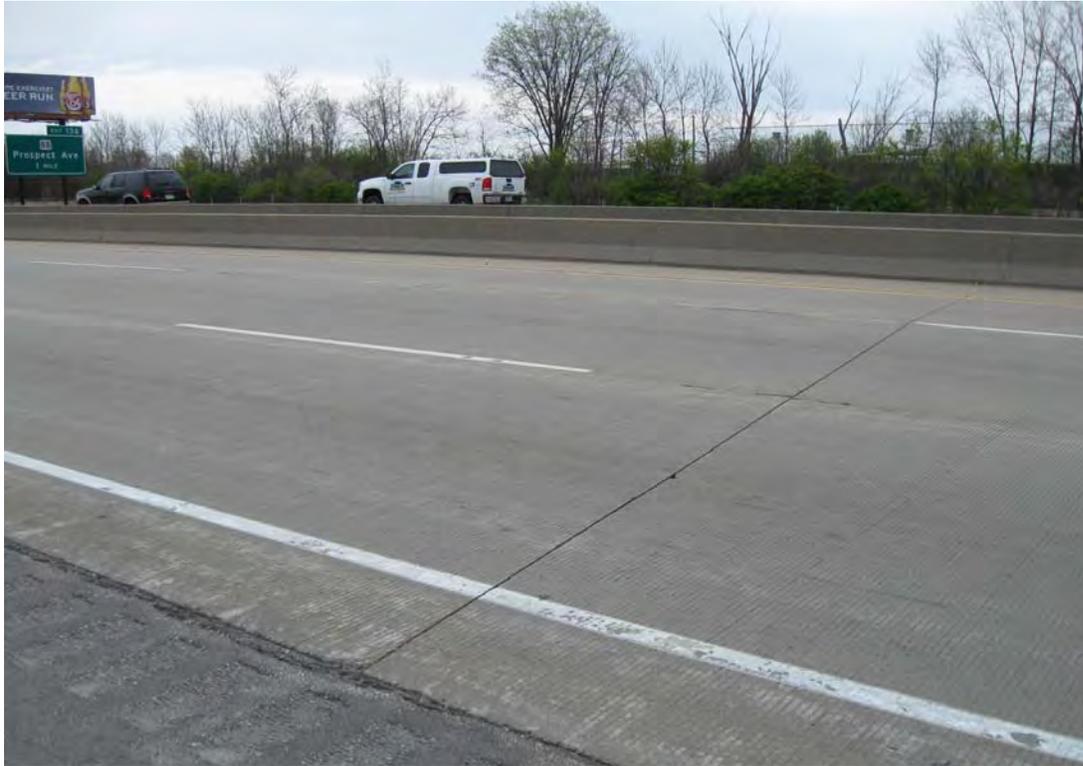
There are currently white pavement markings for the edge lines and lane lines that do not have contrast markings on areas of concrete pavement. This can cause low visibility of the striping over time.

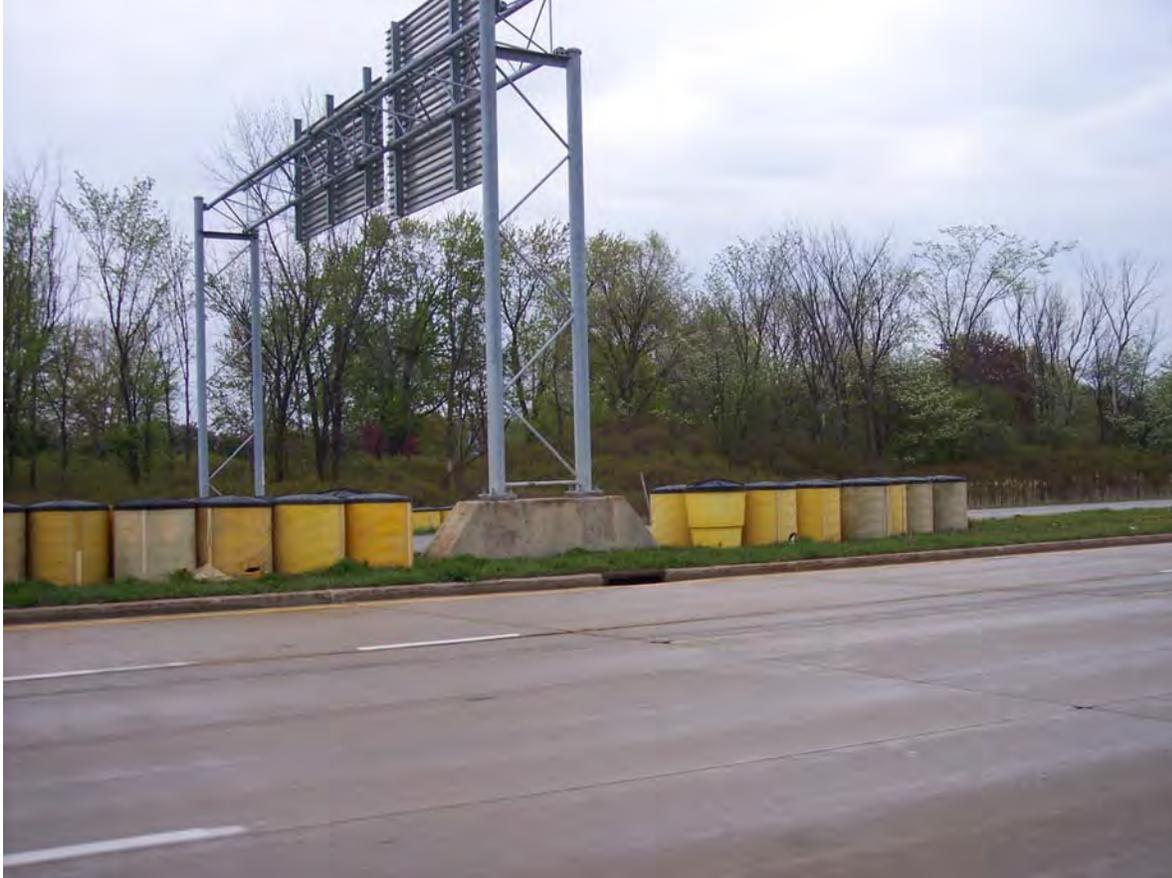
There are sign uprights in the median islands on the Racine Road connector that are within the clear zone.

Sign uprights are recommended to be located outside the clear zone. If this is not possible, they should be shielded appropriately.

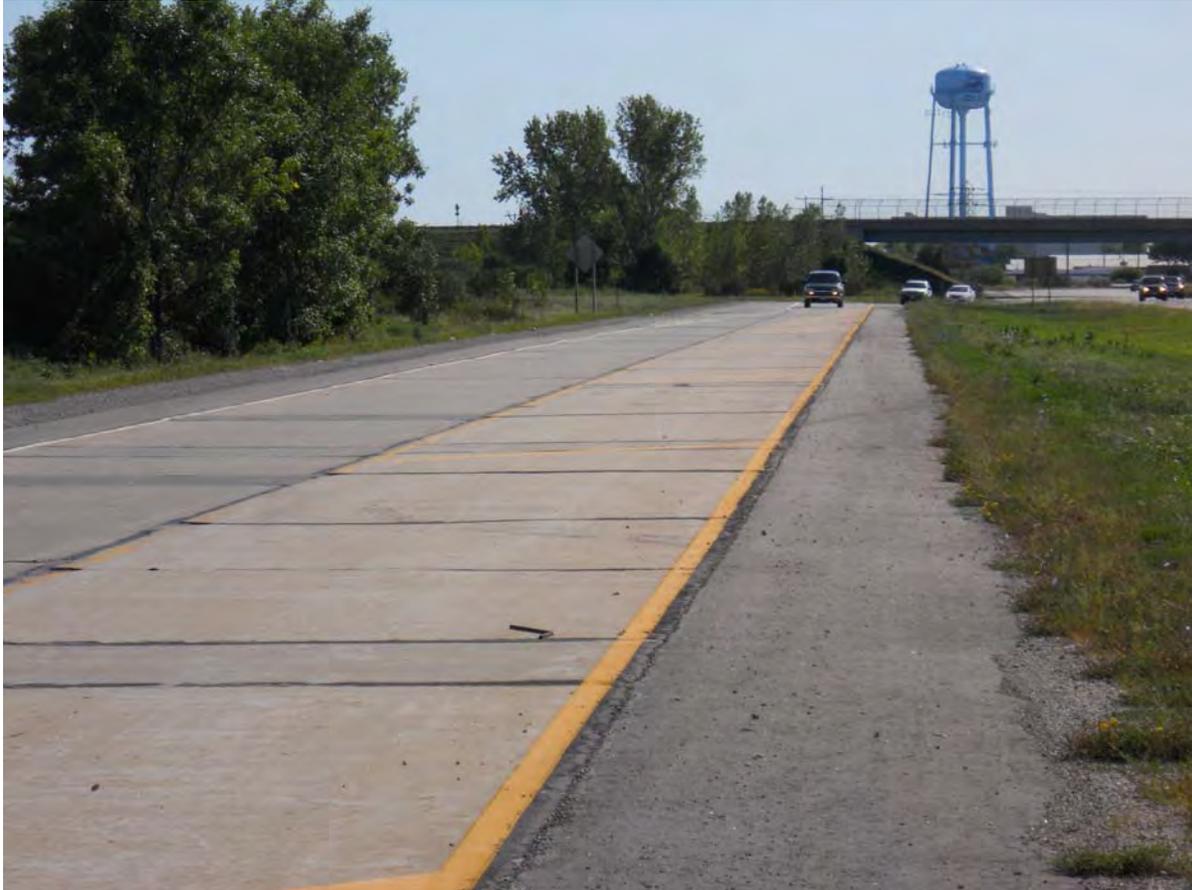
The westbound on-ramp has a lane drop within the curve. Navigating a curve and a lane drop in the same area can be difficult for motorists to navigate.

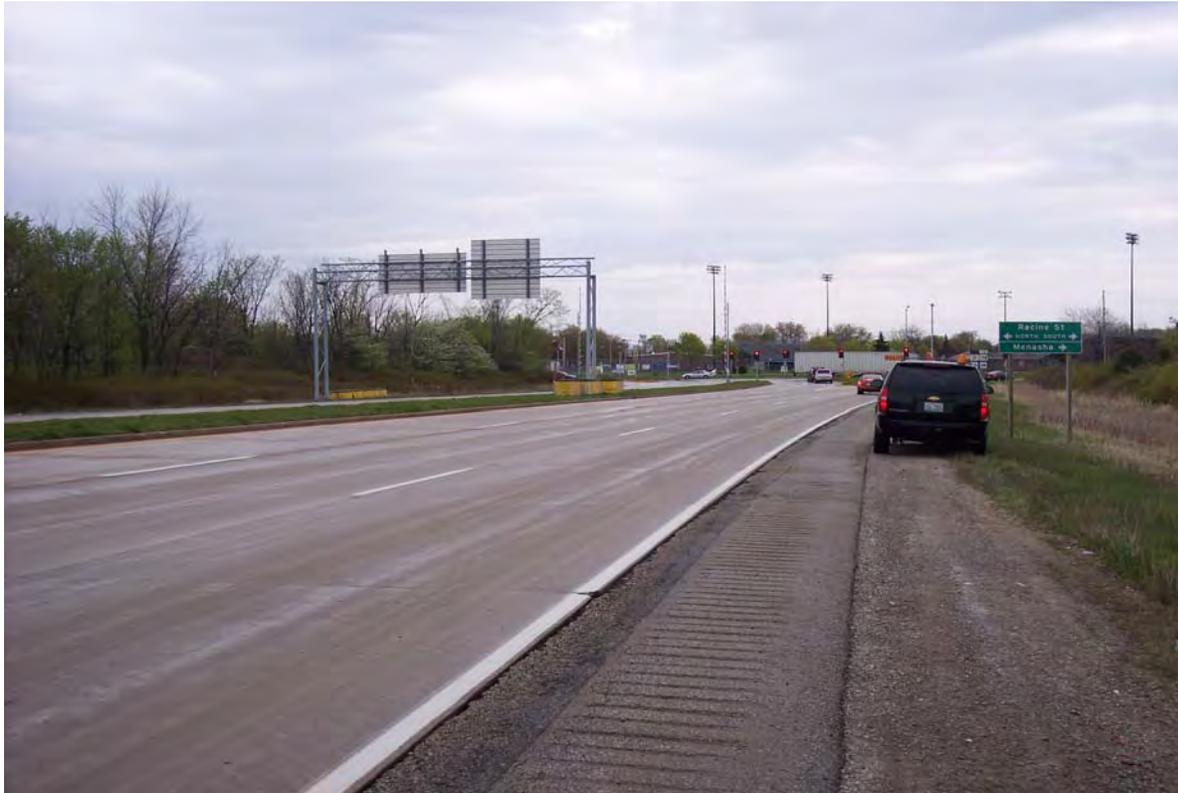
The asphalt shoulder has settled away from the roadway on Racine Road. This causes a difference in elevation at the edge of travel that may be a safety concern if a vehicle overtracks into this area.

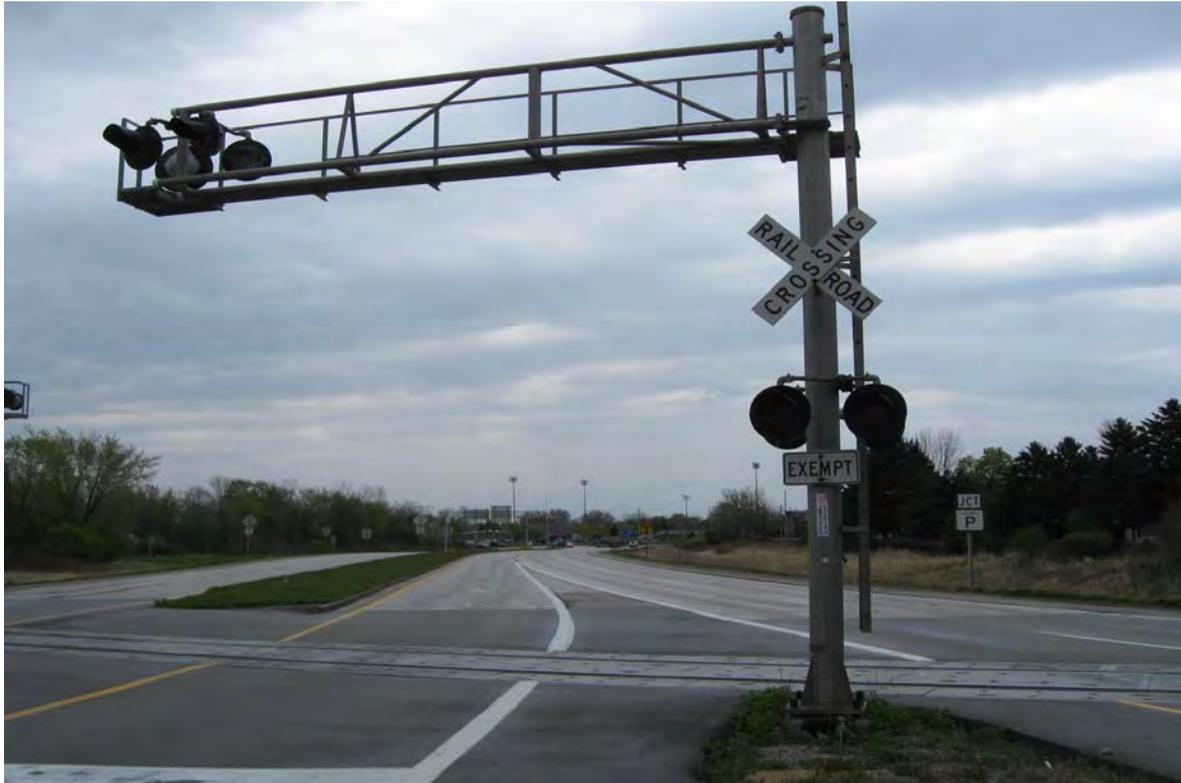
The sight distance to the railroad crossing is low for the eastbound WIS 441 off ramp to Racine Road. This condition will not be improved with the new construction. The railroad crossing has passive control, so vehicles must see the crossing to stop for an oncoming train.

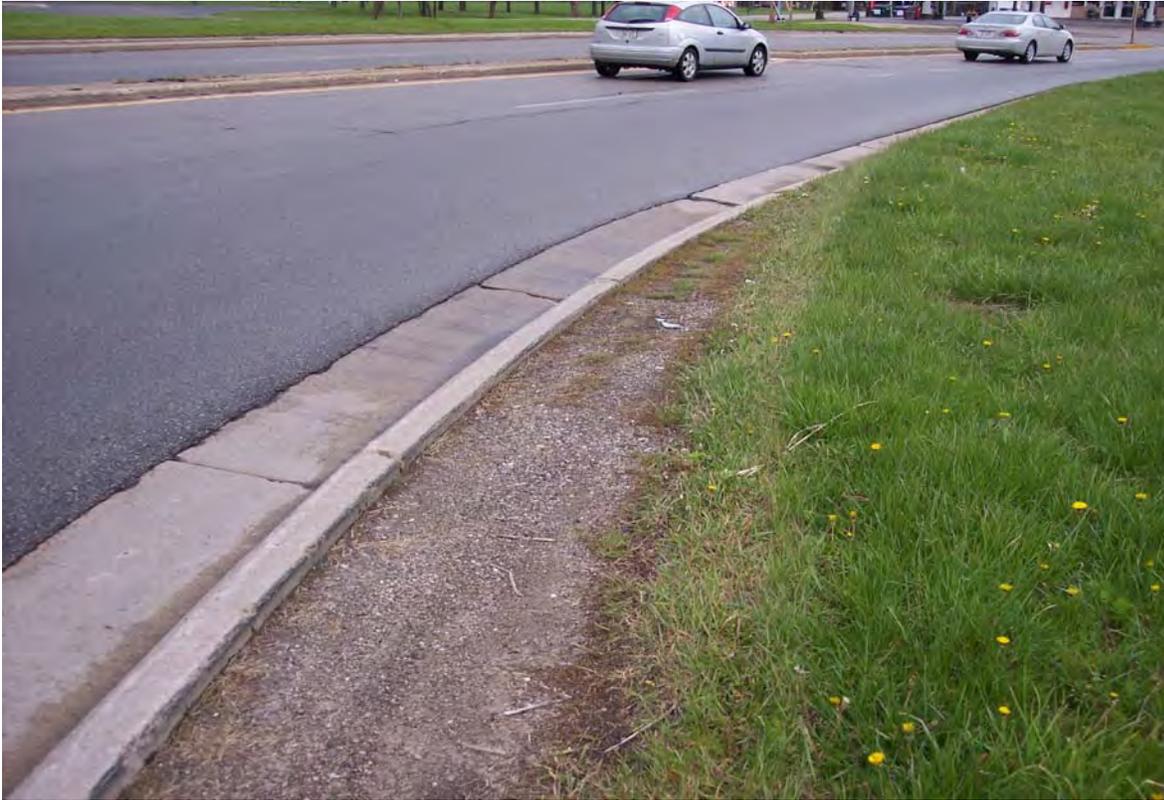
Issue 45: Overtracking observed

We observed evidence of overtracking on both the southwest and northwest corners of the intersection of Racine Road with WIS 441. Heavy vehicles are running off the roadway in this area.

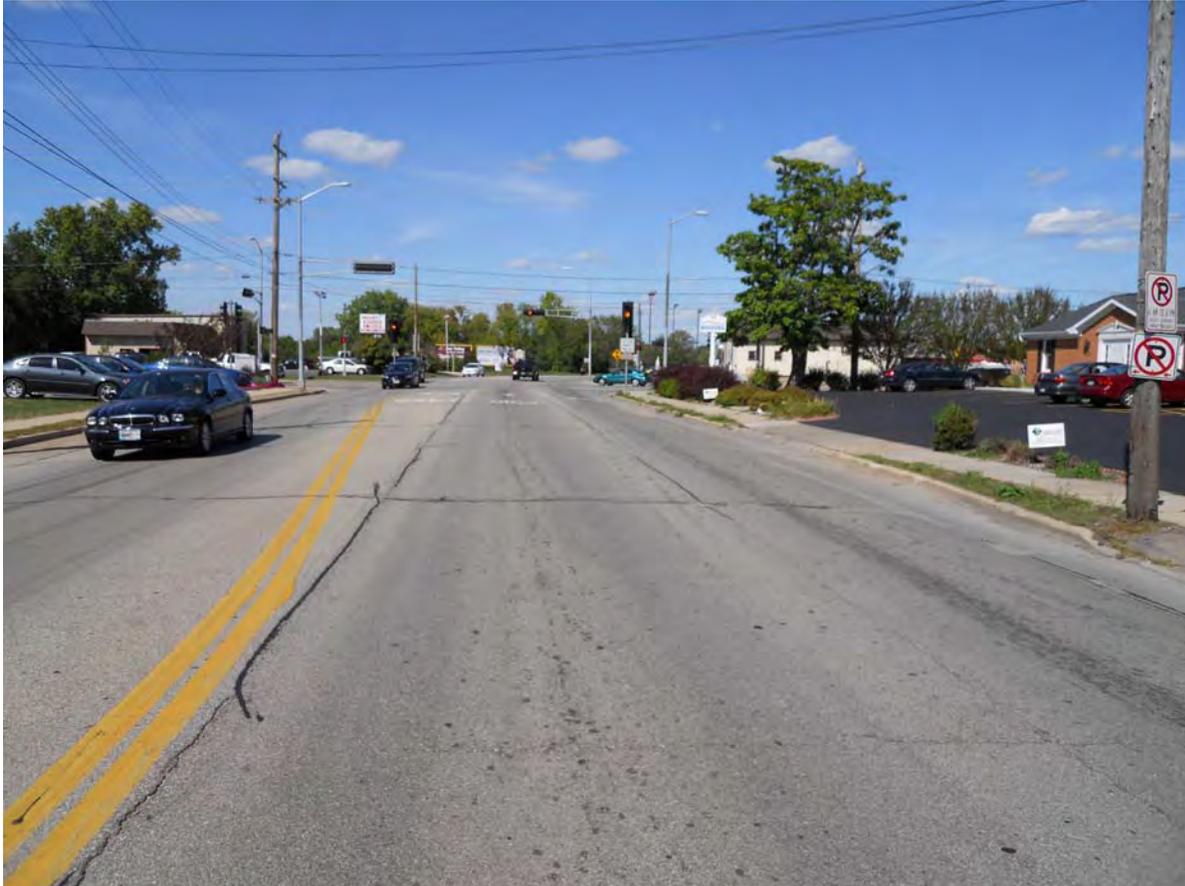
Issue 46: Lane length deficient

At the intersection of Racine Road and 9th Street, the northbound left turn lane does not have sufficient queue length and deceleration length. Also, the eastbound left turn lane queue was observed to overflow into the through lane.

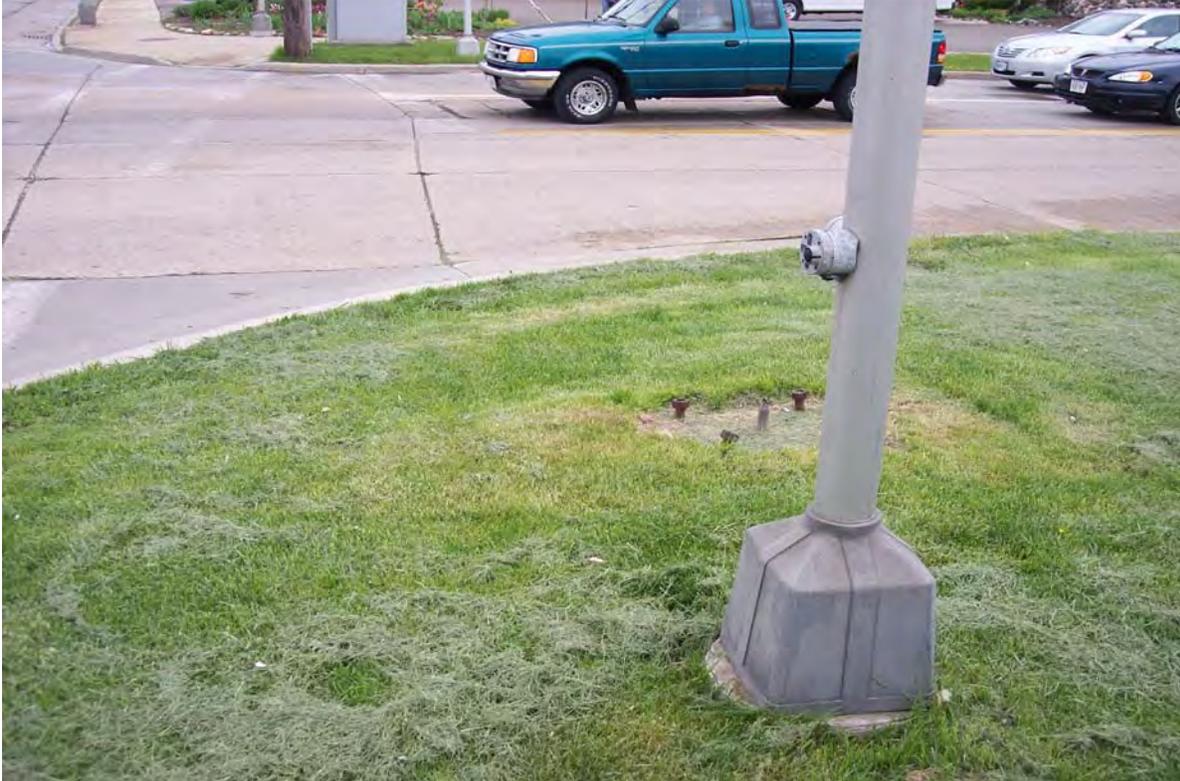
Racine Road is missing sidewalks and pedestrian ramps. This area is not ADA compliant. Not having pedestrian facilities causes the pedestrians to walk on the shoulder of the roadway exposing them to safety issues. The land uses in this area are pedestrian and bicycle generators and attractors.

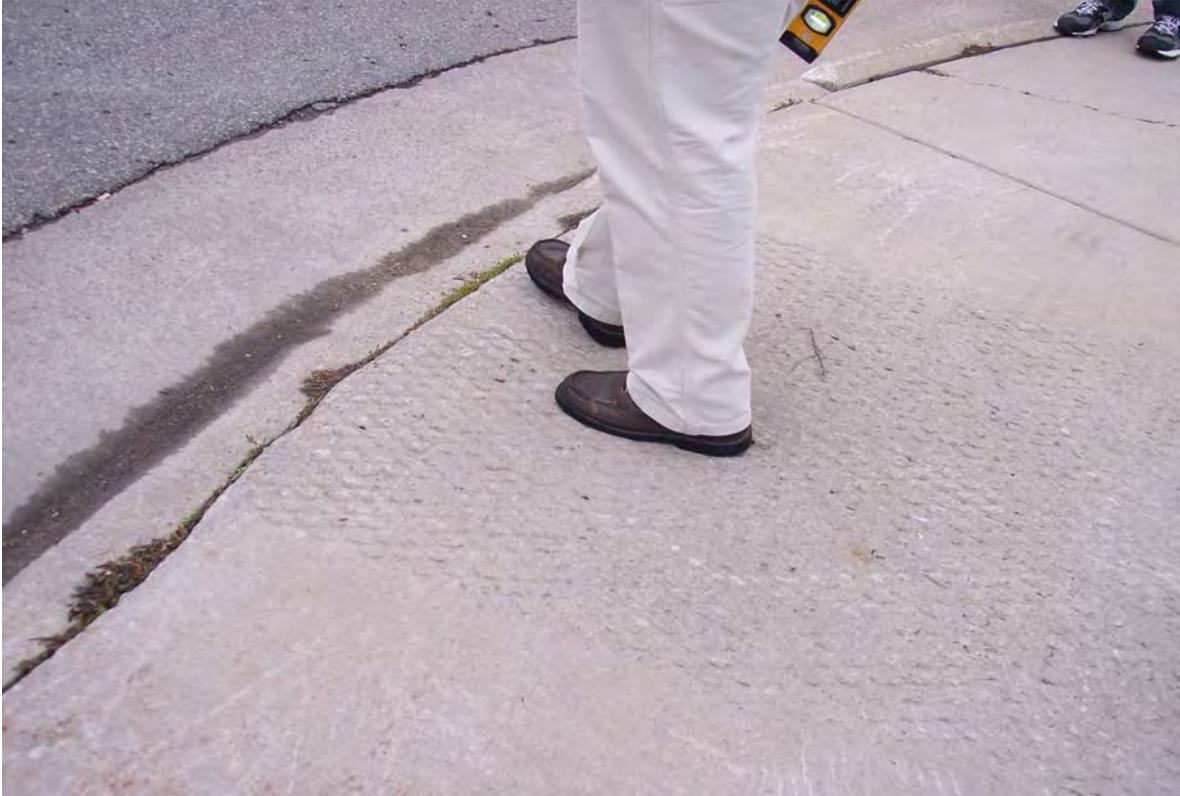
The pedestrian ramp at Racine Road and 12th Street is aligned diagonally. The slope on this ramp is greater than 8%. There are no crosswalks at this intersection. There is a tripping hazard. There is no pedestrian ramp on the north side.

Recommend 2 separate ramps that are ADA compliant, 2 separate pedestrian push buttons that are ADA accessible, and 2 separate countdown pedestrian signals with countdown pedestrian signing on each corner of the intersection.

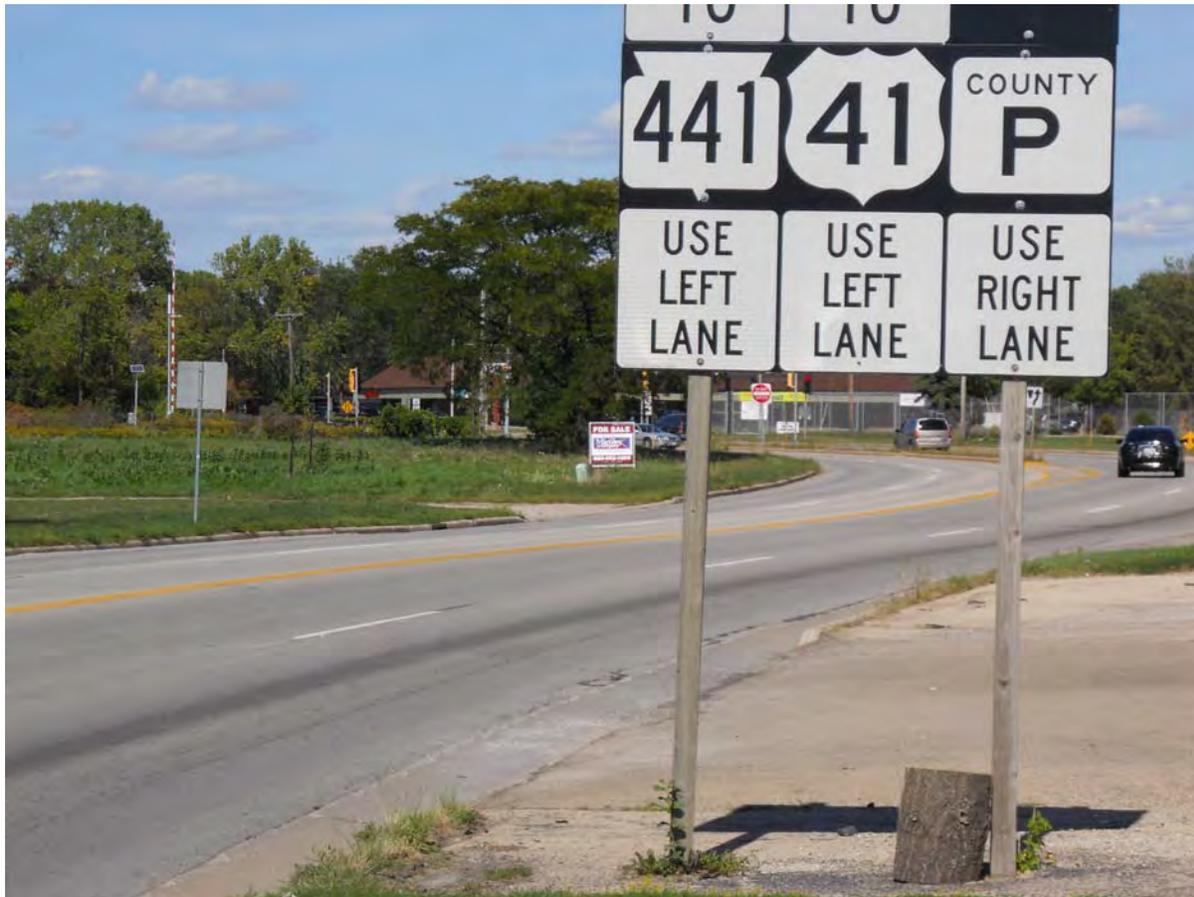
There are driveway accesses to the Citgo gas station and other businesses onto Racine Road that do not have left turn lanes. Vehicles were observed decelerating and stopping in the left through lane to turn into these driveways.
