Road Safety Audit REPORT

WIS 441 Tri-County Project

Date: Apr 25-26, 2012

Realignment of WIS 441 and reconstruction of five interchanges.

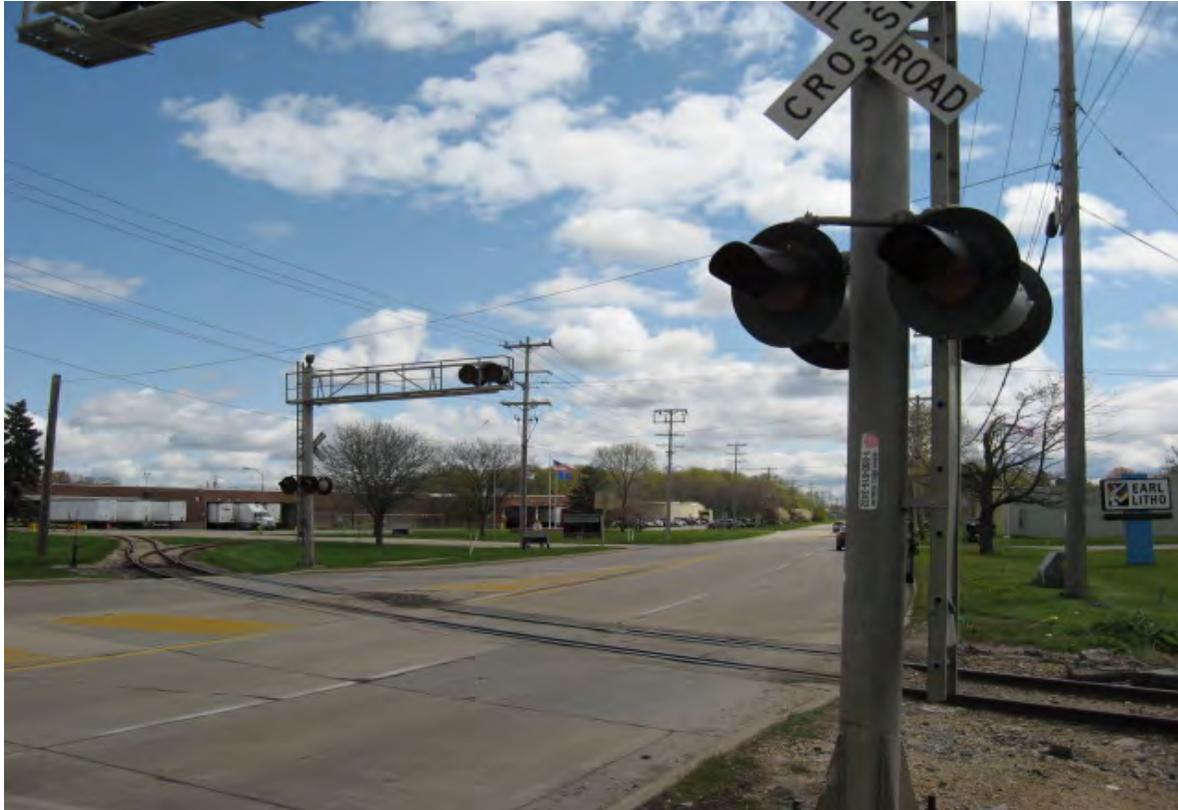
There are overhead power lines near the railroad crossing at Midway Road. These may cause OSHA clearance issues during construction.

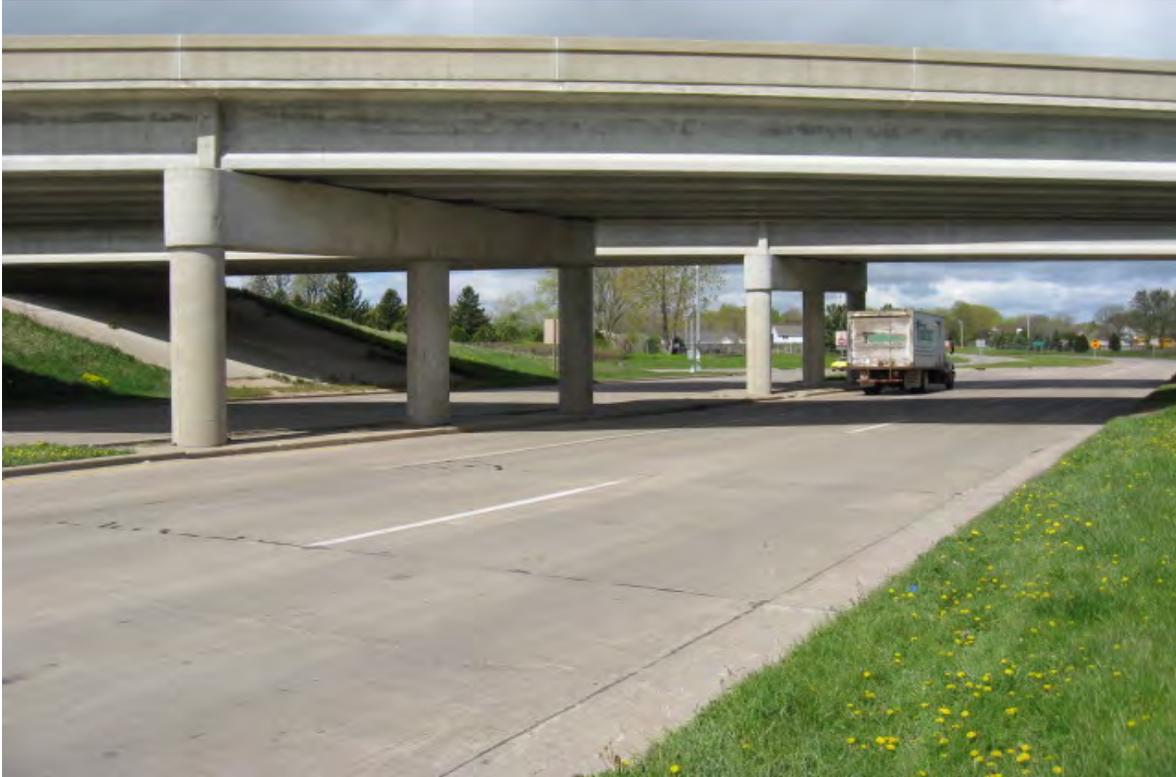
There are bridge piers in the median that are within the clear zone. The bridge piers may be a hazard to motorists that run off the road into the median area. The bridge piers are not shielded.

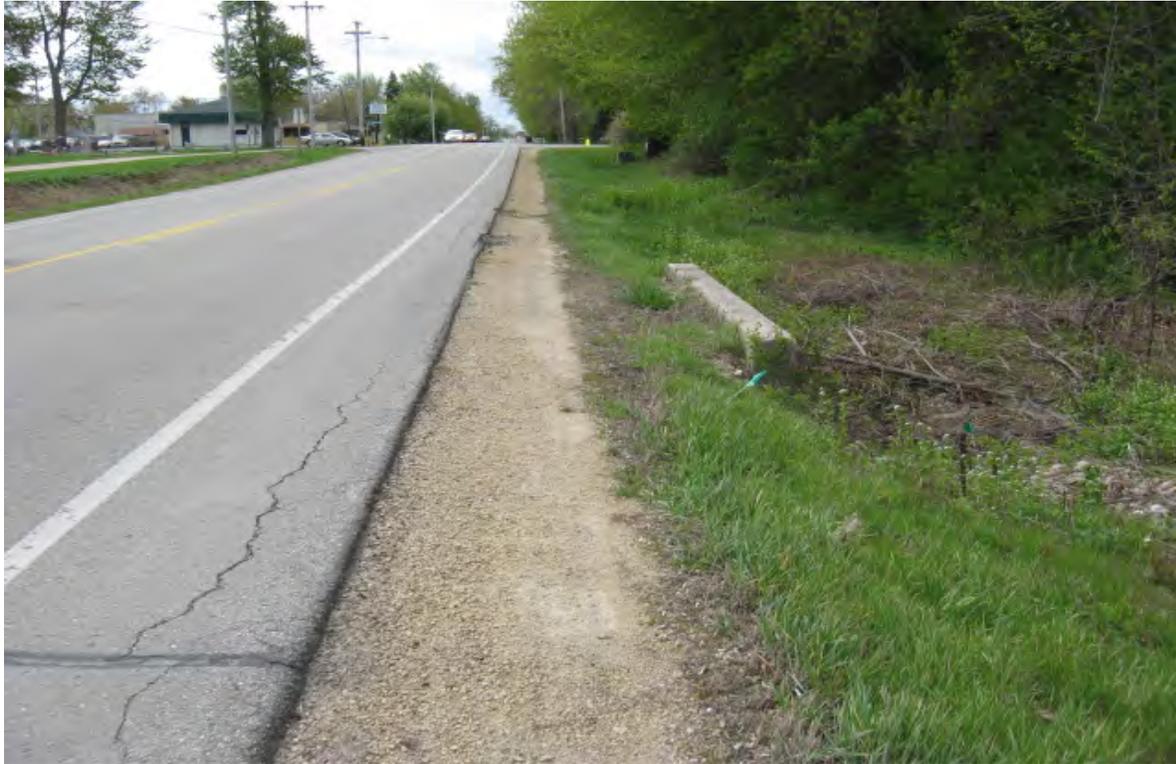
Near the St. Johns cemetery on Racine Road, south of the T-intersection with Midway Road, there are headwalls and a ditch within the clear zone. These present roadside hazards for a vehicle that runs off the road. They are not shielded.

Remove the potential hazards from the clear zone through reconstruction. If this is not possible, shield the mitered end sections and steep back slopes.

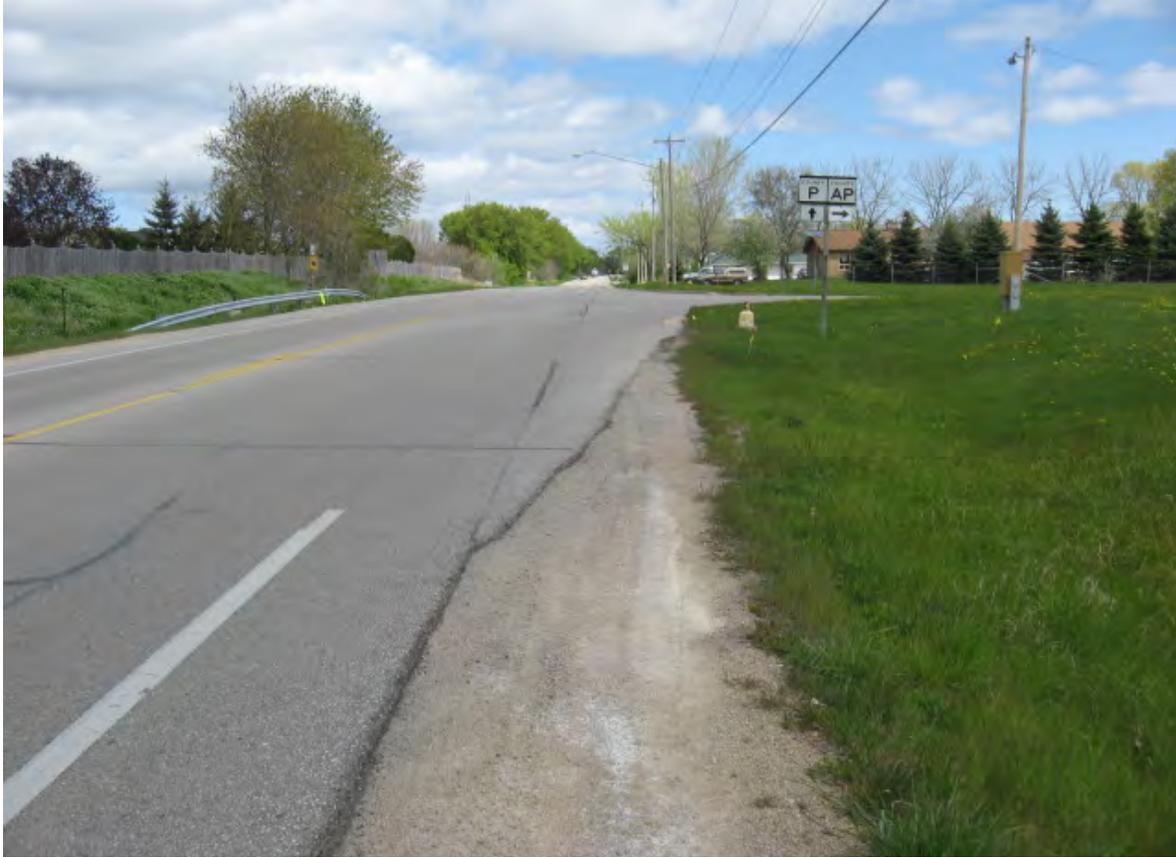
There is not a northbound right turn lane or a southbound left turn lane at the T-intersection of Midway Road and Racine Road. Auxiliary lanes remove turning vehicles from the through lanes and provide an area for deceleration and queuing.

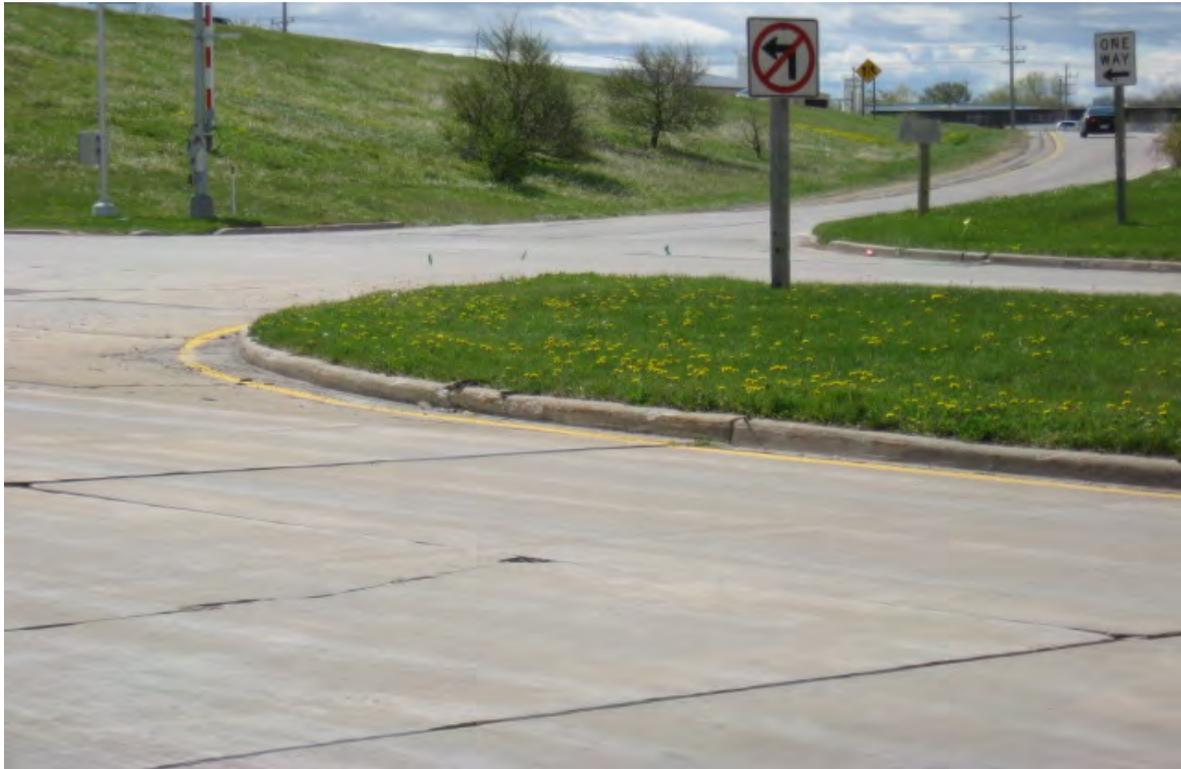
There are no sidewalks, ramps, and other pedestrian features at the intersection of Midway Road and WIS 441. This area is not ADA compliant. Not having pedestrian facilities causes the pedestrians to walk on the shoulder of the roadway exposing them to safety issues.

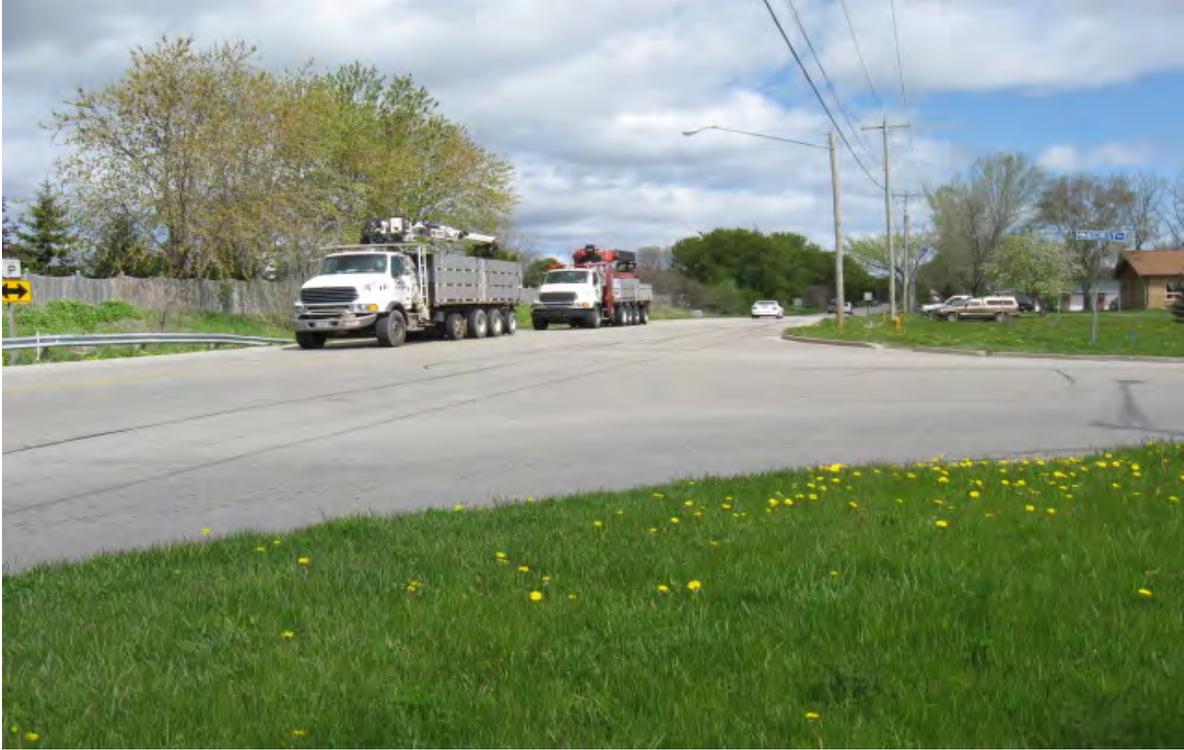
There are no sidewalks and sidewalk ramps at the intersection of Midway Road and Racine Road. This area is not ADA compliant. Not having pedestrian facilities causes the pedestrians to walk on the shoulder of the roadway exposing them to safety issues.

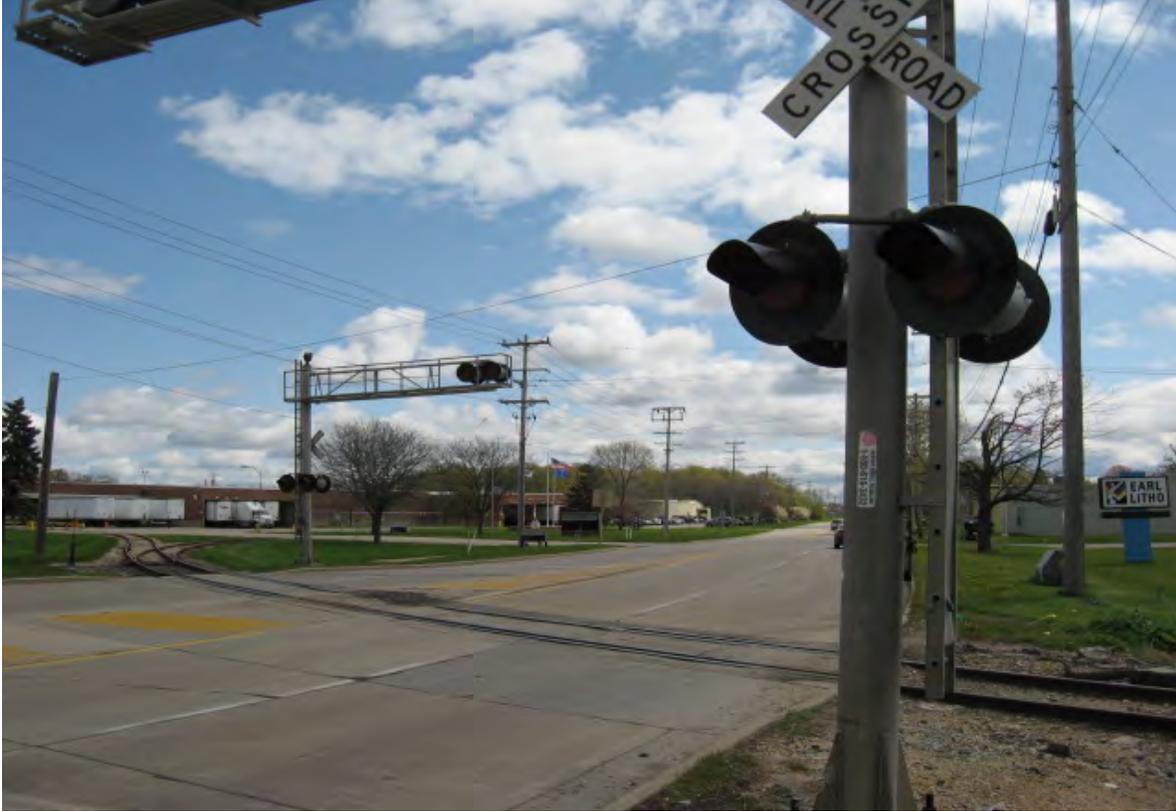
Sidewalk is planned across the railroad tracks. This could cause potential ADA issues.

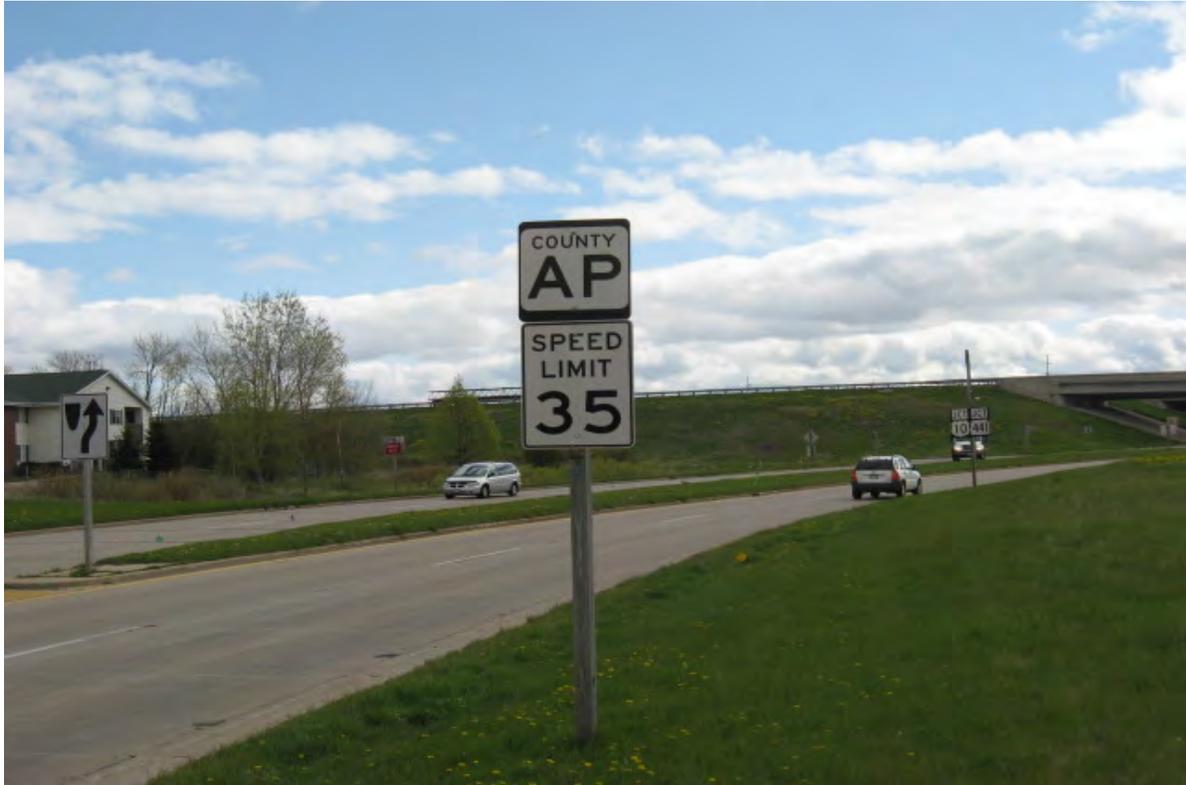
Multiple signs are mounted on the same post. This can cause an overload of information to the motorist or convey confusing or conflicting messages. The sign panels for Speed Limit 35 mph and County AP are on the same post.

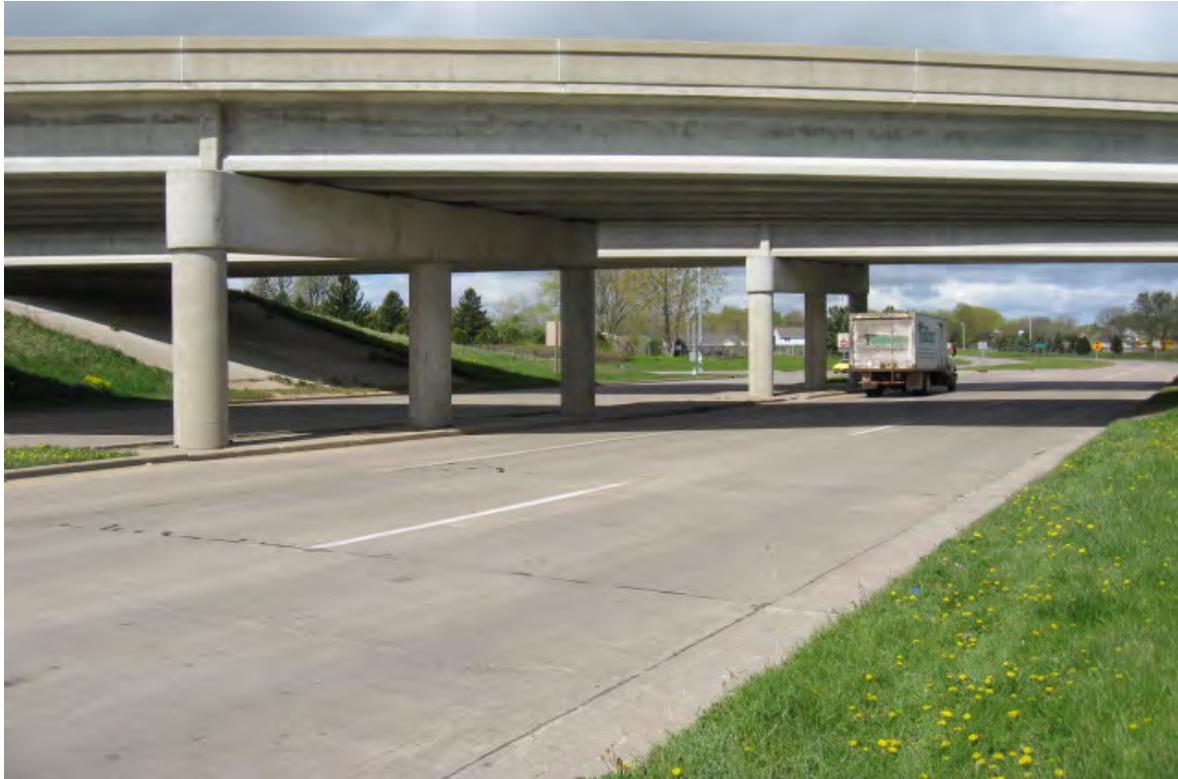
There are no contrast pavement markings or reflective pavement markers at Midway Road and WIS 441. There are currently white pavement markings for the edge lines and lane lines that do not have contrast markings on areas of concrete pavement. This can cause low visibility of the striping over time. Reflective pavement markers help to delineate the roadway for motorists at night and in inclement weather.

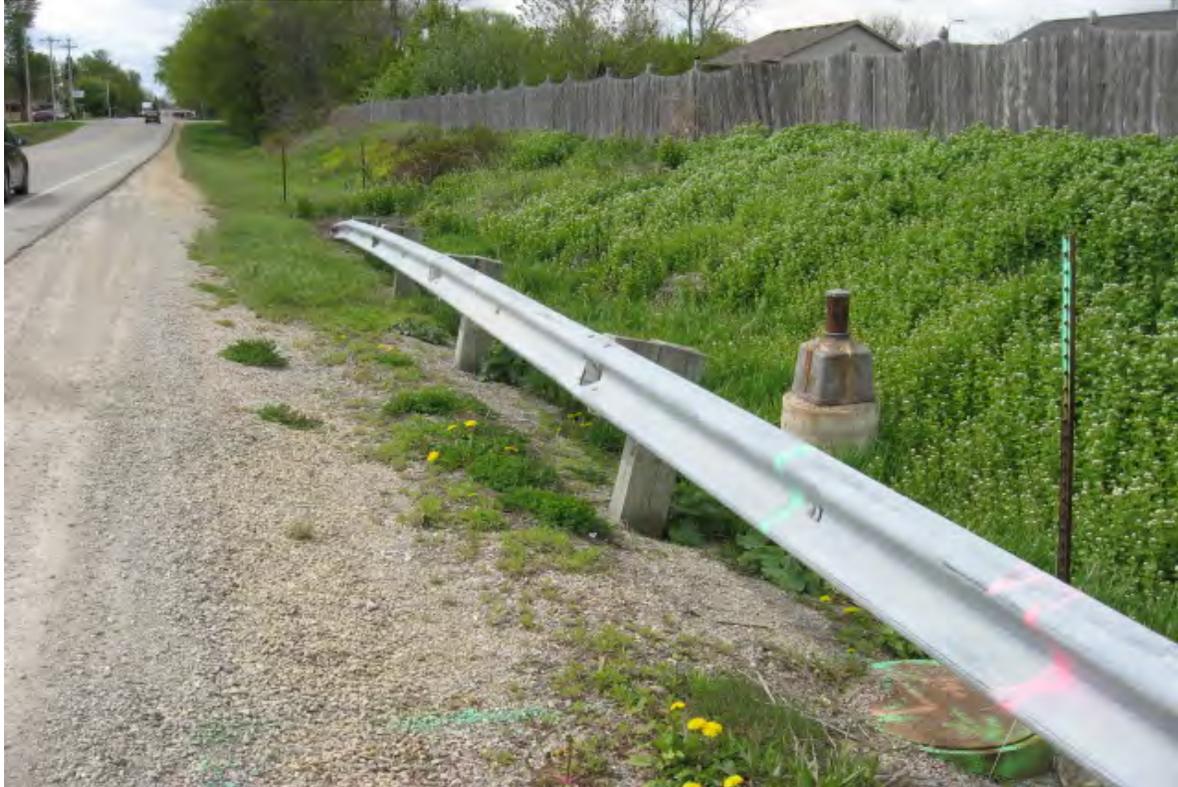
Issue 87: Old signal foundations and equipment

At the T-intersection between Midway Road and Racine Road, there are old signal foundations and equipment on the roadside which could pose a potential hazard.

Remove all unused signal equipment throughout the area of the intersection. This will remove any potential safety hazard from these obstacles.

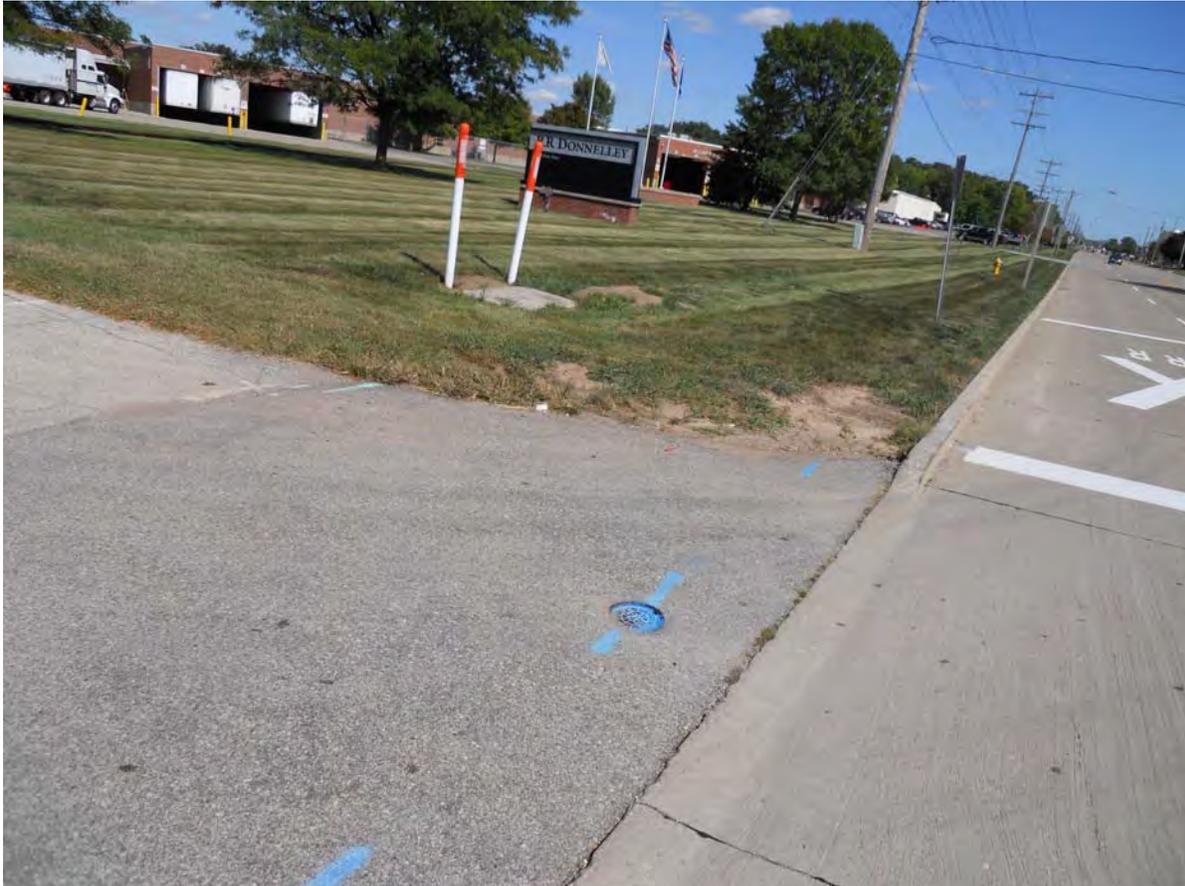
There are no radial returns in the driveway access to RR Donnelley across from Earl Street.

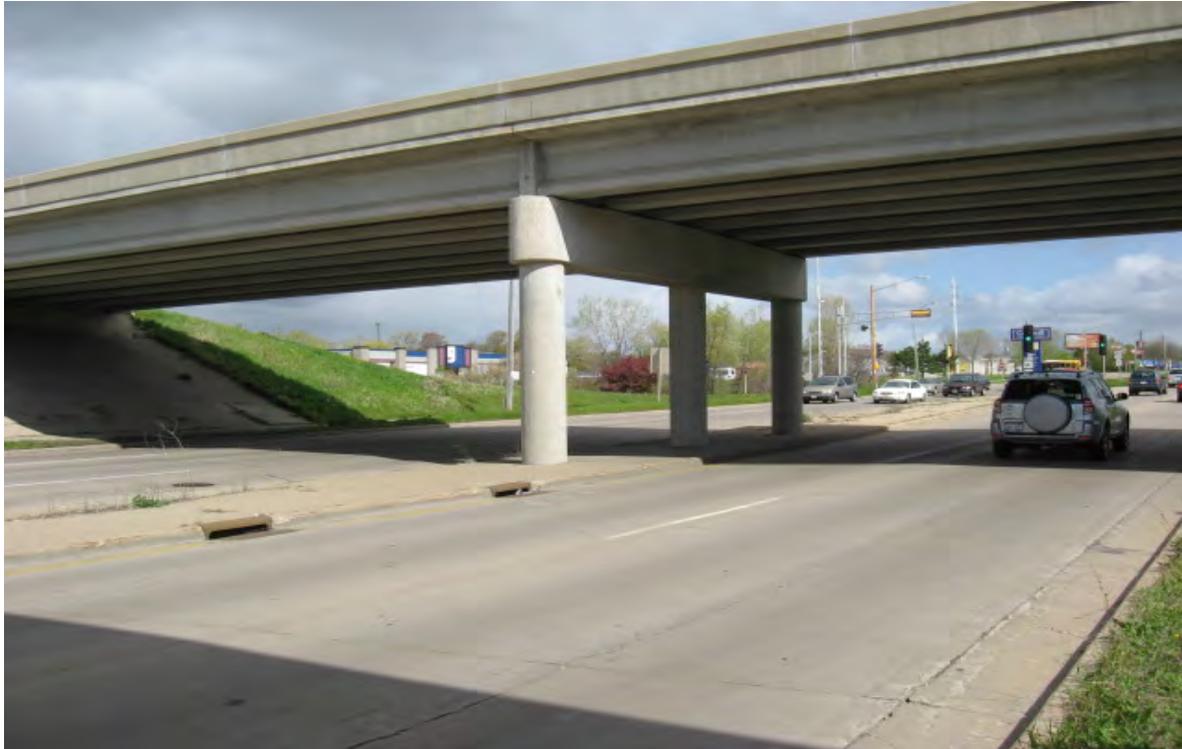
There are bridge support piers in the median within the clear zone that are unshielded. The bridge piers may be a hazard to motorists that run off the road into the median area.

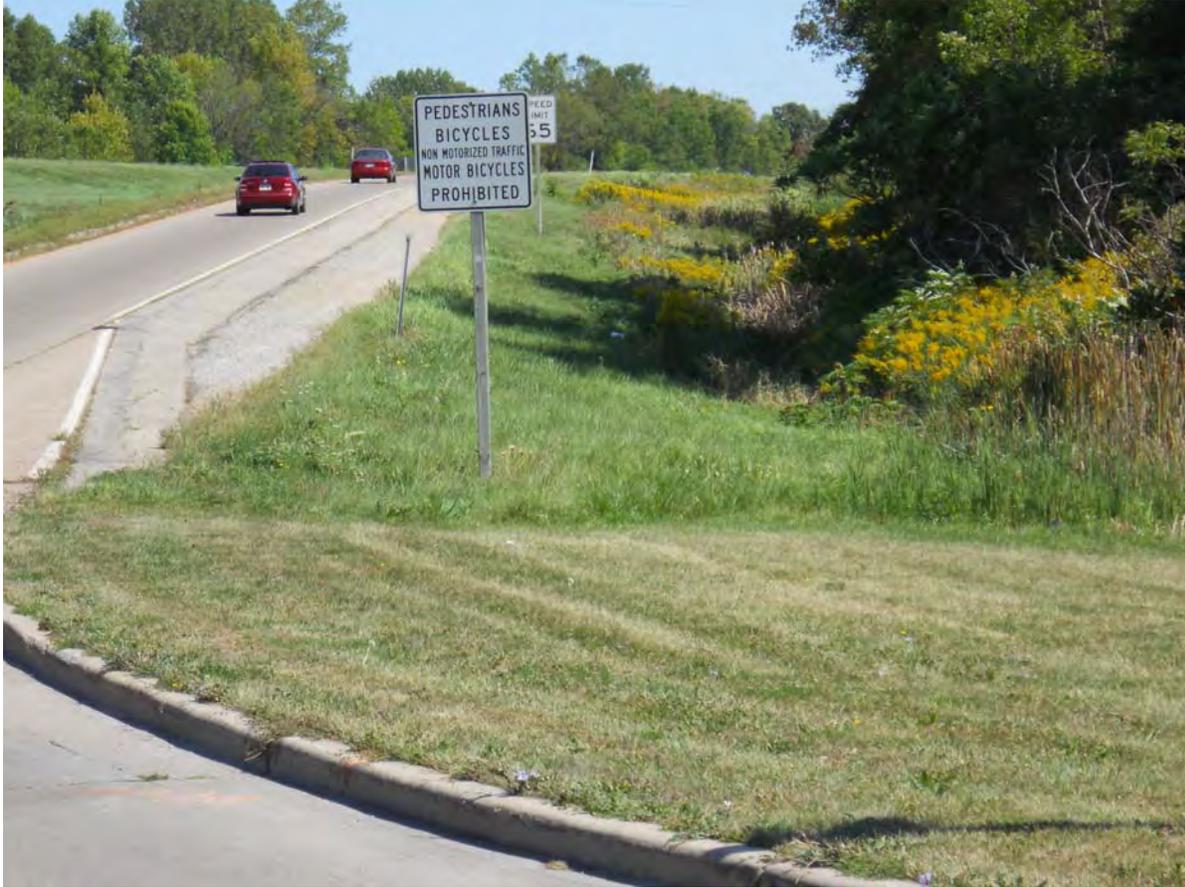
There are unshielded unrecoverable front slopes on Appleton Road, south of WIS 441. This is a safety issue for vehicles that run off the road in this area.

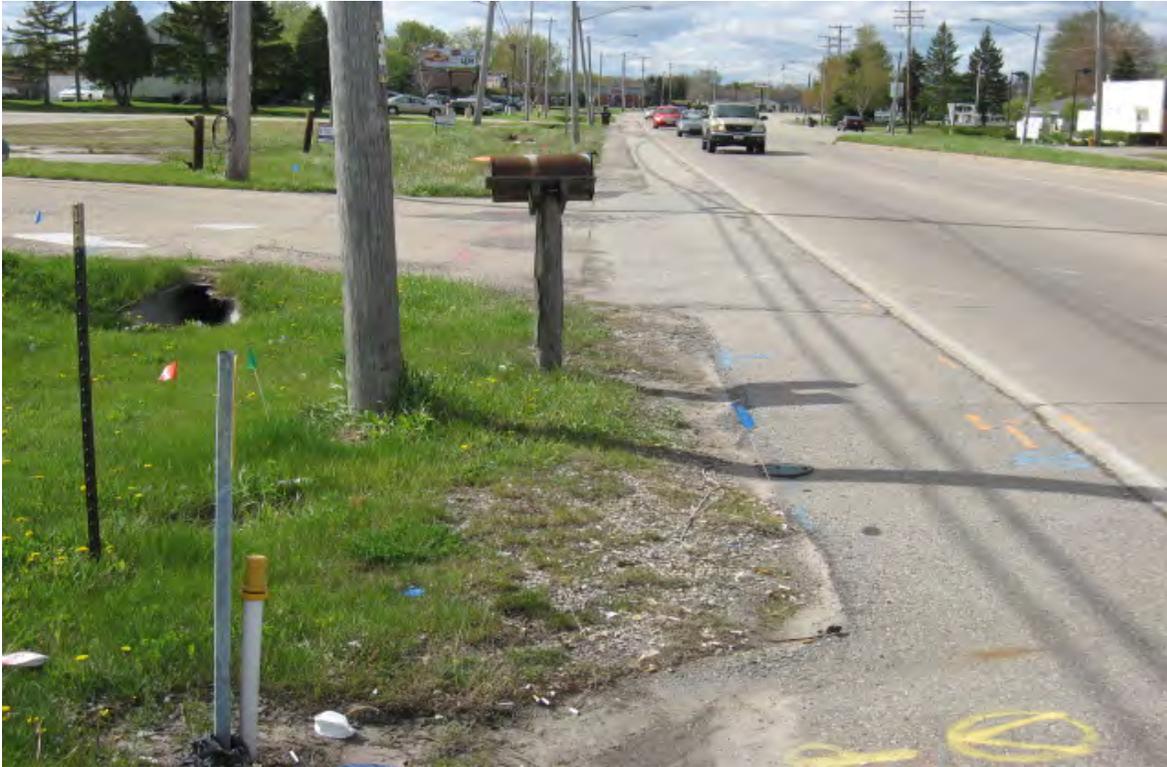
South of intersection of Appleton Road with Midway Road, there are wooden light poles within the clear zone. These present a hazard for vehicles that run off the road in this area.

Relocate the wooden light poles outside the clear zone, or replace them with aluminum poles with a transformer base.

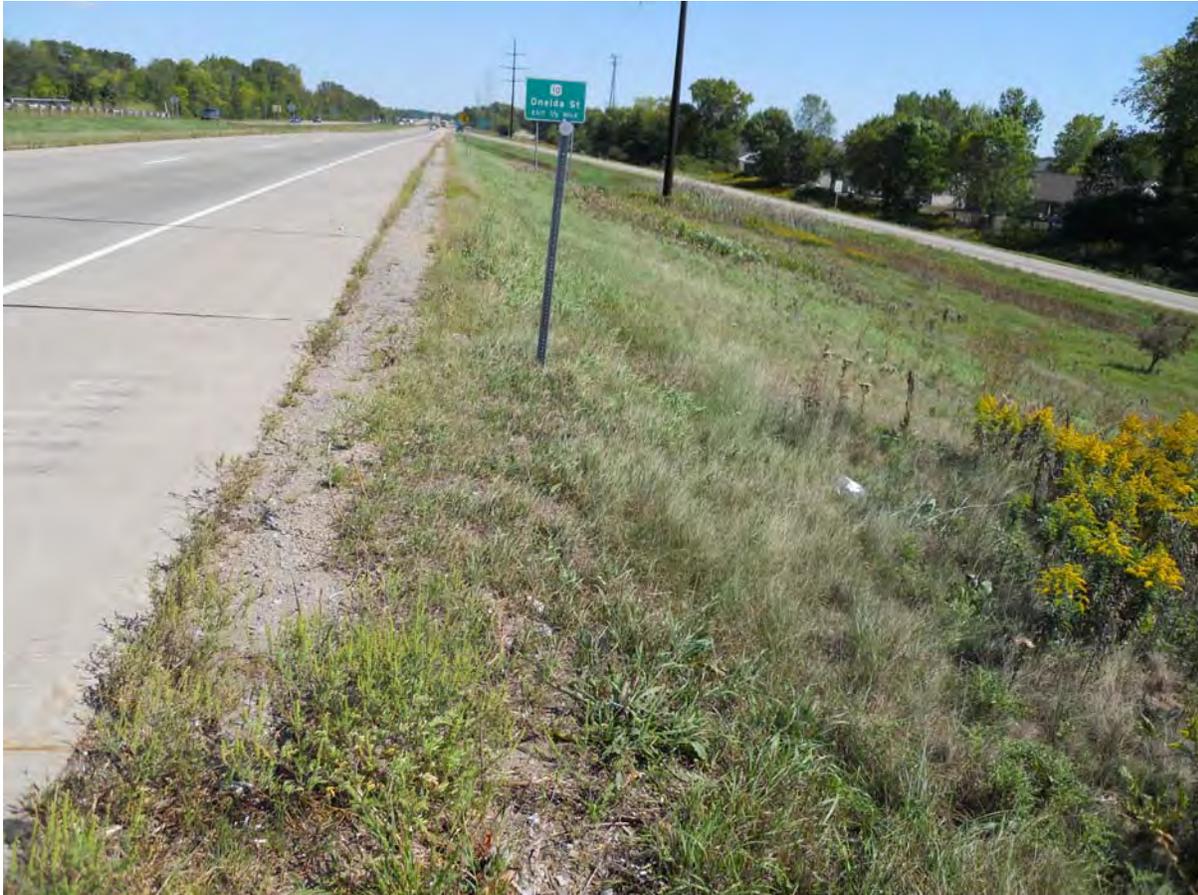
The front slope on the right side of westbound WIS 441 west of Appleton Road is 43%. Also, the slope into the ditch in the median is steep. These slopes are considered to be unrecoverable.

Reconstruct the shoulder and median area to remove the slopes that are considered to be unrecoverable. If this is not possible, shield the potential hazards.

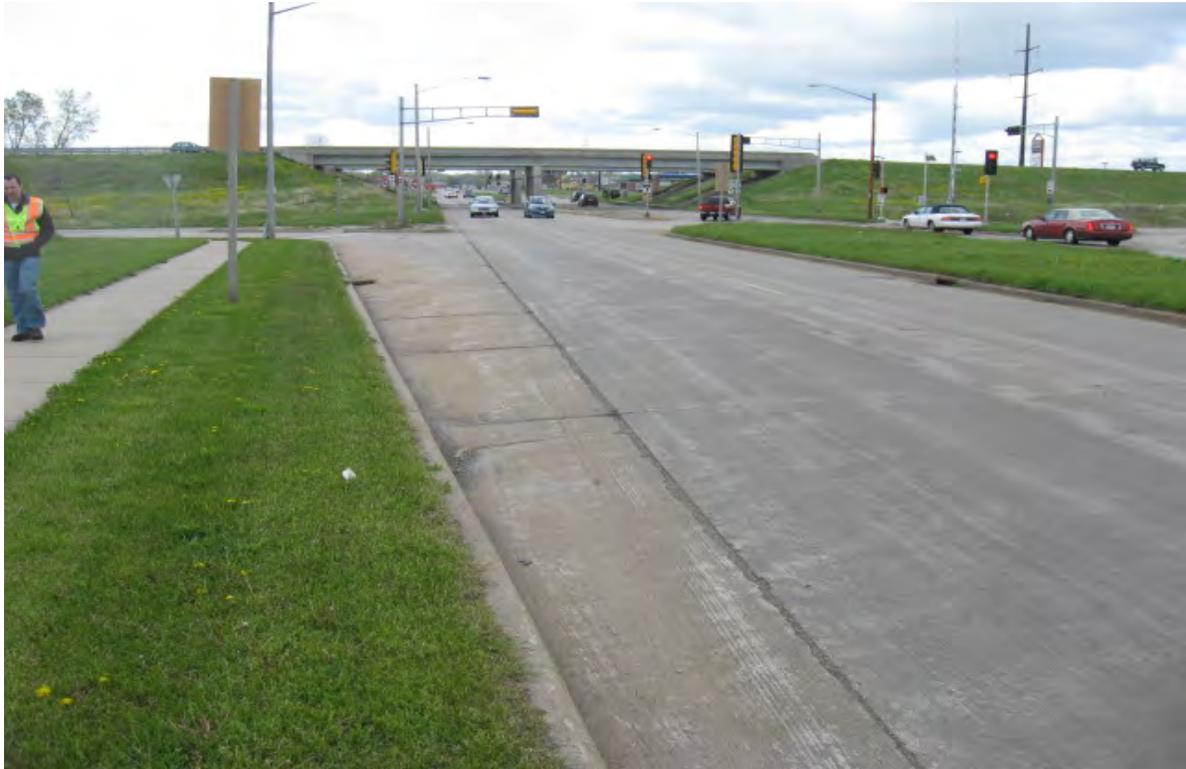
There is an acceleration taper for right turns from the WIS 441 off-ramp. This creates a larger conflict area for right turning vehicles at the intersection. It also causes motorists to look at a more severe angle for a gap in traffic.

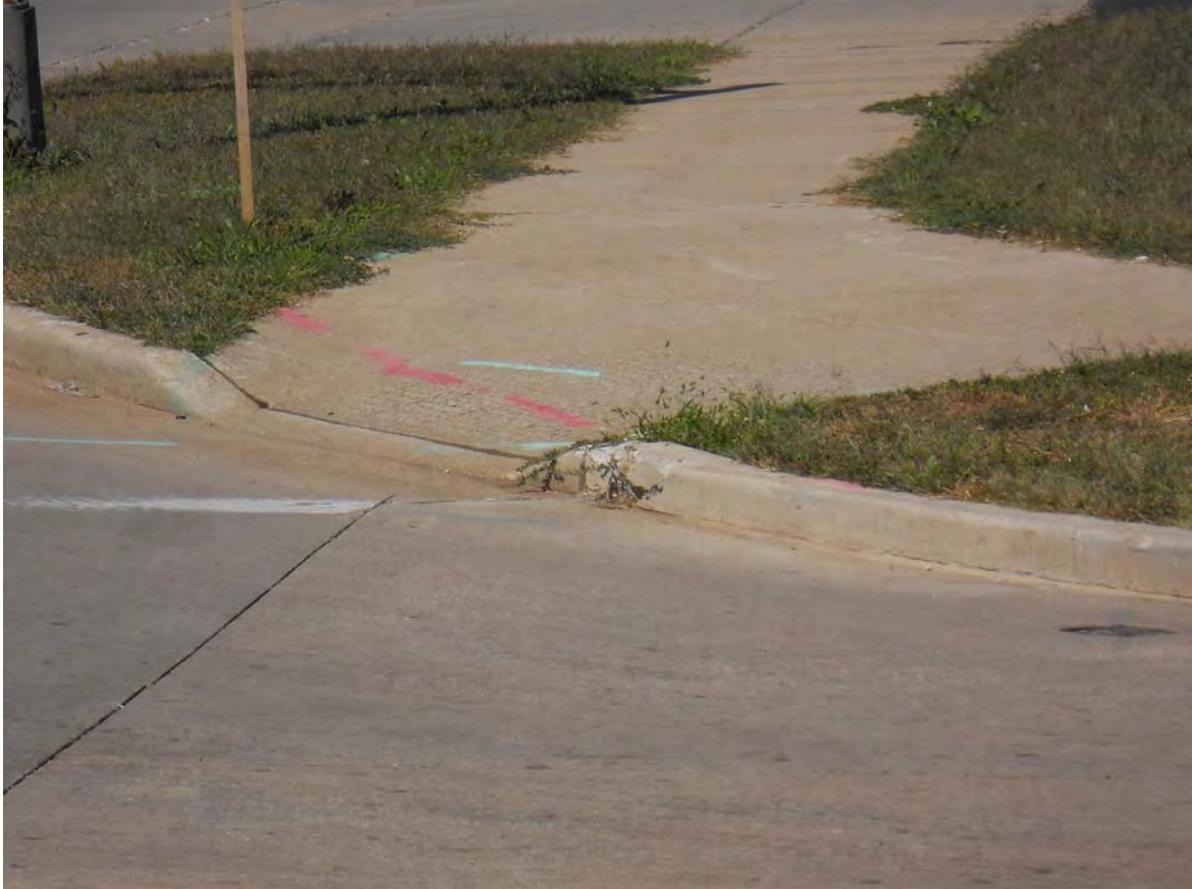
The cross slope on the sidewalk at the NE corner of Midway Road and Appleton Road is 5%. This is not in compliance with ADA guidelines which allows a maximum cross slope of 2%.

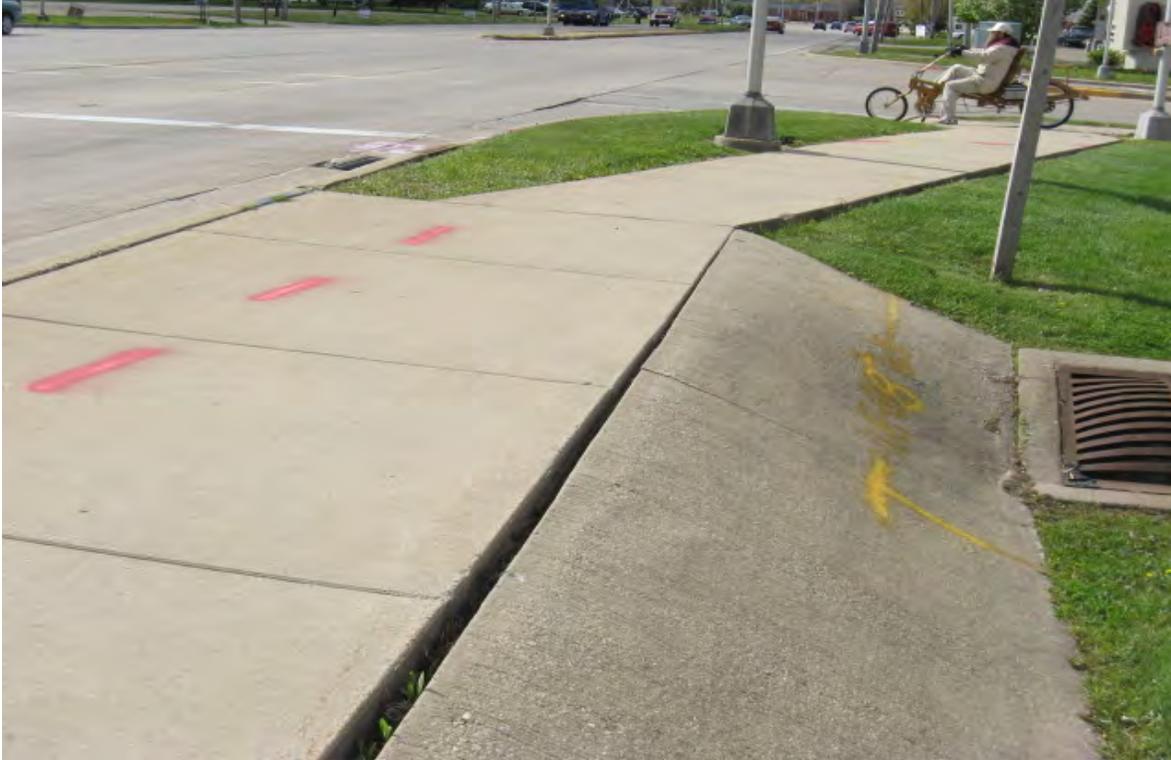
Issue 100: Drop off hazard

There is an unshielded drop off hazard at the NW corner of Midway Road and Appleton Road.

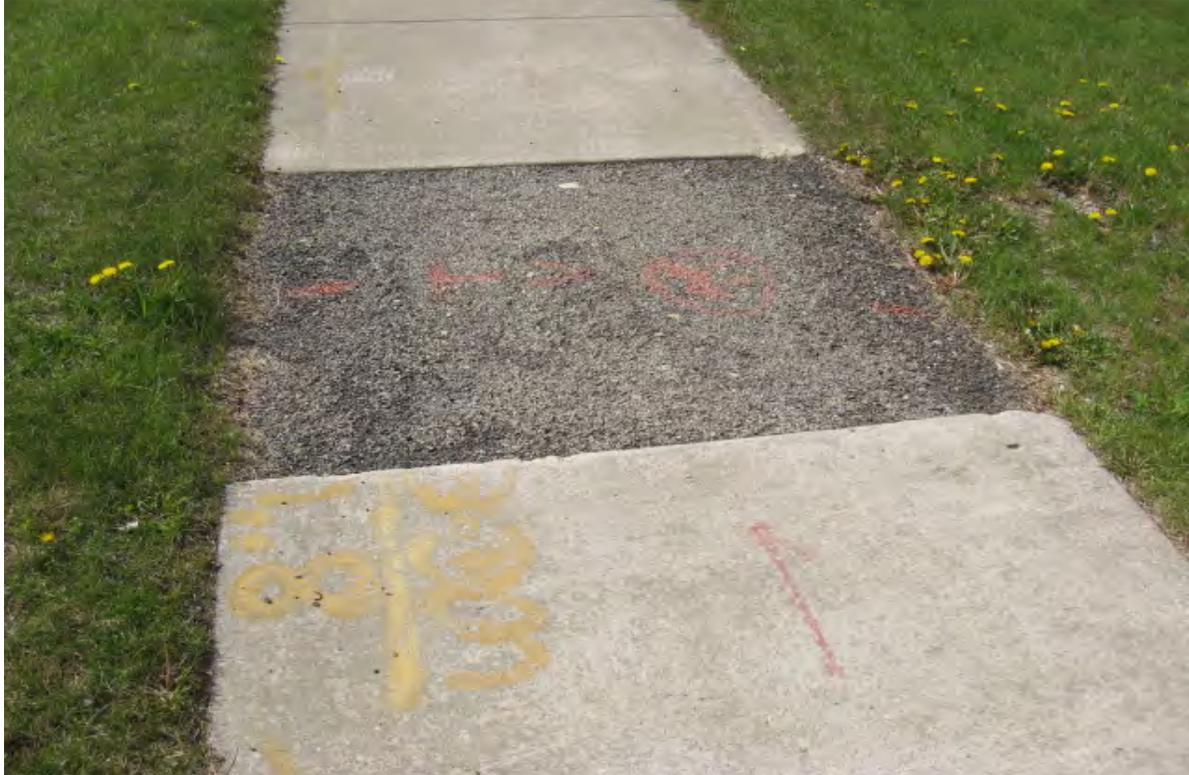
Issue 101: Missing section of sidewalk

On Appleton Road between Valley Road and the WIS 441 ramps, there is a missing section of sidewalk. This is not in compliance with current ADA guidelines.

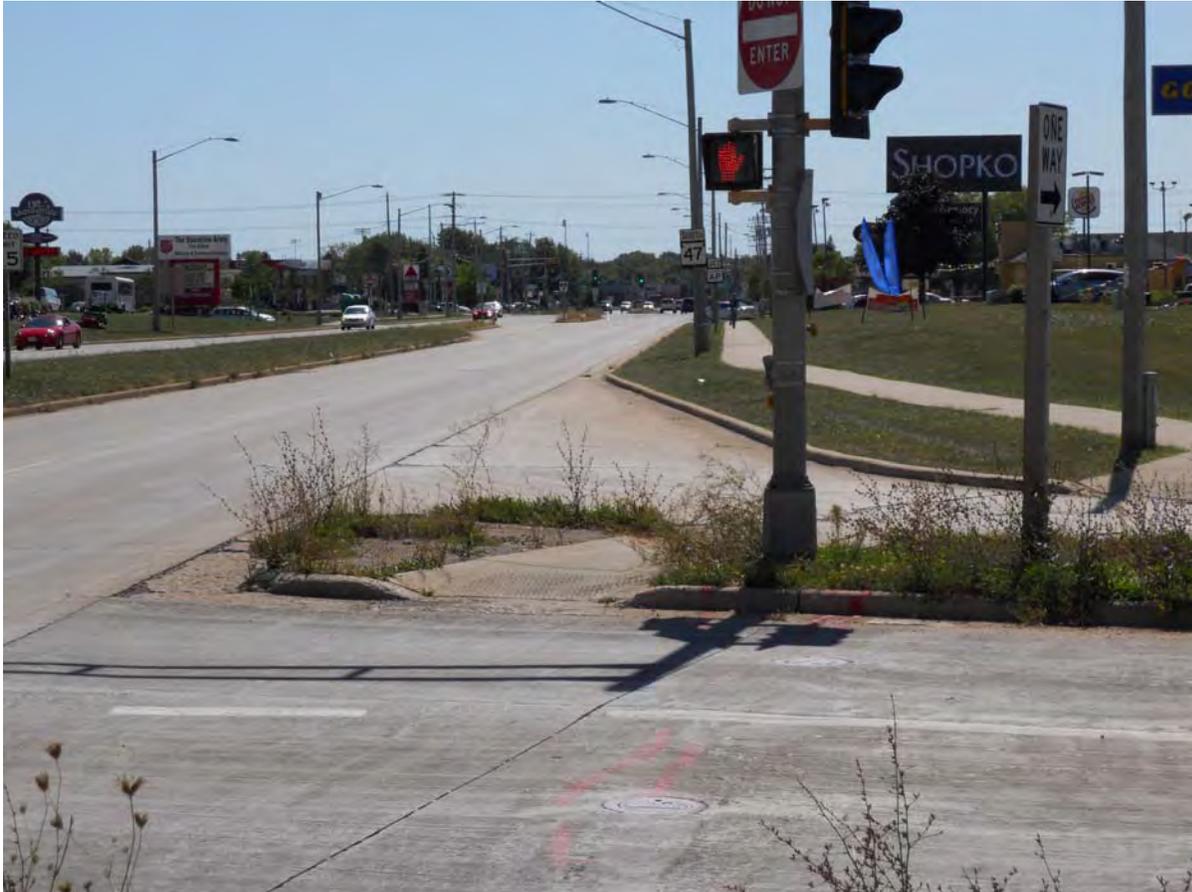
The countdown pedestrian signal across the west side of the eastbound WIS 441 WB ramps on Appleton Road has no countdown signs. The instructions for using the pedestrian signal do not match the pedestrian signal in use at this location.

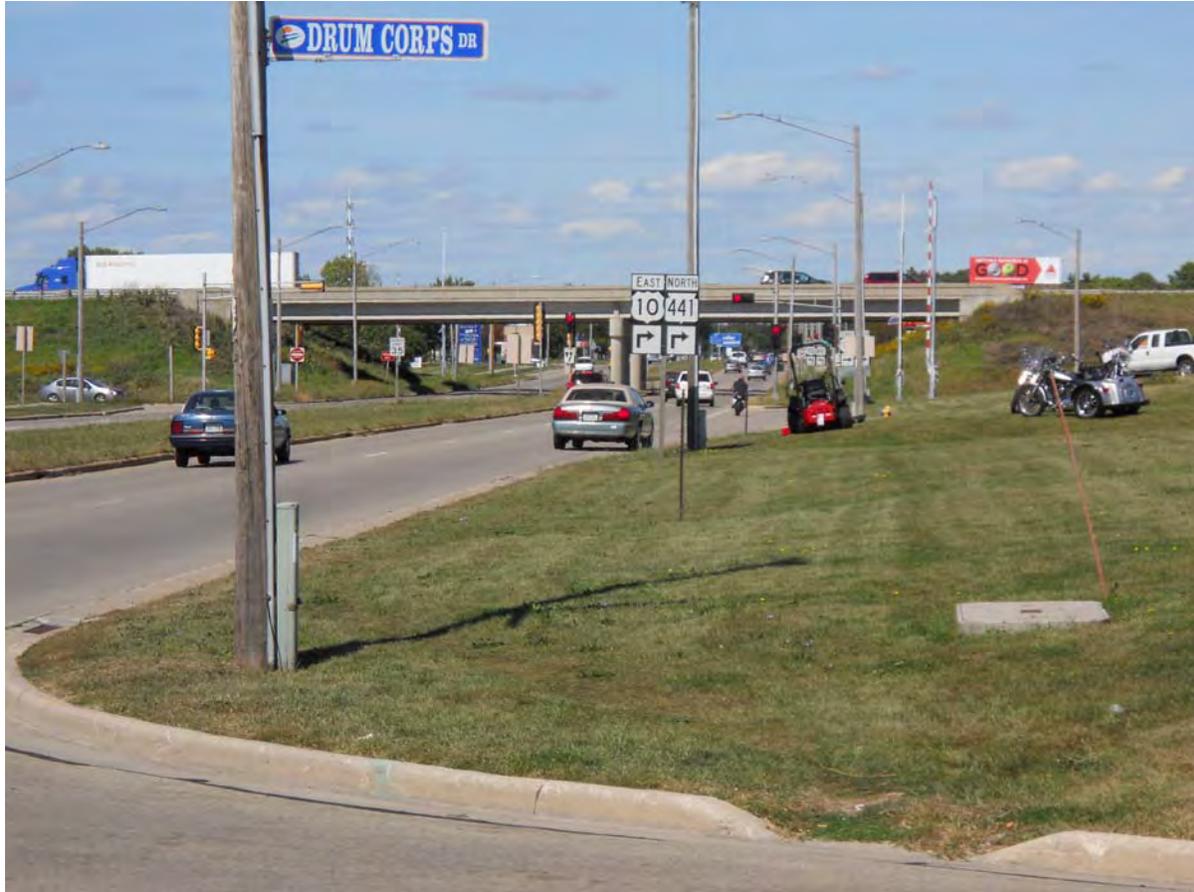
There are no sidewalks or pedestrian ramps north of Drum Corps Drive on the east side of Appleton Road.

Install ADA compliant crosswalks and ramps for pedestrians in this area. Provide pedestrian facilities in the proposed condition.

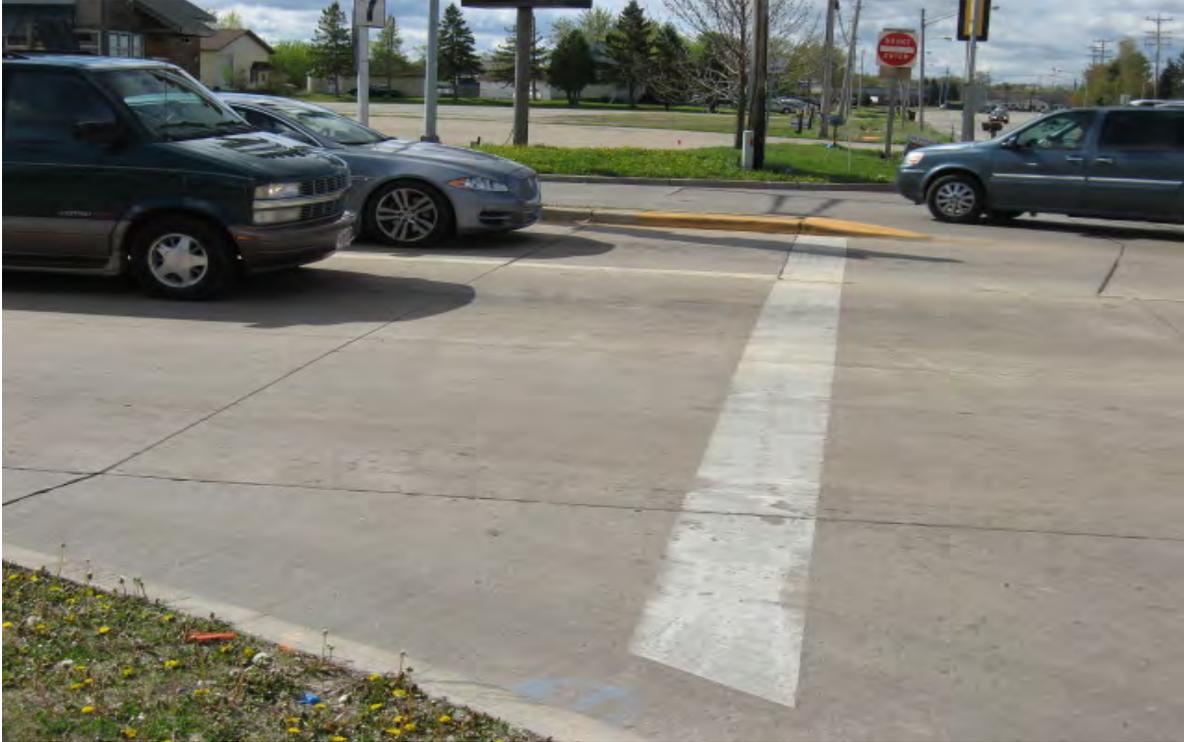
There is an overuse of the "Do Not Enter" signs at Midway Road and Appleton Road. This clutters the roadway and may cause an issue with information overload to the motorist.
