Road Safety Audit REPORT

WIS 441 Tri-County Project

Date: Apr 25-26, 2012

Realignment of WIS 441 and reconstruction of five interchanges.

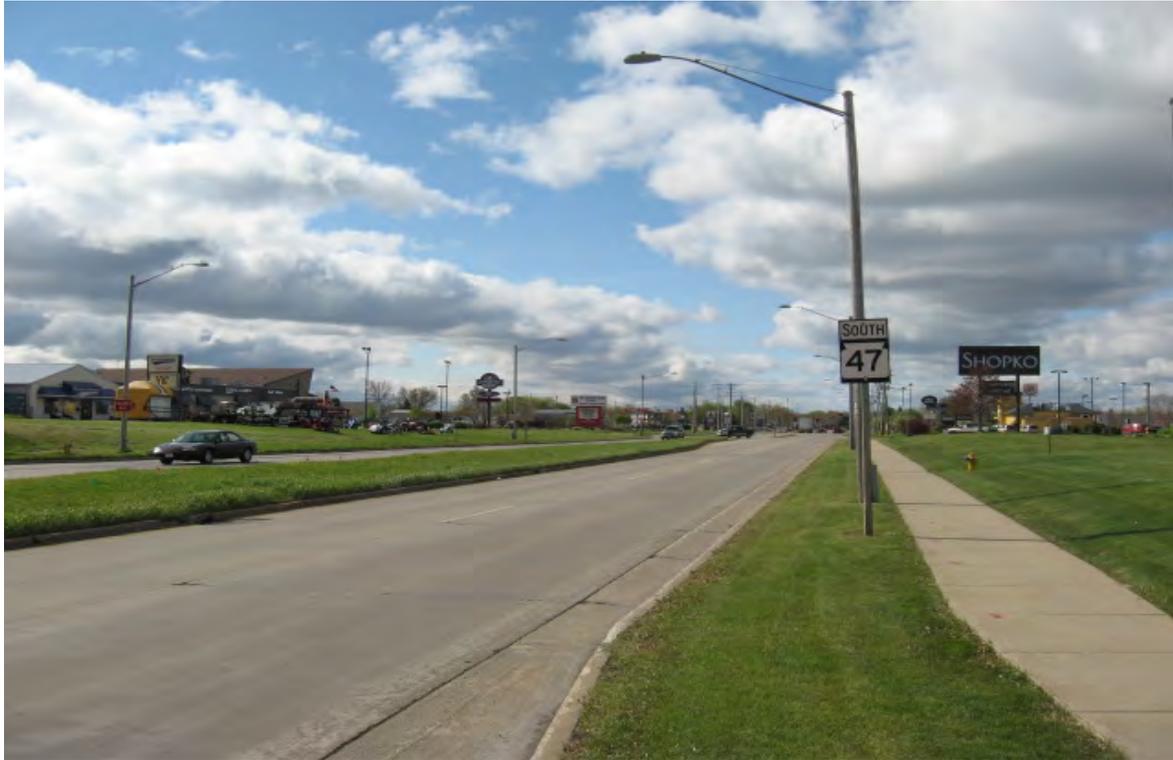
There are currently white pavement markings for the edge lines and lane lines that do not have contrast markings on areas of concrete pavement. This can cause low visibility of the striping over time. There are no reflective pavement markers on Appleton Road. Reflective pavement markers help to delineate the roadway for motorists at night and in inclement weather.

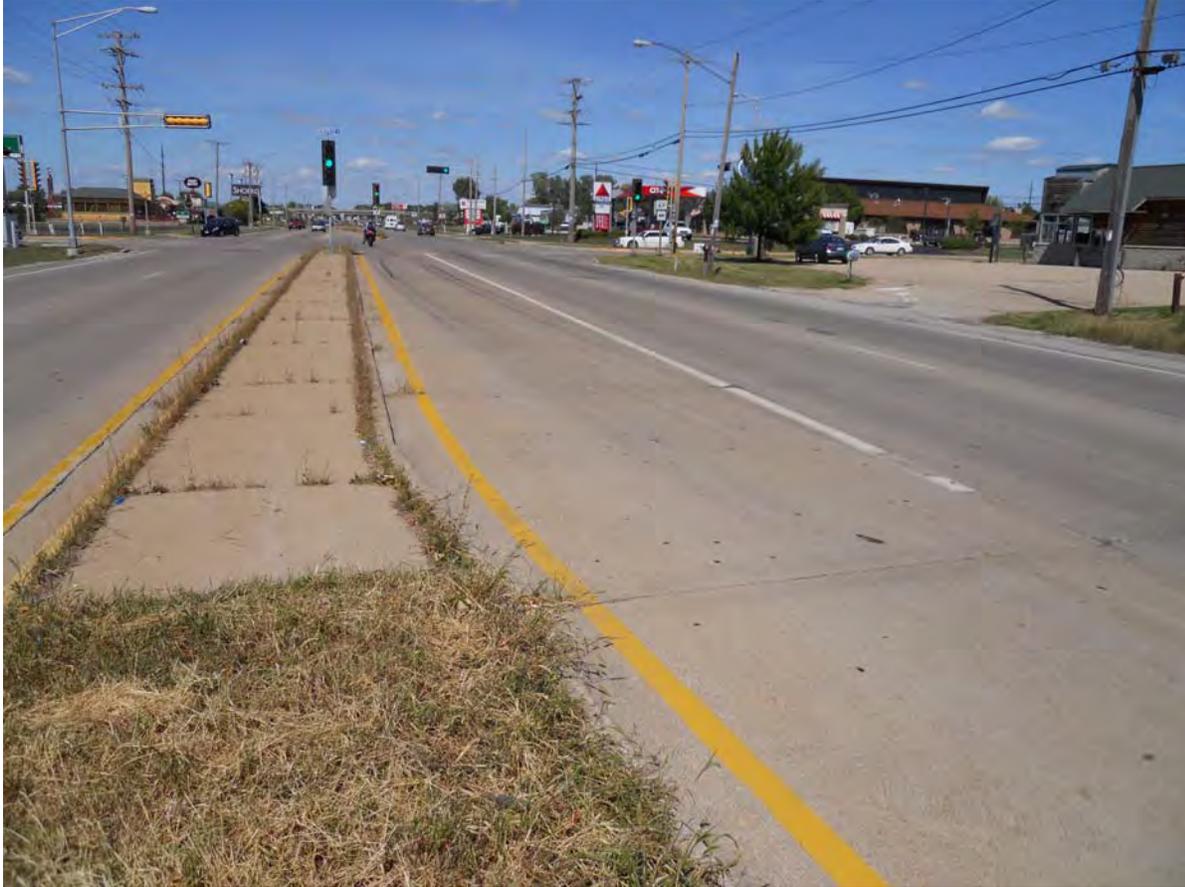
The northbound and southbound left turn lanes at the intersection of Appleton Road with Midway Road do not have left turn arrow pavement markings.

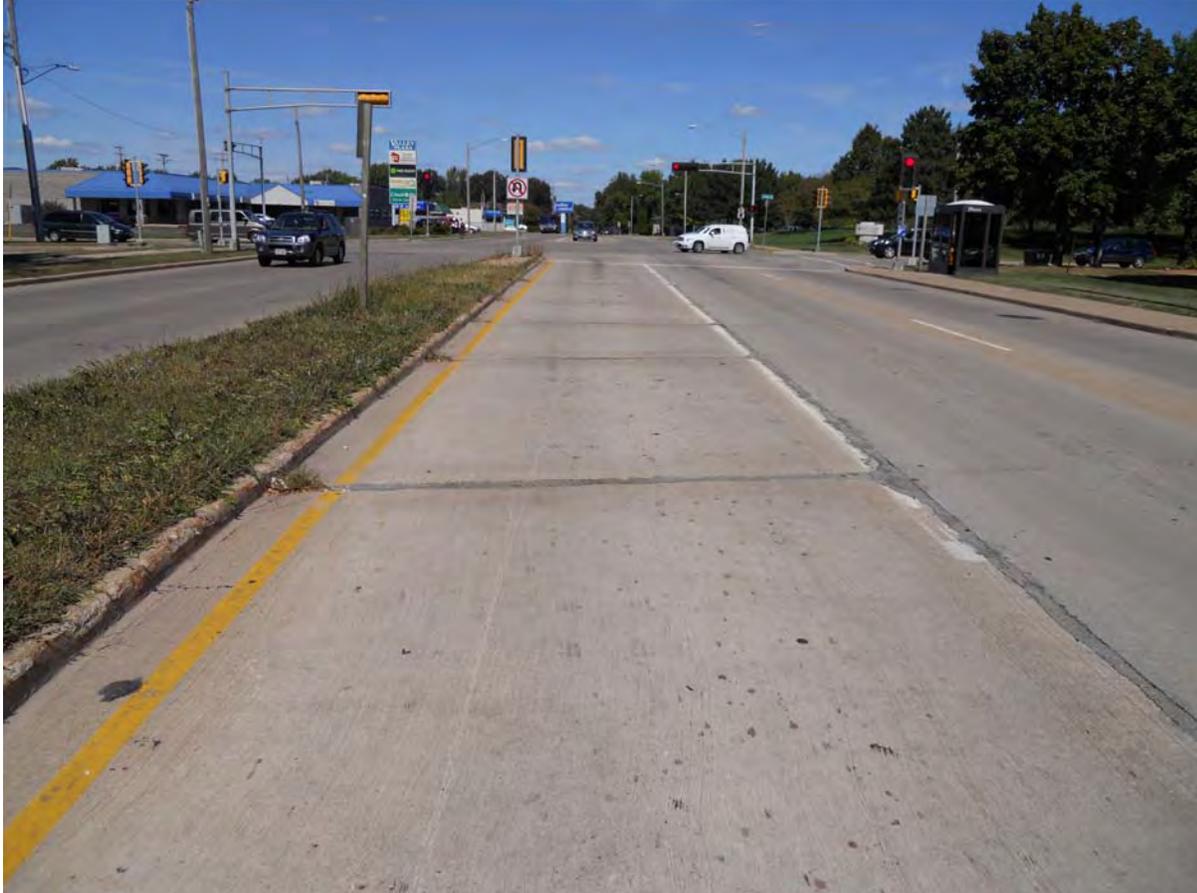
The northbound left turn lane on Appleton Road, north of WIS 441, does not have left turn arrow pavement markings. The median nose is not delineated.

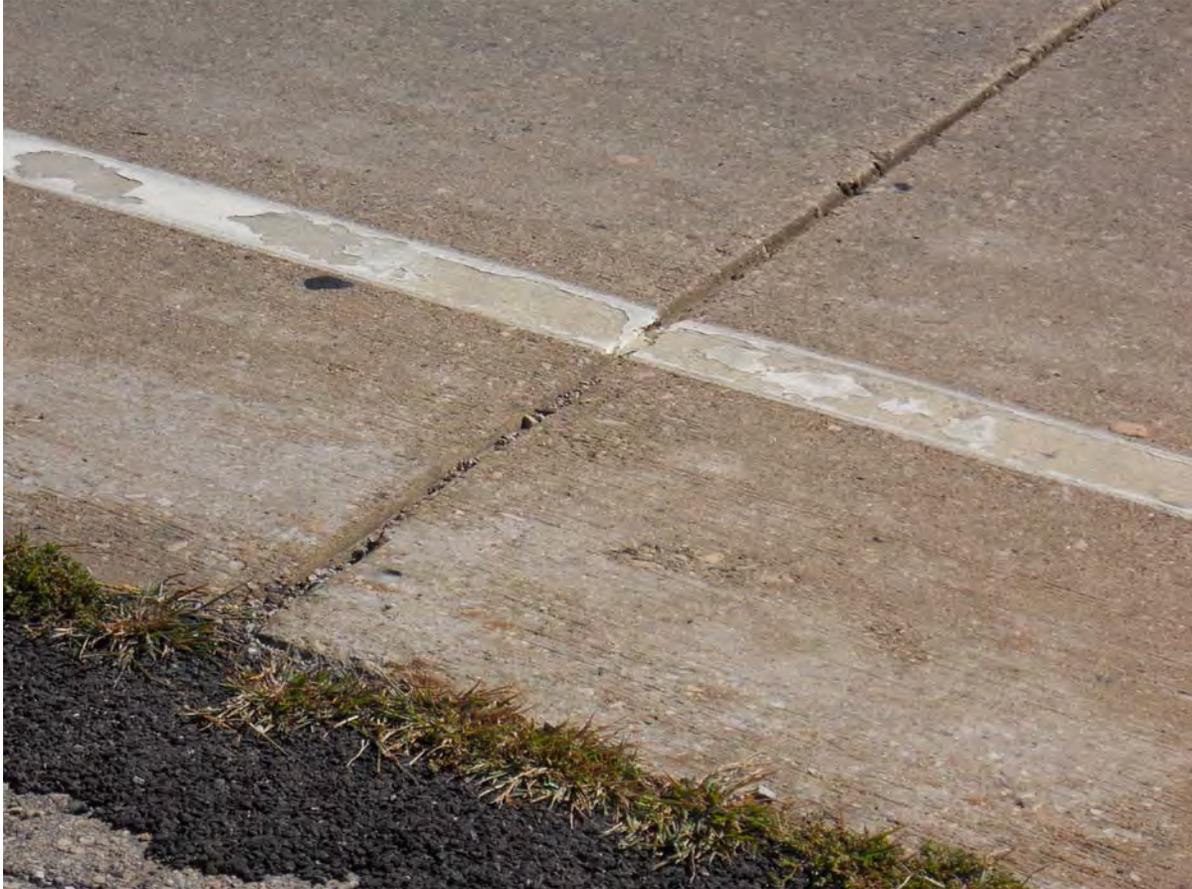
The WIS 441 mainline has standard pavement markings for the edge lines. Many of the crashes in the area occurred during weather events.

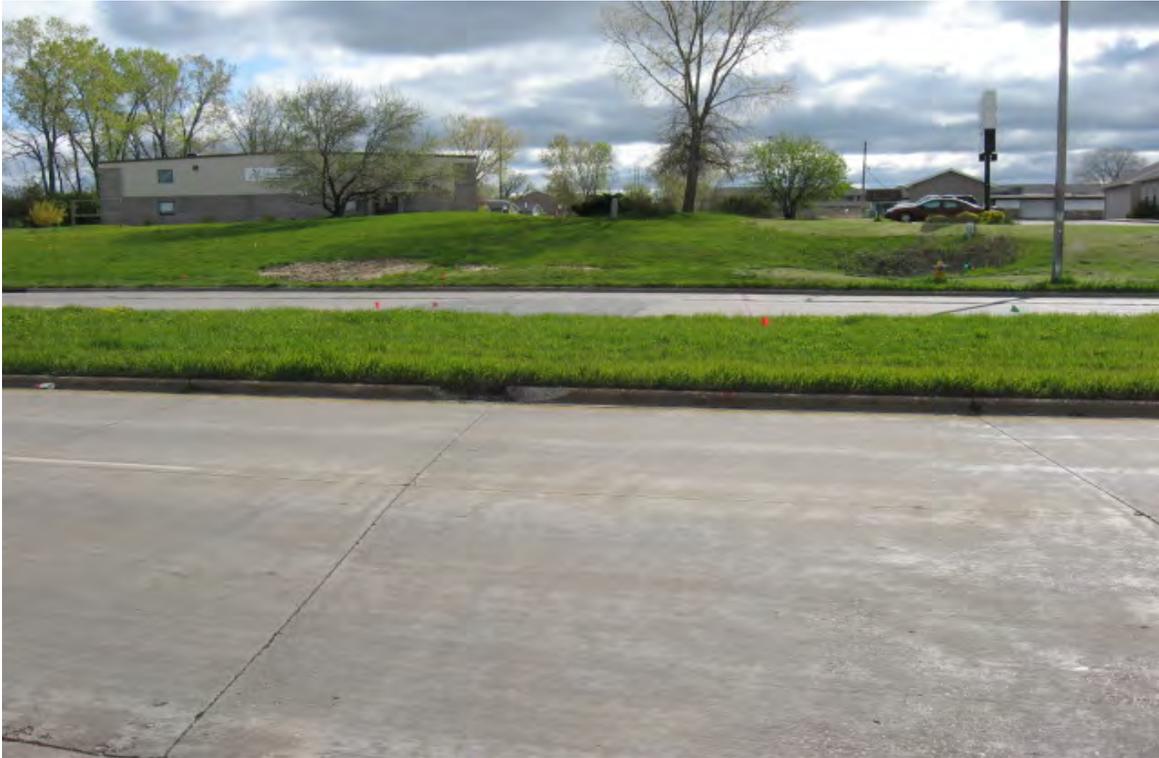
Issue 135: Median curb damaged

The curb in the median is damaged on Appleton Road.

Replace the median on Appleton Road during the proposed reconstruction.

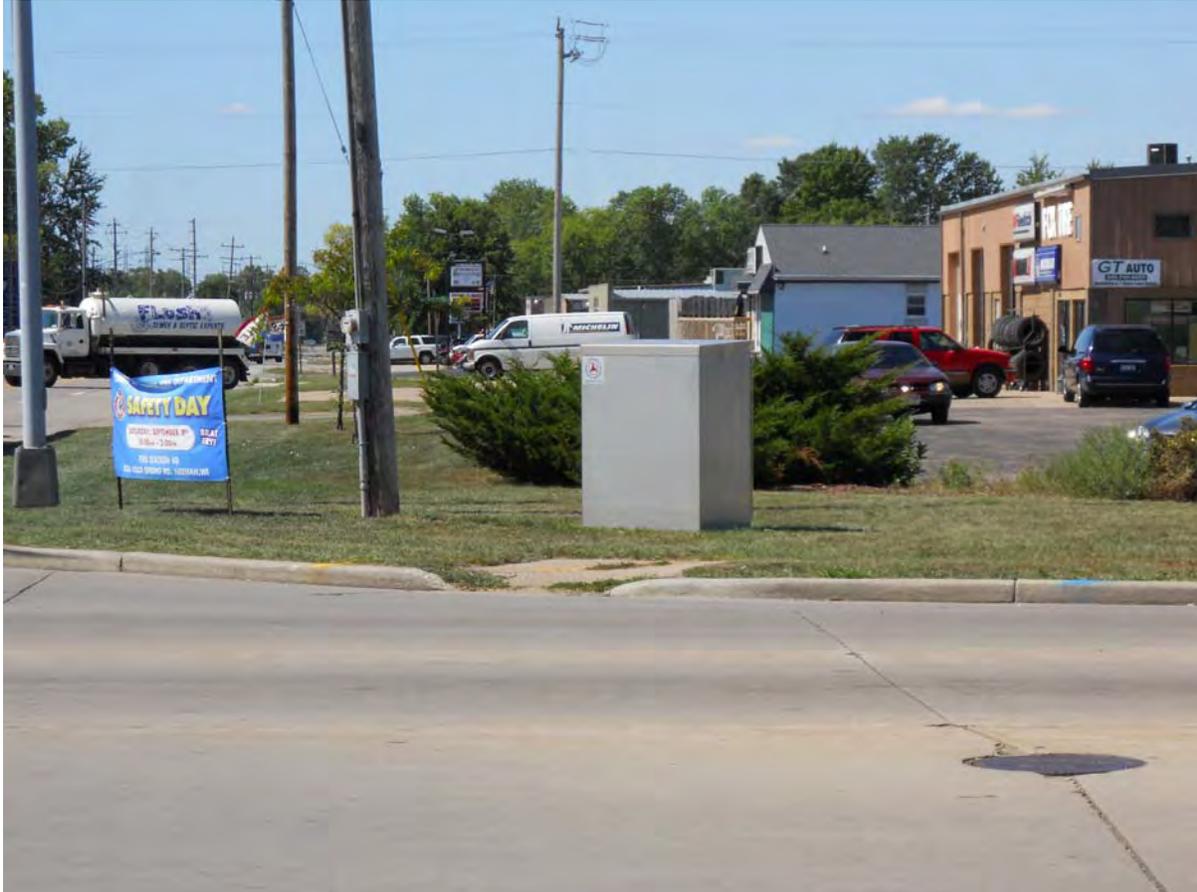
There are no pedestrian features or crosswalks across the north and west sides of the intersection of Appleton Road at Valley Road.

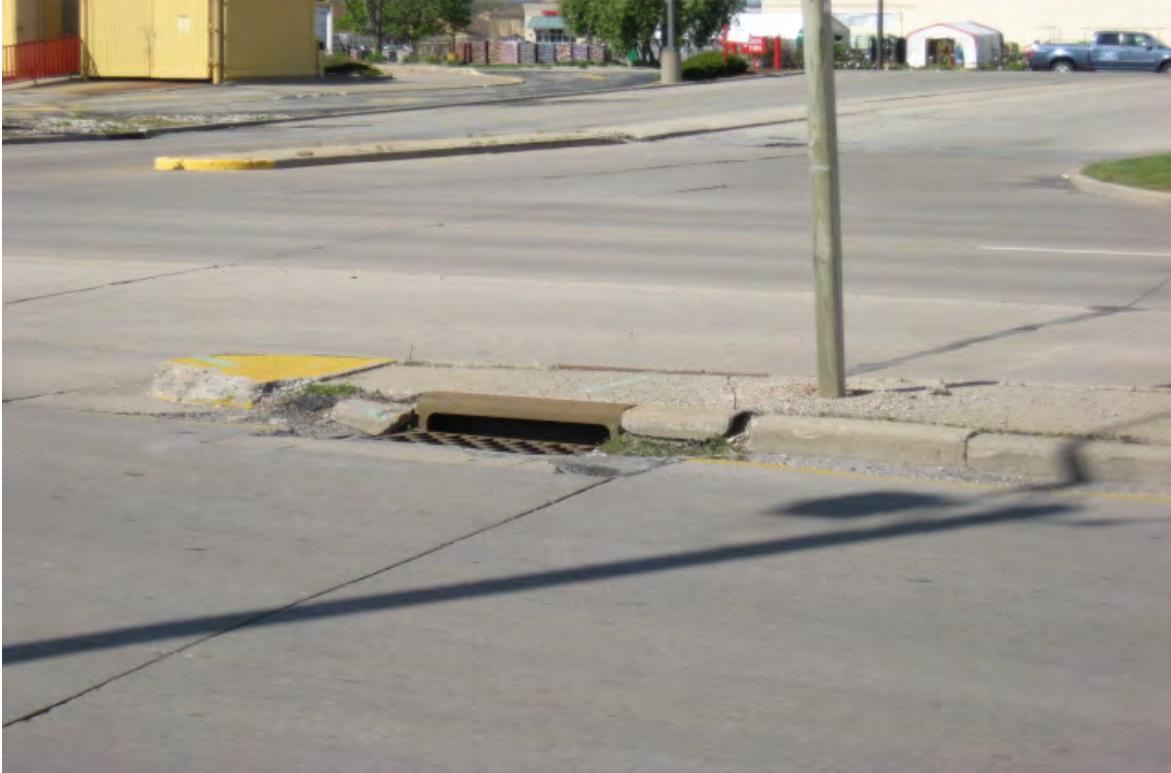
Issue 137: Separator in poor condition

The median separator on Appleton Road between Drum Corps Drive and Midway Road is in poor condition.

Replace the separator on Appleton Road with the proposed reconstruction project.

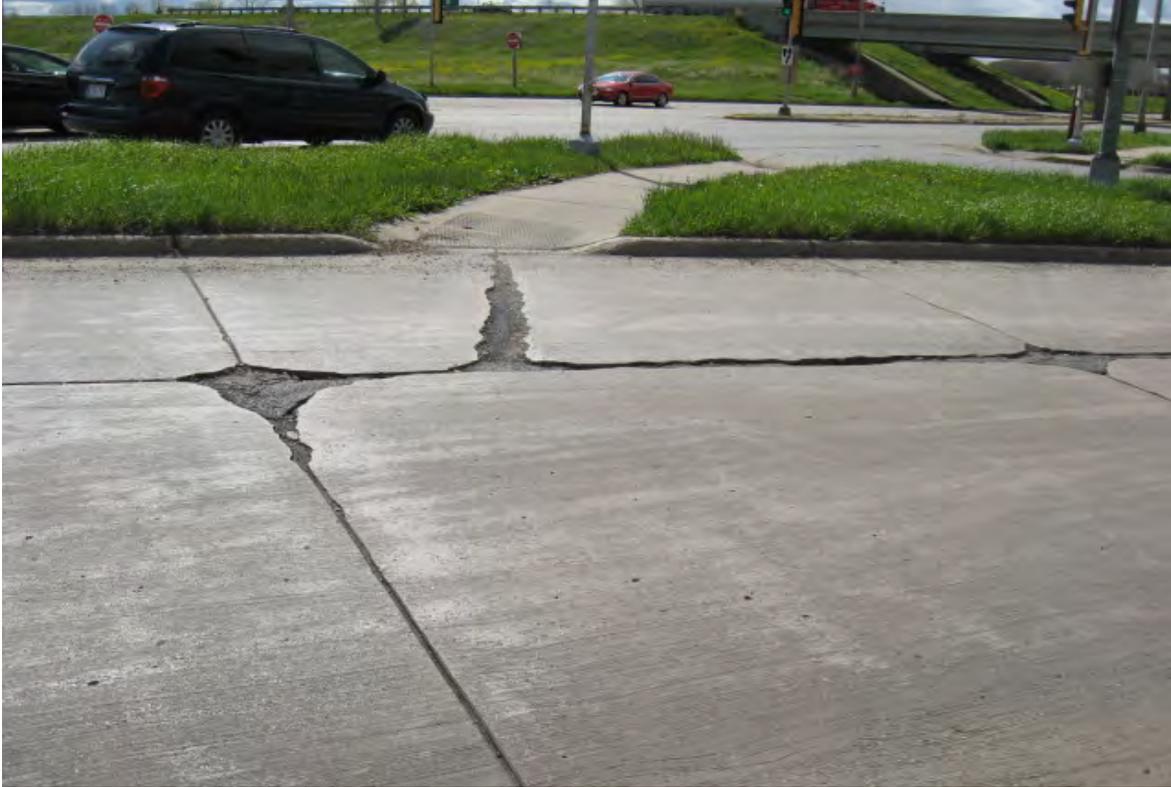
Issue 138: Joint damage, cracking, spalling

There is joint damage, cracks, and spalling in the pavement on Appleton Road.

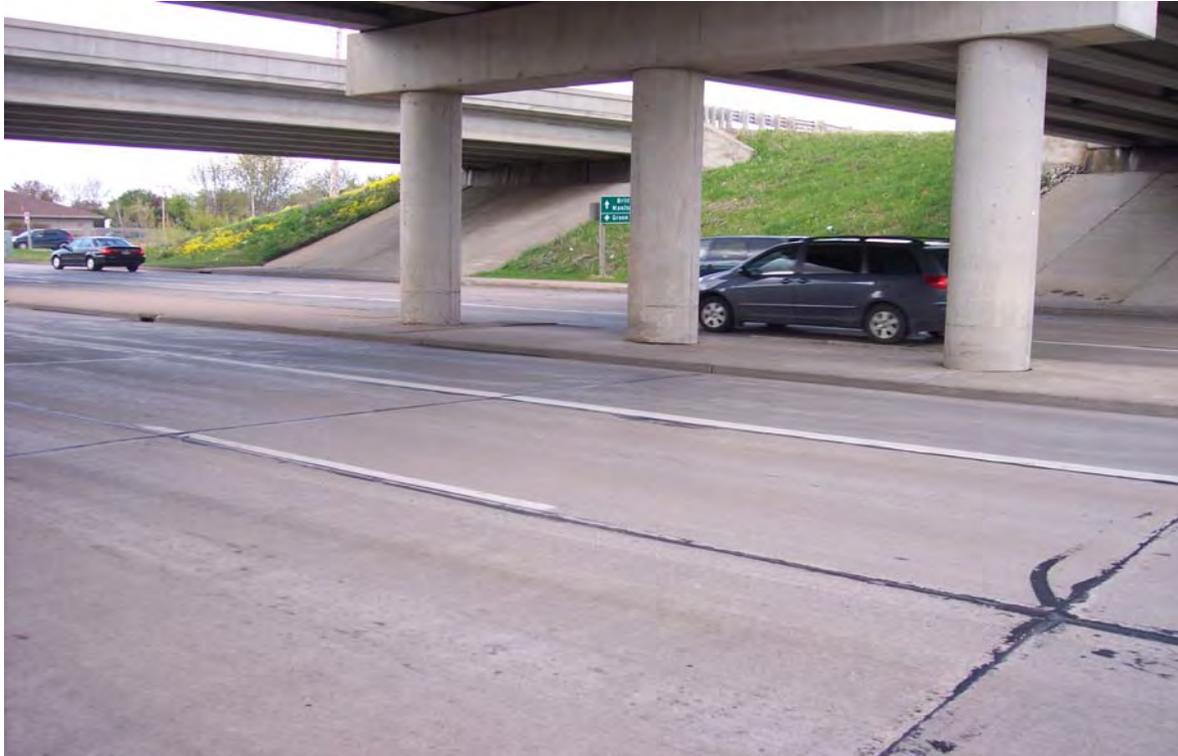
The columns under the overpass on Oneida Street, south of WIS 441 are within the clear zone and unshielded. The bridge piers may be a hazard to motorists that run off the road into the median area.

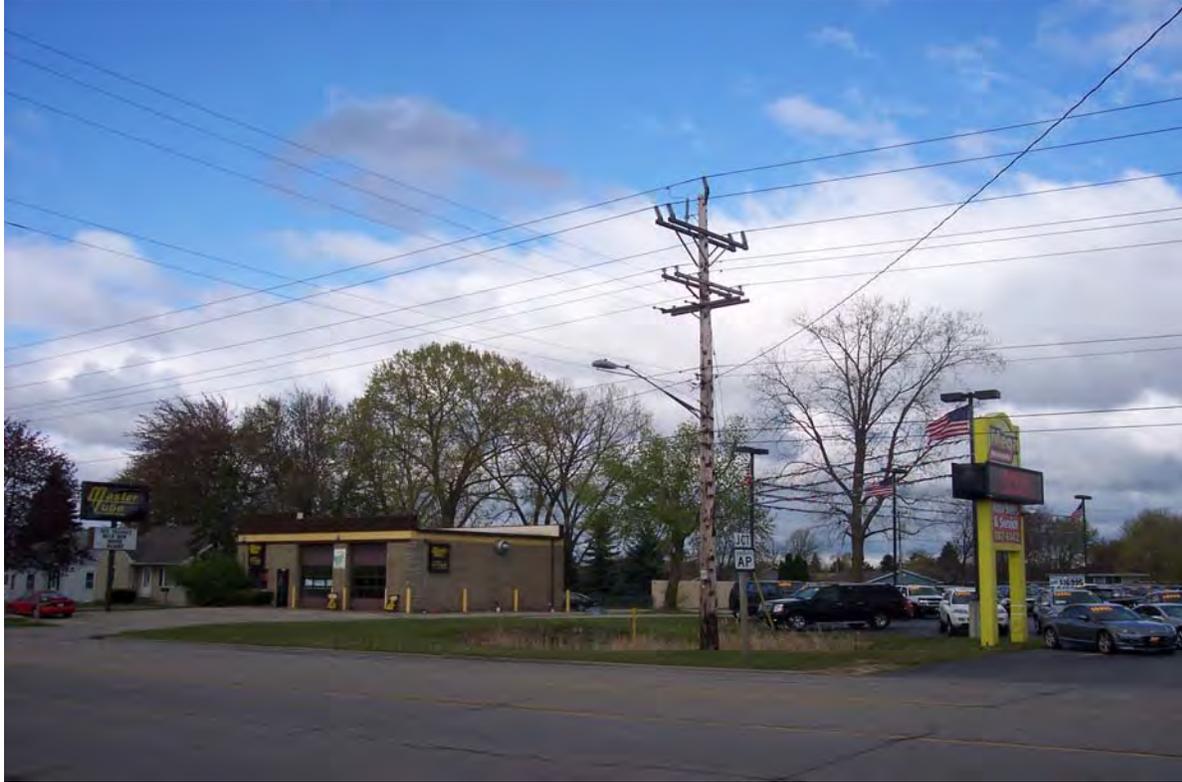
There are power poles with lighting within the clear zone on the west side of Oneida Street. These create a hazard to motorists that run off the road in this area

To remove the hazard, relocate the power poles outside of the clear zone on Oneida Street.

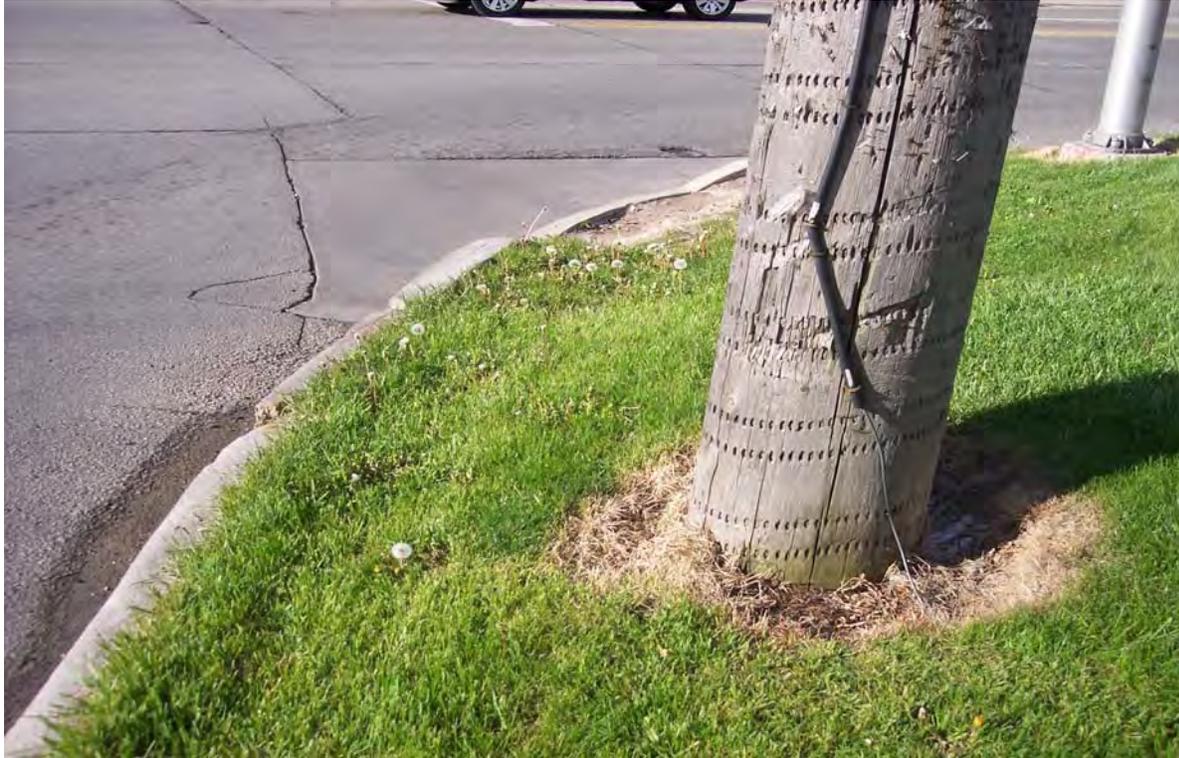
We observed evidence of overtracking at the intersection of Oneida Street with Midway Road. The radius returns at the intersection are too low. Heavy vehicles are running off the roadway in this area.

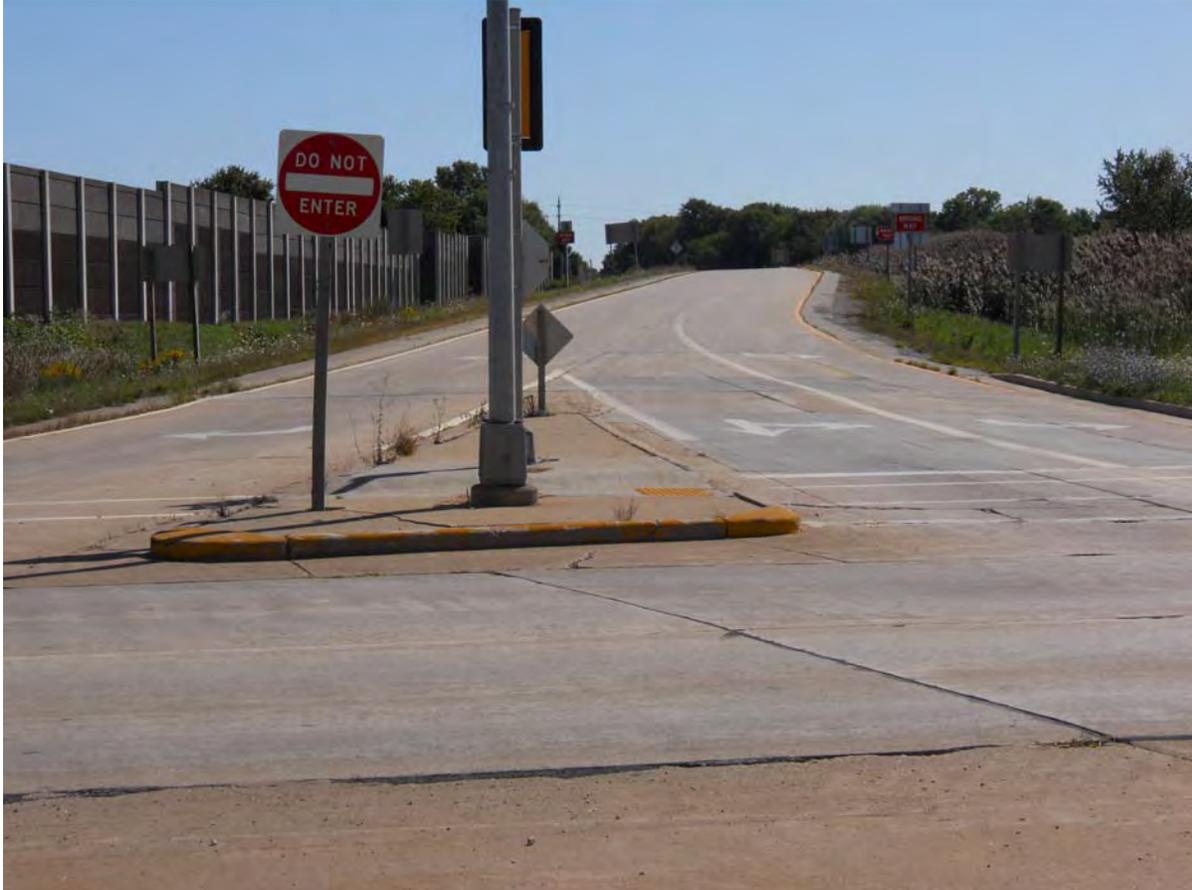
There is an abrupt transition to the auxiliary lanes in the westbound off-ramp of WIS 441 to Oneida Street. The ramp transitions from a single lane into three lanes abruptly without developing the lanes per standards. This area may be subject to rear end collisions due to the geometry.

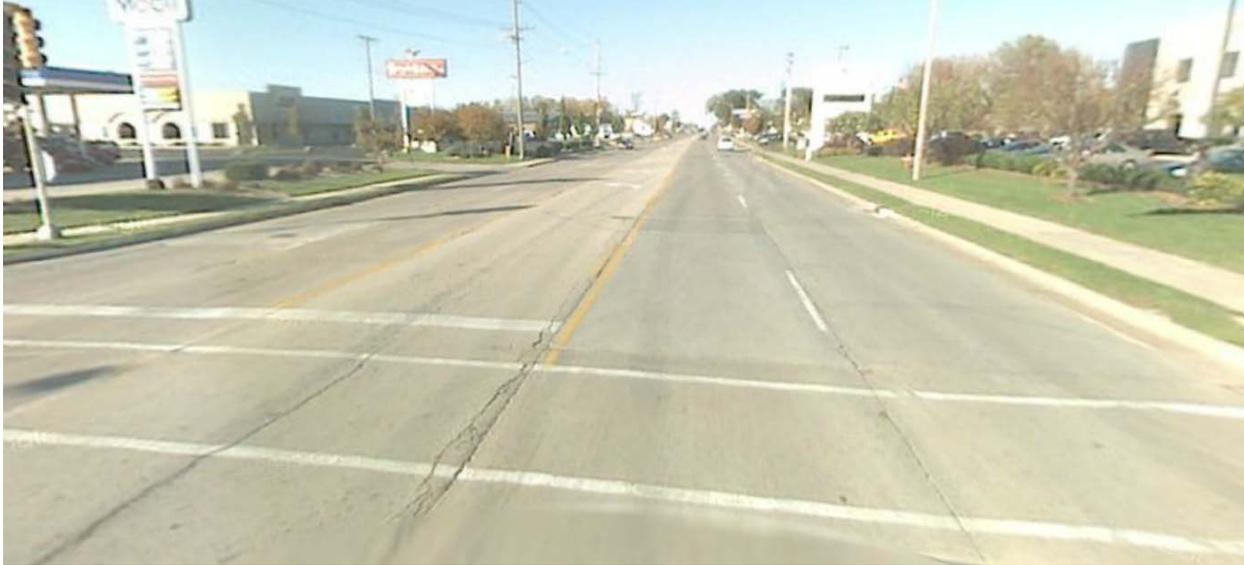
The southbound left turn lane at the Roeland Avenue/Valley Road intersection does not have adequate deceleration length and the transition to the center two-way left turn lane is not per current standards. Inadequate turn lane lengths can cause deceleration and/or overflow in the through lane which can increase the occurrence of rear end collisions.

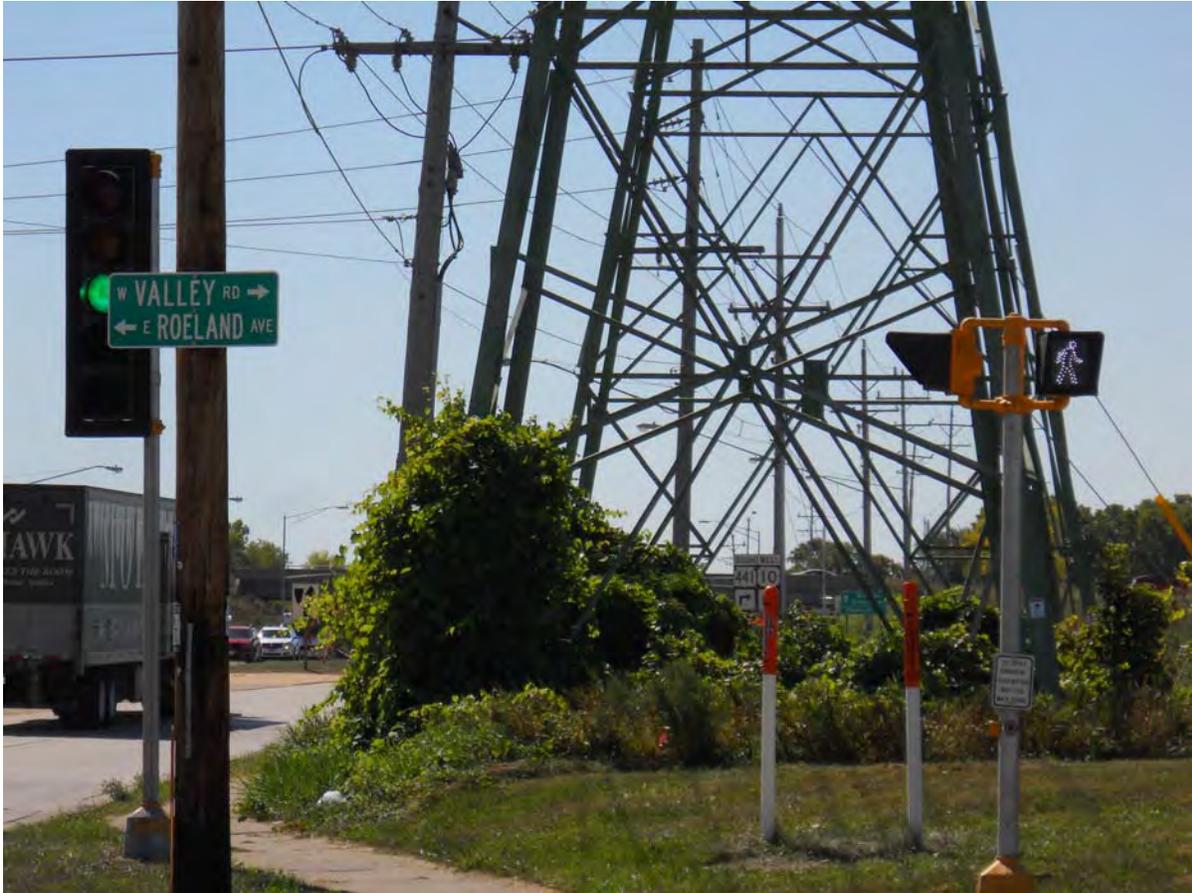
The pedestrian signals at the Roeland Avenue/Valley Road intersection currently do not have filled hands. Filled symbols are more visible to the road users than unfilled symbols.

Install countdown pedestrian signals and signs on all corners of the intersection. These have been found to increase safety for pedestrians.

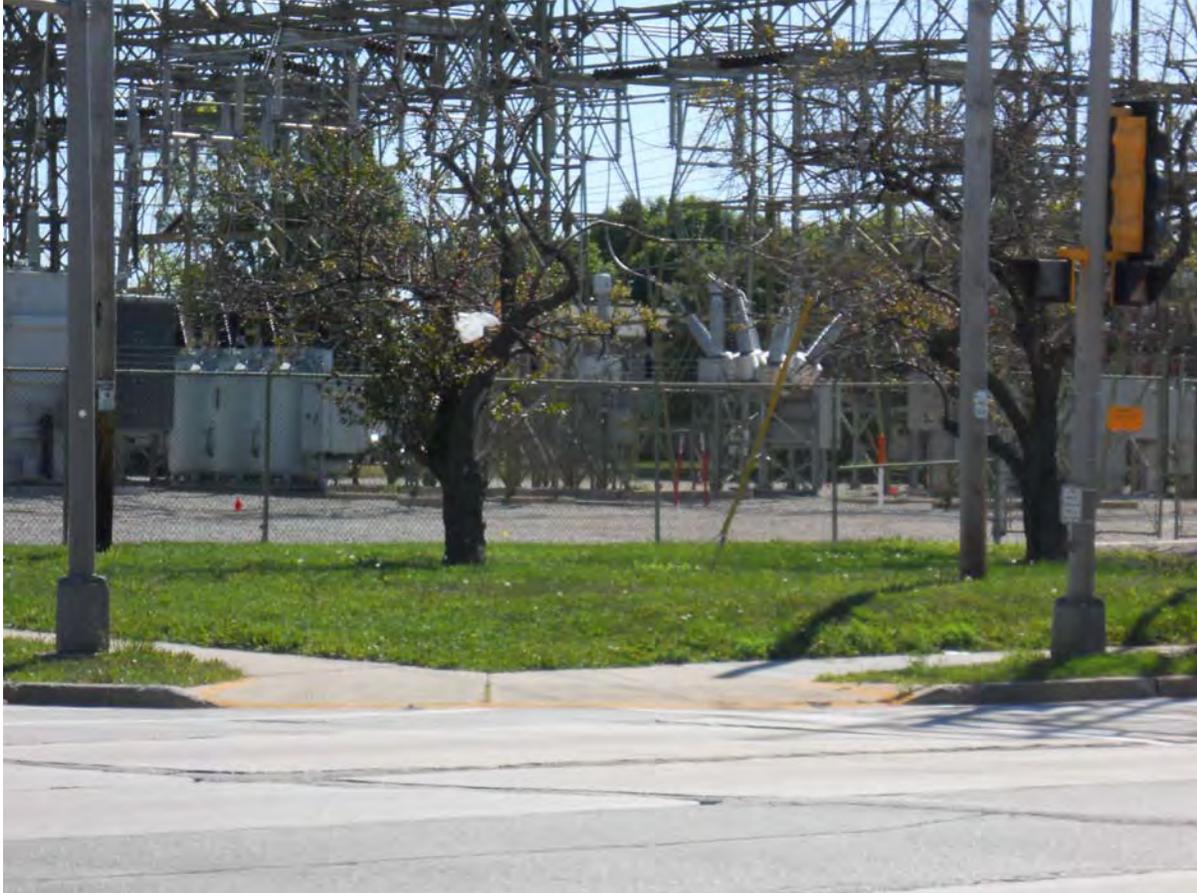
There is a diagonal ramp and pedestrian detector on the signal pole on the SE corner of the intersection with Roeland Avenue/Valley Road.

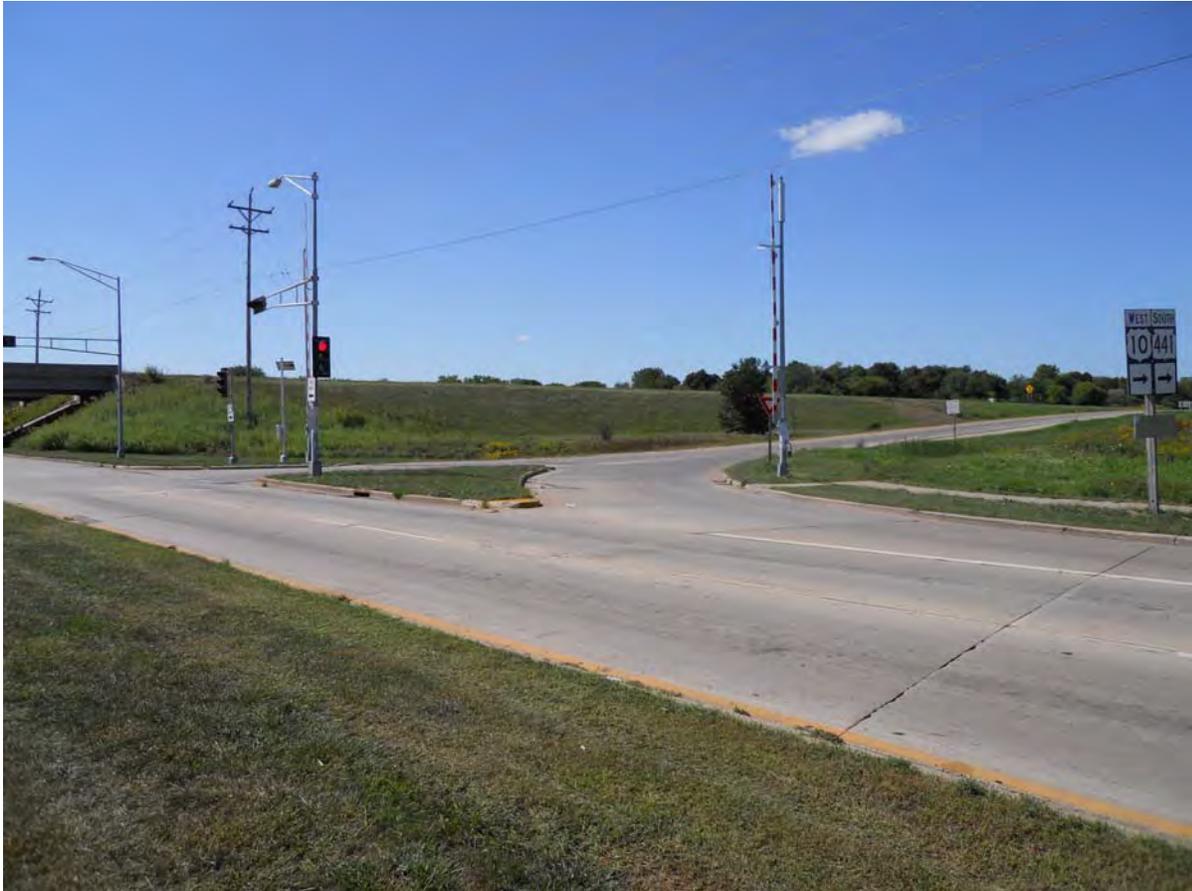
There are no pedestrian signals on Oneida Street, north of WIS 441. The pedestrian ramp at the NE corner is broken/cracked up.

Install ADA compliant crosswalks and ramps for pedestrians in this area. Provide pedestrian facilities in the proposed condition.

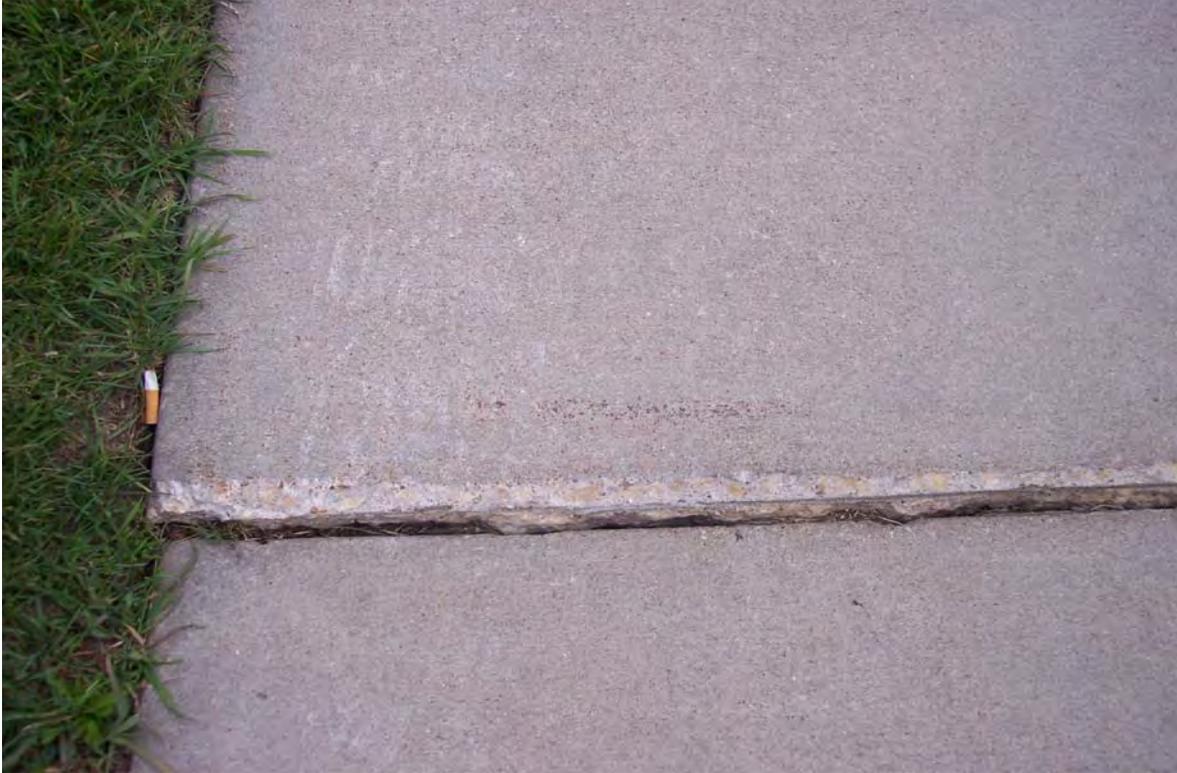
Issue 165: Tripping hazards

The sidewalk on the east side of Oneida Street south of WIS 441 has tripping hazards. The sidewalk on the west side of Oneida Street north of WIS 441 has tripping hazards. This is not ADA compliant.

Repair the sidewalk to be ADA compliant.

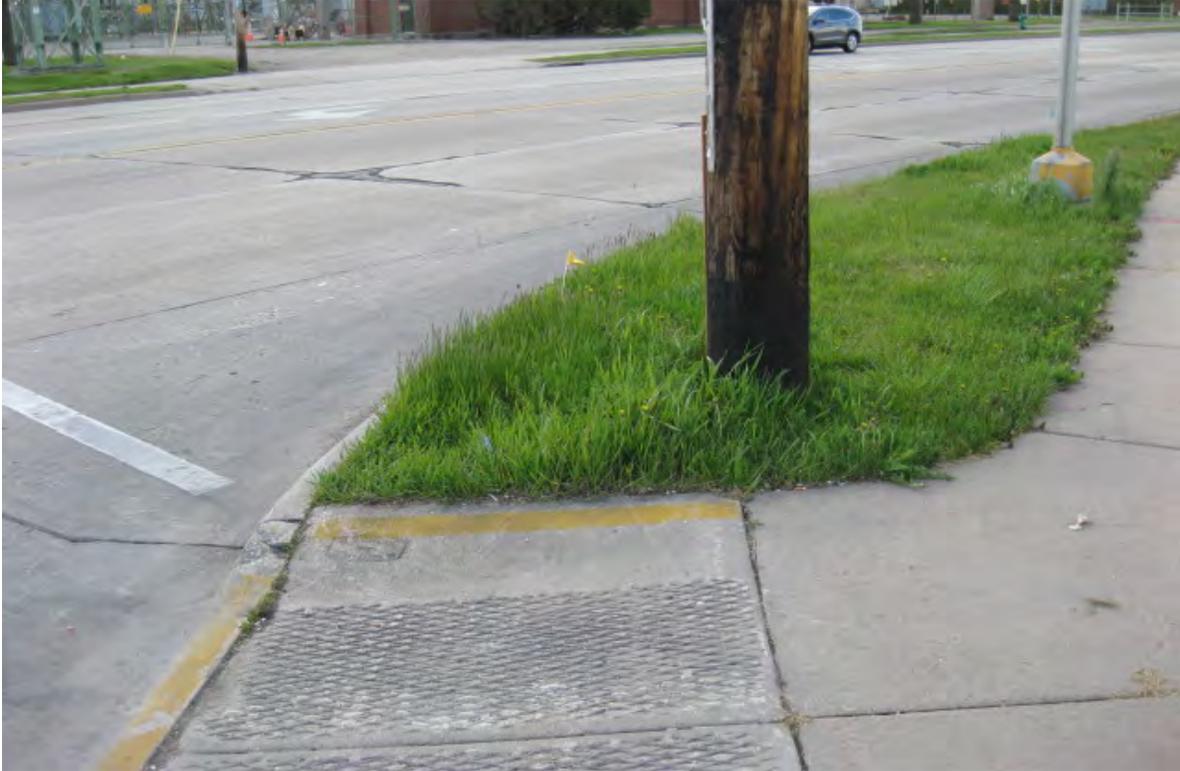
The utility pole next to the sidewalk ramp at the southwest corner of Roeland Avenue/Valley Road intersection has no protection. This can be a hazard to a vehicle that runs off the road in this area.

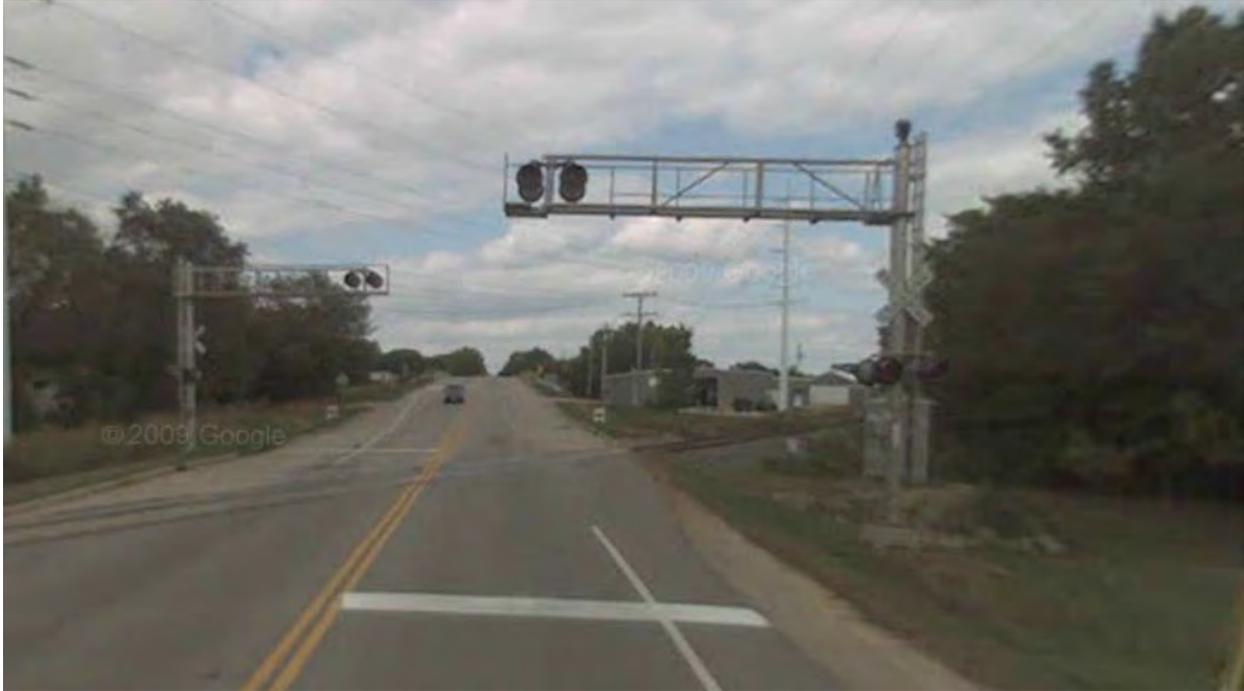
The railroad crossing warning supports for the railroad tracks are within the clear zone. This could be a hazard for vehicles that run off the road in this area.

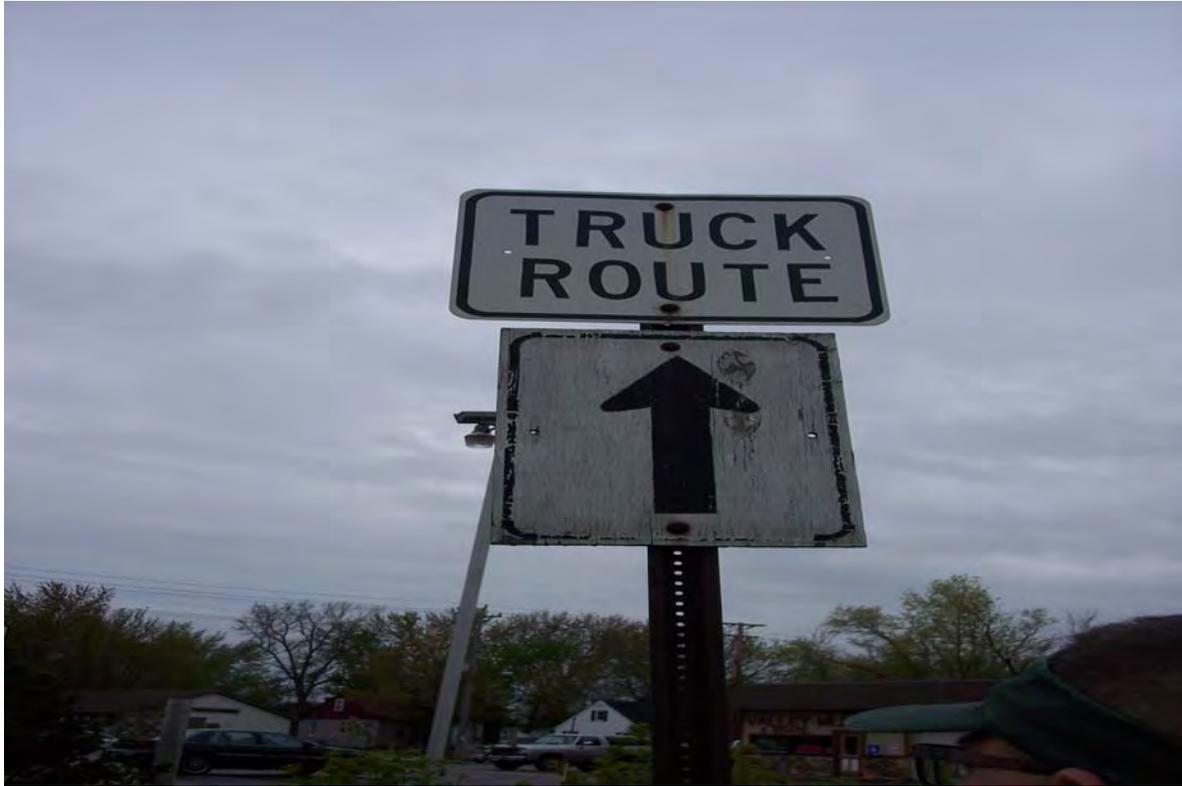
The sign panels on several of the signs on Racine Road have faded. This causes a loss in visibility of the sign messages to the motorist, especially at night.

Replace the current faded signs with new signs that are more visible at night.

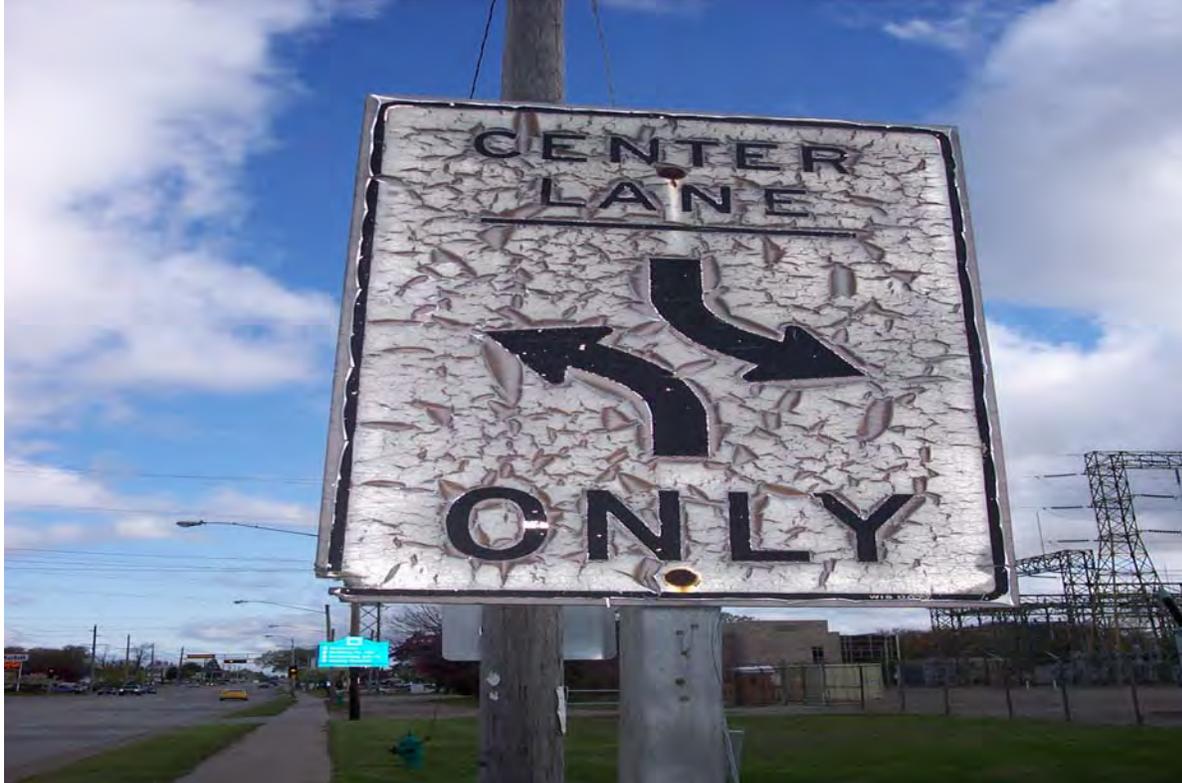
There is a two-way left turn lane sign in the wrong location. The sign is also in poor condition.

Replace and relocate the current with a new sign further north on Oneida Street near the current two-way left turn lane.

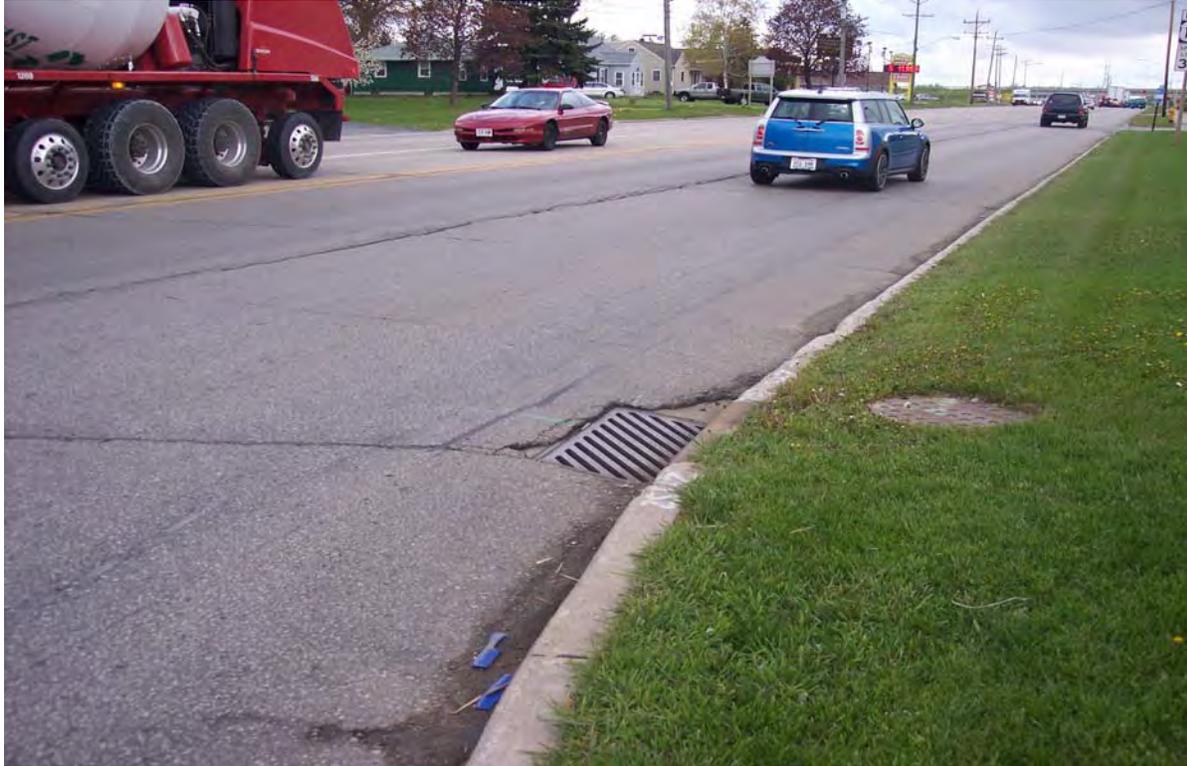
On the northeast corner of the intersection of Oneida Street and Midway Road, there is a drainage inlet within the return. Vehicles were observed driving around to avoid the inlet.

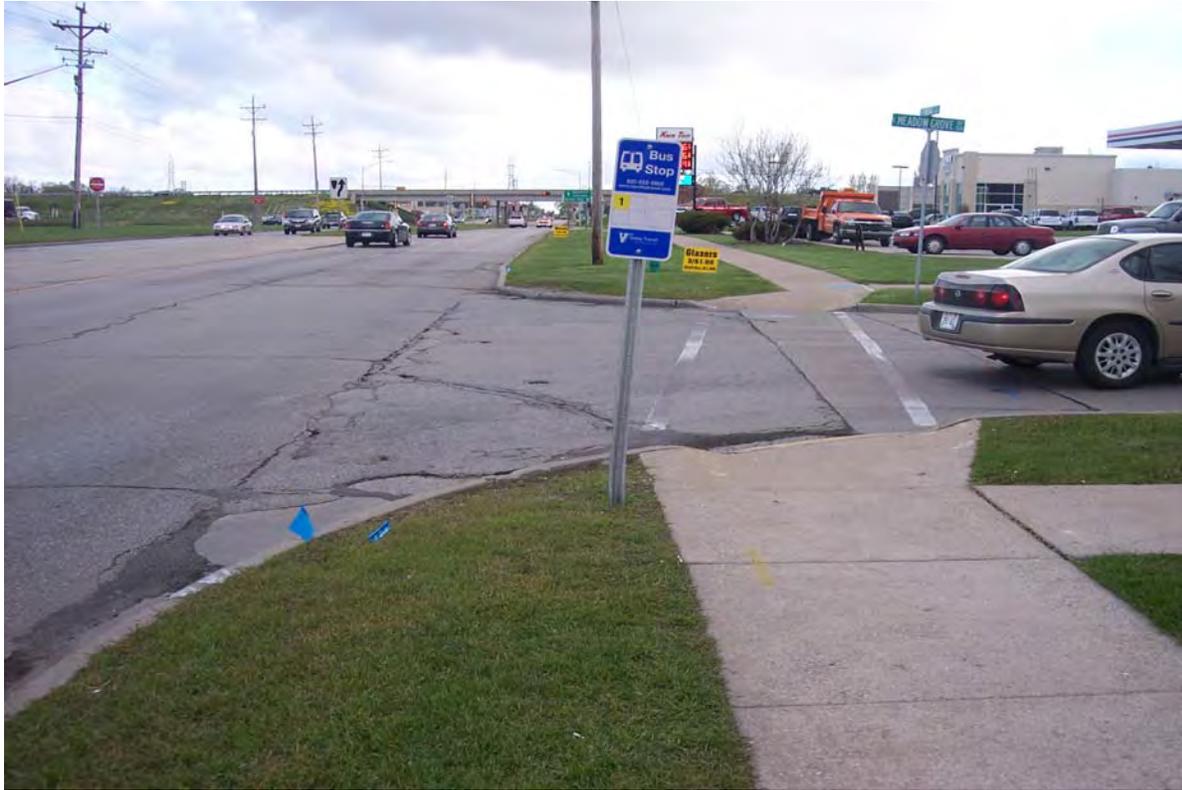
Vehicles were observed driving over the raised concrete gore area to turn left into Meadow Grove Road/Kwik Trip gas station.
