# I-43 Leo Frigo Memorial Bridge Investigation Report

## EXECUTIVE SUMMARY

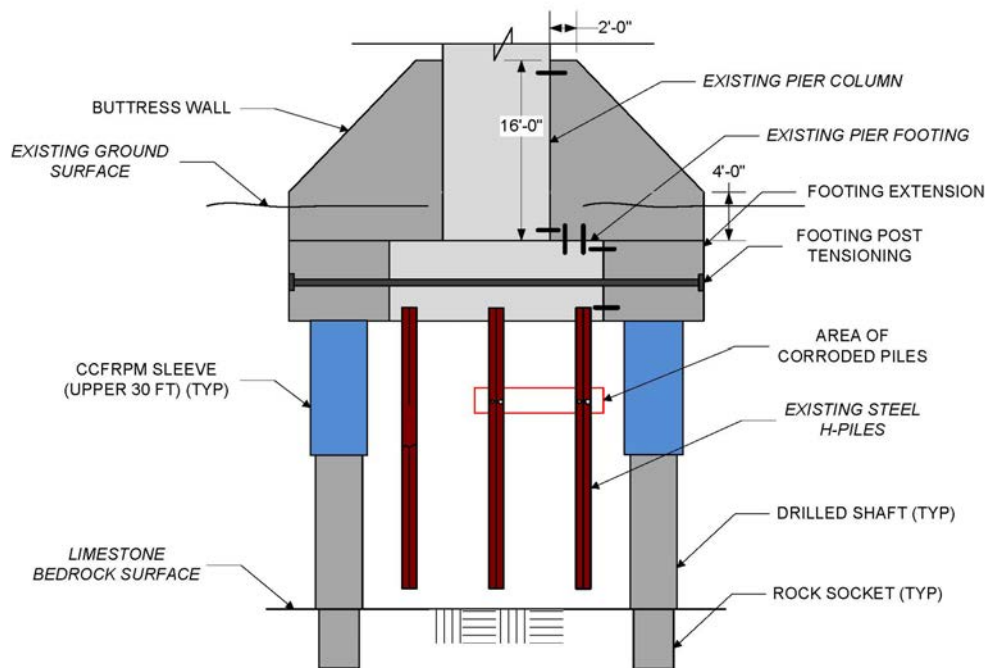
**Schematic of Tier 1 Repair**

**Tier 1 Pier Repairs:** Visual inspection and soil borings confirmed the presence of fly ash surrounding severely corroded steel piles at Piers 21, 22, 23 and 25. While the piles observed at Pier 24 were substantially less corroded, Pier 24 was conservatively treated similar to Piers 21, 22, 23 and 25 based on its proximity to those critically corroded pier locations. Therefore, repairs were performed at Piers 21 through 25 prior to returning the bridge to service. Tier 1 repairs included installation of new concrete drilled shaft foundations, which are capable of supporting the entire pier design load. These new foundations were then connected to the existing piers and provided corrosion protection measures designed to offer 75 years of service life.

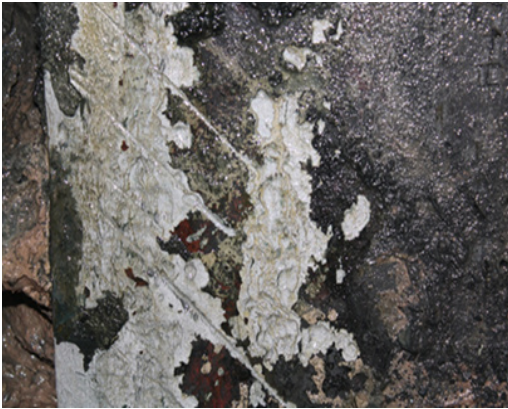
**Tier 2 Pier Monitoring:** Numerous steel piles at pier locations outside the Tier 1 repair area contained localized areas of corrosion pitting and minor section loss. Seventeen of these piers were included in the Tier 2 category.

Typical Tier 2 Corrosion

In order to estimate the future corrosion rates to determine the remaining service life of the Tier 2 steel piles, monitoring probes and steel coupons (pile sample sections) were installed in 2014 adjacent to Piers 6, 13, 19, 32, 39, 44 and 50. Data will be collected from the probes during typical bi-annual bridge maintenance inspections performed by WisDOT. The probe data will be supplemented by section loss measurements conducted on the pile coupons. If the

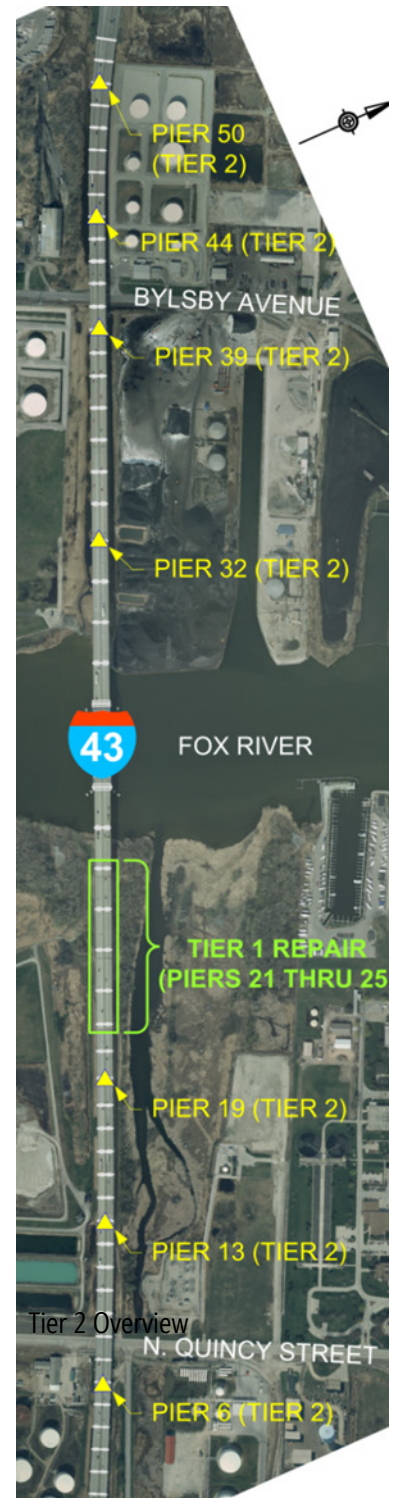
Tier 2 Overview

Tier 2 piers are locations where much lower levels of pile corrosion damage were observed and the soils exhibit characteristics that are potentially corrosive, but much less severe than Tier 1 locations. Tier 2 locations do not include large amounts of industrial fly ash, but do have some combination of organic material, high levels of chlorides, sulfates, or microbes; or low soil resistivity values. None of the Tier 2 locations represent an immediate safety concern. However, the locations do warrant further monitoring to determine if there is potential for long-term corrosion.
