Non-Cementitious Repair Materials Study

Final Report

WisDOT Project No. 0092-18-02
June 2019

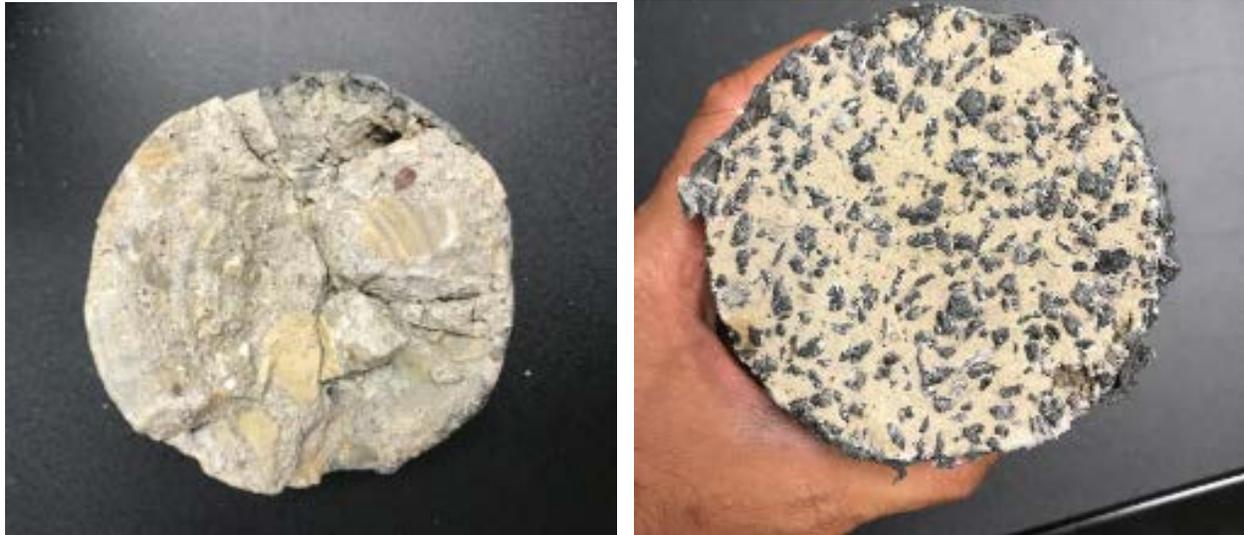
The PDR was debonded from the substrate concrete, but upon examination of the bottom of the debonded repair material (see figure 3-4), it was evident that the failure had occurred in the concrete and not in the repair material.

Figure 3-4. Close-up view of the bottom (left) and top (right) of RM-1 core #1.

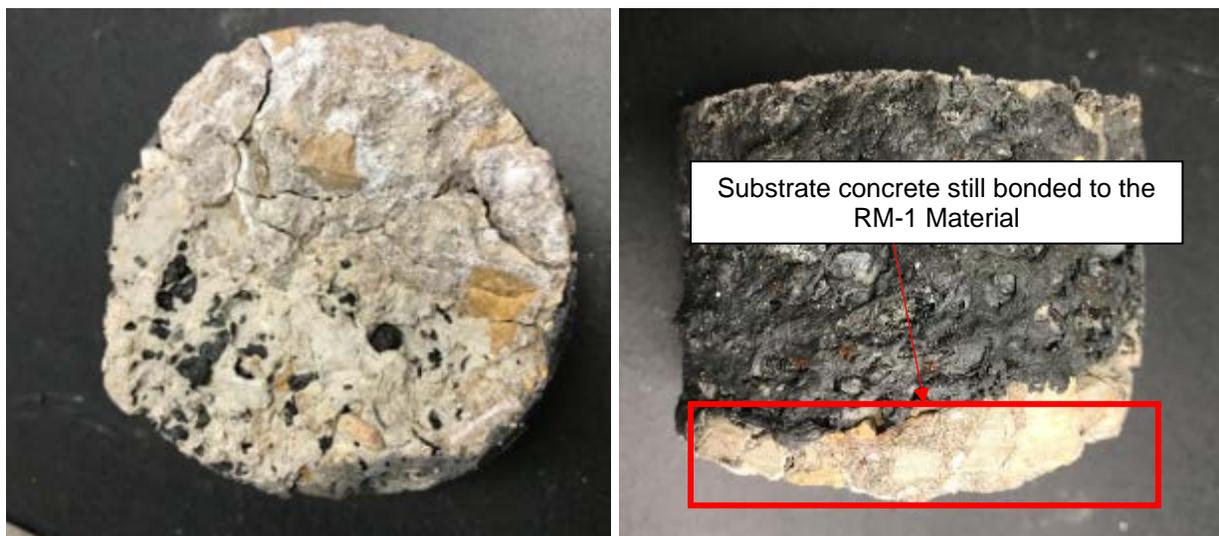
Figure 3-6. Close-up view of the bottom (left) and side (right) of the debonded portion from core #2.

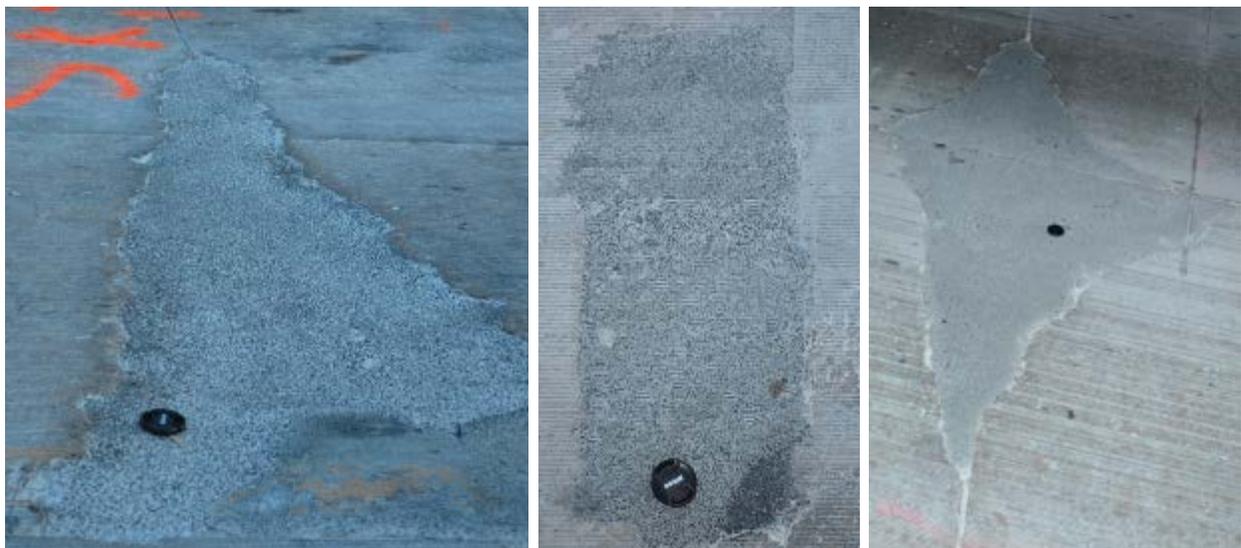
Several other RM-1 PDRs were visually inspected at this site (site #1). On the surface, most of the PDRs showed no signs of damage (see figure 3-9) and the surface condition was noted to be Good to Excellent for most of the PDRs. However, some of the thinner PDRs simply peeled off from the surface (see figure 3-10) when a hydraulic pavement breaker was used to remove the RM-1 PDRs and prepare the repair areas for full-depth repairs using conventional concrete material. Significant amount of substrate concrete material was still bonded to the bottom of the RM-1 PDRs that peeled off. Appendix B includes additional photos from the RM-1 field investigations.

Figure 3-9. RM-1 PDRs on the Madison Beltline.

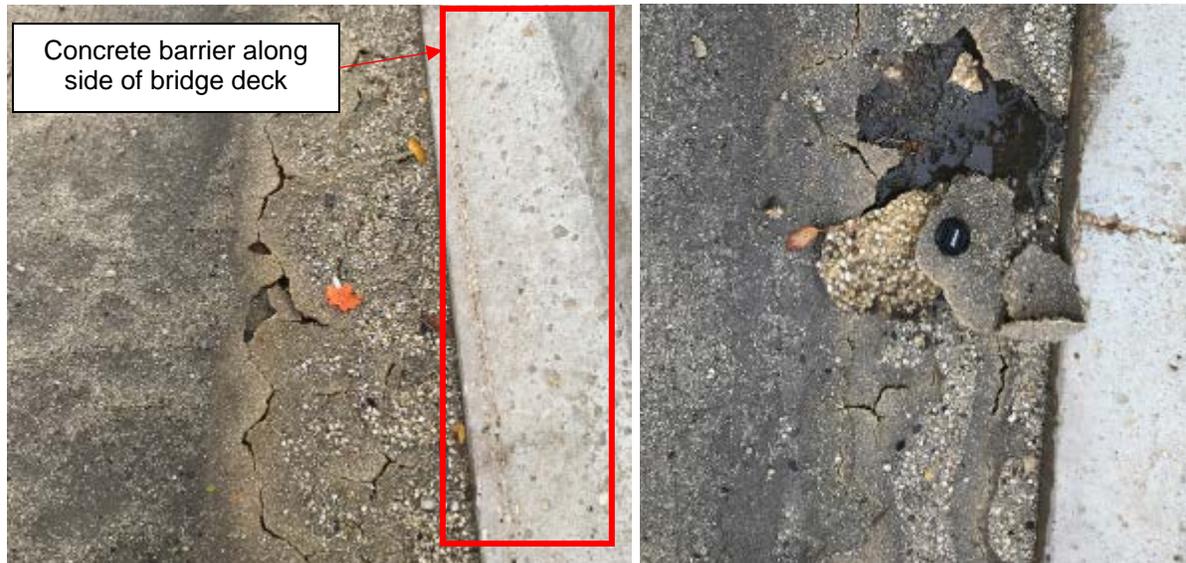
The RM-2 overlay was generally in Excellent condition on all of the bridge deck sites visited. The only exception was Site #3, where the top 0.25 inches of the overlay was peeling off from the deck. This deterioration was isolated to the edge of the decks (see figure 3-12). The material manufacturer has investigated the failure and deduced that the material was either under-catalyzed or the presence of moisture in the mix aggregates resulted in the failure noted. The contractor had agreed to remove and replace the deteriorated areas.

Figure 3-12. Top one-third of the RM-2 overlay peeling off along the deck edge (Site #3).

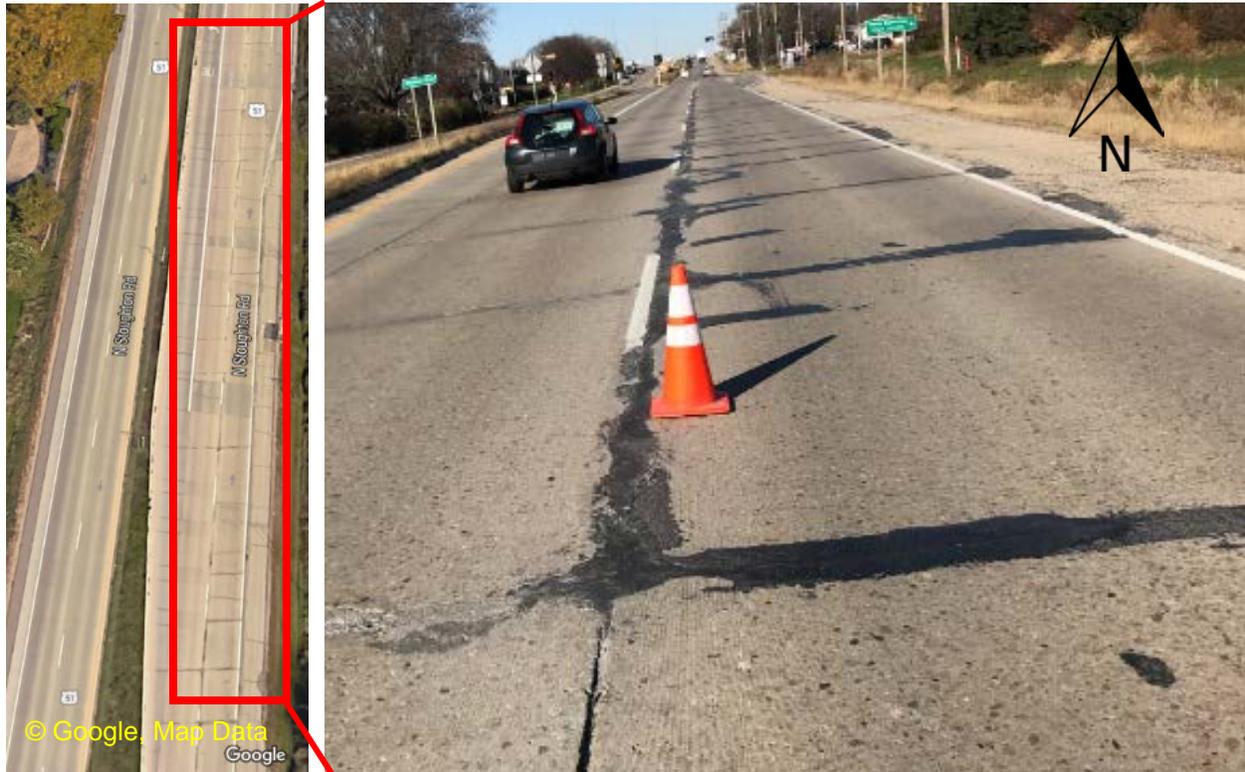
One core each was extracted from the Madison (Site #20) and Waukesha (Site #23) sites. At Site #20, the material was used to repair a heavily distressed transverse joint with severe spalling and cracking along the slab edges. Site #20 is located on US-51/N. Stoughton Road (Northbound lanes, see figure 3-23). Almost every single transverse joint is severely deteriorated at this location (especially the right lane) and has been repaired with either cold patch material or conventional hot mix asphalt. Considering the fact that the material was used to repair a severely distressed area, the performance after two winter seasons has been Good.

Figure 3-23. Overview of US 51/N. Stoughton Rd northbound lanes(top) and satellite imagery showing severely distressed condition of the north bound lanes.

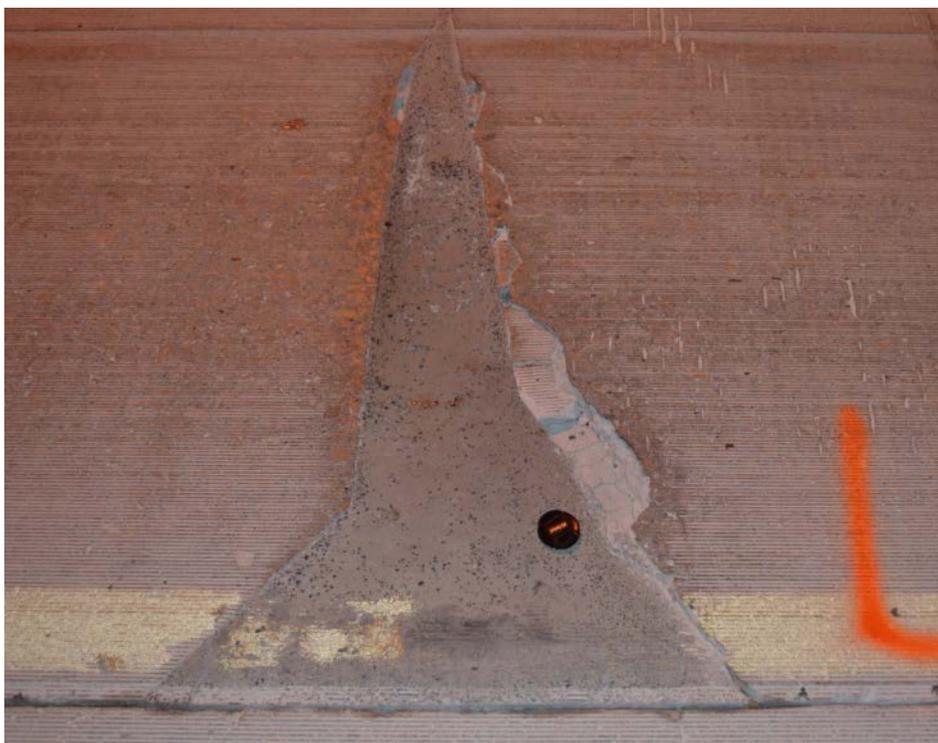
Figure B-6. RM-1 PDR (6)—deterioration along patch edges
(Site #1, US 12/18, Madison Beltline).

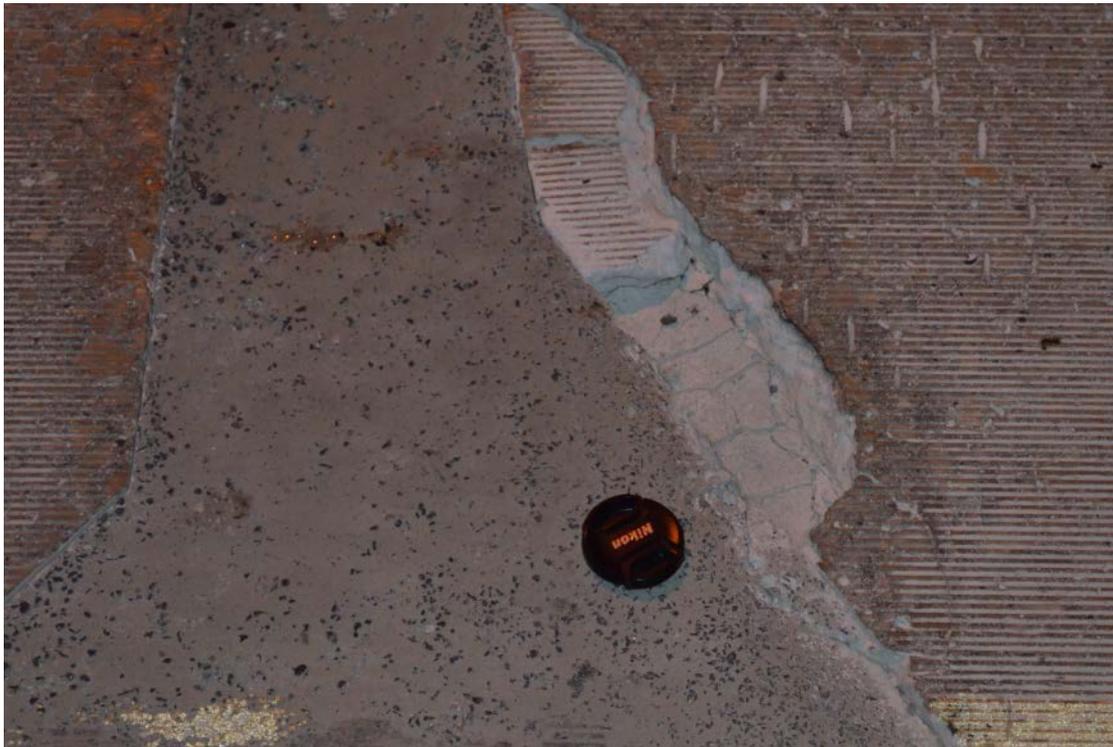
Figure B-7. RM-1 PDR (6)—close-up of deterioration along patch edge (Site #1, US 12/18, Madison Beltline).

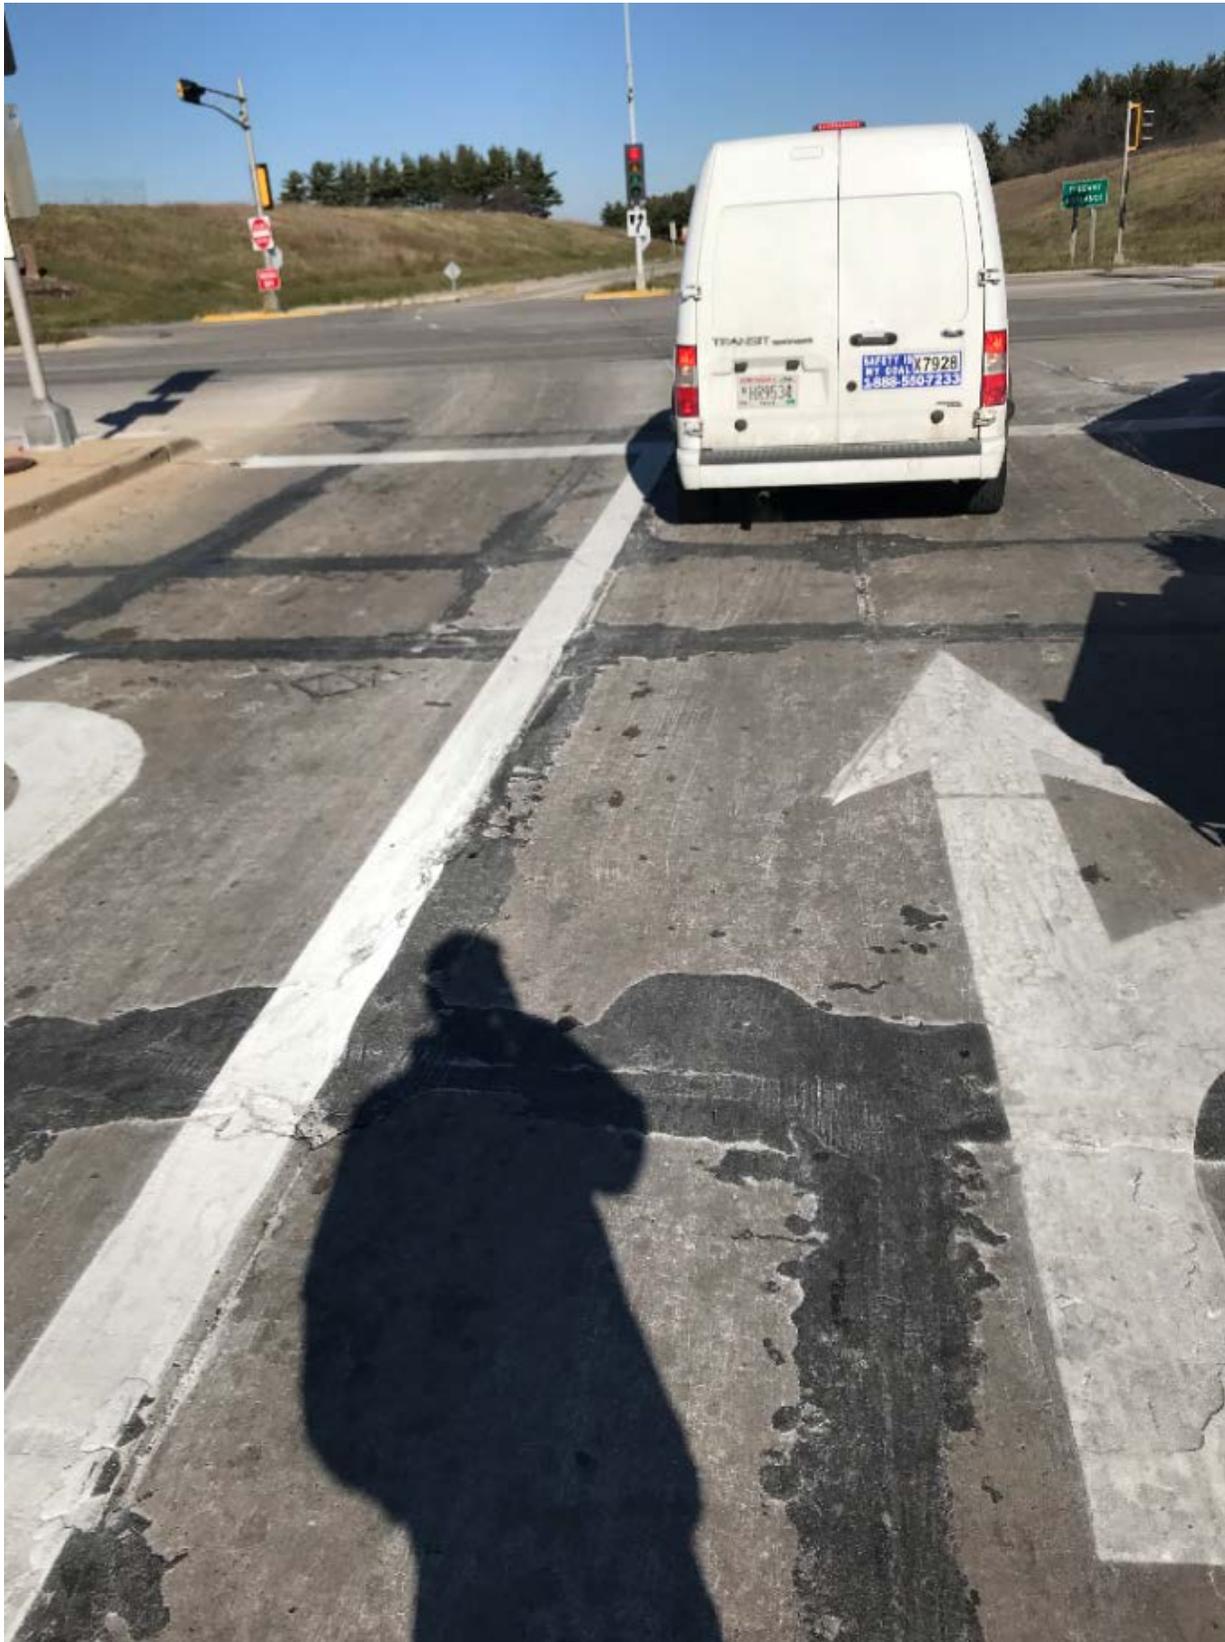
Figure D-1. RM-3 used to repair spalls, deteriorated joints and traffic loops (Site #5, W. Wisconsin Ave, Oconomowoc).

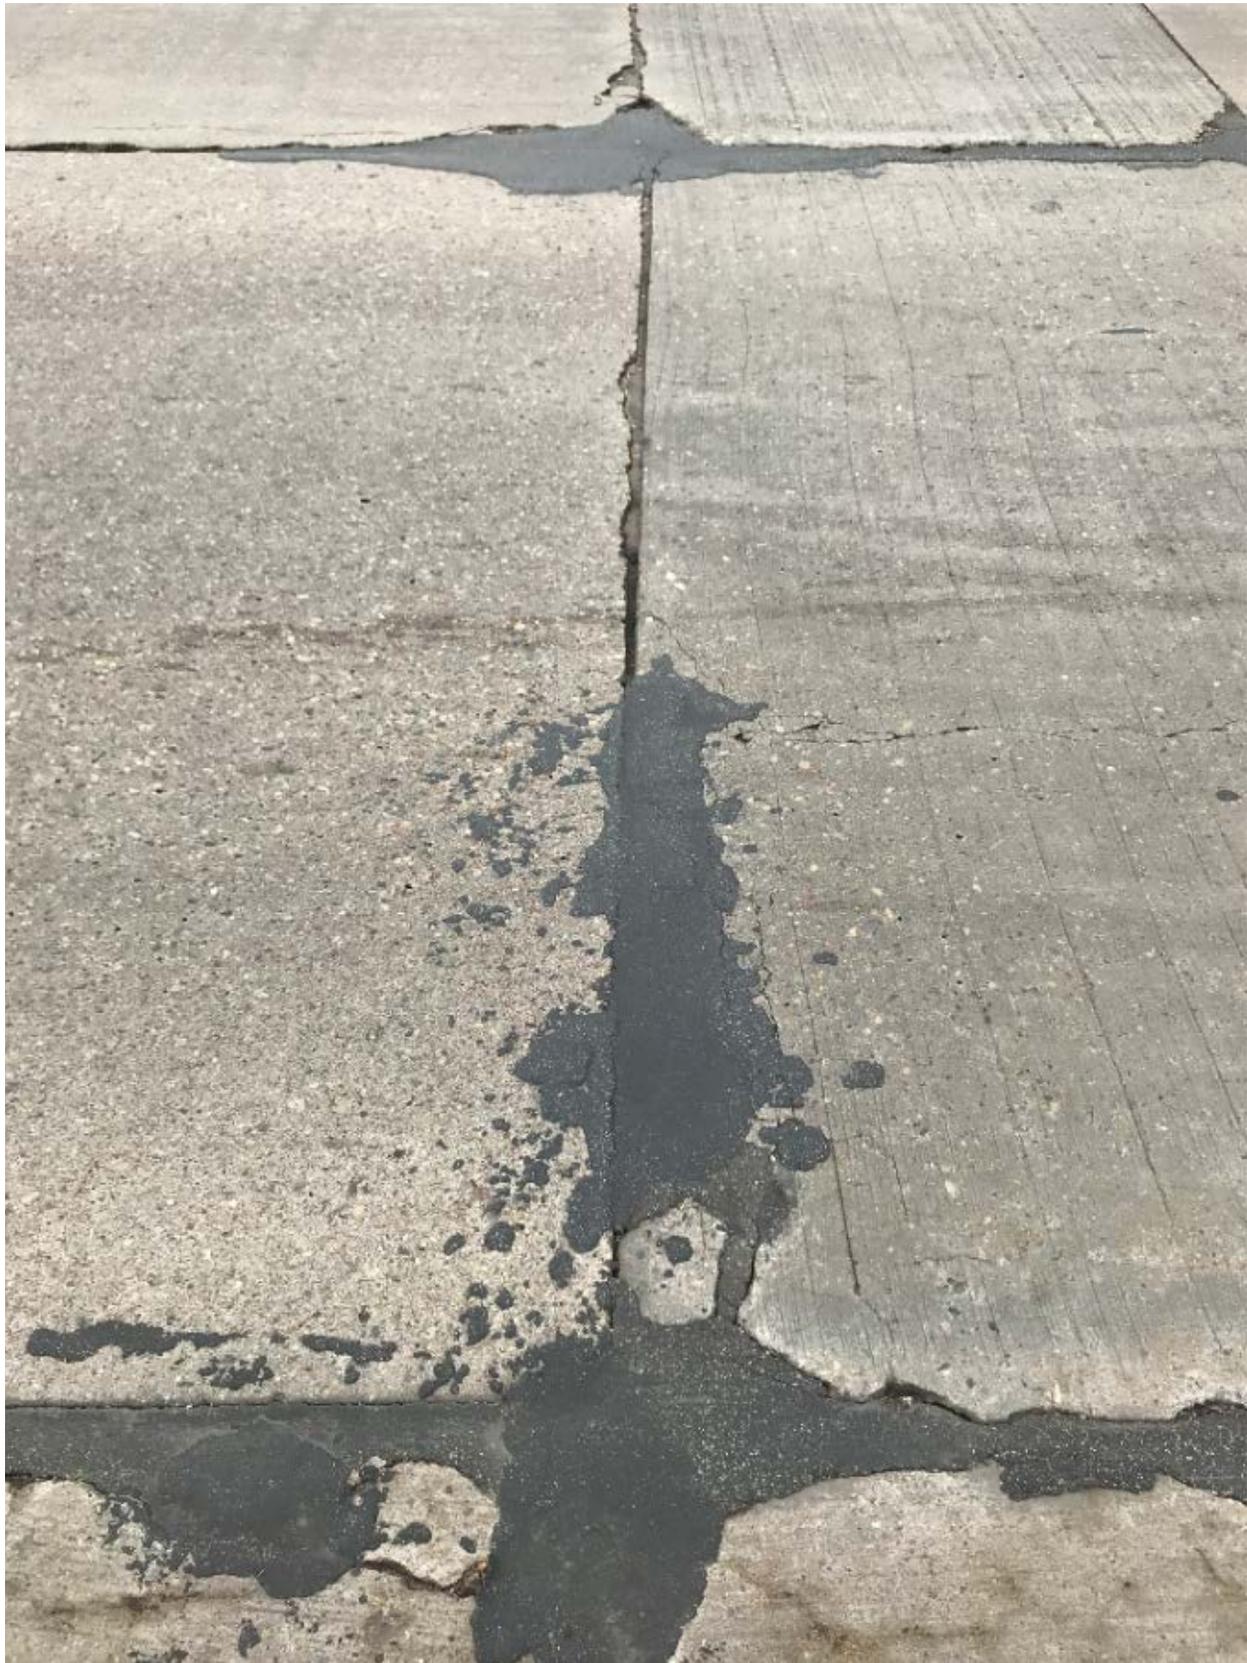
Figure D-2. PDRs to address spalling and deteriorated joints (P Site #6, lower Rd., Plover).

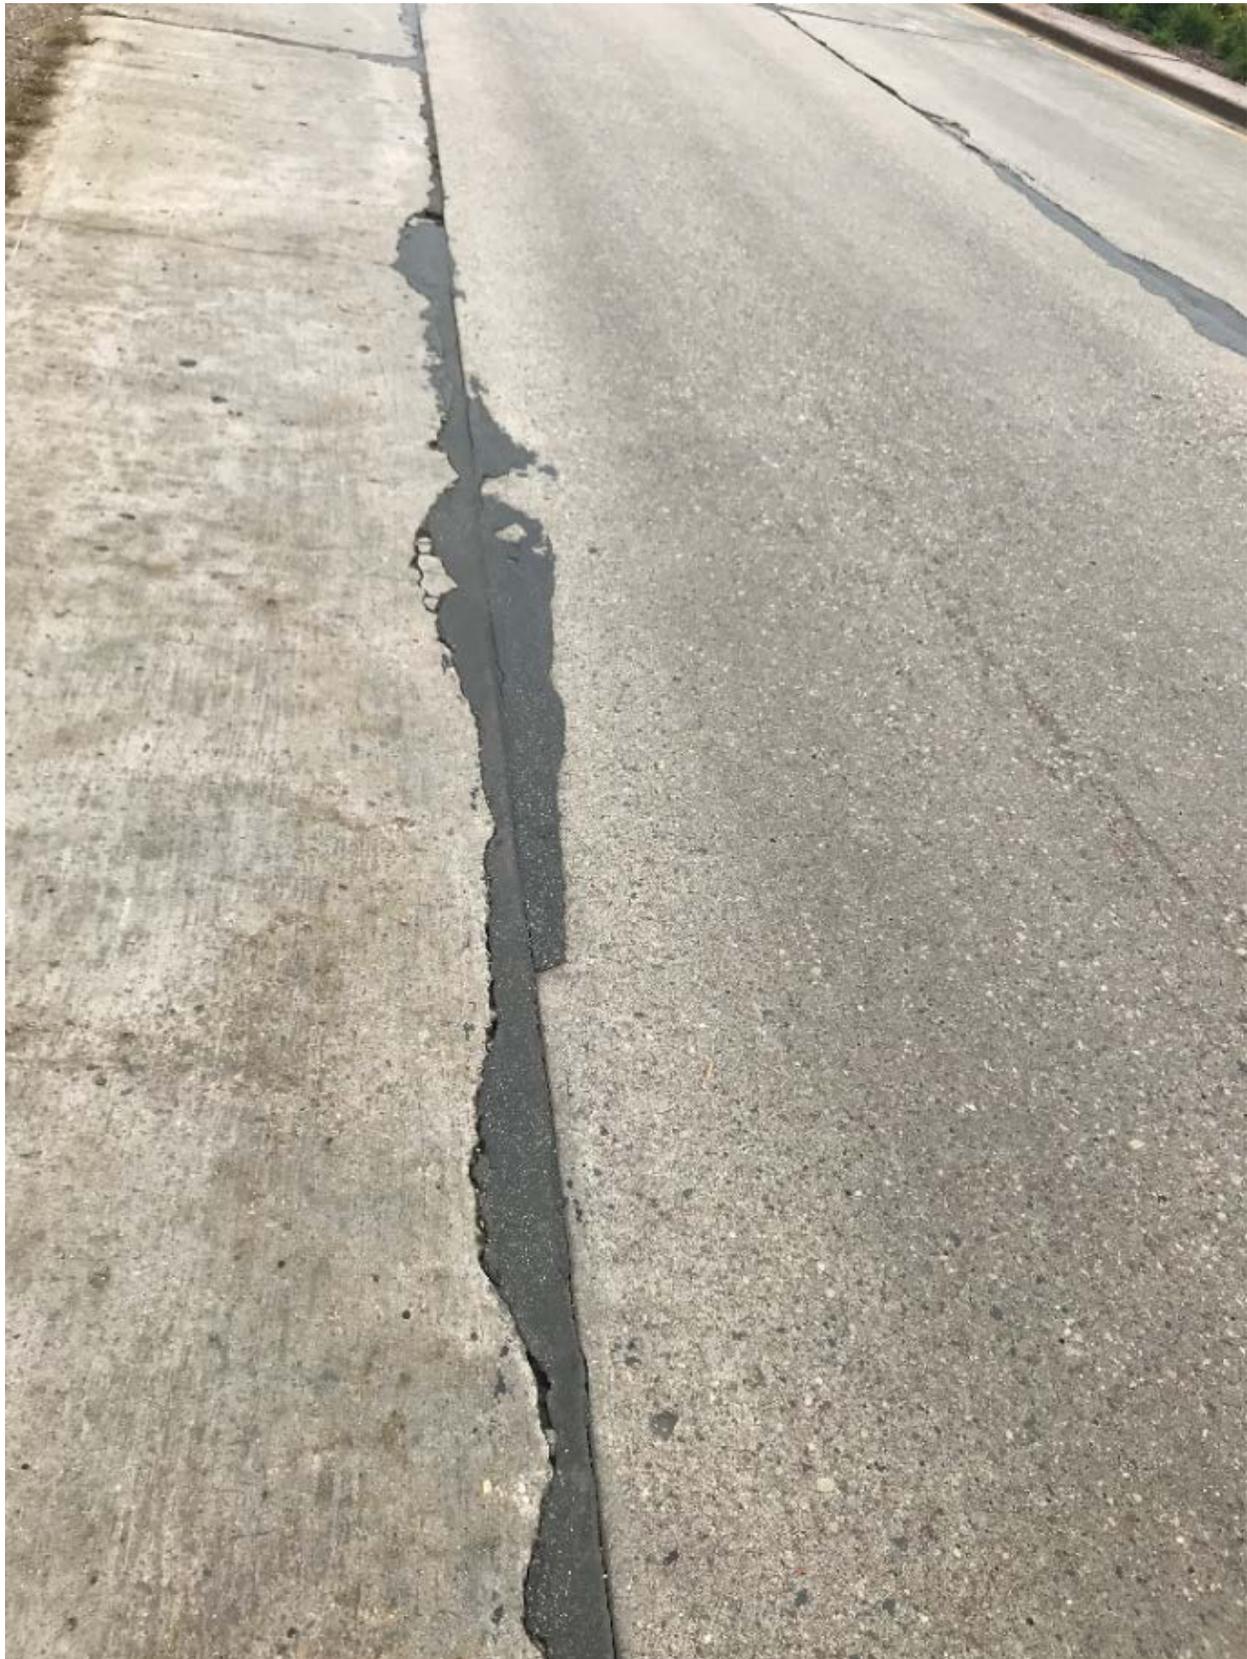
Figure D-3. PDRs to address spalling along lane-shoulder joint (Site #6, Plover Rd., Plover).

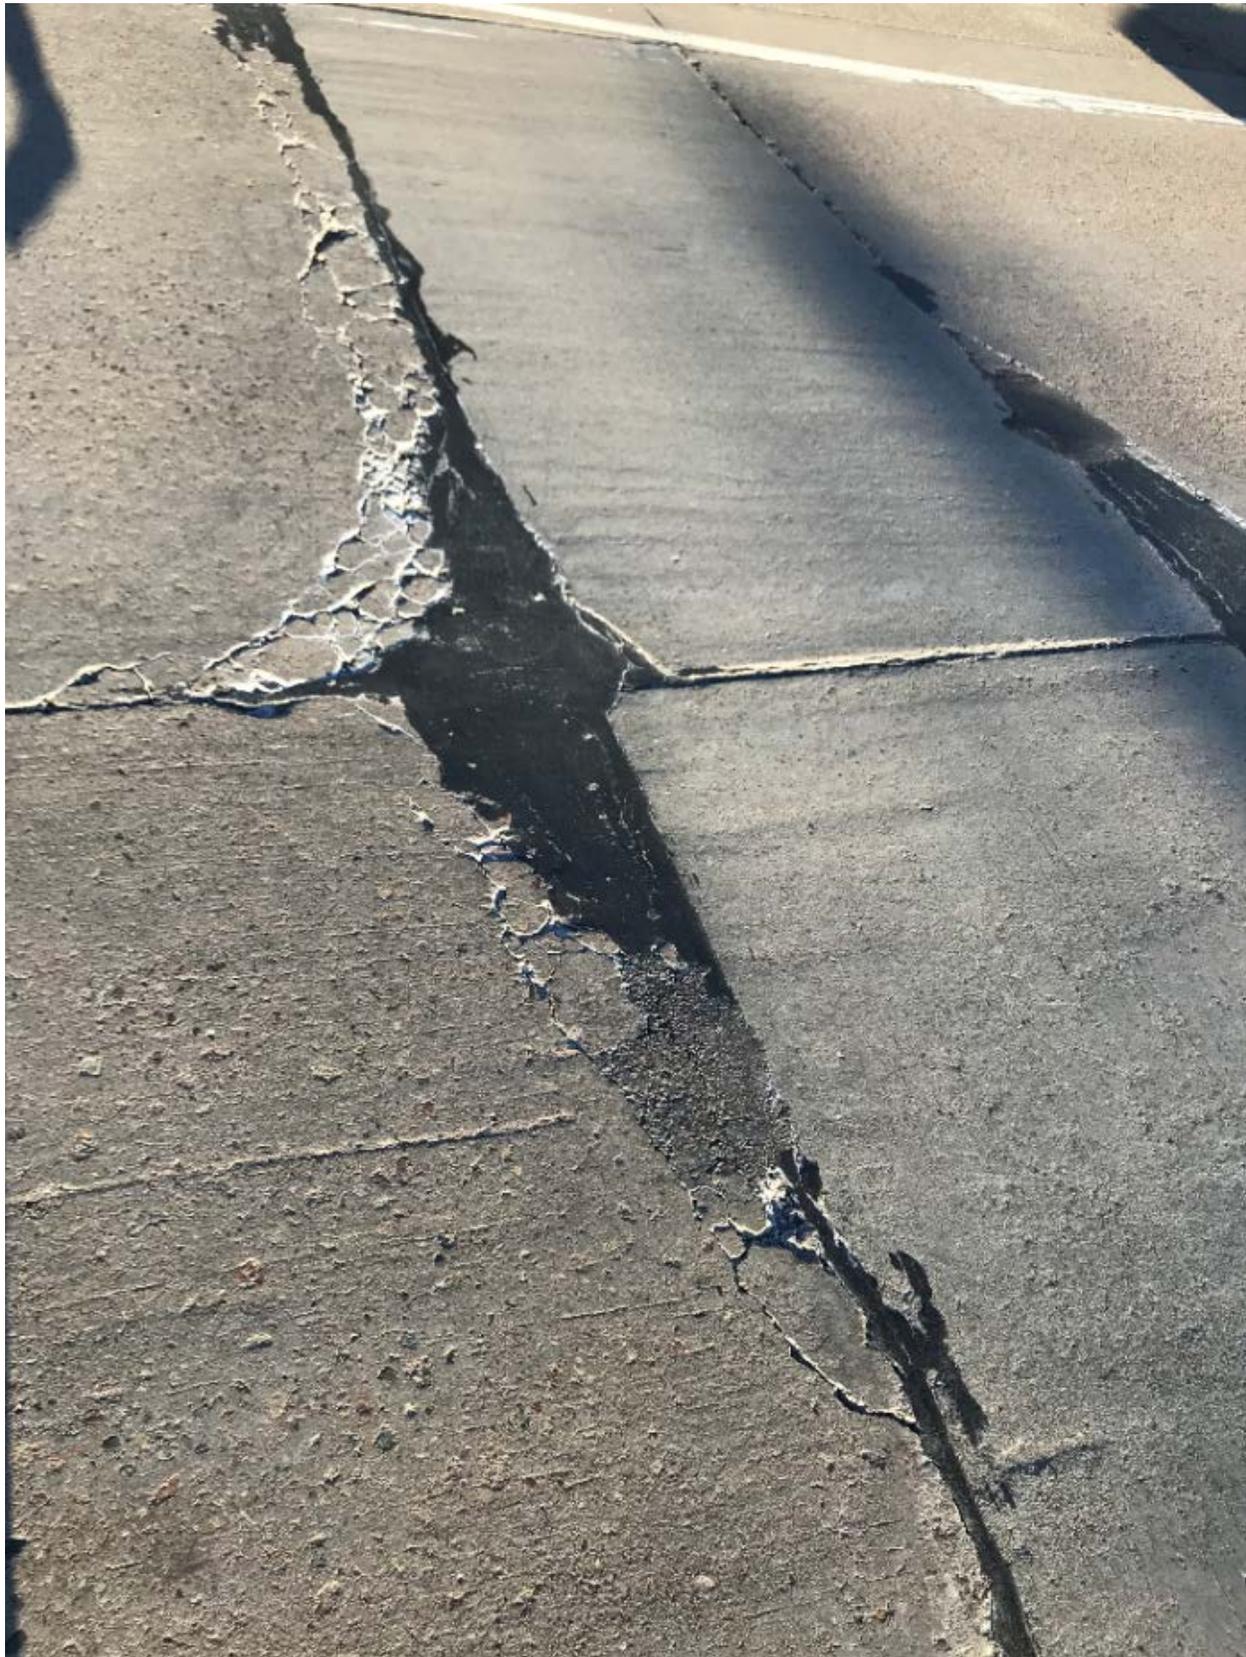
Figure D-8. D Cracking and full-depth repairs in existing concrete pavement (Site #8, State Road 66, Stevens Point).

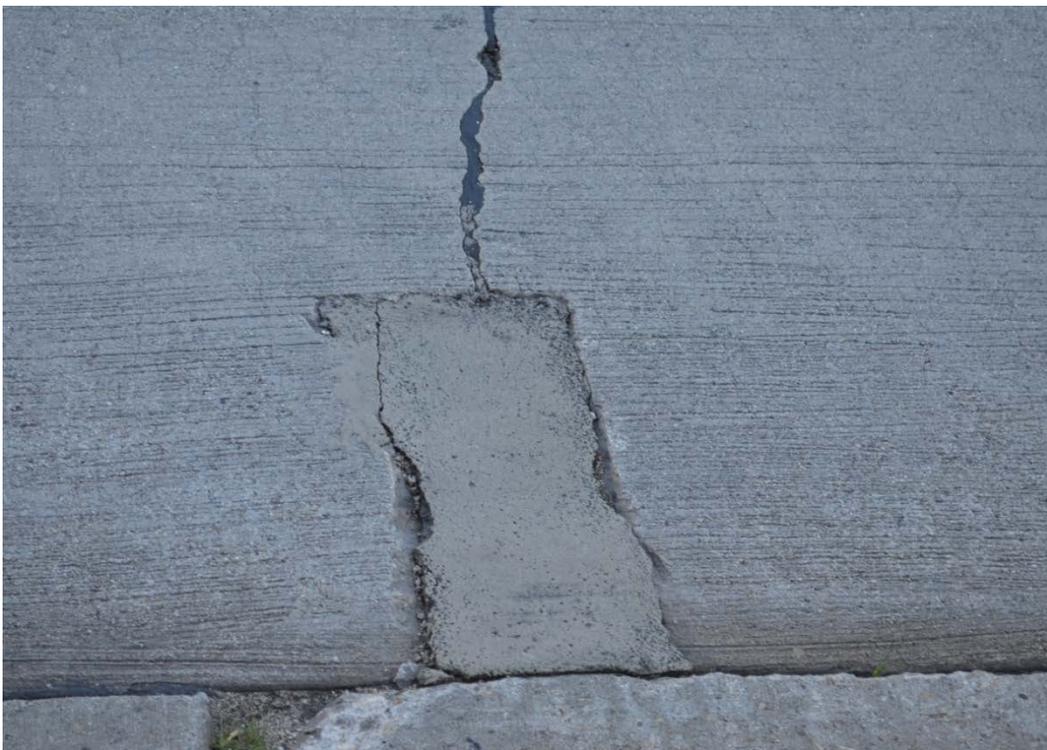
Figure E-4. Material loss along edges of a small PDR
(Site #9, State Road 66, Stevens Point).

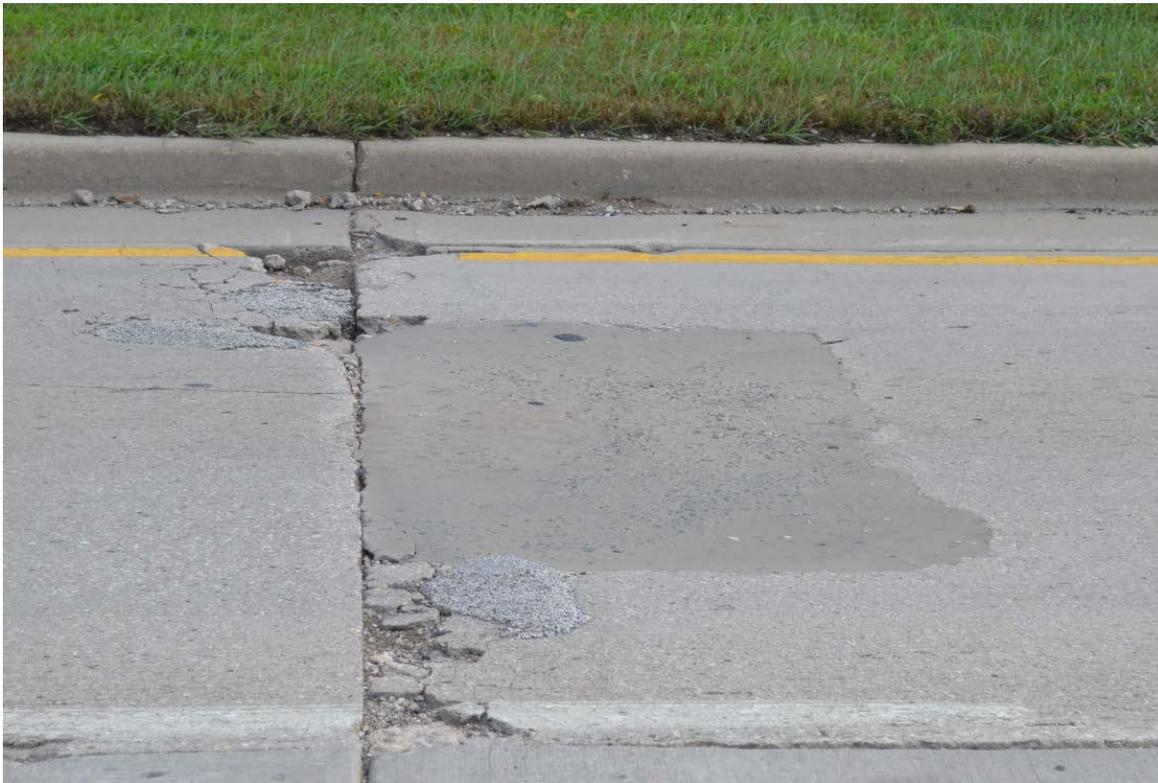
Figure E-5. Concrete pavement deterioration adjacent to PDR
(Site #10, State Road 145, Menomonee Falls).

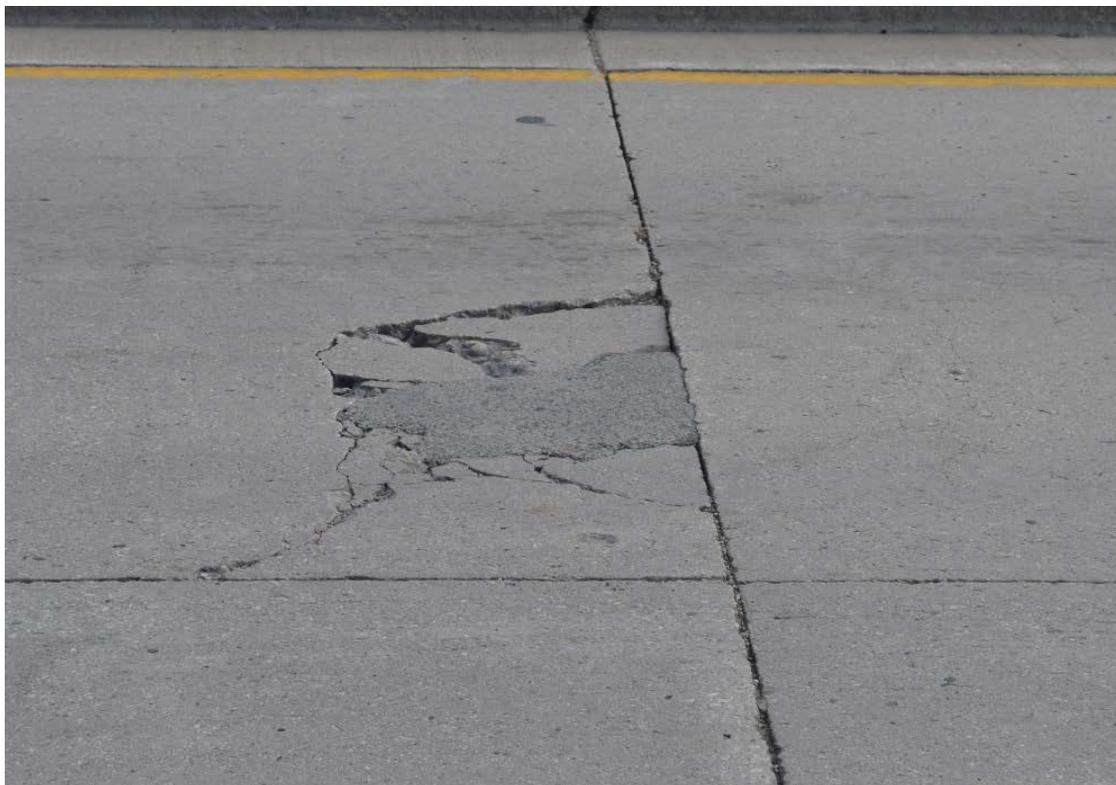
Figure E-6. Concrete pavement deterioration around PDR
(Site #10, State Road 145, Menomonee Falls).

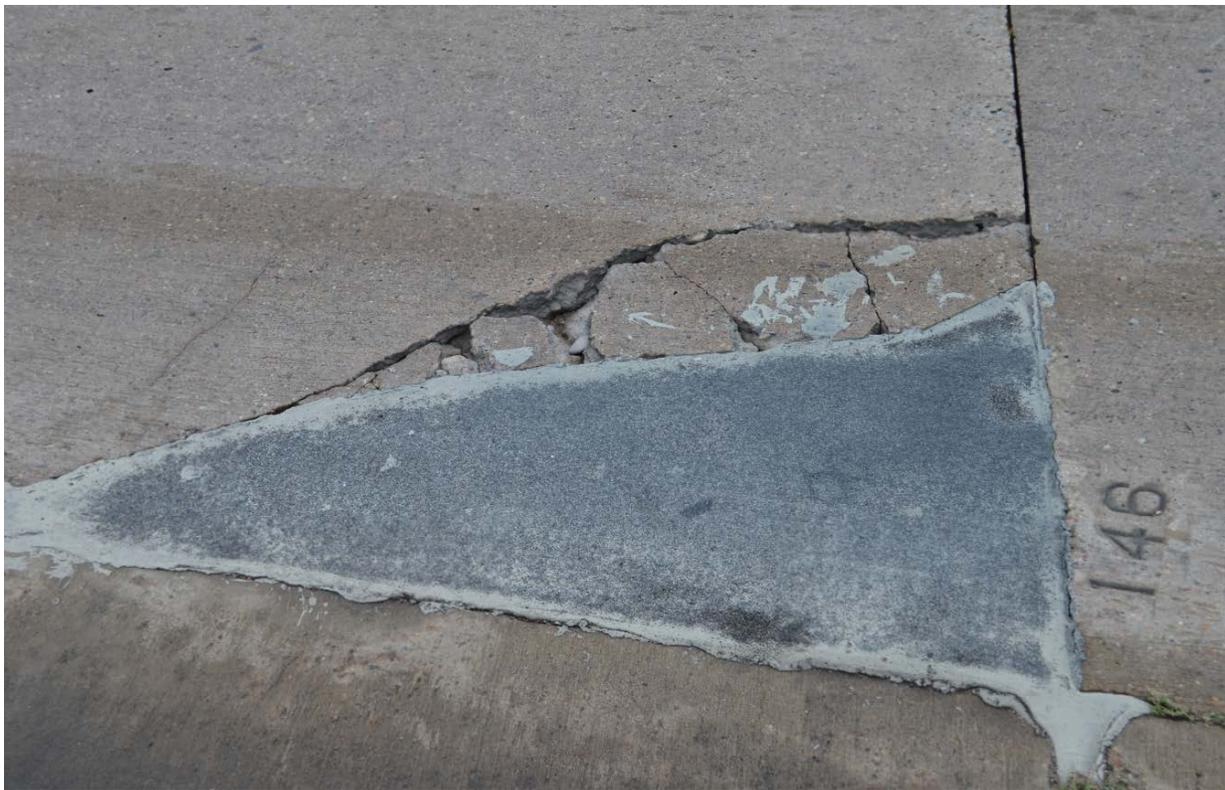
Figure E-8. Concrete pavement deterioration around PDR
(Site #11, US 10, Stevens Point).

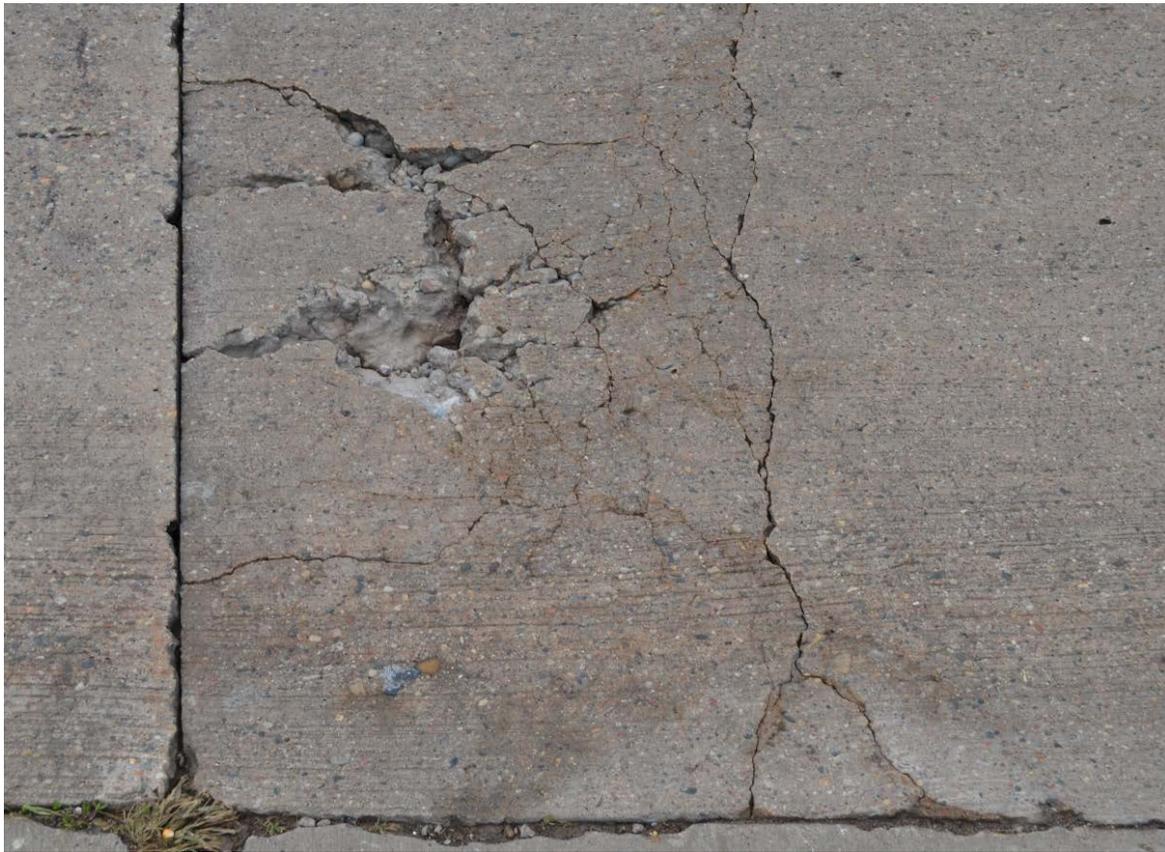
Figure E-10. Severely deteriorated areas in existing concrete pavement (Site #11, US 10, Stevens Point).

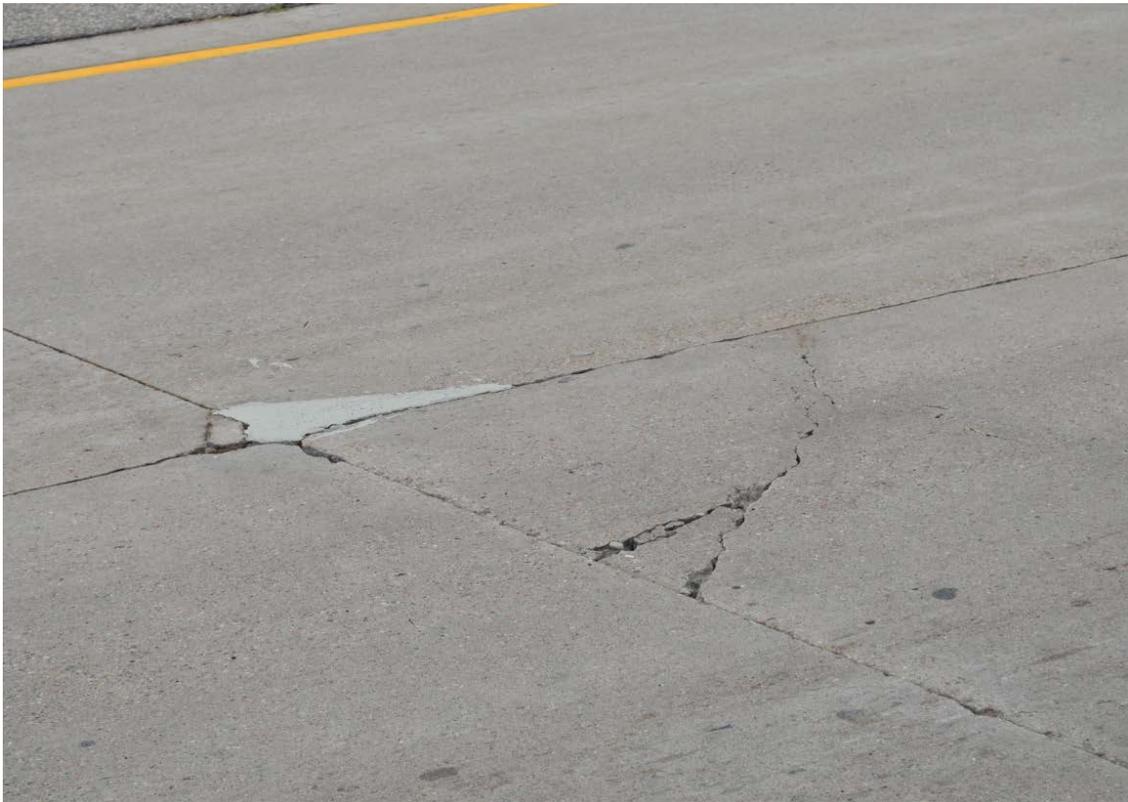
Figure E-12. Corner break in existing concrete pavement (Site #11, US 10, Stevens Point).

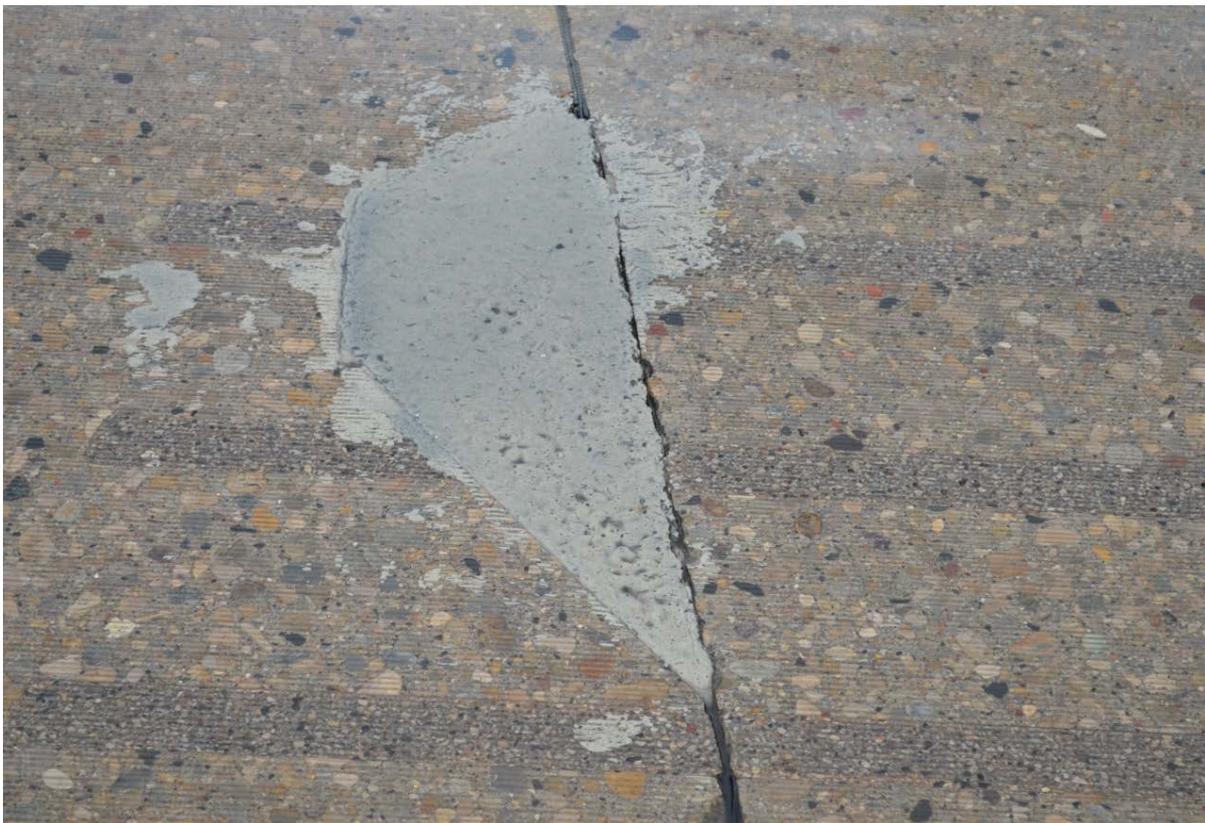
Figure E-15. PDR to address spalling at a transverse joint (Site #12, US 41, Marinette).

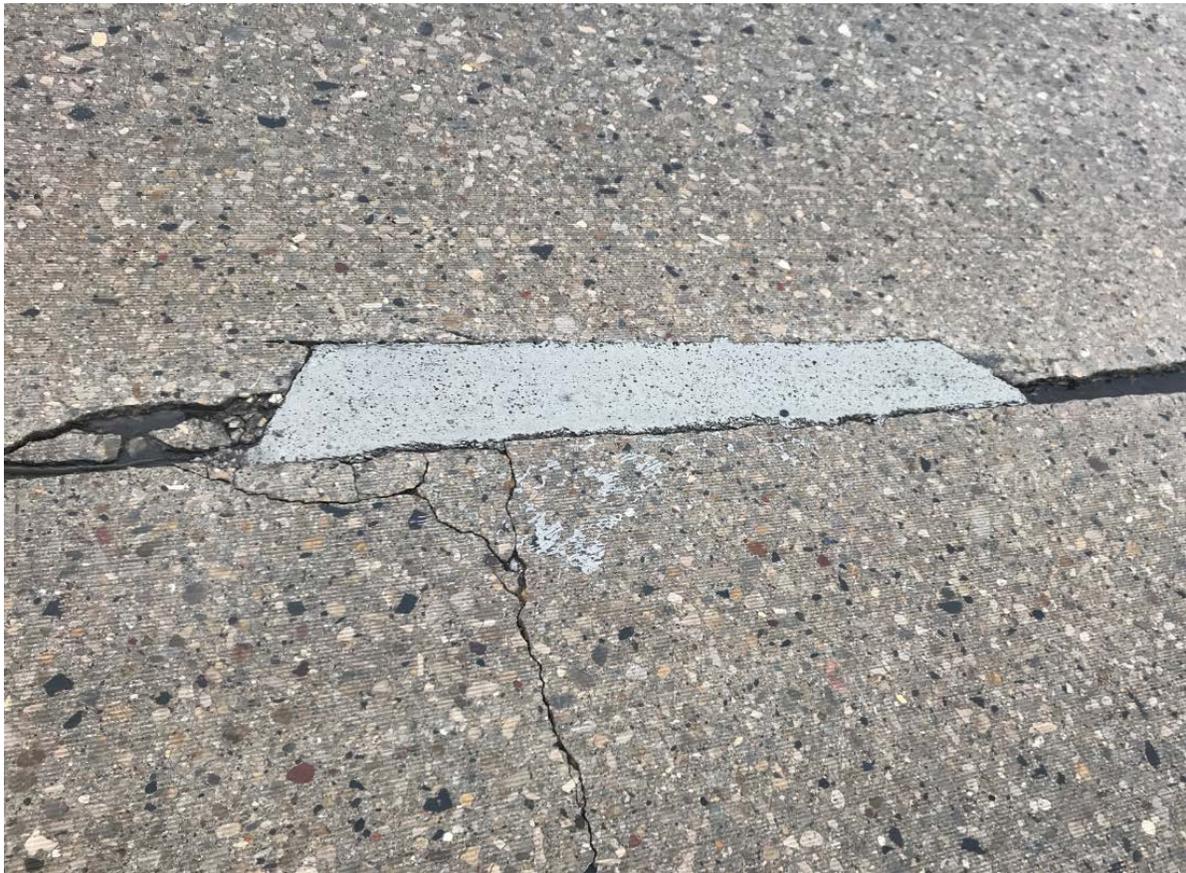
Figure E-16. Concrete pavement deteriorating around the PDR
(Site #12, US 41, Marinette).

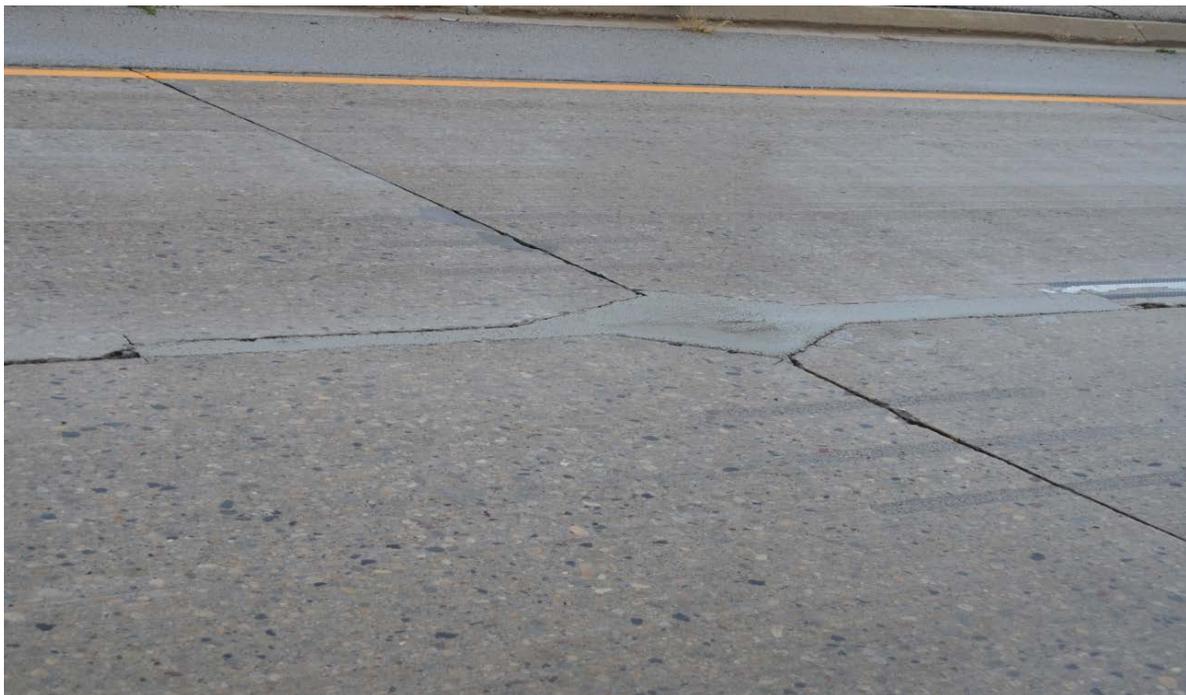
Figure E-17. PDR used to address deteriorated longitudinal joint
(Site #12, US 41, Marinette).
