Non-Cementitious Repair Materials Study

Final Report

WisDOT Project No. 0092-18-02
June 2019

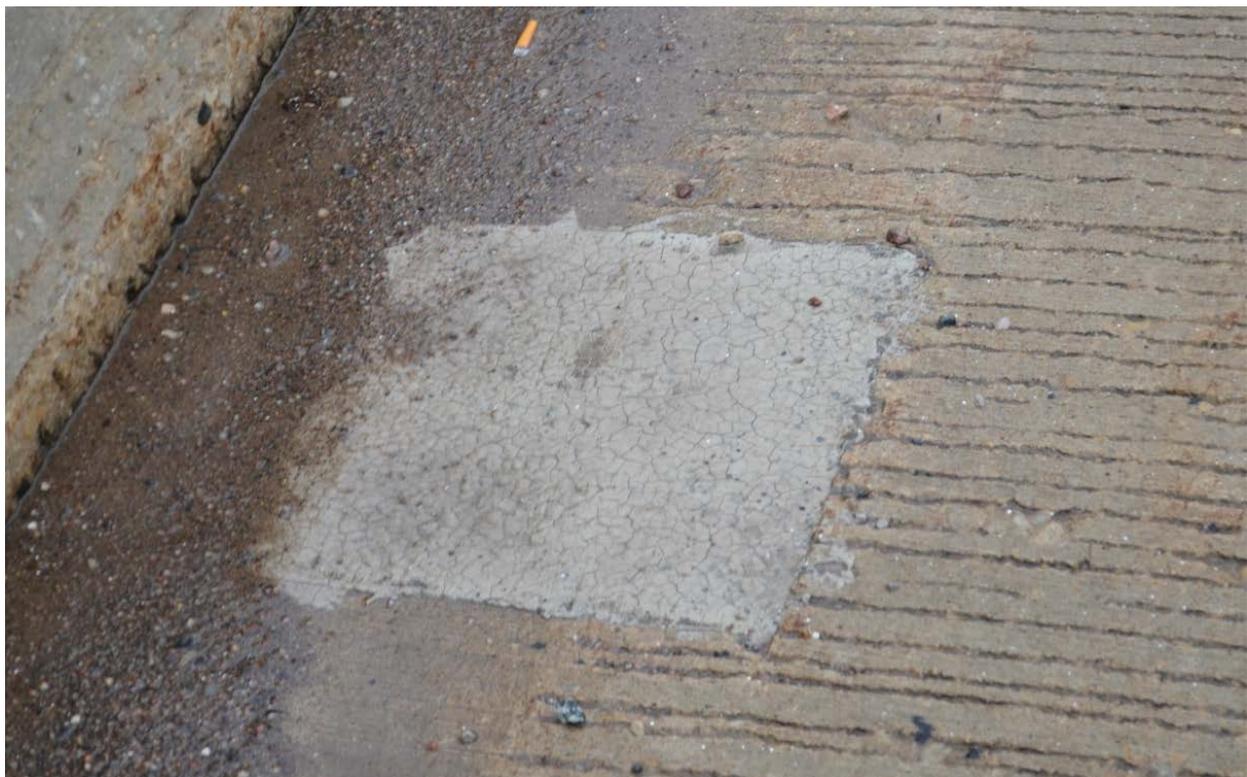
Figure E-19. Map cracking pattern on PDR surface
(Site #13, State Road 32, Mountain).

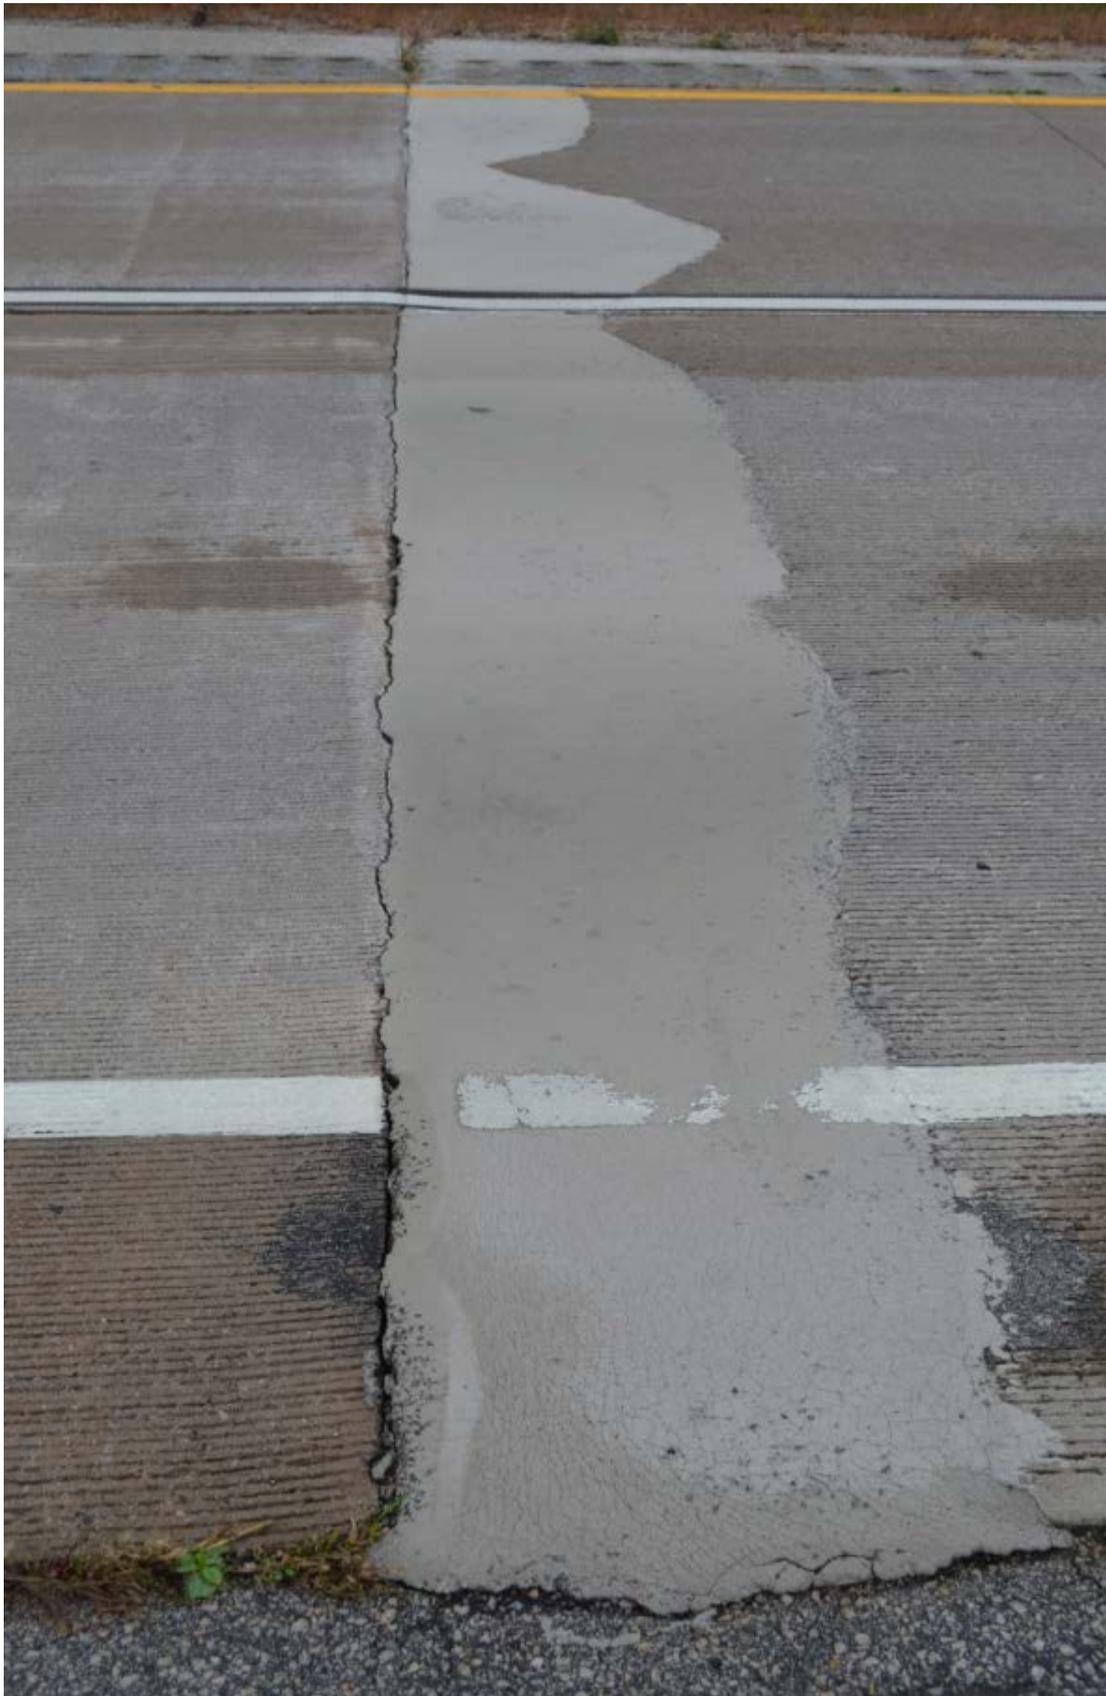
Figure E-21. PDR on bridge deck approach slabs, surface map cracking in shoulder area (Site #14, US 141, Pound).

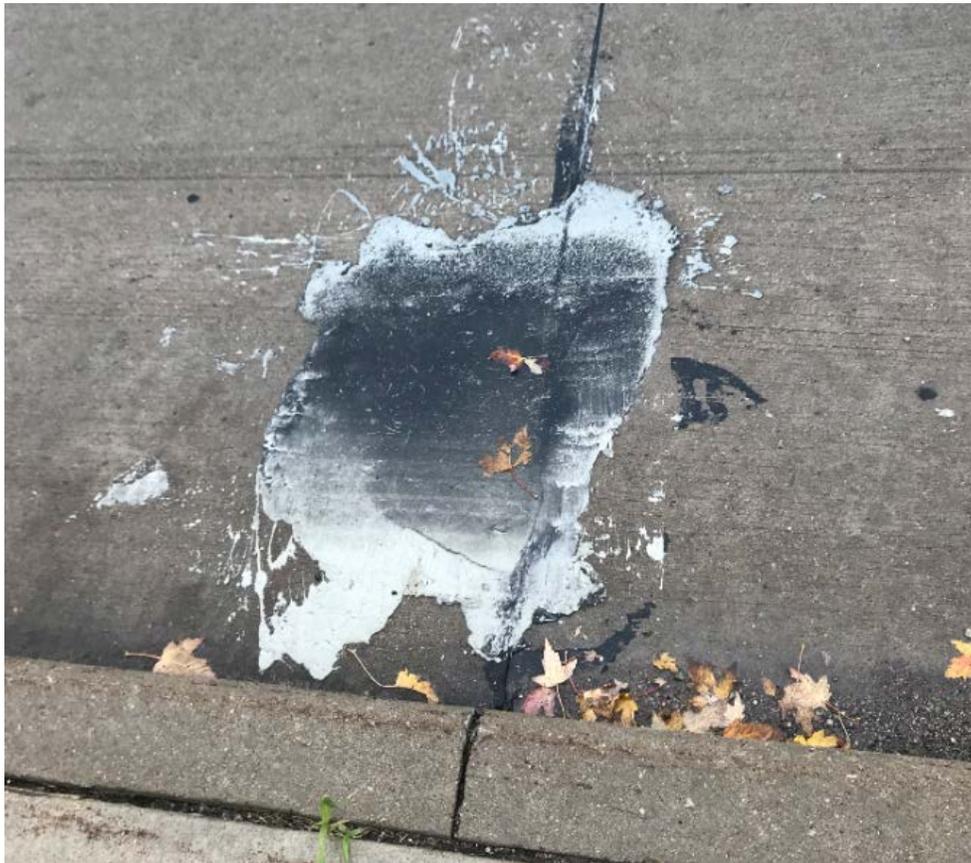
Figure E-22. PDR to address joint spalling
(Site #15, Calumet St., Appleton).

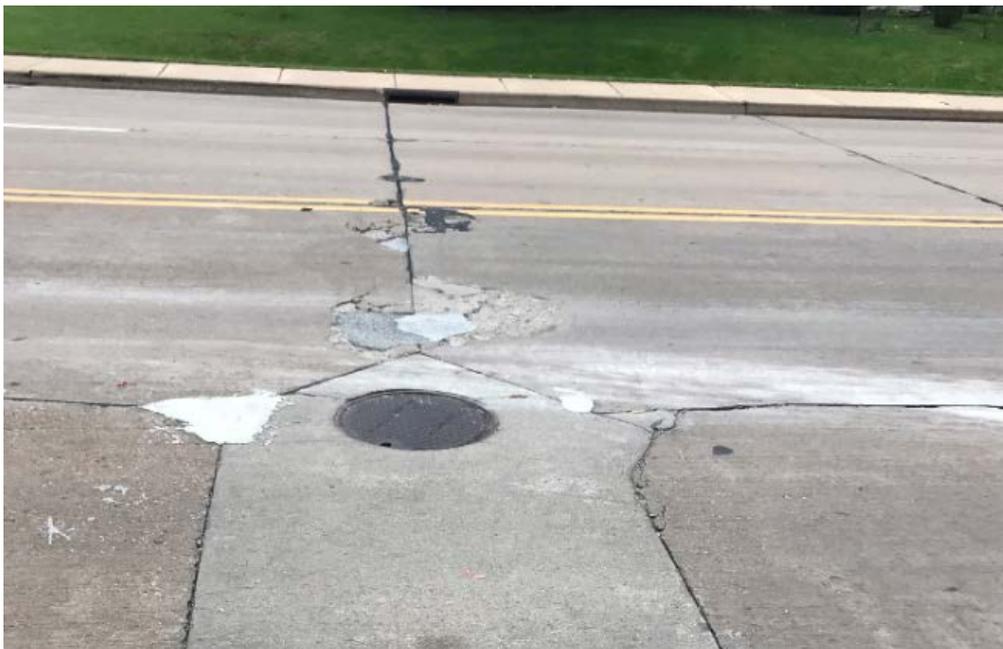
Figure E-23. Existing concrete pavement deteriorating around PDRs
(Site #15, Calumet St., Appleton).

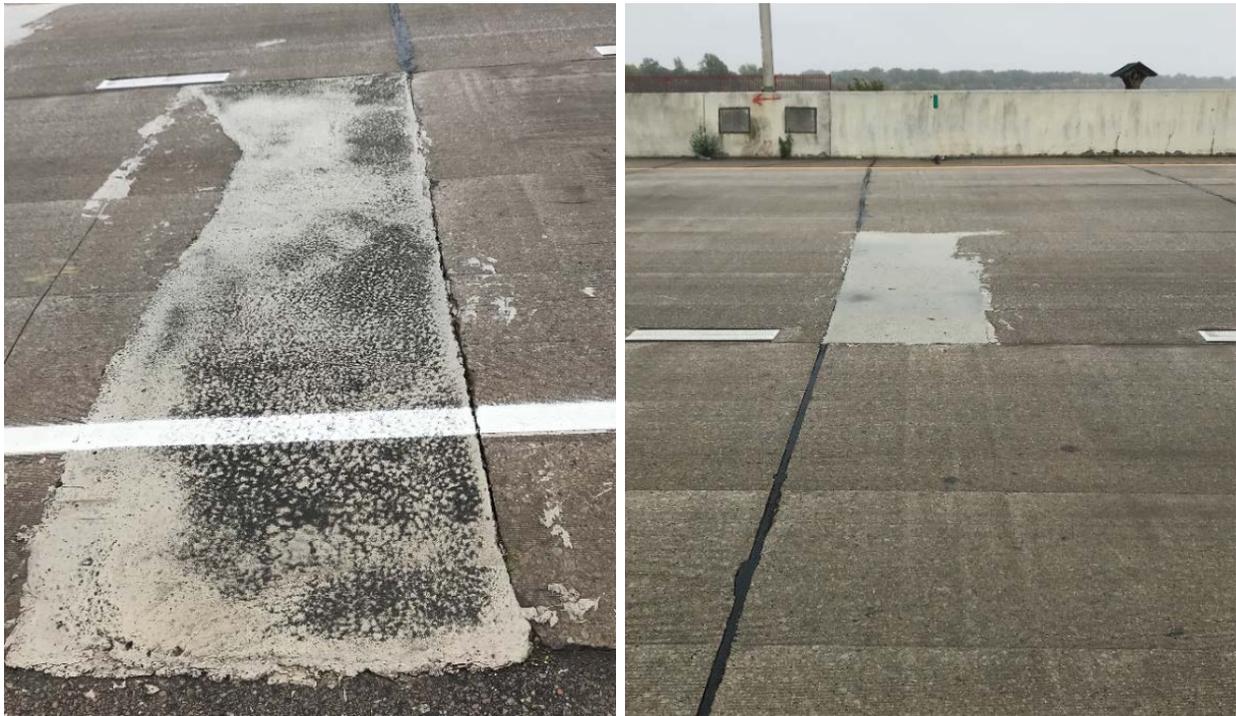
Figure E-28. PDR to address deterioration along transverse joints
(Site #18, I 41, Oshkosh).

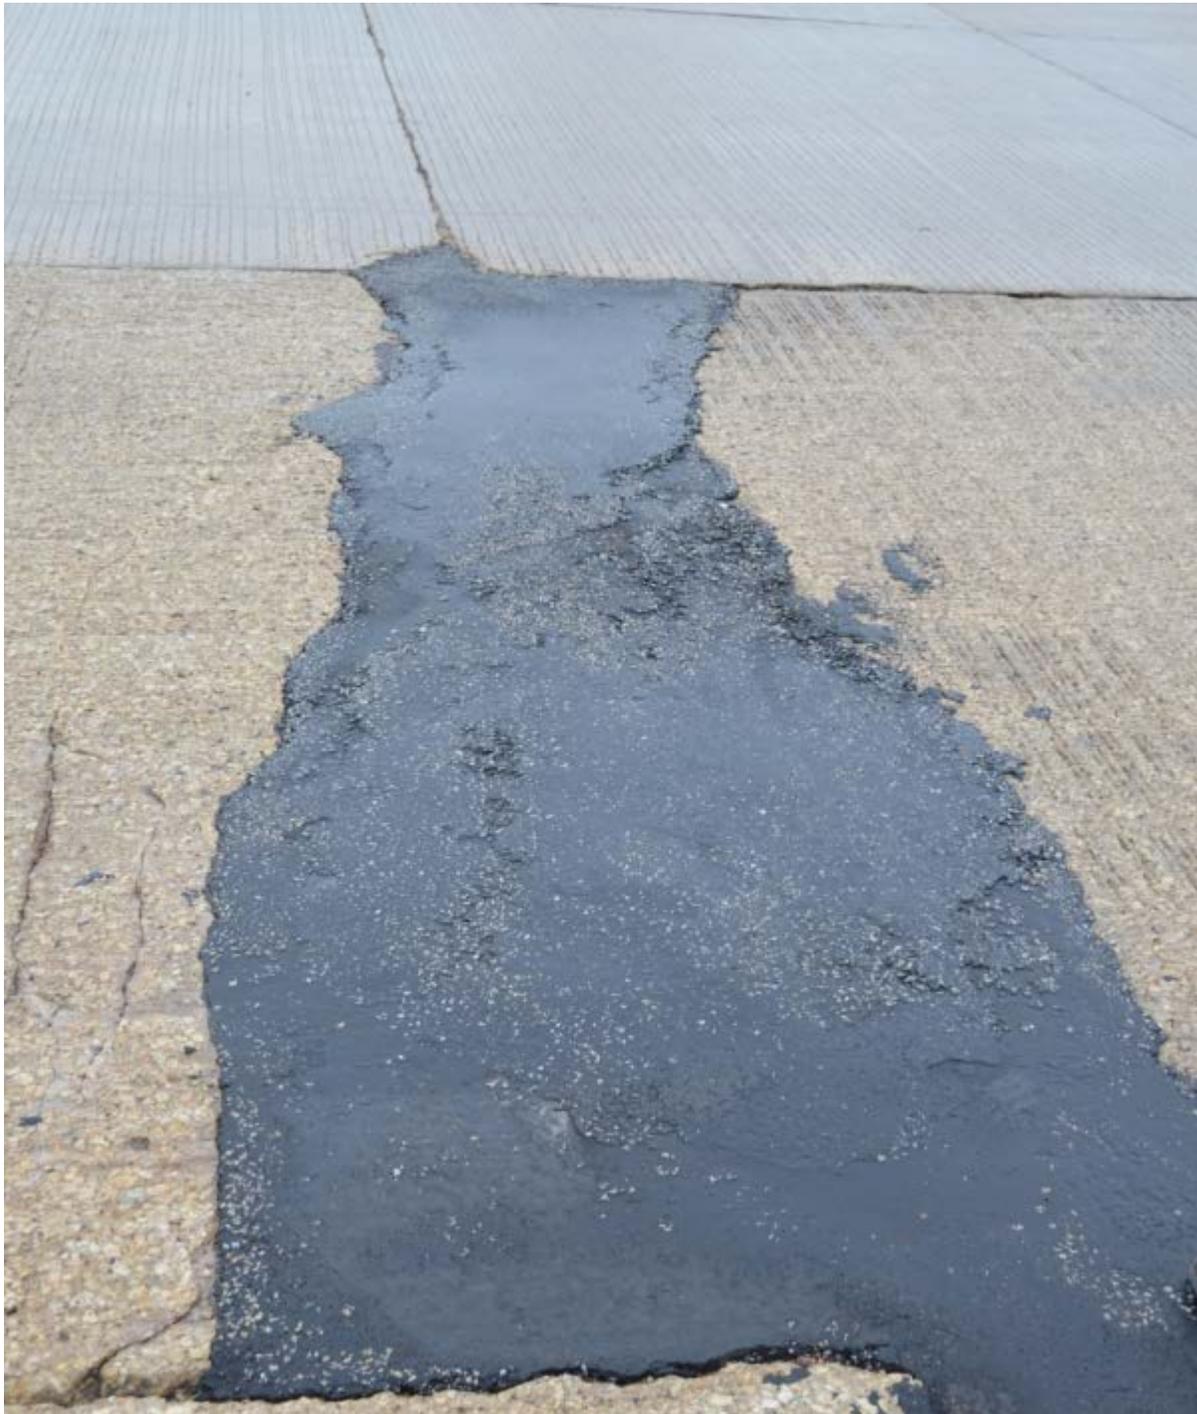
Figure F-1. PDR to address deterioration along transverse joint (Site #19, State Road 93, Eau Claire).

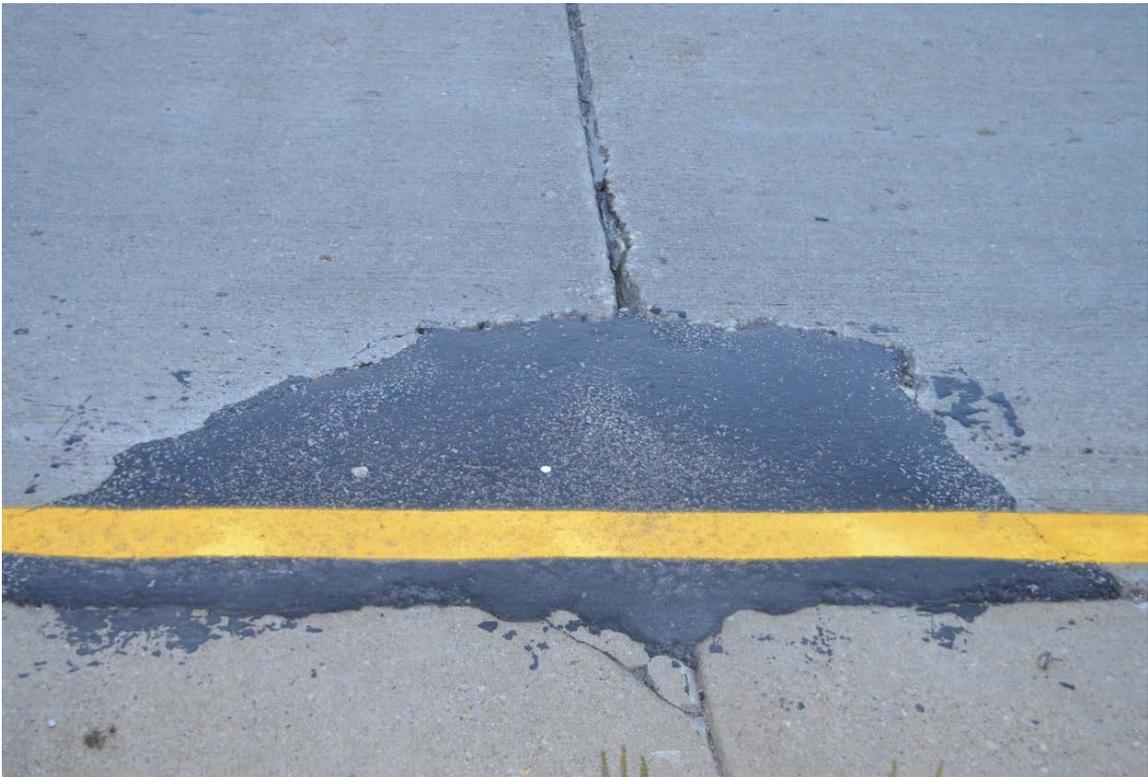
Figure F-6. PDR to address corner spalling
(Site #21, State Road 59, Waukesha).

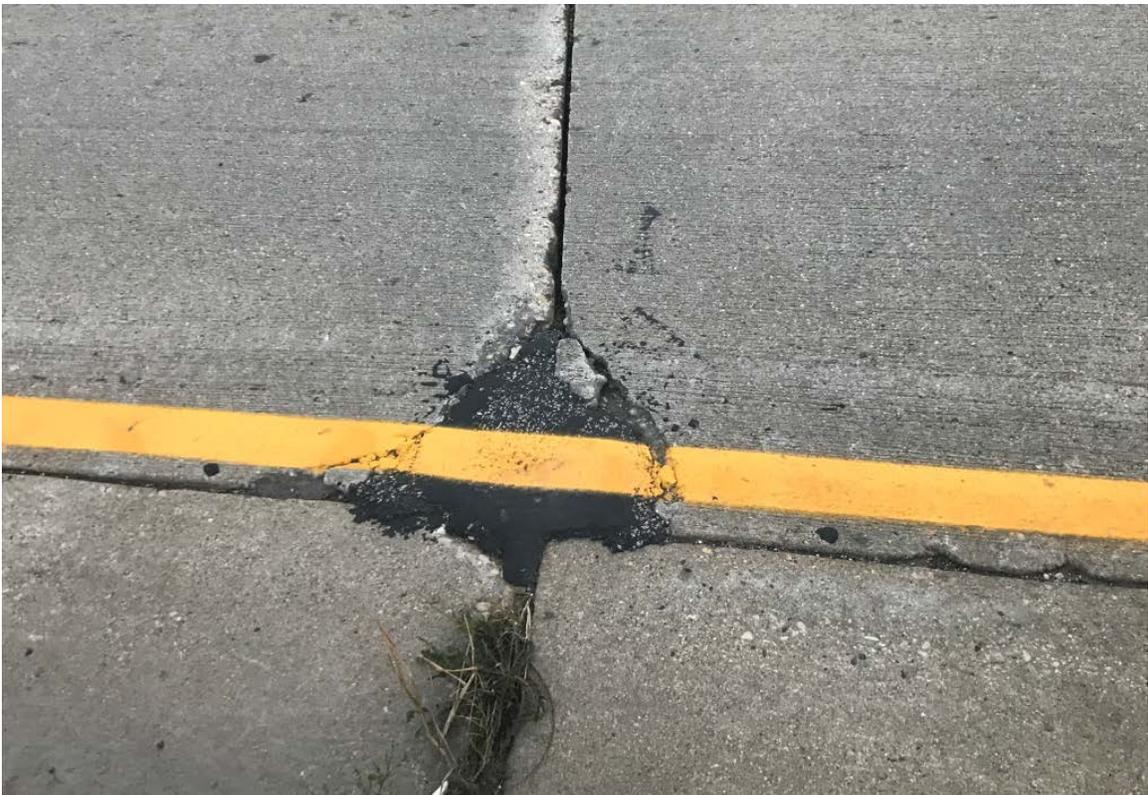
Figure F-7. Existing pavement deteriorating around PDR
(Site #21, State Road 59, Waukesha).

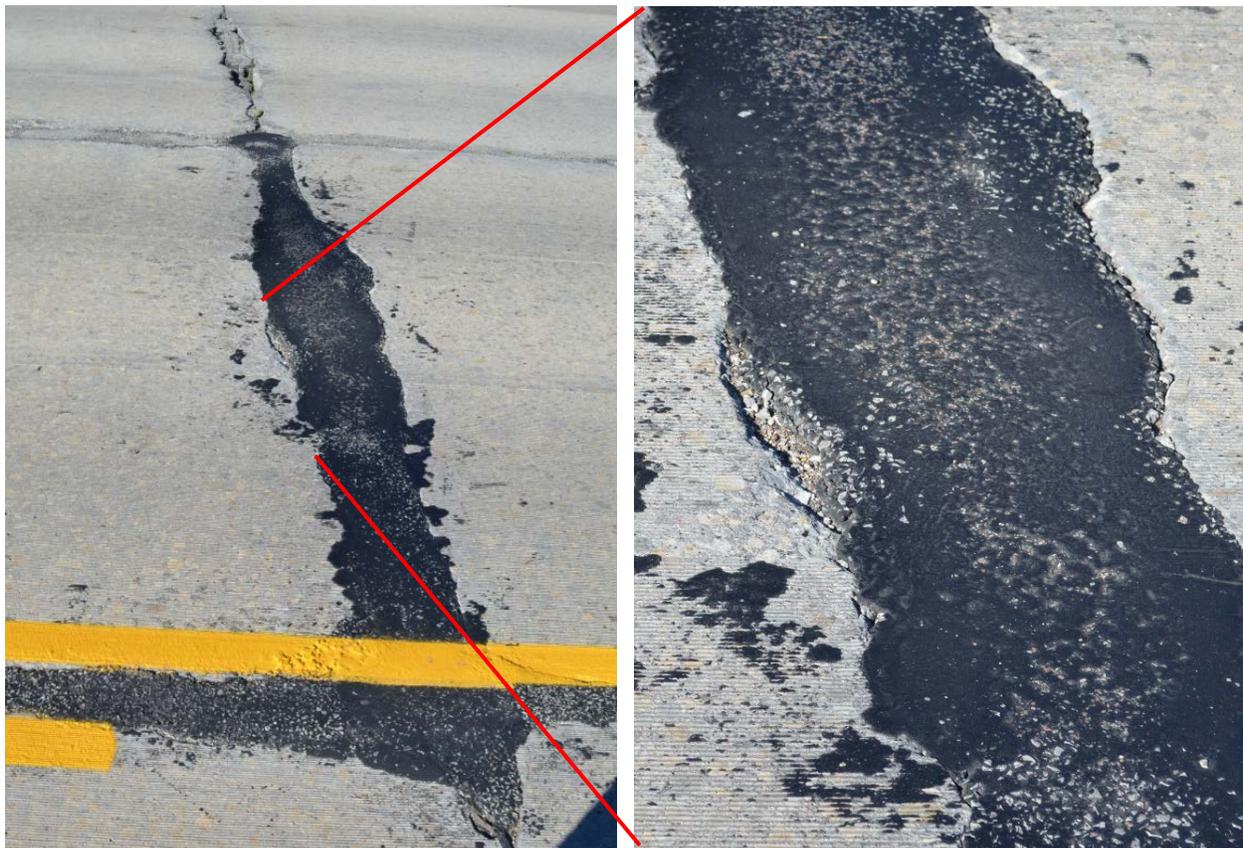
Figure F-9. PDR to address deteriorated joint (left) and existing pavement deteriorating around PDR (right) (Site #22, N. Ballard Rd., Appleton).

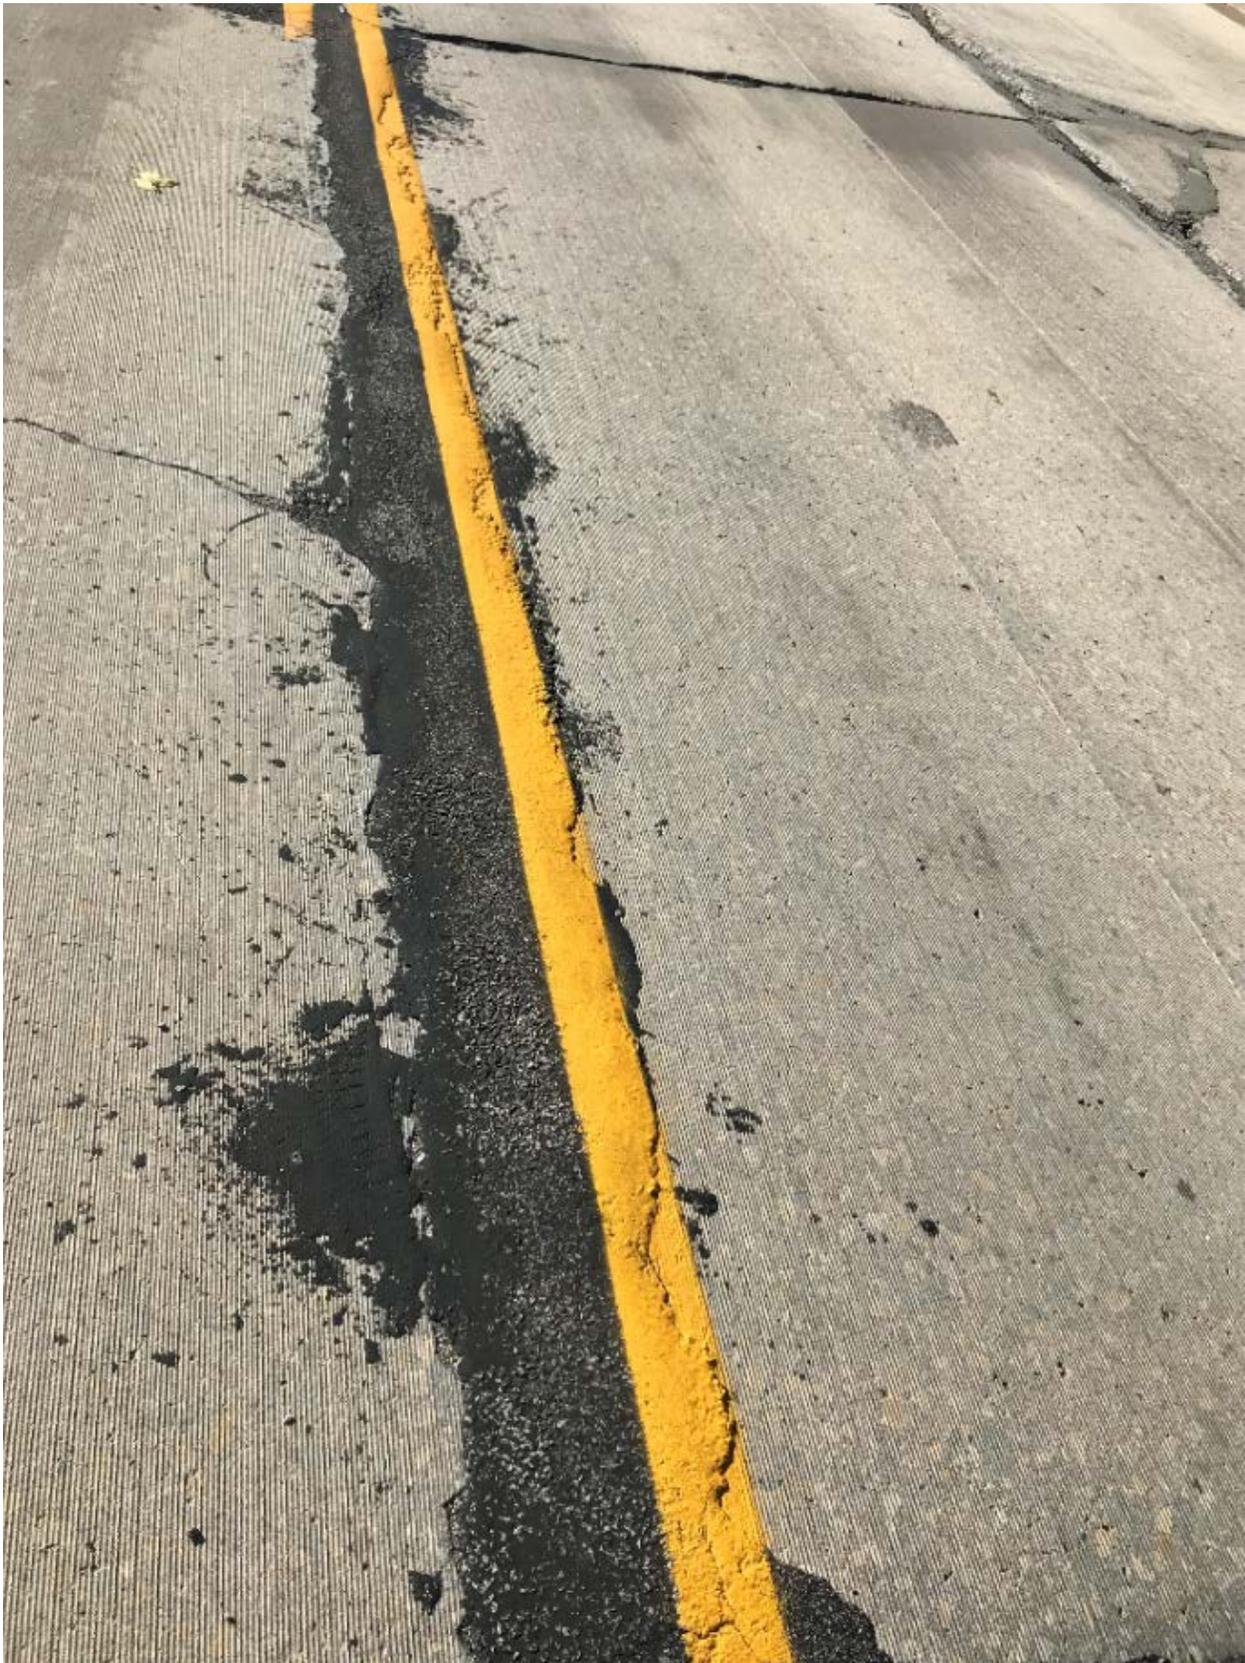
Figure F-10. PDR to address longitudinal joint deterioration
(Site #22, N. Ballard Rd., Appleton).

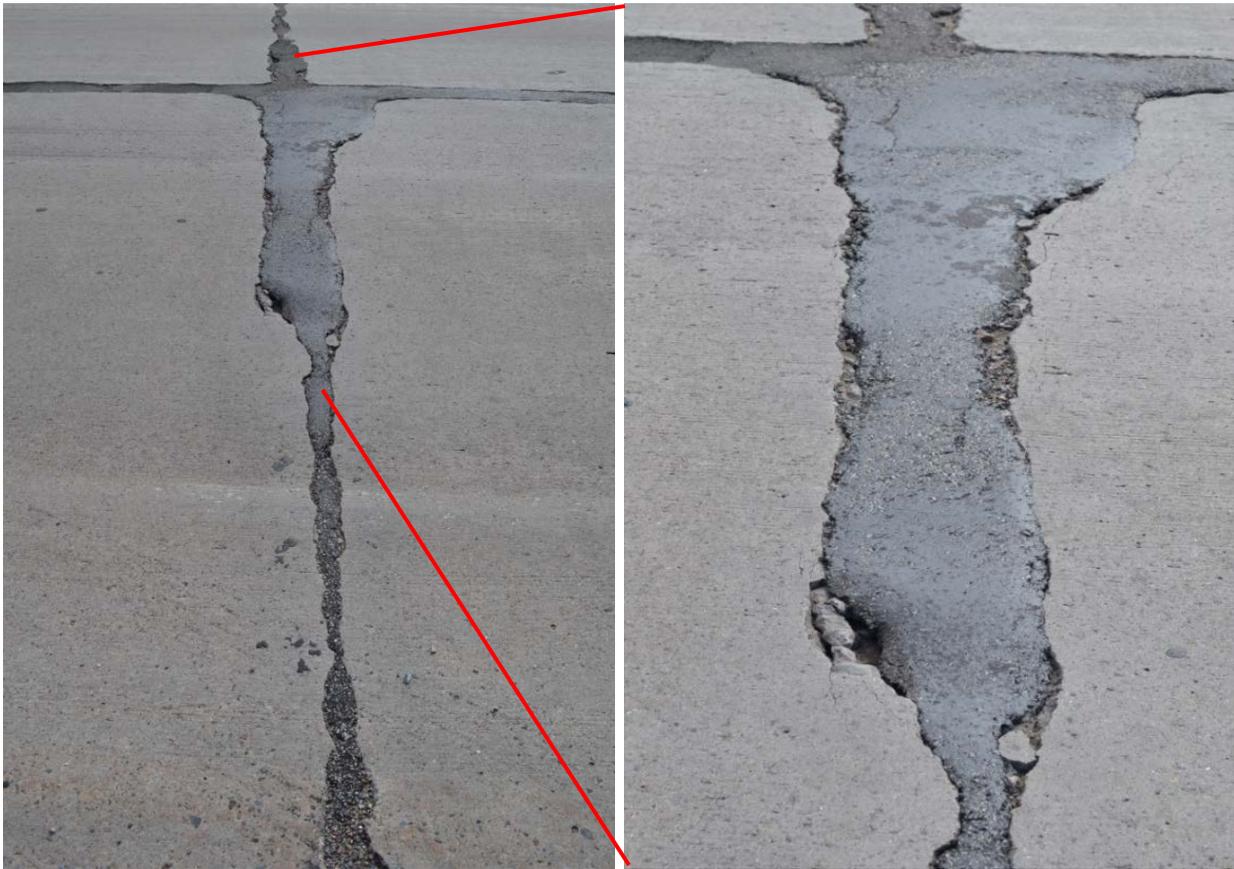
Figure F-12. PDR to address transverse joint deterioration (left) and surrounding concrete pavement deteriorating around PDR (Site #23, W. Kemp St., Rhinelander).

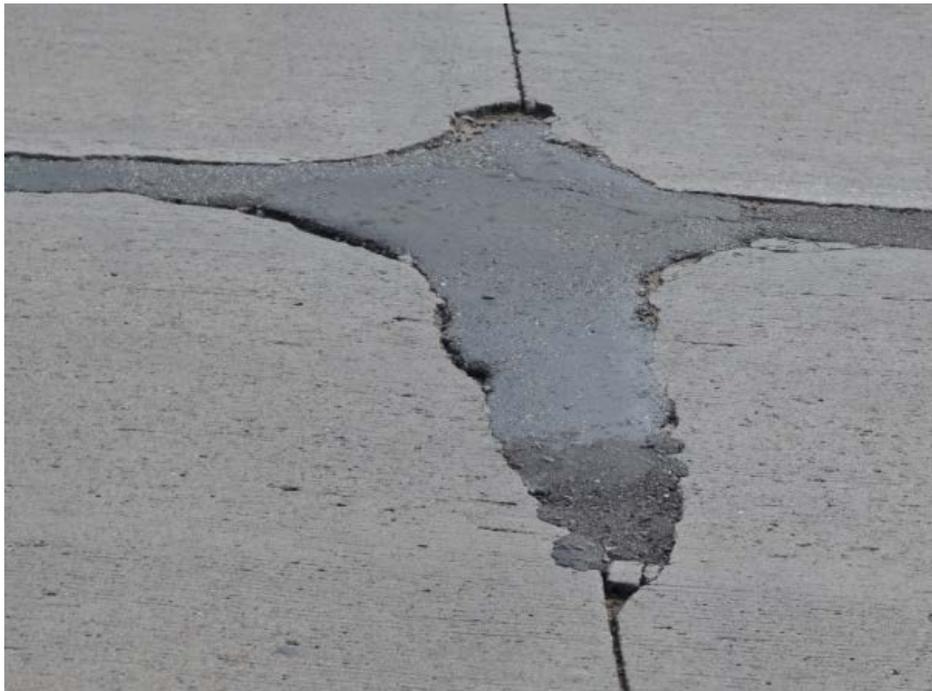
Figure F-13. PDR to address joint deterioration (Site #23, W. Kemp St., Rhinelander).
