# **Analysis of Concrete Pavement Joints to Predict the Onset of Distress**

WHRP 07-13

## ***FINAL REPORT***

Wisconsin Department of Transportation

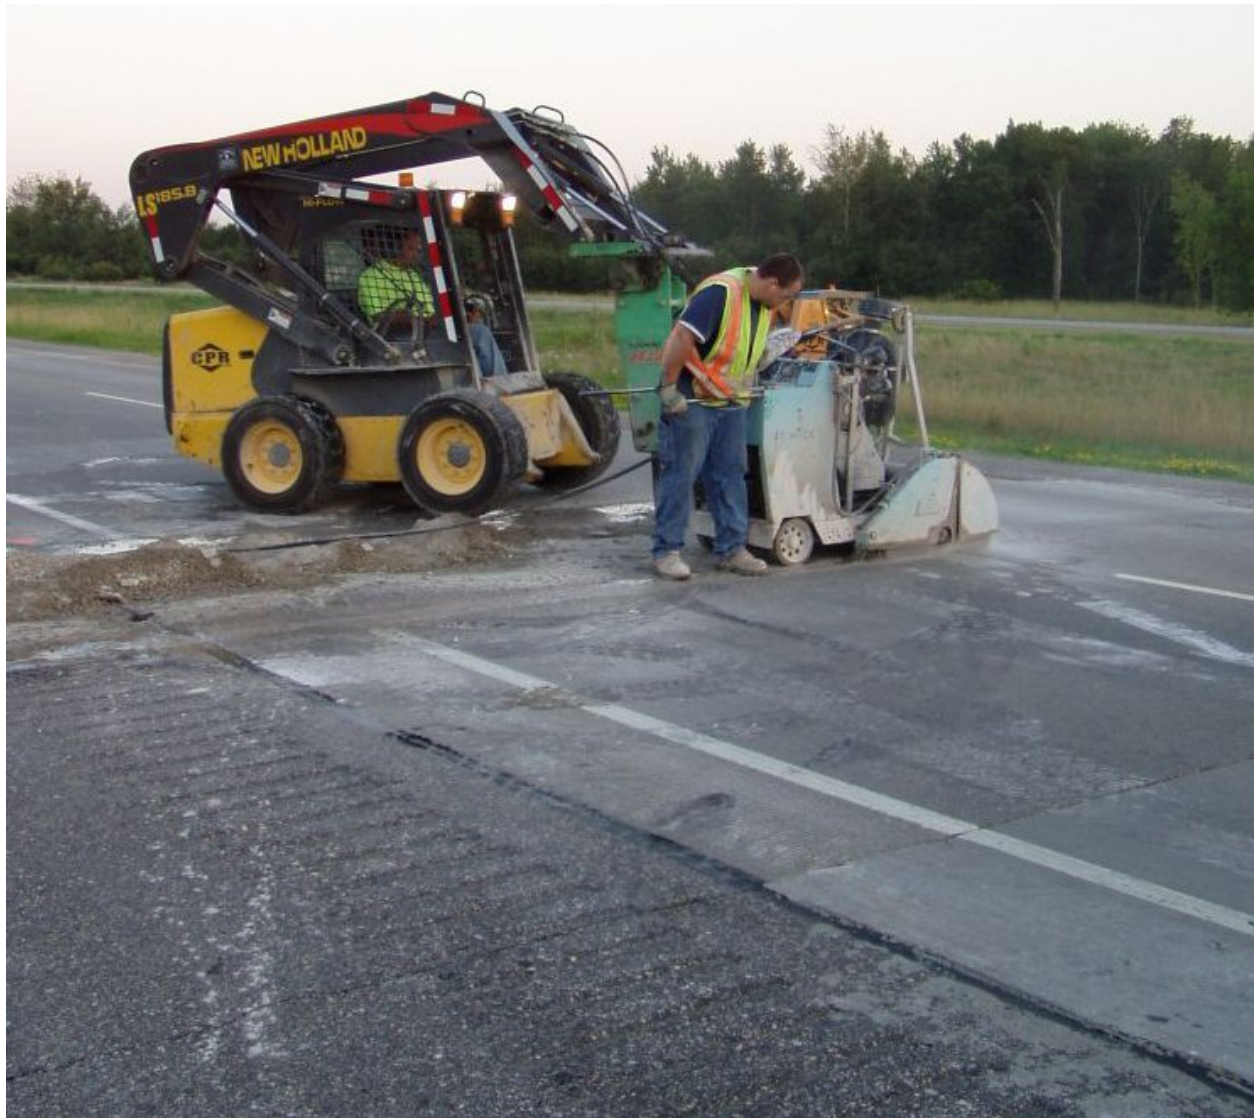
*Figure 1. Sawing on both sides of repair area (flanking distressed joint).*

1. Full-depth sawing of the existing pavement at approximately 5 ft. both upstream and downstream of the distressed joint. A third parallel sawcut is made within a few inches of the upstream cut in order to expedite removal of the edge of the repaired area.
2. A hydraulic hammer on a skid steer is used to chip out the corner of the slab within the narrow trench.
3. A concrete cutter is then lowered into the trench starting at the removed corner, and removes the remaining concrete within the trench.
4. A Slab Crab bucket attached to a large excavator then removes the slab pieces, depositing them into a series of end dump trailers for subsequent transportation to a designated landfill.
5. Once removed, the area is cleaned and dowels are drilled and inserted prior to placement of fast-track patching concrete.

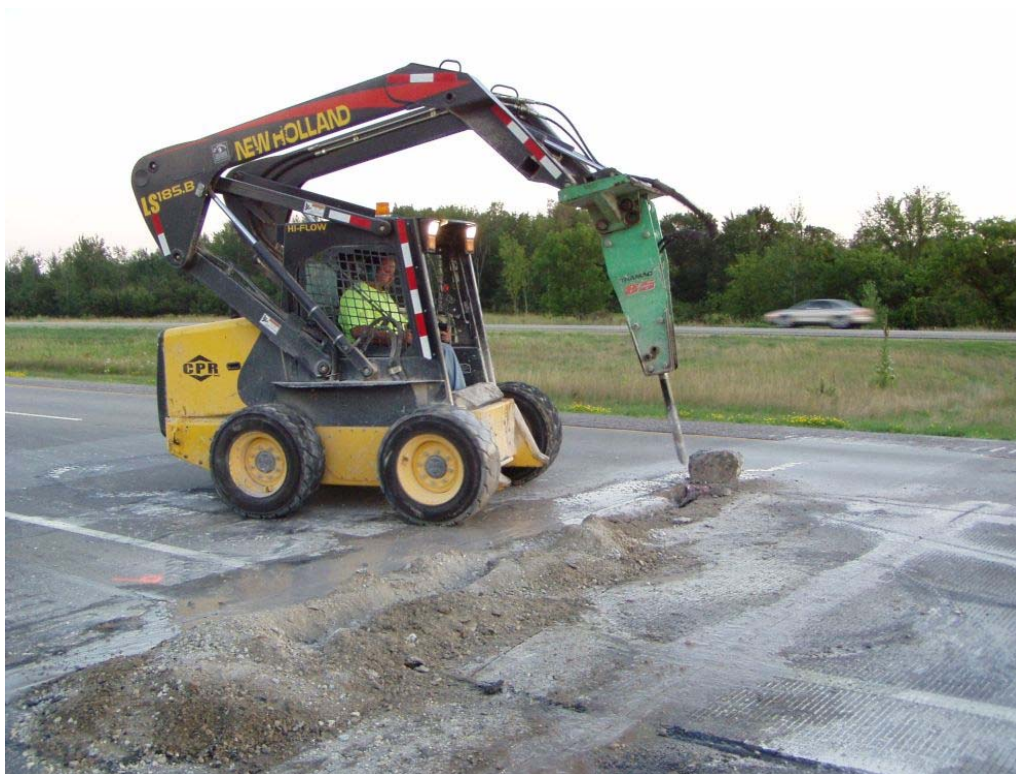
*Figure 2. Removing corner of repair area.*

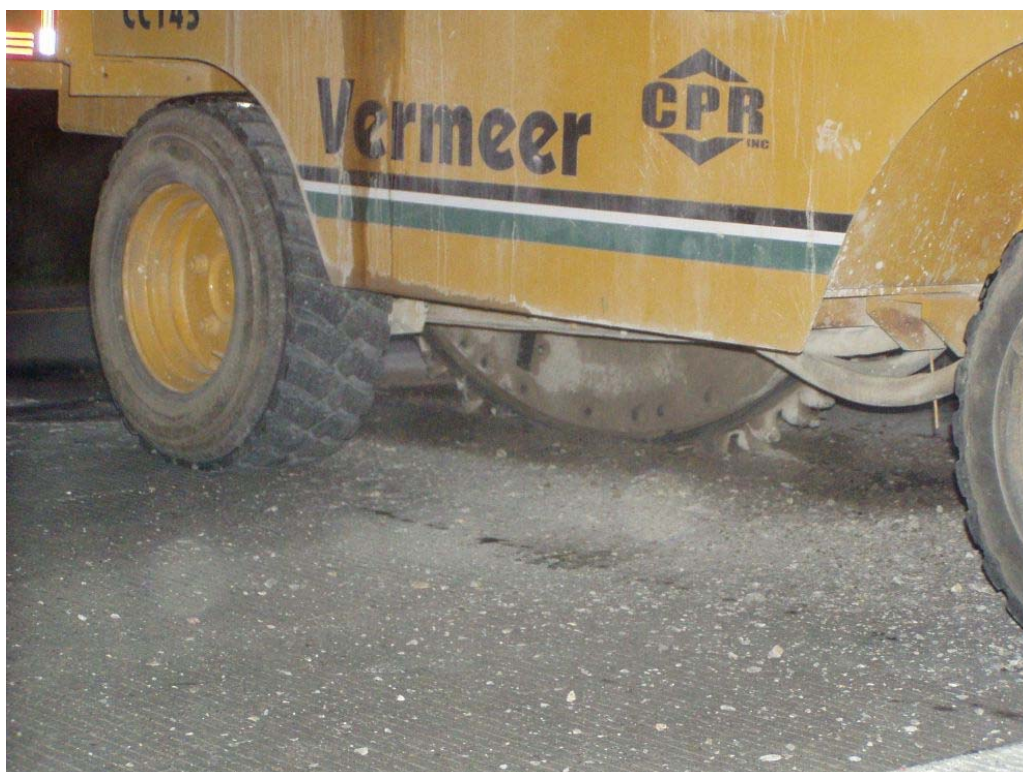
*Figure 3. Concrete cutter to remove edge of repair area.*

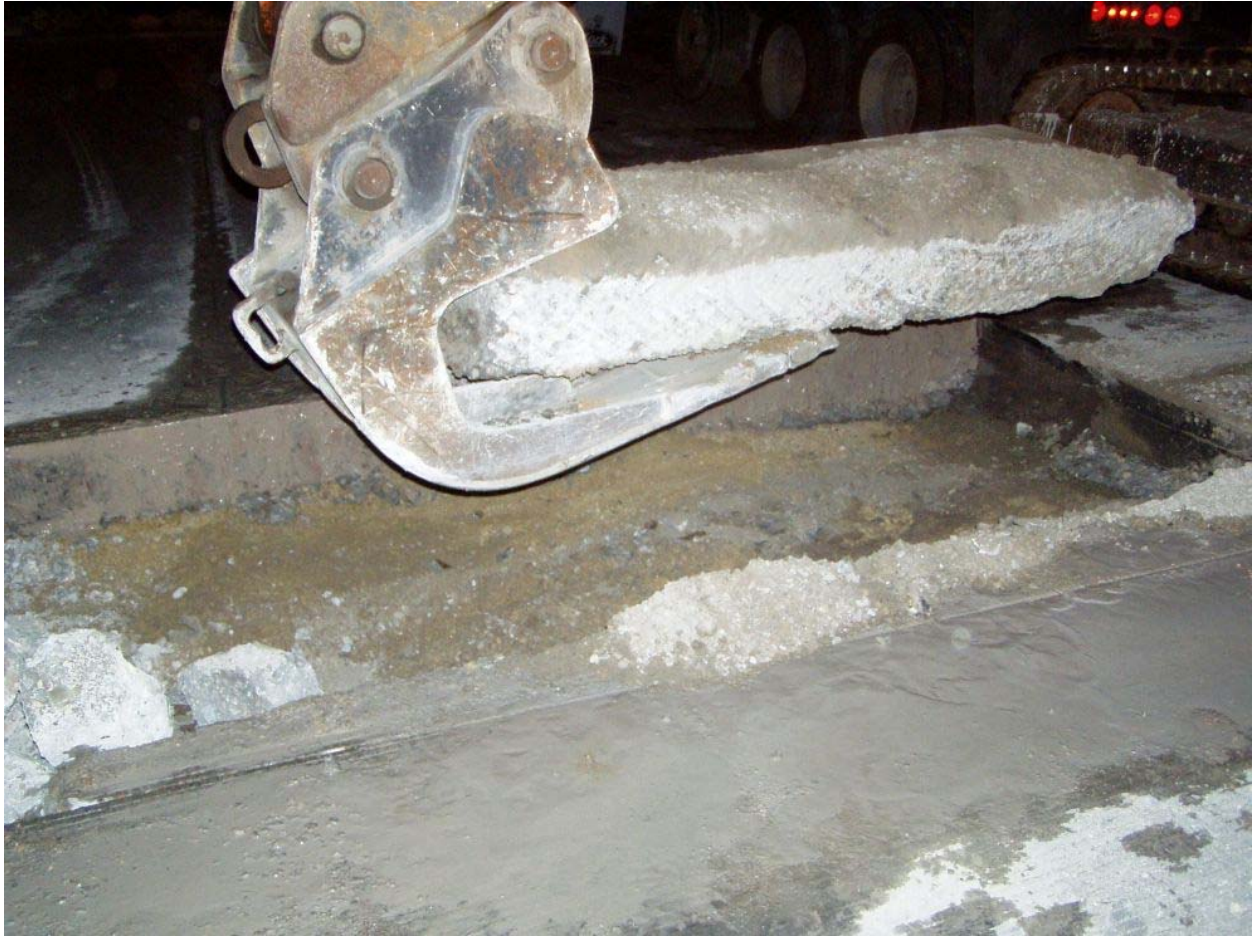
*Figure 4. Slab Crab bucket removing damaged concrete in repair area.*

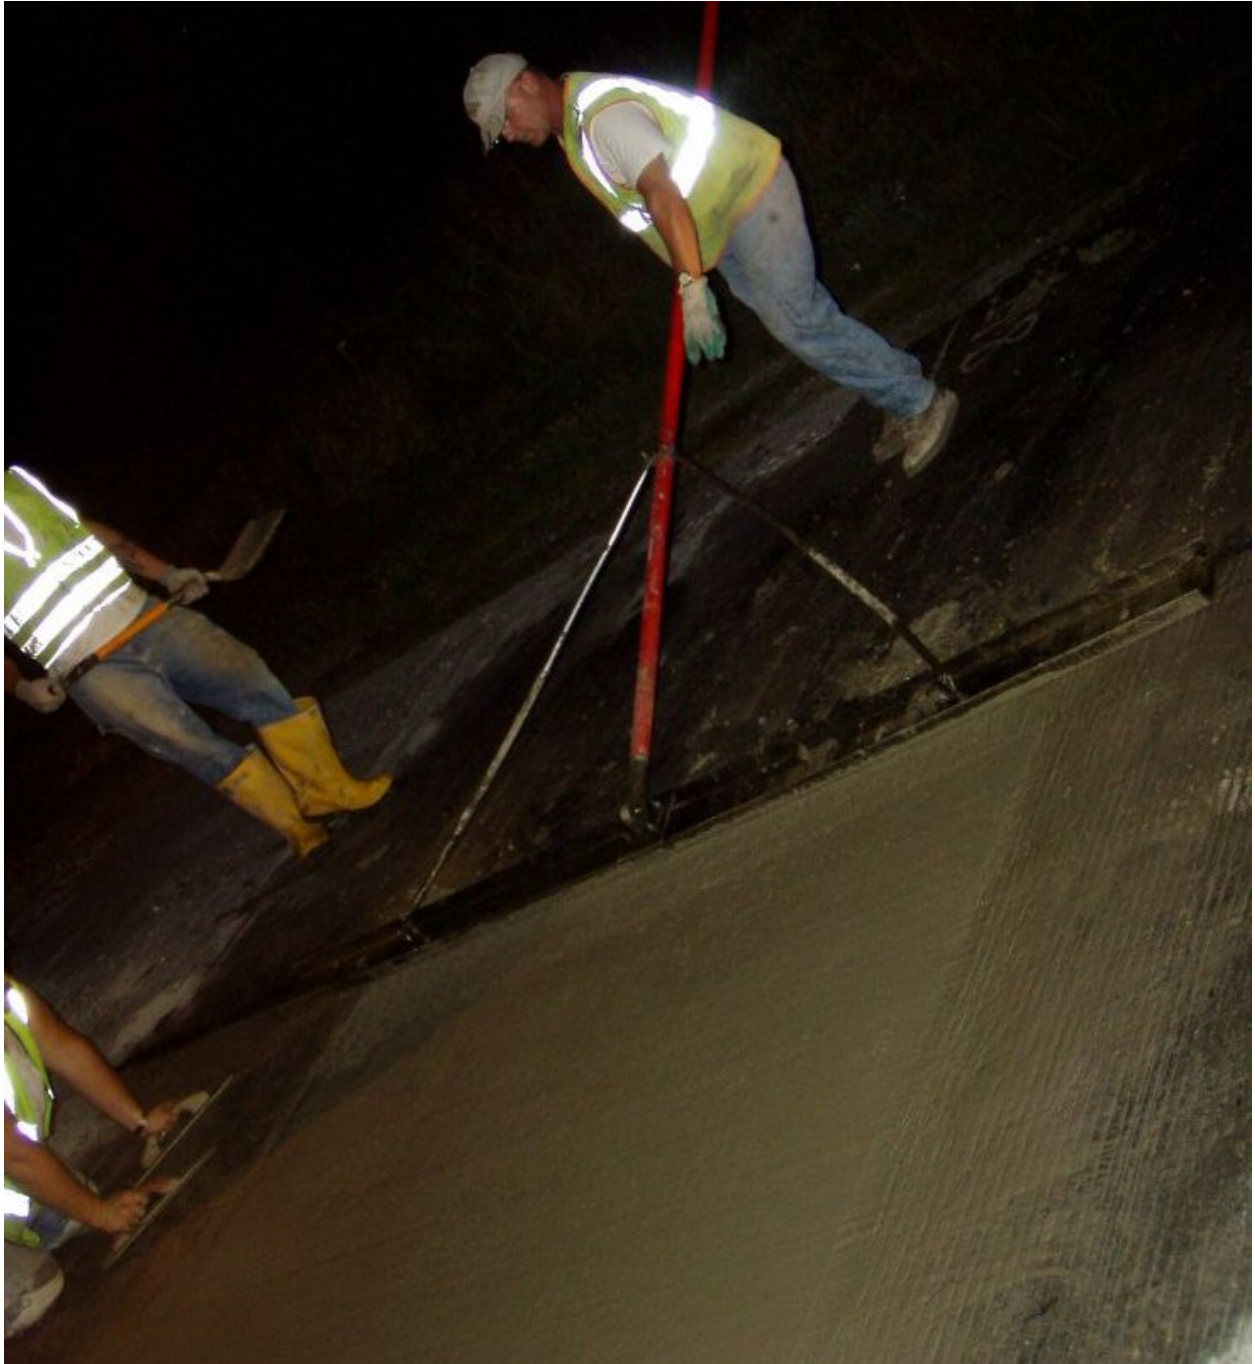
*Figure 5. Patching repair area using fast-track concrete.*

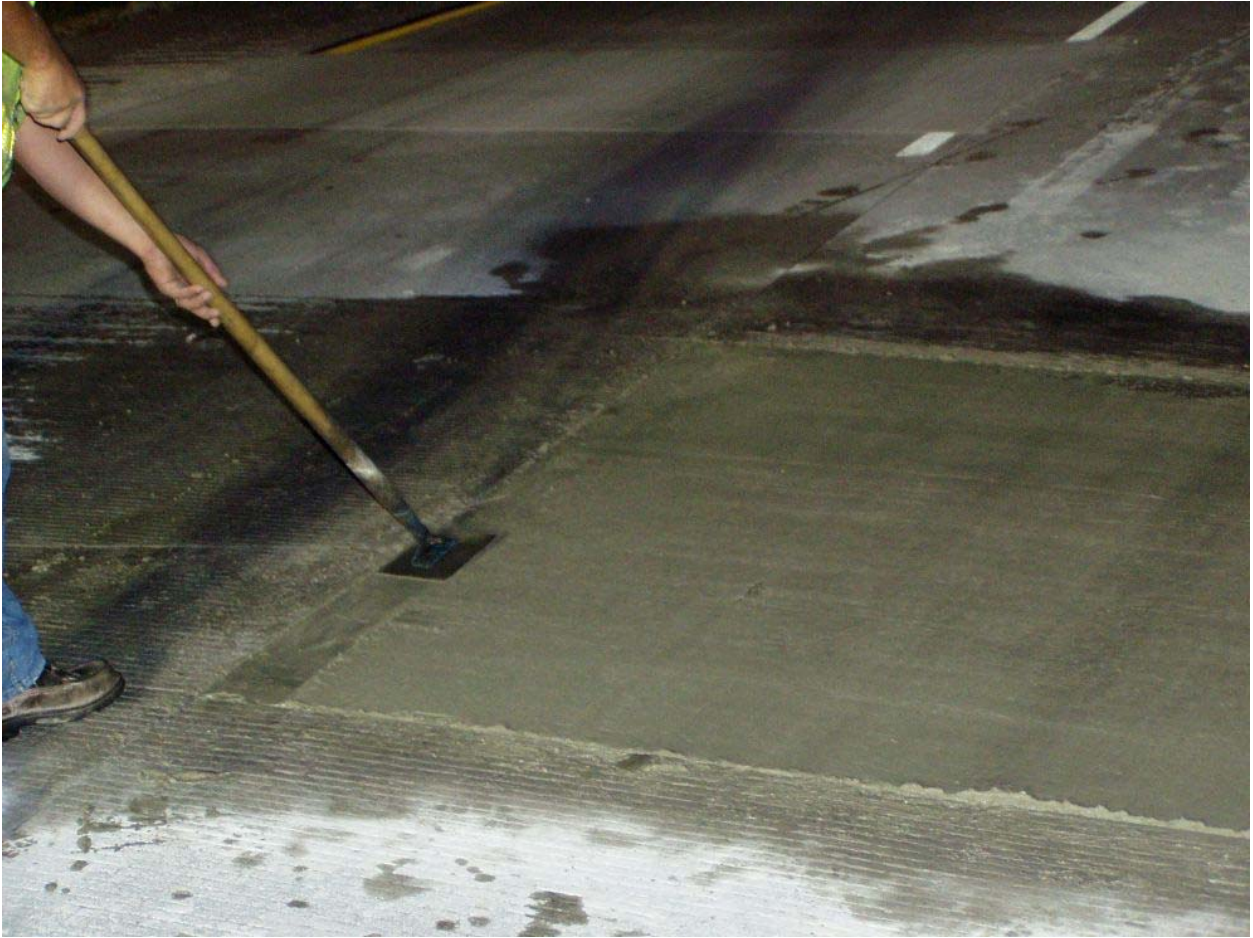
*Figure 6. Patching repair area using fast-track concrete.*

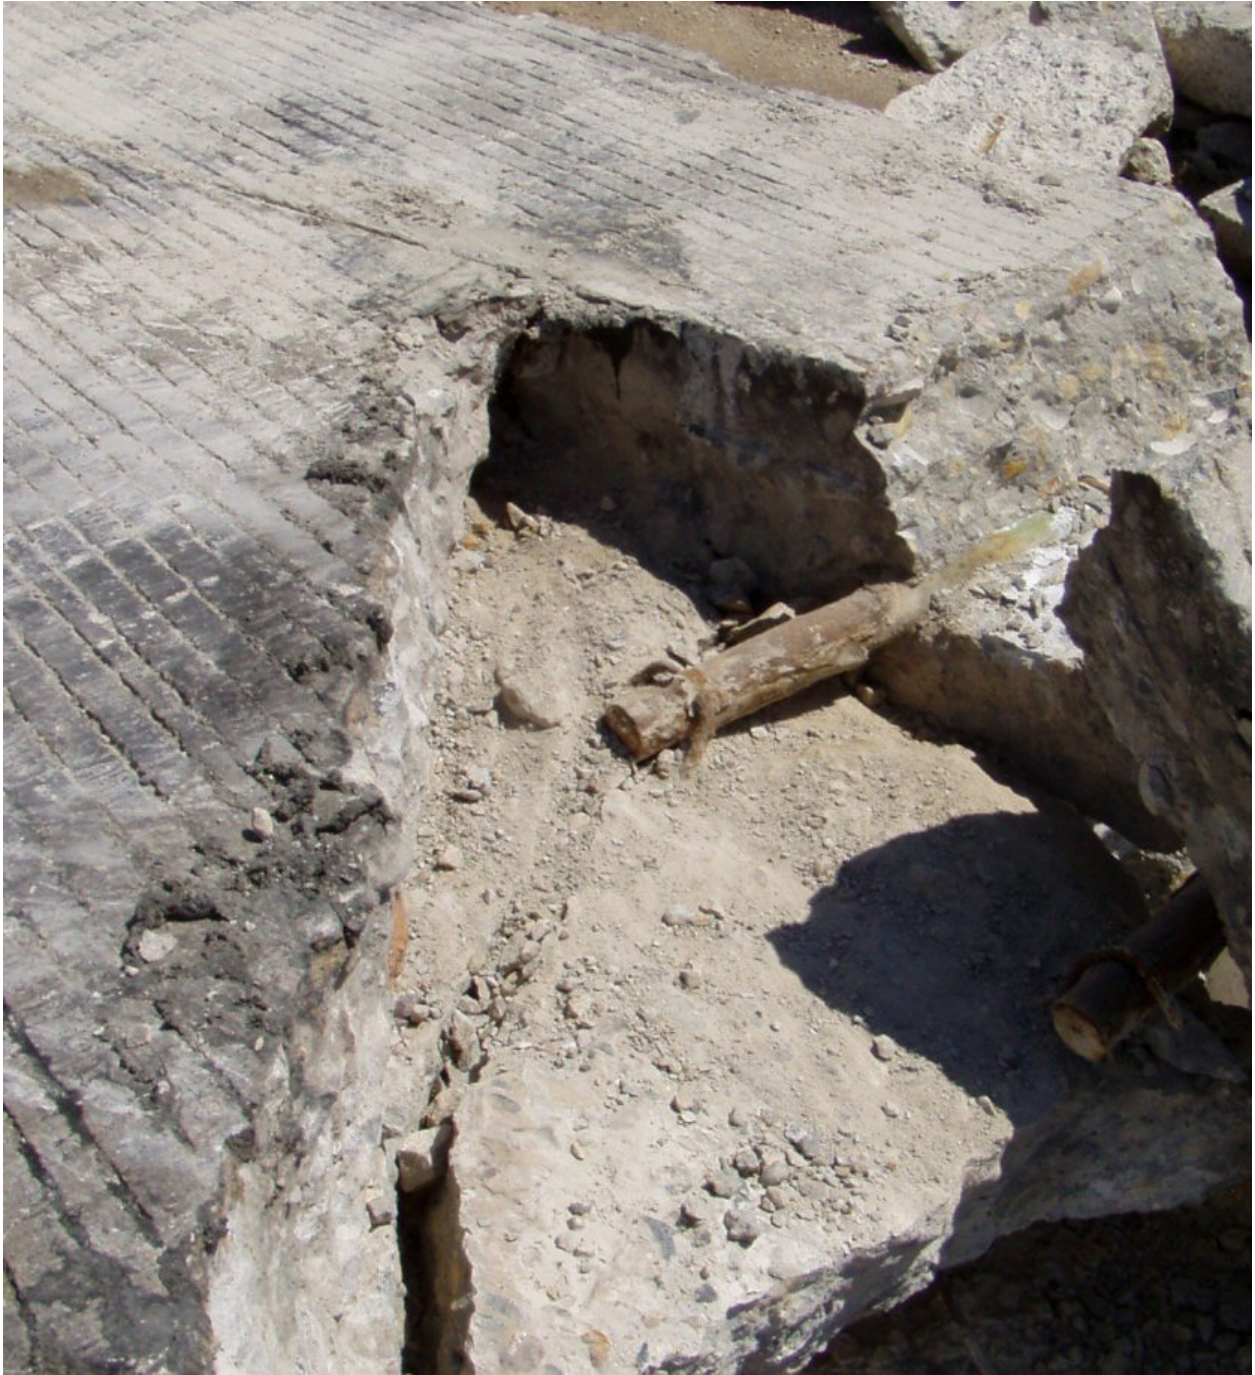
Figure 7 through Figure 13 are representative of the corner cracking distress that is of most significance to this study. As previously reported, the distress was found to occur on the acute angle of the slabs in the vast majority of the cases. The horizontal delamination coincided with the imaginary line intersecting the dowels at mid slab. The cracked area extended approximately 3 to 5 ft. from the slab corner along both joints in most cases. The concrete at mid-depth between the two segments was often observed to be pulverized. The dowel ends that rested between the slab segments had epoxy coating that was loose or non-existent. In some cases, the steel dowels were abraded by (presumably) the grinding action of the two horizontal concrete slab segments.

*Figure 7. Distressed slab corner showing delamination of acute corner at mid depth.*

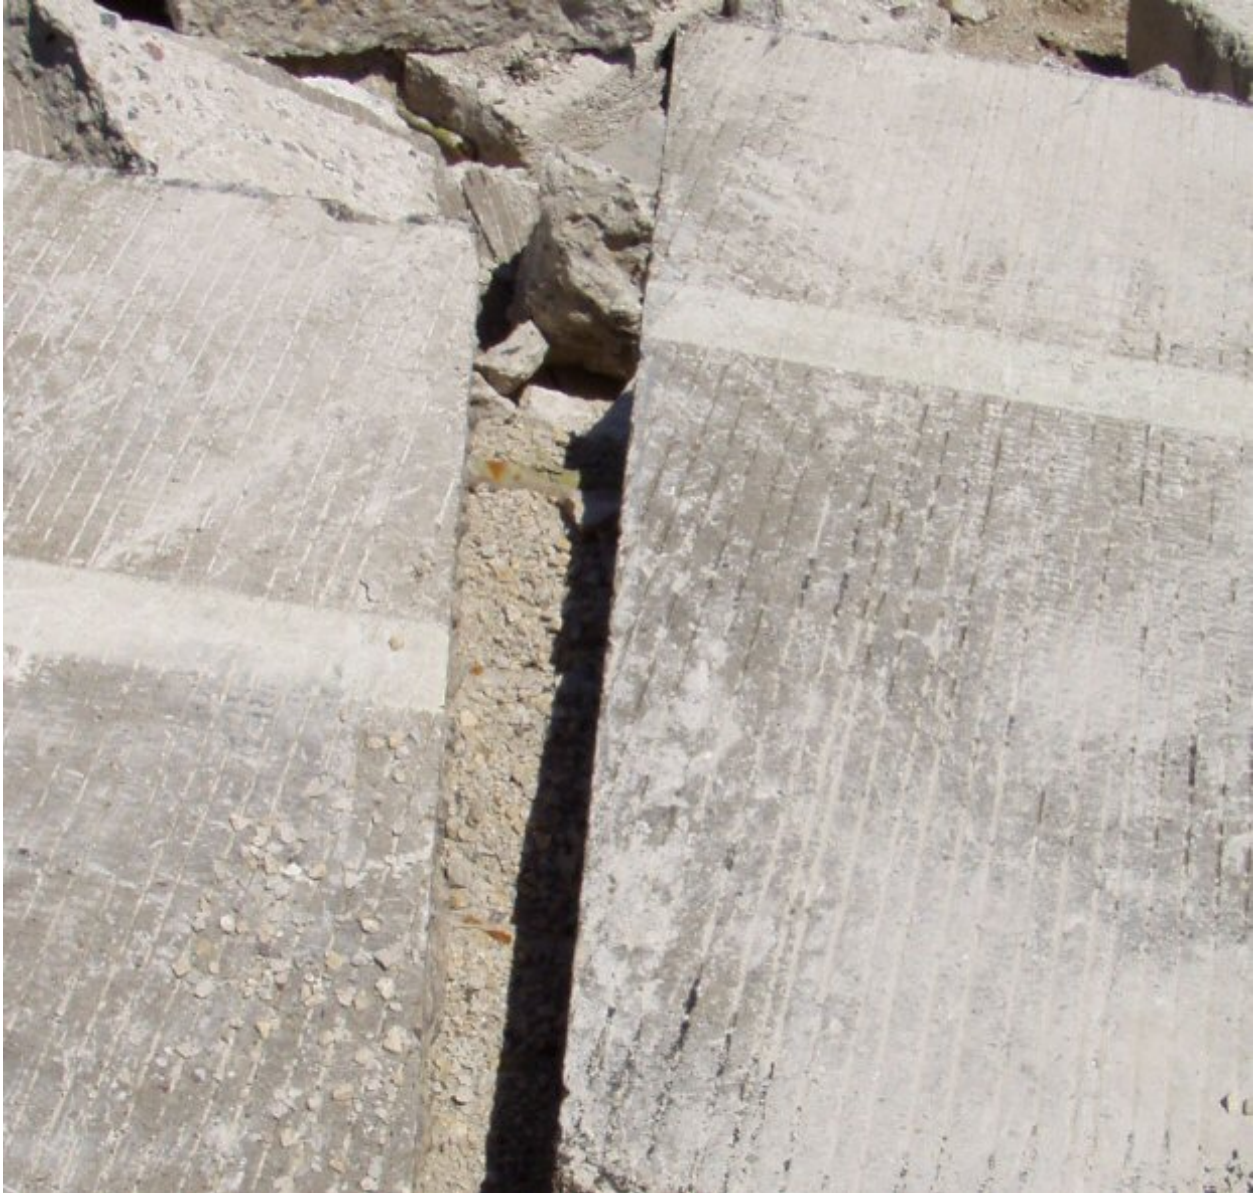
*Figure 8. Slab corner without surface distress, but showing delamination of acute corner at mid depth.*

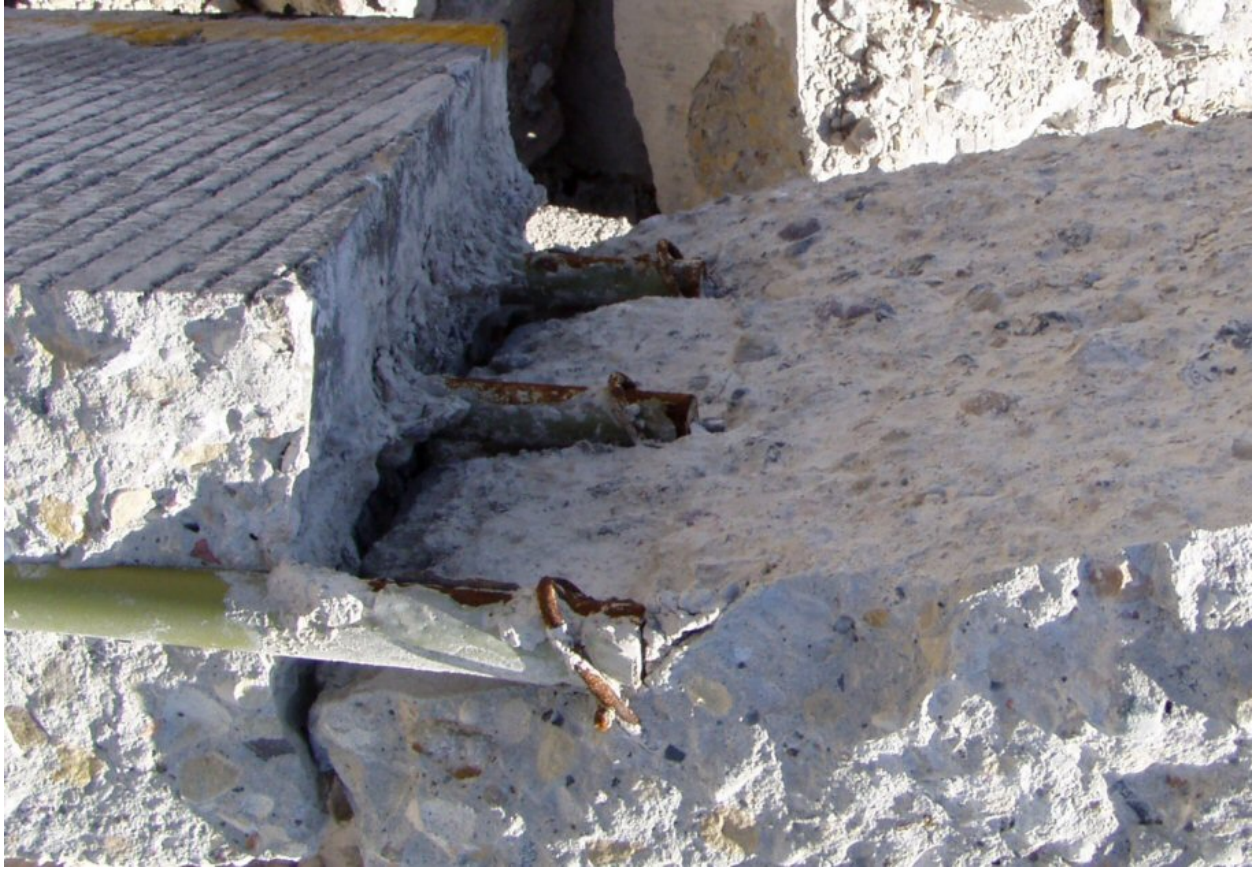
*Figure 9. Distressed slab corner showing delamination of acute corner at mid depth. Note differences in dowel condition on acute corner (right) versus obtuse corner (left).*

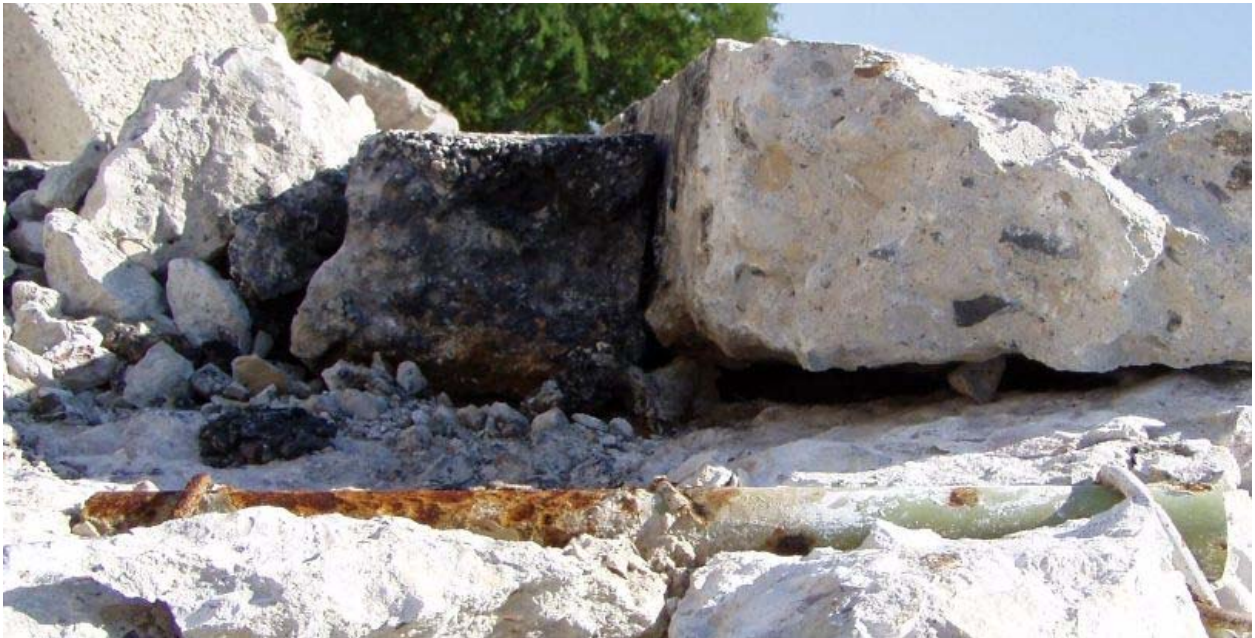
*Figure 10. Side view showing dowel bridging distressed corner. Note differences in dowel condition on acute corner (left) versus obtuse corner (right). Note crack repair material infiltration.*

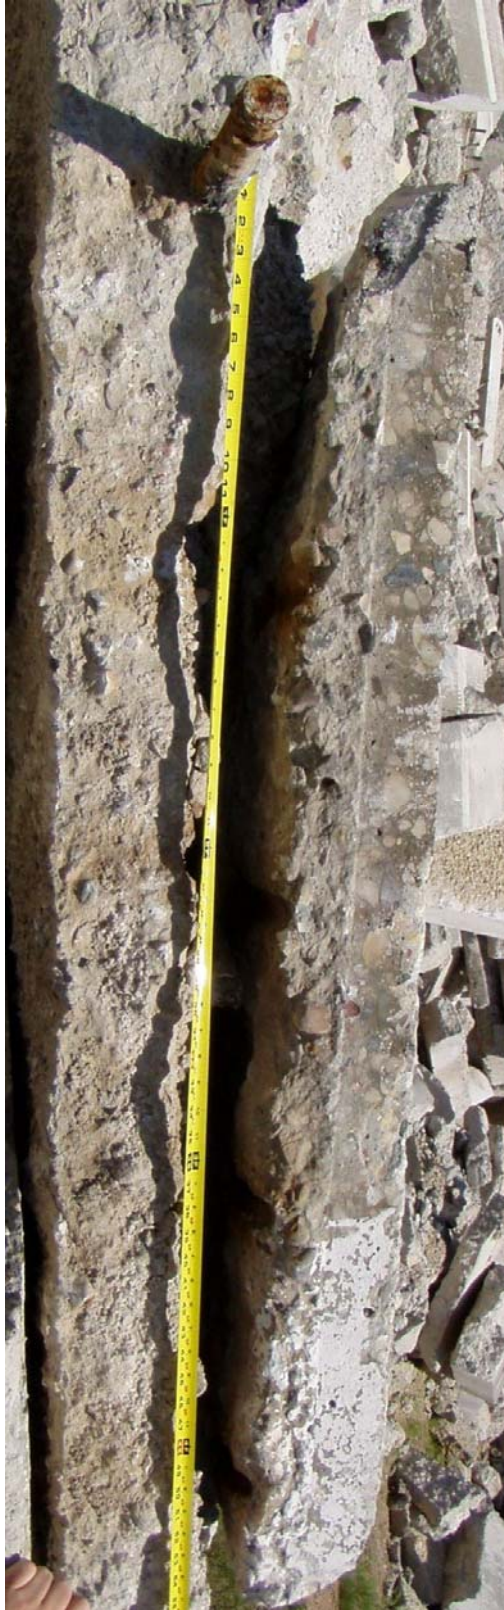
*Figure 11 Mid-depth delamination of slab extended from corner (bottom of photo) to approximately 5 ft. from edge (top of photo), before appearing as surface crack.*

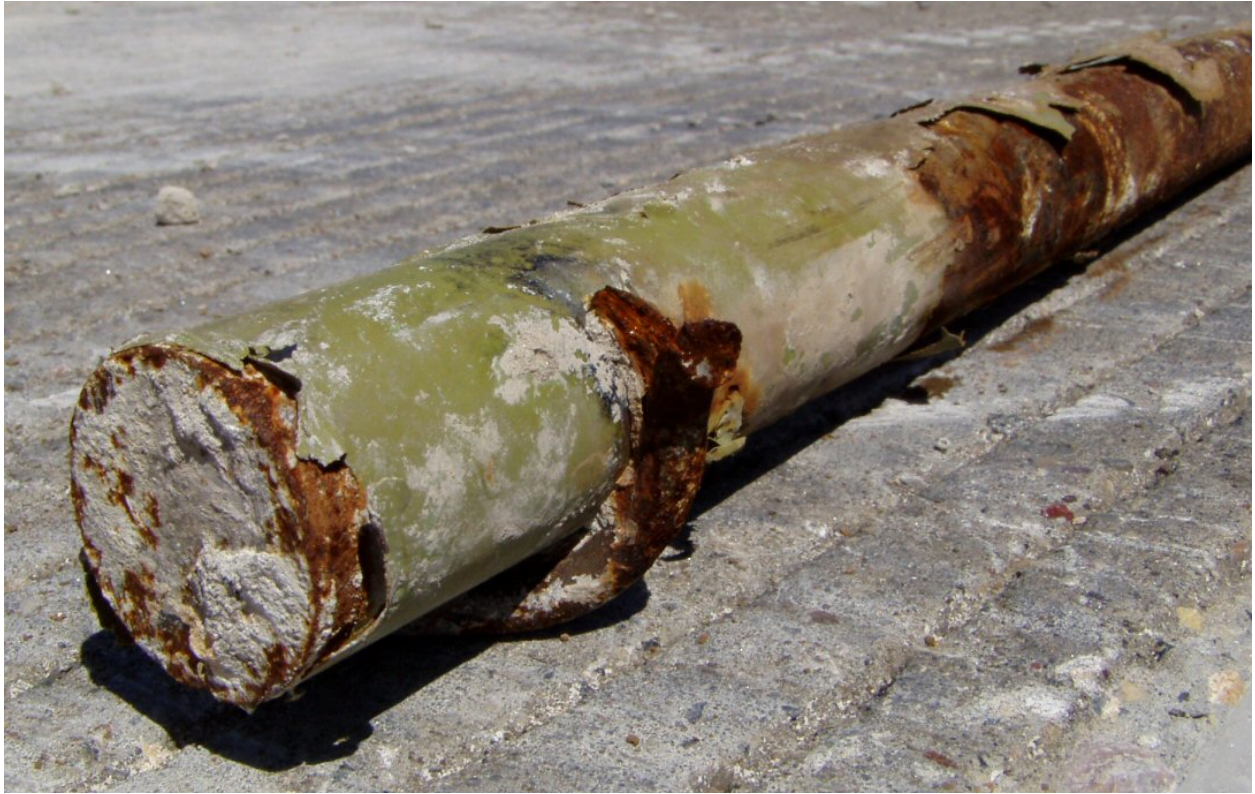
*Figure 12. Loose dowel showing ineffectiveness of epoxy coating once damaged.*

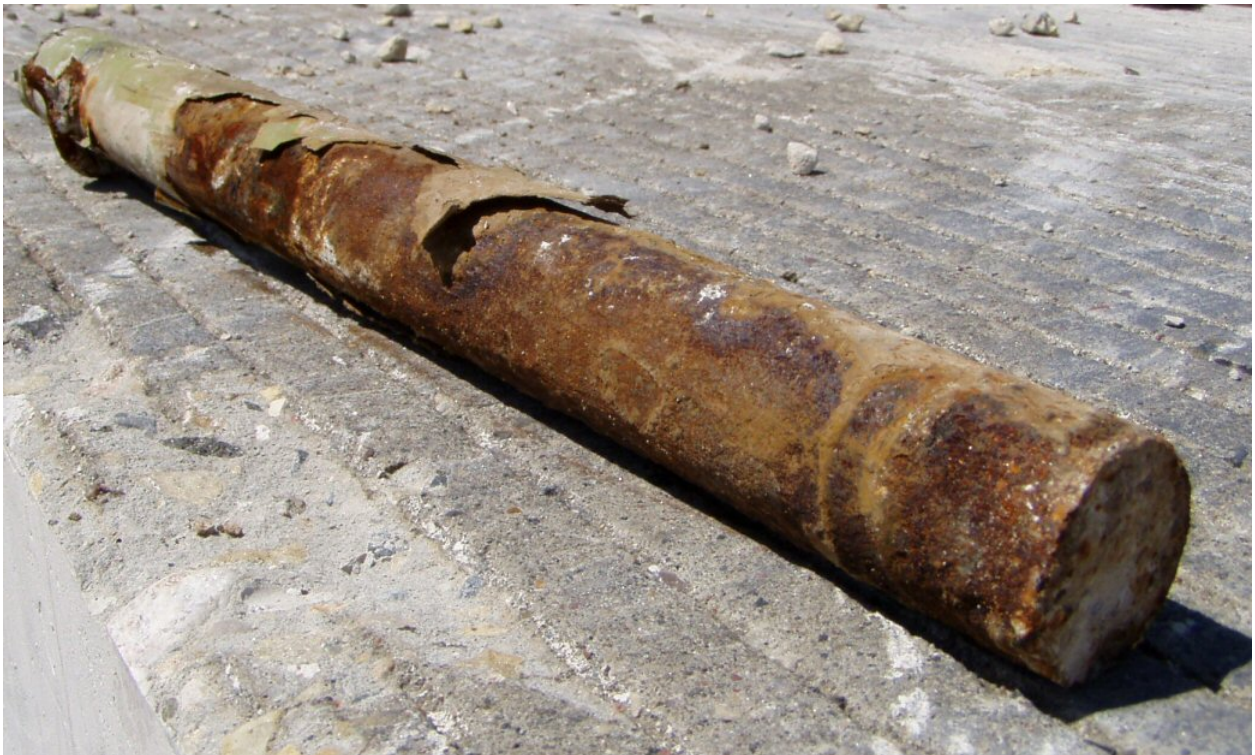
*Figure 13. Loose dowel showing ineffectiveness of epoxy coating once damaged. Note abrasion due to loose state and interaction with concrete.*

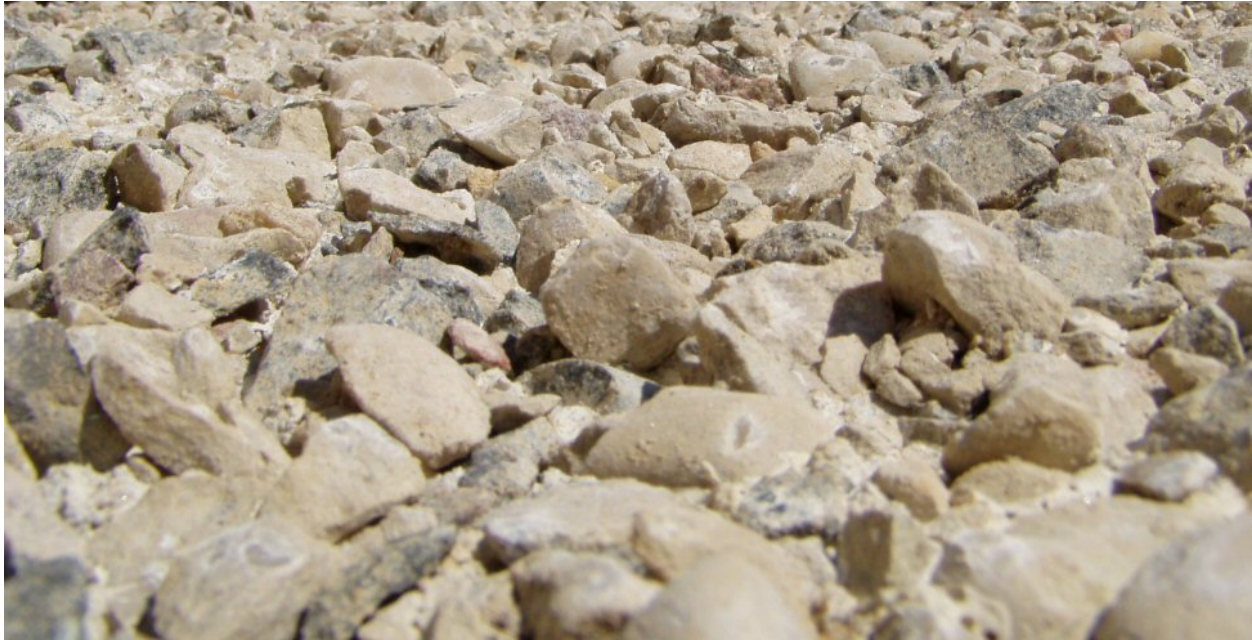
Figure 14 illustrates the open-graded base course that was found to adhere to the bottom of many of the slab segments. As can be seen, the material is nearly uniform in gradation, which is not surprising given the very strict tolerances of the gradation that was specified.

*Figure 14. Open-graded base material (adhered to bottom of slab).*

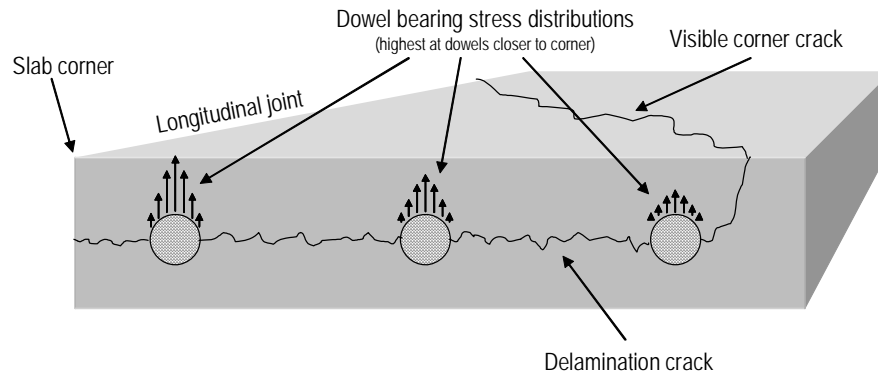
Figure 21. Corner cracking mechanism due to dowel bearing stresses.

The most typical distress observed on this pavement section is a form of delamination that is occurring at the dowel line at approximately mid slab. As illustrated in Figure 21, the distress would normally be hidden from view except that it is limited in lateral extent, and within 3 to 5 ft. from the corner, propagates upwards in the form of a corner crack.

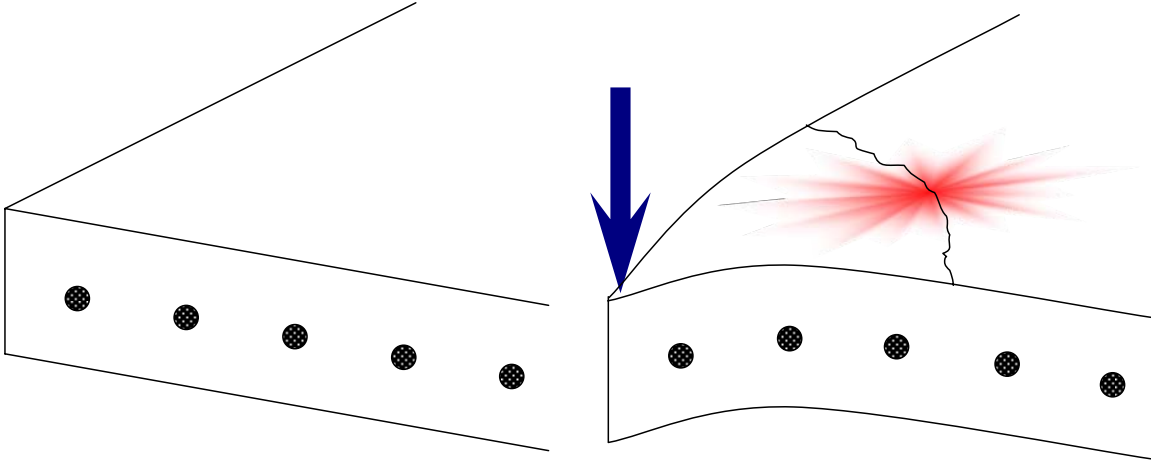
Manifestation of the corner cracking distress is illustrated in Figure 24. When an external (wheel) load is applied near the corner of a slab, stresses will develop in the top fibers of the slab. When high enough, these stresses will lead to cracking. This mode of distress is exacerbated by the delamination distress previously described. The development of corner cracking on thick slabs such as those nominally constructed on this pavement is rare. However, the effective slab thickness is approximately half of the nominal thickness due to the presence of the delamination. Furthermore, the presence of the tip of the horizontal crack at mid-depth led to a weakened plane that further promoted crack growth.

*Figure 24. Illustration of corner cracking distress due to external loading.*

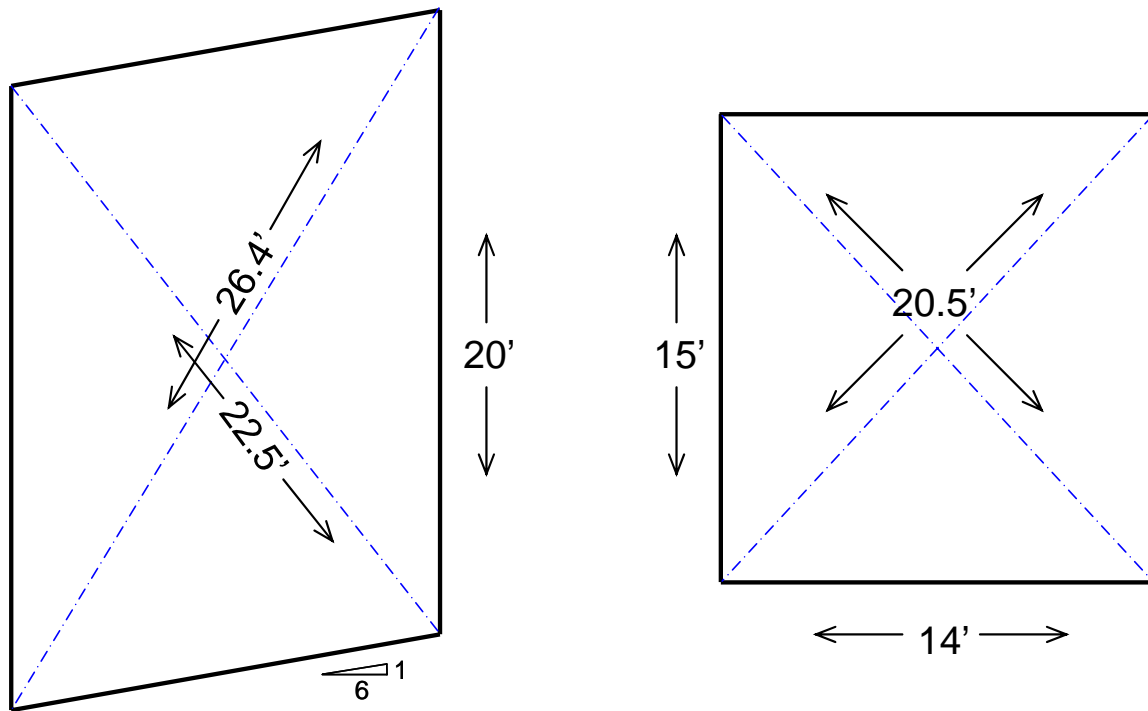
Lateral slab dimensions are a sensitive input to mid-panel cracking. The longer the effective dimensions, the higher the stress, and the greater the potential for a mid-panel crack. Figure 25 illustrates the dimensions of the extreme example from this pavement section to one that is more typical in JCP construction today. Due to the skewed joints, the effective length of the slab is not the same as the nominal length. As illustrated here, the extreme corner-to-corner dimension of a 20-ft. panel with skewed joints can be as long as 26.4 ft., which is 2 ft. longer than the same dimension for a slab with square joints, and nearly 6 ft. longer than a slab with a square joints

and a nominal slab length of 15 ft. The resulting increase in slab length can increase the mid-panel stresses due to curling/warping and subgrade drag. According to the FEM, a typical 5% increase in stress due to the presence of the skewed joint can be expected due to curling/warping restraint. This is illustrated in Figure 26. When subgrade drag theory is applied, an increase in slab length from 15 to 20 ft. can lead to a corresponding increase of stress of 40 to 50%.

Figure 25. Illustration of longer effective panel lengths due to nominal joint spacing compounded by skewed joints.

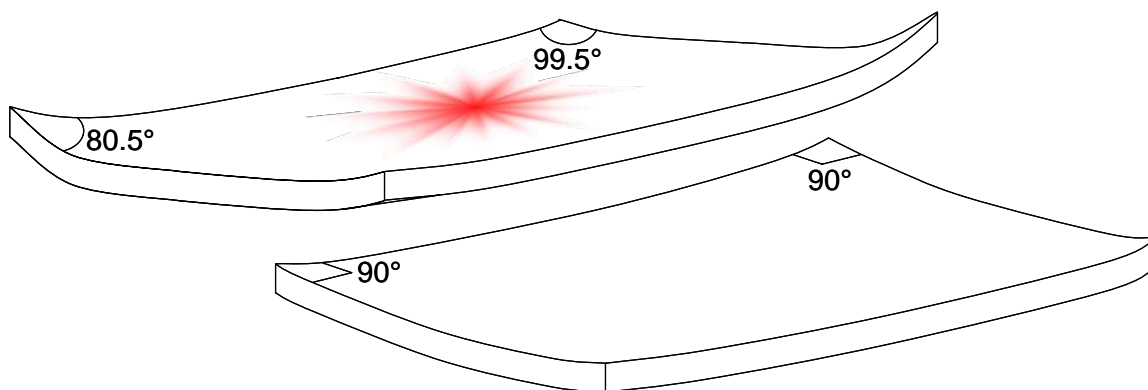
Figure 26. Illustration of higher center slab stress due to skewed joints.
