WHRP 08-06

# EVALUATION OF FIBERGLASS WRAPPED CONCRETE BRIDGE COLUMNS

**Final Report**

Submitted to the Wisconsin Department of Transportation

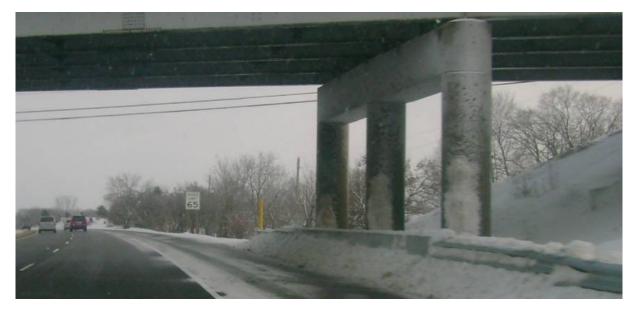
**Figure 1.1:** Snow and deicing solution splash on bridge columns (Interstate I-94 East bound – December 2008).

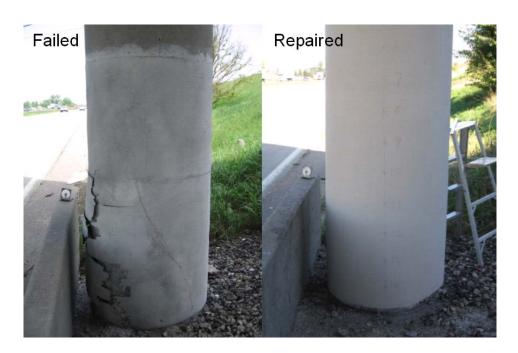
Figure 3.1: Evidence of corrosion activity in fiberglass wrapped column in bridge B-53-71 (I-39/90 under State highway 59). (a) May 2007 and (b) September 2007. After 10 years, WisDOT needed to re-wrap the column because corrosion continued under the fiberglass wrap.

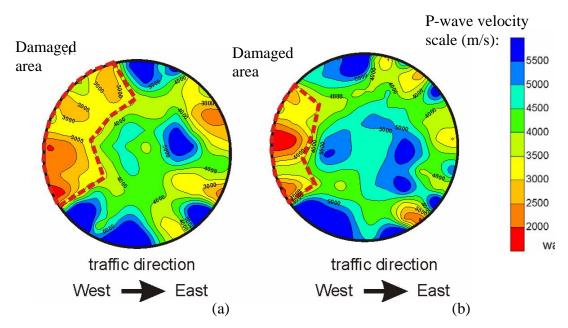
**Figure 4.8:** P-wave velocity tomographic images on Bridge B-28-45 column B: (a) Section at 0.8 m high (b) Section at 0.4 m high (The dashed line limits damaged areas).

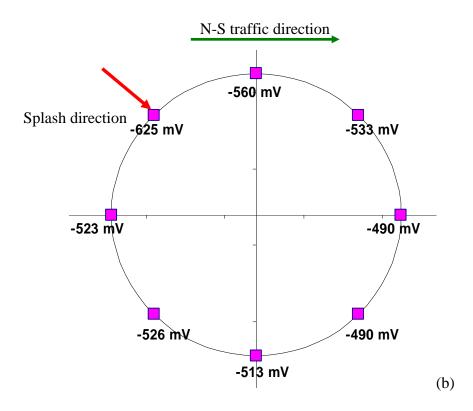
Figure 4.36: Half cell potential measurement in Bridge B-13-144 column G. Data collected just below the fiberglass wrap.
