Evaluation of Various Hot Mix Asphalt Pavement Thicknesses over Rubblized Concrete Pavement

FINAL REPORT

Evaluation of Various Hot Mix Asphalt Pavement Thicknesses
over Rubblized Concrete Pavement
Research Study # WI-93-06a

Report # FEP-07-10

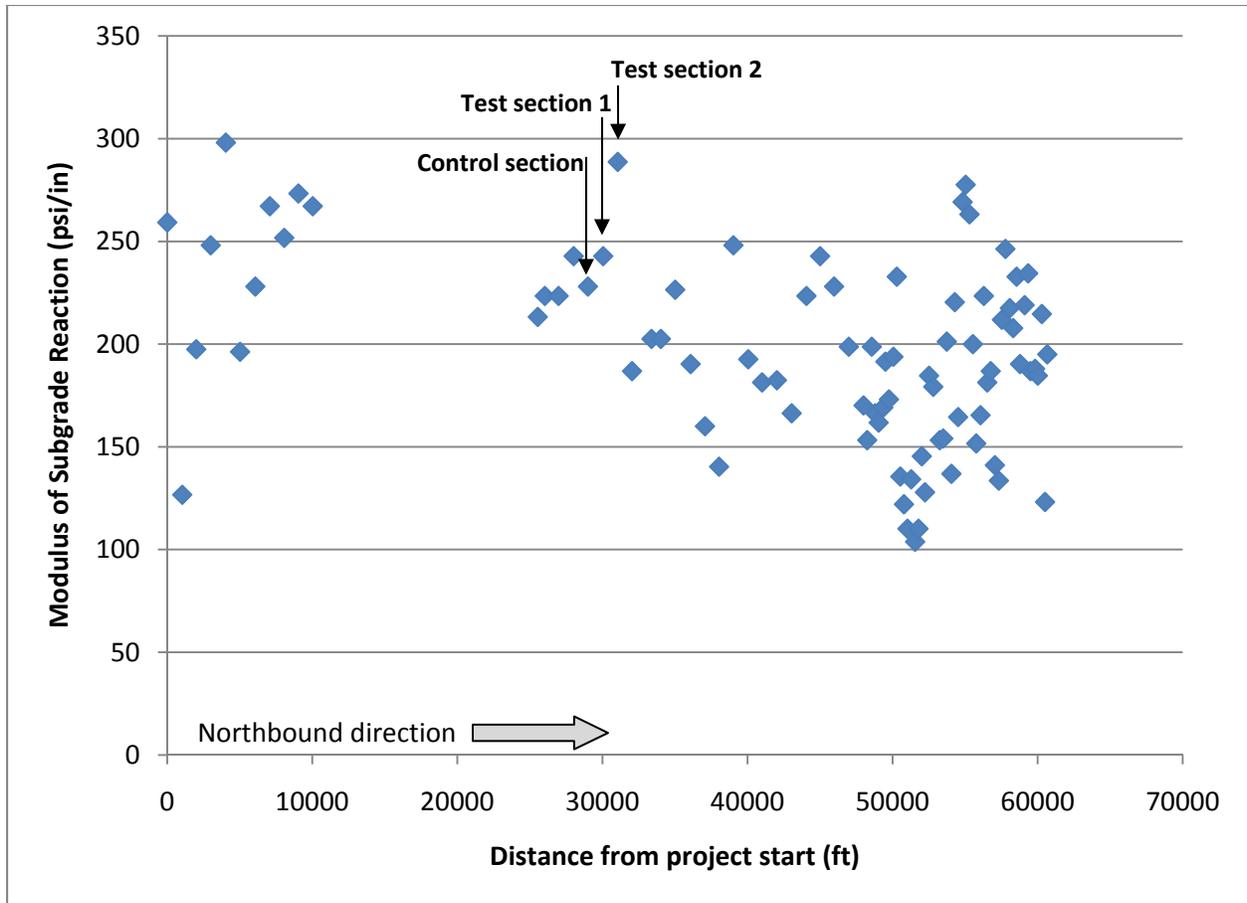
Figure 6. Modulus of subgrade reaction values for rubblization project.

Prior to the rubblization construction project, FWD testing was performed along the length of the northbound PCC pavement. The area between approximately 10,000 and 25,000 ft north of the project start could not be tested because a bridge maintenance project was underway. It was suspected that the northern portion of this project had poor support, as the concrete in that area had more patches and cracking than in the southern portion. The modulus of subgrade reaction was calculated from the FWD results (Figure 6). This value is a measure of PCC slab support; a higher value indicates greater support. Values under 100 psi/in indicate that the foundation materials have a high moisture content.

The northern section of the project did have slightly lower modulus of subgrade reaction values, especially between 50,000 and 53,000 ft north of the project start. However, the support in this area was still within an adequate range for rubblizing. The area chosen for the experimental sections had very good slab support, as shown in Figure 6.

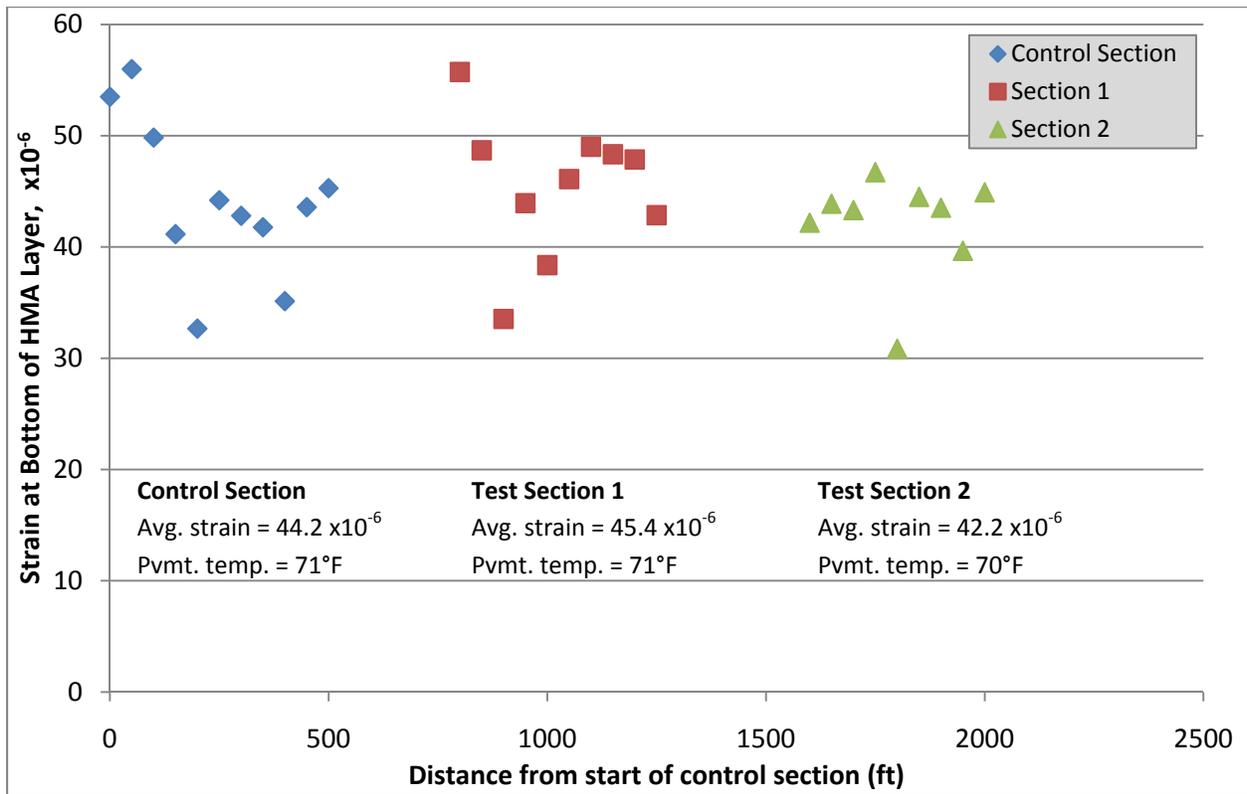
Figure 7. Strain data backcalculated from June 22, 2000 FWD test results, 9.5-kip load.

It is first useful to compare strain data for test sections that were measured by the FWD under equal temperature conditions. Pavement temperatures were approximately equal (within 1°F) among the test and control sections in 2000, 2001 and 2003 (Figures 7, 8, and 10). In these cases, the strain typically decreased with increasing HMA thickness. One exception was that Test Section 1 in 2000 showed a slight increase in average strain compared to the thinner control section (Figure 7). The cause(s) of this anomaly is unknown.

The maximum strain measured in the thinnest (control) section at the 9.5-kip load level was 56 microstrain (Figure 7). This strain level is lower than the 70 to 100 microstrain endurance limit that is commonly associated with a perpetual asphalt pavement. [13, 14] Therefore, while the additional 1.0-in HMA layers resulted in a reduction in strain, the control section provided adequate thickness in terms of protecting the pavement foundation from the cumulative effect of high strain from traffic loadings.

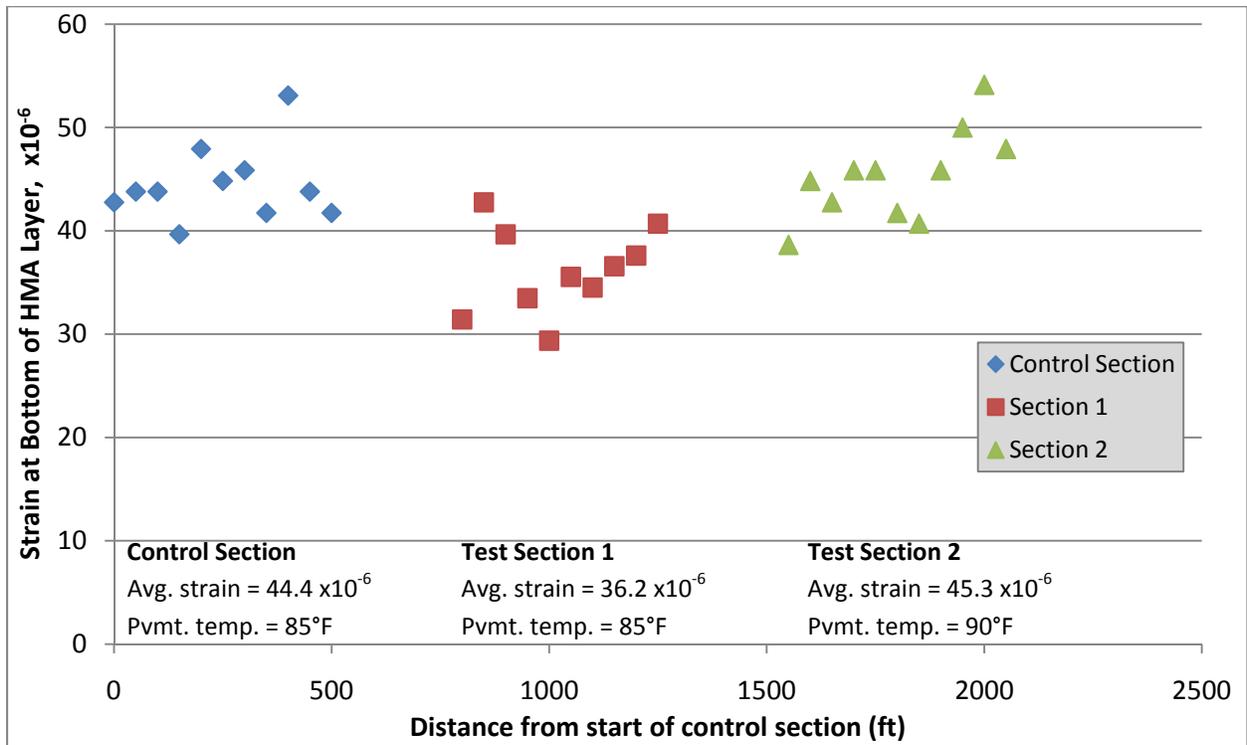
Figure 11. Strain data backcalculated from July 2004 FWD test results, 9.5-kip load.

A second aspect noted in the backcalculated strain data was the effect of pavement temperature on strain level. Considering the 2004 data (Figure 11), the pavement temperature increased from 85°F when the control section was tested to 90°F when test section 2 was tested. As a result, the test section 2 pavement had approximately the same strain level as the control section, despite being about two inches thicker.

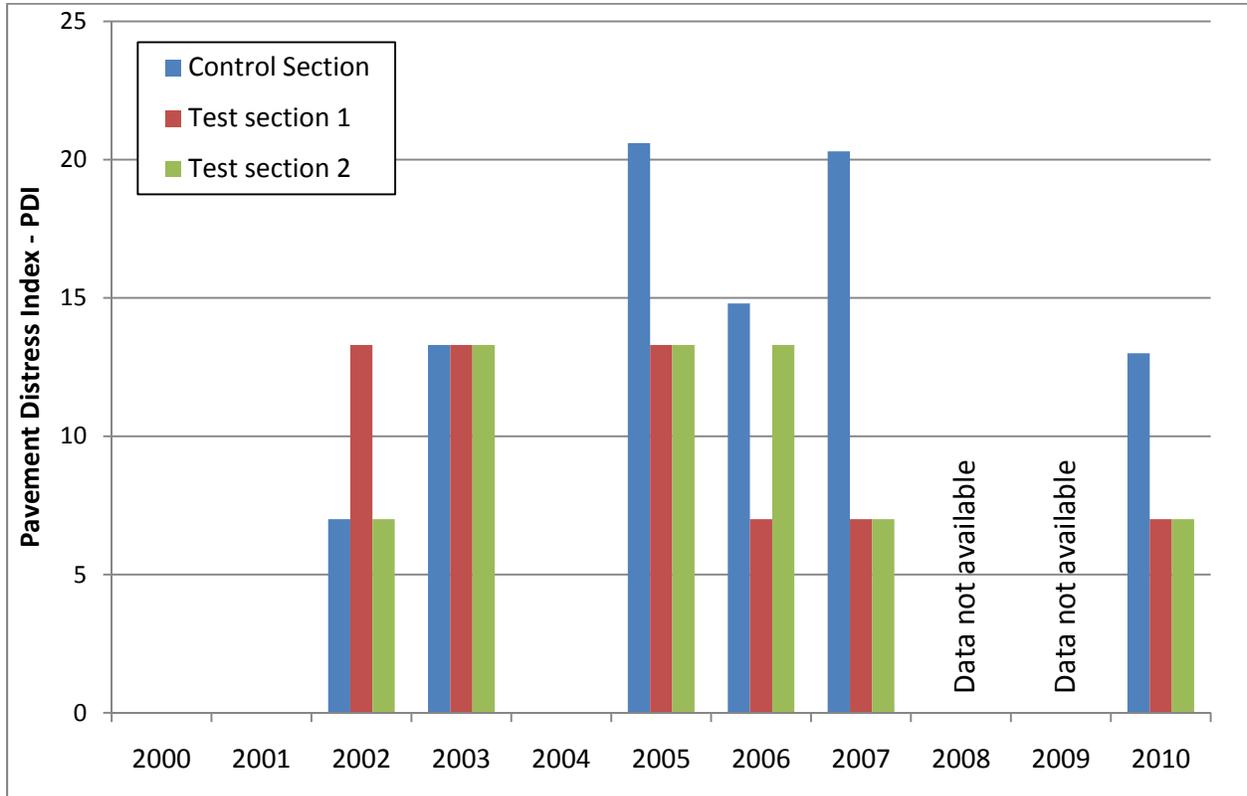
Figure 12. Pavement distress index survey results.

The WisDOT PDI value is a measure of distress in a pavement section, with a value of zero indicating no distresses present and a value of 100 indicating a severely deteriorated pavement. For reference, the PDI of the JRCP in the area of the test and control sections was 71 prior to the rubblization project. PDI data collected for the test and control sections showed no definitive change in PDI over time (Figure 12). In general, the PDI of the two test sections were approximately equal, and the thinner pavement section (control) had a slightly higher PDI. A PDI of zero was measured in all pavement sections in 2000, 2001 and 2004. Slight variation in PDI from year to year is not uncommon due to differences in the surveyor's interpretation of distresses. The relatively low values (PDI of 20 or less) indicated that the rubblized pavement system performed well during the first eleven years in service, regardless of HMA thickness.

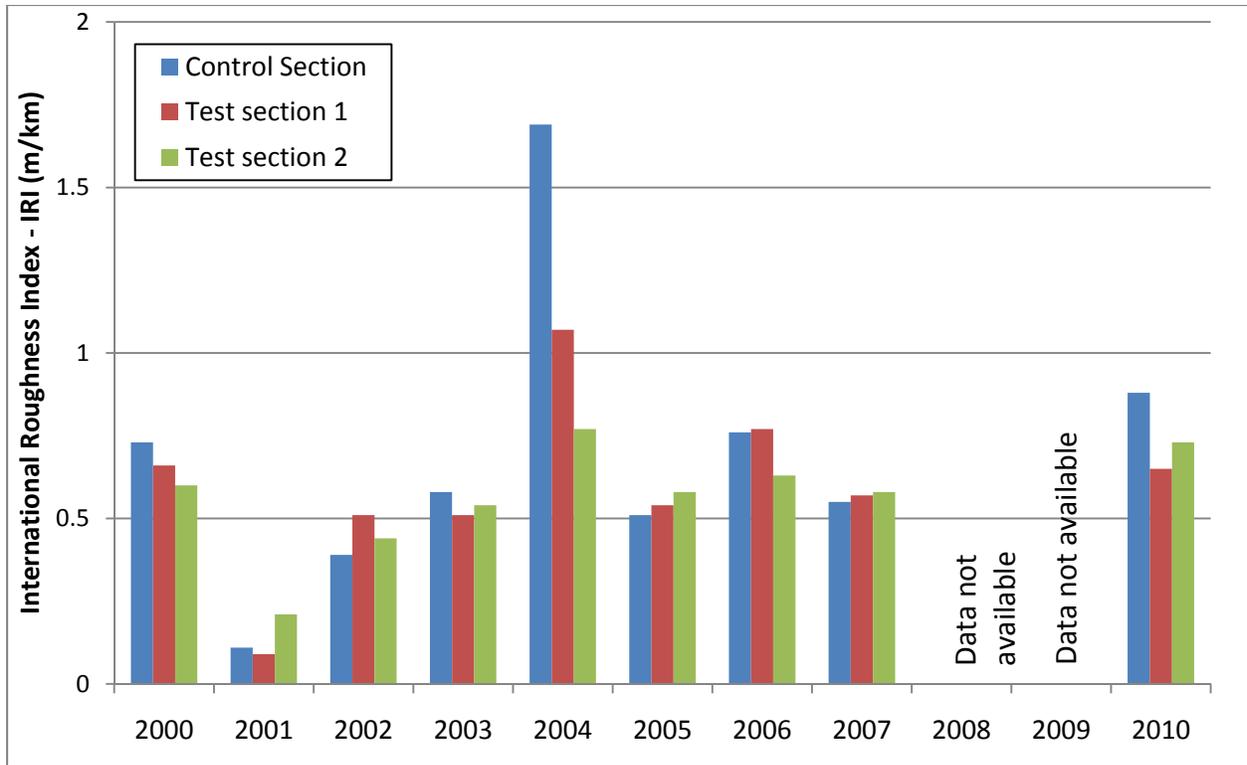
Figure 13. International roughness index survey results.

The IRI value is a measure of pavement ride quality; IRI increases with roughness. For reference, the IRI of the JRCP in the area of the test and control sections was 1.63 m/km prior to the rubblize and overlay project. As expected, there was a slight increasing trend overall in IRI over time (Figure 13). The test and control sections performed at approximately equal levels in most years. In 2010, however, the roughness in the control section was greater than in the thicker test sections. The IRI data indicated excellent performance over eleven years, with values typically less than 1.0 m/km. The data from 2004 was anomalous; the higher measured values could be due to equipment calibration or tracking of the automated survey vehicle. It is puzzling to note that the high 2004 IRI values correlated with PDI values of zero in the same year (Figure 12).

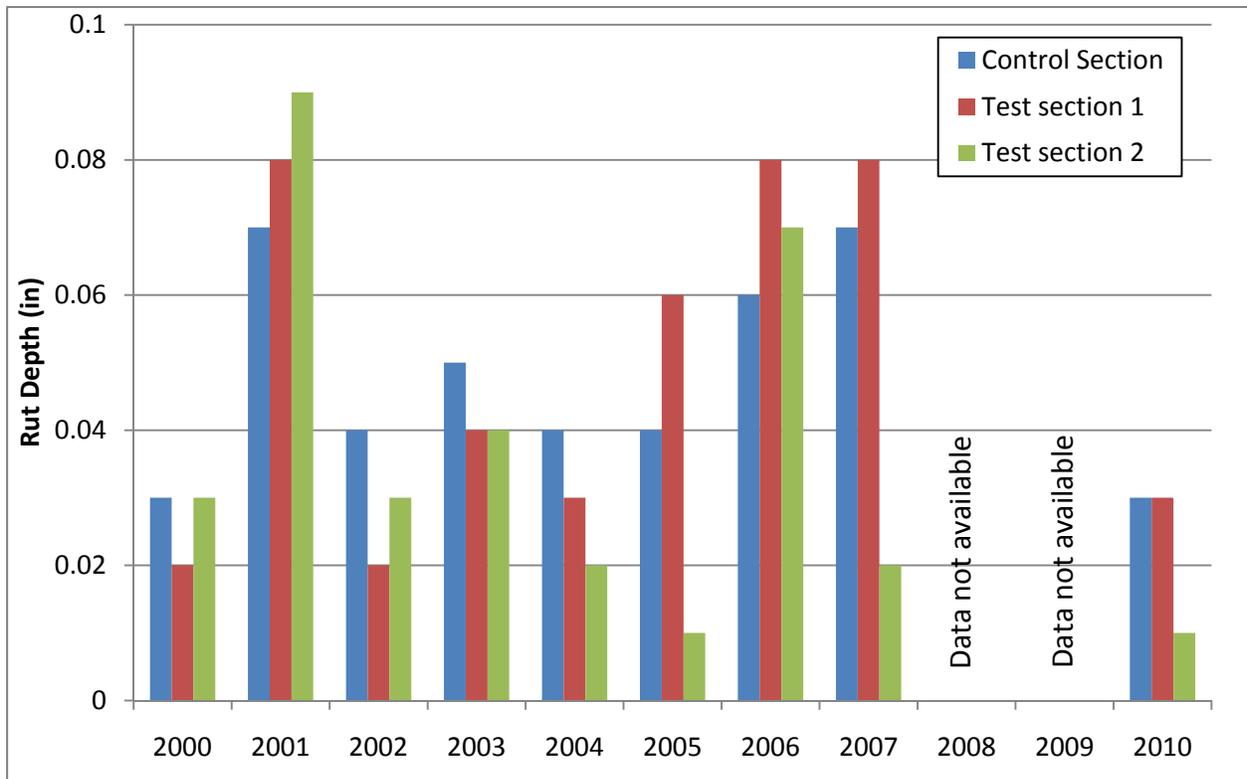
Figure 14. Rut depth survey results.

The measured rut depth data indicates excellent deformation resistance of the pavement layers to truck loads. Rut depth measurements in the test and control sections were less than one tenth of an inch for all 11 years of monitoring (Figure 14). There was no major difference in performance among the sections. As discussed in Section 5.1.2, the measured pavement strain was low in all pavement sections. Low strain at the bottom of the HMA pavement layer typically results in low permanent deformation (rutting), which was confirmed with this survey data.

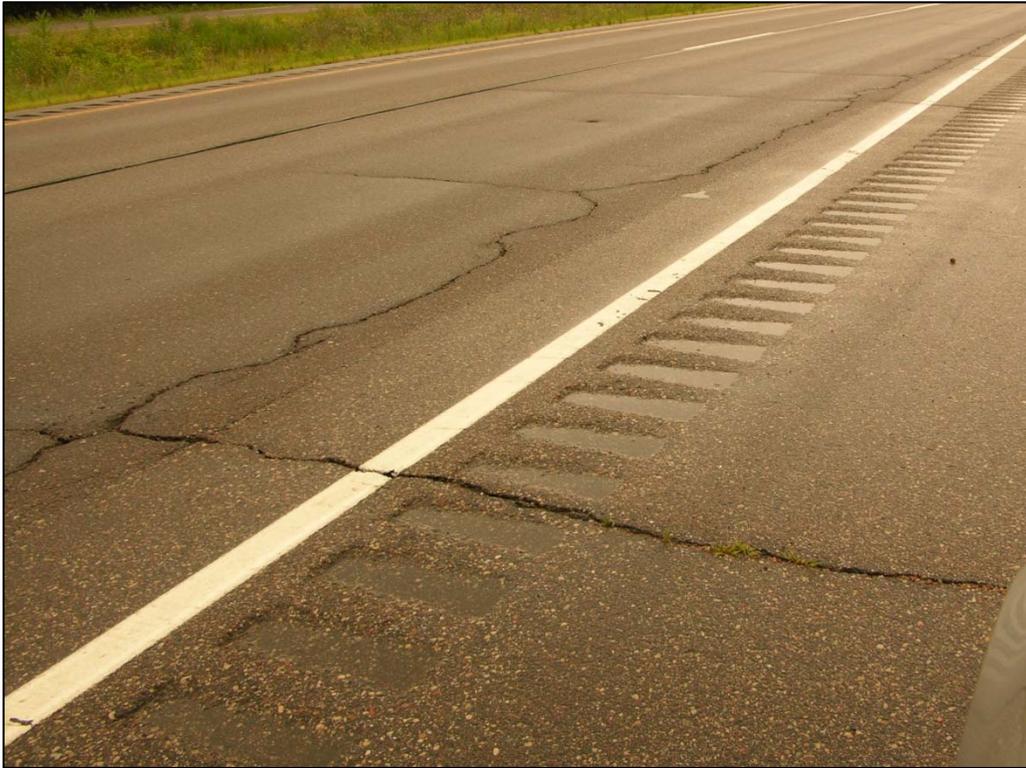
Figure 15. Control section cracking, July 2010.

In the control section, a 200-ft longitudinal crack was noted at the right edge of the driving lane, adjacent to the tapered entrance ramp from CTH HH (Figure 15). The width of this crack was greater than ½-inch, making it a severity level 2 crack according to the WisDOT Pavement Distress Manual. Ten transverse cracks were present that extended from the longitudinal crack half-way into the driving lane. Similar cracking was noted in the pavement just south of the control section. No cracking was noted in the passing lane of the control section.

At the time of the survey, none of the cracks had been sealed. However, the paving joint between the driving and passing lanes had been sealed along the length of the rubblization project.

Based on the results of the visual surveys, it can be concluded that the initiation of cracking was delayed in the thicker test sections by at least three years. This can be confirmed with the PDI data shown in Figure 12 (Section 5.2). The PDI measured in the control section was higher than that of the two test
