Report Number: WI-02-12

An Evaluation of Concrete Bridge Deck Overlays and HMA Bridge Deck Overlays with Waterproof Membranes

March 2012

Irene K. Battaglia, M.S.
Engineering Research Consultant
Construction and Materials Support Center, UW-Madison

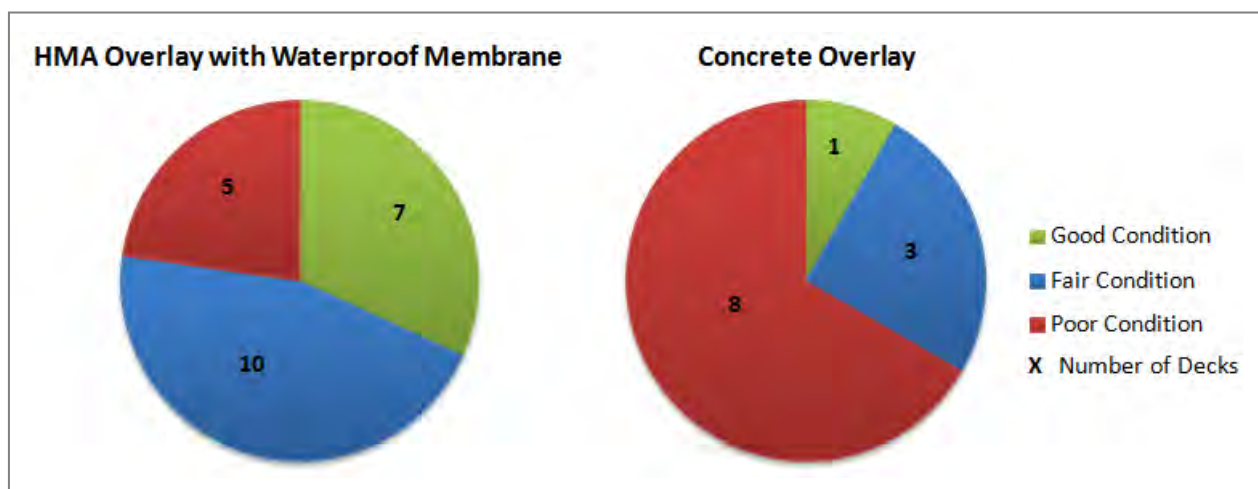
At the 20-year evaluation, all of the overlays had extensive cracking on the surface. Most cracks in the HMA overlays had been sealed, while cracks in the concrete overlays were typically not sealed. The underside of the bridge decks were visually inspected for signs of deterioration due to water penetration. Results of the underside inspections are shown in Figure 1. The subjective rating descriptions were as follows:

A large proportion of the decks with concrete overlays had heavy staining on the underside, indicating water penetration through the deck. The undersides of most decks with HMA overlays and waterproof membranes were in "good" or "fair" condition (77 percent). Only 33 percent of the decks with concrete overlays were in good or fair condition on the underside. This indicates that the HMA overlay with waterproof membrane was more effective at preventing water penetration than the unsealed concrete overlay.

Figure 1. Twenty-year condition rating - underside of bridge decks, I-94, Milwaukee County.
