Dowel Bar Retrofit Performance in Wisconsin

Dowel Bar Retrofit Performance in Wisconsin
Research Study # WI-98-05

Report # WI-02-10

Prepared by:
Irene K. Battaglia, M.S.
Construction and Materials Support Center
UW-Madison

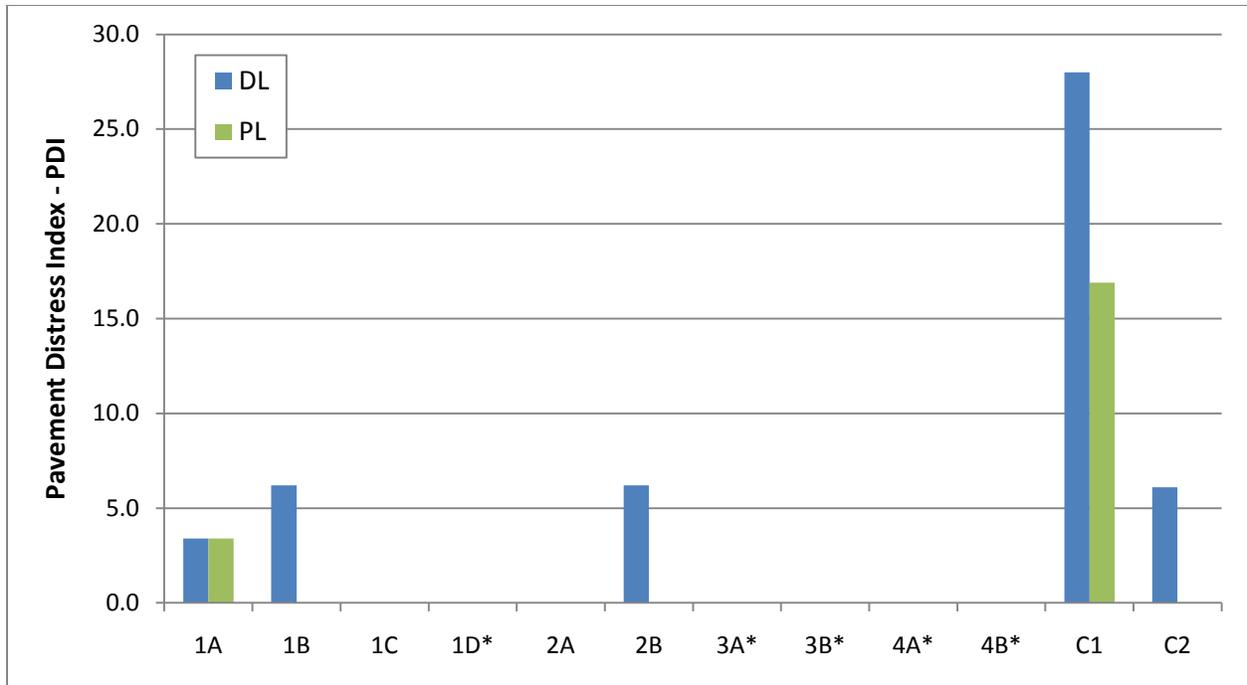
Figure 6. Pavement distress index results for I-39 test sections, 2007. *Denotes section was not surveyed in the PL.

The pavement in control section 1 (3-in HMA overlay) displayed the highest level of distress in 2007. The relatively high PDI value (28.0) indicates that many of the faulted PCC slabs had reflected through the HMA pavement, resulting in cracks at the joint locations (Figure 6).

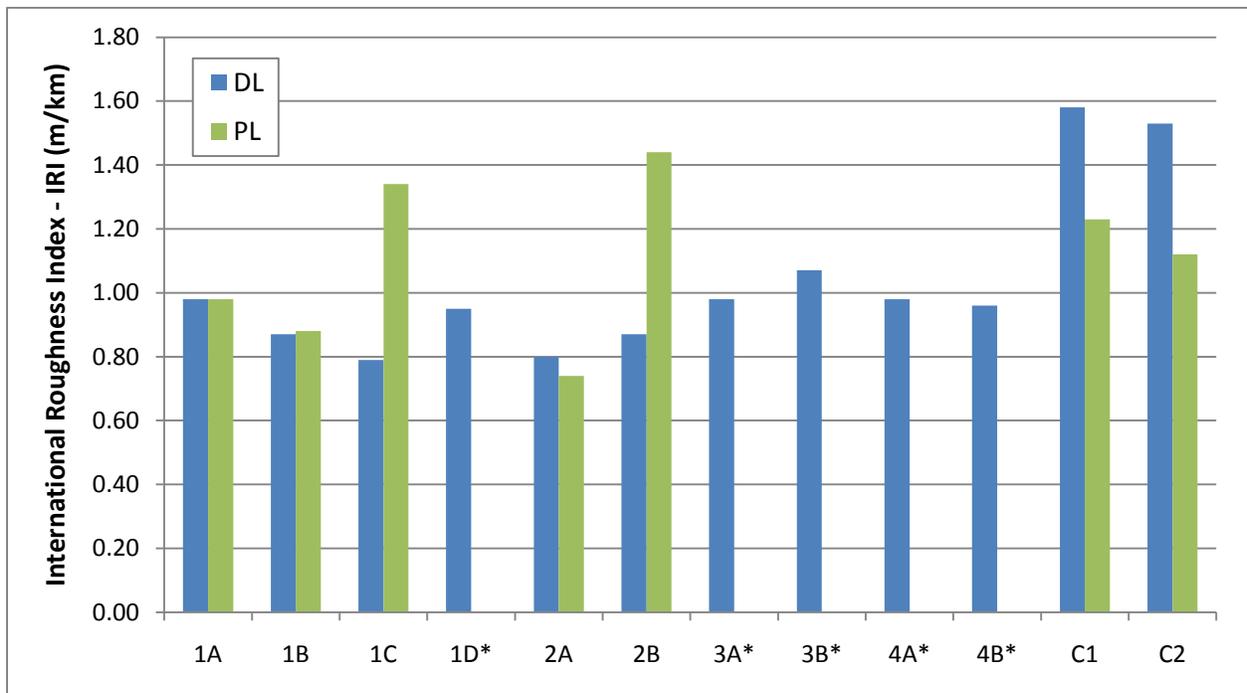
Figure 7. International roughness index results for I-39 test sections, 2007. *Denotes section was not surveyed in the PL.

The automated IRI survey showed that the test sections had smooth riding surfaces after eight years in service, with an IRI value of less than 1.0 m/km in most surveyed test sections (Figure 7). The PLs in test sections 1C and 2B had comparatively high IRI values (1.34 and 1.44 m/km, respectively). The PL in section 1C did not have DBR rehabilitation, and the PL in section 2B did have DBR; the section 2B PL did not match observed trends in other sections. Other surveyed PLs with (2A) and without (1A, 1B) DBR performed as well as the DLs with DBR. It is possible that isolated joints or other bumps in the 1C and 2B PLs resulted in relatively high IRI values. It was also noted in a Washington State study that DBR rehabilitation was more effective at maintaining a smooth riding surface if the initial faulting was lower. [3] It is possible that faulting in section 2B was higher at the time of DBR, resulting in higher IRI measurements after eight years in service.

Both control sections had higher IRI values than the test sections (Figure 7). The rough ride in control section 1 is likely a result of cracks that were also apparent in the PDI survey results. Control section 2, which received diamond grinding only as a rehabilitation strategy, also had higher IRI levels than the test sections. It is unknown why IRI values were higher in section C2 than in the PLs of sections 1A and 1B, which also received diamond grinding only. The control sections' DL IRI results were higher than in the PLs (Figure 7). This outcome is typical, as the DL is subjected to more truck traffic (i.e. heavier loads) than the PL.

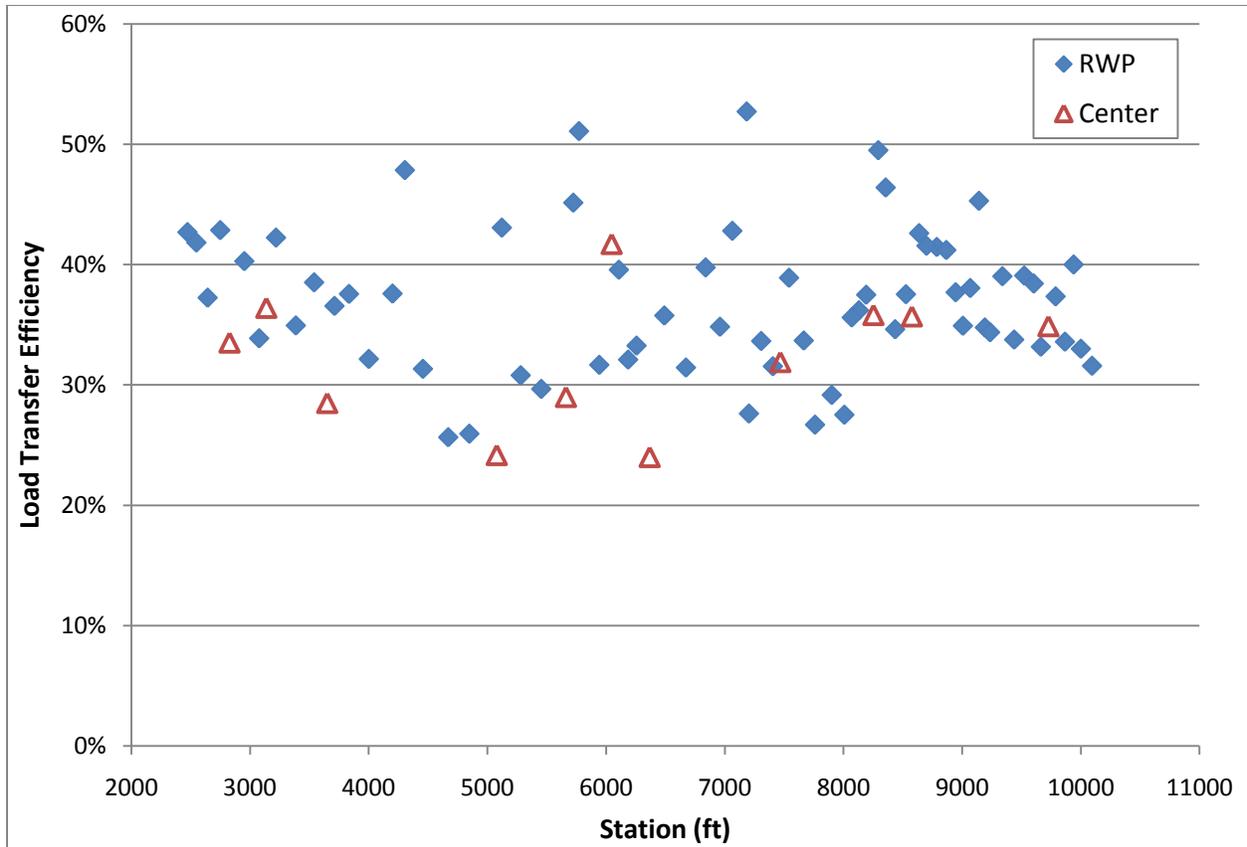
Figure 8. Load transfer efficiency measured at I-39 in June 1999 (prior to DBR).

LTE testing conducted in June 1999 was performed in the northbound lanes of I-39, in the area of future test sections 1B, 1C, 2B, C1, and C2. Testing took place between 10:00 a.m. and 2:00 p.m., with temperatures ranging from 66 to 76°F. Four tests were conducted at each joint using FWD loadings of 5, 9, 14, and 20 kips; an average LTE was calculated for each joint tested. Most measurements were taken in the right wheel path (RWP) of the DL, and some were taken at the center of the DL. The majority of LTE measurements were in the 25 to 50 percent range, which indicates poor load transfer between adjacent slabs (Figure 8).
