**ET-2000  
END TREATMENT FOR GUARDRAIL**

**FINAL REPORT**

Wisconsin Federal Experimental Project FEP-94-01

Final Report FEP-03-07

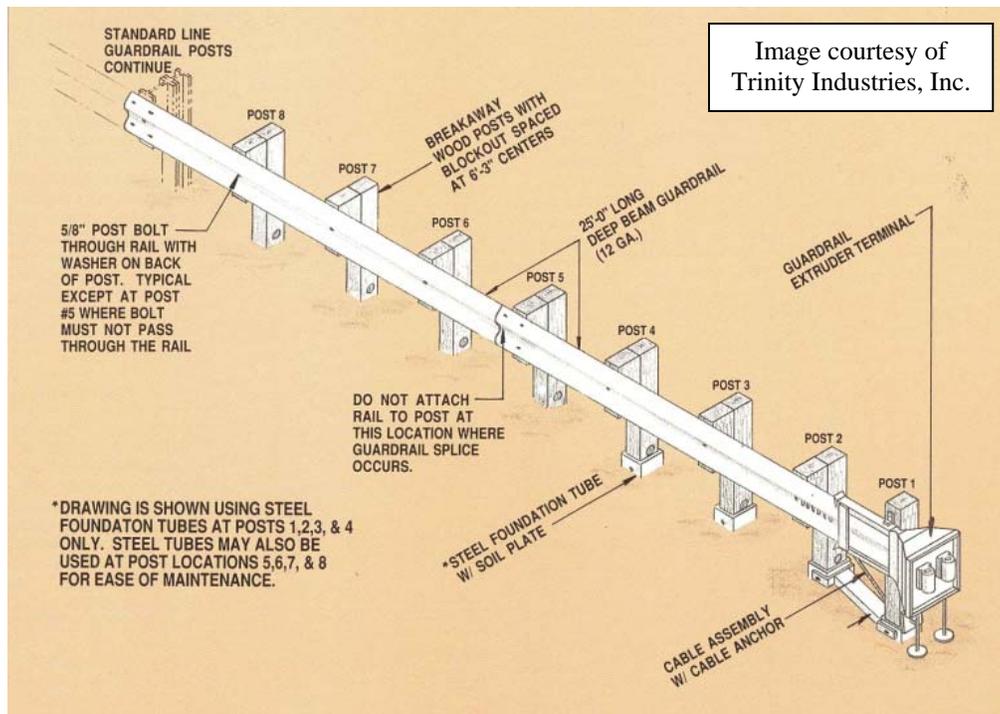
**Figure 2. Components of the ET-2000 System.**

worked well, but posts two through eight were too short to accommodate the extruder bracket lag bolts (see Figure 2 on page 4). Post one was designed several inches taller than the others so that it could accept the extruder bracket, but posts two through eight were only tall enough to support the guardrail. Therefore, short-term fixes usually required replacing at least one post to reattach the extruder.

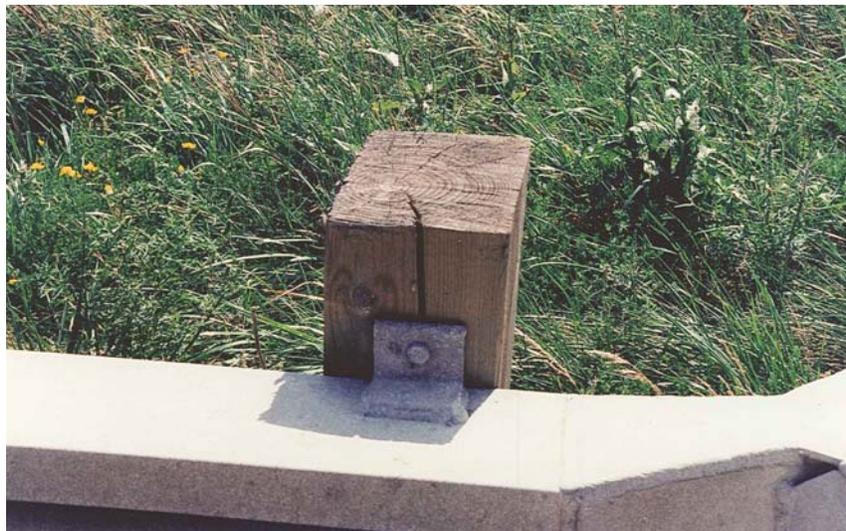
There were numerous “nuisance” hits to extruder heads by snowplows, automobiles, and trucks, possibly due to the lack of set back from the shoulder that is required with other systems. These hits usually caused minimal damage but generally required maintenance. Slight impacts to the extruder head would cause post one to split at the connection to the guardrail (Figure 3). Because there was only one hole in the bracket that connects the post to the extruder, the extruder could only be mounted in one location, i.e. where the post had split and could no longer adequately support the extruder. Post 1 would then need to be replaced. If the bracket were designed wider and with additional mounting holes, the extruder could be remounted to the remaining solid section of the post. Post replacement would not be necessary.

**Figure 3. Split in post at location one.**
