Strength and Serviceability of Damaged Prestressed Girders

This brief summarizes Project 0092-17-02,
 “Strength and Serviceability of Damaged Prestressed Girders”
 Wisconsin Highway Research Program

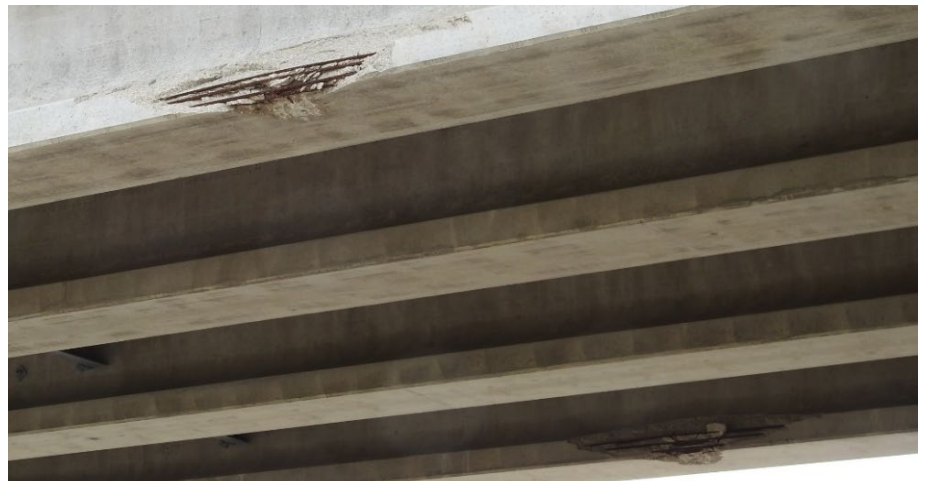
Initial-impact (top left) and rebound-impact (bottom right) damage
