# Evaluation of Roadway Concrete Barriers and Materials

University of Wisconsin – Madison  
Department of Civil and Environmental Engineering

WisDOT ID no. 0092-19-03

July 2021

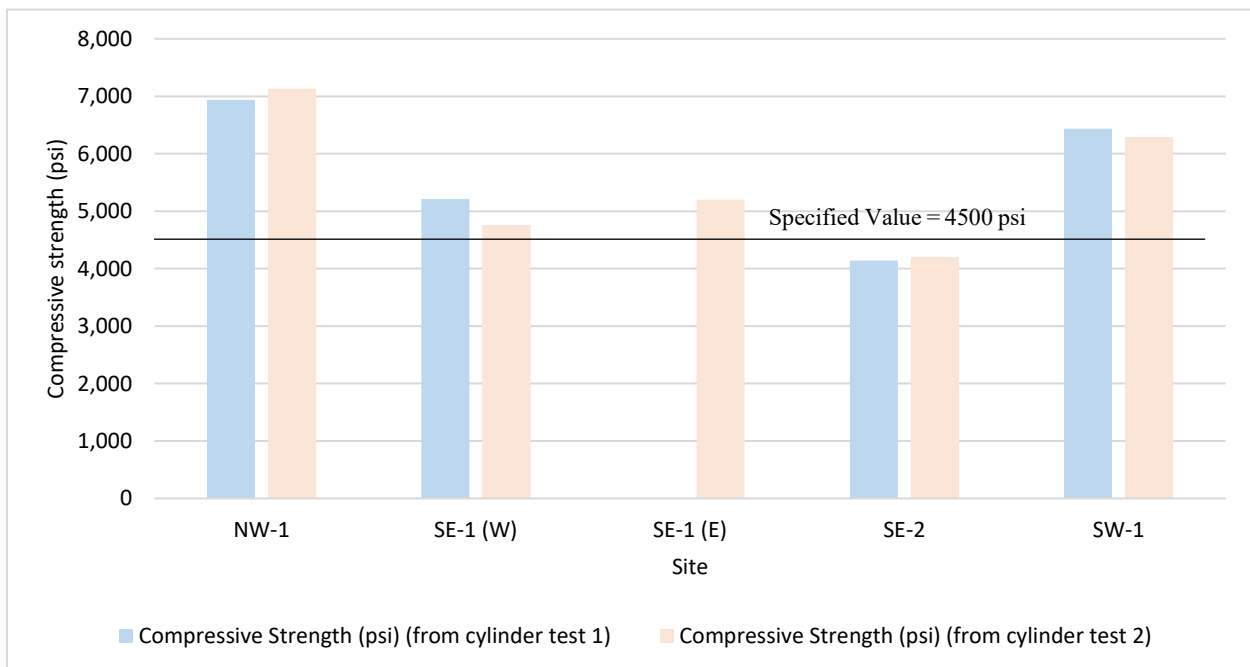
By comparing the compressive strength of the barriers as per the cylinder test reports cast closest to the segment visited at each site ([10]–[13]) with the specified value, it can be seen site SE-2 is the only one with compressive strength less than the specified value (Figure 4.1). This site was the most distressed one among all the visited barriers. On the other hand, site NW-1 which was in the relatively best condition compared with the other sites shows a compressive strength of about 50% higher than the specified value. It is worth noting that due to lack of information regarding the specified compressive strength value of each site, they were all assumed similar to the available value for site SE-2 (i.e. 4500 psi [14]).

Figure 4.1: Compressive strength based on the cylinder test results vs the specified value (notes: 1) at site SE-1, west (W) and east (E) segments were poured on different days, 2) one cylinder test data was available for the east segment, and 3) cylinder test data are provided by WisDOT)

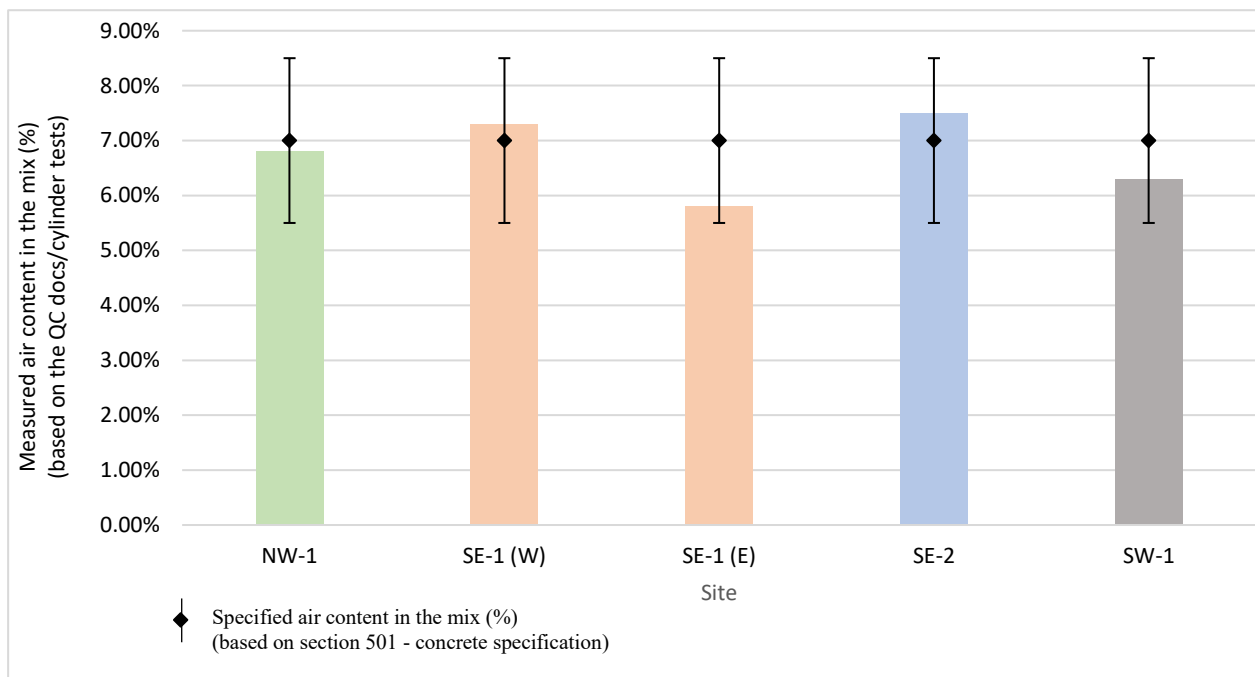
Furthermore, by looking at the measured air content which is provided in quality control documents or cylinder test reports ([10]–[13]) of the visited sites, and comparing them with the specified range (i.e. 5.5% to 8.5% [16]), it can be seen all the air contents are in the specified range in (Figure 4.2). However, site SE-1 (E) is in the very low range.

Figure 4.2: Measured air content based on the cylinder test reports and quality control documents vs specified range (note: at site SE-1, west (W) and east (E) segments were poured in different months)

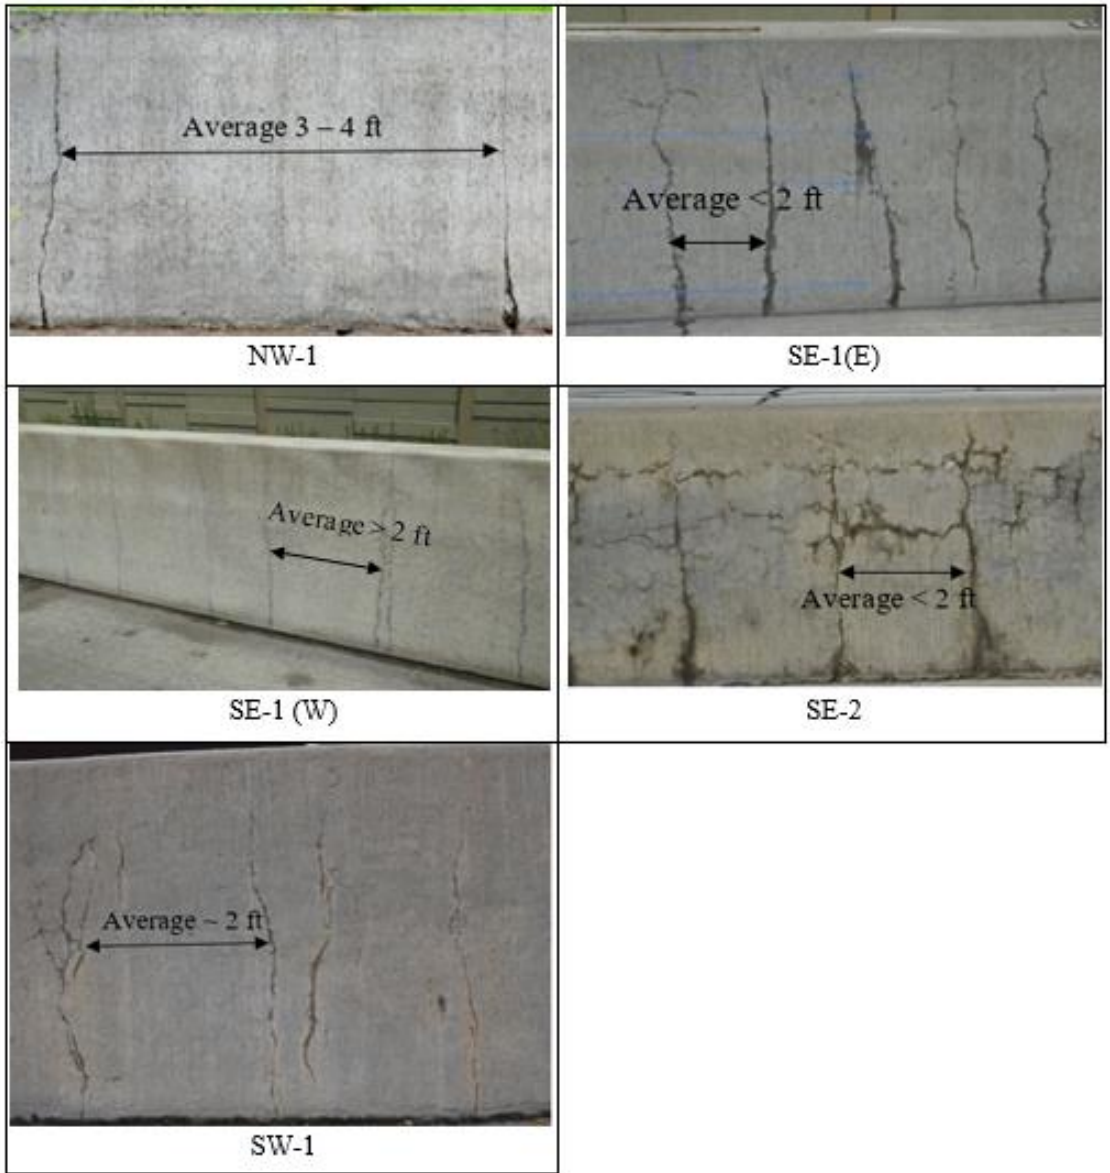
Figure 7.1: Typical crack patterns observed at each site

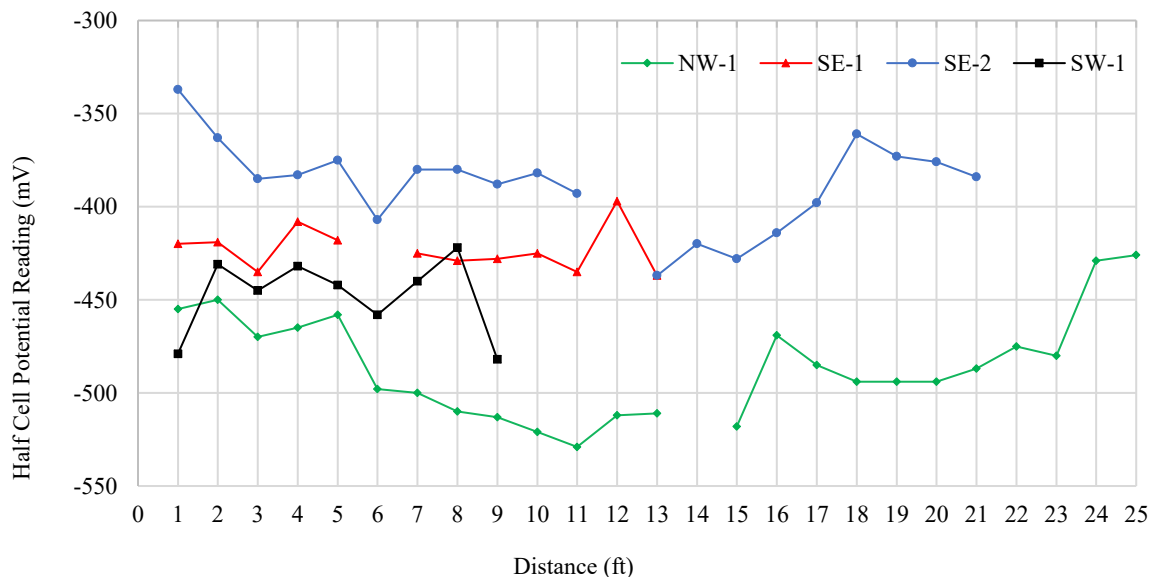
To detect the likelihood of corrosion activity in the barriers, half-cell potential measurements were taken in each as described in section 5.5. Profiles of half-cell potential readings obtained at various locations along the length of the barriers are shown in Figure 7.2. As can be seen, the potential readings vary, but they do not show large drops (greater than 100 mV) along the inspected lengths. This result suggests that there is a low probability of or simply no corrosion activity in any of the barriers. This result is consistent with the absence of rust stains on the surface of the barriers (Table 7-1). Therefore, it is concluded that corrosion was not a source of deterioration of the inspected barriers.

Figure 7.2: Half-cell potential readings along one longitudinal rebar at each site

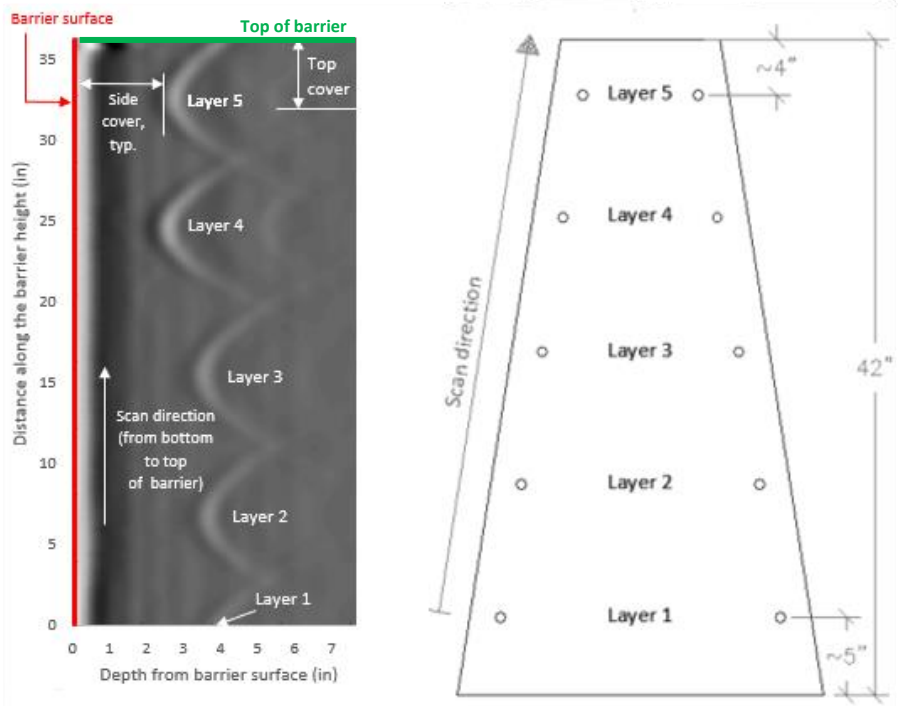
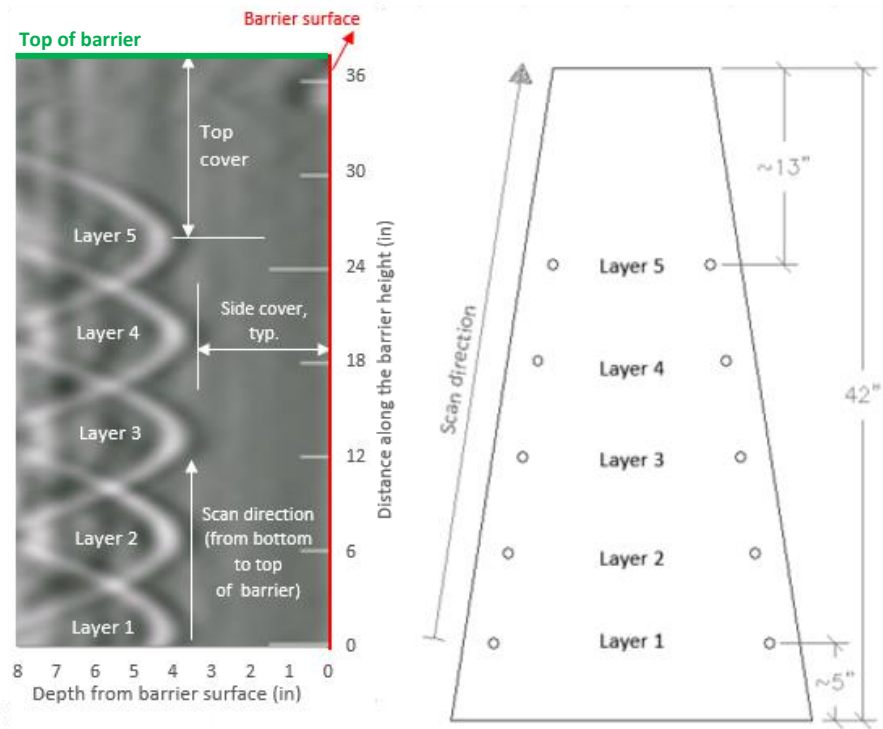
Furthermore, GPR scan images at the barrier terminal end at site NW-1 show the existence of no vertical rebars. However, number 4 stirrups are specified within around 30 inches from the terminal ends of the barrier in the as-built drawings.

Figure 7.3: Gray scale image of vertical GPR scans obtained along the barrier height: a) site NW-1 and b) site SE-1(W)

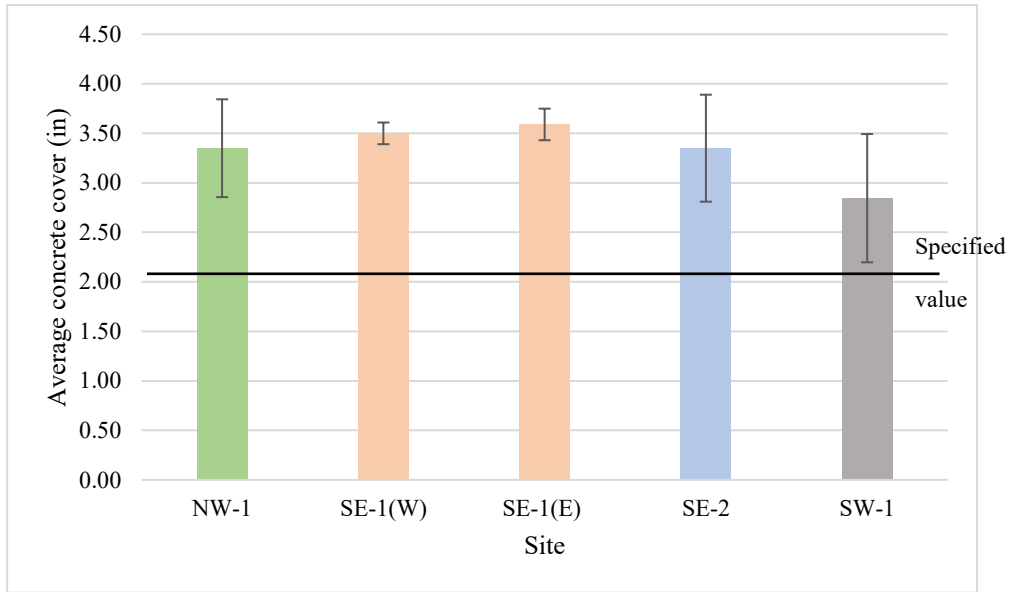
Figure 7.4: Average measured side concrete cover at different sites based on the GPR data

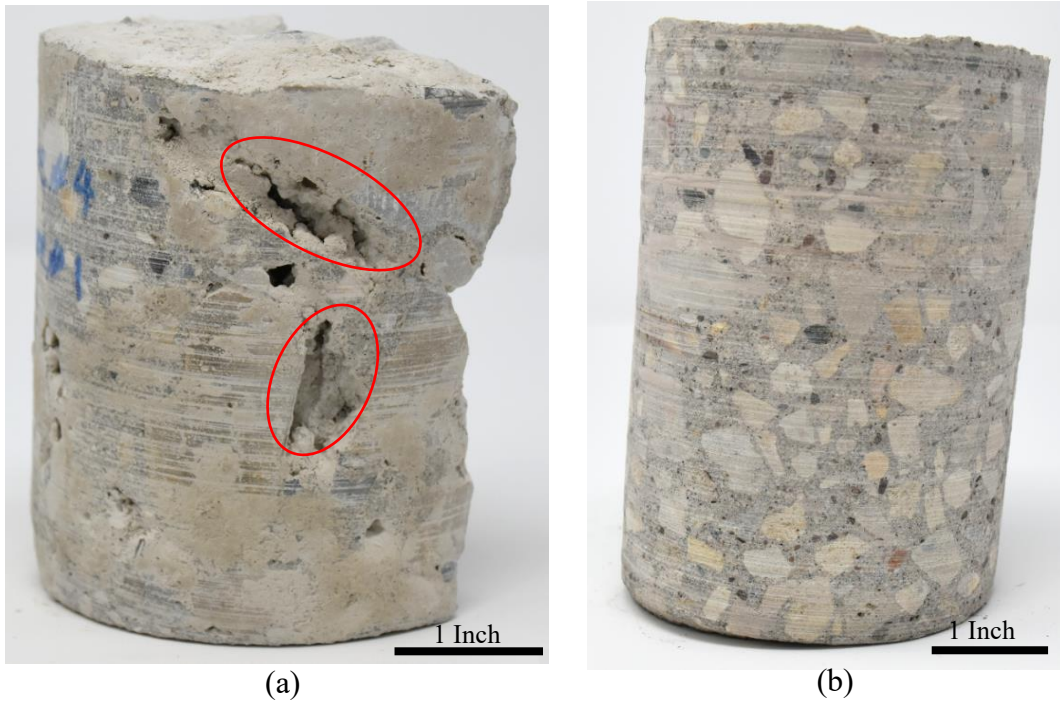
Figure 8.2: Level of honeycombing in the extracted cores: a) SE-2 (the most distressed barrier), b) NW-1 (the least distressed barrier)

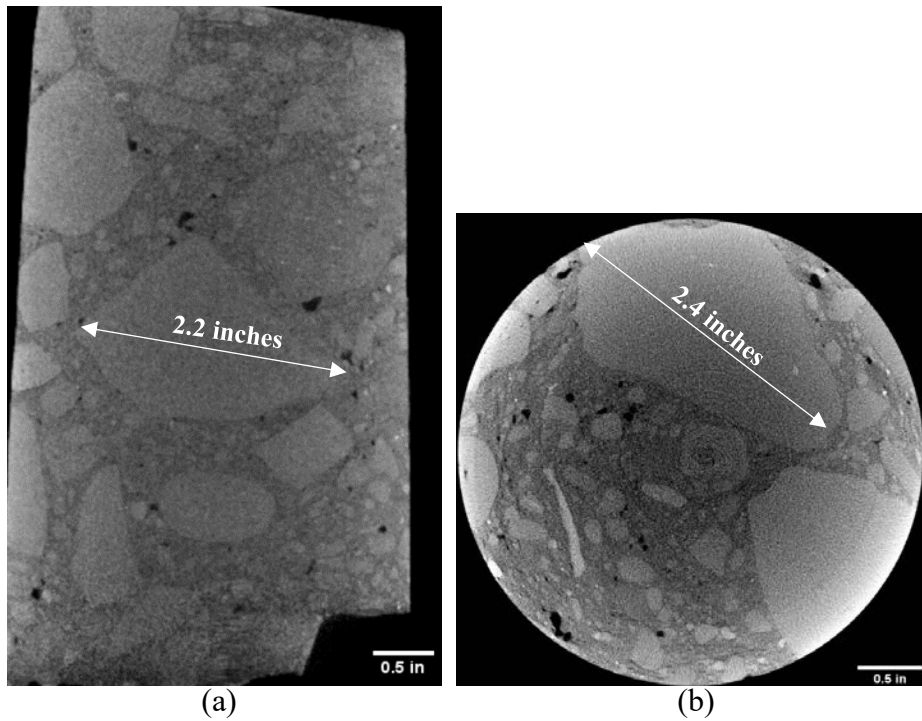
Figure 8.3: Coarse aggregate greater than the specified dimension at site SE-1: a) longitudinal view, b) cross-section view

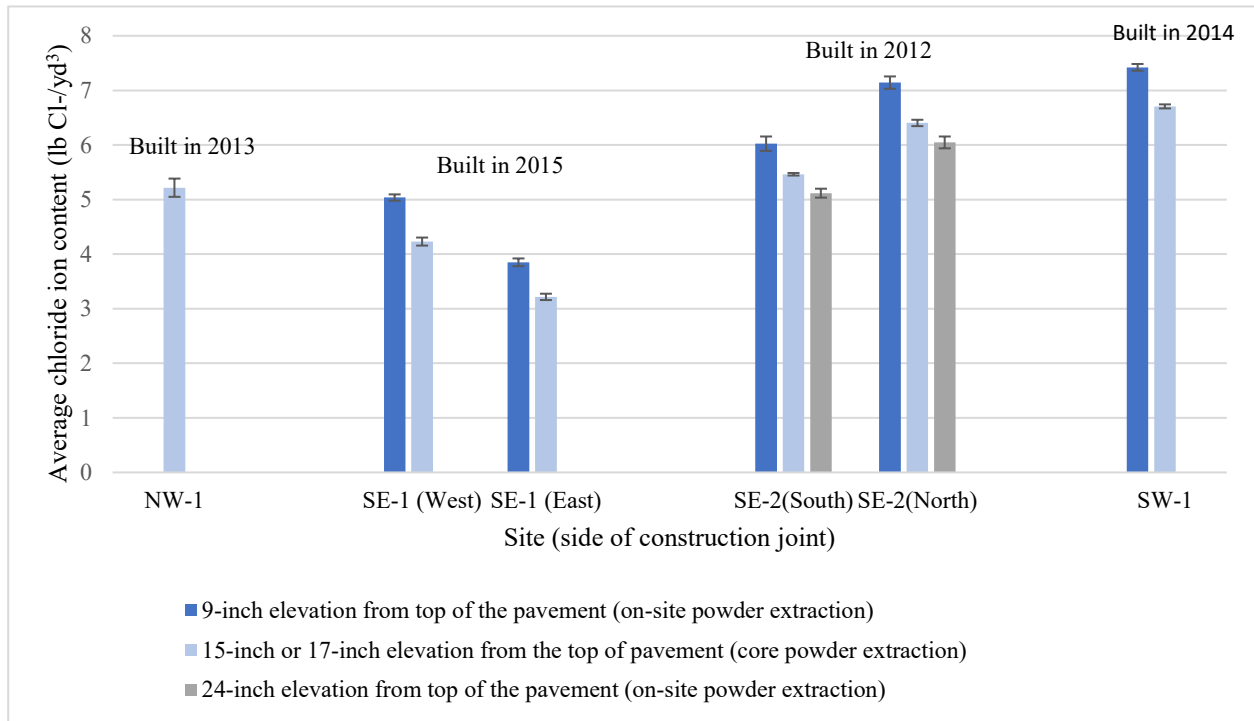
The average chloride ion content measured at the surface (0.5 – 1 inch deep) at various barrier elevations is shown in Figure 8.5. As may be expected, the chloride ion content is highest in the lower part of the barrier compared with the upper portions, ranging from 3 to 7 lb/yd<sup>3</sup>. Given the large cover of the reinforcement, it was estimated that the bar-level chloride ion content was less than the threshold which could cause corrosion activity of the epoxy-coated rebars [34]. Even though chloride ion content was high, no sign of corrosion activity was observed and hence is not attributed to the distress level of the barriers.

Figure 8.5: Measured chloride ion content of the extracted concrete samples at 0.5 inches to 1-inch depth (note: there was no construction joint at this sites NW-1 and SW-1)

As seen in Figure 8.5, the chloride ion content is less in the east segment than in the west segment at site SE-1. Since these two segments are exposed to the same environmental condition and they were constructed in the same year, the reason could be the difference in their concrete mix design. Reviewing the provided QC documents shows that the measured air content in the east segment was less than in the west segment (Table 8-3). Though the data are limited, this result suggests that the porosity of the latter segment could lead to higher chloride penetration.
