Impact of Railcar Weight Changes on Bridges of the State of Wisconsin- Owned Railroad System

Westbrook Associated Engineers, Inc., and E80 Plus Constructors, LLC

Final Report No. 0092-05-13

August 2006

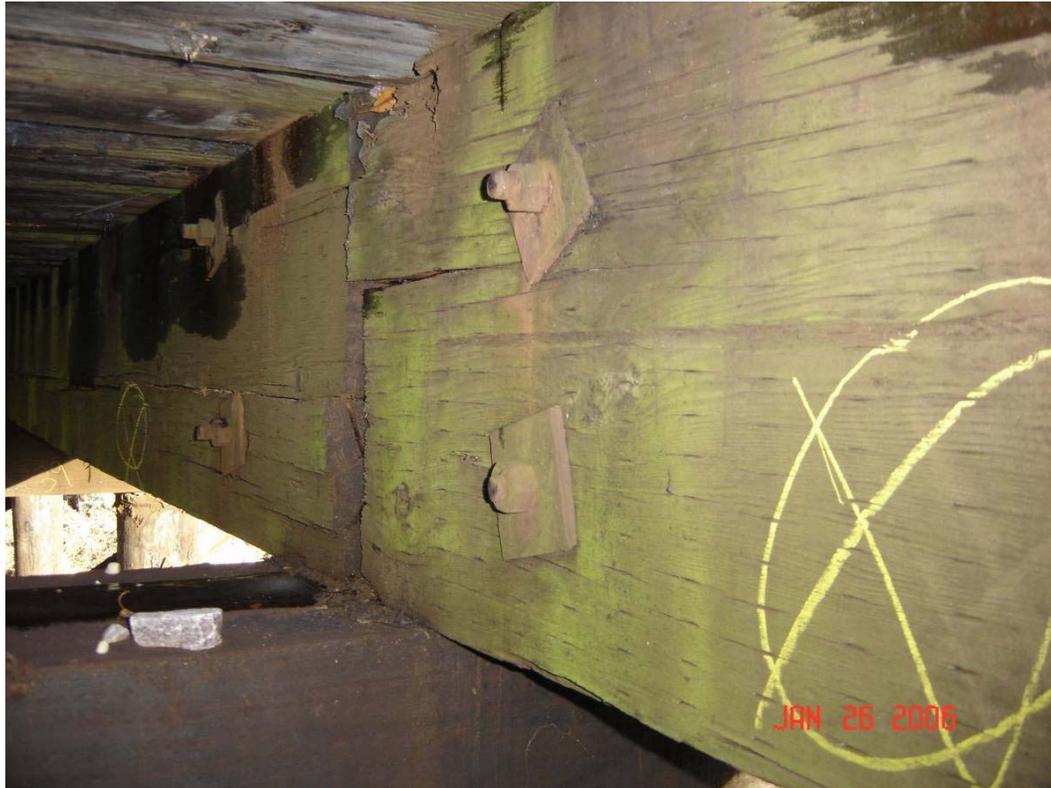
Defective Stringers - Timber stringers exhibiting decay at a pier cap.

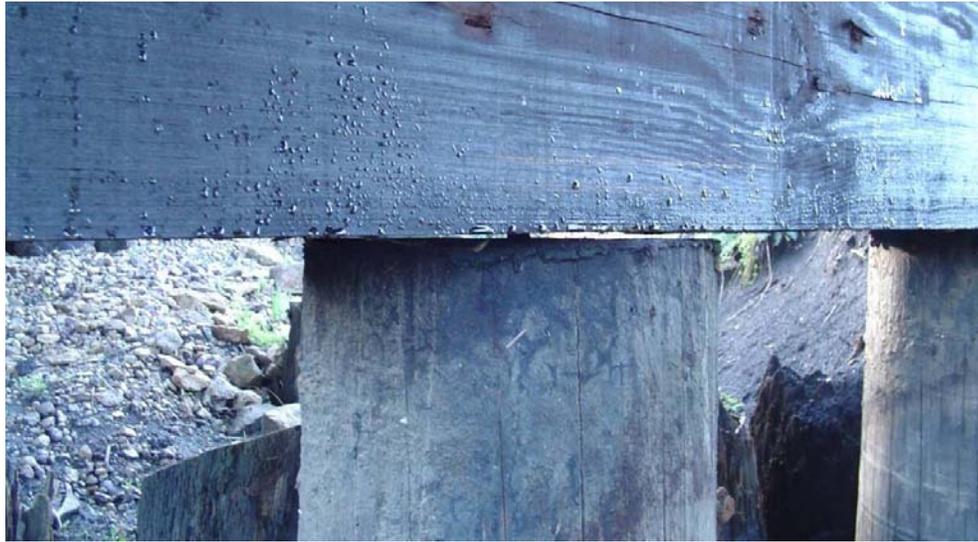
Many of the timber piles are loaded beyond their capacity due to poor pile spacing. This is evident as pile settlement and is often noted in the inspection report. Pile loads were determined using the AREMA method for division of pile load among piles in a bent as discussed in Chapter 7, Section 2.4.5 - Bents. The pile loads based on ASLRRA distributions were not used for rating, as they do not make any consideration for pile spacing, however they are included in the calculations for comparison.

Pile Settlement – Note daylight shining between pile and cap.

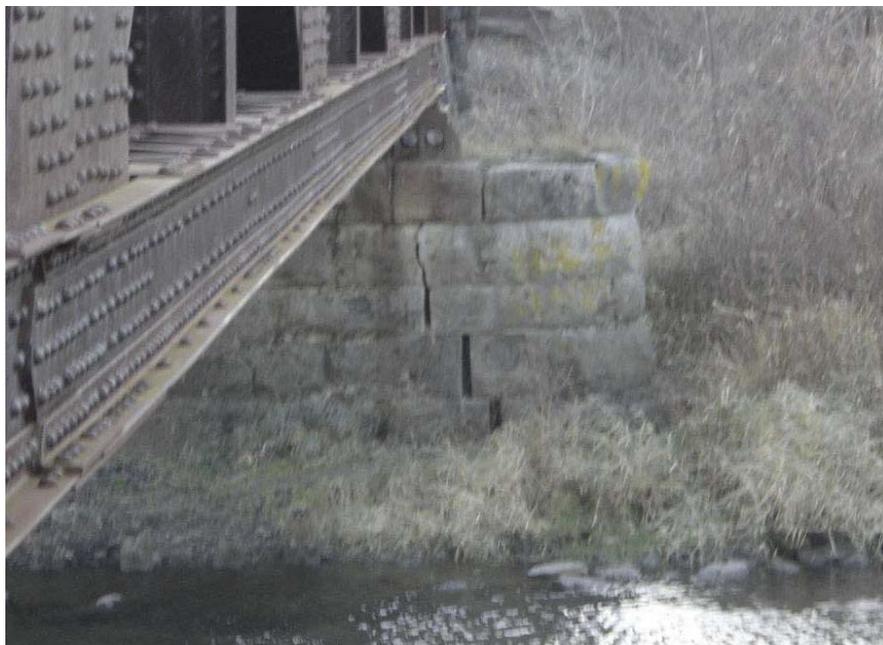
The inspection report noted that pier 2 at the west end of the pony truss has settled and that the stone has deteriorated at the south bearing. The differential settlement of the pier opened a large crack in the masonry at the north end of the pier. See photo below. A 1971 railroad survey noted both the stone deterioration at the bearing and the settlement crack. The size of the crack in the 1971 survey is approximately the same as it is today. This indicates that the pier is stable and may continue to carry load. However, measures should be taken to repair the crack and the deteriorated stone. See the section *Inspection Findings* for further discussion and the section *Recommended Maintenance and Repairs*.

Bridge F-84, Pier 2 – Differential settlement of masonry pier.

The primary item of concern with the steel and concrete bridges inspected is the settlement of Pier 2 at Bridge F-84 of the Monroe Subdivision. This masonry pier was constructed in 1882, and a 1971 survey indicated much the same deterioration. This differential settlement has opened the joints in the masonry, and has broken some stones in the pier. Overall the pier appears to have settled around 2". Without an existing plan or record of construction it is difficult to assess the reasons for settlement. The most likely cause is an increase in footing bearing pressure due to increased traffic loads and/or differential stiffness of the supporting soil.

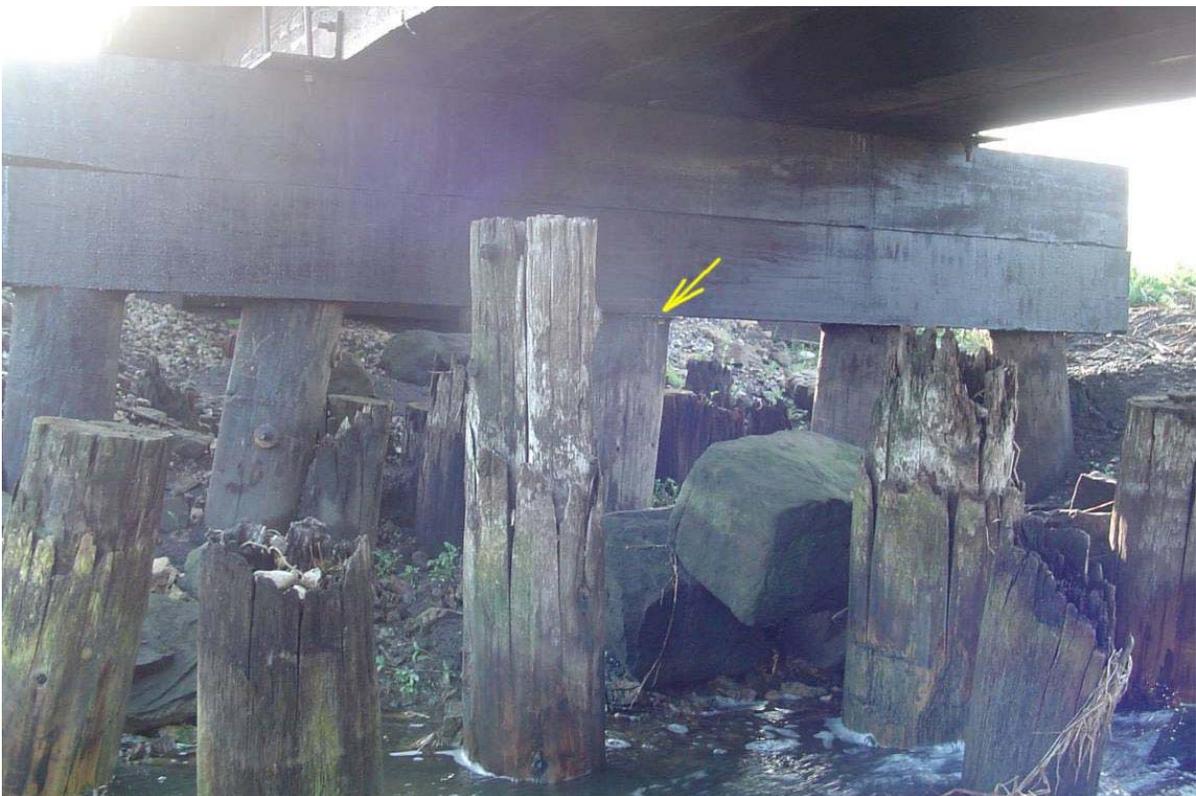
Double Pile Cap – Pile settlement may continue to occur.

There is conjectural evidence that railroads have had success at slowing pile settlement by cutting down the piles and installing a double pile cap at each bent. However, there is no published study that our team is aware of that has investigated the effectiveness of installing a stiffer cap section to slow pile settlement, or determined what section would be most effective. For this reason, we recommend closely monitoring the bents that receive double caps to evaluate the effectiveness of this approach to limit pile settlement. As well as monitoring the proposed double caps, it may be advantageous to investigate other configurations of stiffer cap sections. Possible alternatives include deeper concrete caps, double caps with provisions for shear transfer between the two timbers, or reinforced bent bracing to improve load distribution.
