SECTION 626 Energy Absorbing Terminals

626.1 Energy Absorbing Terminals

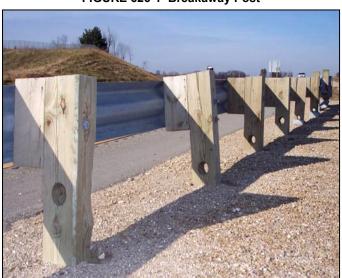
FIGURE 626-1 Breakaway Post

The breakaway holes in figure 626-1 are too high. During a head-on impact, the undercarriage of a vehicle could snag on a post. Objects taller than 4 inches on a 5-foot chord are potential snag hazards. The second post from the left also appears to be out of plumb and may not absorb

enough impact energy or an errant vehicle may vault over the EAT. In either case, the errant vehicle may engage a roadside hazard that the EAT was installed to protect.

Object taller than 4 inches on a 5 foot chord are considered to be potential snag hazards.

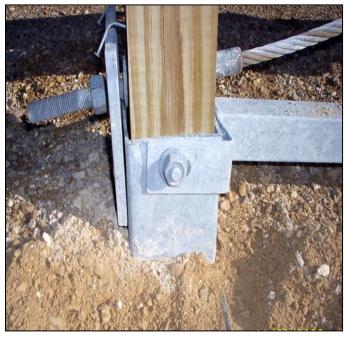
The steel foundation tube in figure 626-2 is too high and may snag a vehicle during an impact with an EAT. Also, the cable has slack in it which can cause excessive deflection or rail failure for the whole installation of semi-rigid barrier. Finally, the bearing plate is not installed correctly.

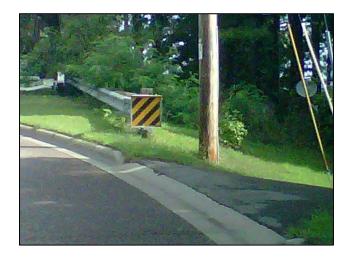
Collisions into multiple fixed objects are more likely to have negative consequences, especially with EATs. A fixed object in front of and EAT may channel drivers into an EAT (figures 626-12 and 626-13). On the other hand, fixed objects installed within the adjacent or runout areas can be struck by an errant vehicle after it has impacted an EAT (figures 626-14 and 626-15).
