FDM 14-25-10 Concrete Pavement Rehabilitation Guidelines

Exhibit 10.1 Concrete Pavement Rehabilitation Manual

Concrete Pavement Rehabilitation Manual

WISCONSIN DEPARTMENT OF TRANSPORTATION

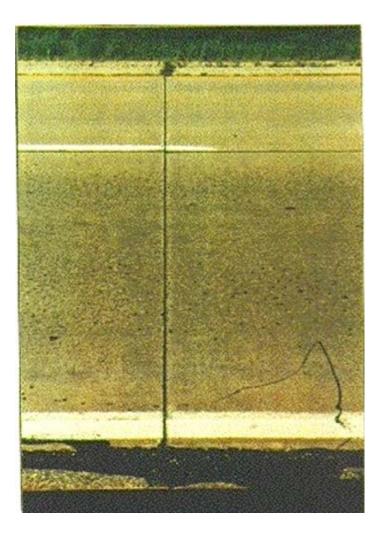
1. JOINT

Joint is in excellent condition. No repair required.

Same

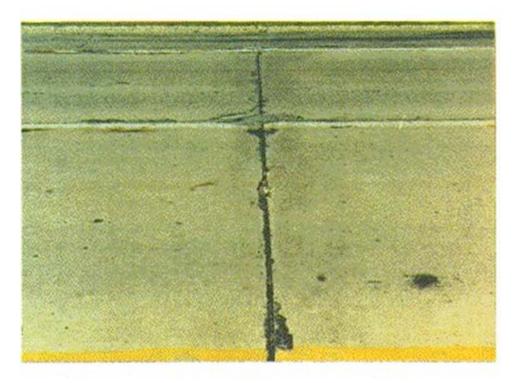
1. JOINT

This joint is in good condition. There is a minor amount of spalling at the surface along the joint, but this will be removed during the grinding operation. Note the asphalt sealant material around the joint and make sure this material is not masking more severe distresses. This joint should be left alone for this rehabilitation alternative.

This joint is in good condition and requires no additional treatment prior to overlay.

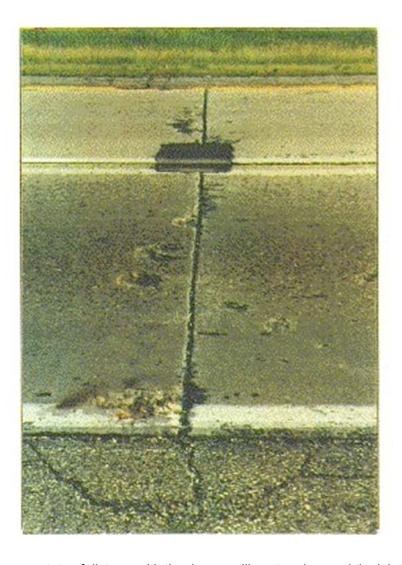
1. JOINT

This joint is in a more severe state of distress with the deep spalling at and around the joint. Also, the asphalt patch at the centerline is a sign of additional deterioration at the joint. The asphalt patch would not be compatible with the grinding operation. This joint should be selected for a full depth, full lane concrete repair under this rehabilitation alternative.

This joint is still in good condition for this rehabilitation alternative. The spalled areas should be jackhammered or ground to remove the delaminated concrete and filled with AC or concrete before placement of the overlay.

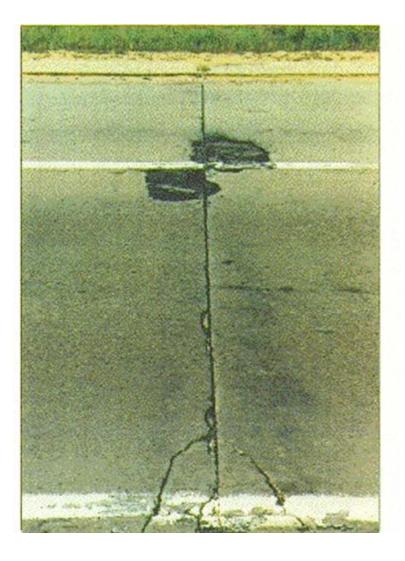
1. JOINT

This joint should be repaired as part of the rehabilitation strategy. The broken pieces at the edge and center of the pavement are not compatible with the grinding operation.

As part of the resurfacing rehabilitation, this joint should be repaired due to the broken pieces as the edge and centerline of the pavement. Note the staining around the joint, this is an indication of age not of a significant D-cracking problem, (this pavement is 25 years old.) If this were a significant D-cracking problem the staining and subsequent cracking would have occurred much earlier in the pavement's life. Caution should be exercised in using the staining as a basis for repair. When cracking around the joint begins to develop along with the staining a repair is warranted. However, a joint with staining only should be more closely investigated and compared to the overall condition of the joints over the entire project. From that engineering judgment should be used to decide on whether to repair or leave in place.

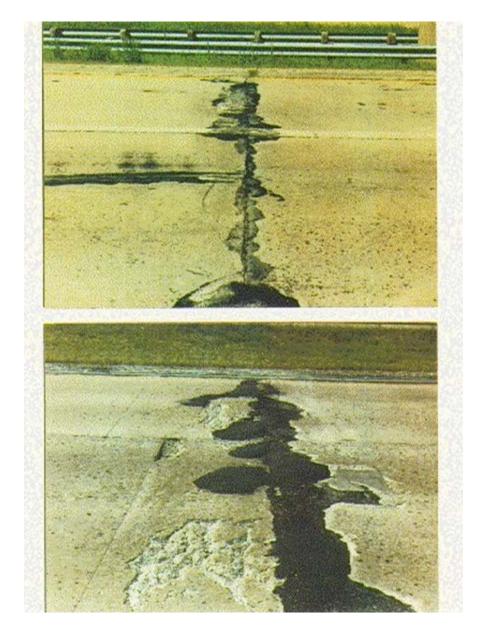
1. JOINT

These joints require full depth repair regardless of rehabilitation strategy. The repair should be completed as outlined for each rehabilitation strategy. There is parallel cracking along the joint and material is being removed by traffic.

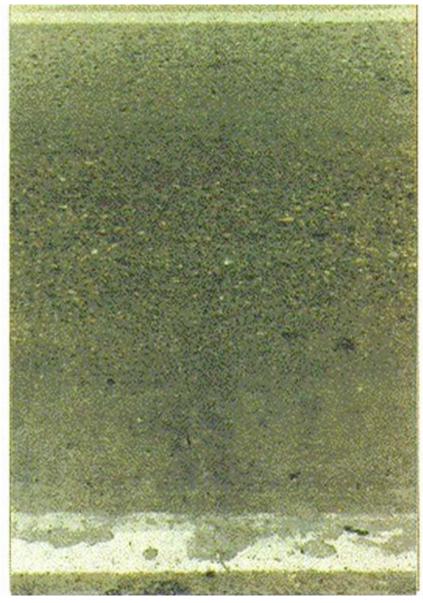
1. CRACK

This hairline crack requires no attention regardless of rehabilitation strategy.

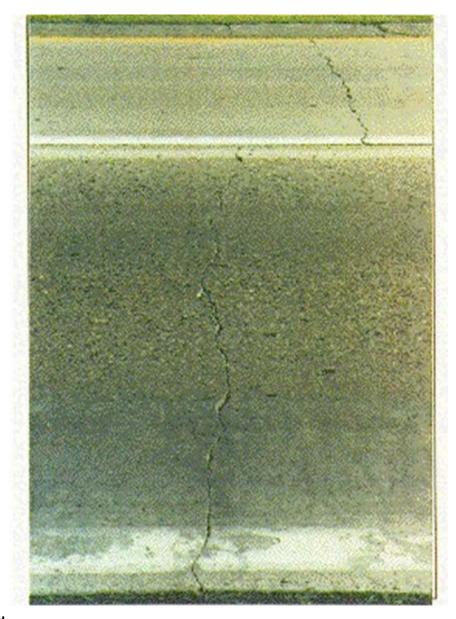
1. CRACK

This crack is in good condition with a few minor spalls along the length of the crack. These spalls will be removed as part of the grinding operation.

No treatment required prior to placement of the overlay.

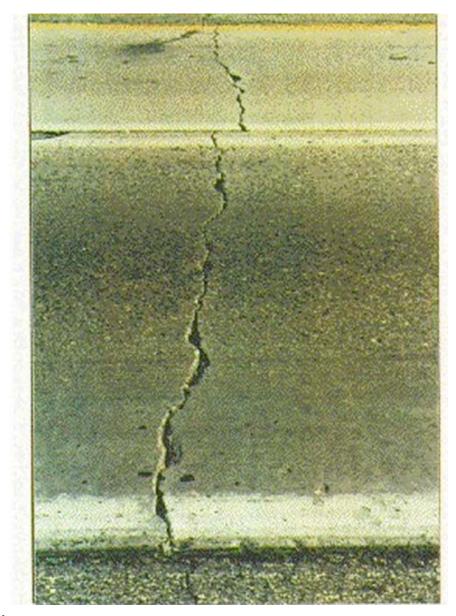
1. CRACK

This crack has more severe spalling, but is not faulted. A careful inspection of the spalled areas needs to be made. If the depths of these spalls are significant (1-3 inches) and additional visible distress is evident, the pavement should be repaired. This particular crack shows no distress other than the spalls. Therefore, it should not be repaired as part of this rehabilitation alternative.

This crack would not require repair prior to overlay.

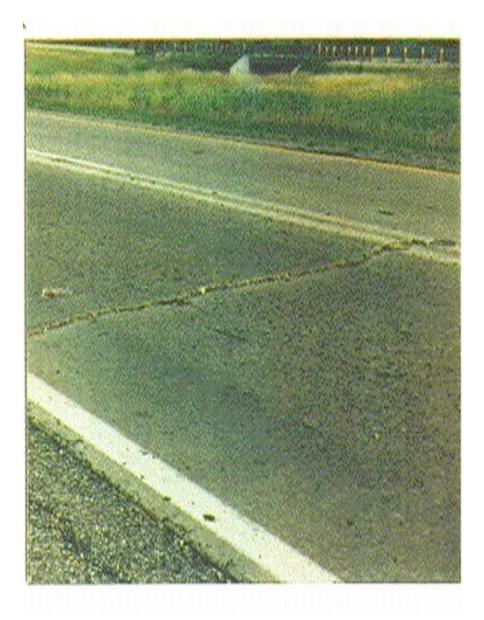
1. CRACK

This crack is in good condition with exception of the faulting. No repair is required prior to the grinding operation **Repair and Overlay**

No repair is required as part of this rehabilitation strategy. Recent practice has been to construct a leveling course of AC prior to the binder course to aid in bridging significant faults.

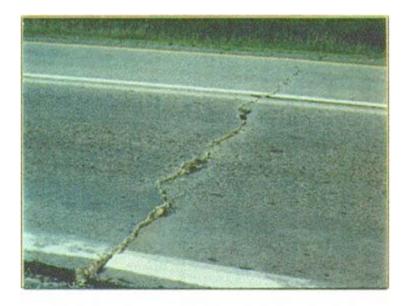
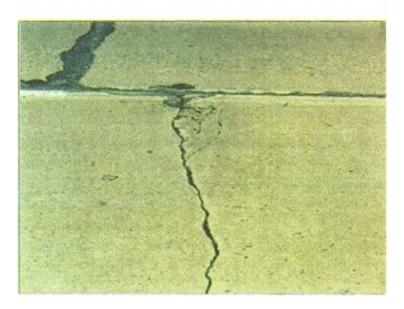
1. CRACK

Both of these cracks have secondary cracking adjacent to them that have formed large pieces of concrete. These pieces would be dislodged during grinding and form a large void at the surface. The secondary cracking is also an indication that more advanced distress has occurred. This crack should be repaired.

Due to the secondary cracking these cracks should also be repaired prior to the overlay.

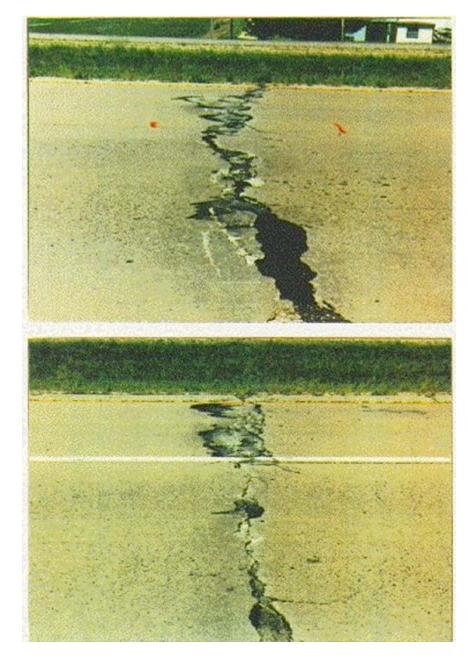
1. CRACK

These cracks require full depth repair regardless of rehabilitation strategy. The repair performed should be as previously outlined for each rehabilitation strategy.

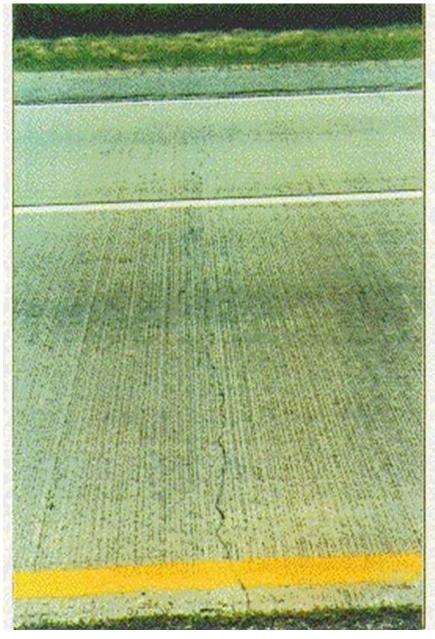
1. SINGLE TRANSVERSE CRACK

This crack requires no attention regardless of rehabilitation strategy. This is a typical crack for CRCP pavements and it normally occurs at 3-10 foot intervals.

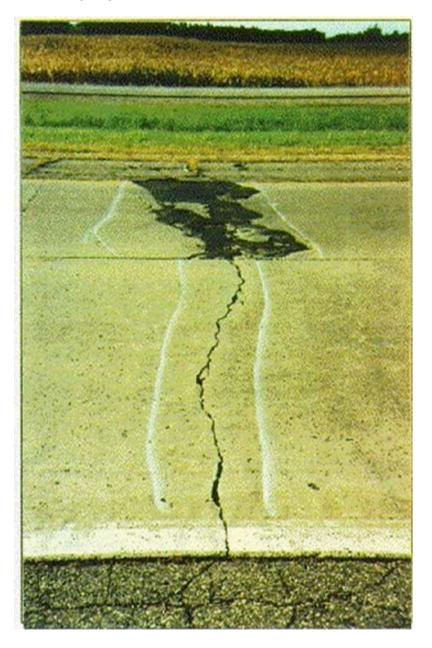
1. SINGLE TRANSVERSE CRACK

Both lanes require a full depth repair when using this rehabilitation strategy. It is obvious that the inside lane requires repair. However, the outside lane is not so obvious. As a general rule, any crack on a CRCP pavement with a crack width of ¼ inch or greater is an indication that the steel has ruptured across the crack and load transfer has been lost. This makes that crack a location with the potential for additional distress to occur in a very short time. Therefore, a full depth repair is also recommended for the outside lane.

Under this rehabilitation strategy only the inside lane requires a full depth repair prior to placement of the overlay. The additional structure of the overlay should bridge the formation of additional distresses occurring at the crack in the outside lane.

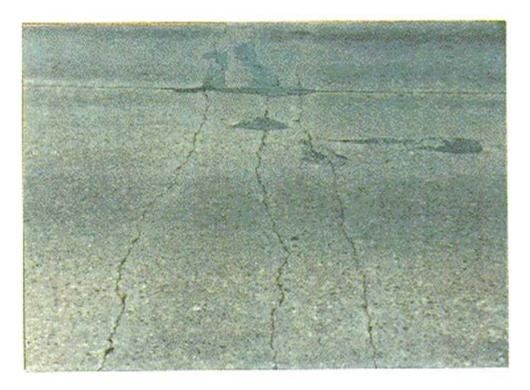
1. MULTIPLE TRANSVERSE CRACKS

This series of cracks does not require repair. They are all still tight with insignificant spalling. Close inspection of the CRCP is required here. The presence of longitudinal cracking must be determined here. The confirmation of the existence or nonexistence of the longitudinal cracking is important to assure performance of the repair.

These cracks do not require repair as part of this rehabilitation alternative.

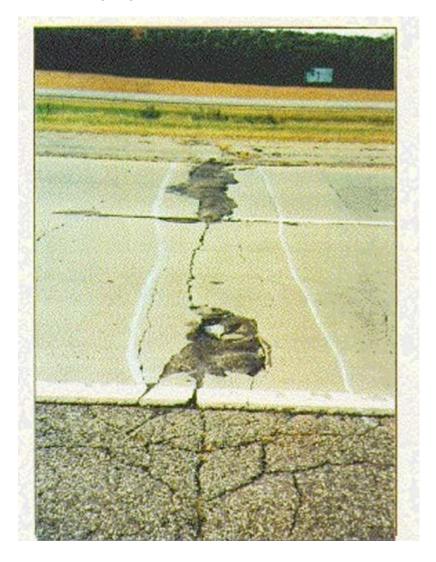
1. MULTIPLE TRANSVERSE CRACKS

The distress that has taken place at this location between cracks requires a full depth repair as part of this rehabilitation strategy. The steel has ruptured at the cracks and additional deteriorated areas have formed adjacent to the crack.

A full depth repair is also required for this rehabilitation strategy prior to place of the overlay.

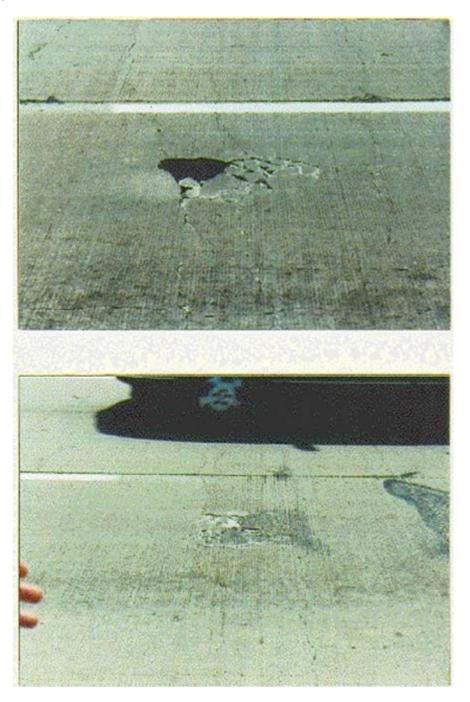
1. DETERIORATED AREAS

These deteriorated areas require repair as part of this rehabilitation strategy.

A determination of the extent of the deterioration must be made. If the deterioration is full depth, a full depth repair is required. If it is partial depth, a partial depth repair with either AC or concrete is required prior to placement of the overlay.

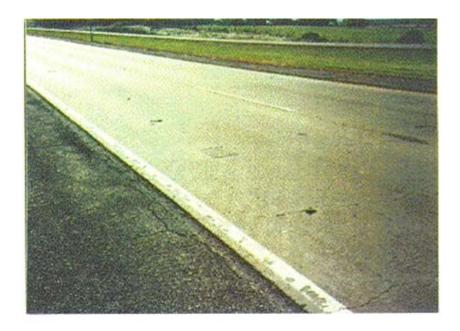
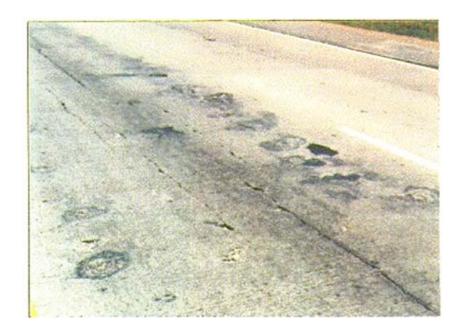
1. SPALLS

The top pictures is a section of CRCP with a few minor spalls in the background. Repair of spalls is difficult because full depth repair is not required. The bottom picture is a severely distressed section of CRCP with spalls caused by high steel, a full depth repair is required if this is a localized condition.

No repair is required for the top section of CRCP prior to the overlay. If the condition in the bottom photo is not localized and occurs over a significant amount of the project repair and overlay is the correct rehabilitation strategy. Partial depth patching with AC or concrete prior to placement of the Hot Mix Asphalt (HMA) overlay is required.

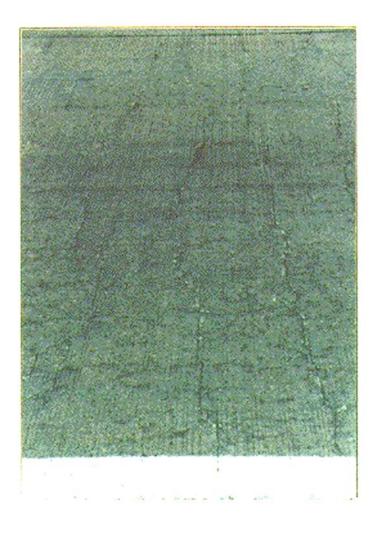
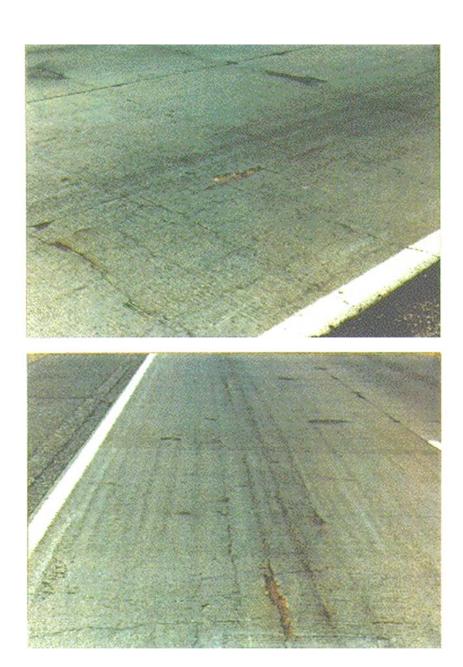
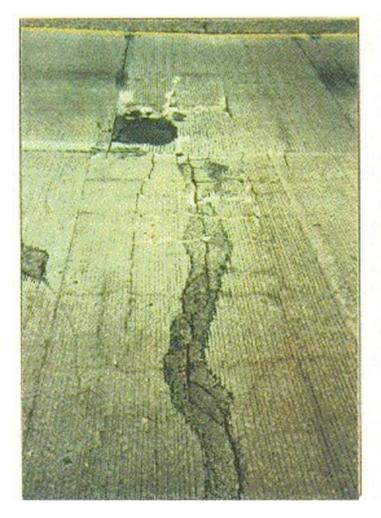
1. CRCP ADVANCED DISTRESS

The following pictures are of CRCP in advanced stages of distress. A repair is required on a short section of pavement with an isolated distress. It is also necessary for the repair to be adjacent to sound concrete. Because of the distressed condition of these pavements, the areas in need of repair are likely to be extensive and the existence of sound concrete is unlikely. Therefore, extensive repair of these sections is not recommended from a practicality standpoint. Repairs should be minimized to those locations where it is absolutely required for placement of the overlay. These pavements warrant reconstruction of the pavement structure. However, if funding or some other factor requires that these pavements be rehabilitated the best option available would be placement of an HMA overlay with minimum repairs being made to the concrete.

A full depth repair is required at this location regardless of rehabilitation strategy. The punchout failures at the centerline and far lane must be repaired prior to placement of the HMA overlay.

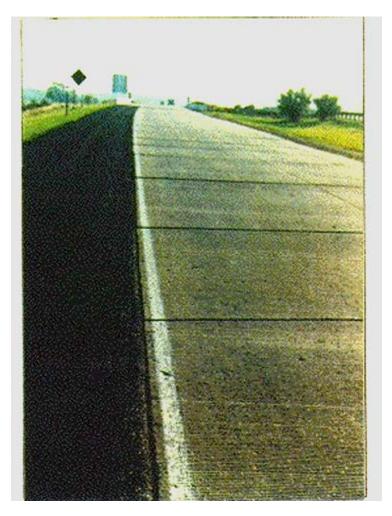
1. FAULTED JOINTS

This section of highway is a faulted pavement. Although it is faulted, there are no visible distresses to the individual slabs. This section of highway is an excellent candidate for this rehabilitation strategy because faulting on the average is less than $\frac{1}{2}$ inch.

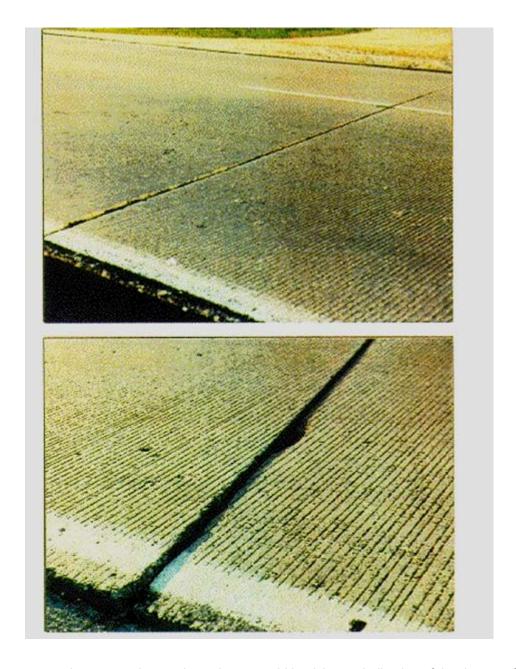
1. FAULTED JOINTS

These pictures are supplements to the previous picture to aid in giving an indication of the degree of faulting on that particular section of highway.

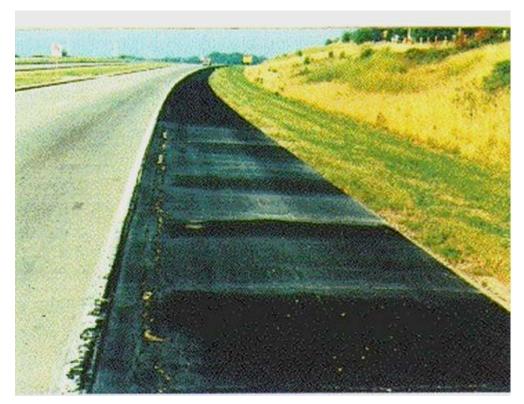
1. PUMPING

The white staining on the shoulder in the above picture is an indication that pumping of the base is taking place. All necessary repairs to the concrete pavement that are required as previously outlined should be performed. The past practice of retrofitting a longitudinal edgedrain in this situation is not recommended. Current research efforts by the Department indicate that these retrofit drains are not draining water from the pavement structure and are not preventing recurrence of faulting in these types of pavements.

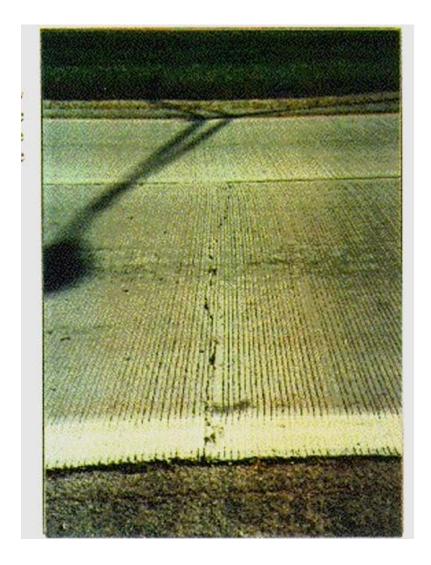
1. CRACK

This crack is in good condition with a few minor spalls along the length of the crack. No repair is required. These spalls will be removed as part of the grinding operation.

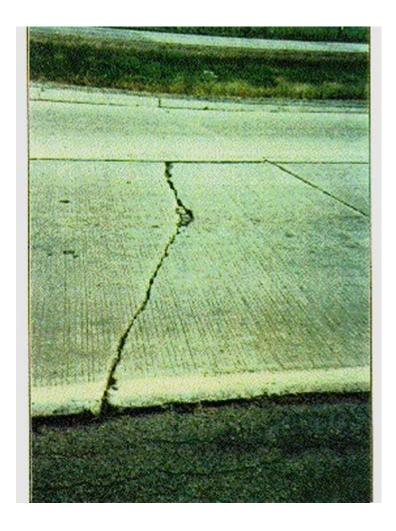
1. TRANSVERSE CRACK

The above crack is faulted, spalled and has some secondary cracking running parallel to it. A replacement of this slab is required for this rehabilitation strategy.

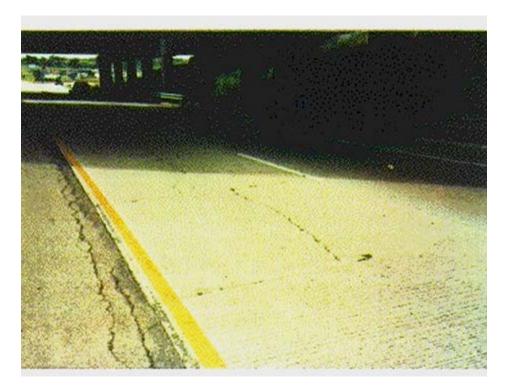
1. LONGITUDINAL CRACKING

Longitudinal cracks should be assessed from two standpoints. The first is the condition of the crack and secondly is the affect is has on ride quality. The cracks shown in the photo above are in successive slabs and have significant spalling. The slabs have also settled along the shoulder. This type of distress is an indication of a base or subgrade problem and a full depth repair is needed. However, it is not the intention of this manual to make a recommendation on subgrade or base repair.
