HIGHWAY WORK PROPOSAL - RAZING AND REMOVING

COUNTY	STATE PROJECT ID	PROJECT DESCRIPTION	HIGHWAY
Milwaukee	1229-04-21, Parcels 5, 10	I-43 North South Freeway Silver Spring to STH 60	IH 43
Ozaukee	1229-04-23, Parcel 55	I-43 North South Freeway County Line Rd to STH 60	IH 43
Milwaukee	1229-04-24, Parcels 3, 8	I-43 North South Freeway Silver Spring to County Line Rd	IH 43

PHOTOS OF THE SUBJECT

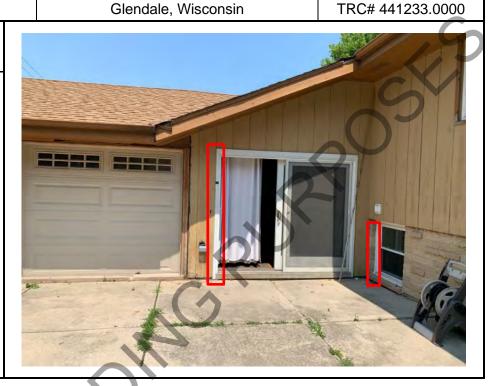
White caulk around exterior window and door frames, non-detect for ACM

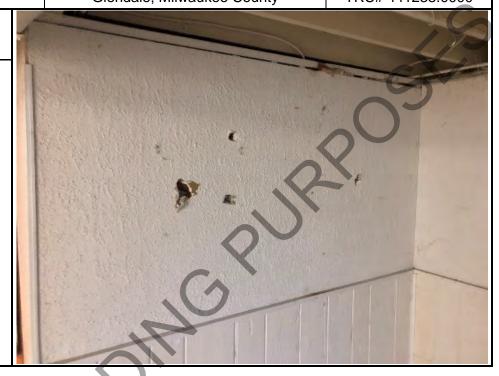
Popcorn texture and drywall on basement walls

Both non-detect for ACM

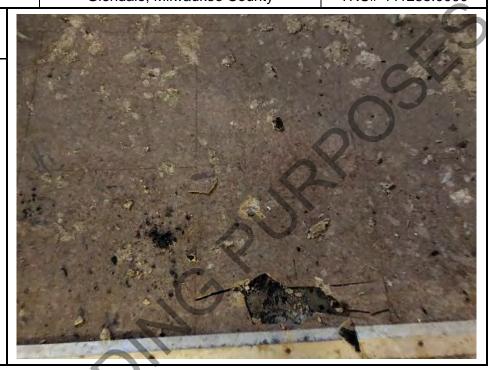
Black adhesive and 8"x8" brown/tan vinyl tile on floor in basement utility room

Adhesive is non-detect for ACM, 8"x8" brown/tan vinyl tile contains 5% non-friable ACM

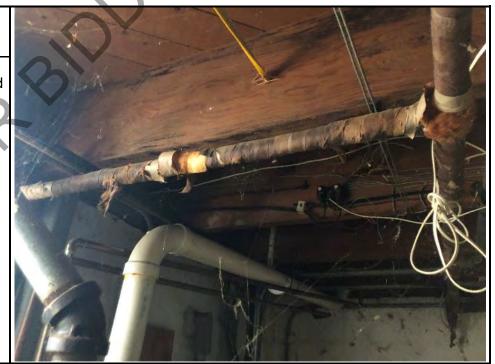
Insulation paper/wrap around piping in basement utility room

Non-detect for ACM

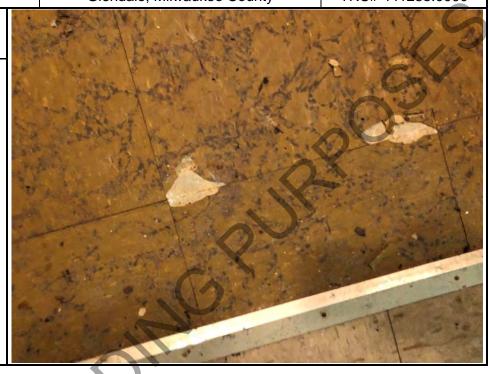
Adhesive and 8"x8" yellow/tan vinyl tile on floor in basement bathroom

Adhesive is non-detect for ACM, 8"x8" yellow/tan vinyl tile contains 3% non-friable **ACM**

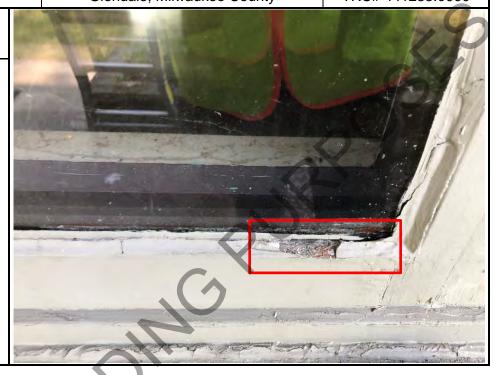
White window glaze around exterior window

Contains 2% non-friable ACM
