Road Safety Audit

Project I.D. 6145-01-01
USH 12 (Wisconsin Dells Parkway)
Broadway Street to Whitlock Street
Sauk County, WI

US 12 (Wisconsin Dells Parkway) Road Safety Audit

STH 23 (Whitlock Street) to STH 13 (Broadway Street)

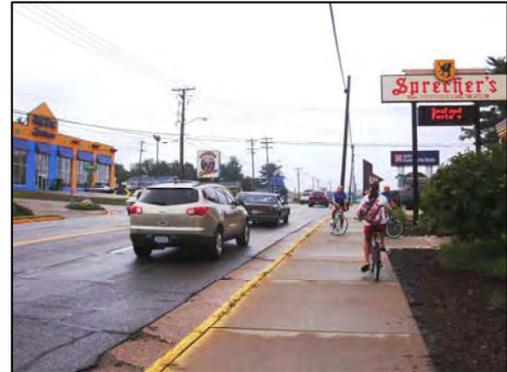
- The sidewalks are unusually close to the roadway and too narrow for shared use. Drivers have difficulty setting up for egress while needing to attend to the presence of pedestrians on the sidewalk. Moreover, numerous bicyclists compound the motorists driving task of gap seeking in moderately fast roadway

traffic. Driver expectancies are violated by bicyclists traveling on the sidewalk in the wrong direction with respect to motorists making lefts into driveways.

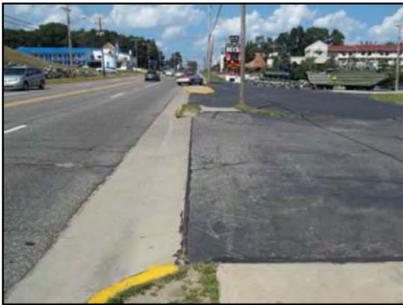
Steep grade likely influences excessive speed	D		Consider conducting a speed study to determine if the speed limit should be lowered
CTH A Intersection	Pedestrian push buttons appear to be placed backwards and are not conveniently located for pedestrians on the sidewalk	N/A	Relocate pedestrian push buttons	
	No pedestrian countdown timers	C	Install pedestrian countdown timers	
Corridor	Roadway lighting appears inconsistent and could cause nighttime vision issues	D	Based on field observation, roadway lighting should be added in the following areas: <ul style="list-style-type: none"> • North of Spring Creek crossing • Lake Avenue intersection • South of CTH A 	
	Pedestrian facilities are incomplete	E	Provide sidewalk ramps Upgrade marking for crosswalks at signalized intersections Install pedestrian countdown timers Education and training programs	
	Drivers are not yielding to pedestrians and bicycles on sidewalks. Sidewalk is inconsistent and not clearly marked. The sidewalk seems to disappear in locations with wide driveways.

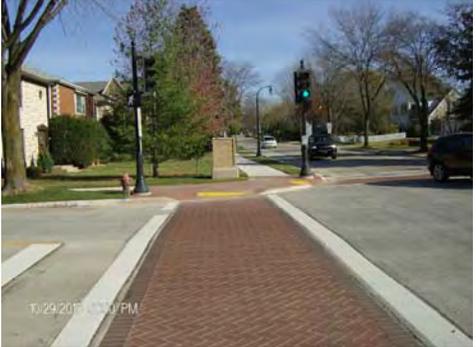
<p><i>Exhibit 5-56: Common styles of crosswalk markings used in Wisconsin.</i></p>
<p>Decorative Crosswalks Decorative crosswalks are often used to alert motorists that pedestrians may be present at these locations.</p>

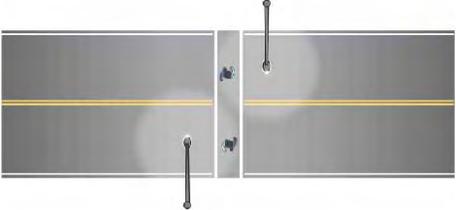
<p>In Pavement Crosswalk Lighting Lights are embedded in the pavement on both sides of the crosswalk and activated by a pedestrian push button. Long term maintenance should be evaluated and compared to other options.</p>

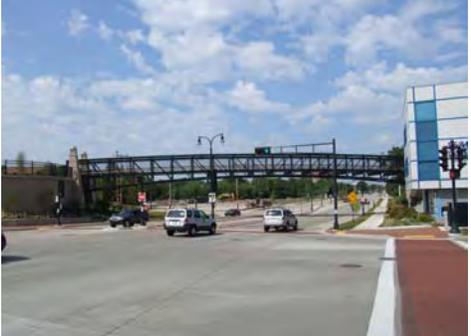
<p>Pedestrian Bridge A grade separated crossing is the safest crossing for pedestrians and bicycles.</p>

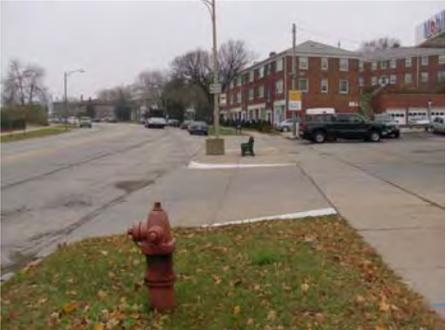
<p>Consistent Sidewalk Network Sidewalk is an off-road concrete walkway (minimum 5 foot width) to accommodate pedestrians.</p>

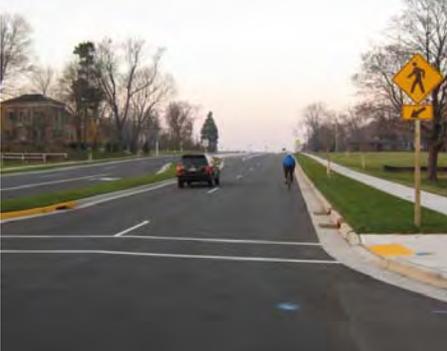
<p>On Road Bicycle Accommodations Bicycle accommodations include a wider outside travel lane (minimum 14 foot width) to accommodate bicyclists on both sides of the roadway to travel in the direction of vehicular traffic.</p>

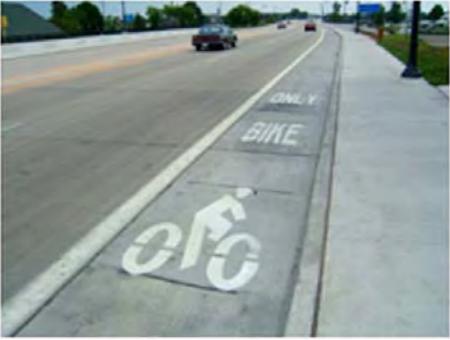
<p>Bicycle Lane A bicycle lane is a designated on-road lane (minimum 5 foot width) provided on both sides of the roadway for bicyclists to travel in the direction of vehicular traffic.</p>

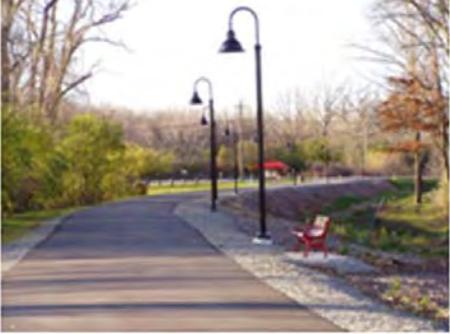
<p>Multit-Use Path (Off Road) A multi-use path is an off-road asphalt path to accommodate bidirectional pedestrian and bicycle traffic (minimum 10 foot width). It should be noted that vehicles yield to the pedestrians and bicycles in a multi-use path. Therefore, a multi-use path is not recommended in locations with a high number of access points.</p>

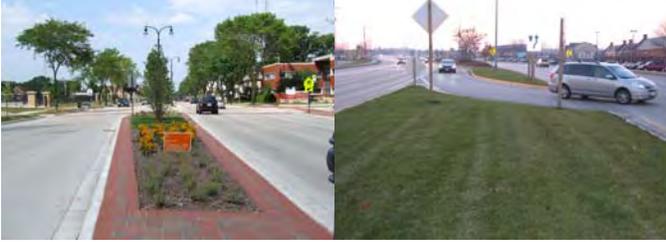
Limit direct access to major roadways	Relocate, consolidate or close driveways
Separate the number of conflict points	Proper spacing of intersections and driveways improvements safety and operations.
Remove turning vehicles from through traffic lanes	Provide exclusive turn lanes
Manage left-turn movements with a raised median. Raised medians provide greater flexibility in restricting or eliminating specific movements.

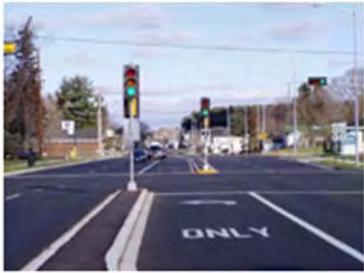
<p>Traffic Signal</p> <ul style="list-style-type: none"> • Creates gaps in traffic to improve operations at adjacent stop controlled intersections or driveways. • Specific signal timings can accommodate special event traffic. • Allows u-turns to promote access restricted by medians.

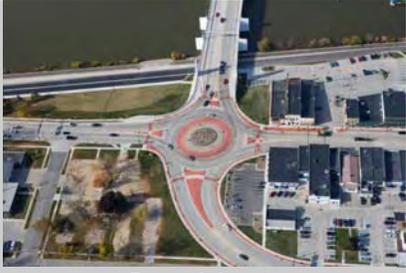
<p>Roundabout</p> <ul style="list-style-type: none"> • Fewer conflict points and slower speeds resulting in safer intersections. • Typically less delay and shorter queues than traffic signals. • Accommodates safer u-turns than traffic signals to promote access restricted by medians.

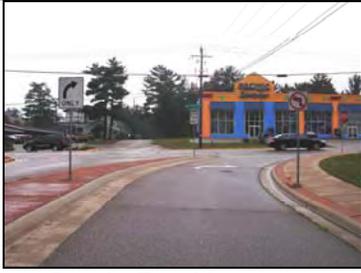
<p>Restrict Turn Movements</p>

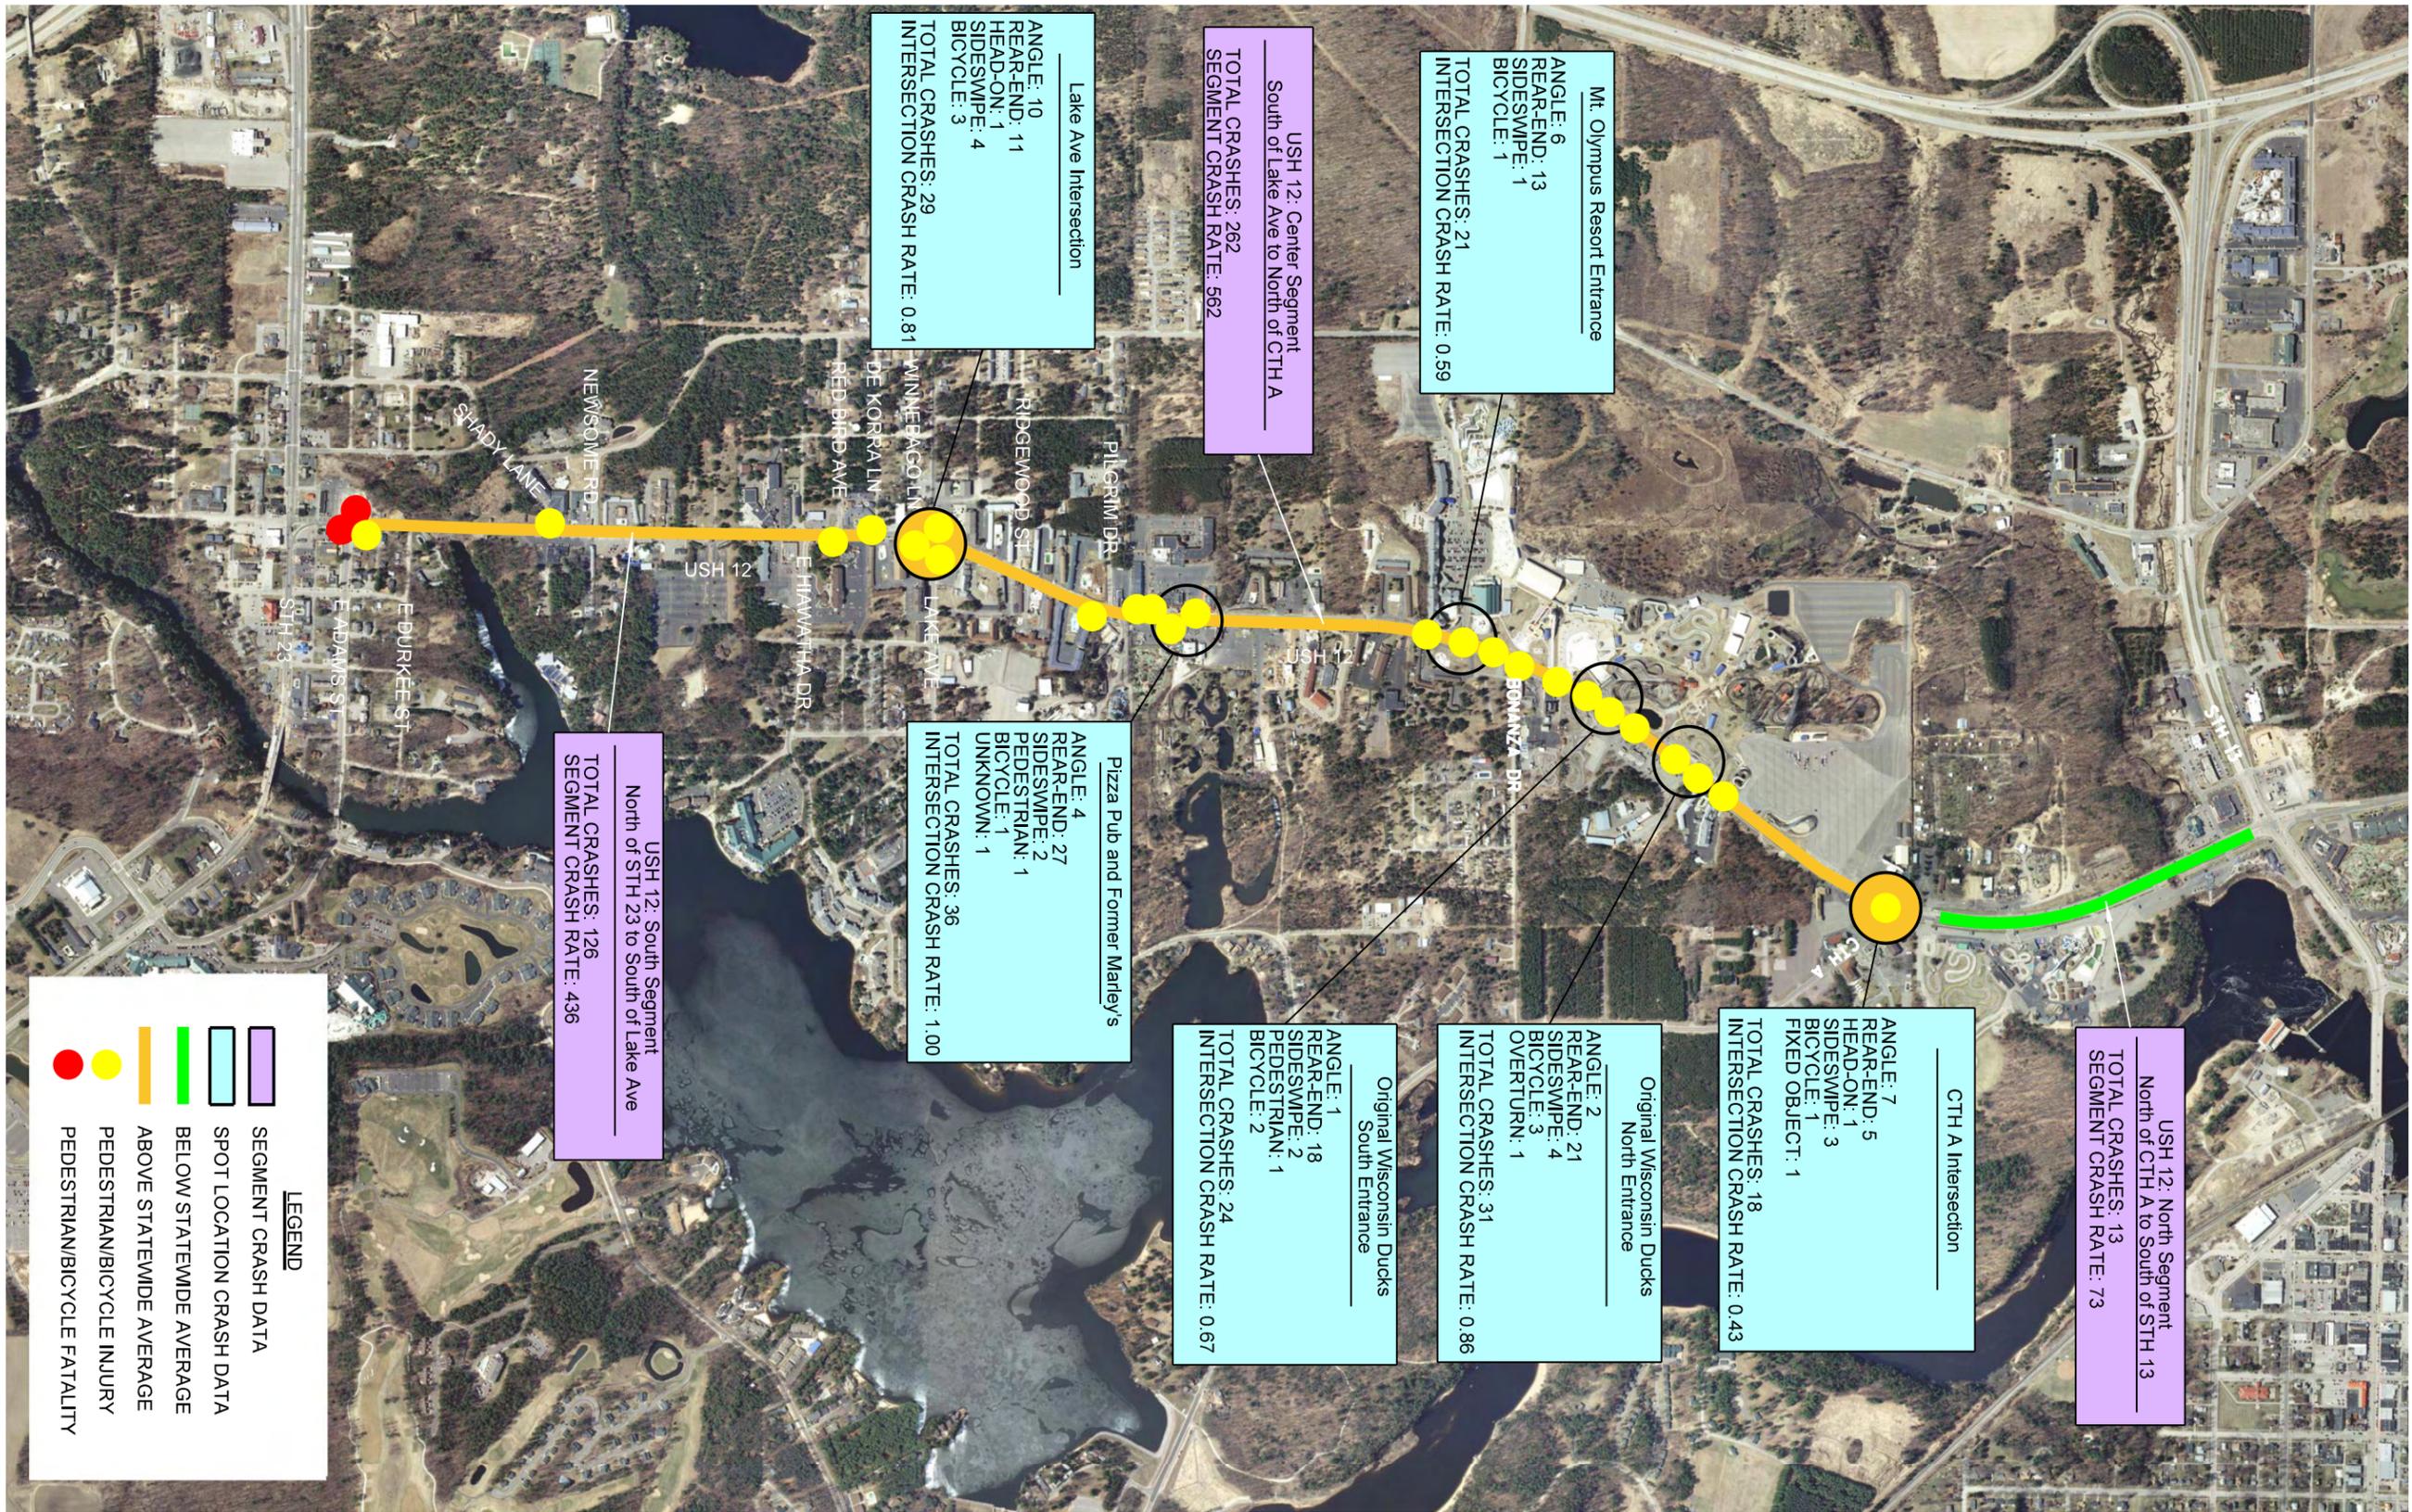
EXHIBIT 2
CORRIDOR CRASH RATES
US 12 ROAD SAFETY AUDIT
PROJECT ID 6145-01-32
SAUK COUNTY, WISCONSIN

For comparison purposes, crash rates for roadway segments are calculated in units of crashes per 100 million vehicle miles (HMVM). Table 1 summarizes the crash rate for the three roadway segments included in the study area. The roadway crash rates are also illustrated on Exhibit 2.

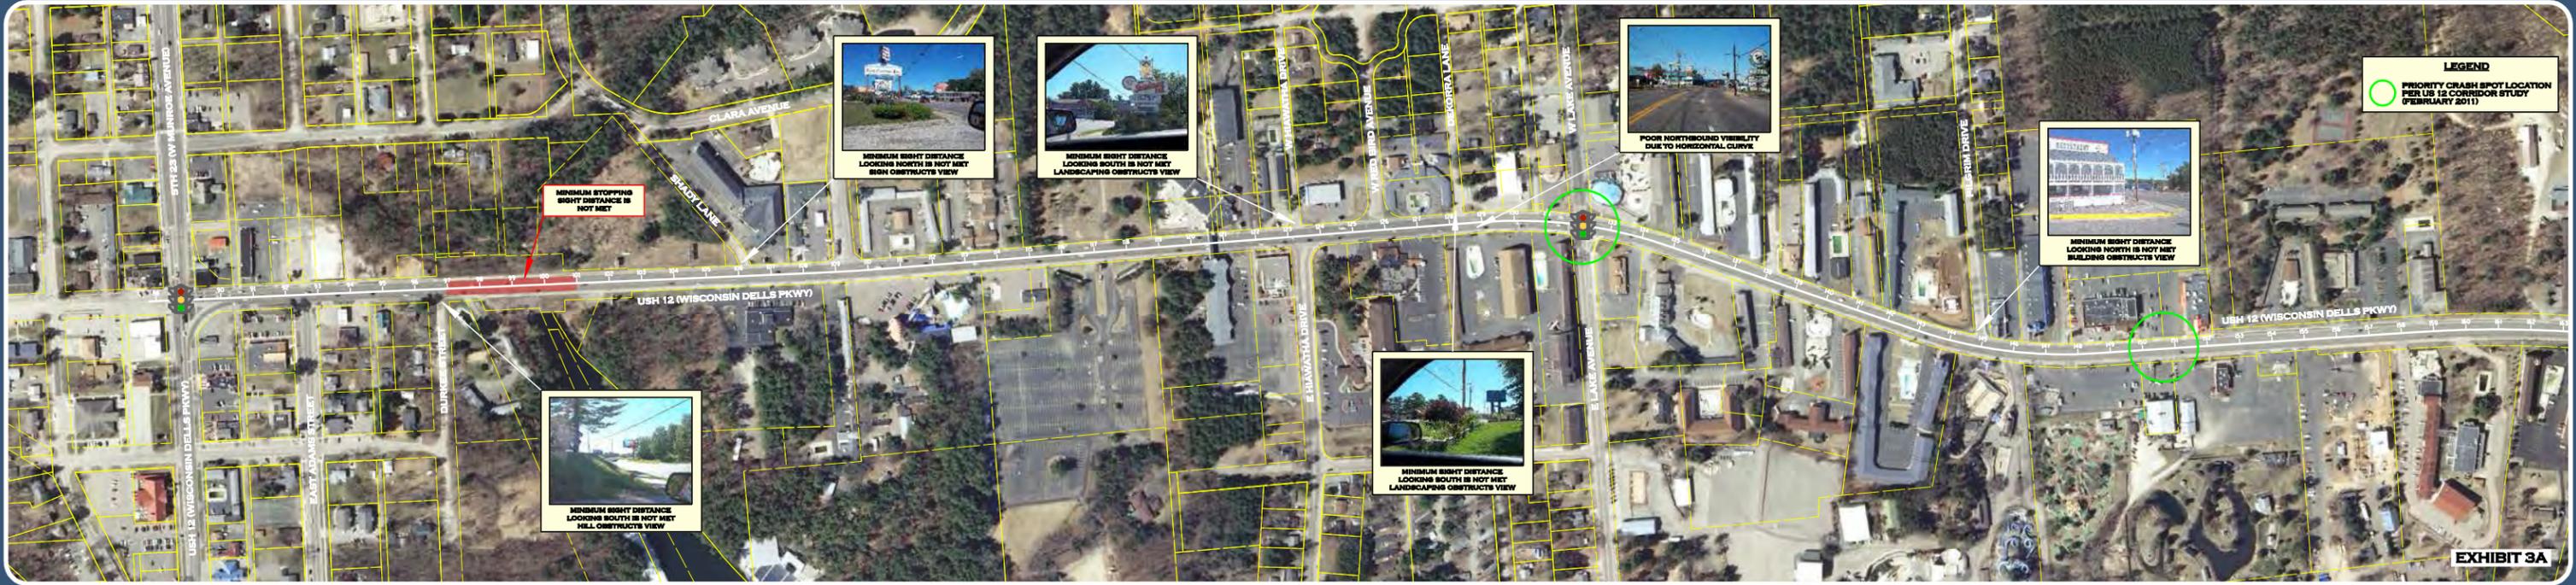
EXHIBIT 3A

EXISTING CORRIDOR DEFICIENCIES
USH 12 (Wisconsin Dells Pkwy)
 SAUK COUNTY, WISCONSIN

A summary of existing safety issues for the US 12 corridor was assembled based on the review of collision diagrams and crash history, field safety review and existing geometric deficiencies. Tables 6 and 7 summarize the safety concerns identified in the road safety audit. The existing corridor deficiencies are shown on Exhibit 3.

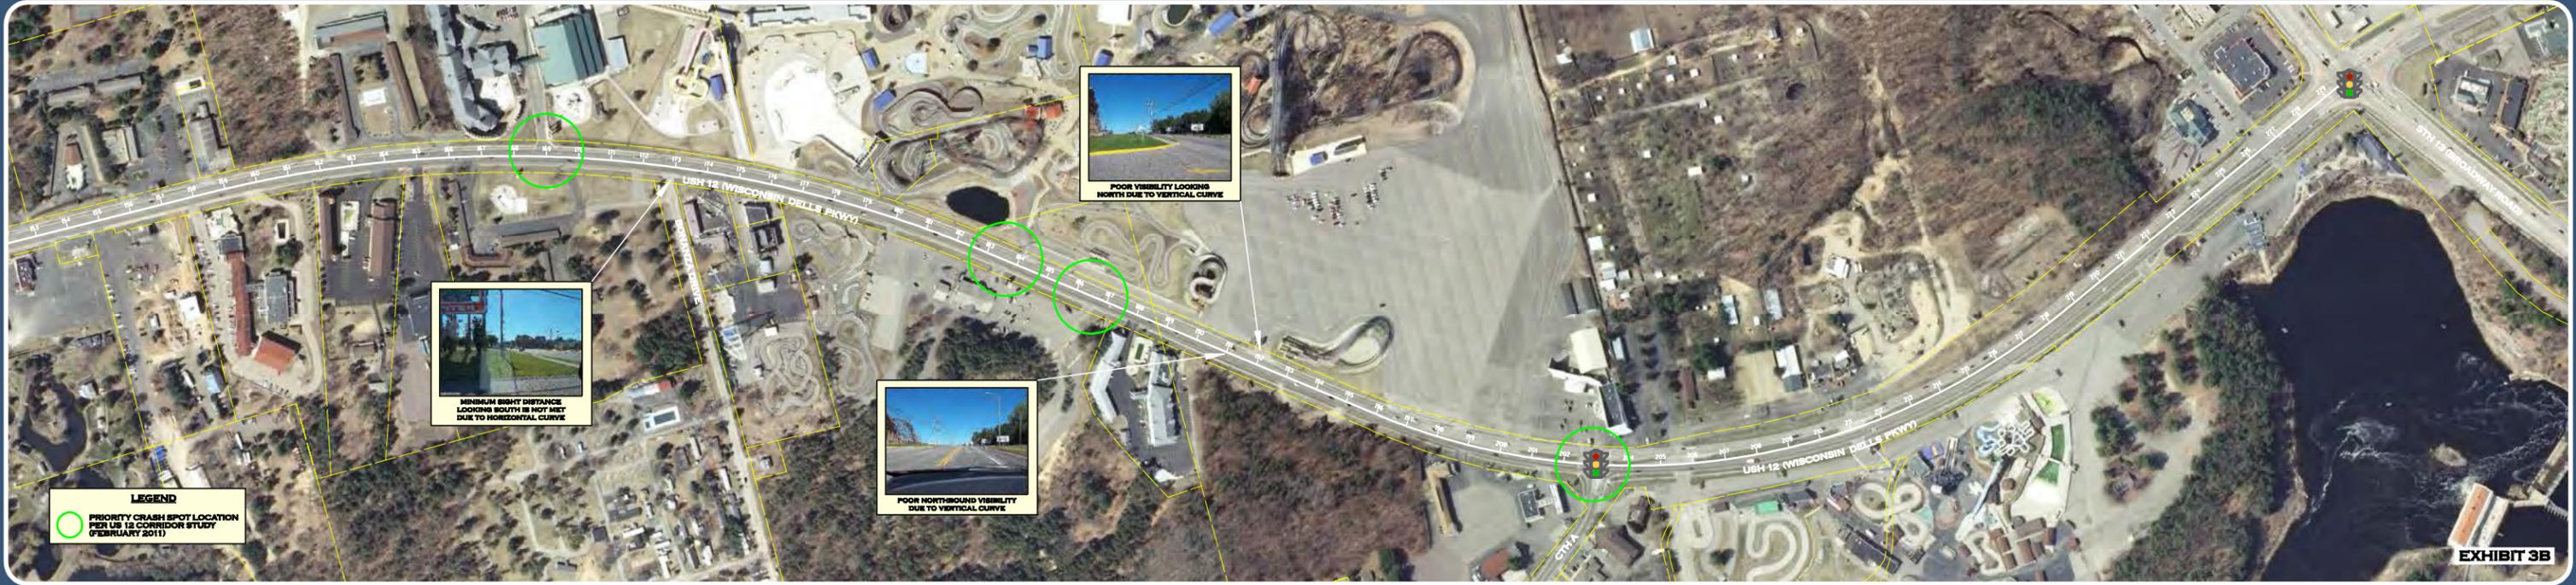
EXHIBIT 3B

EXISTING CORRIDOR DEFICIENCIES
USH 12 (WISCONSIN DELLS PKWY)
 SAUK COUNTY, WISCONSIN

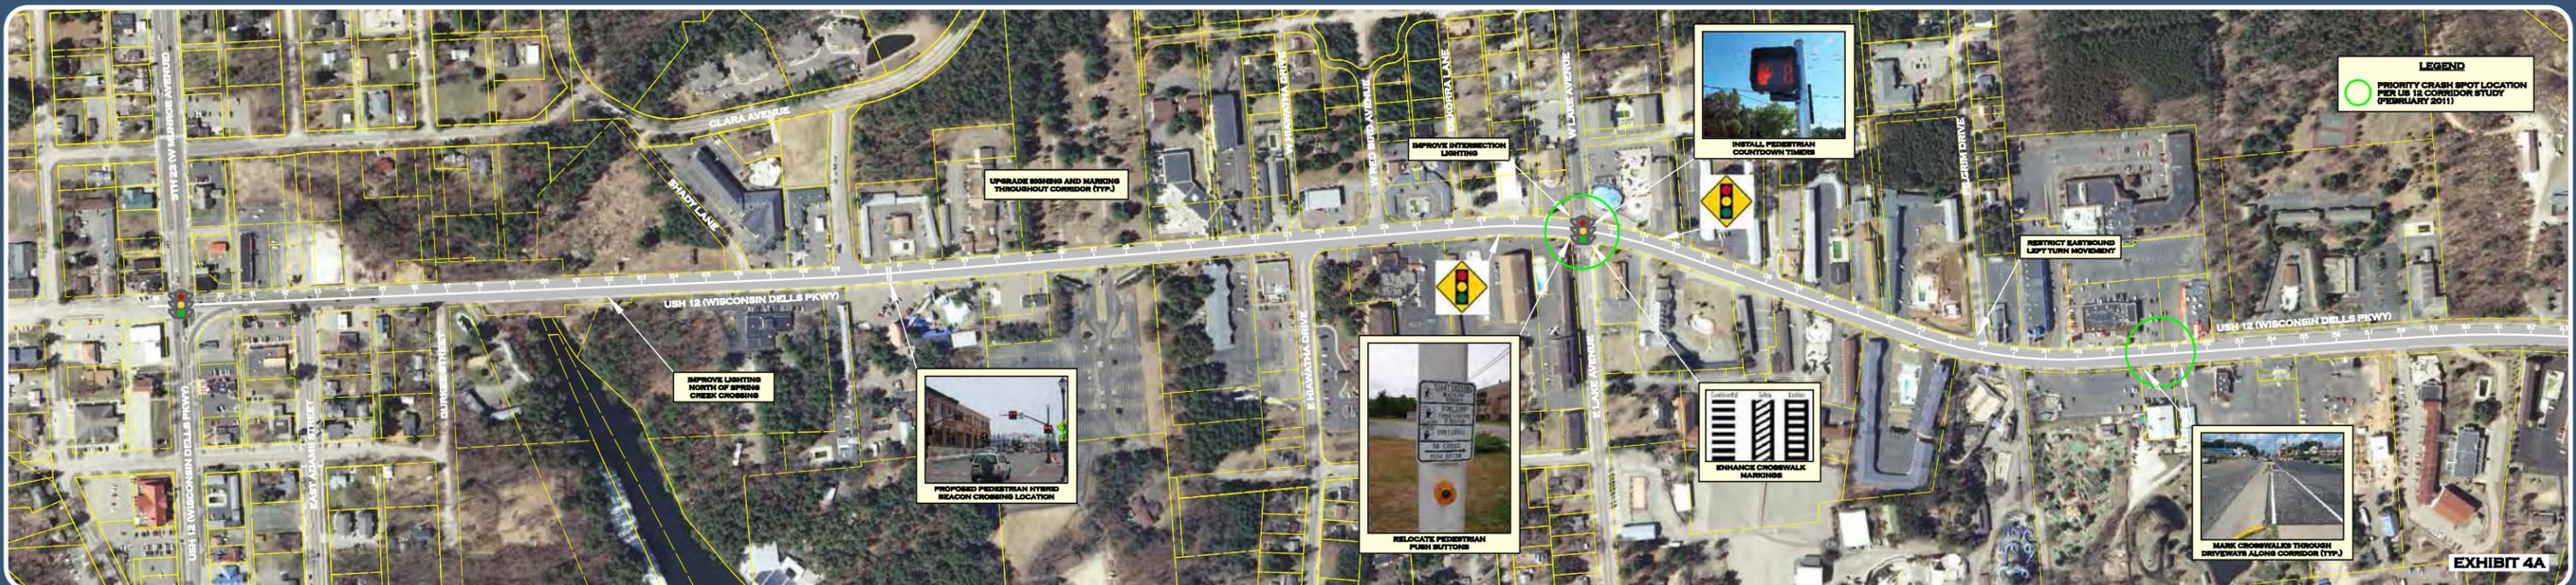
EXHIBIT 4A

UPGRADE SIGNING AND MARKING THROUGHOUT CORRIDOR (TYP.)

IMPROVE INTERSECTION LIGHTING

PROPOSED RESURFACING IMPROVEMENTS EXHIBIT
USH 12 (WISCONSIN DELLS PKWY)
 SAUK COUNTY, WISCONSIN

The recommendations for the resurfacing project are limited due to constraints (right-of-way, excavation, project schedule, etc.). The recommended improvements are listed below and shown on Exhibit 4:
