US 51 Stoughton Road Corridor Study, exhibit - Crash diagrams, Pflaum to Pierstorff

VEHICLE CRASH INVENTORY

2005 through 2008
 U.S. Highway 51
 (Stoughton Road)
 Corridor Study

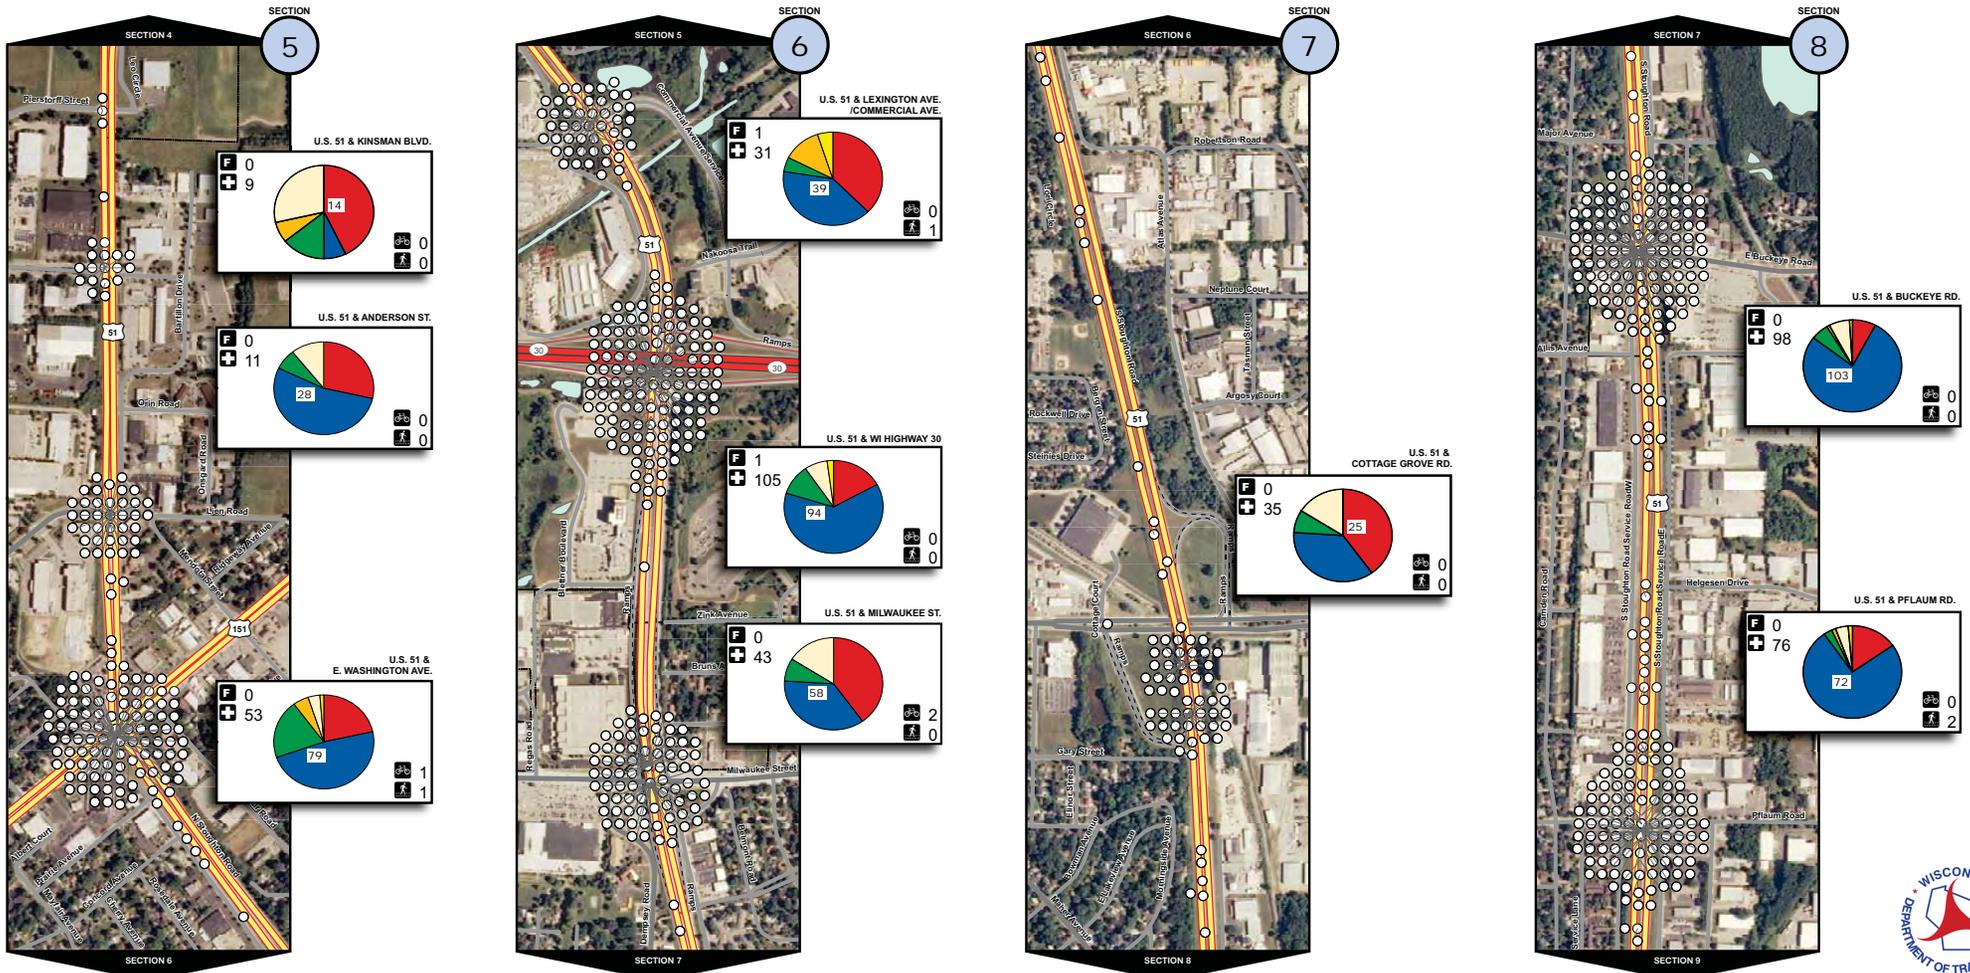
Crash data shown was provided by the Wisconsin Department of Transportation. The data shown was located on 1:100,000 base maps based on measurements from known reference points. National Map Accuracy Standards for 1:100,000 scale data specify a minimum horizontal accuracy of plus or minus 167 feet. Therefore, enlarging the data to the scale shown on this map introduces inaccuracies; therefore, crash locations shown on this map are only approximate, and should be used to evaluate relative crash density and intensity.
