# US 51 Stoughton Road Corridor Study, exhibit - Crash diagrams, Voges to Broadway

**VEHICLE CRASH INVENTORY**

2005 through 2008  
U.S. Highway 51  
(Stoughton Road)  
Corridor Study

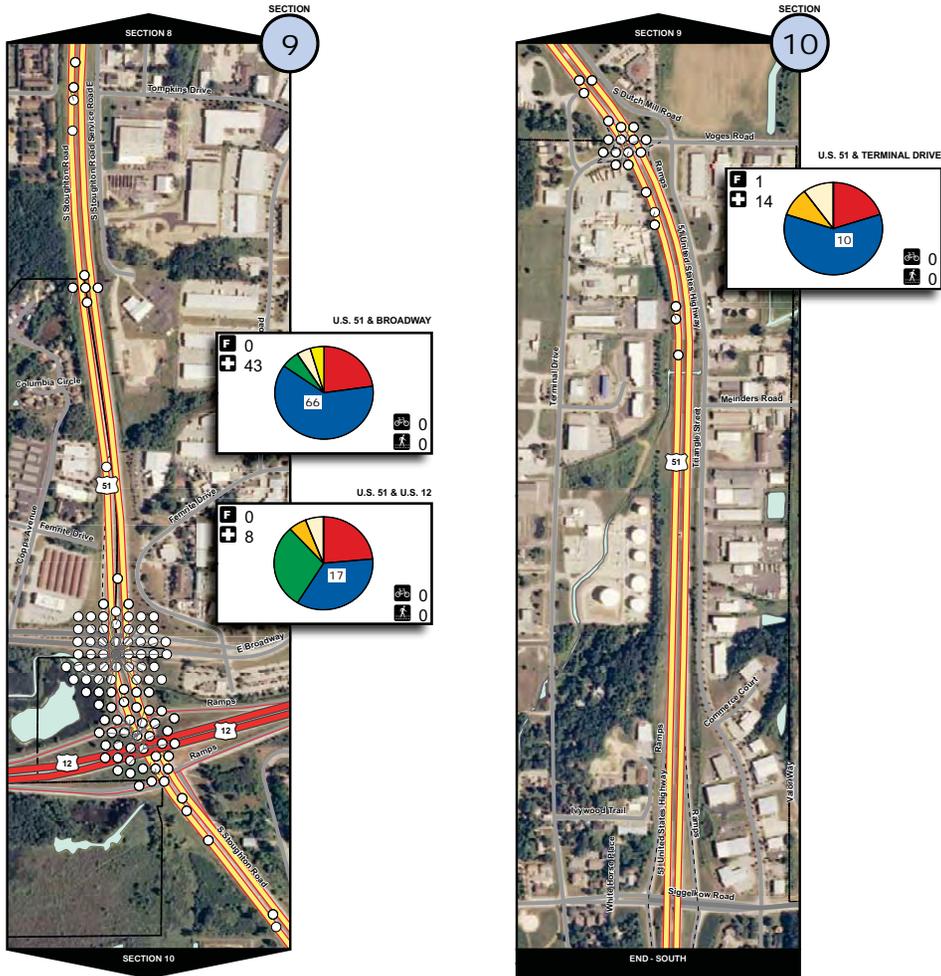
### Intersection Crash Summaries

### Crash Type

- Angle
- Rear End
- Side Swipe
- Head On
- Deer/Other Animal
- Fixed Object
- Miscellaneous

Crash data shown was provided by the Wisconsin Department of Transportation. The data shown was located on 1:100,000 base maps based on measurements from known reference points. National Map Accuracy Standards for 1:100,000 scale data specify a minimum horizontal accuracy of plus or minus 167 feet. Therefore, enlarging the data to the scale shown on this map introduces inaccuracies; therefore, crash locations shown on this map are only approximate, and should be used to evaluate relative crash density and intensity.
