Reflective Cracking between Precast Prestressed Box Girders

Western Michigan University

WisDOT ID no. 0092-14-01

June 2017

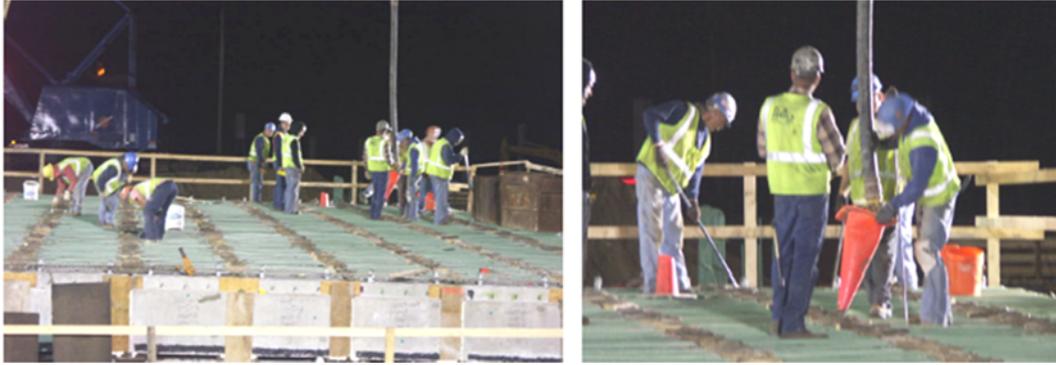
Figure 2-11. Grouting adjacent box-beam shear keys using type R-2 grout (Oakland Drive over I-94, MI)

Grout placement methods include dry packing, gravity flow (pouring), and pumping (Figure 2-11, Figure 2-12, and Figure 2-13). Dry packing is commonly used for shear keys. Moreover, grout mixed at flowable and fluid consistency can be pumped into tight spaces. The pumping process requires a leak-proof formwork that can withstand the pumping pressure. Joints are commonly sealed with a foam backer rod, which is flexible and may not be sufficient for pressure grouting.

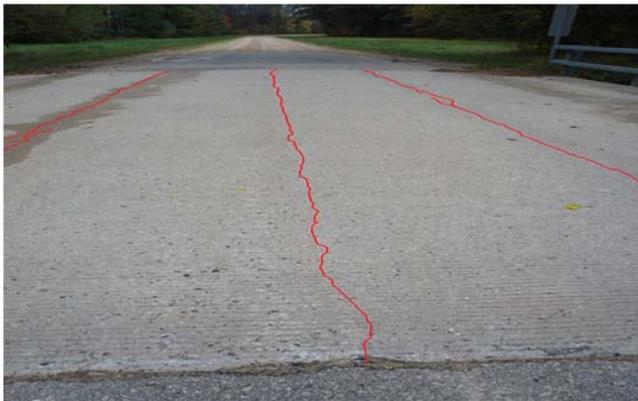
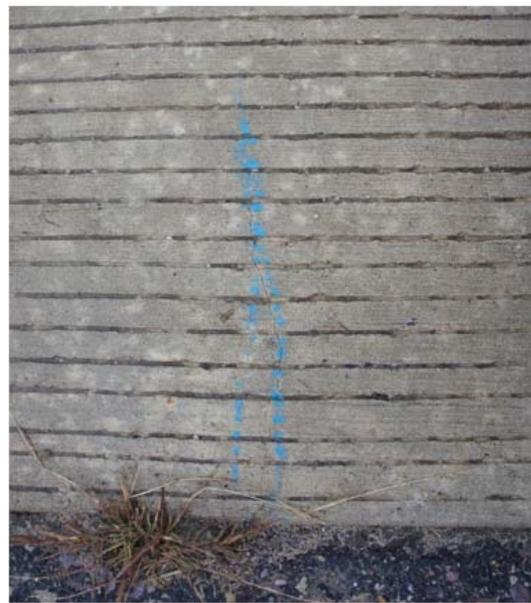
1. Irrespective of the age or the design changes, reflective cracking was documented on all the bridge decks (Figure 4-10). Where full-length reflective cracking was not present, short-length cracks directly over the piers or abutments and above the shear keys were documented. This observation verifies that the reflective cracking initiates over the supports (piers and abutments) and develops to full-length cracks under live loads. Table 4-7 summarizes the inspection data in terms of reflective deck cracking and moisture and efflorescence documented at the shear keys.

(a) Full-length reflective cracks

(b) A short crack over the abutment and above a shear key

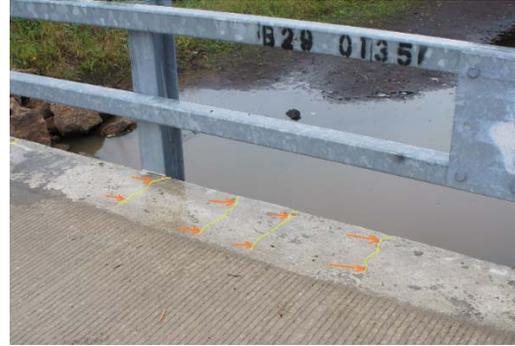
(a) Fascia beam with an integral curb

- Two different fascia beam geometries have been used since 1983. In one case, a curb is integrated into the beam geometry (Figure 4-11a). The most recent design incorporates a solid block with reinforcement detail to attach bridge railings (Figure 4-11b). Irrespective of these changes, transverse cracking was documented on the fascia beams.

(i) Fascia beam detail

(ii) Transverse cracks over the curb

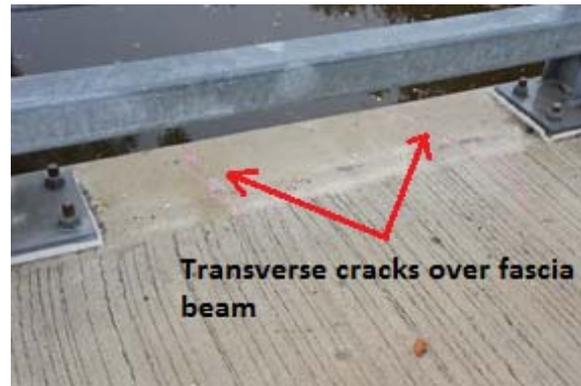
(b) Fascia beam without an integral curb but with a solid block

(i) Fascia beam detail

(ii) Transverse cracks over the fascia beam

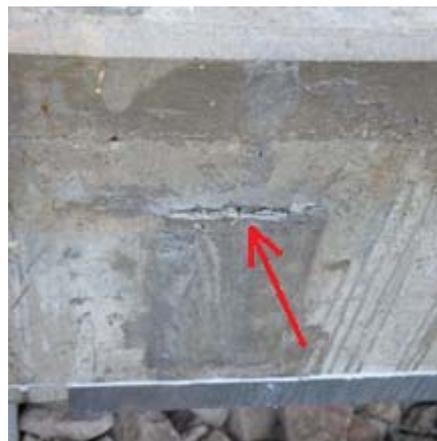
Figure 4-12. A stress pocket exposed to surface water

- The current bridge superstructure configuration permits surface water laced with deicing salts to drain over the fascia beam and into the stress pockets (Figure 4-12).

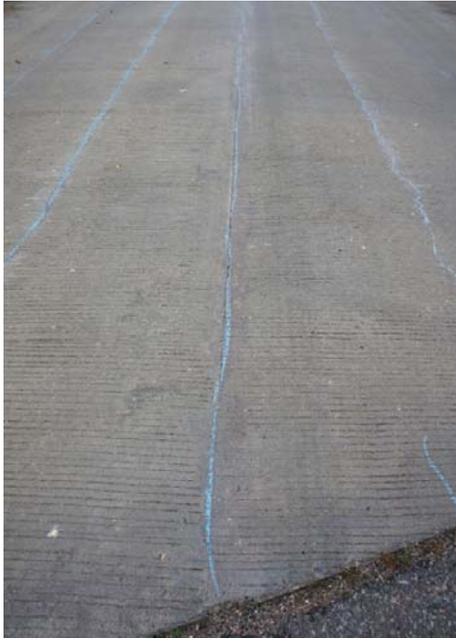
- In some bridges, the construction joint of the deck overlay was placed directly over the shear key located at the bridge centerline (Figure 4-13). This joint has not been sealed. Hence, the surface water can seep through this joint moistening the shear key and the beams.

(a) The deck overlay construction joint

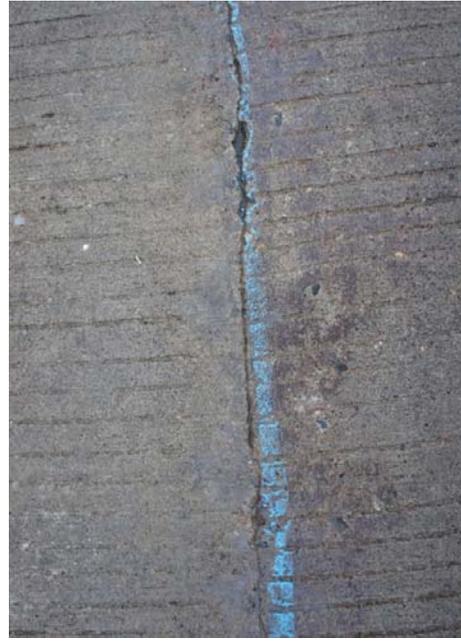
(b) Close-up view of the construction joint

Figure 4-13. The deck overlay construction joint

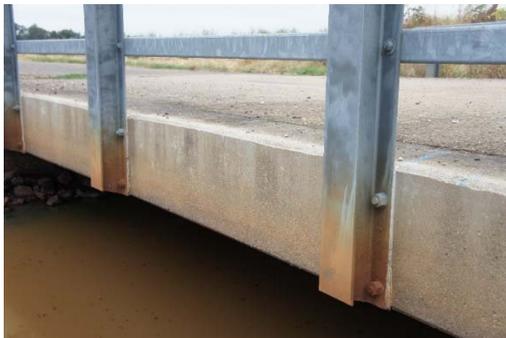
(a) Indication of flood water level

Figure 4-14. Flood water trapped inside boxes

- As shown below, the flood level had reached the superstructure of one of the inspected bridges. As a result, flood water percolated through the drains at the beam soffit. The efflorescence at the drains is an indication of the amount of water trapped inside the boxes (Figure 4-14).

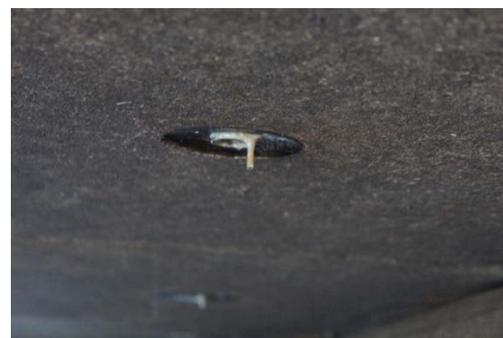
(b) Drains with moisture and efflorescence

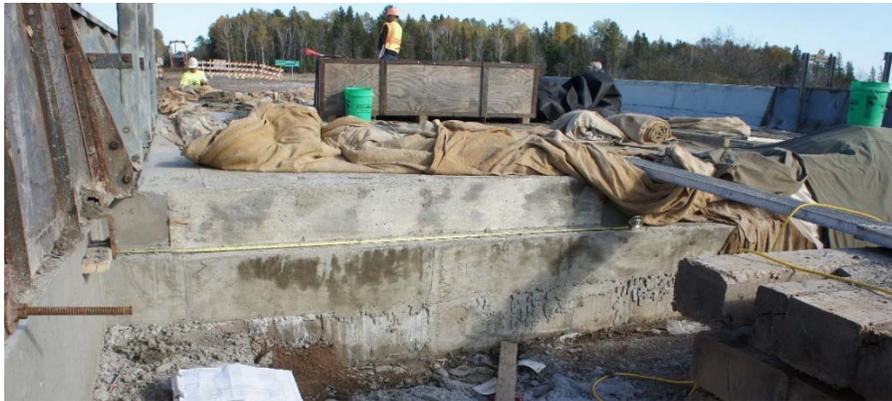
Figure 5-2. Monolithically cast end diaphragm and deck slab

As shown in Appendix F, bridge details provide two options for casting deck slab and end diaphragms: in a single operation or with two discrete operations executed within two weeks. For this project, the contractor selected the first option, and the slab and end diaphragms were poured on the 6th of October (Figure 5-2). The bridge deck was first inspected on October 10th and 11th for longitudinal cracking. Ambient temperature during these two days ranged from the mid 50’s to high 60’s in Fahrenheit while there was a rain in the morning of October 11. The slab was inspected prior to pouring the approach slab and allowed inspection of slab cross-section over the abutments. As specified in the plans, the deck was moist cured for seven days by placing a wet burlap over the entire deck and covering the burlap with a large plastic sheet and a tarp. Figure 5-3 shows a general view of the bridge.

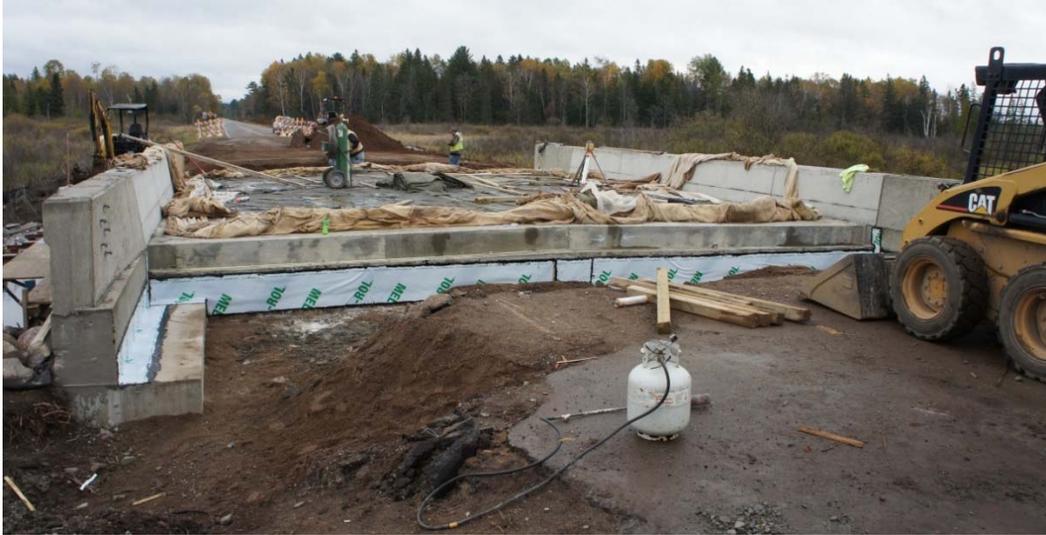
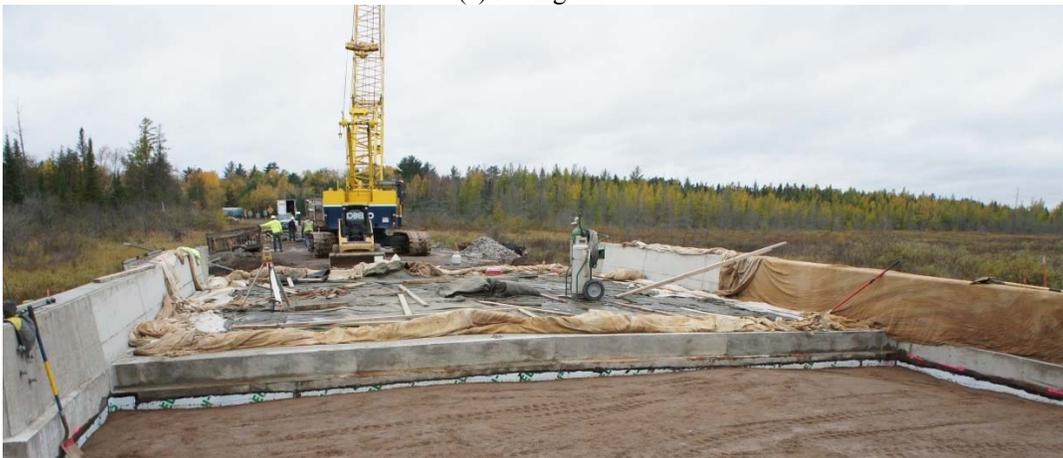
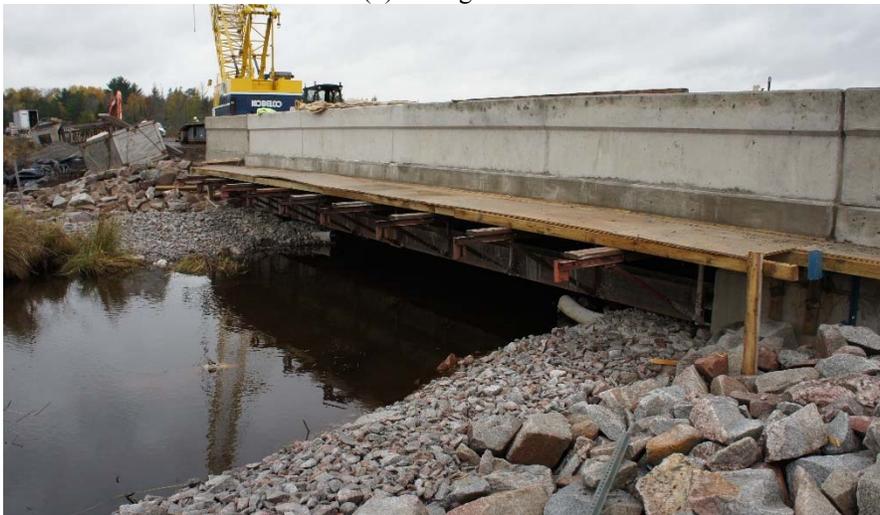
Figure 5-3. A general view of the bridge

(a) Facing east

(b) Facing west

(c) Side view

As shown in Figure 5-3c, due to site constraints, only the deck slab was inspected. Two cracks were identified over the west abutment. Both cracks had an average width of less than 0.005 inches. Figure 5-4 shows the crack locations in reference to the bridge cross-section. The first crack was located above the shear key between beam 5 and 6. Figure 5-6 documents the geometry of the crack. As shown, the crack has reached the full depth of the slab; additionally, the crack has propagated approximately 8 inches along the deck. Since the end diaphragm stem length parallel to bridge longitudinal axis is 12 inches, the crack has not propagated to the deck slab over the beams.

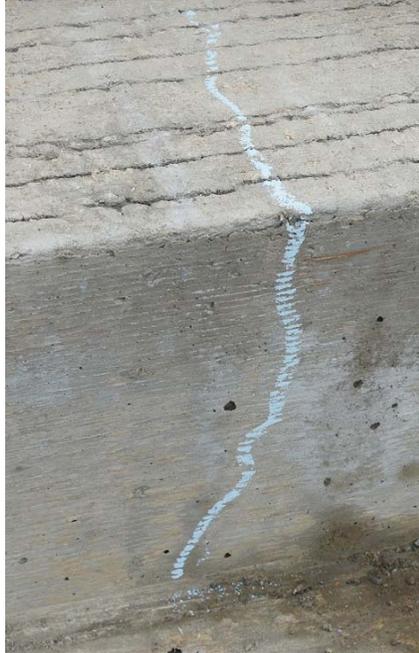
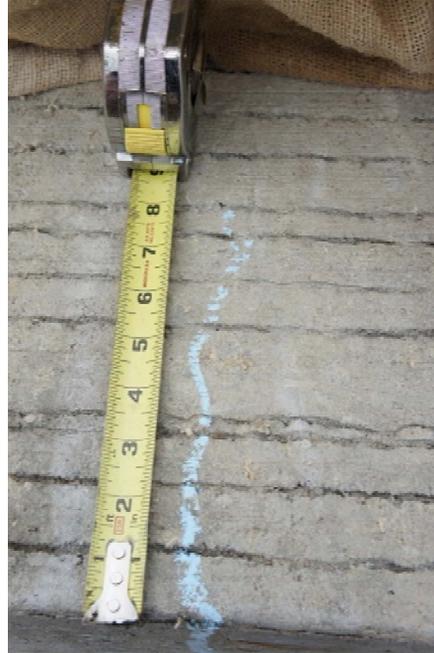
(a) Full-depth crack

(b) Crack propagation along deck

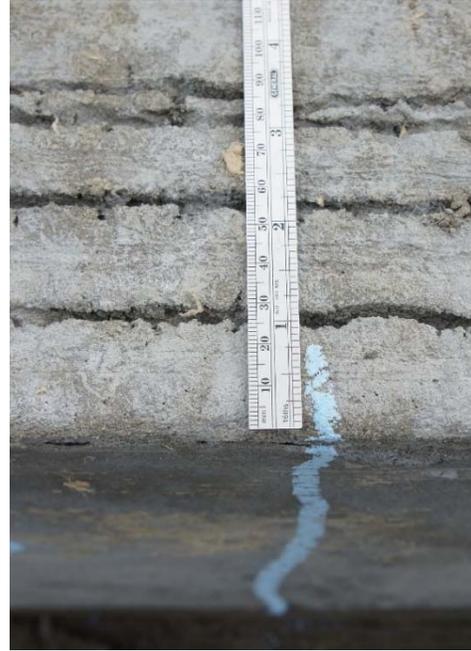
The second crack was documented above beam 2. It is located 14 inches towards beam 3 from the shear key between beams 1 and 2. The crack appeared slightly smaller, widthwise, than the other crack. This crack also had reached the full depth of the slab and had propagated approximately 2 inches along the deck (Figure 5-7 and Figure 5-8).

(a) Full-depth deck slab crack

(b) Crack propagation along deck

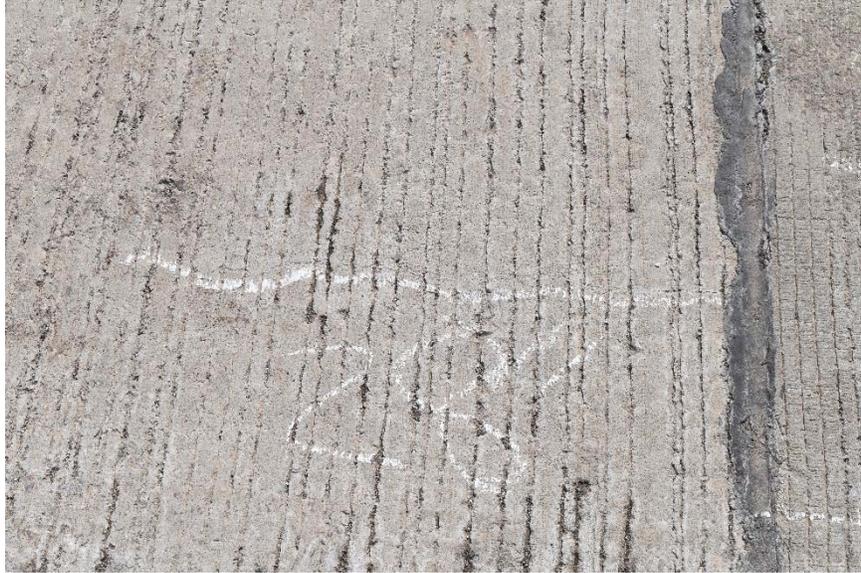
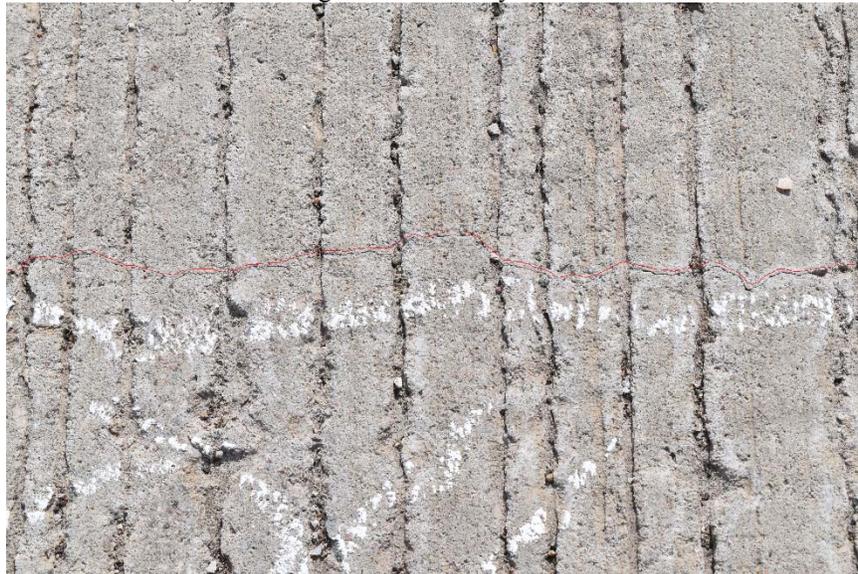
Figure 5-9. Longitudinal crack along the 4th shear key over west abutment

A follow-up inspection was conducted on March 8, 2017 (five months after initial inspection). By March, the bridge had been subjected to several months of winter weather conditions. On the day of inspection, the ambient temperature was about 20 °F but feeling much colder with high winds. A detailed summary of inspection data is presented in Appendix G. Several cracks were documented over the shear keys. The length and width of the longest crack over the west abutment was about 28 inches and 0.02 in., and located along the 4th shear key (Figure 5-9). The length and width of the longest crack over the east abutment was about 60 inches and 0.01 in., and located along the 4th shear key (Figure 5-10).

(a) Crack along the 4th shear key on west abutment

(b) A close up view of the crack

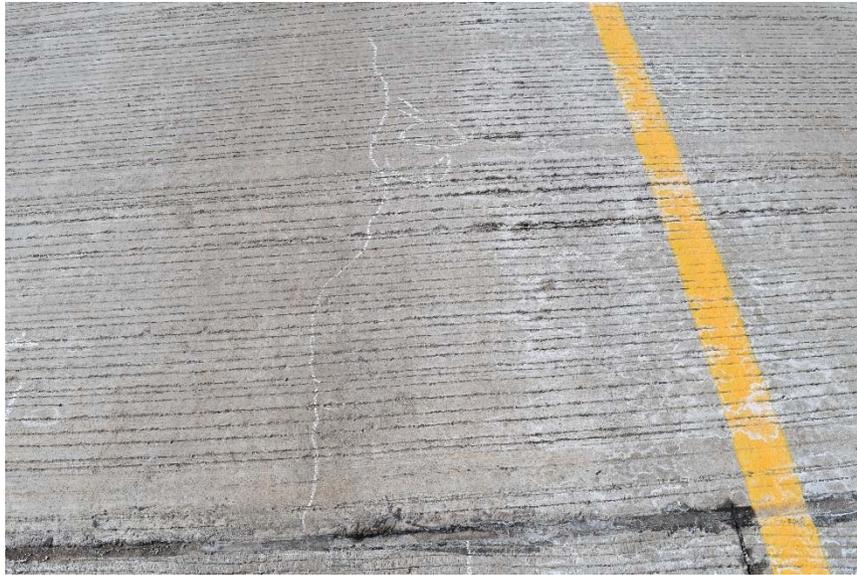
(a) Crack along the 4th shear key on east abutment

(b) A close up view of the crack

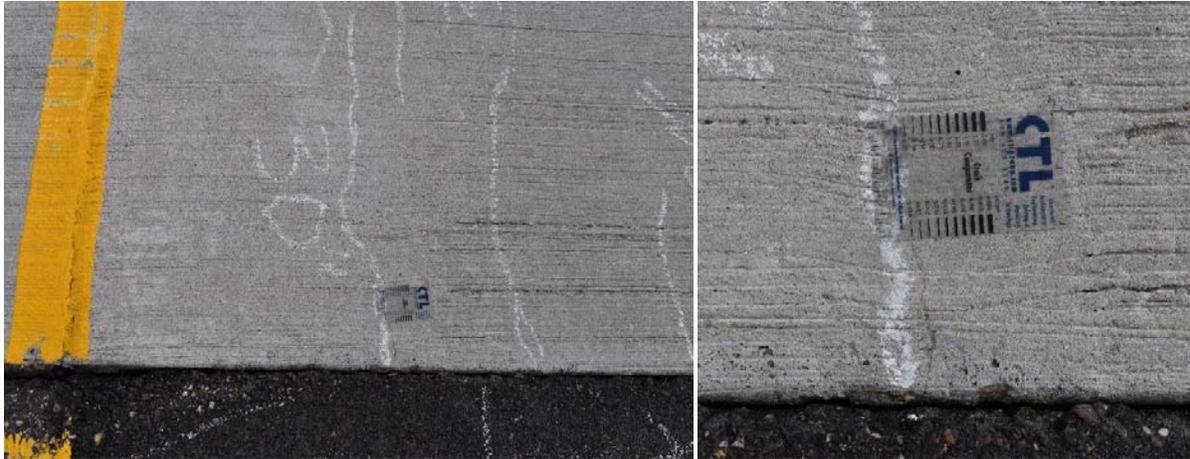
Figure 5-12. Cracks over the west abutment

A general view of the bridge is shown in Figure 5-11. Several closely spaced cracks were documented over the abutments (Figure 5-12). The width of those cracks was about 0.01 in. A few cracks with the length ranging from 24 in. to 36 in. were documented over the shear keys. Since the scope of the project is to evaluate the bridge performance in terms of longitudinal deck cracking, the large number of hairline cracks that were observed after spaying water on the bridge deck was not documented. Observation of such hairline cracks is expected with the mix design used for the overlay. Low water levels at the bridge allowed inspecting beam soffits and the shear keys. As shown in Figure 5-13, no shear key grout leak was observed.

(a) Cracks over the west abutment

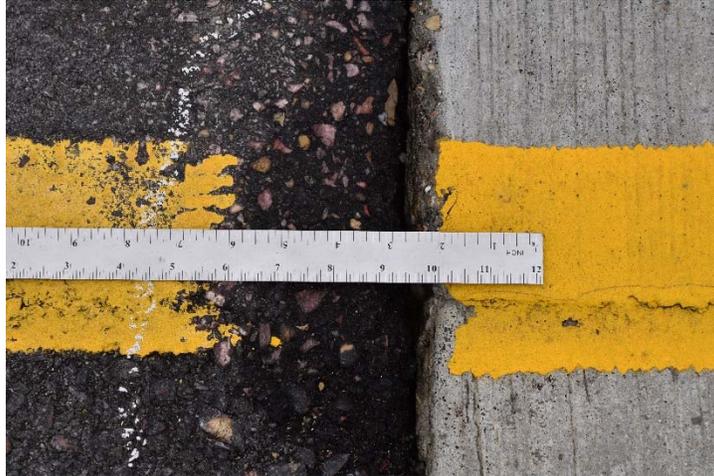
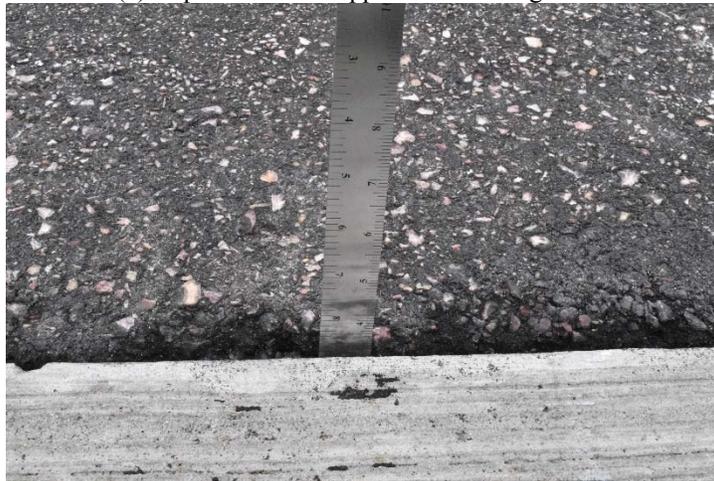
Figure 5-14. Condition of the joint between the approach and bridge deck

The other observations include the opening at the joint between approach and bridge deck (Figure 5-14) and erosion of the backfill material (Figure 5-15). A gap of about 0.25 in. wide was recorded at the joint between the approach and the bridge deck. This is expected due to contraction of bridge superstructure under cold weather conditions.

(a) Gap between the approach and bridge deck

(b) Depth of the gap (3.5 in.) between the approach and bridge deck

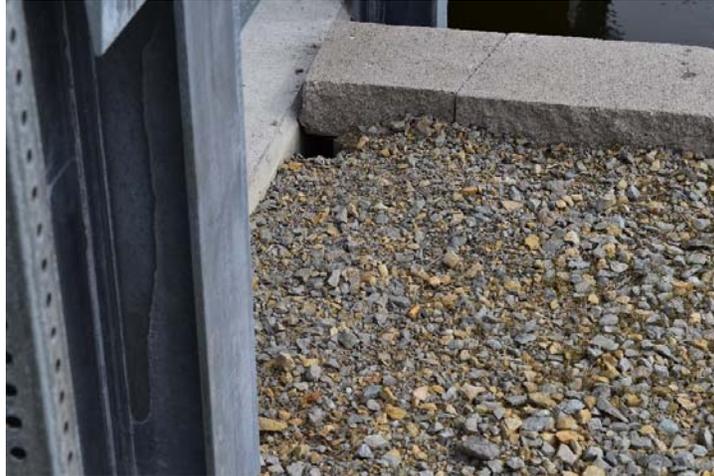
(a) Erosion of backfill material near the fascia beam

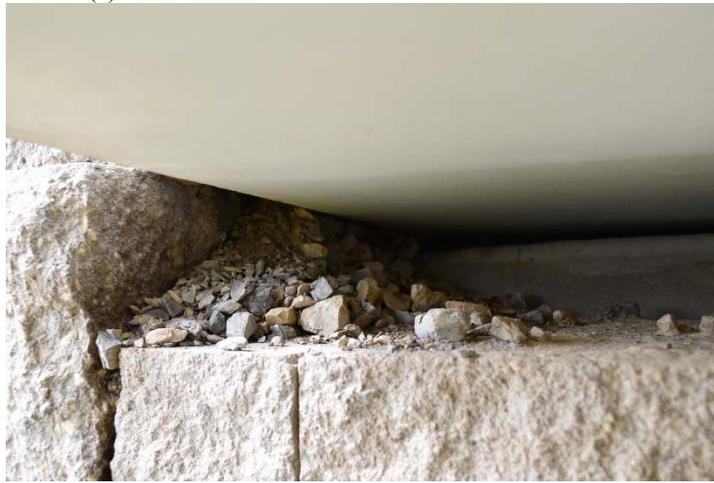
(b) Backfill material underneath the fascia beam

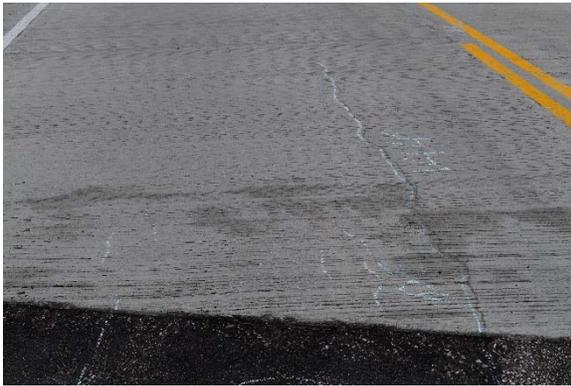
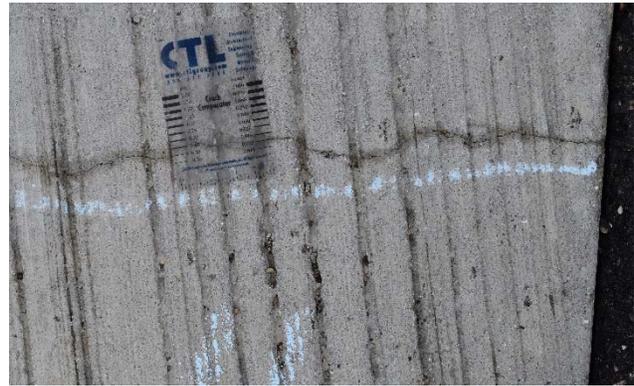
Figure 5-17. Cracks over the east abutment

A general view of the bridge is shown in Figure 5-16. A 12 ft long, 0.013 in. wide crack was documented at the east abutment and over the 3rd shear key (Figure 5-17). In addition, several short cracks were documented at both abutments. Similar to B-14-216, erosion of backfill material was observed (Figure 5-18).

(a) A 12 ft long crack over the east abutment

(b) A close up view of a crack

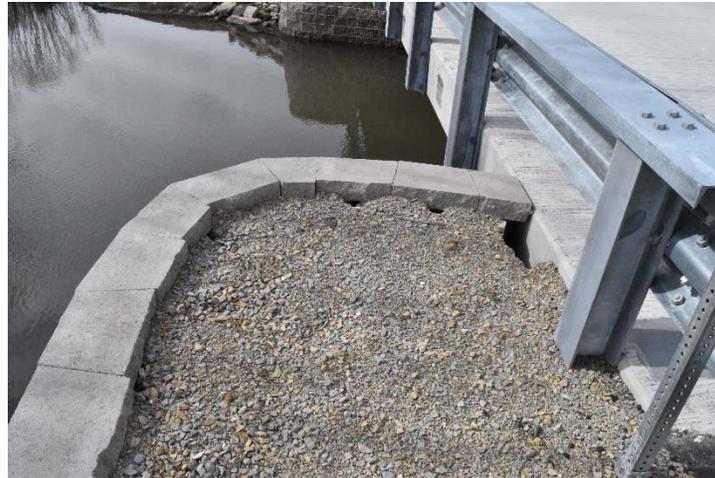
(a) Erosion of backfill material near the fascia beam

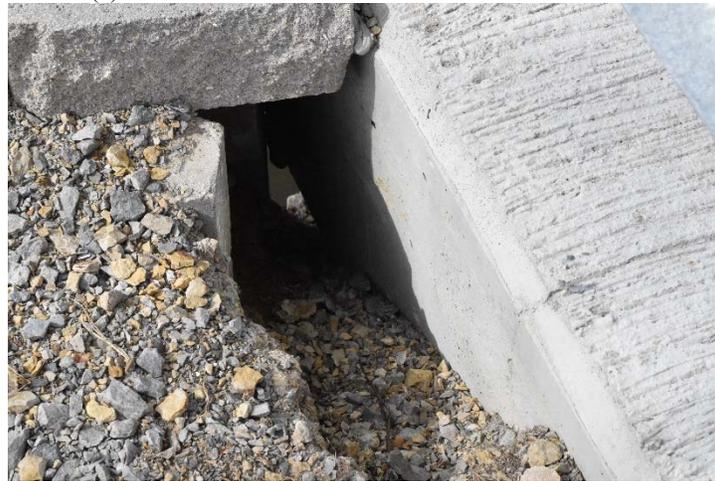
(b) A close up view

Figure 5-18. Erosion of backfill material

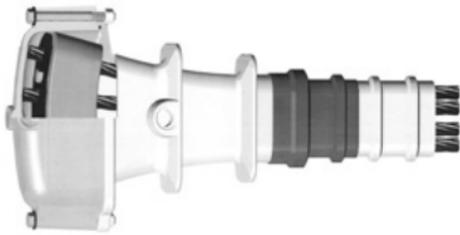
(a) Flat anchorage system

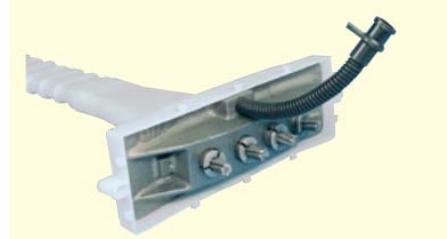
(b) Anchorage with 4 - 0.6 in. strands
