**Wisconsin Highway Research Program
0092- 02-13**

**PHASE 1: Evaluation of Interlayer Bonding In
HMA Pavements**

**PHASE 2: Effect of Stiffness Ratio on Slippage
Cracking Due to Interlayer Bonding Failure in
Hot Mix Asphalt Pavements**

Final Report

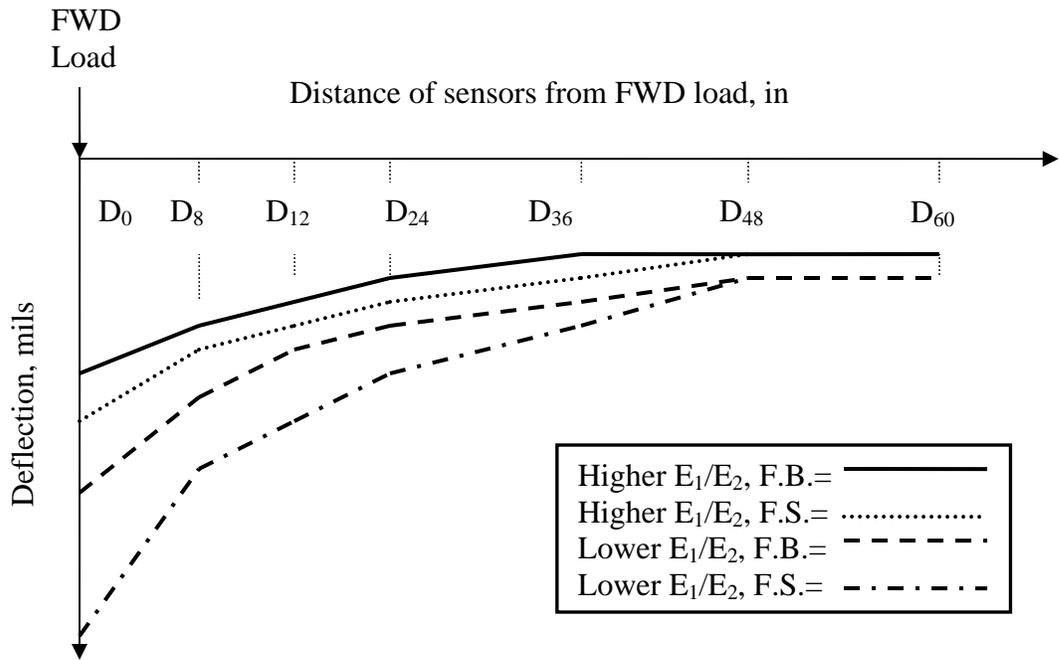
Figure 1: Schematic diagram for the measured deflection due to the FWD load for the full bond (F.B.) and the full slip (F.S.) interface conditions.

FWD data can be used to estimate the stiffness of the pavement layer for both no distress and high distress sections. This estimation of the stiffness of the layers can be performed through a method called backcalculation. Based on the measured surface deflections, the backcalculation programs determine the pavement layer stiffness. For the same FWD load, the deflections of the high distress sections (fully slipped, F.S.) are higher than that of the no distress sections (fully bonded, F.B.), which is shown schematically in Figure 1. The deflection sensors along with the distance from the center are shown in Figure 1.

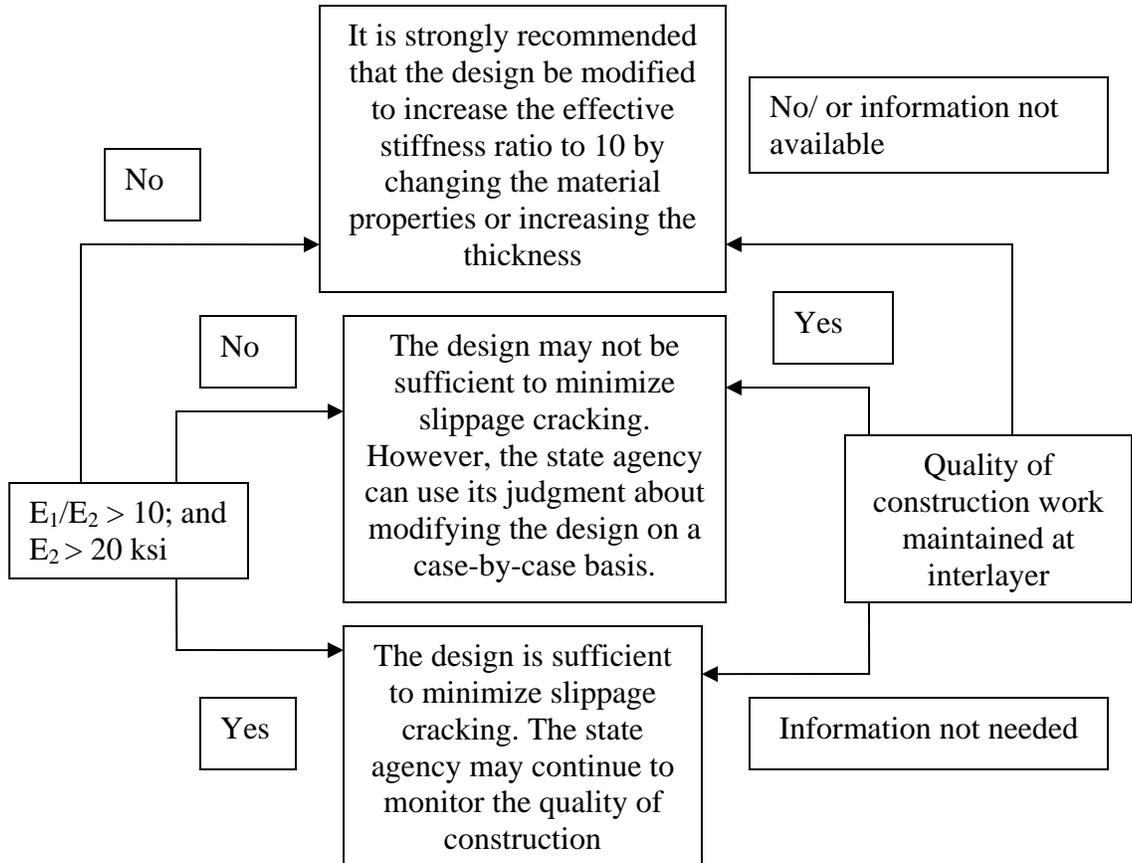
Figure 2: Recommendation to the state agency for minimizing slippage failure.

interlayer bonding failure. In this analysis it was observed that higher E_1/E_2 ($E_1/E_2 > 10$ and $E_2 > 20$ ksi) consistently showed better interlayer bonding performance. The significance of this study for the state agency is described as a flow chart, as shown in Figure 2.

During pavement design, the designer may calculate a certain stiffness ratio necessary for the pavement to last the design life for the given traffic, the subgrade, and the environmental conditions. However, if the designer requires a stiffness ratio less than 10, there may be a possibility of slippage failure if proper construction practices are not followed. To minimize this probability it might be advisable to invest earlier during construction by providing a minimum E_1/E_2 of 10. Low stiffness ratio ($E_1/E_2 < 10$) may give an economical design but there may be a greater probability of slippage at low stiffness ratios; if the contractors do a bad job or the quality of the work is not maintained. It will be expensive to reconstruct the slipped pavement once the slippage has happened.

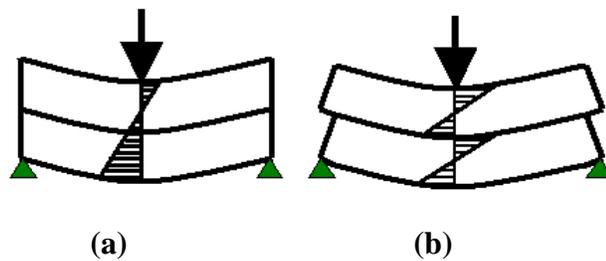
Figure 1.1: Failure Mechanism: (Gomba, et al., 2004).
(a) Fully Bonded Pavement Acting as One System
(b) Fully Slipped Pavement Acting as Two Systems

between the two layers (Shahin et al., 1987). The surface layer must be able to withstand traffic loads and resulting strains on its own for a fully slipped section. The upper layer should be sufficiently stiff or thick for two reasons: (1) to minimize the strains at the interlayer and (2) to enable the layer to resist applied strains if the layer slips and separates from the lower layer. Thus the pavement structure influences the effect of slip between layers. Structures with very stiff or very thick surface layers may experience low effect of slips (Gomba, et al., 2004). Pavement structures with higher surface stiffness compared to the layer below (higher stiffness ratio) will withstand much of the load itself than that of pavements with a lower stiffness ratio due to better load distribution. As a result of this, the effect of interlayer bonding failure is minimal for a higher stiffness ratio as compared to a lower stiffness ratio. This study focuses on providing an appropriate stiffness ratio between the top two layers to minimize the impact of slippage.

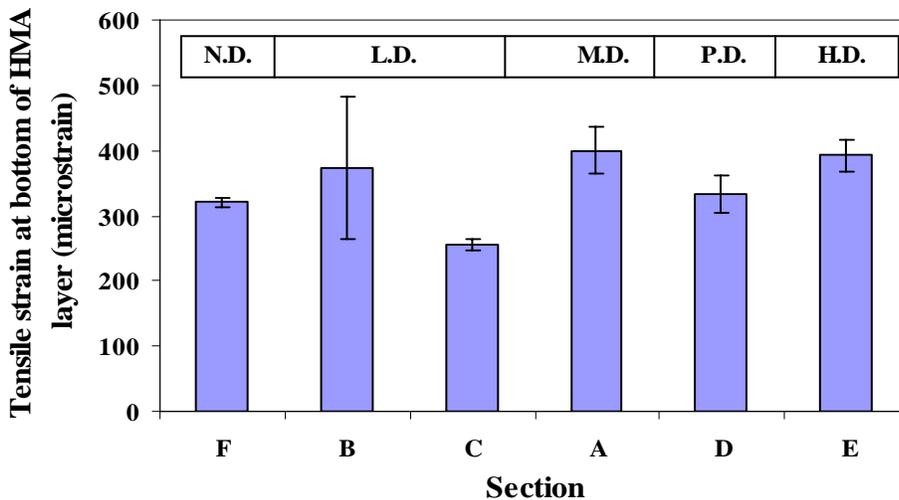
Figure 3.2. Tensile strain at the bottom of the HMA layer (ϵ_{AC}) vs. sections (USH 18)

Although sections B, A, and E are L.D, M.D., and H.D. sections respectively, the average tensile strain (with 95% confidence interval) at the bottom of the HMA layer of section B, A, and E are similar, which is shown as Figure 3.2. Both sections B and C are L.D. sections but the average tensile strain at the bottom of the HMA layer are not similar.

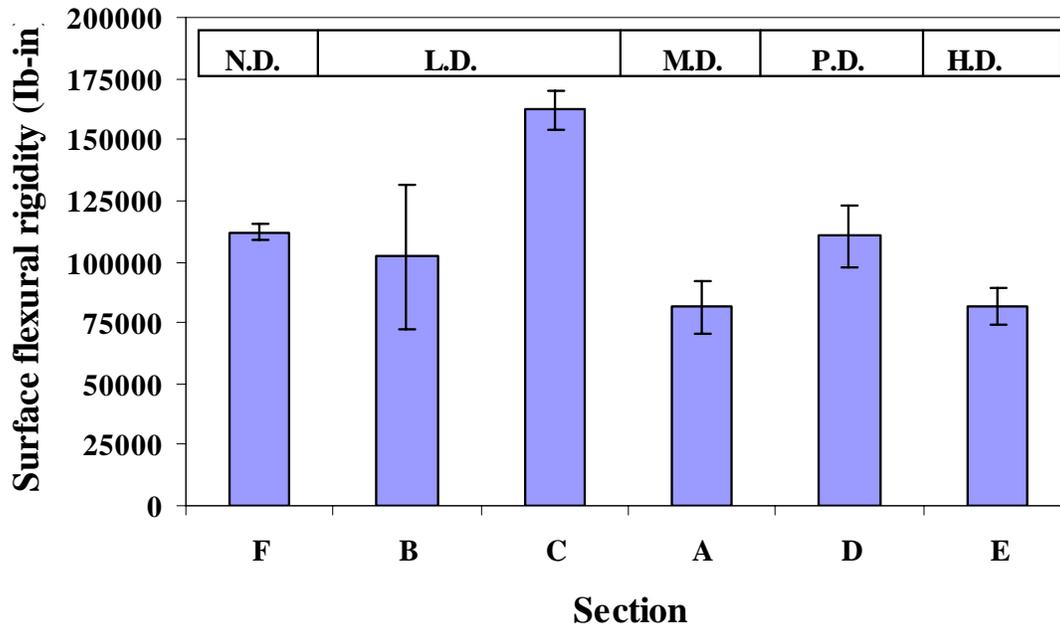
Figure 3.6. Surface flexural rigidity vs. sections (USH 18)

Both sections B and C of USH 18 are low distress sections but the average surface flexural rigidity of sections B and C are not similar, which is shown as Figure 3.6. The average surface flexural rigidity of sections A and E are similar, although sections A and E are M.D. and H.D. sections respectively.

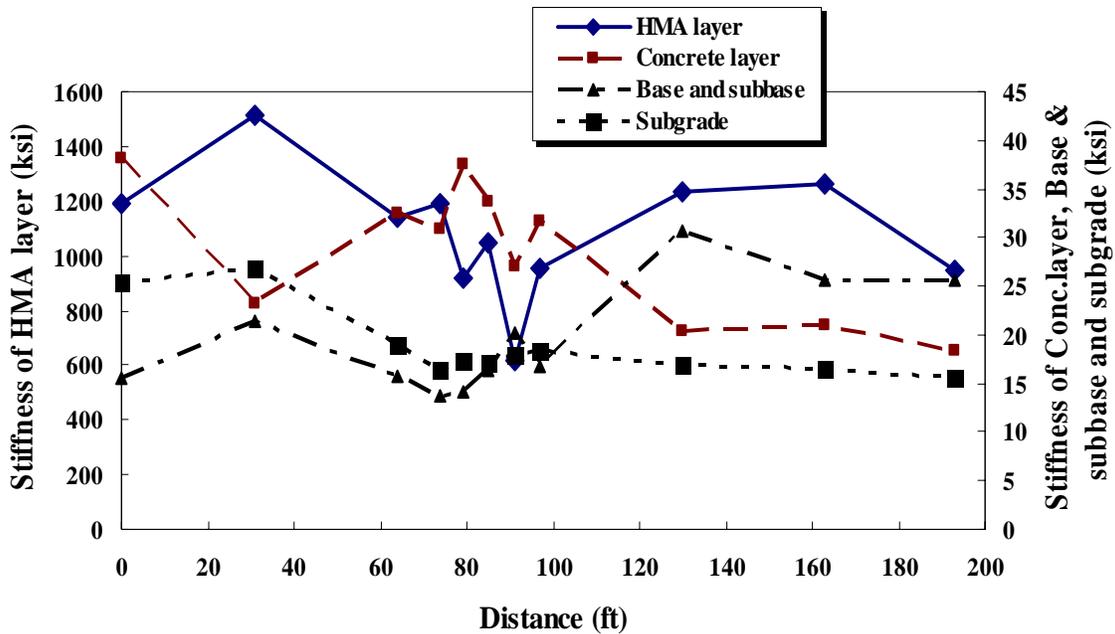
Figure 4.1. Stiffness vs. distance (N.D, I-94 EB, F.B., actual)

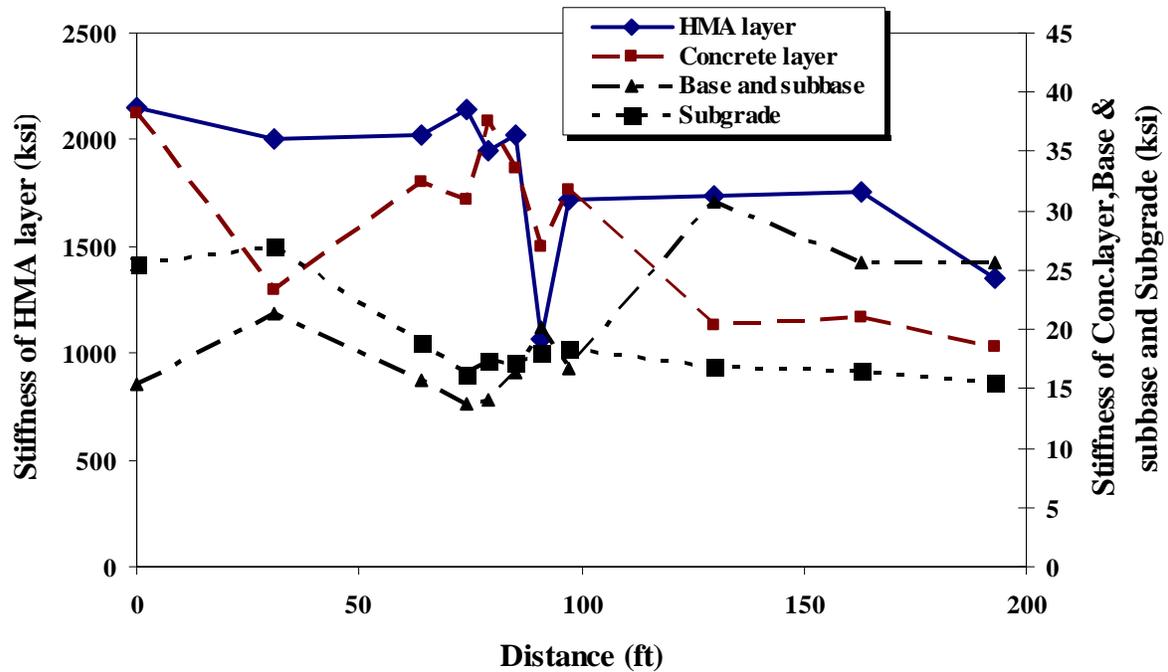
Figure 4.2. Stiffness vs. distance (N.D, I-94 EB, F.S., assumption)

Initially the stiffness of all the layers were allowed to be calculated by the program in full slip assumption. However, this leads to the stiffness of the HMA for the full slip assumption which was a lot lower than the full bond condition. The concrete layer showed an exactly reverse trend (swapping was occurring). In some cases there was swapping between the concrete layer and the combined base and the subbase layer. These results appeared to show that the values were counterintuitive and hence incorrect. To avoid this problem, the lower layers were kept constant between the full bond condition and the full slip assumption. Even though, their stiffness values may not be similar, their assumptions were realistic in-lieu of the trends observed between the layers when they were allowed to be calculated by the program. The stiffness of all layers of section A (N.D.) for the full slip assumption is shown in Figure 4.2.

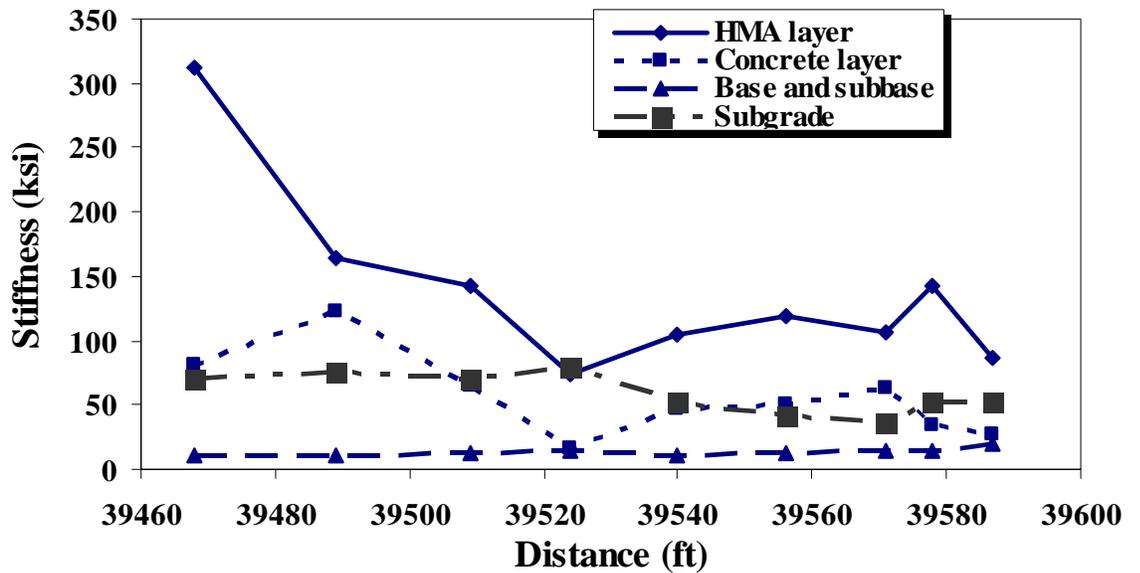
Figure 4.3. Stiffness vs. distance (H.D. I-94 EB, F.S., actual)

The stiffness of all the layers of section E (H.D.) for the full slip condition and the full bond assumptions are shown in Figures 4.3 and 4.4, respectively.

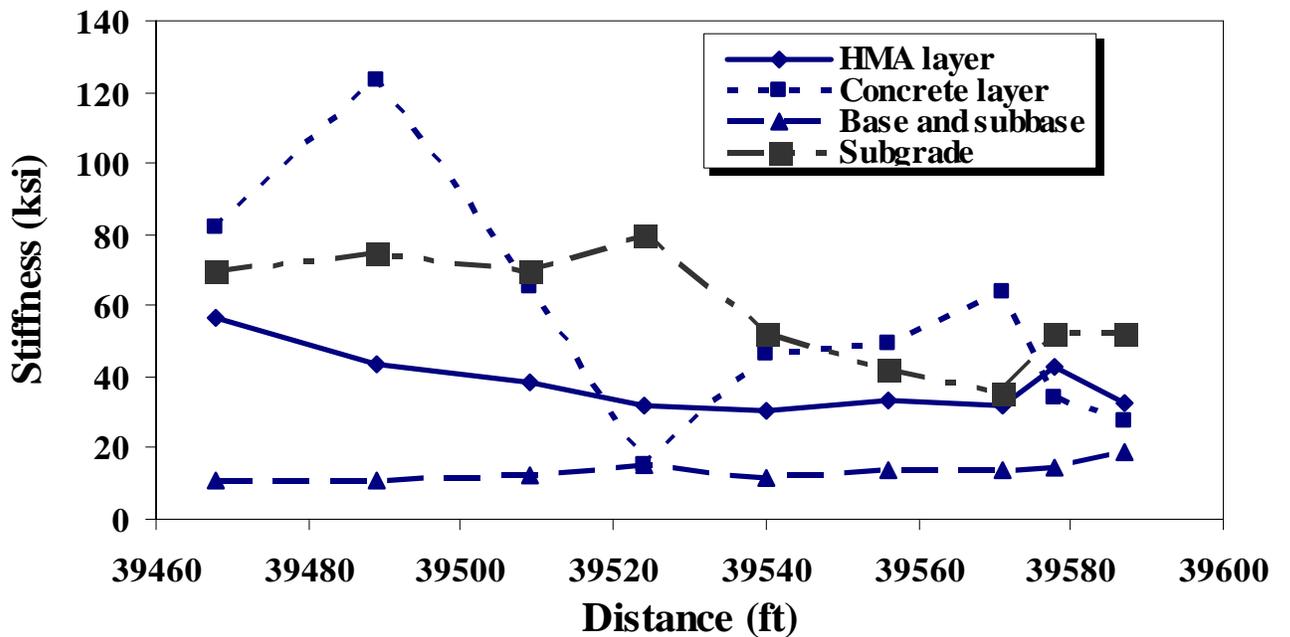
Figure 4.4. Stiffness vs. distance (H.D. I-94 EB, F.B., assumption)

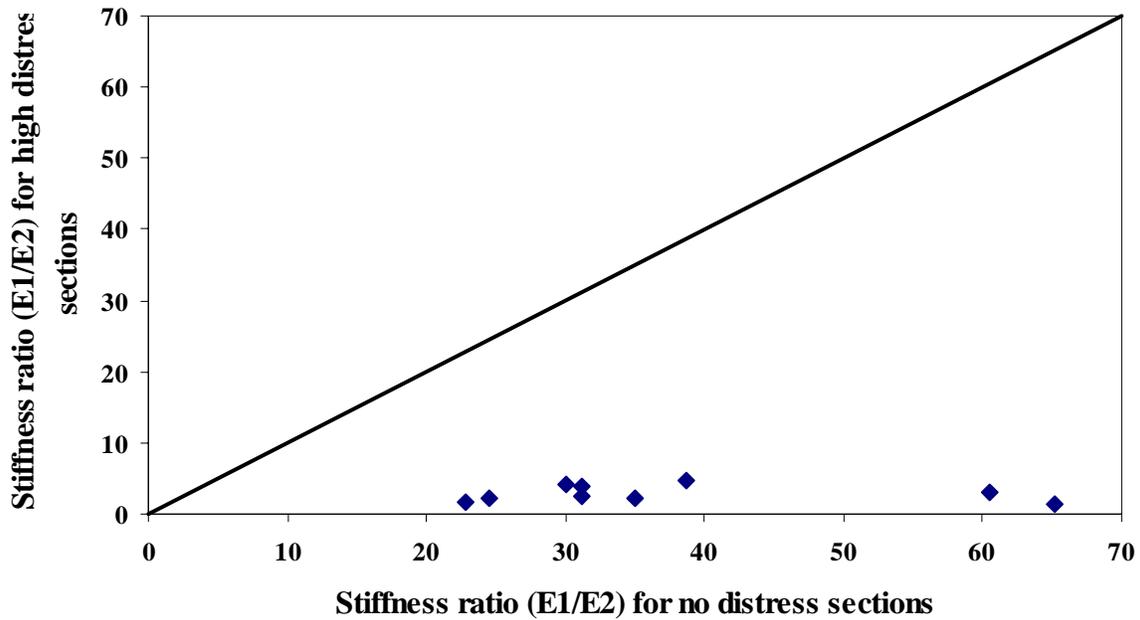
Figure 4.5. Stiffness ratio (E_1/E_2) for no distress vs. high distress sections (I-94 EB)

In I-94 EB, it was observed that the stiffness ratio between the top two layers (23-65) for the no distress sections were higher than that of the high distress sections (1-5), which is shown as Figure 4.5.

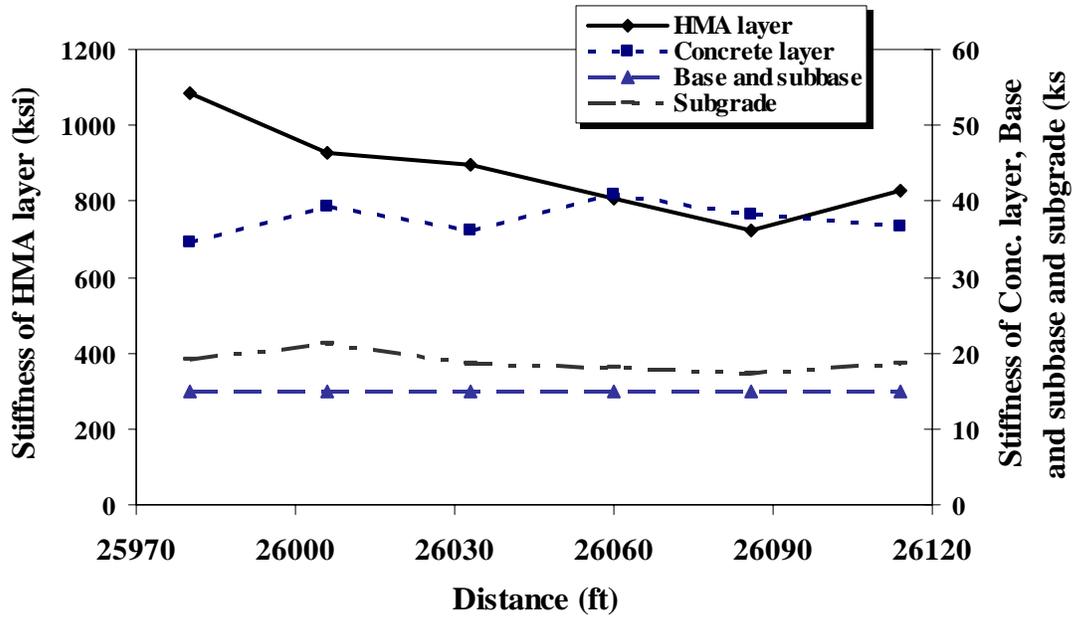
Figure 4.6. Stiffness vs. distance (N.D. USH 18, F.B., actual)

The stiffness of all layers of USH 18 were calculated using the BAKFAA software program. The stiffness of all layers of section F (N.D.) for the full bond condition and the full slip assumption are shown in Figures 4.6 and 4.7, respectively. The “Actual” in the figure labels refer to the field condition of the road. For example, Figure 4.6 shows that the section was a no distress (N.D.) section and the analysis was done for the Full Bond (F.B.) condition which reflects the actual condition of the no distress observed in the field. On the other hand, Figure 4.7 shows that the analysis was done on a no distress section with a full-slip assumption which is contrary to what was observed in the field.

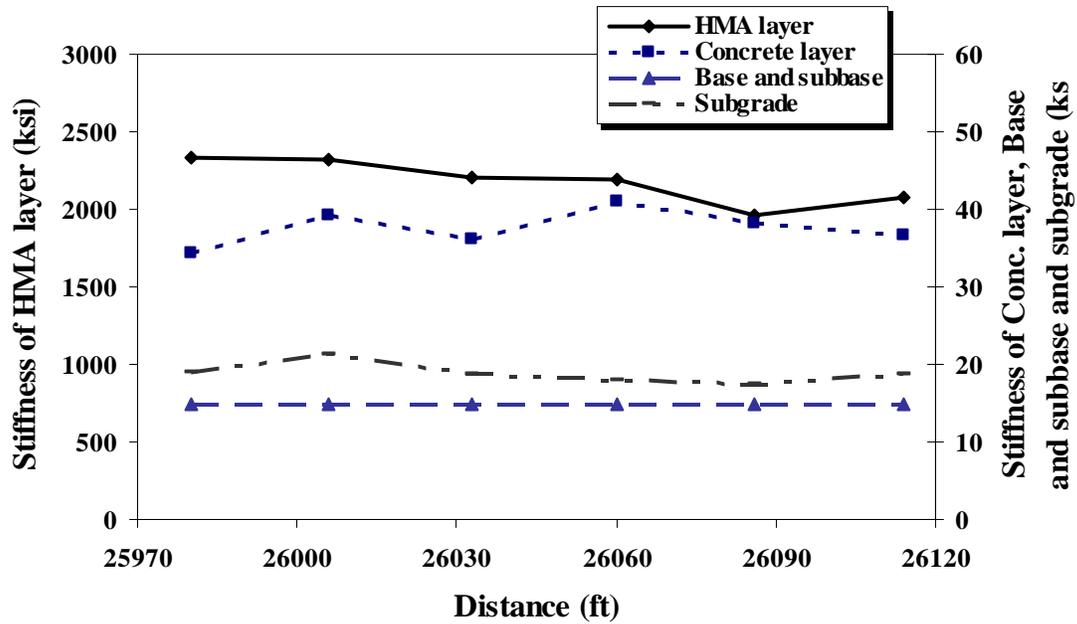
Figure 4.7. Stiffness vs. distance (N.D. USH 18, F.S., assumption)

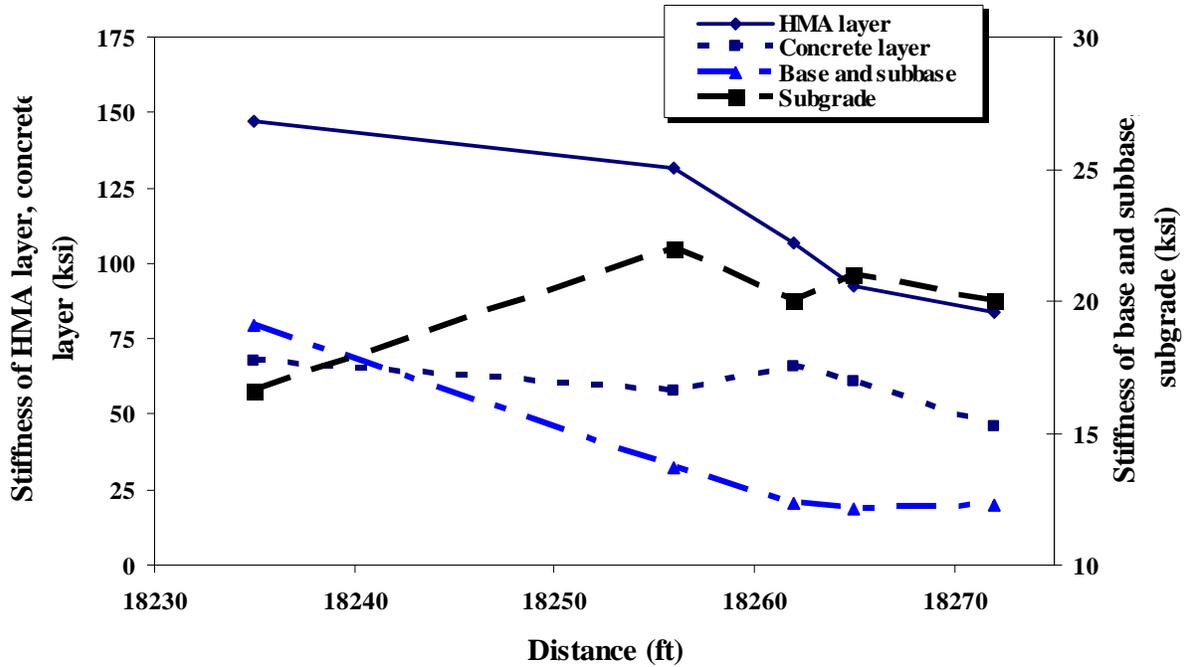
Figure 4.8. Stiffness vs. distance (H.D. USH 18, F.S., actual)

The stiffness of all layers of the high distress section for the full slip condition and the full bond assumption are shown in Figures 4.8 and 4.9, respectively.

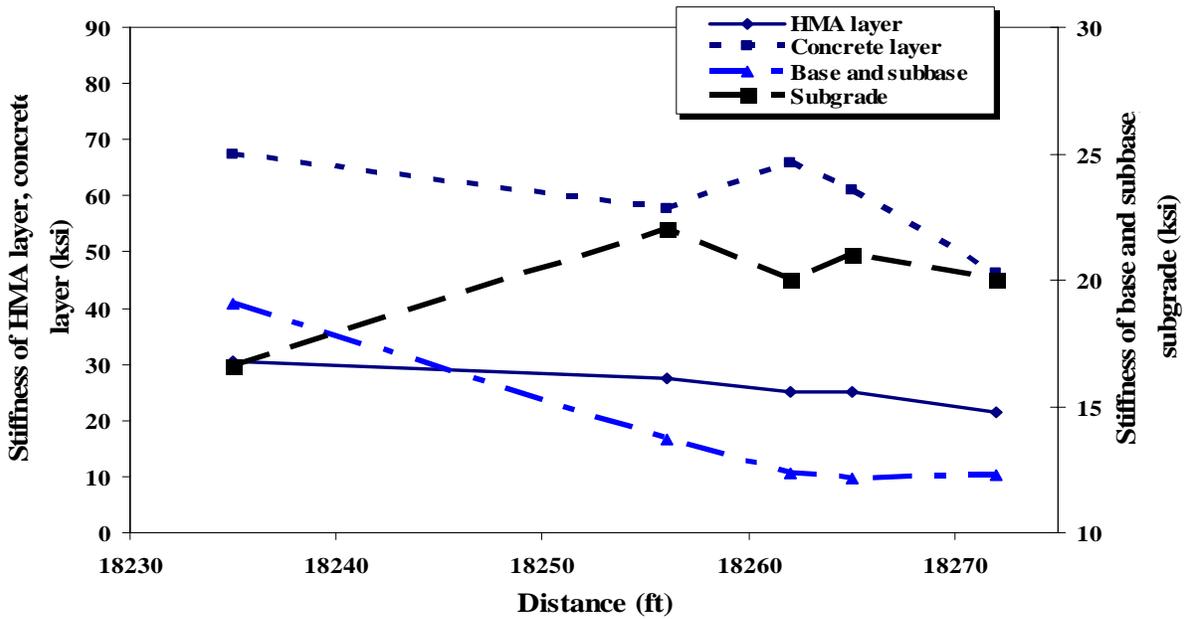
Figure 4.9. Stiffness vs. distance (H.D. USH 18, F.B., assumption)

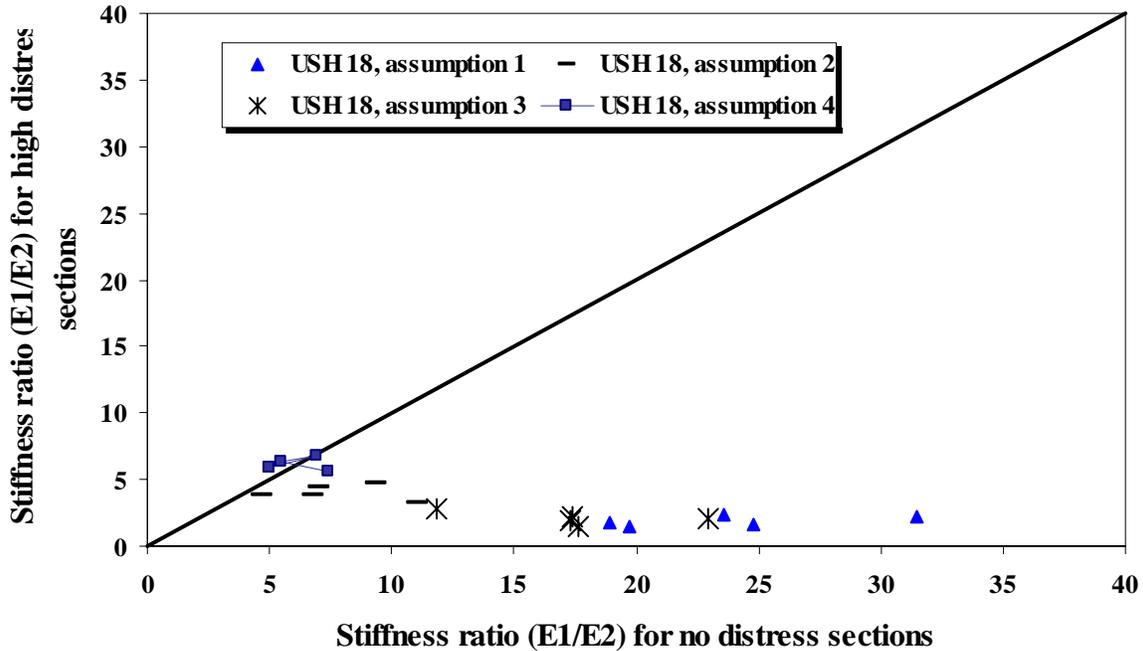
Figure 4.10. Stiffness ratio (E_1/E_2) for no distress vs. high distress sections (USH 18)

The different assumptions are related to different thickness assumptions that were made due to lack of structural data. Figure 4.10 appears to indicate that the stiffness ratio for the no distress section is significantly higher than that for the high distress section for the same pavement structure. This trend is true irrespective of the pavement structure. This comparison shows that the stiffness ratio can be correlated to distress.

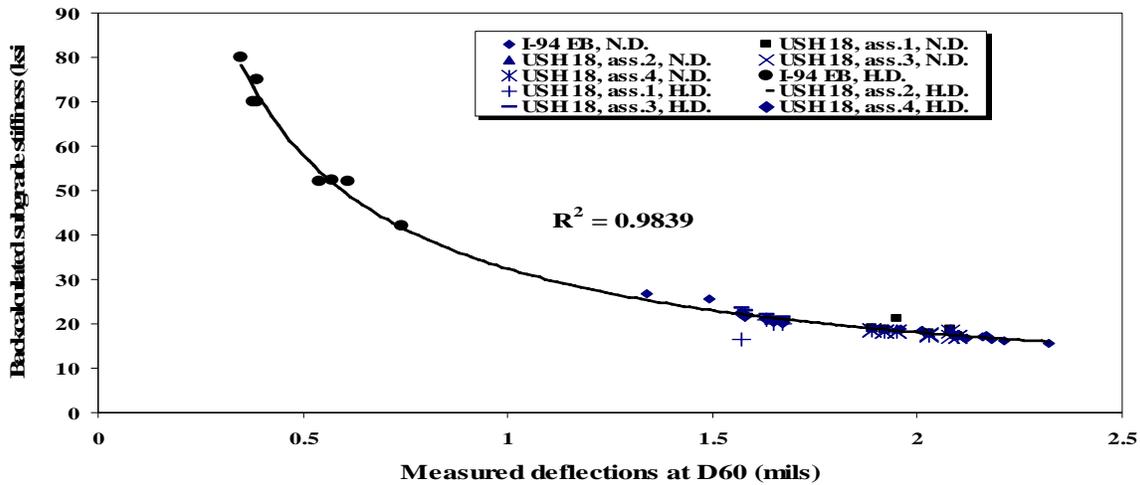
Figure 4.11. Backcalculated subgrade stiffness vs. the measured deflections at D₆₀

The accuracy of the backcalculated stiffness is significantly affected by the seed value. To obtain reasonable seed values, at first the stiffness of the different layers were calculated by the program. In the FWD test, the deflections far away from the loading plate depend mainly on the stiffness of the subgrade. Then the analysis was done first by calculating the subgrade stiffness by manually changing it in the program to match the measured deflection at 60" (d_{60}). The inverse correlation between the backcalculated subgrade stiffness and the measured deflections at d_{60} for both I-94 EB and USH 18 were very good (the root mean square value of the curve was 0.98), which is shown as Figure 4.11. A good correlation indicates that the subgrade stiffness appropriately reflects the FWD deflection basin values.

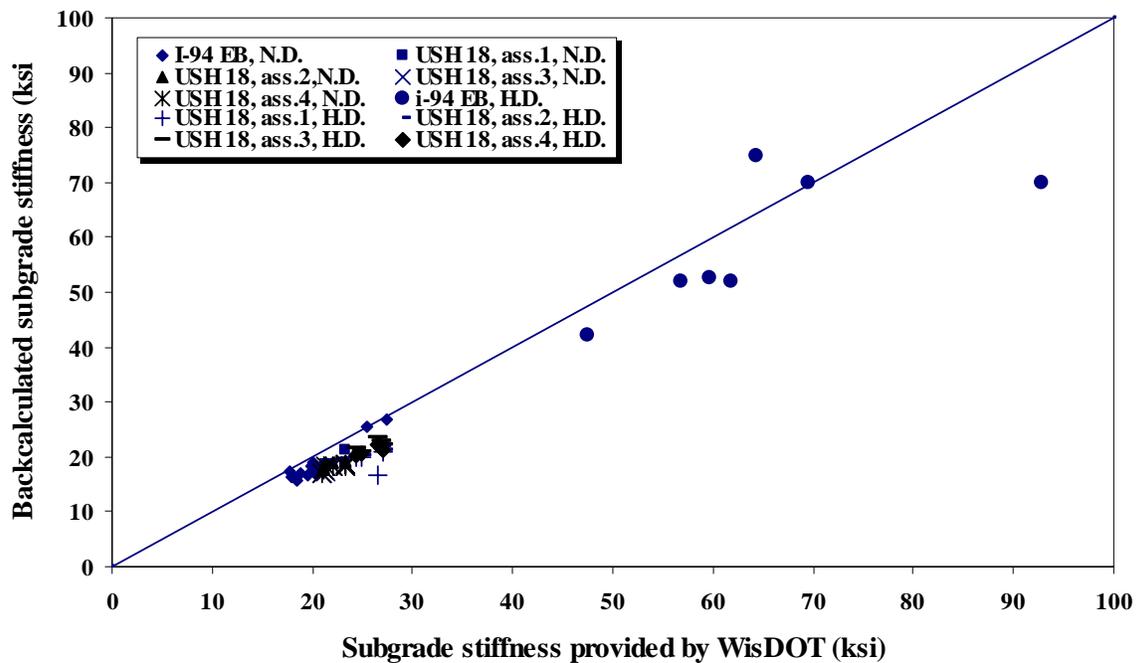
Figure 4.12. Backcalculated subgrade stiffness vs. the subgrade stiffness provided by WisDOT.

For both I-94 EB and USH 18, it was observed that the backcalculated subgrade stiffness was close (within 36%) to the values of the subgrade stiffness given by WisDOT, which is shown as Figure 4.12.

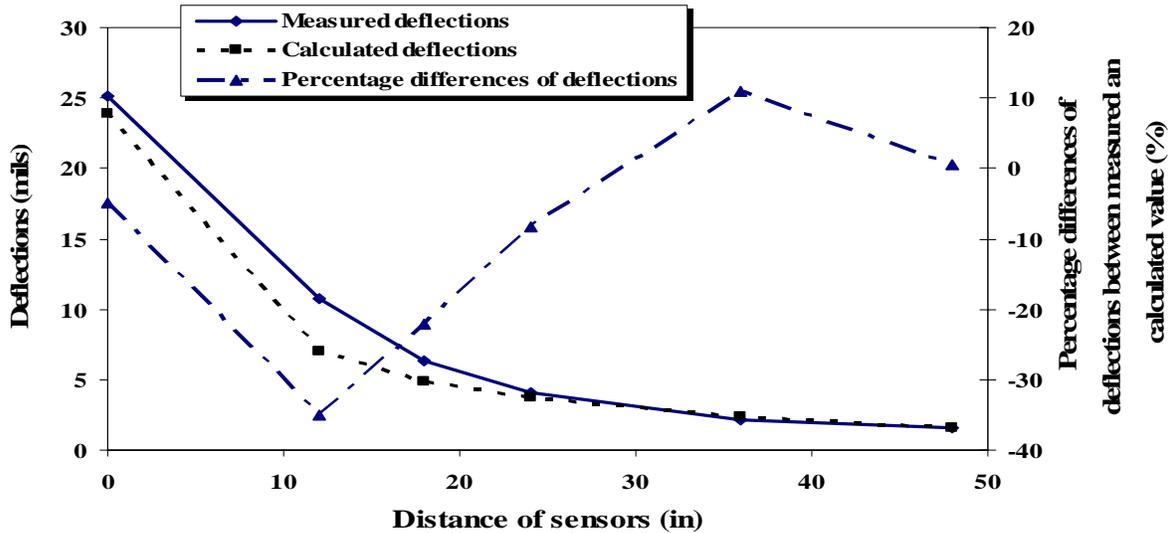
Figure 4.13. Deflections vs. the distance of sensors and the percentage differences of the deflections between the measured and the calculated values vs. the distance of sensors (RMSE 1.59, F.B.)

The measured and the calculated deflections with the distance of sensors for the full bond condition are shown in Figures 4.13, 4.14, and 4.15 for the RMSE values 1.59, 0.88, and 0.61 respectively. The percentage differences of deflections between the measured and the calculated values are also shown in those figures.

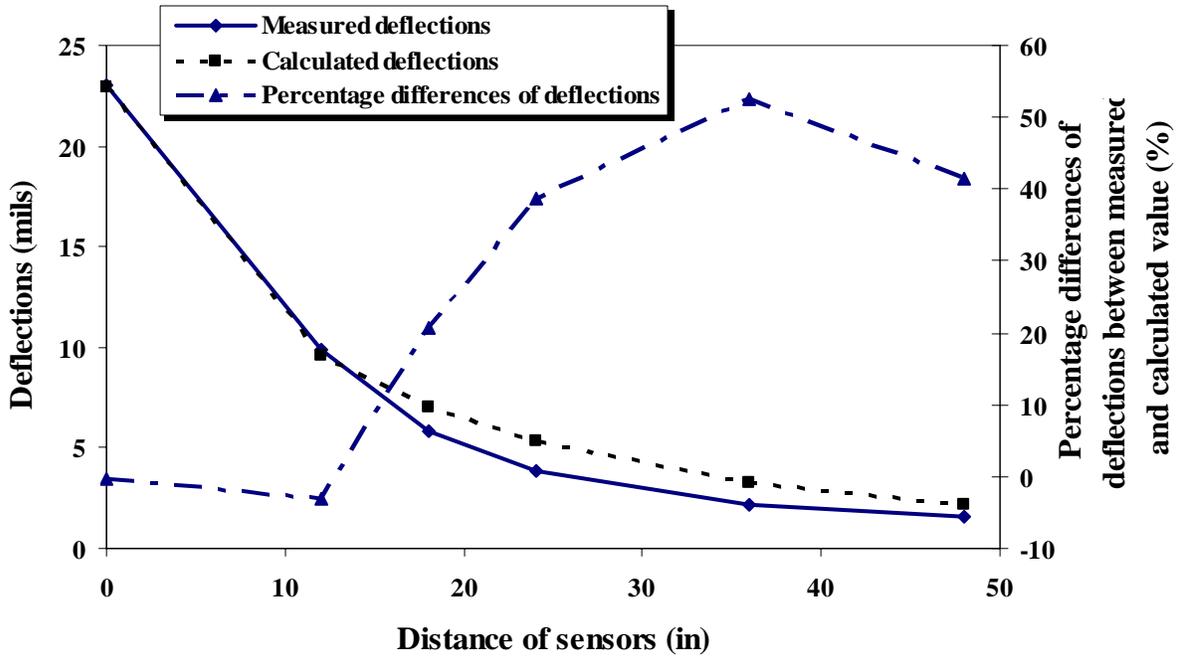
Figure 4.14. Deflections vs. the distance of sensors and the percentage differences of deflections between the measured and the calculated values vs. the distance of sensors (RMSE= 0.88, F.B.)

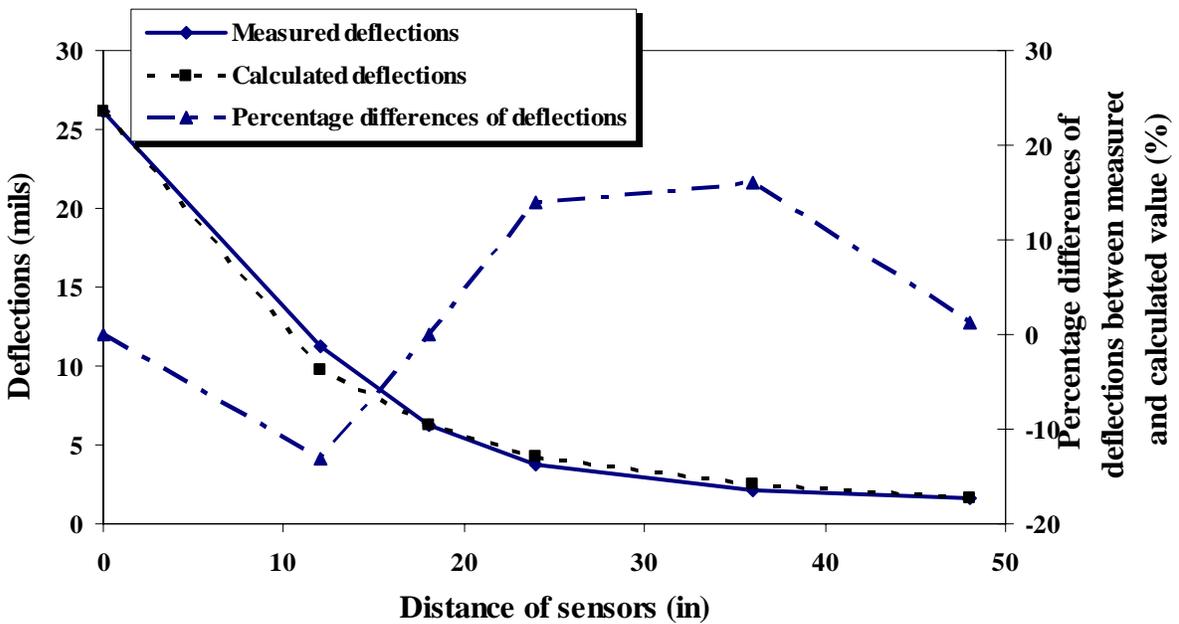
Figure 4.15. Deflections vs. the distance of sensors and the percentage differences of deflections between the measured and the calculated values vs. the distance of sensors (RMSE= 0.61, F.B.)

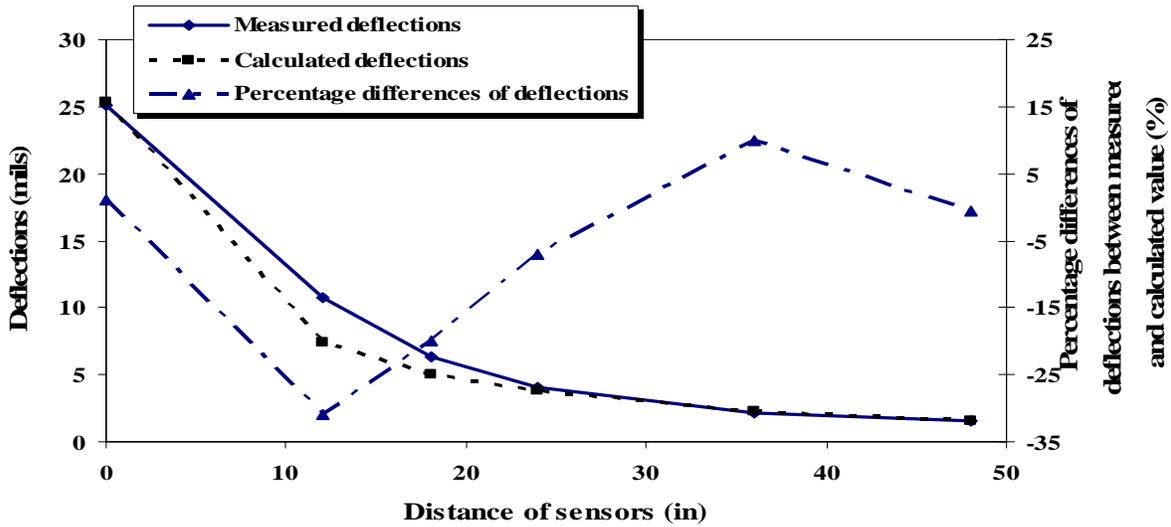
Figure 4.16. Deflections vs. the distance of sensors and the percentage differences of the deflections between the measured and the calculated values vs. the distance of sensors (RMSE= 1.36, F.S.)

0.80 respectively. The percentage differences of deflections between the measured and the calculated values are also shown in those figures.

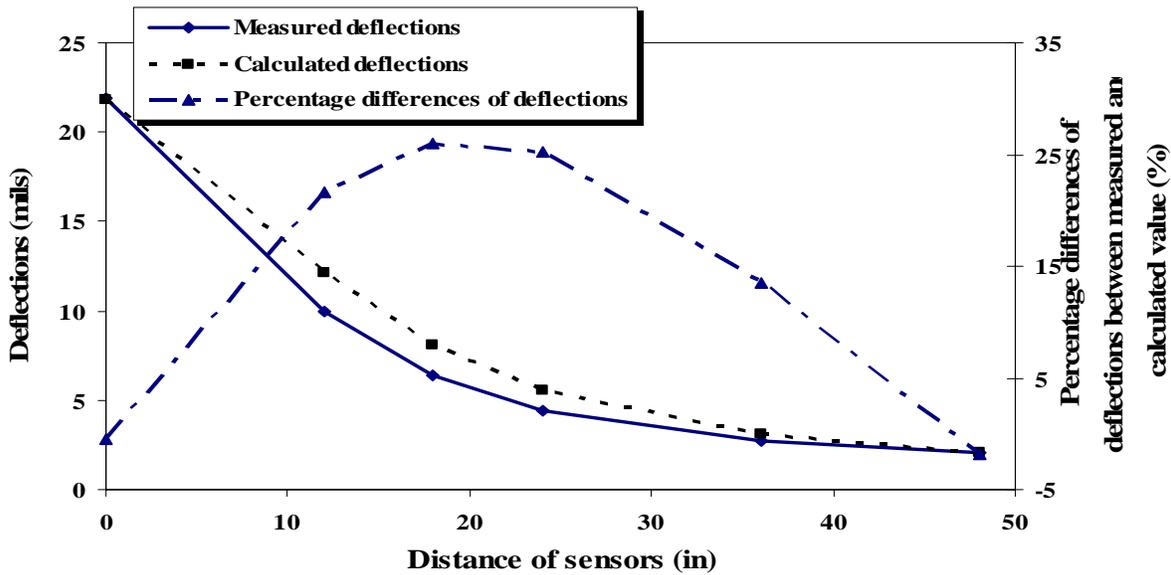
Figure 4.17. Deflections vs. the distance of sensors and the percentage differences of the deflections between the measured and the calculated values vs. the distance of sensors (RMSE= 1.12, F.S.)

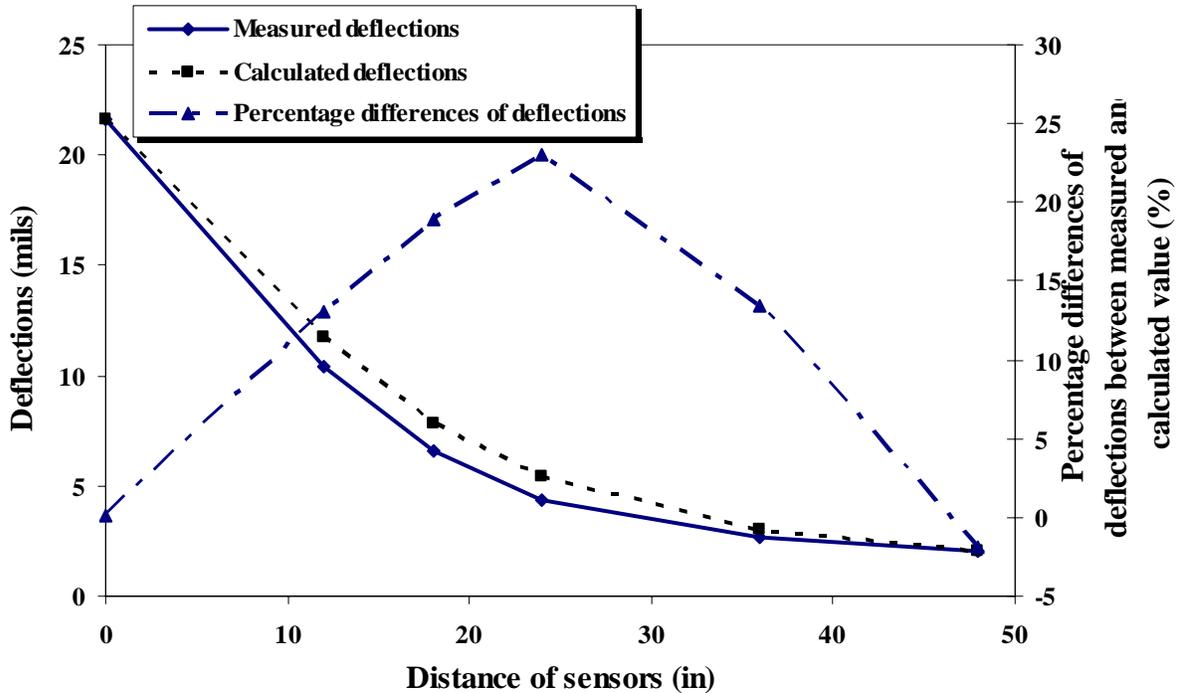
Figure 4.18. Deflections vs. the distance of sensors and the percentage differences of deflections between the measured and the calculated values vs. the distance of sensors (RMSE= 0.80, F.S.)

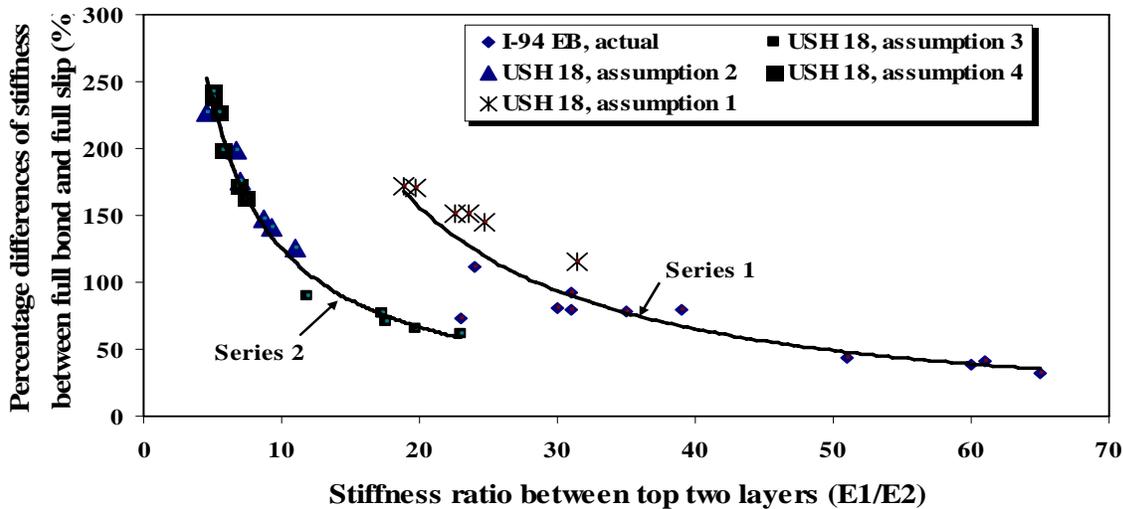
Figure 5.1. Percentage differences of stiffness between the full bond and the full slip vs. the stiffness ratio (E_1/E_2)

The percentage differences of stiffness between the full bond and the full slip (P.D.) vs. the stiffness ratio (E_1/E_2) between the top two layers for the no distress section are shown in Figure 5.1. As the stiffness ratio increases, the percentage differences of stiffness between the full bond and the full slip decreases. Two zones were observed among these points. These two zones were represented by two series, which is also shown in Figure 5.1. For the same stiffness ratio the percentage differences of the stiffness between the full bond and the full slip for the points of one zone were higher than the points of the other zone.

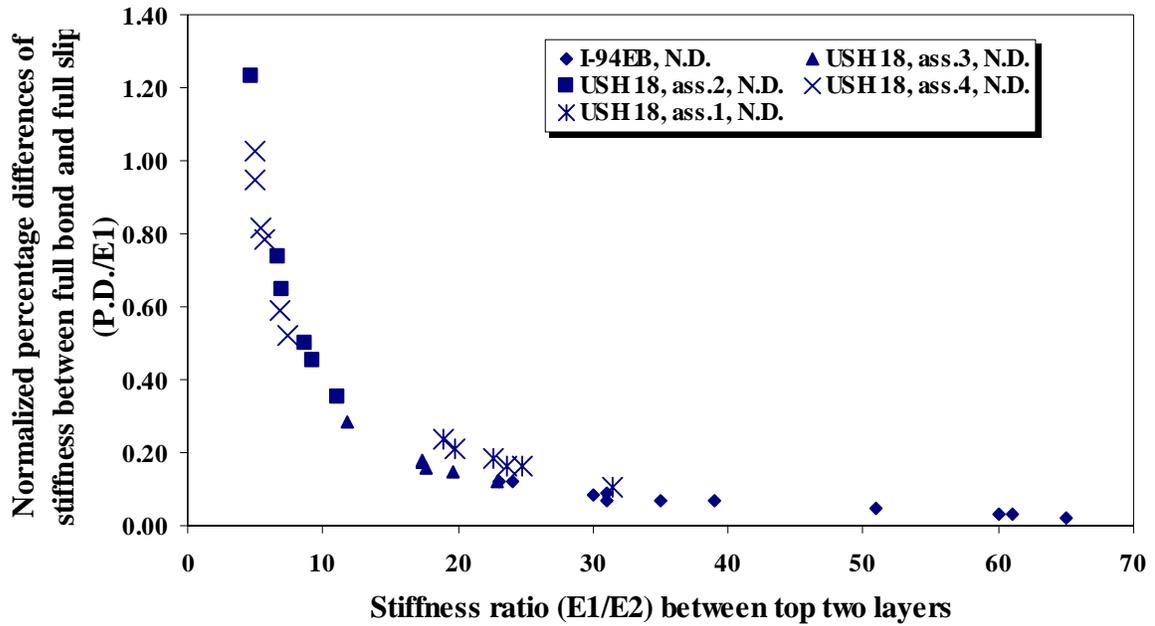
Figure 5.2. Normalized percentage differences of stiffness between the full bond and the full slip ($P.D./E_1$) vs. the stiffness ratio (E_1/E_2) for no distress sections.

The normalized percentage differences of stiffness between the full bond and the full slip of the no distress and high distress sections are plotted with the stiffness ratio between the top two layers, which are shown as Figure 5.2 and Figure 5.3 respectively.

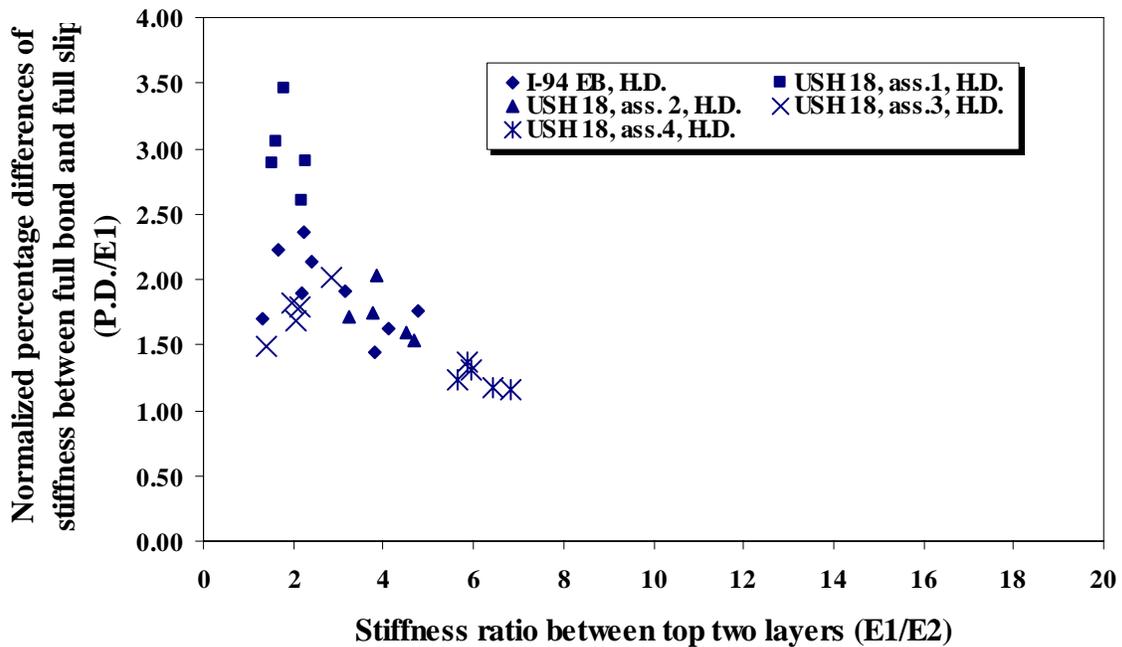
Figure 5.3. Normalized percentage differences of stiffness between full bond and full slip ($P.D./E_1$) vs. the stiffness ratio (E_1/E_2) for high distress sections.

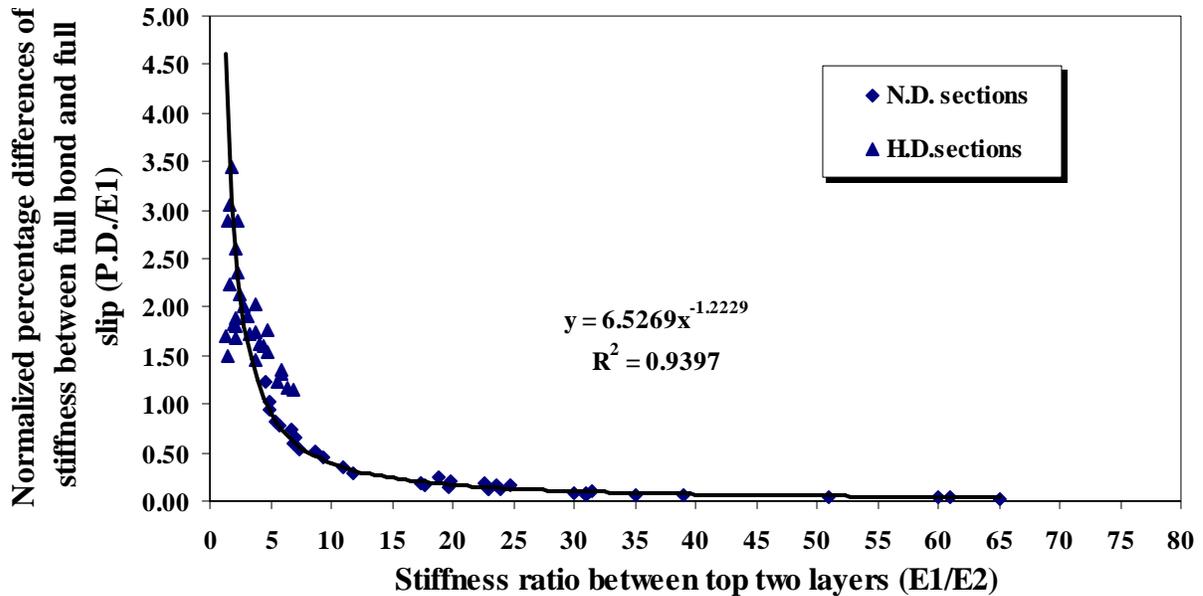
Figure 5.4. Normalized percentage differences of stiffness between the full bond and the full slip (P.D./E₁) vs. the stiffness ratio (E₁/E₂) .

Normalized percentage differences of stiffness between the full bond and the full slip for both the no distress and high distress sections were inversely correlated with the stiffness ratio and the root mean square value of that correlated curve was 0.94, shown as Figure 5.4.

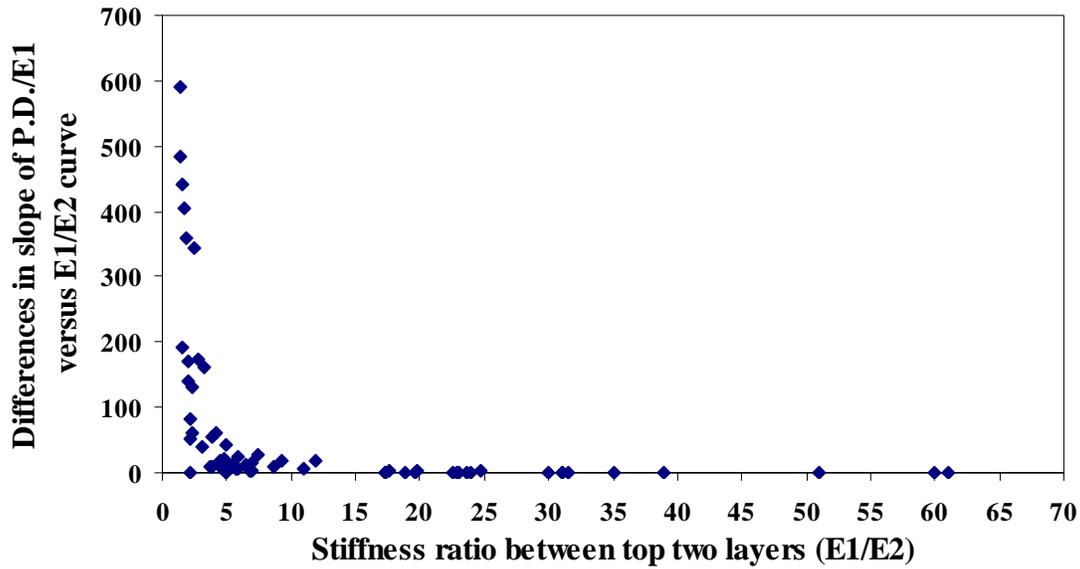
Figure 5.5. Differences in slope of curve (P.D./ E_1 vs. E_1/E_2) vs. stiffness ratio (E_1/E_2).

To quantify the stiffness ratio at which the differences of the slope of the curve are minimum, the differences in the slope of the curve (P.D./E₁ vs. E₁/E₂) vs. the stiffness ratio are plotted, which is shown in Figure 5.5. When the stiffness ratio is greater than 10 the differences in the slopes of the curve (P.D./E₁ vs. E₁/E₂) are almost zero. Since P.D./E₁ directly relates to the impact of the slip, when E₁/E₂ is greater than 10, the pavement is not as adversely impacted due to poor interlayer bonding.
