**Wisconsin Highway Research Program
0092- 02-13**

**PHASE 1: Evaluation of Interlayer Bonding In
HMA Pavements**

**PHASE 2: Effect of Stiffness Ratio on Slippage
Cracking Due to Interlayer Bonding Failure in
Hot Mix Asphalt Pavements**

Final Report

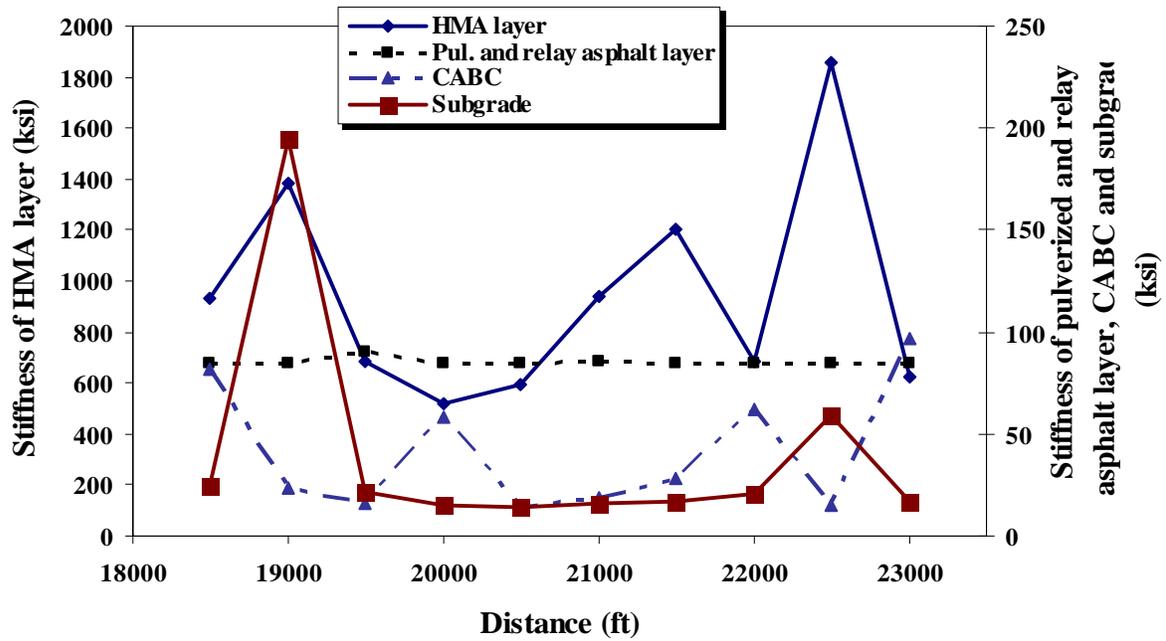
Figure 6.1. Stiffness vs. distance (N.D, HWY 81, F.B., actual)

The stiffness of all layers of the no distress section (LWP) for the full bond condition and the full slip assumption are shown in Figures 6.1 and 6.2, respectively.

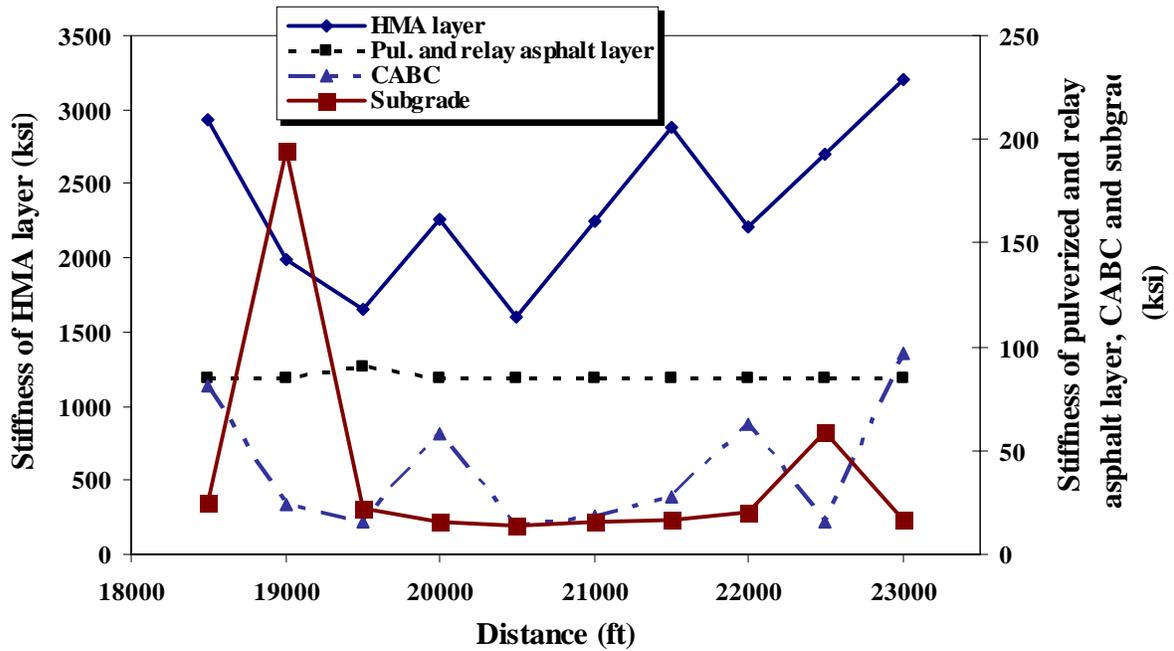
Figure 6.2. Stiffness vs. distance (N.D, HWY 81, F.S., assumption)

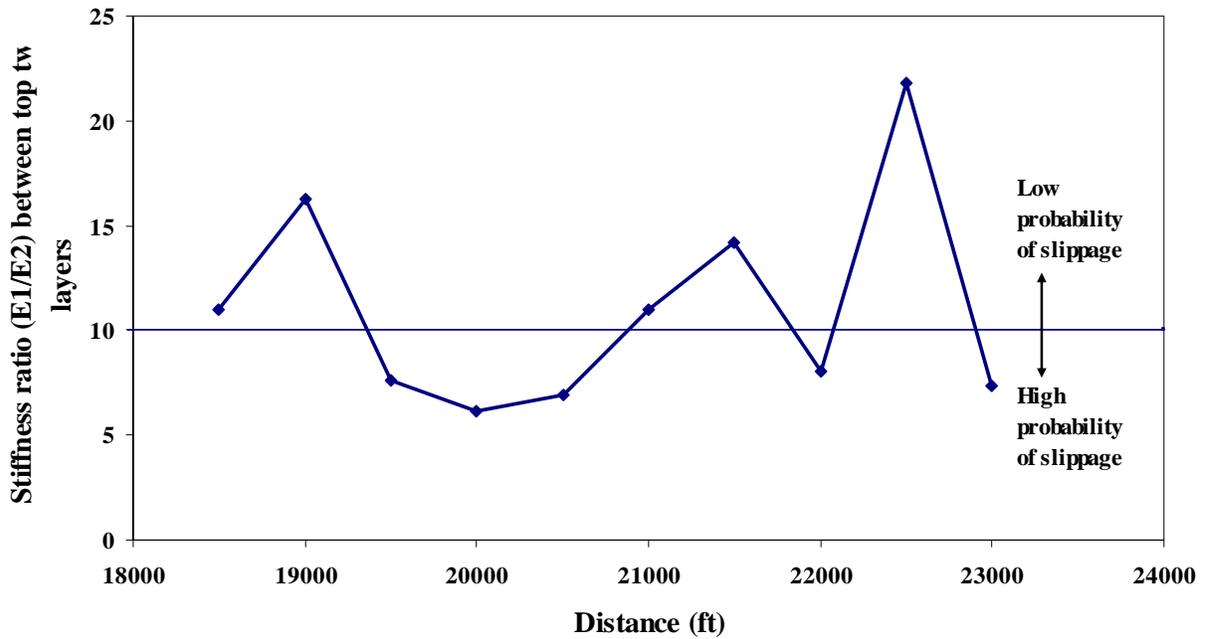
Figure 6.3. Stiffness ratio (E_1/E_2) vs. distance (N.D., HWY 81)

Stiffness ratios (E_1/E_2) between the top two layers of the no distress section were 6-22. Stiffness ratios (E_1/E_2) of the no distress section between the top two layers with the distance are shown in Figure 6.3. It was observed that for a few stations the stiffness ratios were from 6 to 10, but they were not slippage sections.

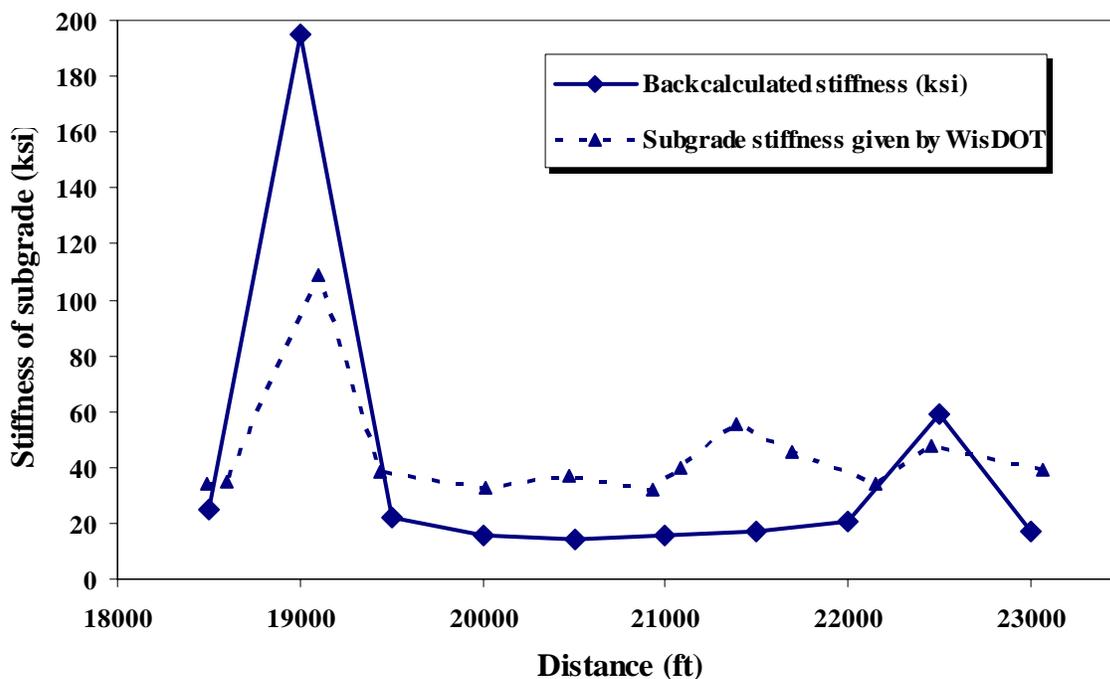
.Figure 6.4. Stiffness of subgrade vs. distance (N.D. LWP, HWY 81)

The analysis for 22000' and 22500' station for the no distress section (LWP) are summarized in Table 6.2. The RMSE values were 0.12 to 0.15 for the full bond condition and 0.19 to 0.61 for the slippage assumption. As stated earlier, the stiffness of the base was kept constant at 85 ksi. The subbase stiffness was within the specified range 14 ksi to 63 ksi. The backcalculated subgrade stiffness and the subgrade stiffness provided by WisDOT are plotted with distance, which is shown as Figure 6.4.

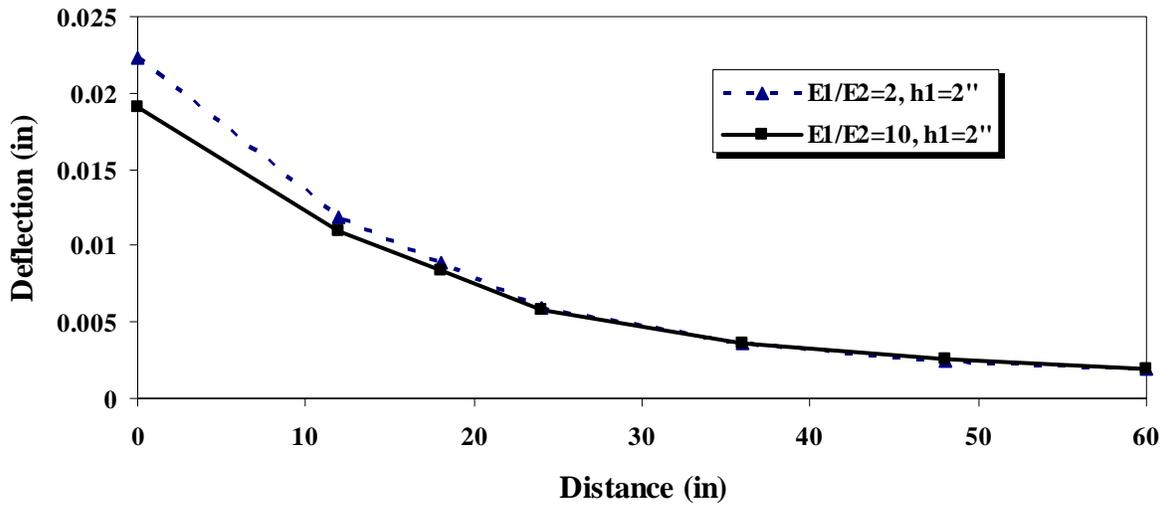
Figure 7.1. Deflections of the surface layer (2") vs. distance from the FWD load.

To demonstrate the above concept, this analysis was done for six stations with a stiffness ratio between the top two layers of two ($E_1/E_2 = 2$). All six stations were taken from the high distress sections of I-94 EB and USH 18. It was observed that the additional thickness needed to achieve the stiffness ratio of $E_1/E_2 = 10$ depended on the existing top layer thickness. By increasing the thickness of an existing 2 in the pavement layer, the structural capacity of the pavement increased from a lower stiffness ratio of 2 to as high as the stiffness ratio of 10 for an existing 2 in top layer thickness, which are shown as Figures 7.1 and 7.2. On the other hand, the structural capacity of a pavement with an existing 3 inch top layer was increased by a 4 inch thick surface layer for an increase in stiffness ratio from 2 to 10, which are shown as Figures 7.3 and 7.4. The influence of the thicker surface layer on the deflection basin is greater than that of the thinner layer. Therefore, the thicker surface layer with the lower stiffness needs to be modified significantly more than that for a thinner layer to change the shape of the deflection basin. For that reason, the existing 3 inch layer needed more thickness as compared to the 2 inch layer to achieve the structural capacity of a higher stiffness ratio from the initial value of 2.

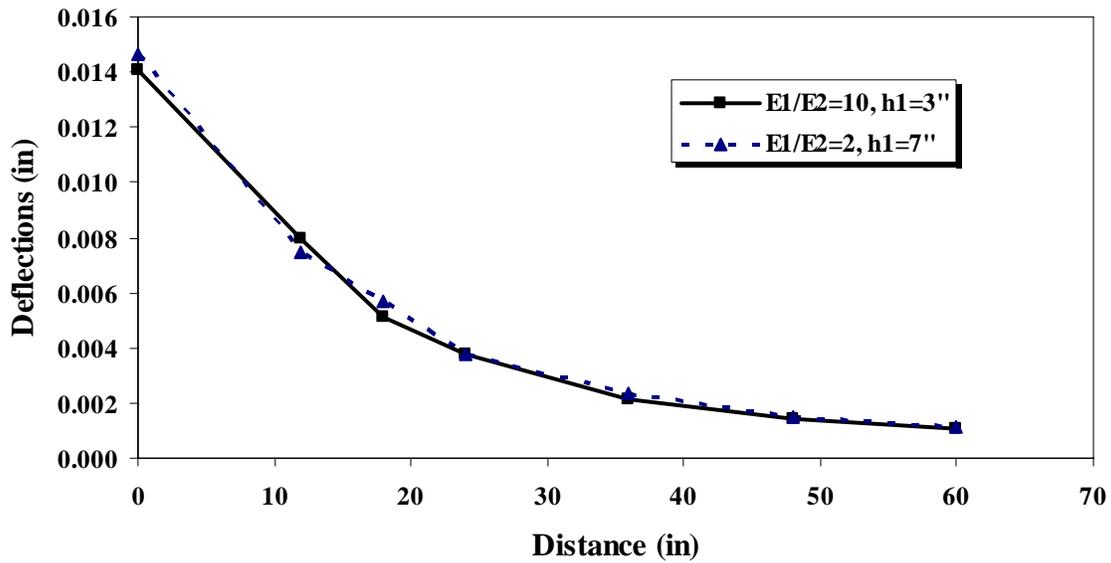
Figure 7.4. Deflections of the surface layer vs. the distance from the FWD load.

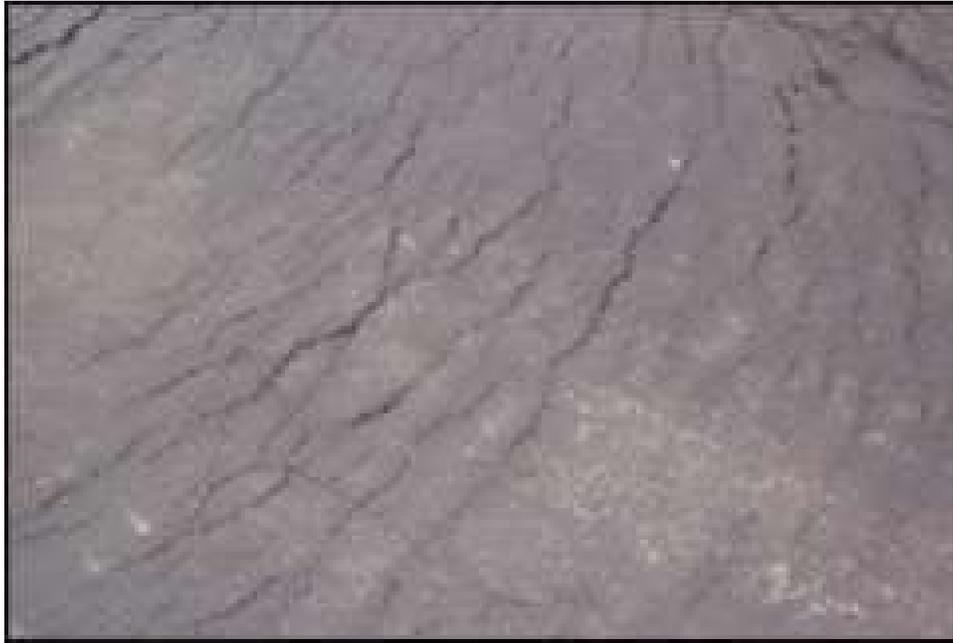
Figure 1. Slippage Cracking

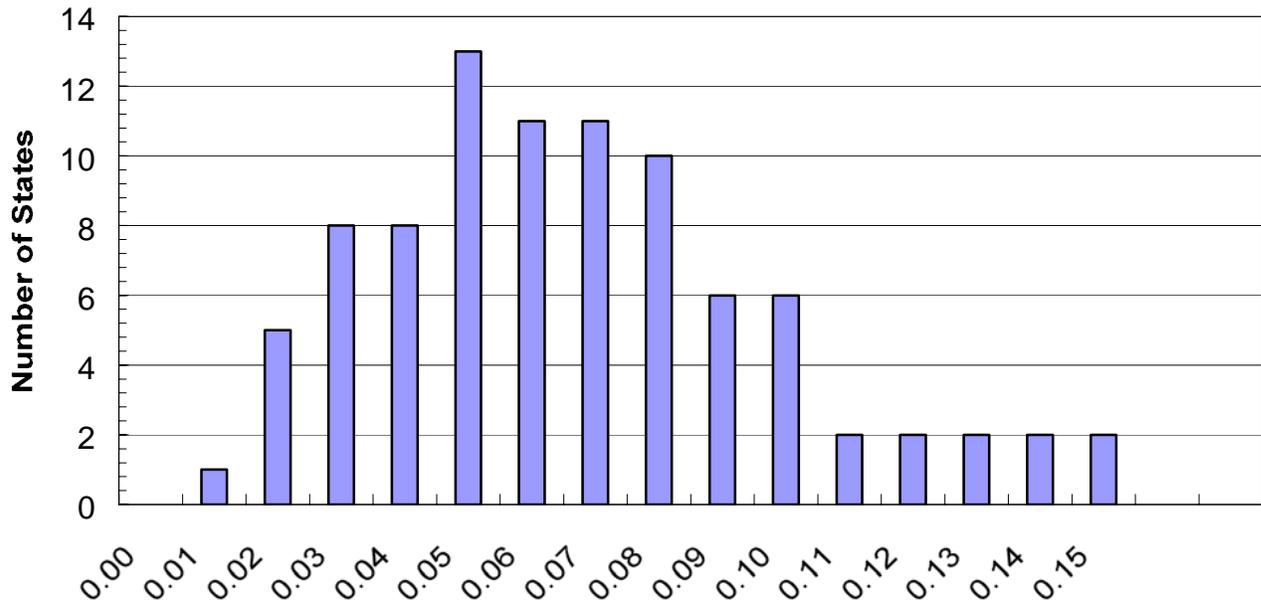
Tack Coat Application Rate

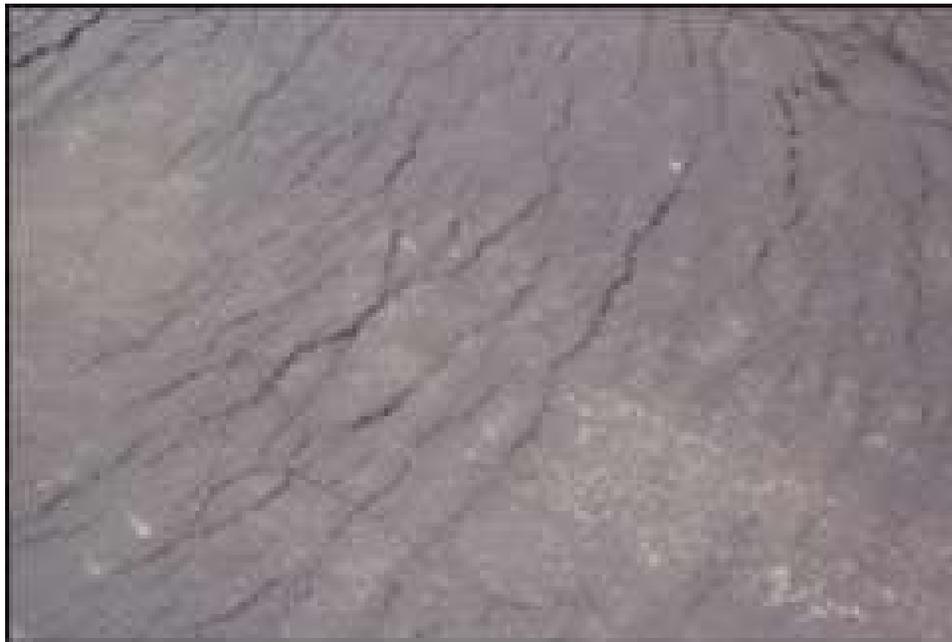
Figure 2.1. Slippage Cracking

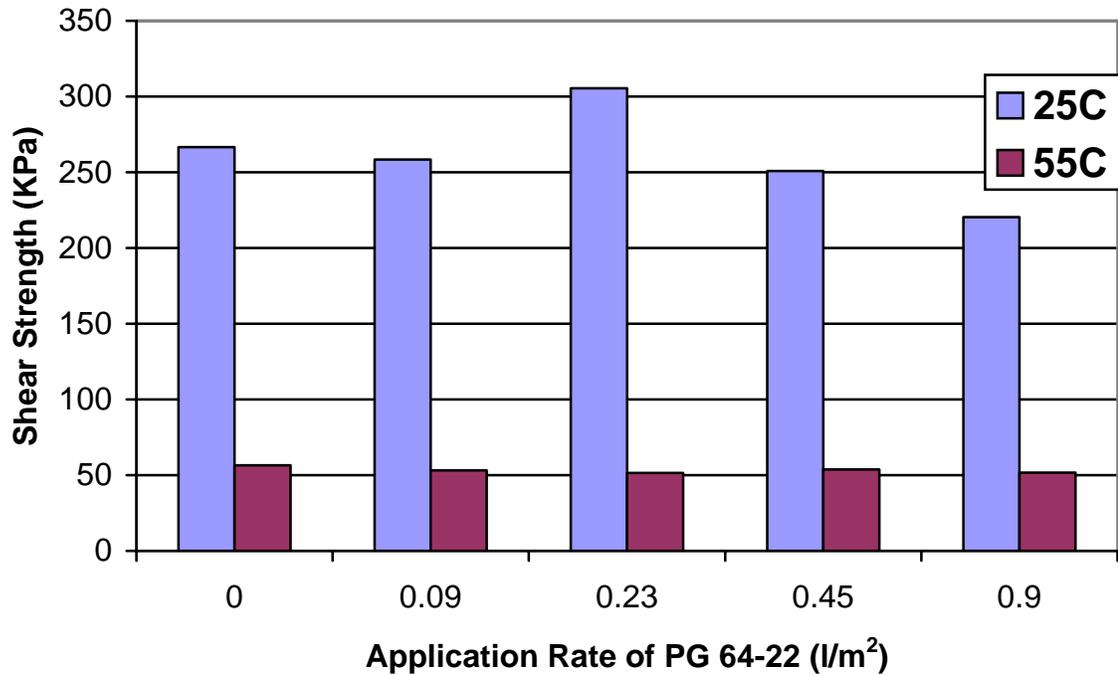
Figure 2.2. Tack Application Rates vs Strength, (Mohammad et al., 2002)

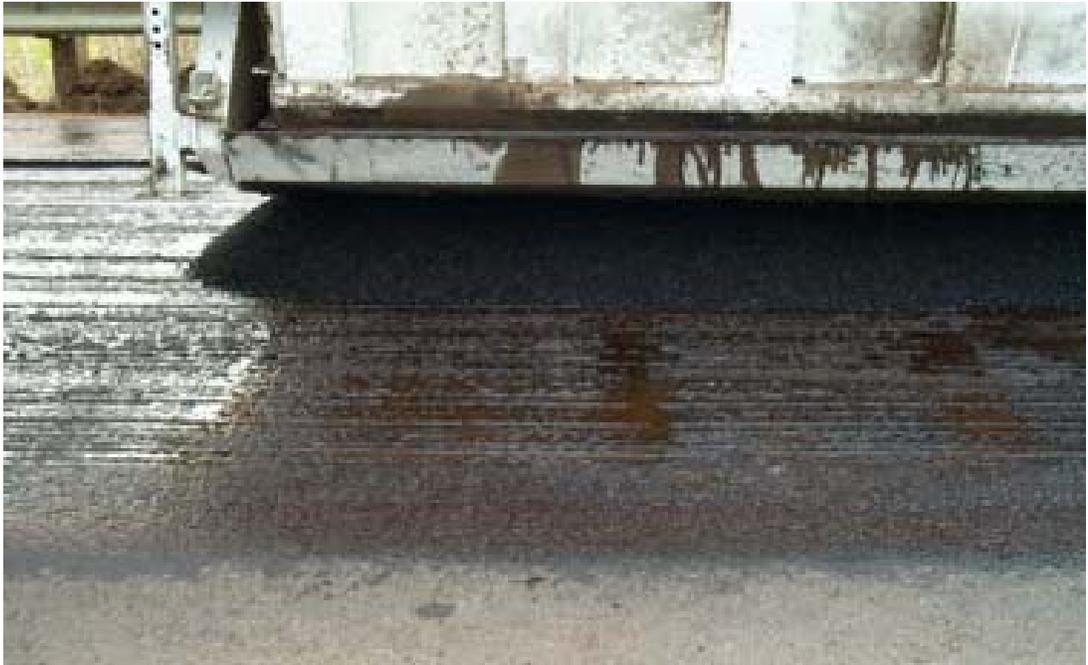
Figure 2.3. Excess Application

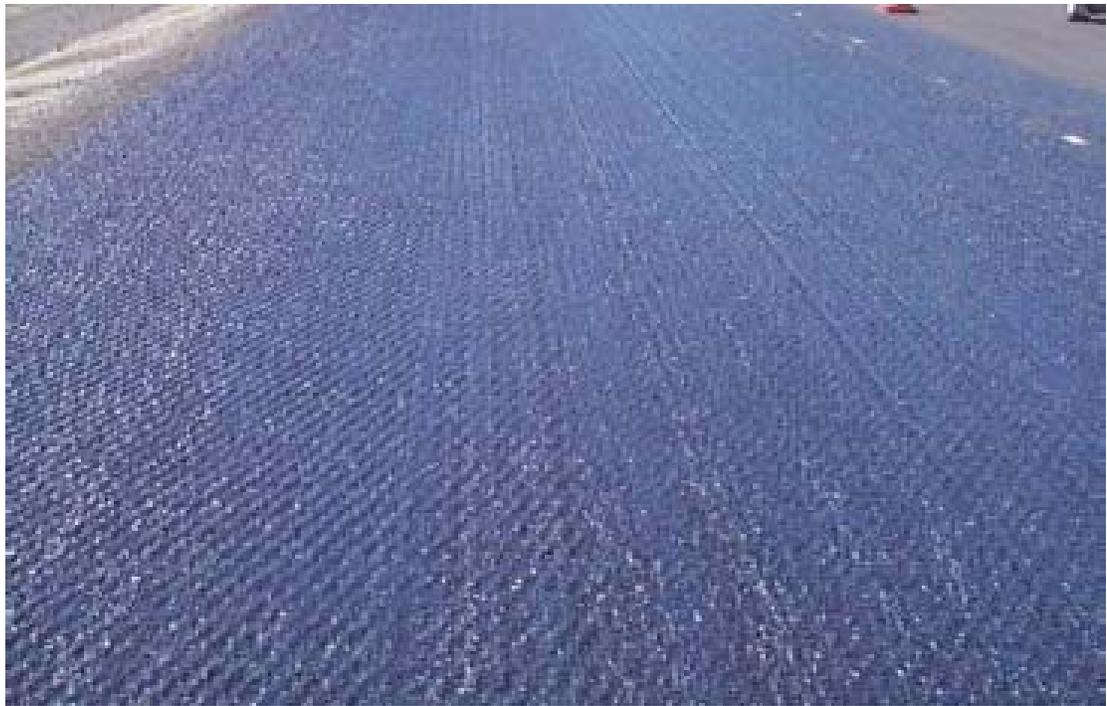
Figure 2.4. Appropriate Application Amount

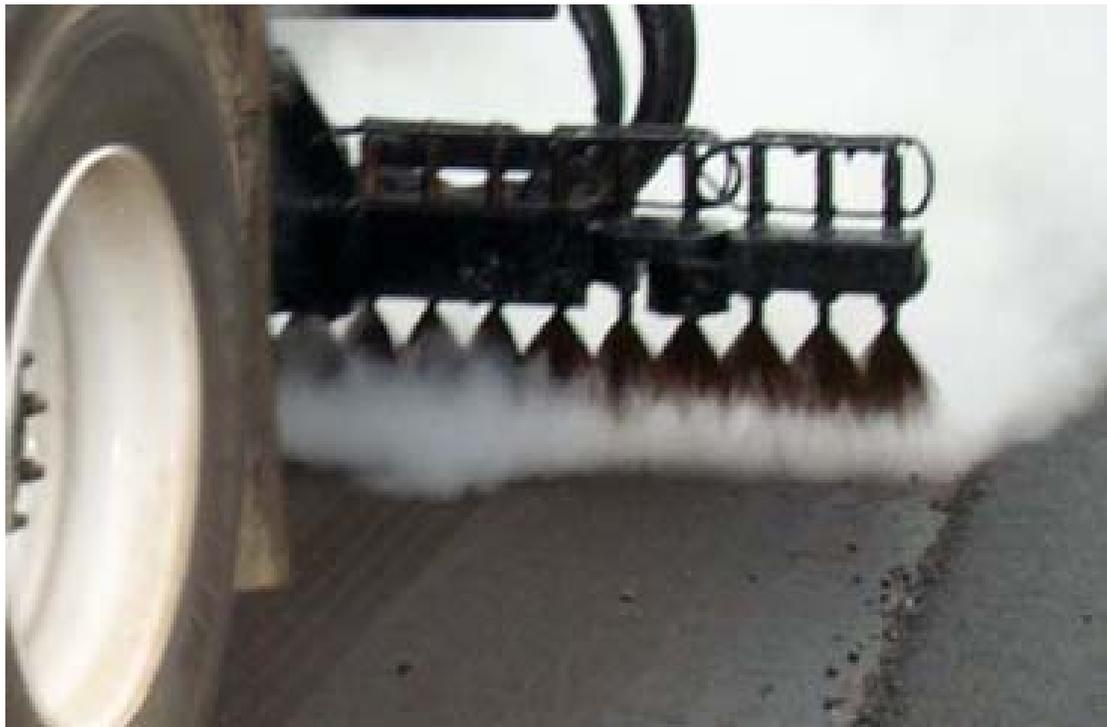
Figure 2.5. Proper Spraying

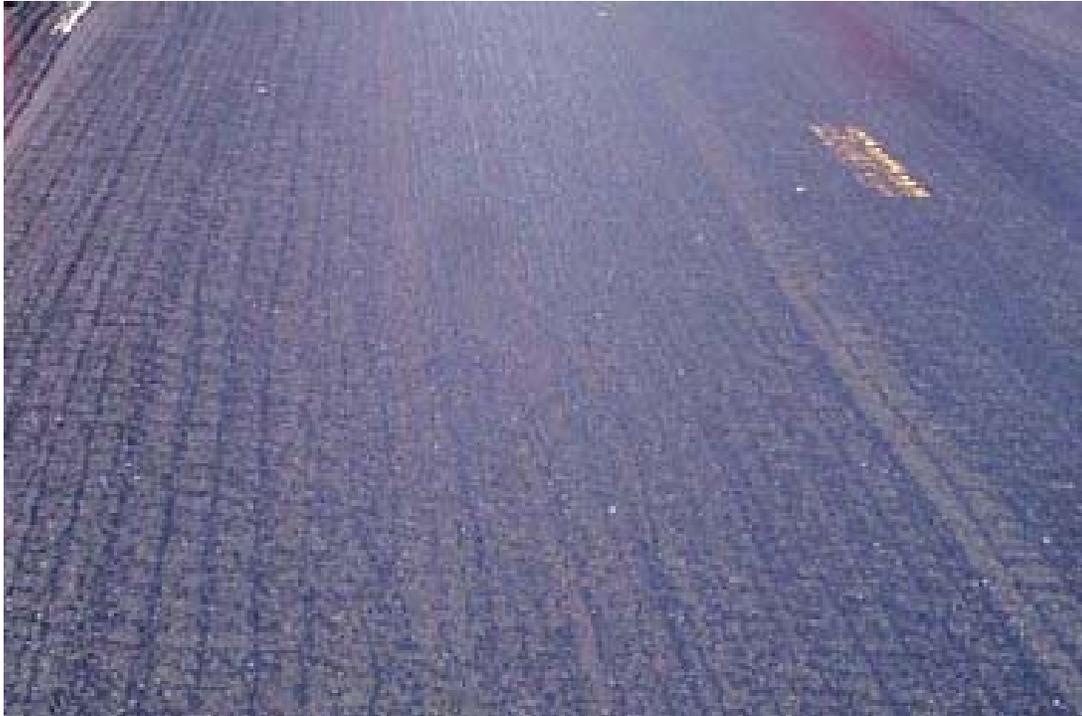
Figure 2.6. Result of Poor Spraying and Application Rate

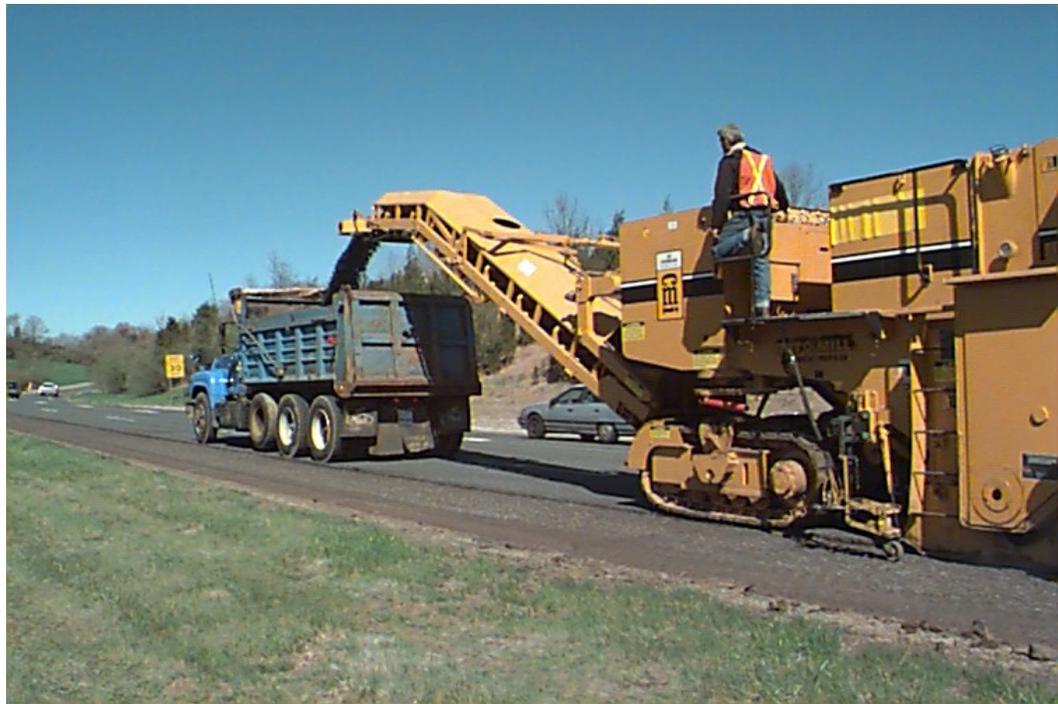
Figure 2.7. Milling Operation

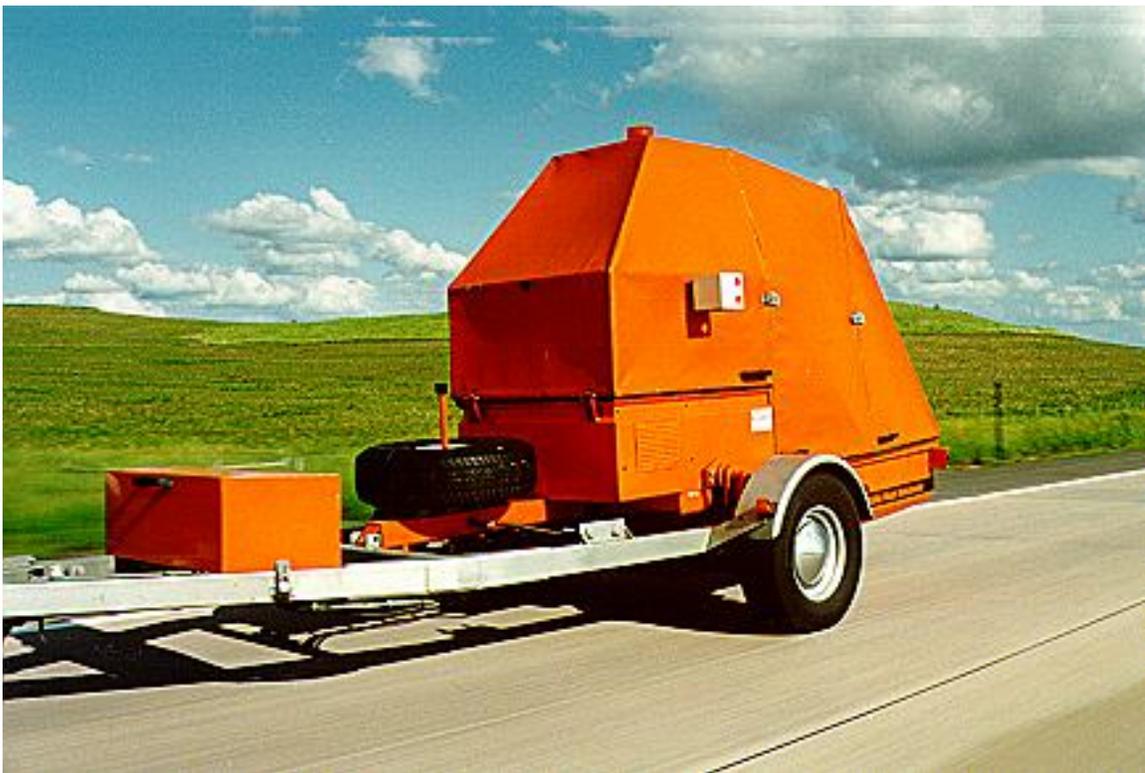
Figure 2.8. FWD Machine

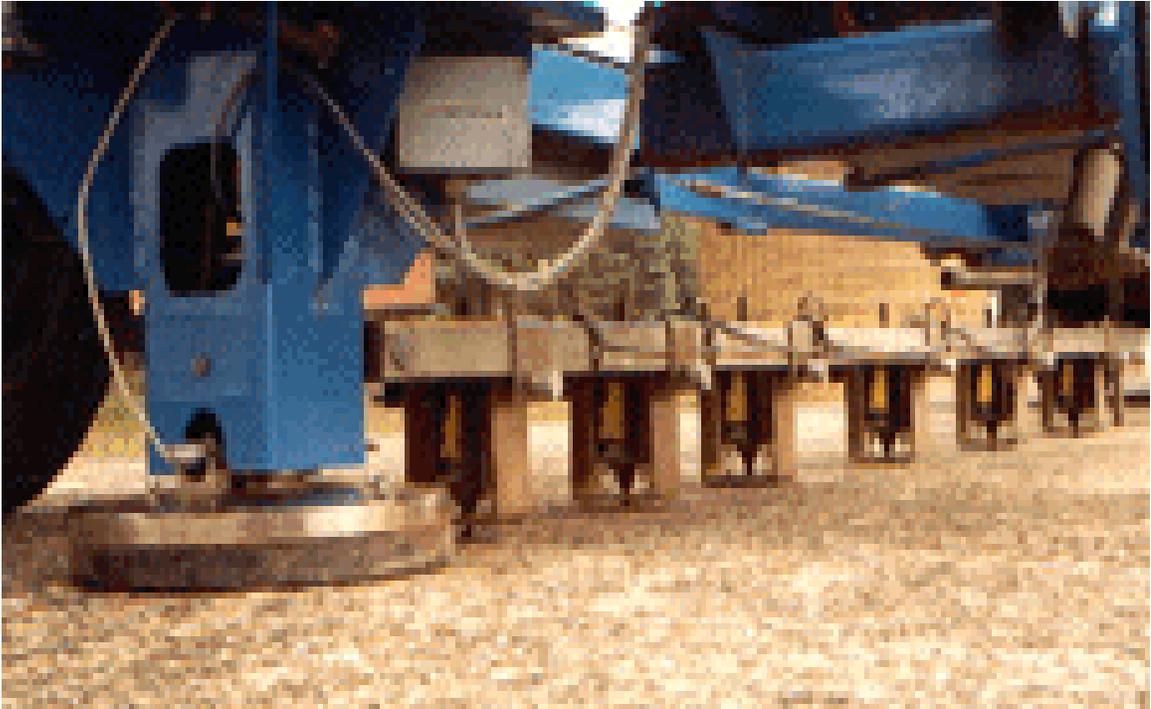
Figure 2.9. FWD Loading Plate and Sensors

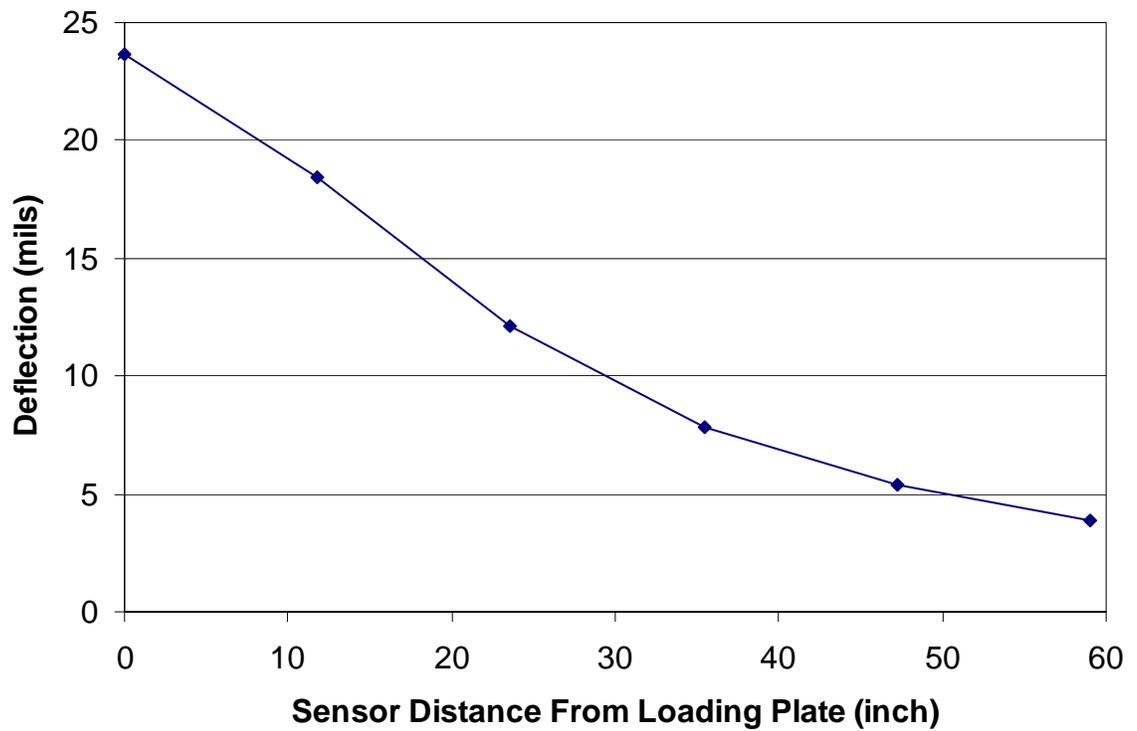
Figure 2.10. Typical Deflection Basin

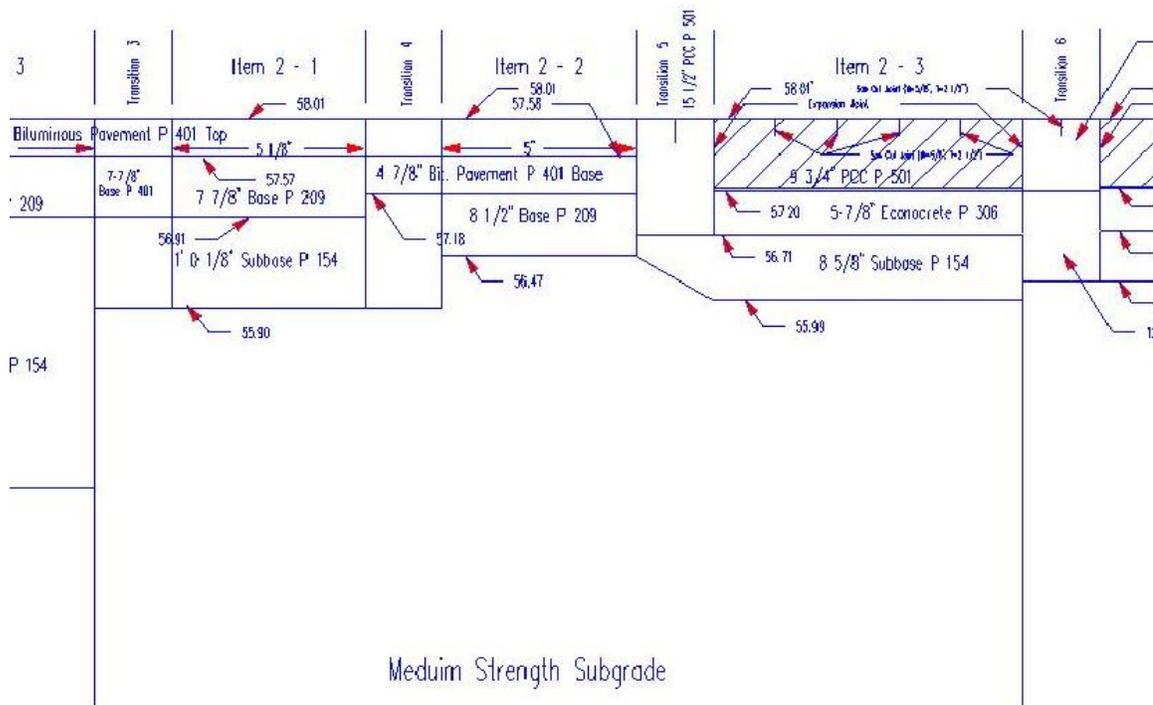
Figure 3.2. Medium Strength Subgrade Section (FAA NAPTF, 2003)

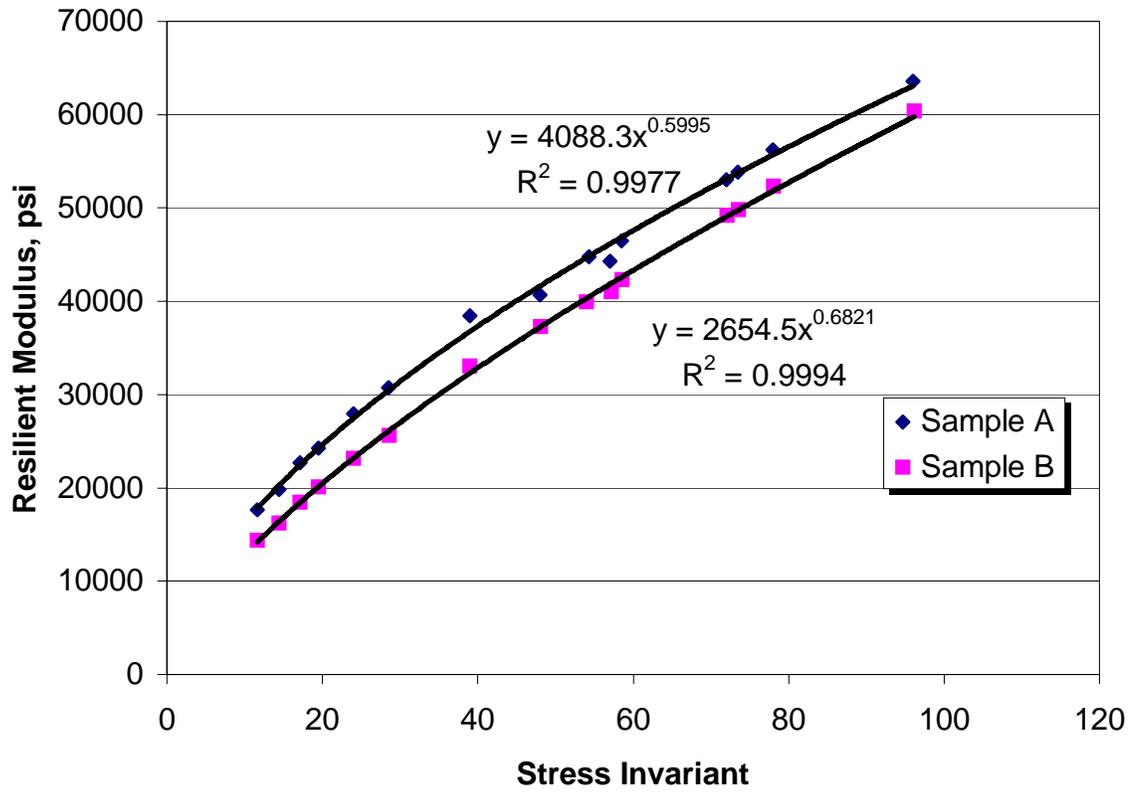
Figure 4.1. Calculation of K_1 , K_2 for Base (P-209)

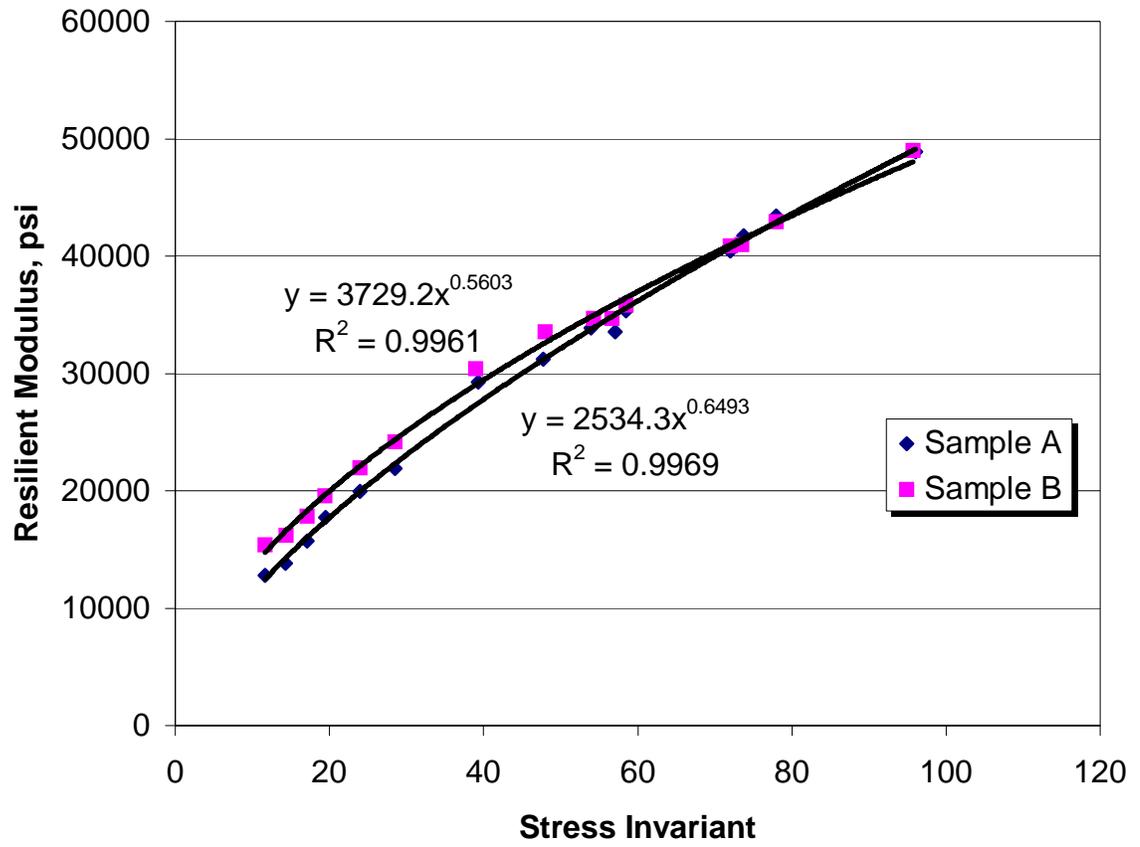
Figure 4.2. Calculation of K_1 , K_2 for Subbase (P-154)

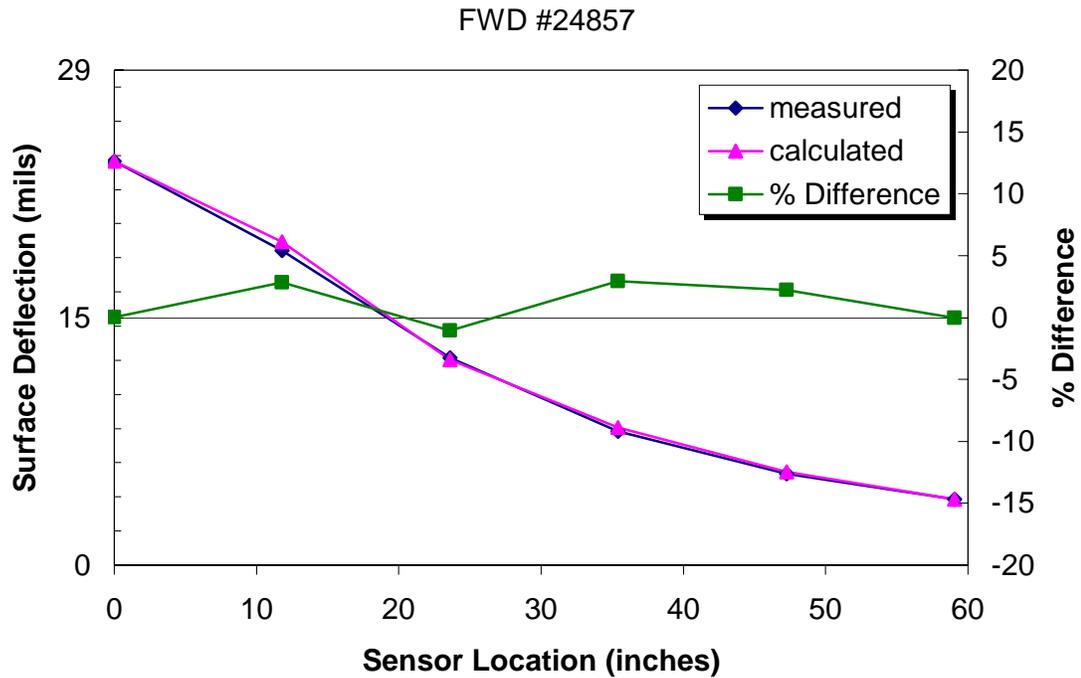
Figure 4.3. Typical Match of Measured and Calculated Deflection Basins

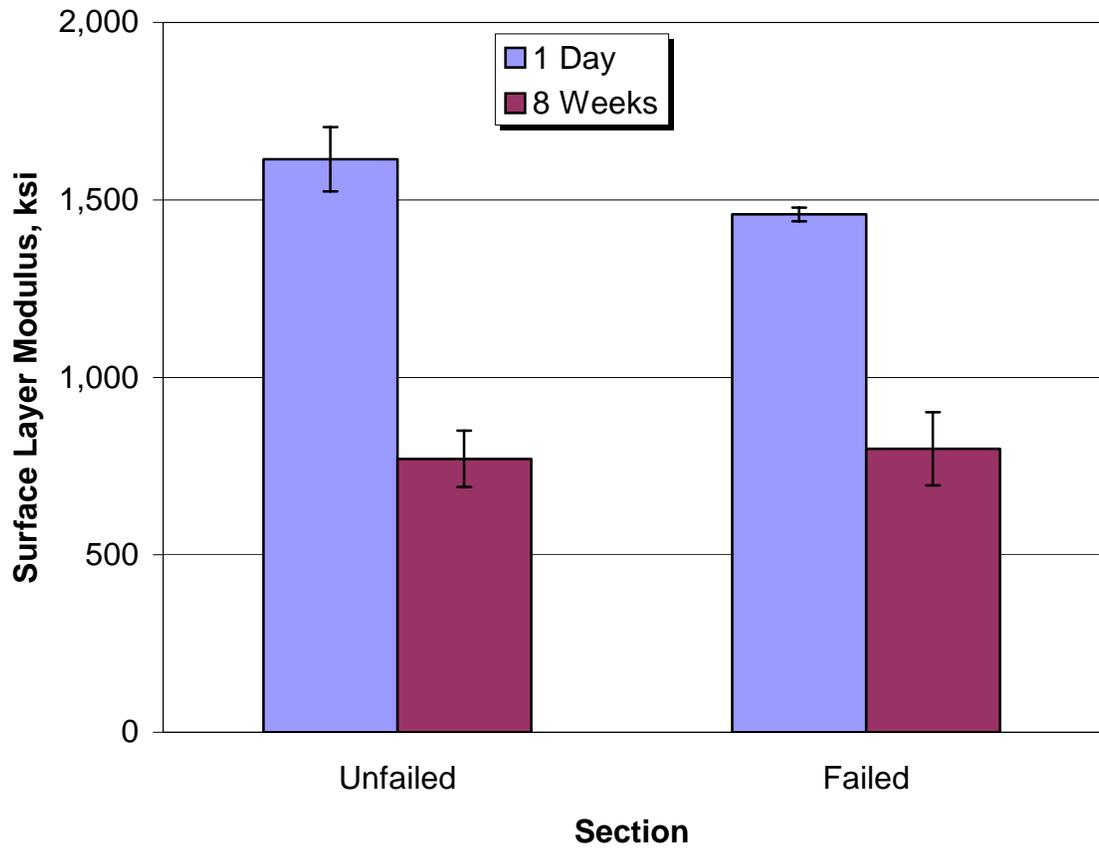
Figure 4.4. Surface Layer Moduli of Failed and Unfailed Sections (C/L, 12 kip load)

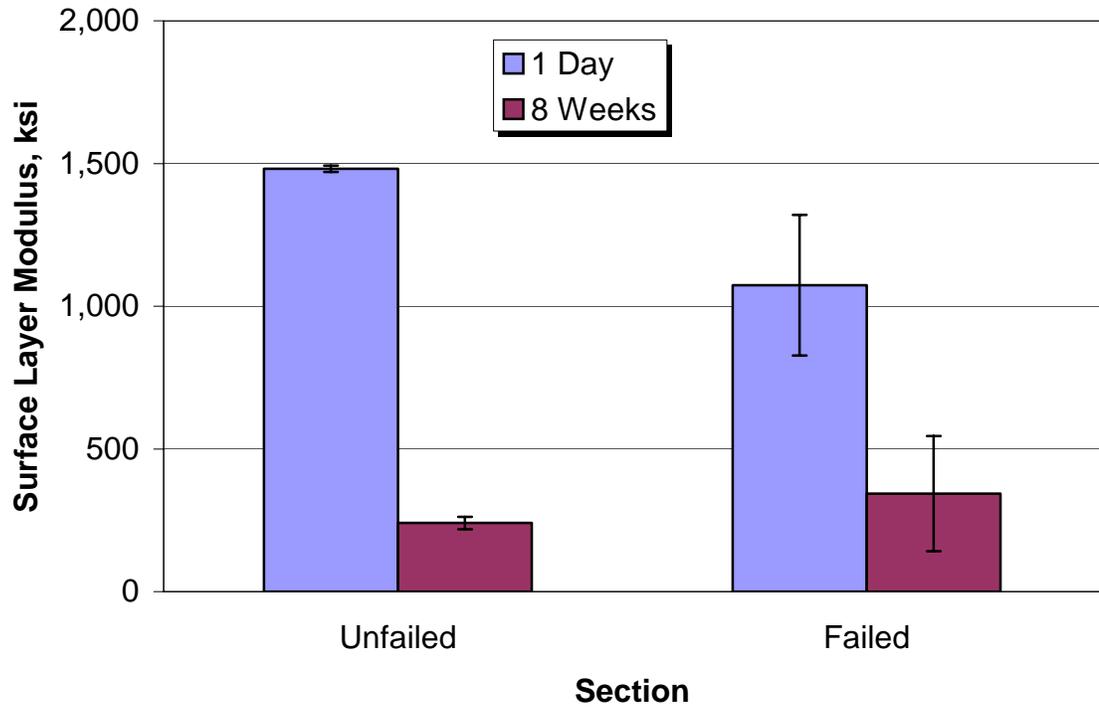
Figure 4.5. Surface Layer Moduli of Failed and Unfailed Sections (C/L, 24 kip load)

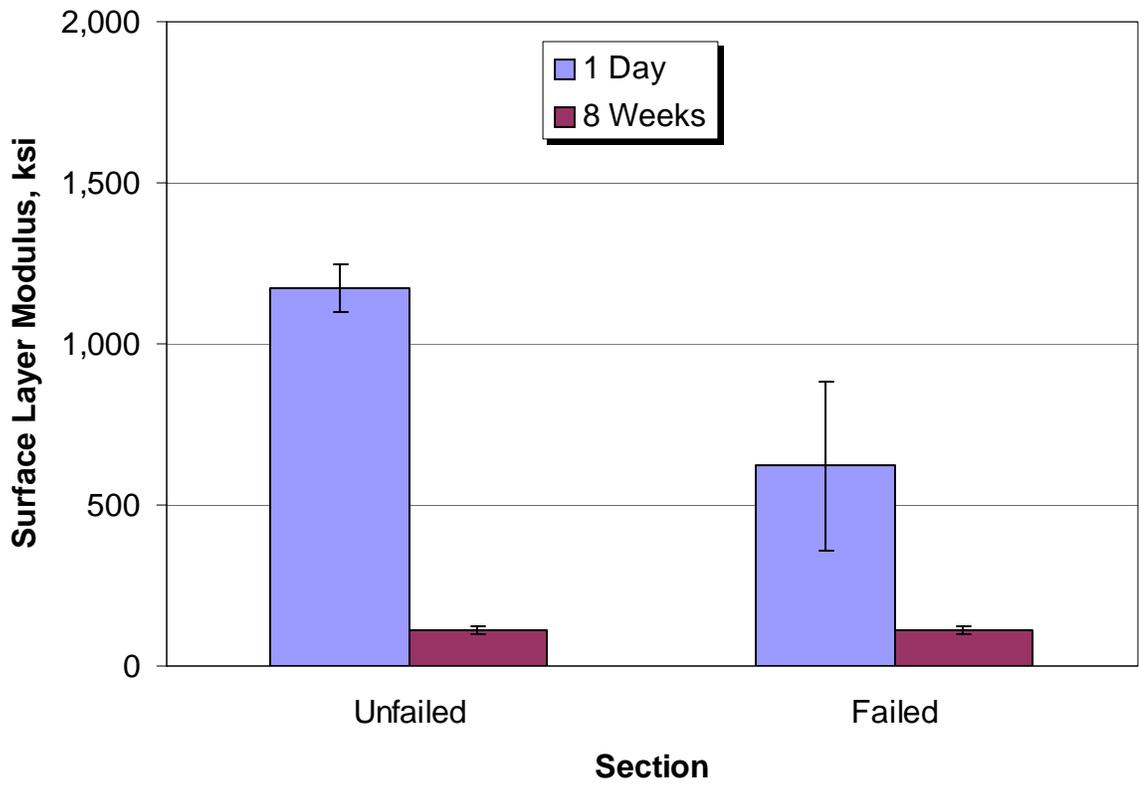
Figure 4.6. Surface Layer Moduli of Failed and Unfailed Sections (C/L, 35 kip load)

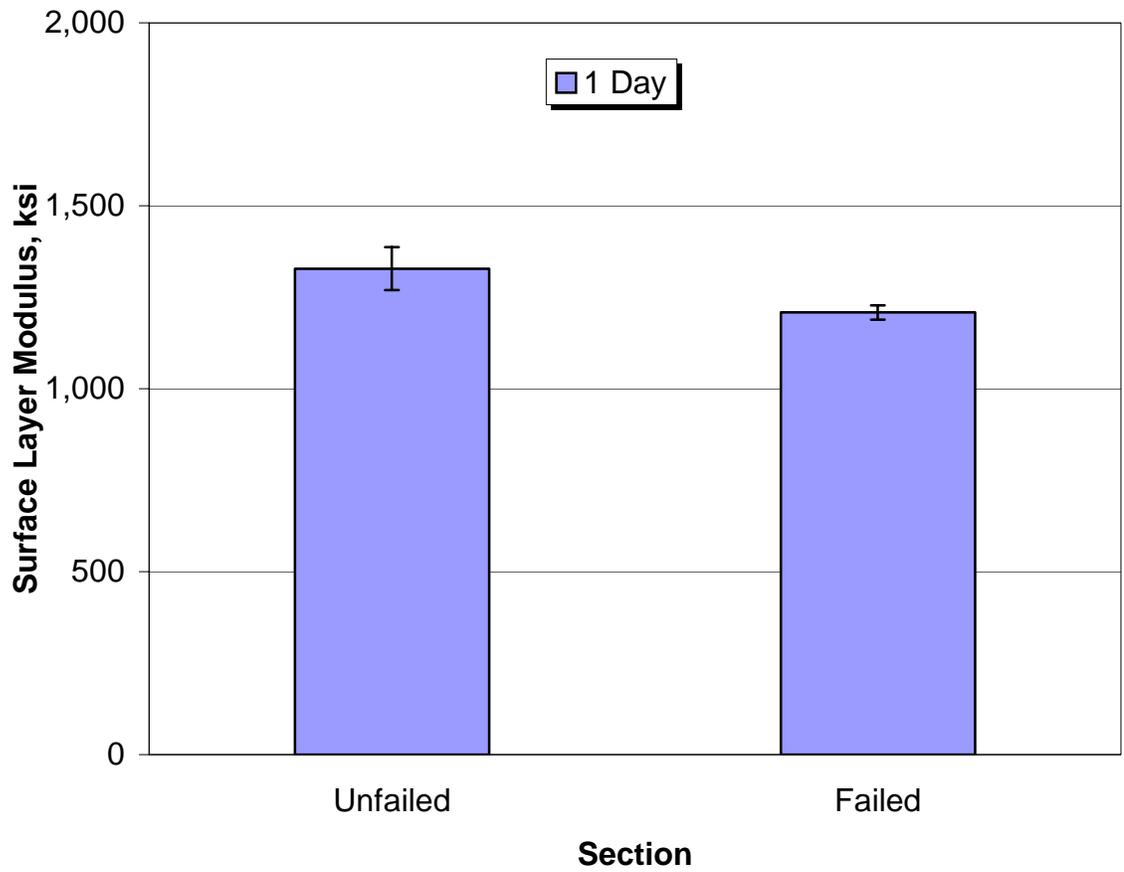
Figure 4.7. Surface Layer Moduli of Failed and Unfailed Sections (Lane 5, 12 kip load)

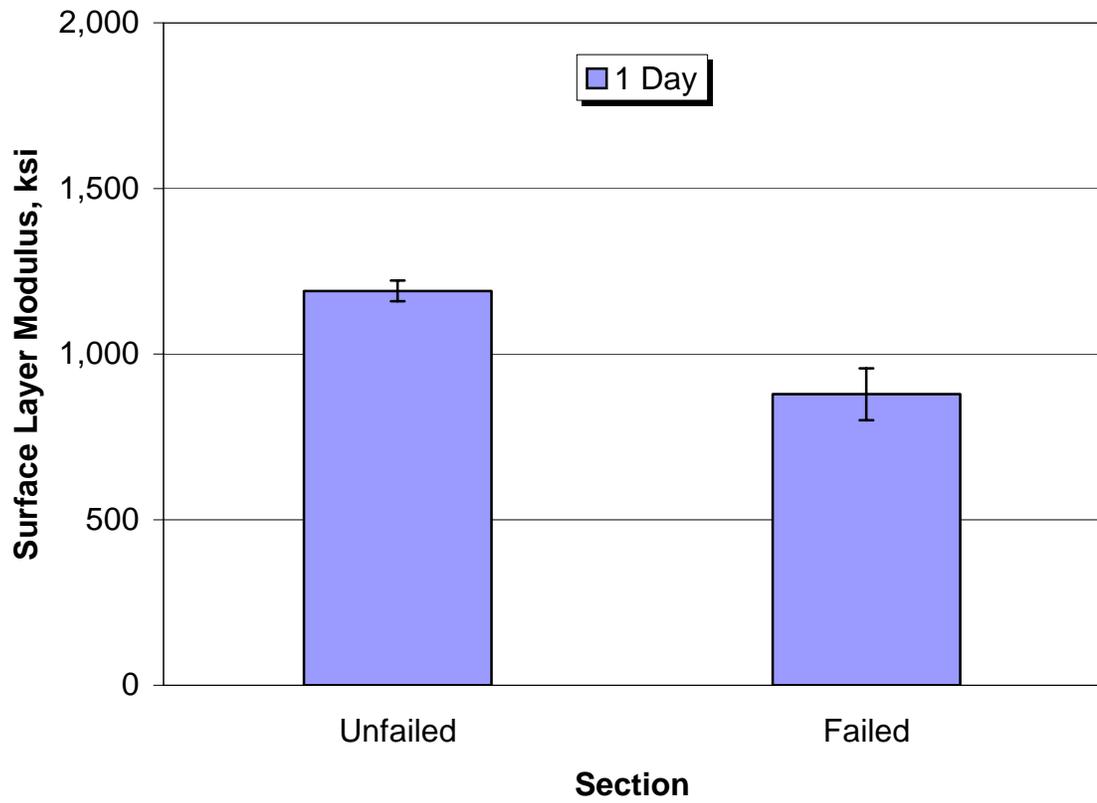
Figure 4.8. Surface Layer Moduli of Failed and Unfailed Sections (Lane 5, 24 kip load)
