**Wisconsin Highway Research Program
0092- 02-13**

**PHASE 1: Evaluation of Interlayer Bonding In
HMA Pavements**

**PHASE 2: Effect of Stiffness Ratio on Slippage
Cracking Due to Interlayer Bonding Failure in
Hot Mix Asphalt Pavements**

Final Report

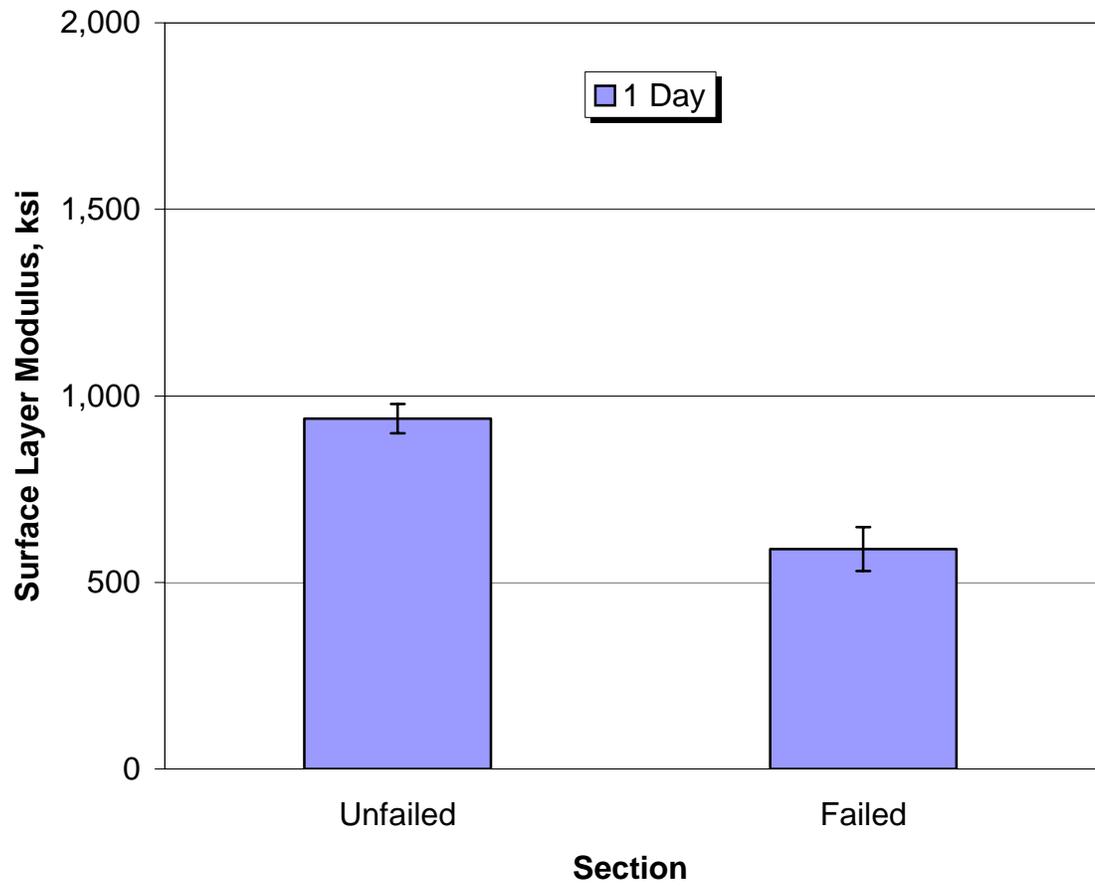
Figure 4.9. Surface Layer Moduli of Failed and Unfailed Sections (Lane 5, 35 kip load)

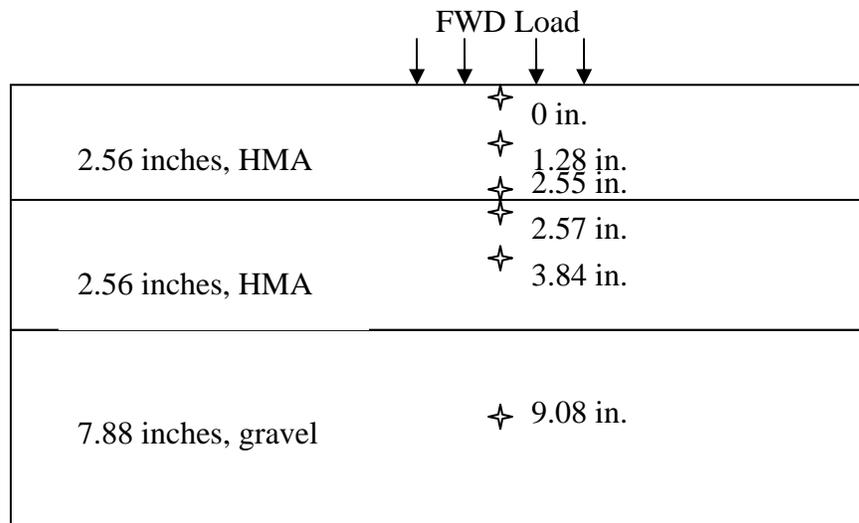
Figure 5.2. Structure and Evaluation Points Used for Preliminary Investigation

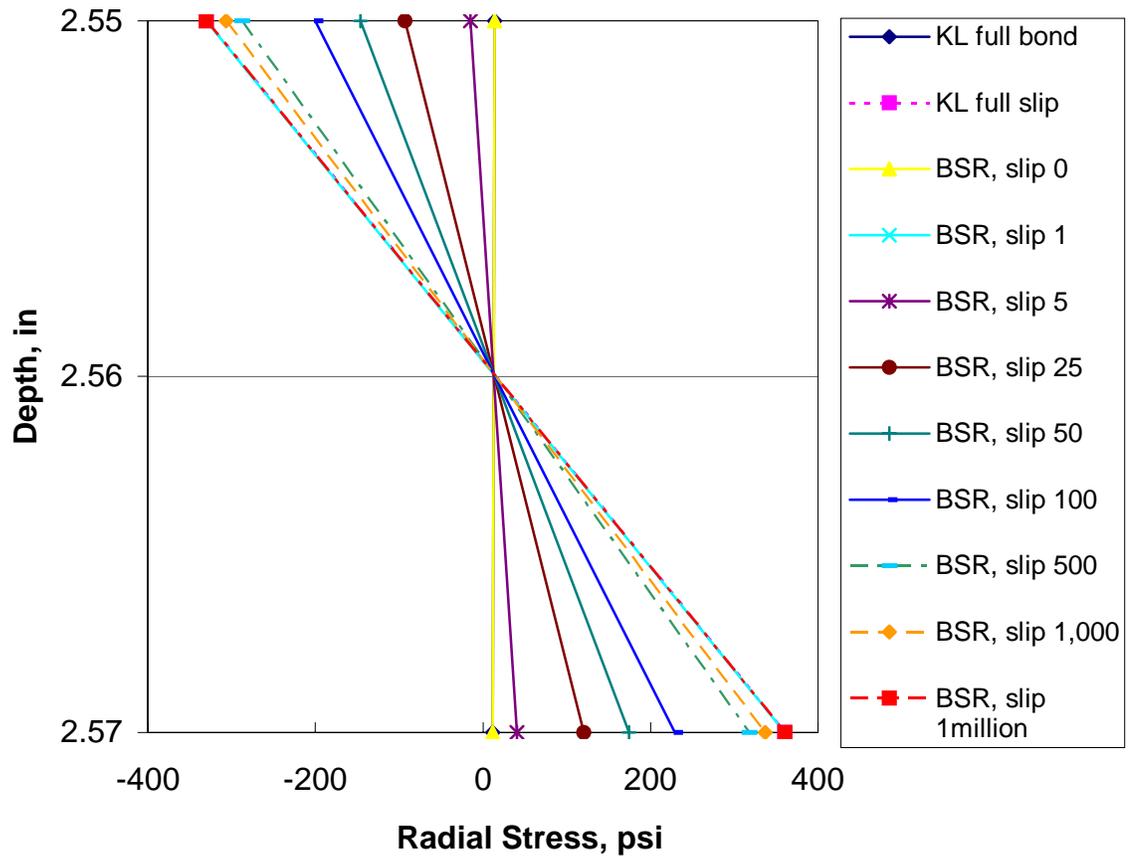
Figure 5.3. Radial Stresses at Points Above and Below Interface, for Varied Slip

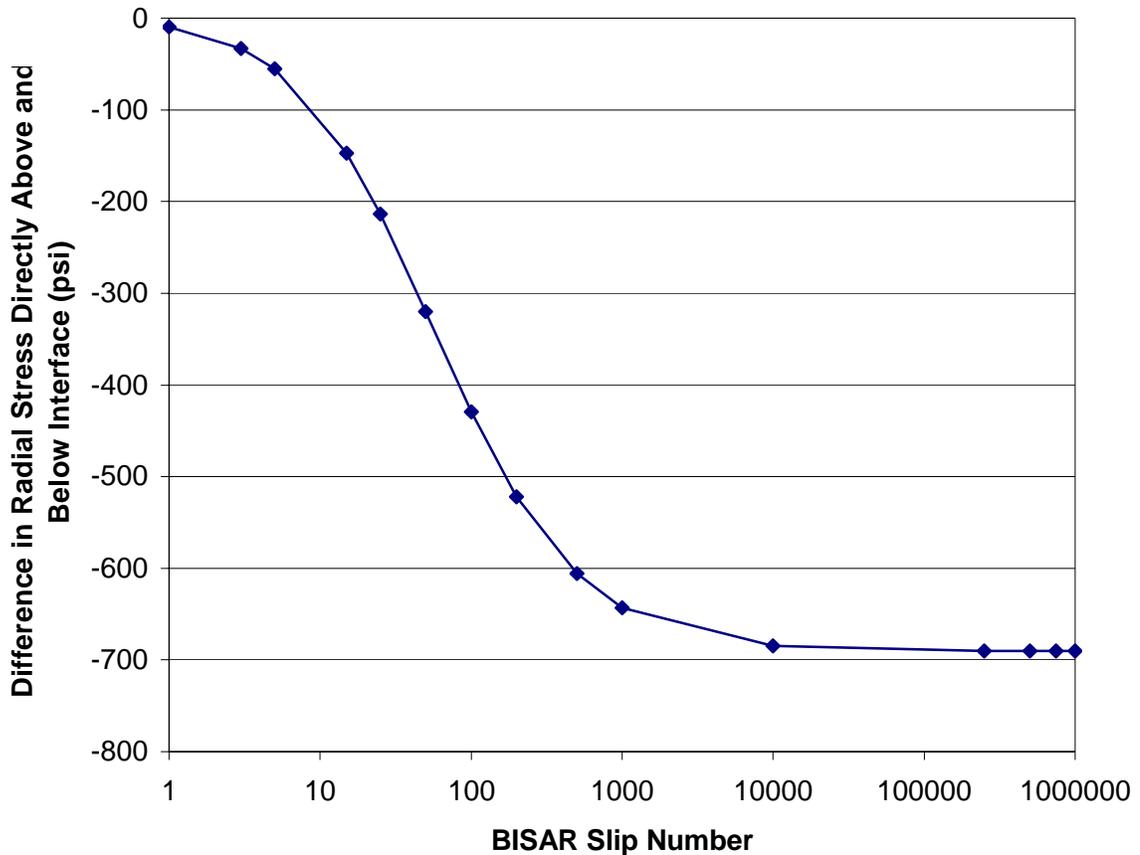
Figure 5.4. Radial Stress Differences vs. BISAR Slip Number in BISSAR Investigation

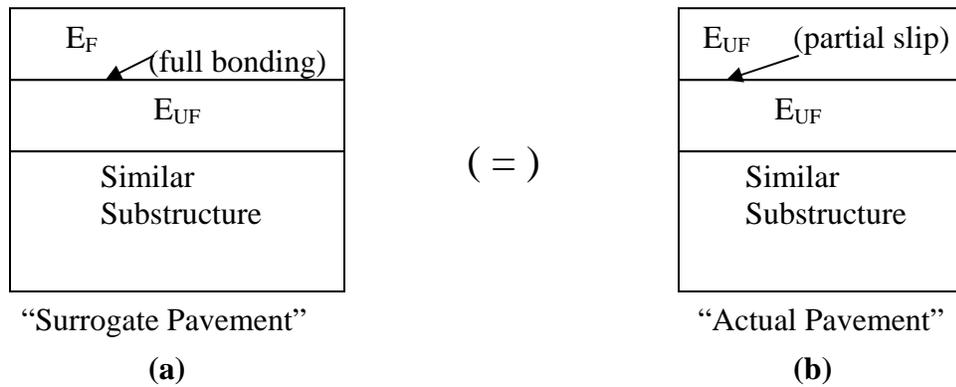
Figure 5.5. MFC Failed Section Analysis, Pavement Structure Cases

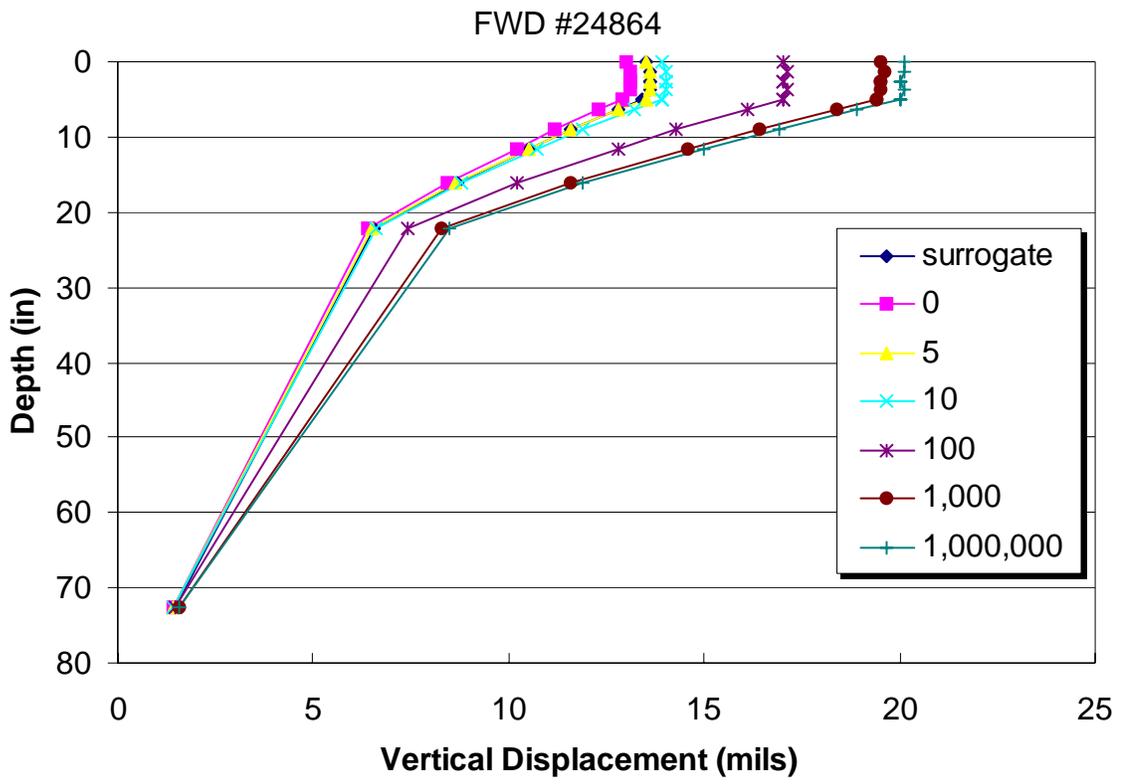
Figure 5.7. Typical Vertical Displacement Plot

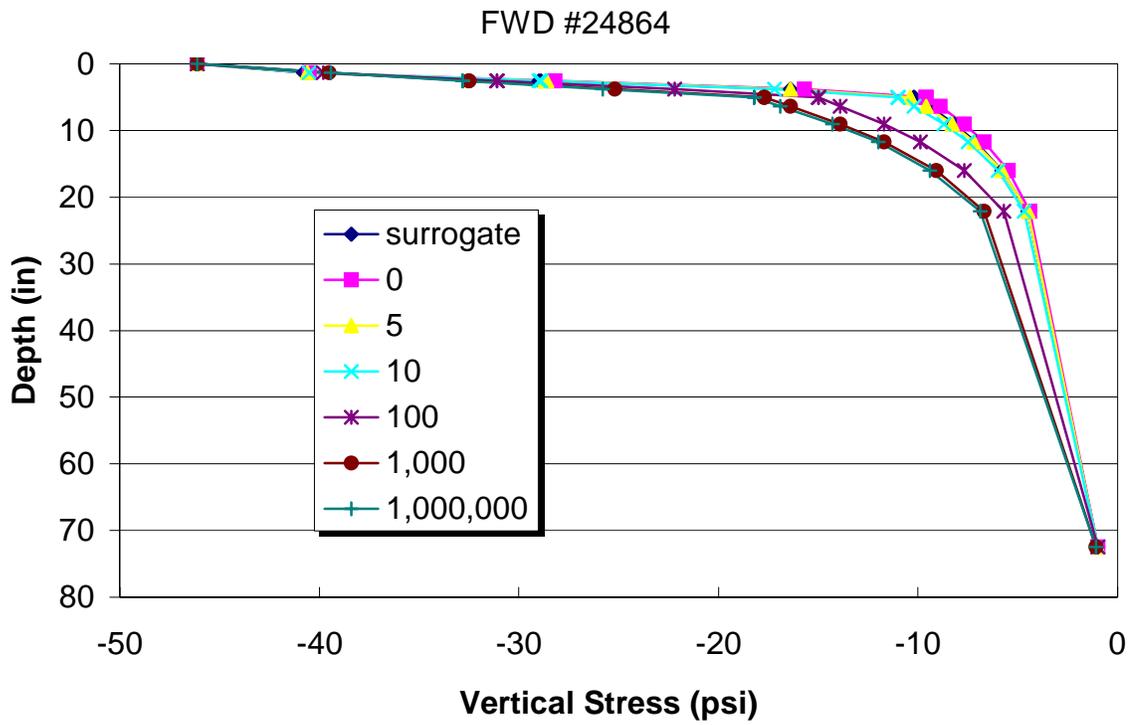
Figure 5.8. Typical Vertical Stress Plot

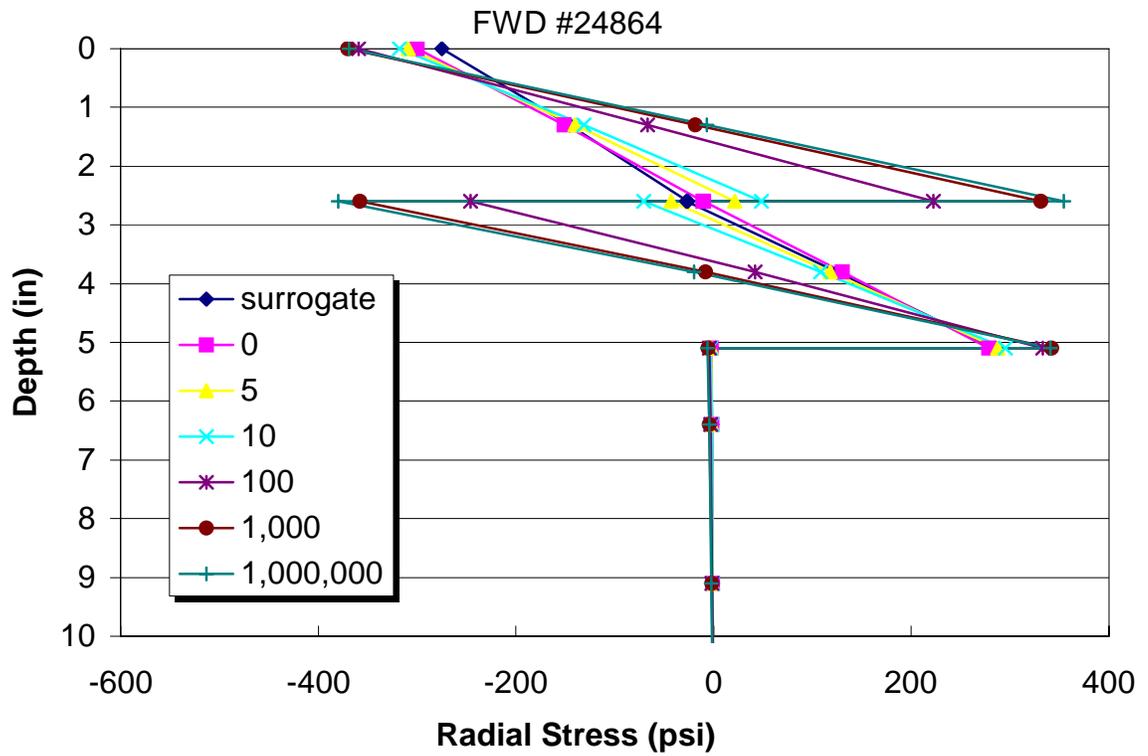
Figure 5.9. Typical Radial Stress Plot

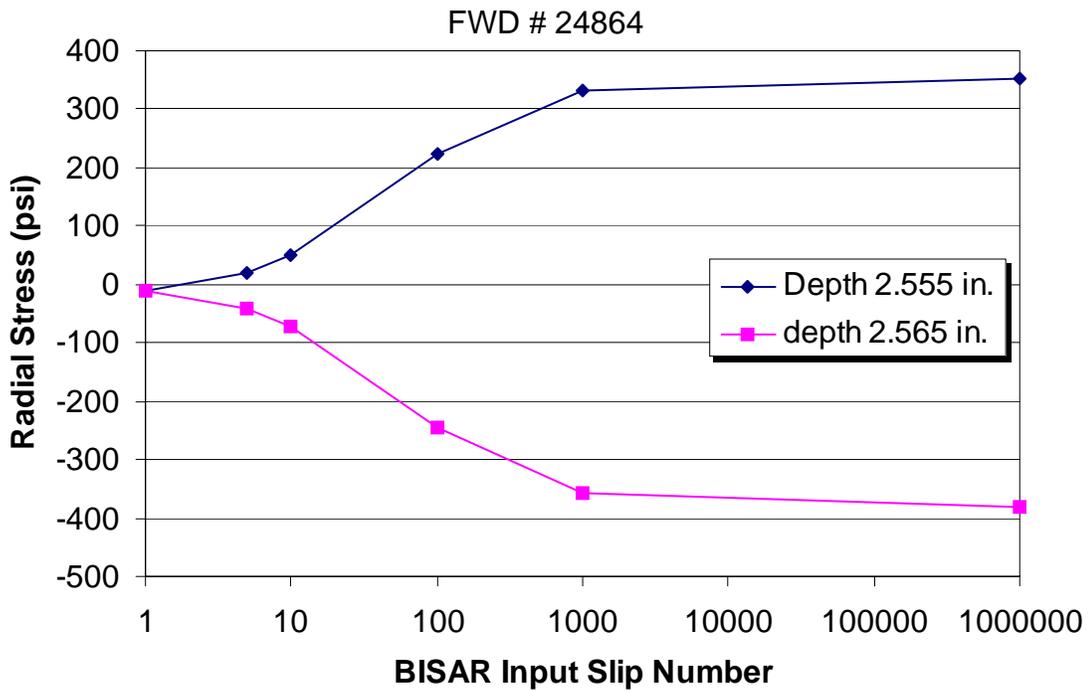
Figure 5.10. Typical Plot of Radial Stresses Just Above and Below the Interface

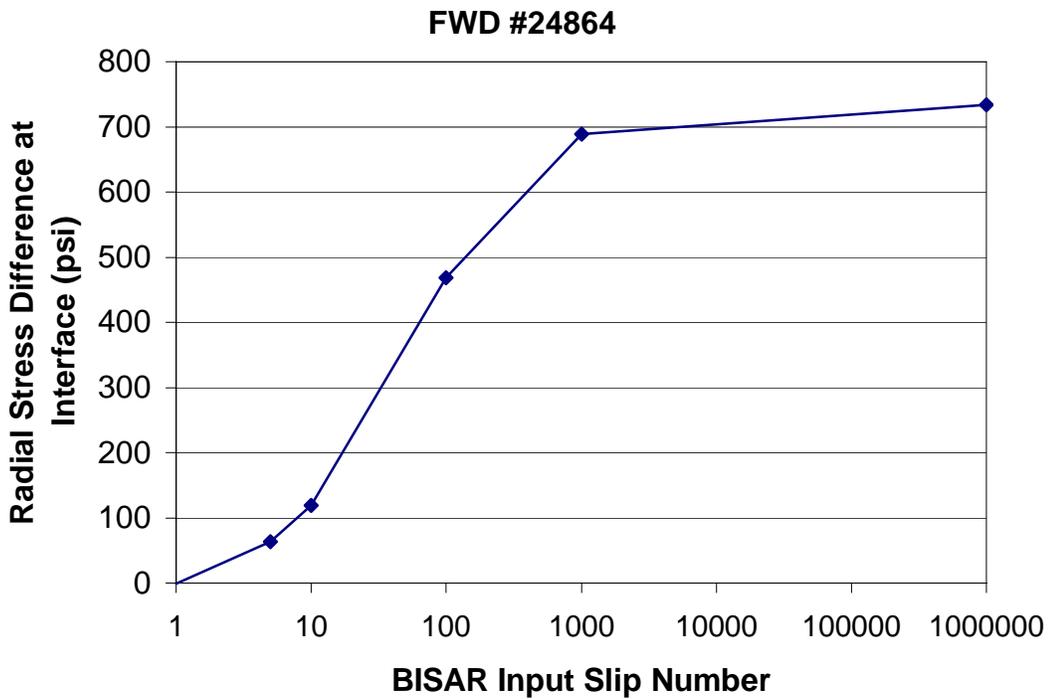
Figure 5.11. Typical Plot of Radial Stress Difference at Interface

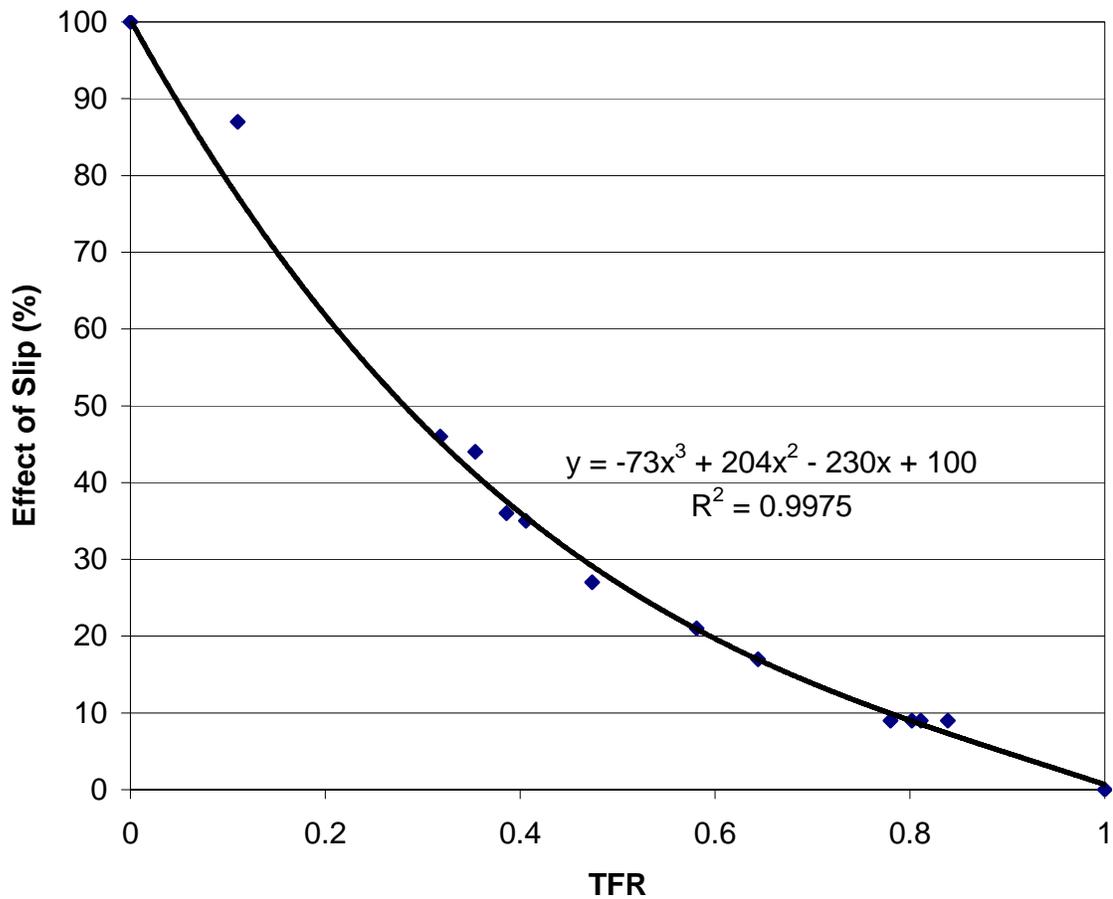
Figure 5.12. Effect of Slip / TFR Correlation

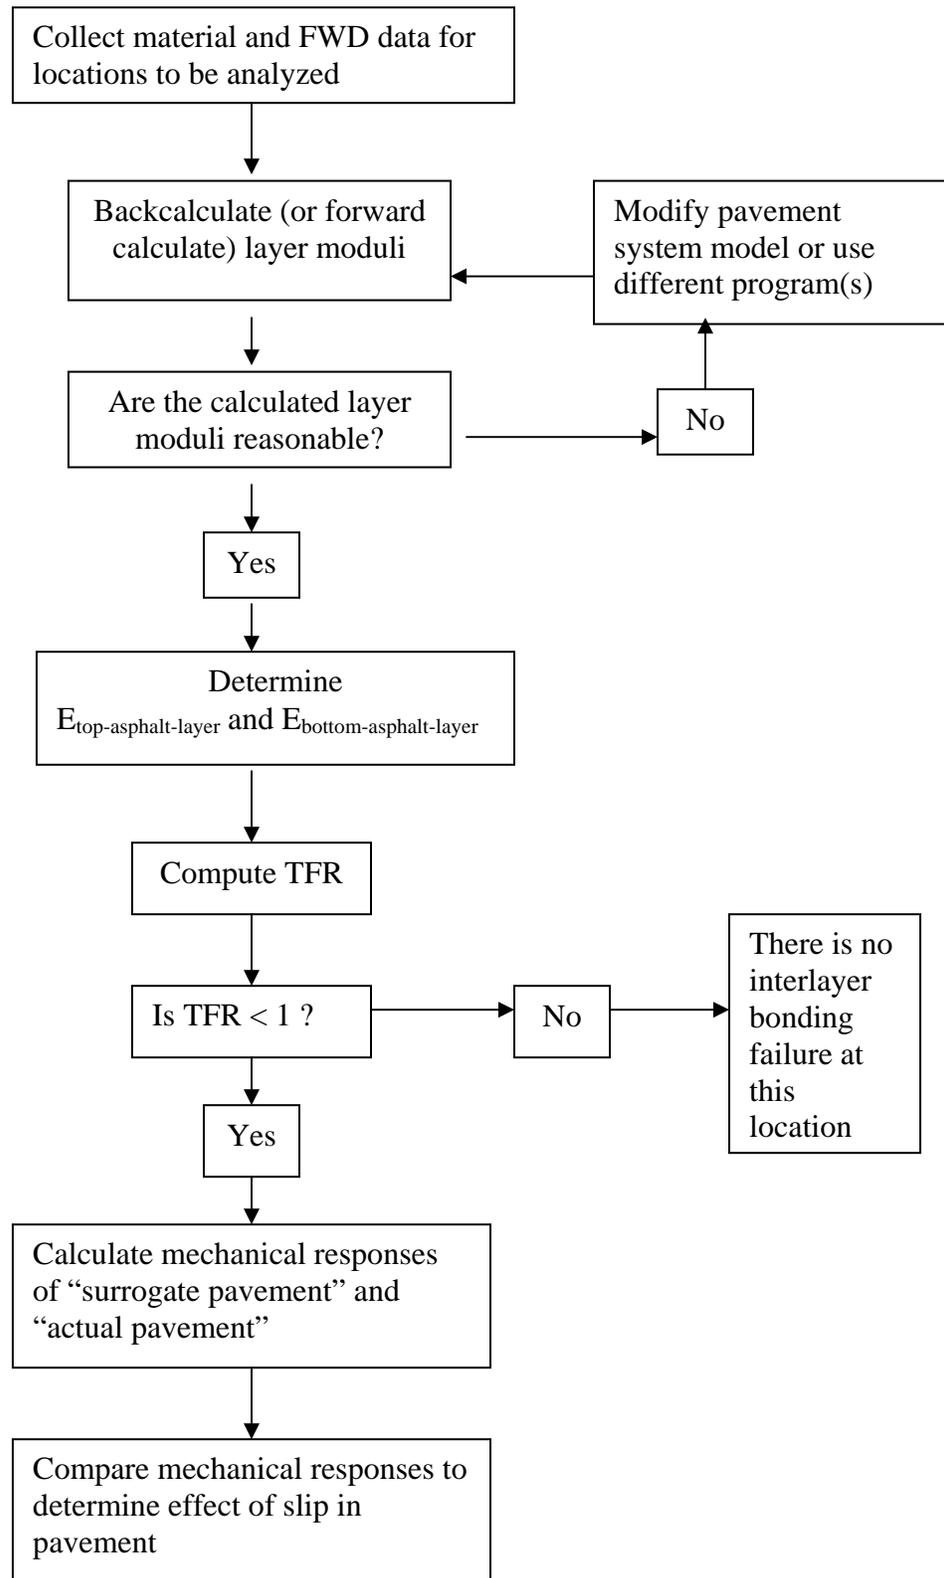
Figure 5.13. Framework of FWD Data Use in Interlayer Slip Analysis

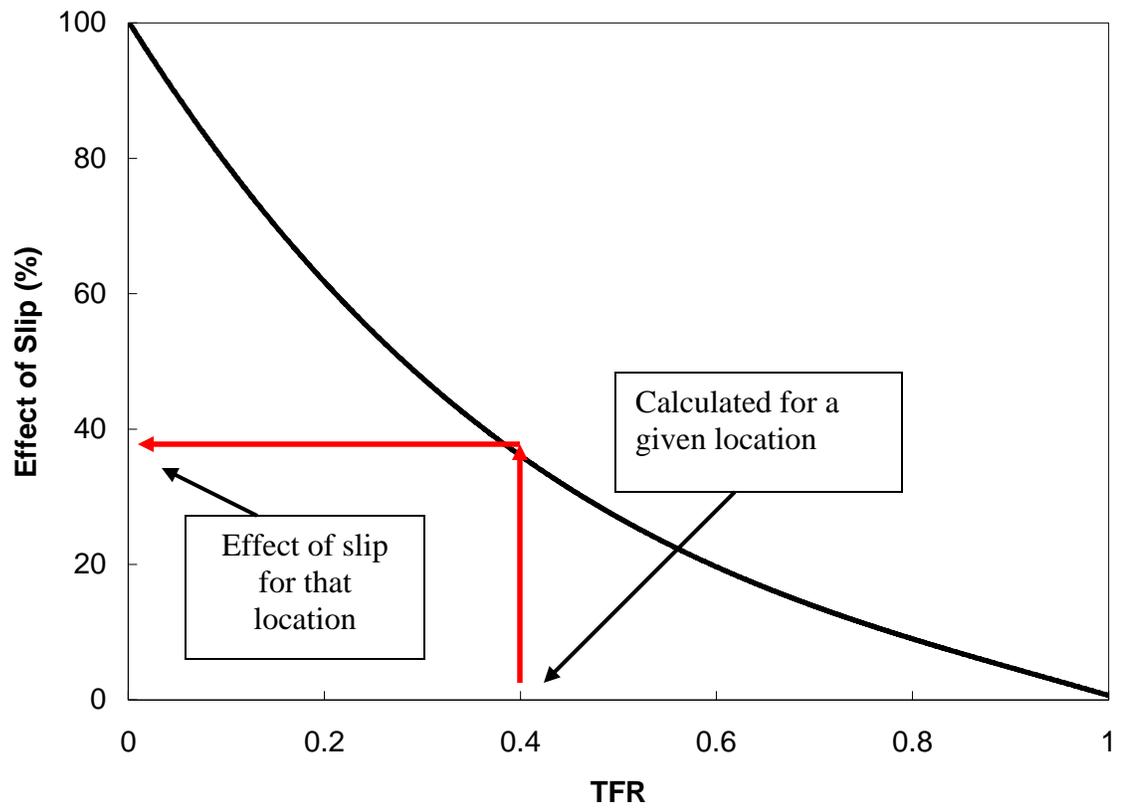
Figure 5.14. Agency Use of Effect of Slip / TFR Correlation
