BRIEF

Preventing Interlayer Bonding Failures in Asphalt Pavement

This brief summarizes Project 0092-02-13, “Evaluation of Interlayer Bonding in HMA Pavements,” produced through the Wisconsin Highway Research Program for the Wisconsin Department of Transportation Research Program, 4802 Sheboygan Ave., Madison, WI 53707.

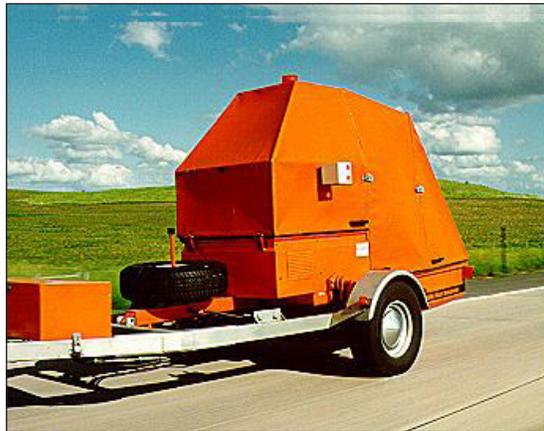
A falling weight deflectometer can identify the extent of delamination, or de-bonding, between pavement layers.

Stiffness ratios, a comparison of the stiffness or stability of the top layer to that of the second layer, were determined with the help of a falling weight deflectometer. High deflection measurements should indicate stiff, well-bonded pavement structures.
