**Perpetual Pavement
Instrumentation
for the Marquette
Interchange Project-
Phase 1**

SPR #0092-06-01

**Nicholas J Hornyak, James A Croveti
David E. Newman, Jay P. Schabelski
Transportation Research Center
Marquette University**

Marquette Interchange Perpetual Pavement Instrumentation
Project: Phase I Final Report

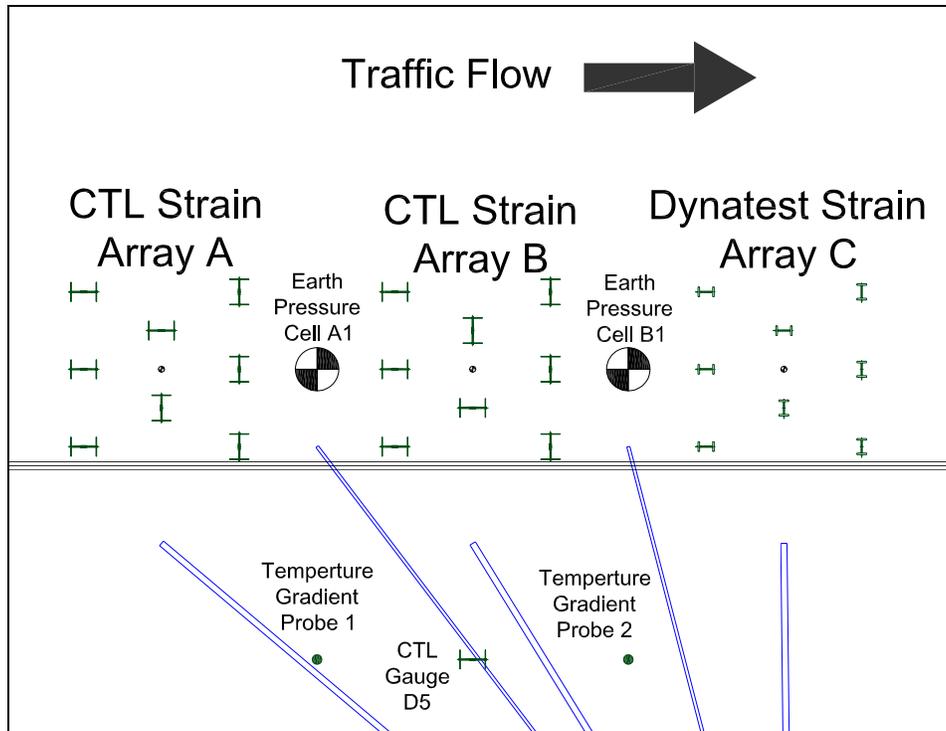
Figure 2-1 - Layout of the three strain gauge arrays, earth pressure cells, and pavement temperature gradient probes.

It is recommended that each sensor group be pre-cast into a thin asphalt stratum measuring 2 ft by 4 ft (plan) by 1 inch or less in thickness using representative paving materials obtained from Payne & Dolan. This embedment will be done by MU-TRC team members in a controlled laboratory environment to ensure the placement orientations of each sensor. These pre-cast sections will then be positioned in the field immediately prior to paving operations which will limit the exposure and maximize the survivability of each sensor. During normal paving operations, each strain sensor will be monitored by the data collection equipment to provide a record of the pre- and post-paving output of each sensor.

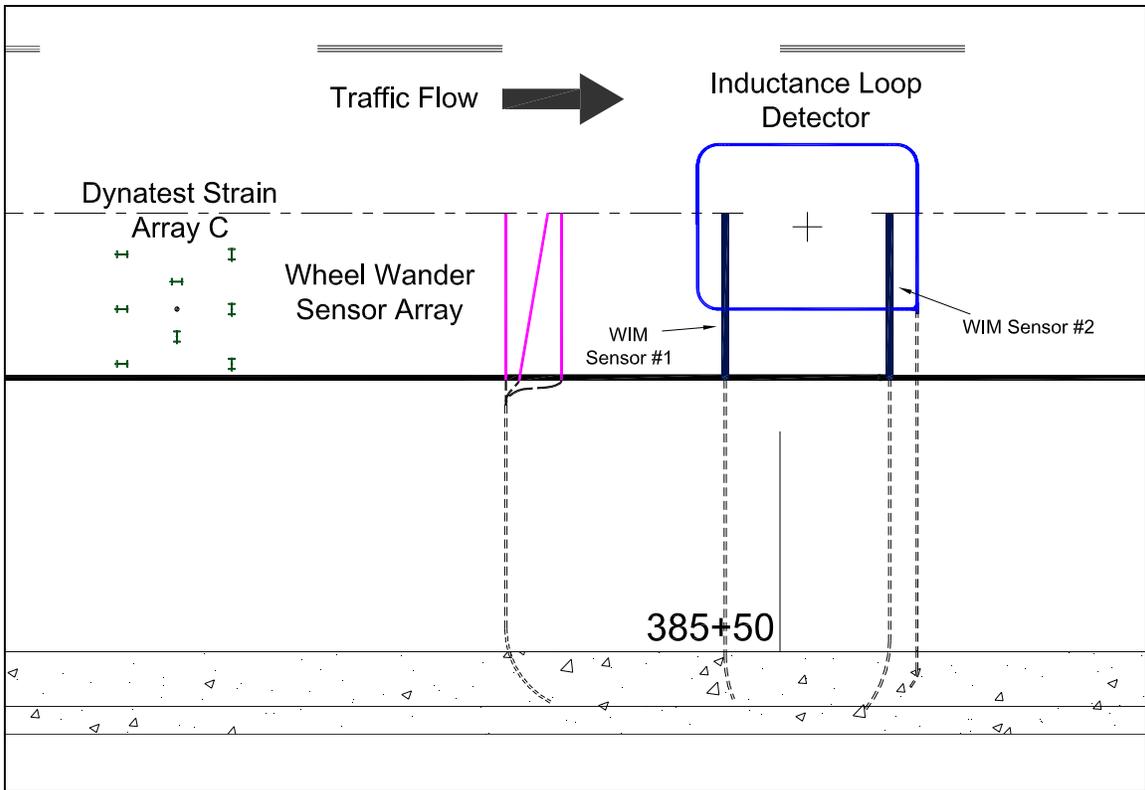
Figure 2-2 – Layout of the WIM and wheel wander systems.

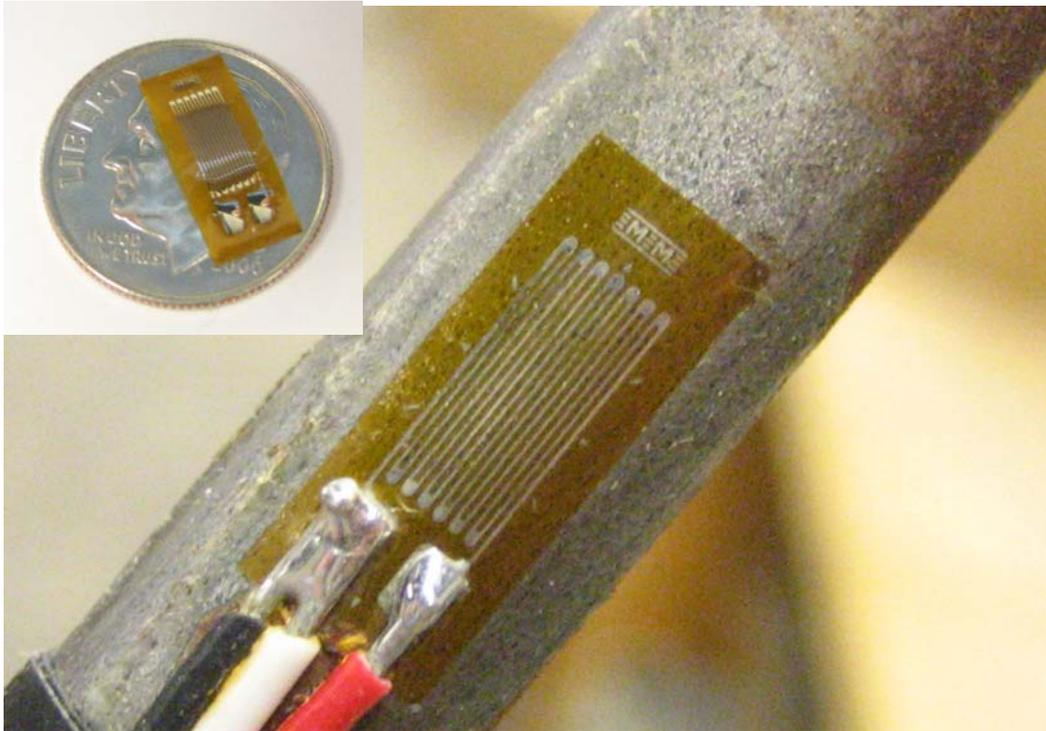
Figure 3-1- Bonded electrical resistance strain gauge mounted to a steel rod.

The sandwiched strain gauge package is adhered to the surface of the material in the location of interest (i.e. where strain is to be measured). For example, if we want to measure the strain in a steel bar under tension/compression loaded along its longitudinal axis, the strain gauge would be adhered to the bar’s surface along the longitudinal axis. The adhesion between the strain gauge and the steel rod means that when the rod is subject to loading, the strain on the surface of steel rod is transmitted to the strain gauge. It is theoretically assumed that the strain in this sandwiched package of material is the same strain in the steel bar (although there is a loss depending on the effectiveness of the adhesive securing the gauge to the rod).

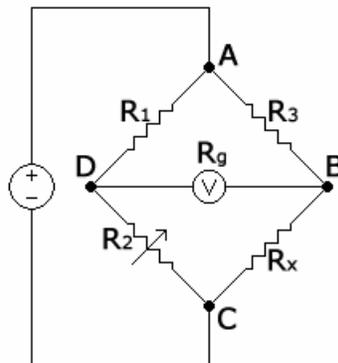
Figure 3-2 - Wheatstone Bridge circuit.

This relationship is quite simple in theory, in practice however this change in resistance is not measured directly. Samuel Hunter Christie in 1833 developed an instrument to measure unknown resistances. This tool was popularized by Sir Charles Wheatstone and became known as the Wheatstone Bridge. The Wheatstone Bridge can best be described as a DC circuit with four resistors; two parallel circuits containing two resistors in a series as shown below in Figure 3-2.

For the purposes of measuring strain, the resistors in the diagram can be replaced with any number strain gauges (actually only one, two, or all four for practical applications). There are multiple arrangements, but the broadest

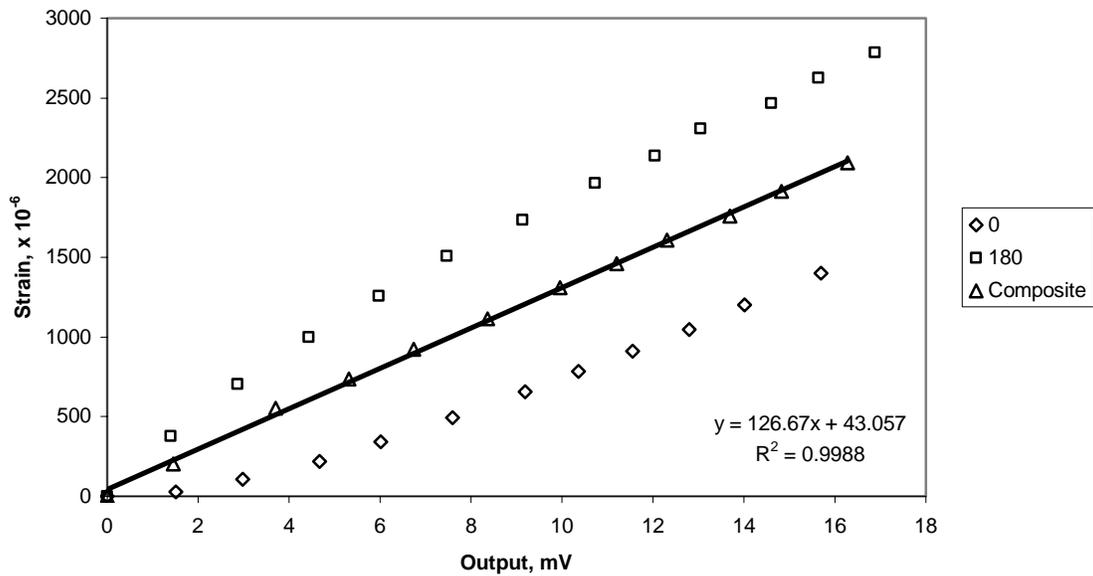
Figure 3-4 - Example of calibration data.

The result was two sets of data that both contained data from the extensometer and the CTL ASG. Since the load steps were exactly the same for both tests, pairs of data from each data set could be combined; the addition of which balanced out bending strains generated during the test. An example of the data pairs and their combination is shown below for one such test.

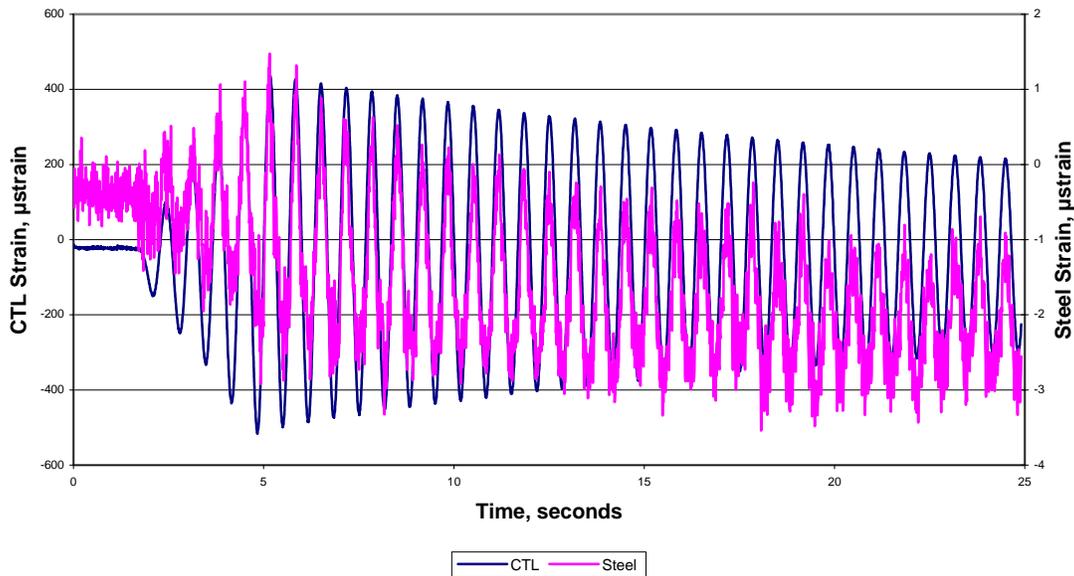
Figure 3-5 - Dynamic response of CTL gauge.

service. It should be pointed out the even if an accumulation of strain were observed, in service conditions would most likely push the gauge back to its original position due to its encapsulation in the pavement. This could be checked experimentally by casting the gauges into a block of epoxy or some other material (preferably something linearly elastic) and running more dynamic tests.

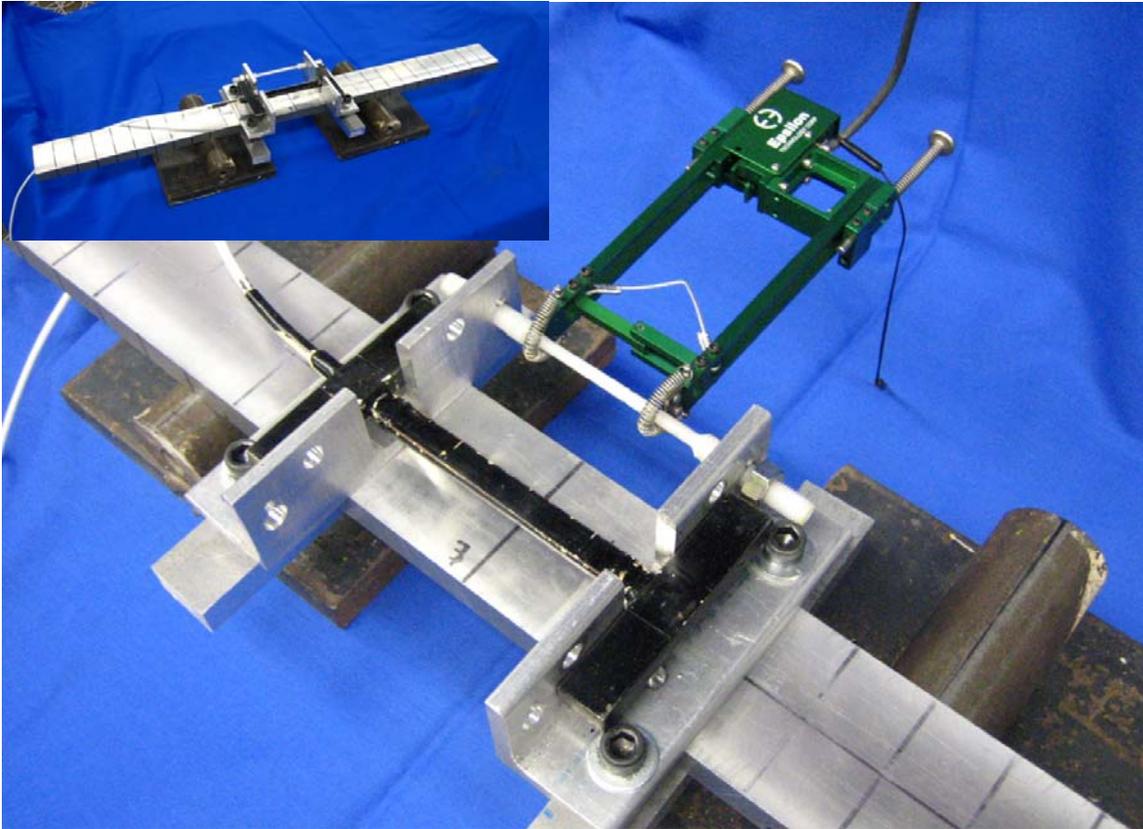
Figure 3-6 - Test setup for calibration of the Dynatest gauges.

The first trial had problems with remaining straight during testing, so the second iteration of the experiment was developed using an aluminum beam. The supports from the first design were modified and tightly clamped to the beam. The gauge and a small nylon rod could then be securely placed between the clamps. The clamps, rod, and Dynatest gauge were located at mid-span of the aluminum beam. The beam was then subjected to loading that placed the mid-section under a constant bending moment. This setup allowed for a secure connection between the rod, Dynatest gauge, and the beam. Loading the beam then caused tension in the Dynatest gauge and the nylon rod. The step is shown below.

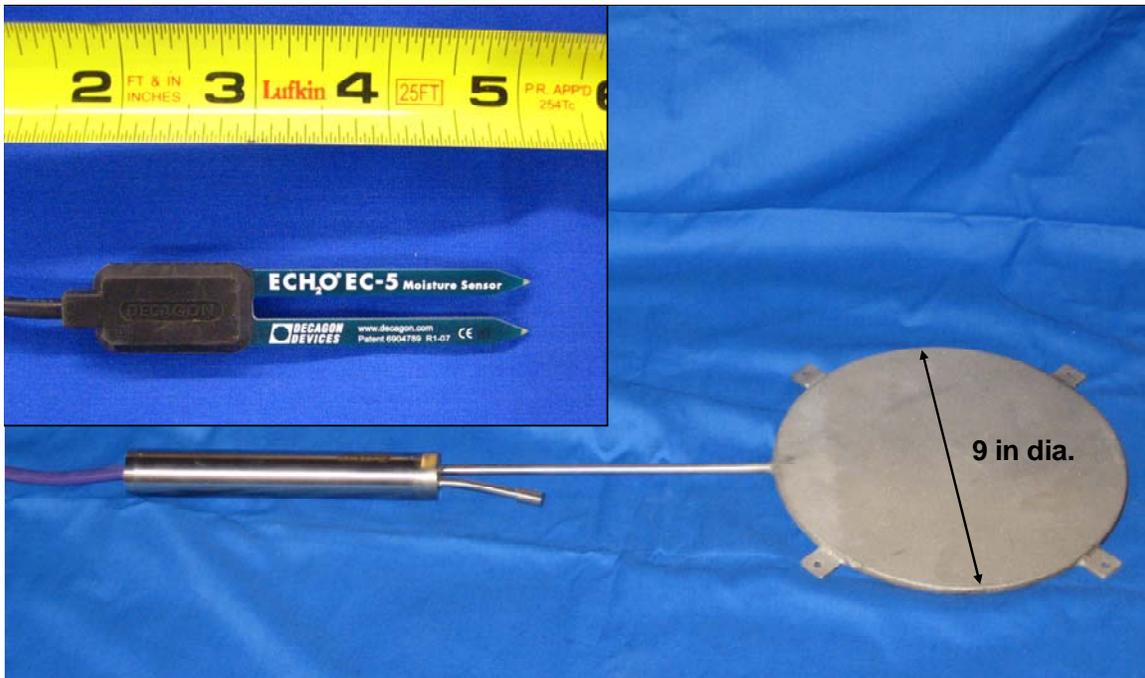
Figure 3-7 - Geokon earth pressure cell and Decagon soil moisture probe.

The Geokon earth pressure cell (EPC) is a sensor created to measure pressures applied to its flat circular surface (Figure 3-7). There are a handful of different models all adapted to measure pressures exerted by various materials in any orientation. For this research project, the EPC's will be used to measure vertical pressures due to gravimetric soil and pavement loads in combination with dynamic traffic loads. These particular sensors were selected for this research project based on past use in other pavement research programs (8, 9, 17).

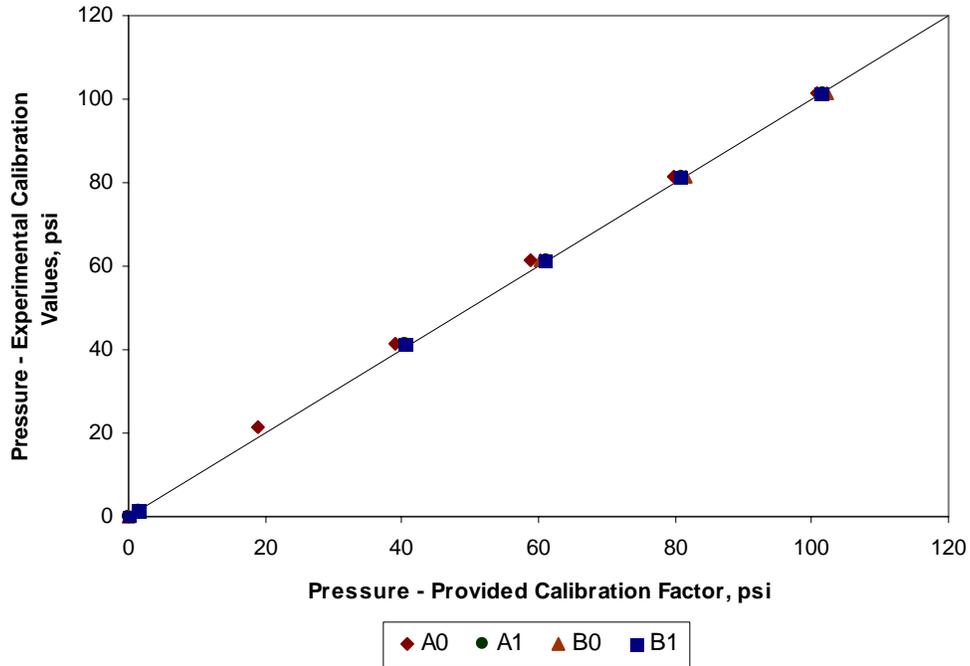
Figure 3-8 - Earth pressure cell calibration data.

Testing consisted of putting the plate into the vessel and increasing the pressure in steps while measuring the output of the transducer. The load and output voltage data were then plotted and the data points fitted with a best fit line. It was concluded that the plates performed very well and fell within the manufacturer's specified range. The manufacturer's specified calibration factor is 0.2 MPa/Volt (29.008 psi/Volt). The experimental calibration yielded factors just slightly higher by 0.1 to 0.2% of the given value. Figure 2 illustrates the calibration values obtained during calibration testing compared to those supplied by the manufacturer.

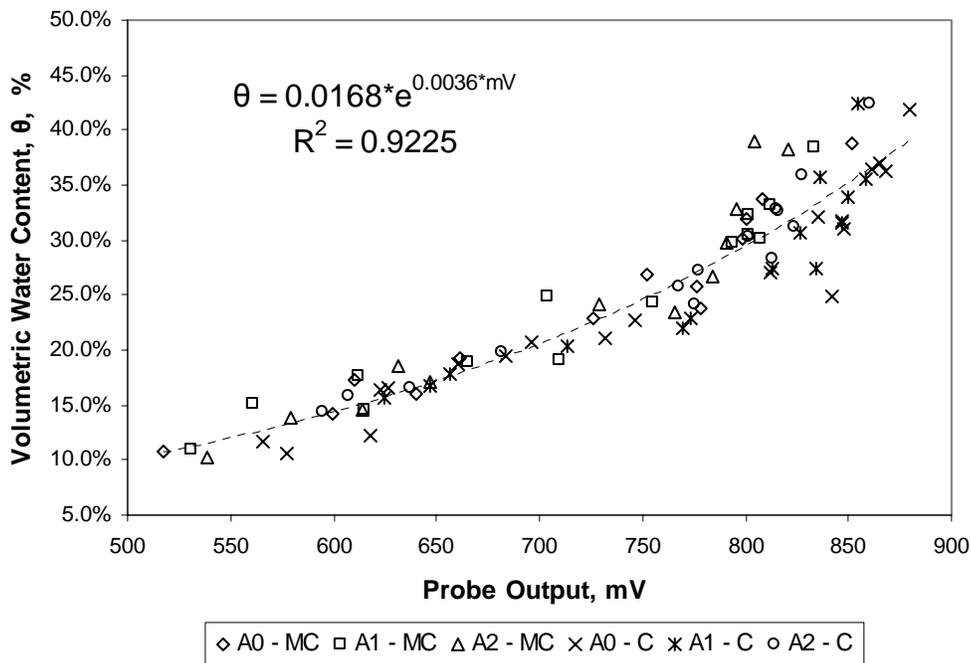
Figure 3-9 - Relationship generated between probe output and volumetric water content (θ) for three probes and two different soil types. The probes and soil type are designated respectively as A0, A1 and A2; and MC (silty-clay) and C (clay).

calculated. A plot of output voltages versus volumetric water content was created for each soil type and probe combination. The trends were in fact all very similar for the different soils and probes. The manufacturer calibration equations suggest a linear trend. They acknowledged, along with other studies, that a non-linear relationship exists between output signal and volumetric water content, especially at high moisture contents (21, 22).

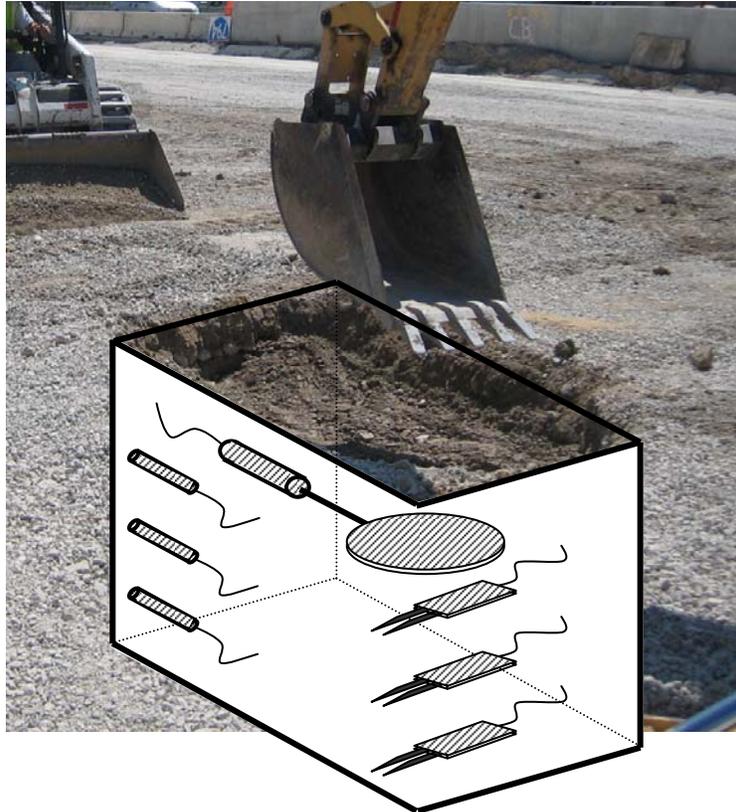
Figure 3-10 - The final arrangement of the sensors after installation. The EPC is aligned so that the sensor leads point into the direction of traffic. All moisture sensors have the pronged end facing east and all temperature sensors have their leads facing north.

soil level brought up to the next level and so on until all temperature/moisture sensors were installed as shown below in Figure 3-10.

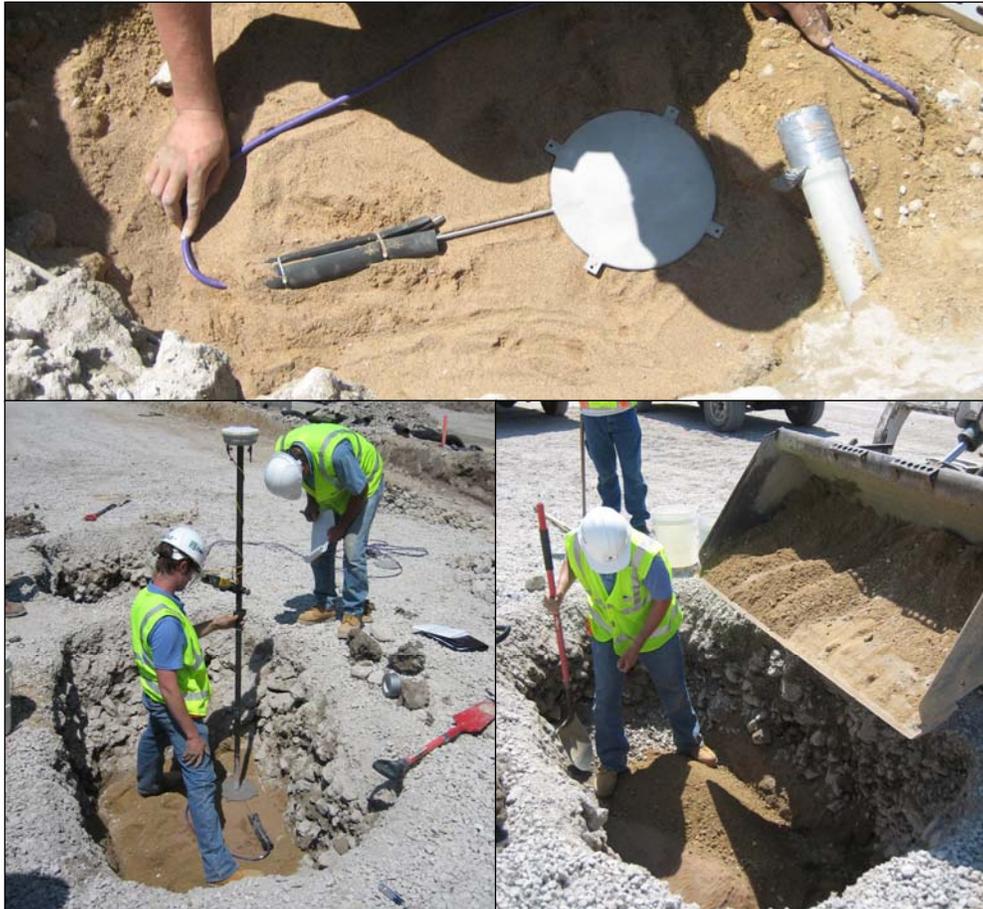
Figure 3-11 –Top: Placing EPC in a bed of fine sand and routing sensor cable carefully. Bottom left: Measuring and recording the final location of the EPC with a GPS based measuring device. Bottom right: Backfilling against the EPC with sand.

materials were placed in lifts and compacted by dynamic force from the bucket of a backhoe being dropped repeatedly. The possibility of damage to the instruments after the fine sand layers were placed became minimal.

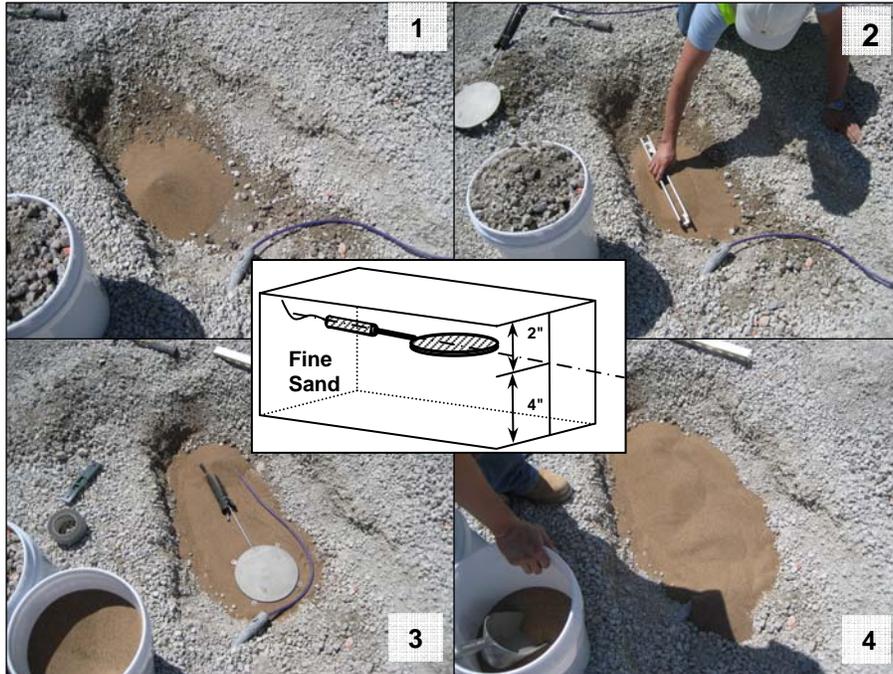
Figure 3-12 - Steps in installing EPC. 1) Filling the cleaned excavation with a bed of fine sand. 2) Leveling the sand out and preparing for EPC placement. 3) Leveling the cell and routing the sensor lead in a safe direction. 4) Backfill against the cell with more sand which would then be followed by the pre-existing base material, compacting each layer by hand. The inset sketch shows the layout of the sensor schematically.

procedures for installing the plates followed the manufacturer's instructions provided with the instruments. A few important steps for installing the pressure cells are shown pictorially in Figure 3-12.

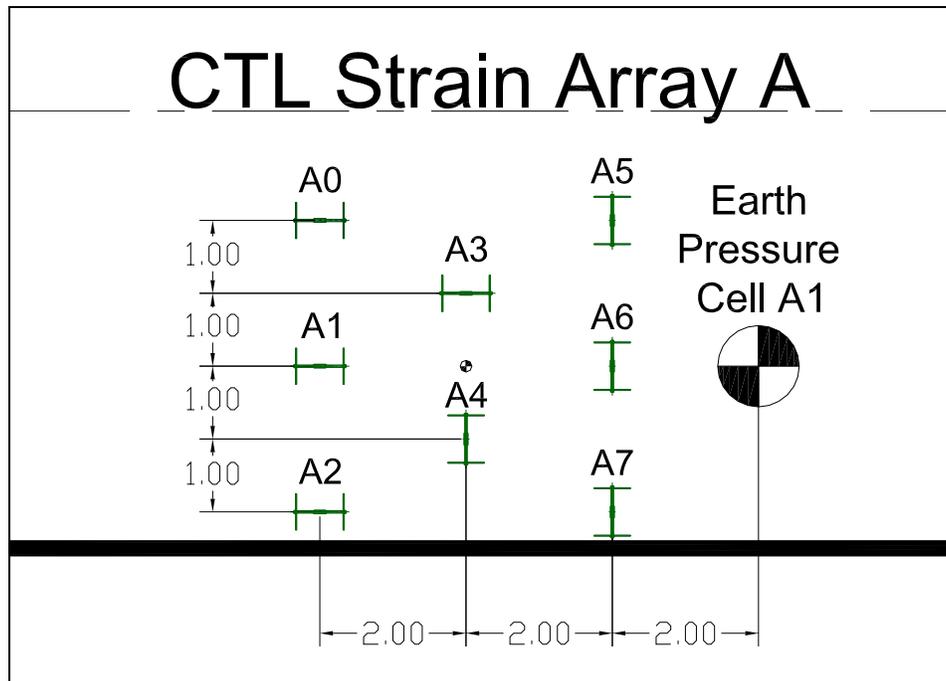
Figure 3-13 - Spacing of the strain gauges and earth pressure cells are shown above. All units are in feet. Note that the orientation of the two gauges in the middle of the array alternate rotation angles (transverse vs. longitudinal) for the two CTL arrays as shown in Figure 3-14.

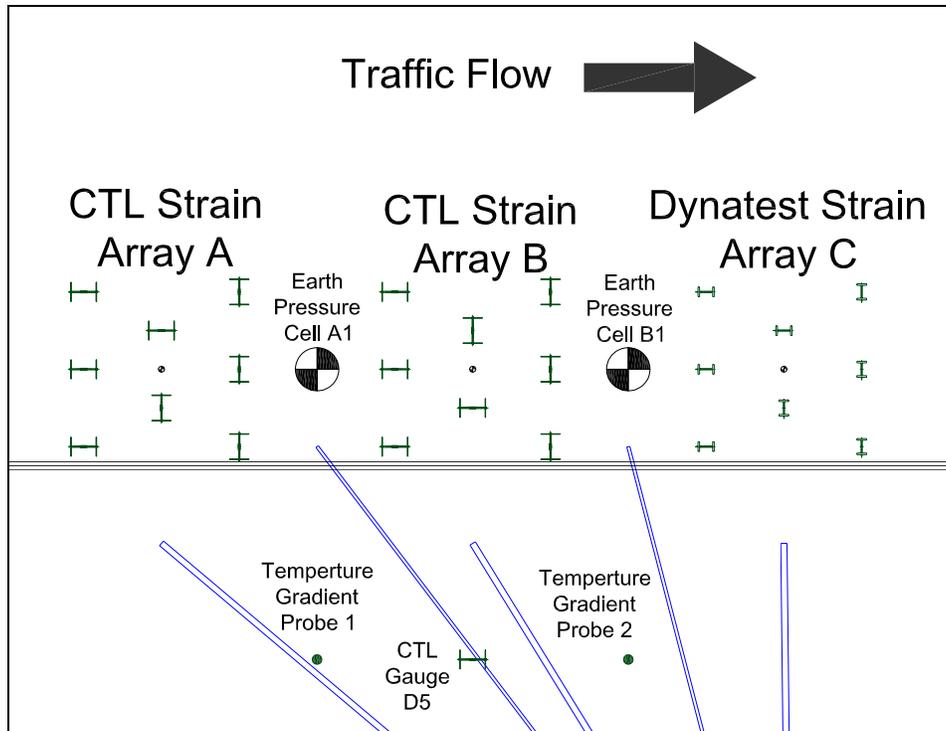
Figure 3-14 - Final configuration of strain gauges, earth pressure cells, and pavement temperature gradient probes.

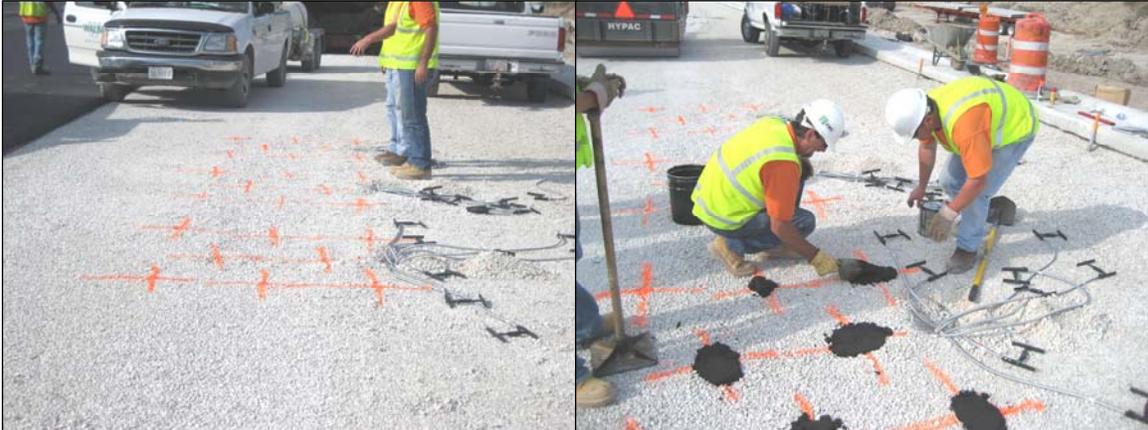
Figure 3-15 - Left: Marking the proposed locations of the gauges. Right: Placing sand/binder pad and fitting gauges.

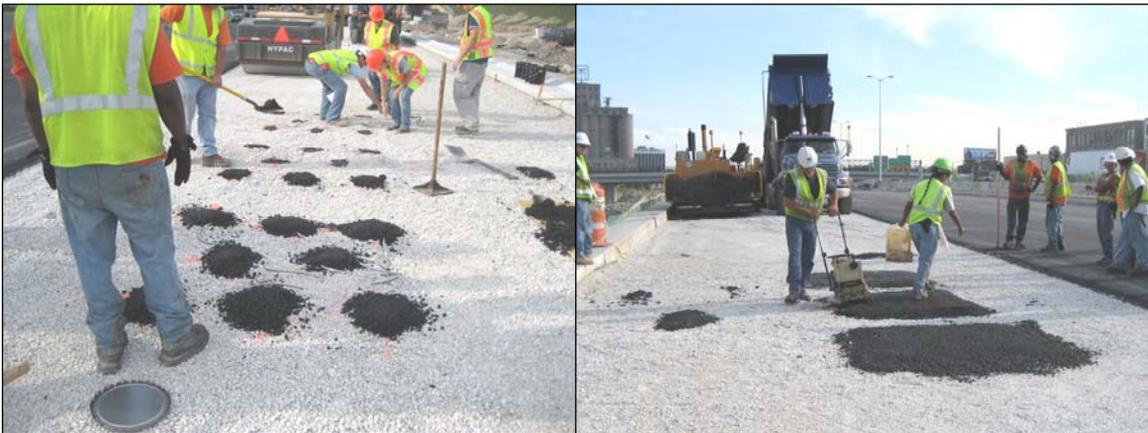
Figure 3-16 - Left: Placing screened asphalt on top of gauges and carefully compacting. Right: Compacting the unscreened asphalt over the gauge arrays with the paving crew approaching.

with screened asphalt, the gauges were checked once more for sensor leads that were misplaced. A layer of unscreened asphalt (about 2 inches thick), was placed on top of the gauge arrays and compacted using a gas powered plate tamper shown below in Figure 3-16.

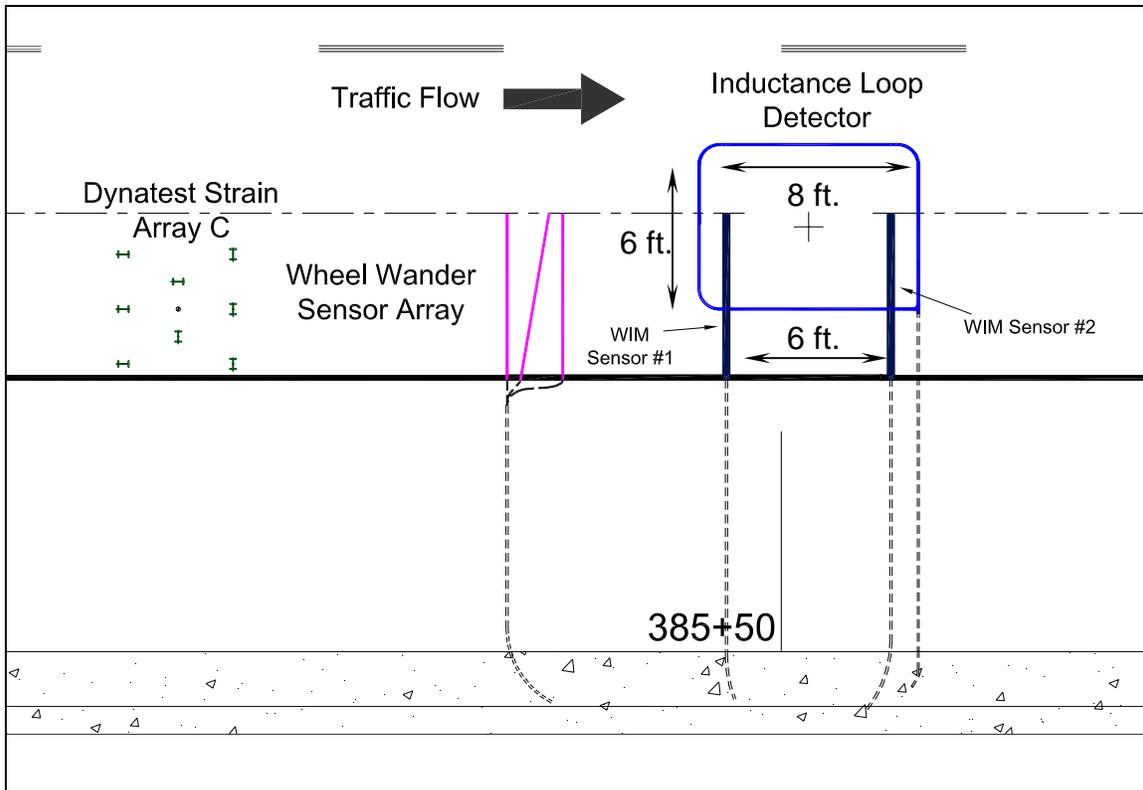
Figure 3-17 - Layout of the WIM sensors (loop detector and two quartz piezo strips) and the wheel wander sensors. The conduits installed into the pavement are also shown as hidden lines extending from the instruments to the curb.

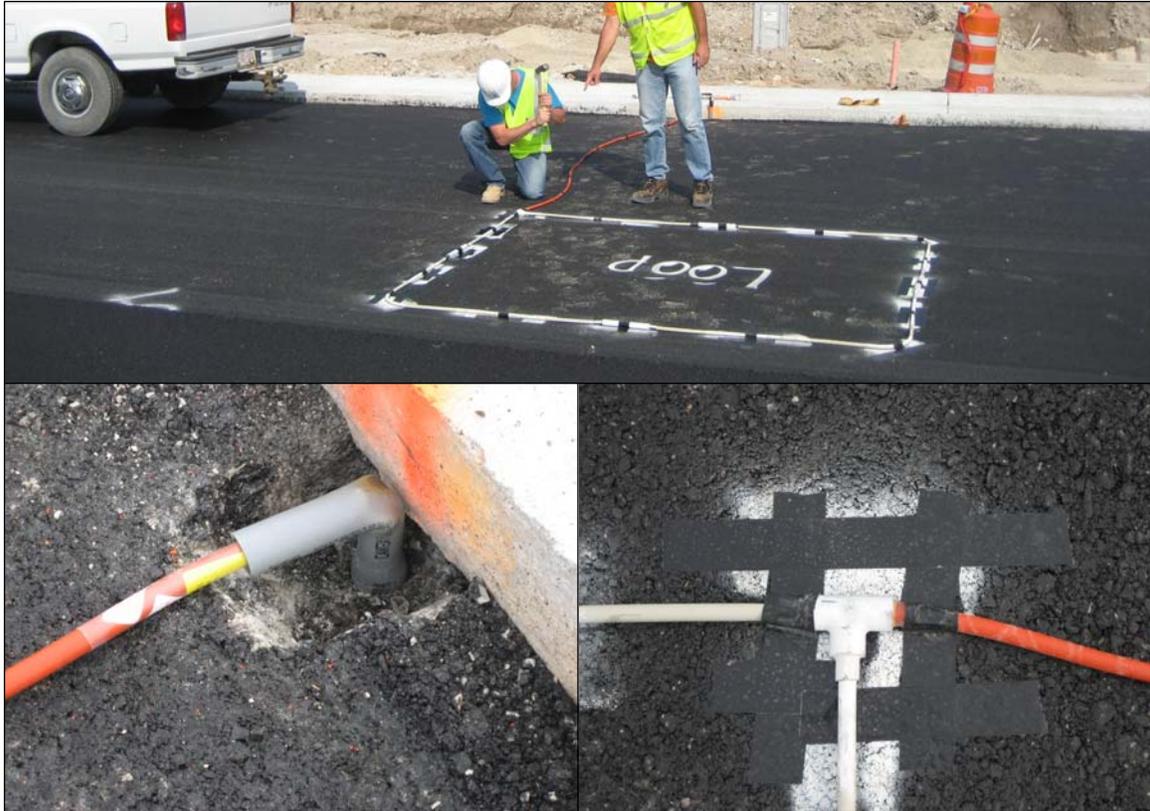
Figure 3-18 - Pictures showing various parts of the loop detector installation. Top: The fiberglass tape was hammered lightly to create a good bond to pavement. Bottom left: The asphalt around the conduit was removed with a cold chisel and hammer to expose enough conduit to install a “homemade” 90° elbow. The rather thick looking orange cable actually ends just inside this elbow and only two small wires actually pass through the elbow. Bottom right: A close up showing how the corner was adhered to the pavement and also the construction of the Never Fail Loop.

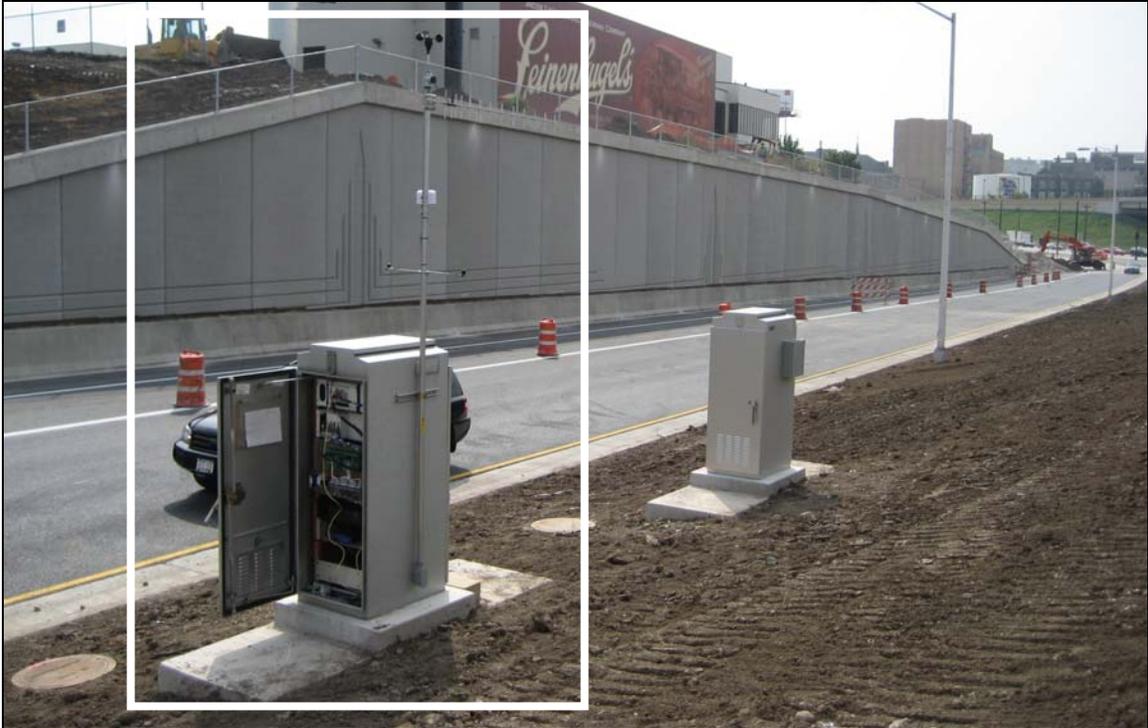
Figure 3-19 - The highlighted cabinet is occupied by the equipment for this project. The mast connected to the cabinet holds environmental sensors as well as the wireless communications antenna. The cabinet in the background houses various traffic control devices for WisDOT. The two cabinets are connected by a limited number of conduits.

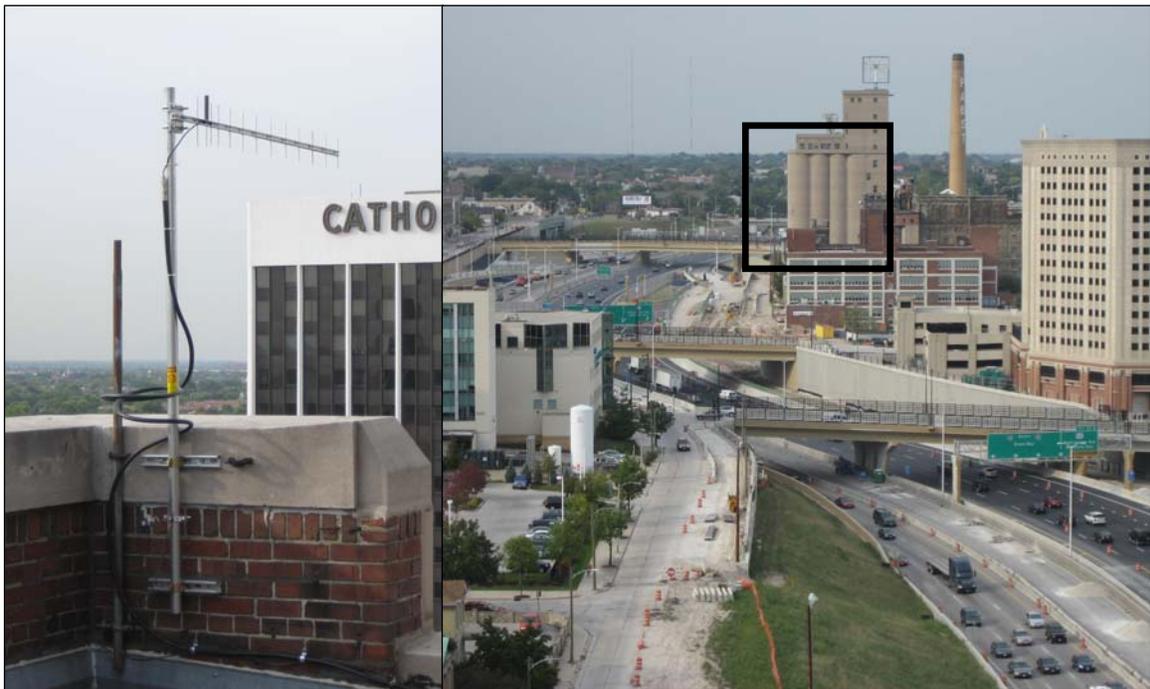
Figure 3-20 - Left: The wireless antenna mounted on the corner of Carpenter Tower Hall at Marquette. Right: View from the antenna location at Carpenter Tower. The test section is located just behind the grain elevators in the highlighted area.

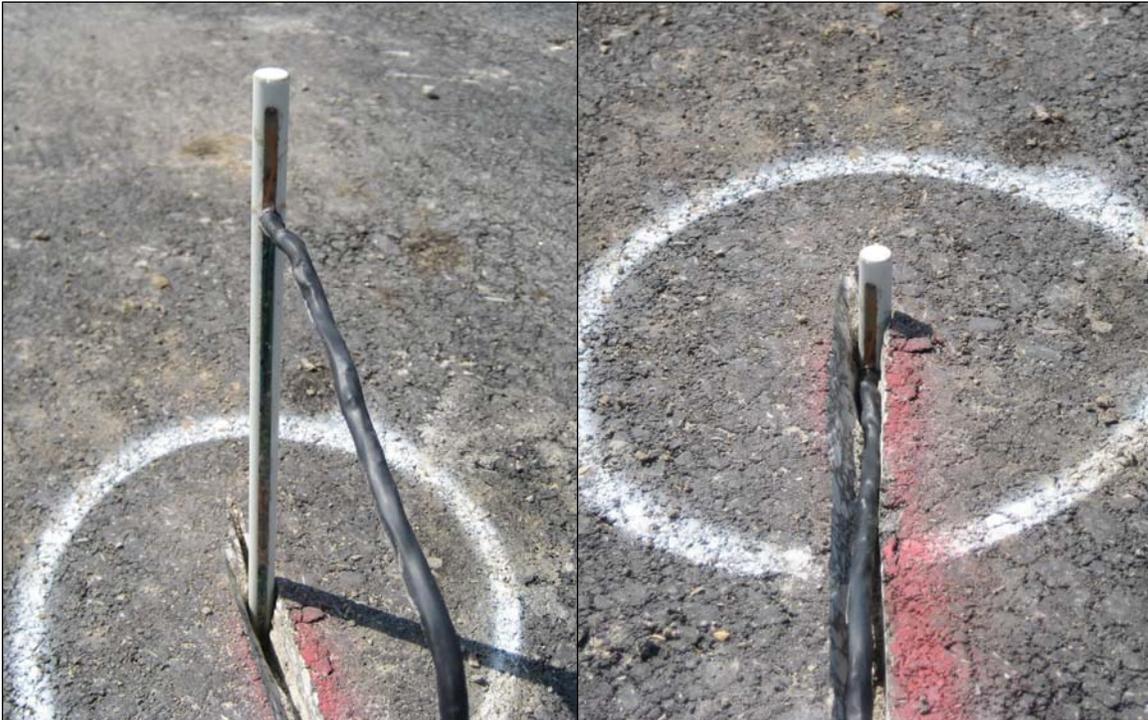
Figure 3-21 - The photograph on the left shows almost the entire length of the temperature probe. The photograph on the right shows the temperature probe fully inserted to its final position. Note that the sensor lead is fitted into its channel, but has not been sealed yet.

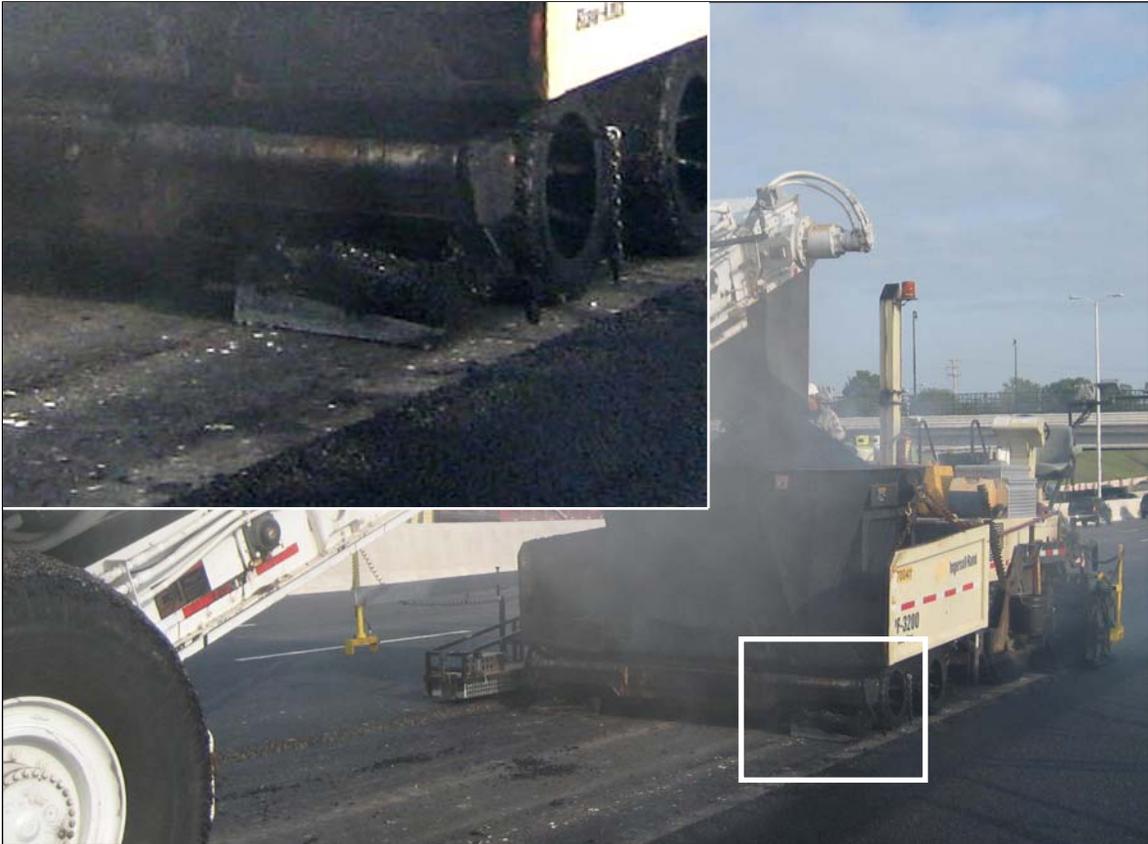
Figure 3-22 – The scraper in the wheel paths of the pavers should be lifted off the pavement surface to avoid destroying sensors and their wiring. The inset picture is a close-up of the scraper which is in the down position, resting on the pavement surface.

be (typically) easily lifted up and secured with chains (usually welded right to the paver).

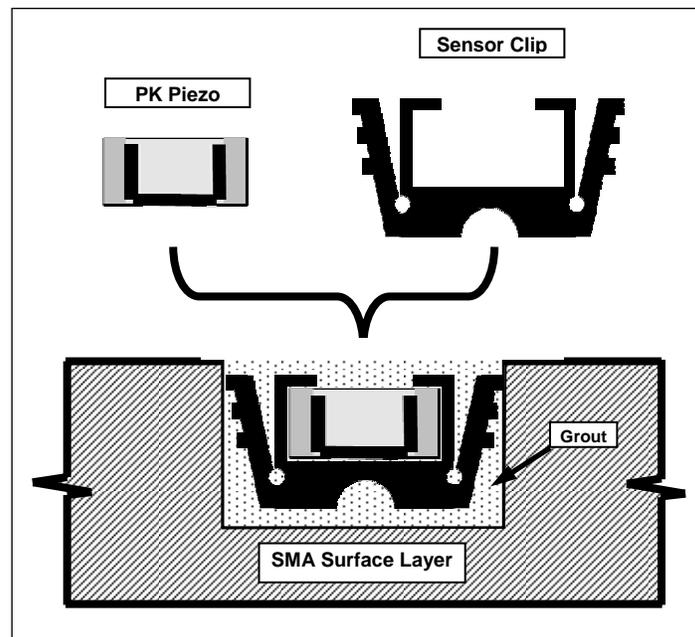
Figure 3-23 – Cross section of the PK piezo strip used for the wheel wander grid showing how it is assembled in the pavement.

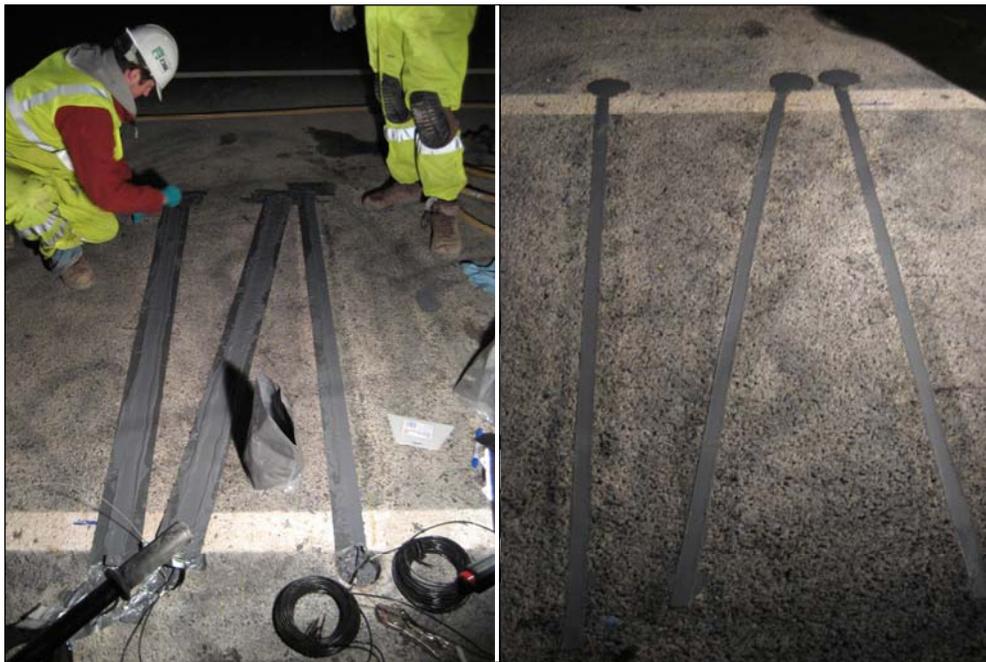
Figure 3-24 - Left: All three wheel-wander sensors have been installed and the grout on the final sensor is being leveled with the pavement surface before hardening. Right: All three sensors installed with the tape removed. Note the pictures have been taken from opposite sides.

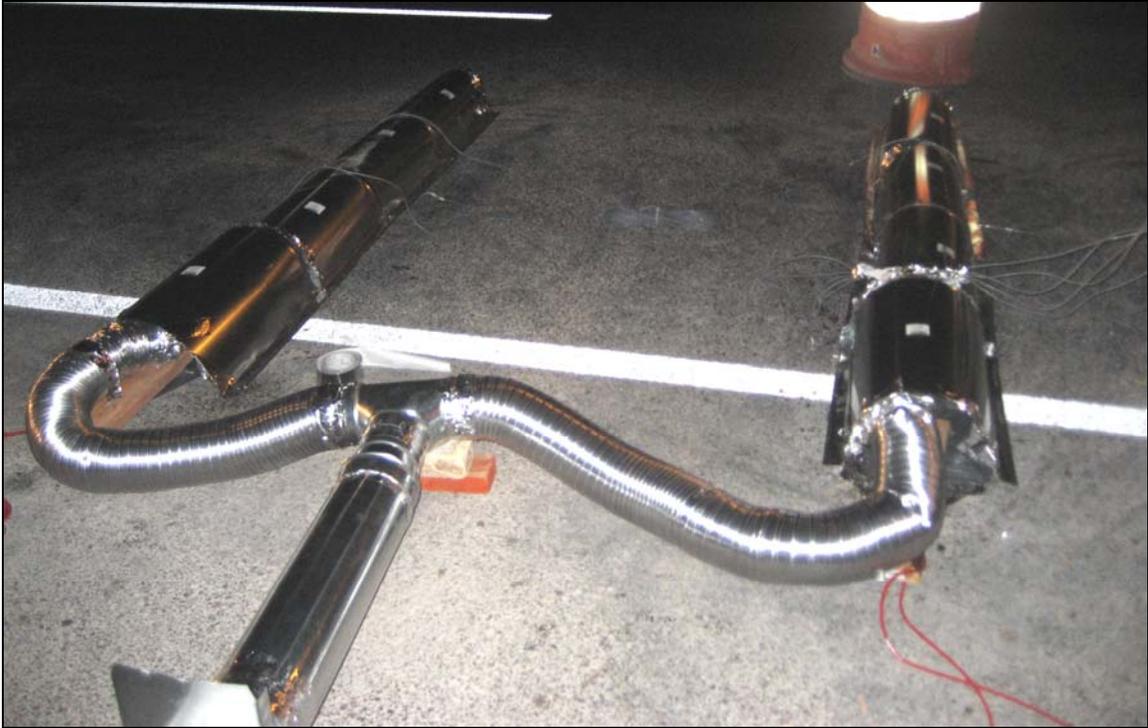
Figure 3-25 - The heating assembly was placed over the two slots cut for the WIM sensors. Heat was supplied by a forced-air kerosene fueled heater (not pictured). The sections of the assembly were sealed with aluminum ducting tape to minimize heat loss. Multiple temperature probes were in place to accurately measure pavement temperatures.

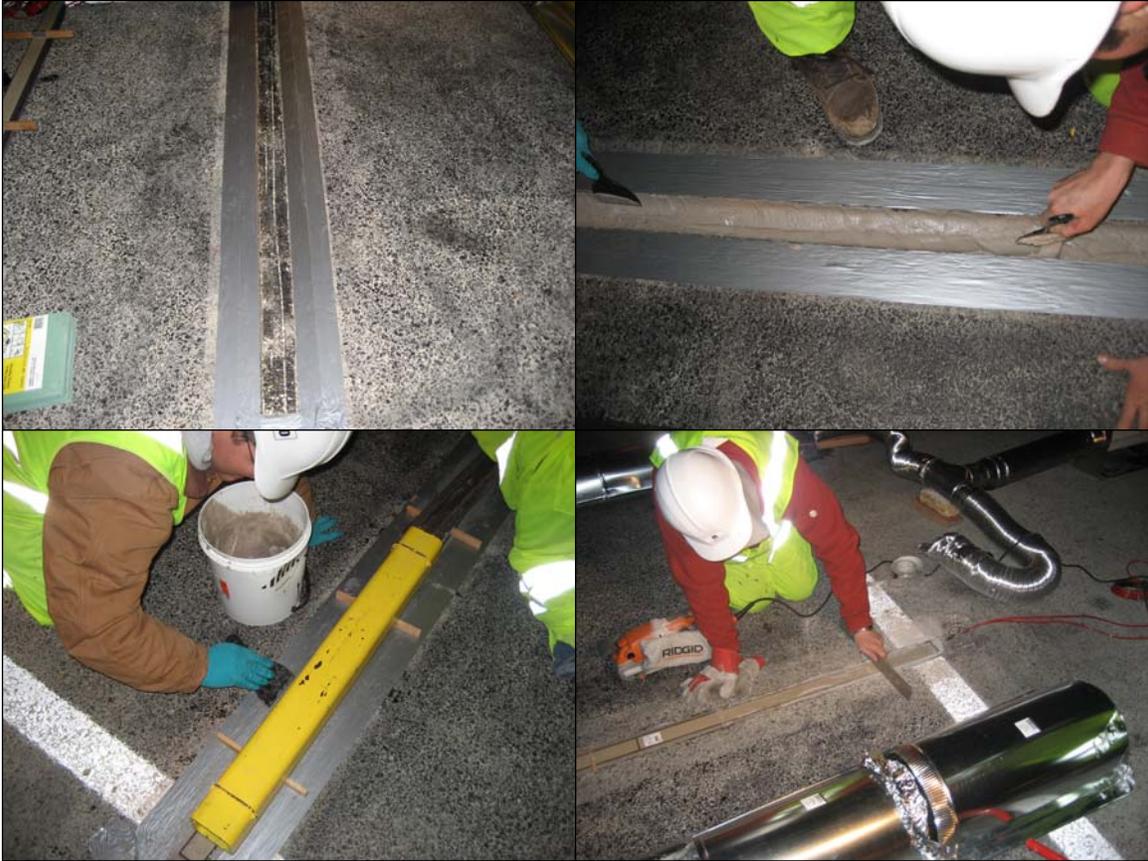
Figure 3-26 - Upper left: Channel for the WIM sensor ready for installation. Upper right: Grout for the sensor being distributed into the channel. Lower left: Sensor in place with pieces of steel placed across the leveling beams to keep sensor from floating out of the grout. Touch up work to the grout was done before its initial set. Lower right: The sensors were ground flush with the surrounding pavement and checked using an 18-inch long straight edge.
