**Perpetual Pavement
Instrumentation
for the Marquette
Interchange Project-
Phase 1**

SPR #0092-06-01

**Nicholas J Hornyak, James A Croveti
David E. Newman, Jay P. Schabelski
Transportation Research Center
Marquette University**

Marquette Interchange Perpetual Pavement Instrumentation
Project: Phase I Final Report

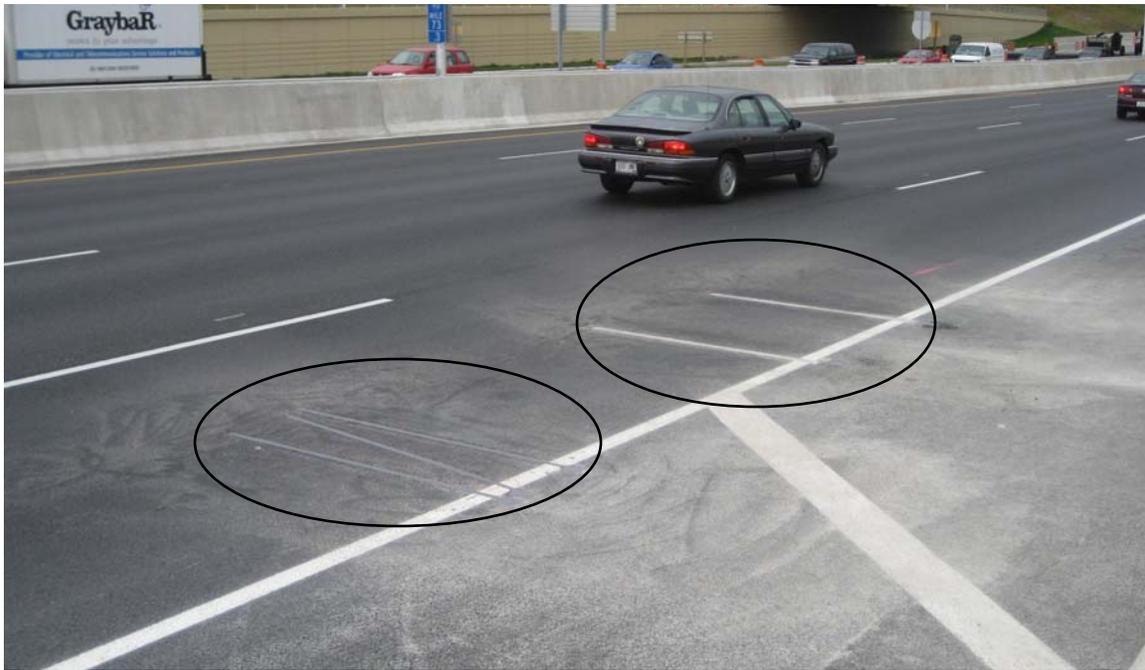
Figure 3-27 – Test section opened to traffic with the wheel-wander and WIM sensors installed (circled areas).

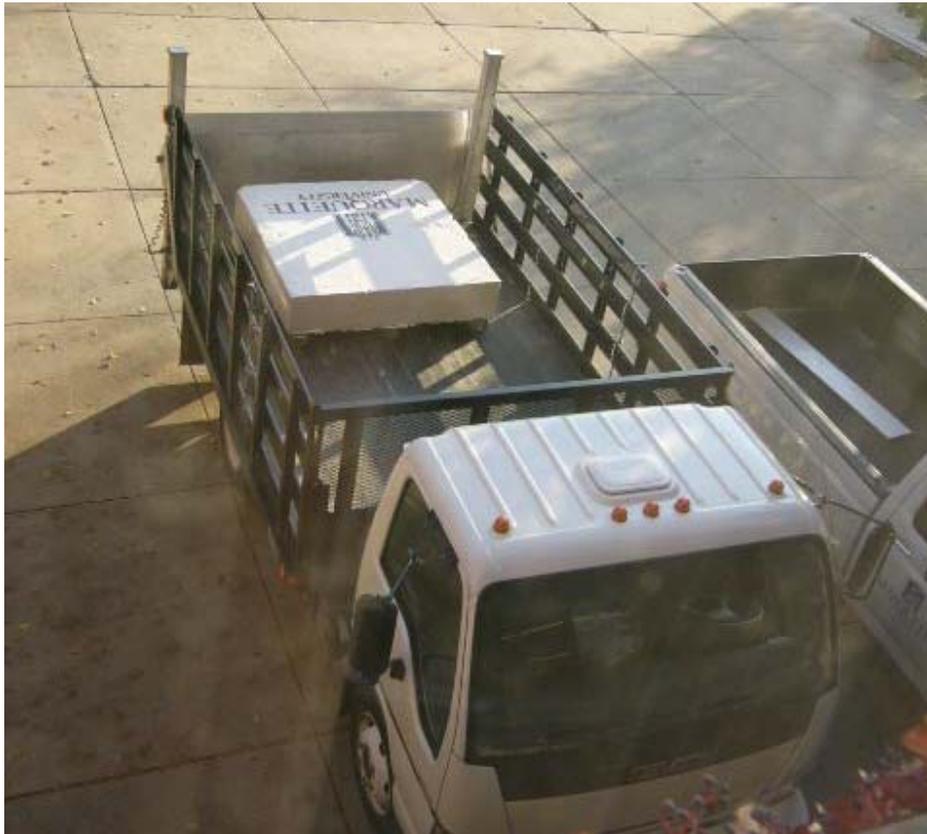
Figure 3-28 - Vehicle used to calibrate the WIM system. Note the concrete slab placed in the bed of the truck over the rear axle.

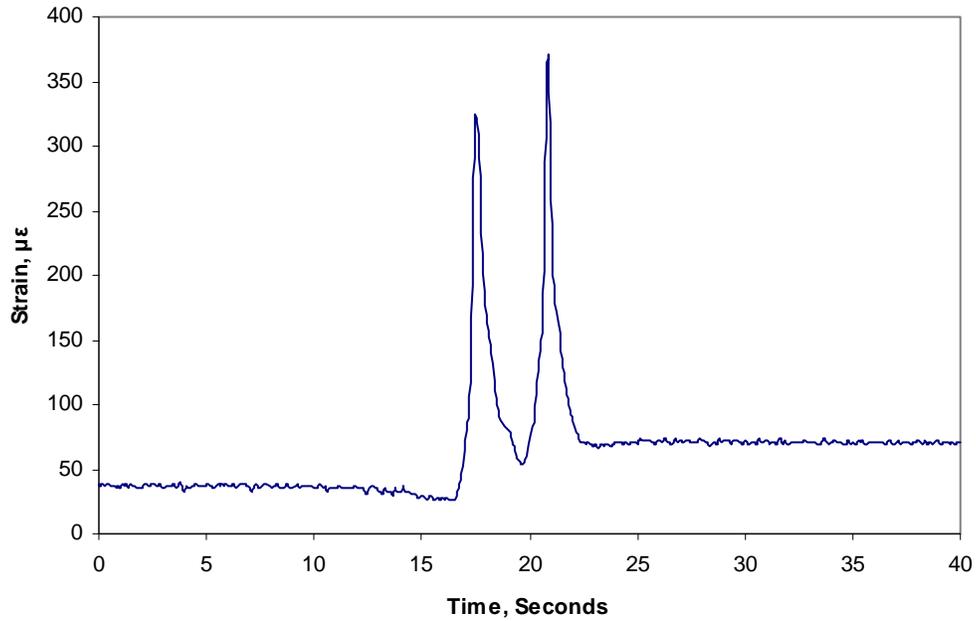
Figure 3-29 - Dynatest PAST II - AC gauge C4 response to roller pass.

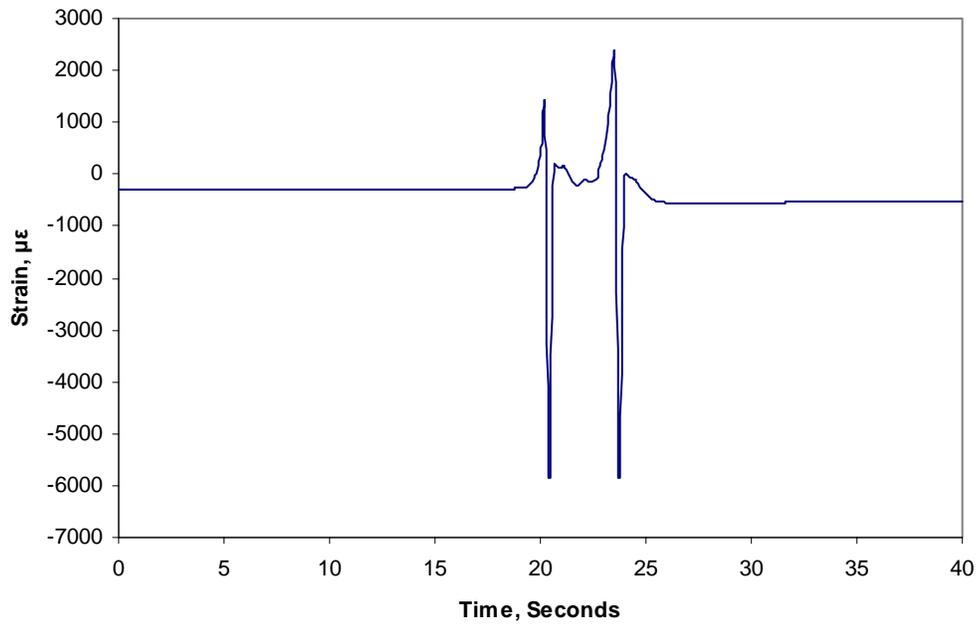
Figure 3-30 – CTL ASG gauge B0 response to roller pass.

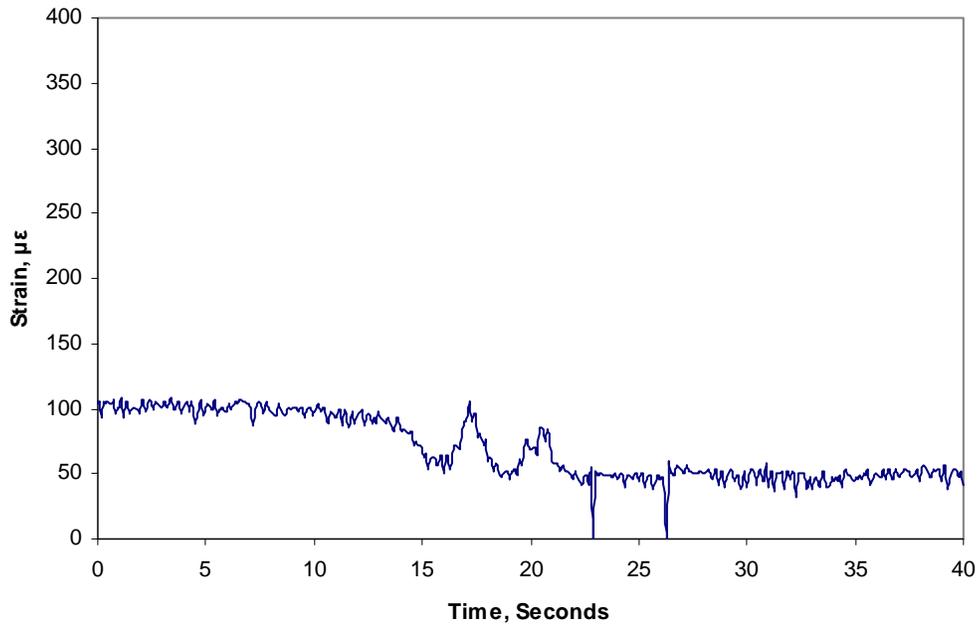
Figure 3-31 – Dynatest PAST II – AC gauge C7 output. Although not explicitly clear, this sensor has a substantial amount of signal noise compared to similar gauges.

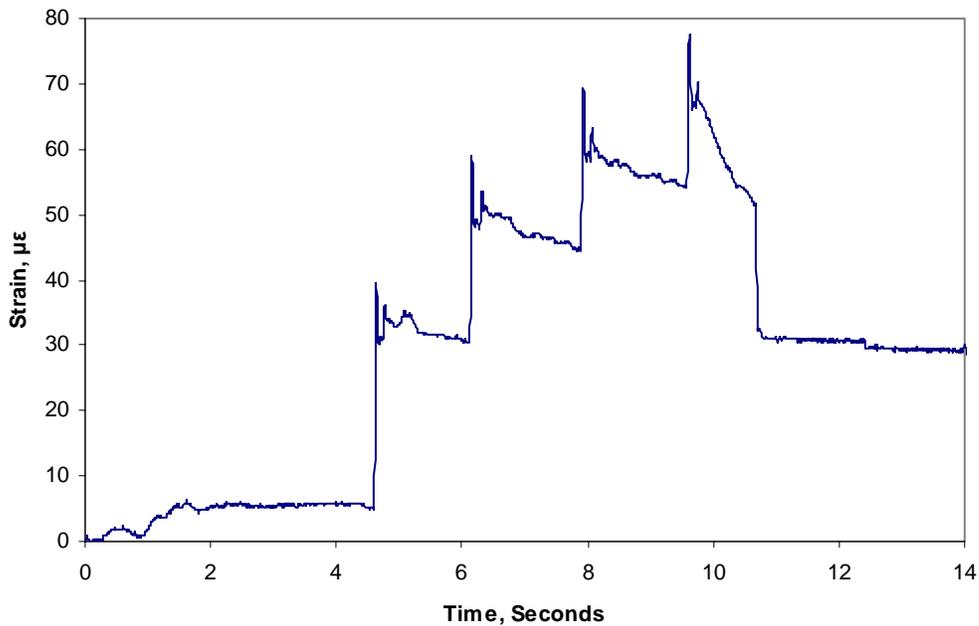
Figure 3-32 – CTL gauge A0 strain in response to a series of four Marshall Hammer drops in succession.

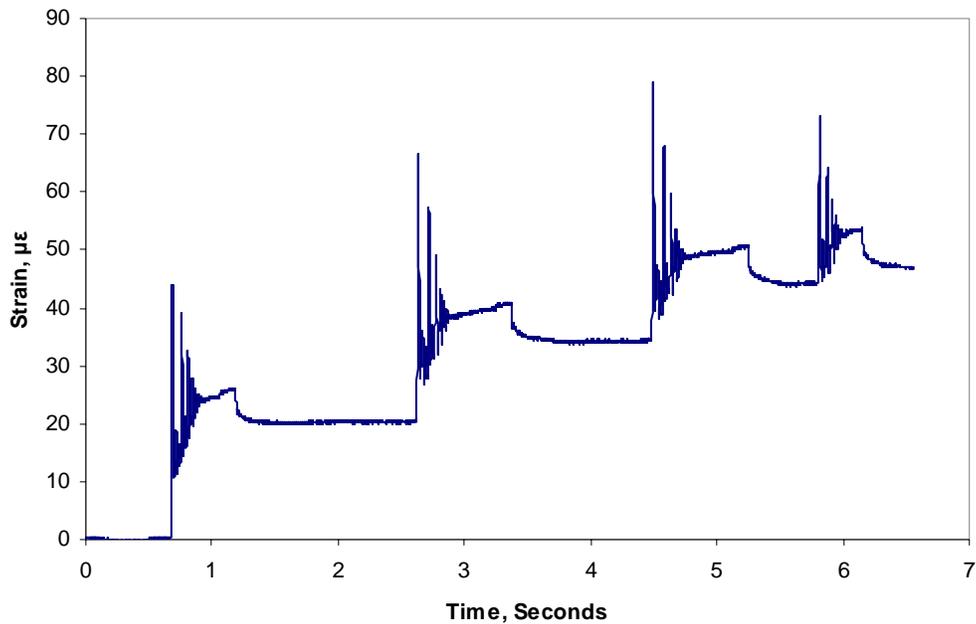
Figure 3-33 – CTL gauge B1 strain response to an impulse loads generated from and FWD.

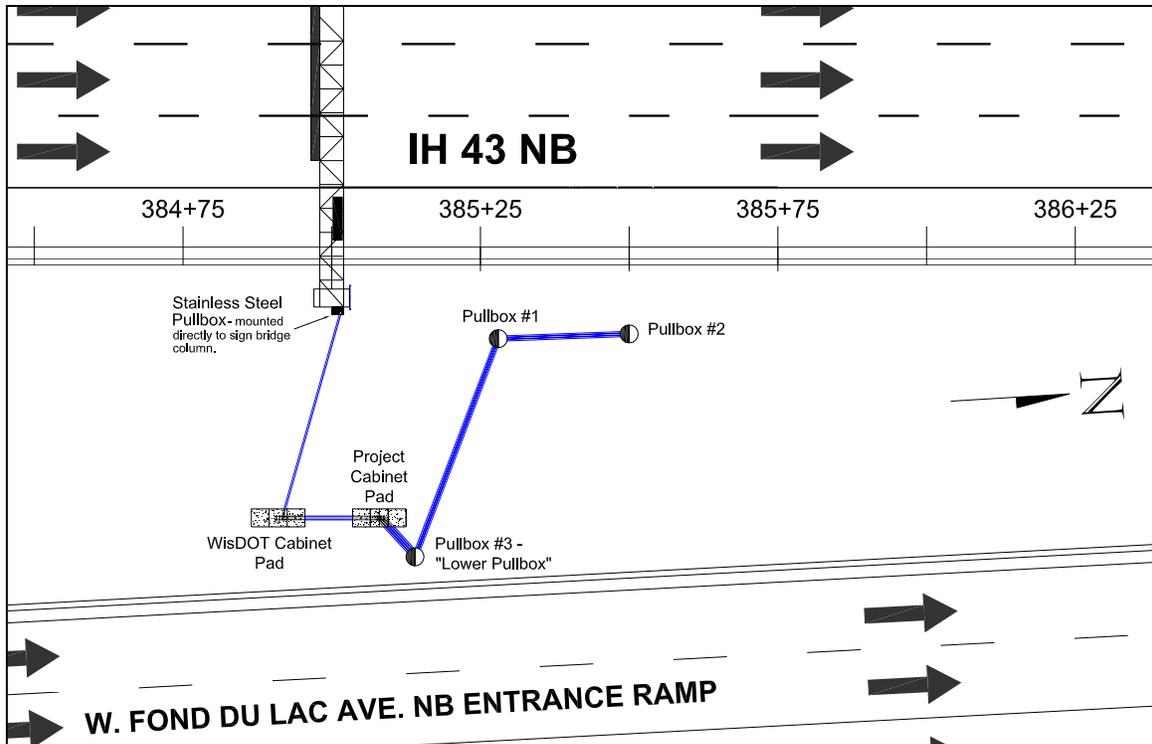
Figure 3-34 - Pullbox locations and the network of conduits connecting them.

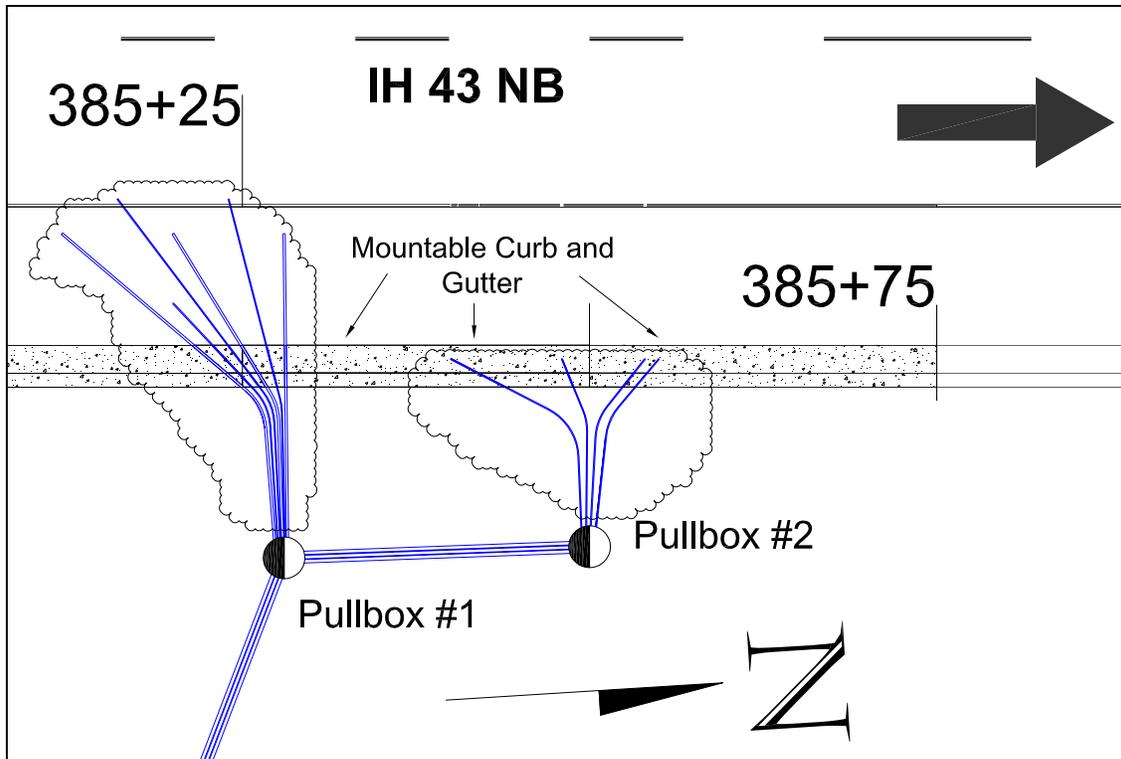
Figure 3-35 – The conduits within the cloud are those installed for the strain sensors, base EPCs, WIM and Wander components.

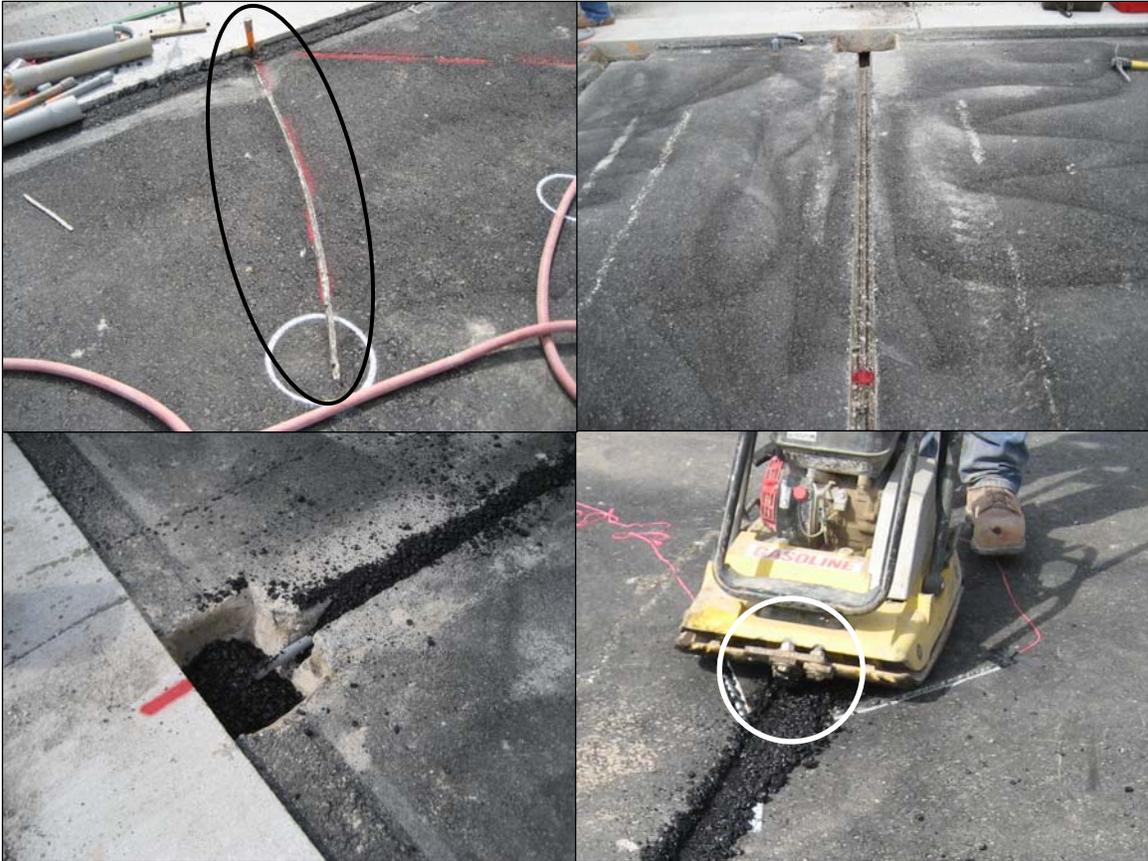
Figure 3-36 - Installation of the WIM, wheel wander, and temperature sensor conduits. Top left: Grooves were cut with a saw for the sensor leads for the pavement temperature gradient probes. Top right and bottom left: Groove cut with conduit in place for a WIM sensor. Bottom right: Asphalt being re-compacted into groove cut for the wheel-wander sensors. The plate tamper had a bolt-on bar (circled) mounted on the bottom to fit into the cut to increase compaction efficiency.

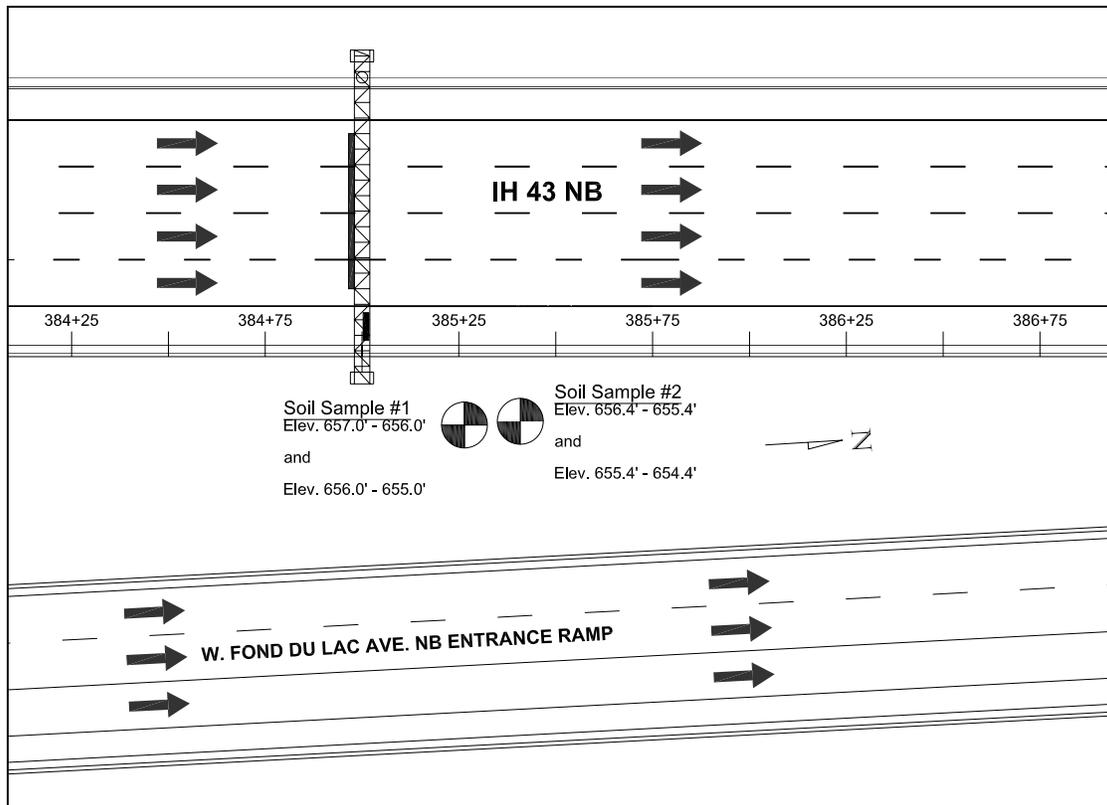
Figure 3-37 - Location of soil samples taken for the project.

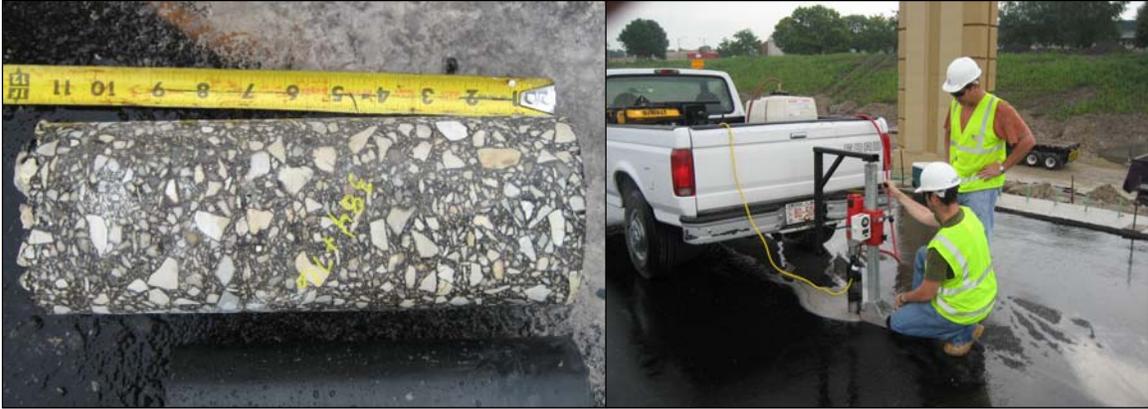
Figure 3-38 – Left: Core sample removed from the pavement. Right: The core-drill was secured against the weight of a vehicle to produce samples with very smooth side walls for possible future testing.

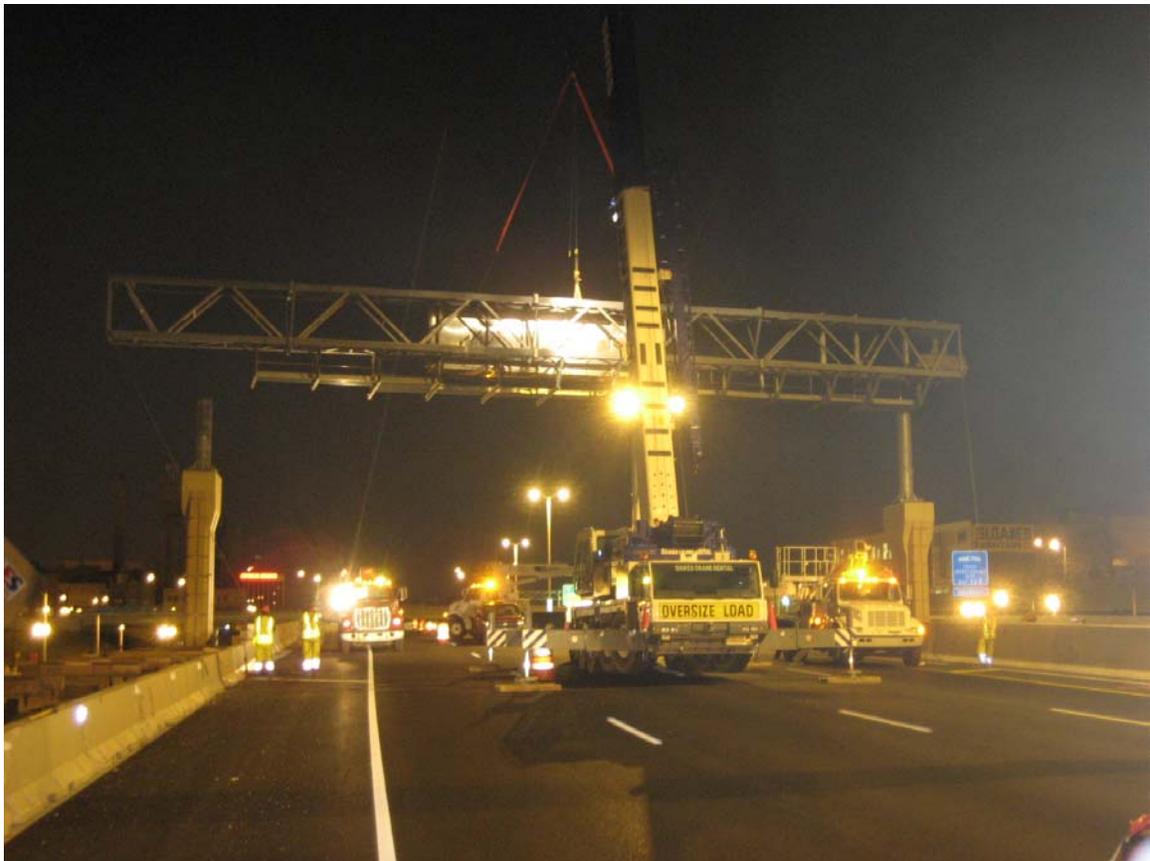
Figure 3-39 - Heavy crane lowering the sign bridge into its final resting position. Note that the outriggers for the crane came close to the sensor locations.

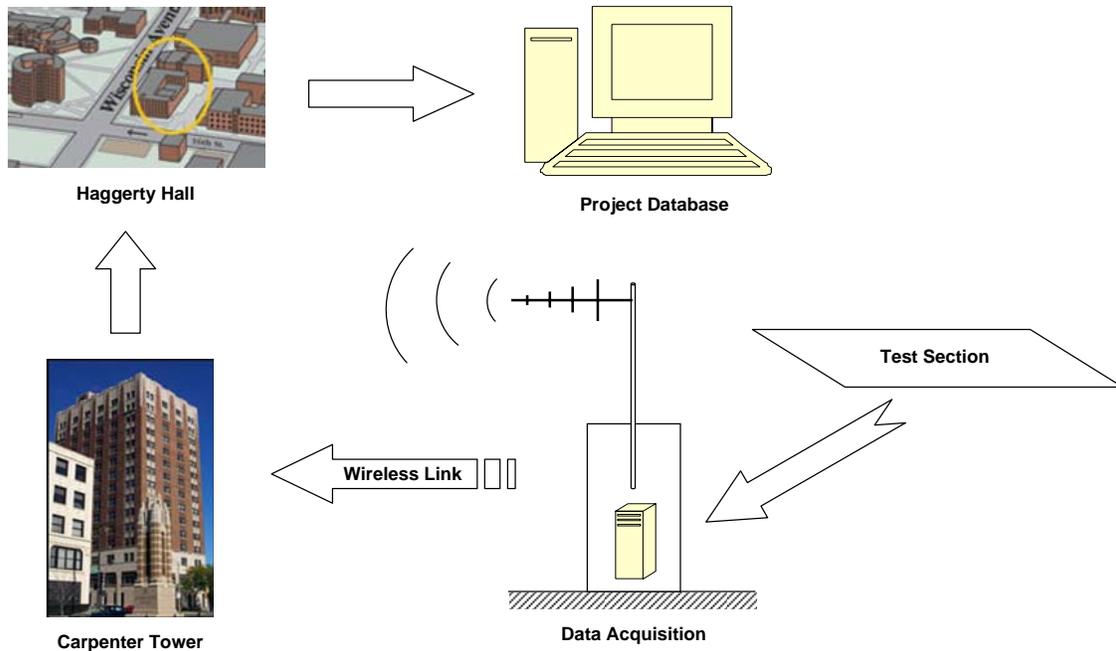
Figure 4-1 – Data transmission path.

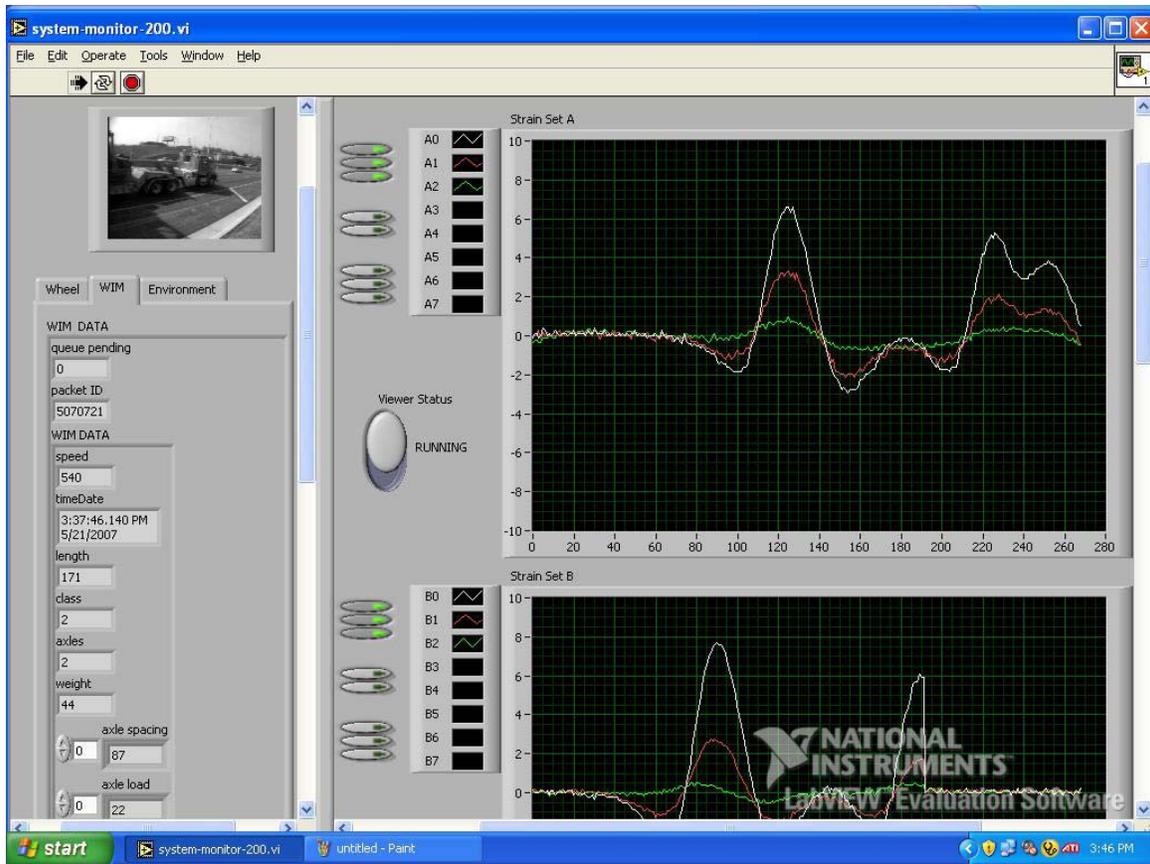
Figure 4-3 - Screenshot of data viewer
