> October 2009 WHRP 09-04

WISCONSIN HIGHWAY RESEARCH PROGRAM #0092-06-06

EVALUATION OF SELECT METHODS OF CORROSION CONTROL, CORROSION PREVENTION, AND REPAIR IN REINFORCED CONCRETE BRIDGES

FINAL REPORT

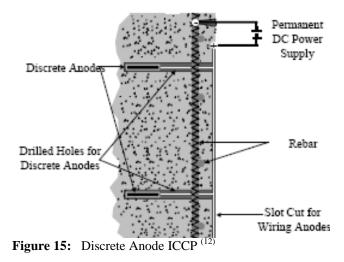
ICCP systems (Figure 15) use an external power source that provides the necessary current, $5 - 20 \text{ mA/m}^2 (0.5 - 1.9 \text{ mA/ft}^2)$, to mitigate corrosion activity. ⁽³⁵⁾ An ICCP system consists of "the reinforcement to be protected, an anode, a power source, concrete

surrounding the steel, a monitoring system, and cabling to carry the system power and monitoring signals." ⁽⁴²⁾

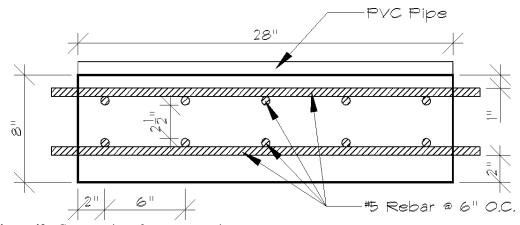
Figure 42: Cross section of concrete specimen

To represent typical bridge deck thickness and reinforcing patterns, concrete specimens that measured 28" in width, 28" in length, and 8" in thickness were cast with two layers of #5 reinforcing bars placed at 6" on center (Figure 42). Although the specimen thickness and reinforcement spacing reflect a typical bridge deck, the repair and prevention approaches studied in this project are not limited to bridge decks alone, and can be applied to all parts of concrete bridges.

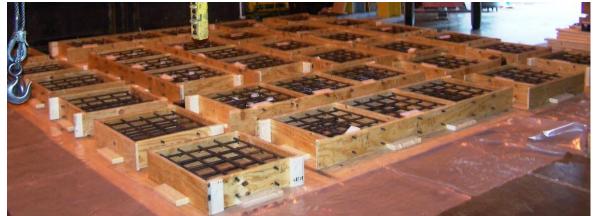
Figure 45: Setup of laboratory specimens for concrete pour

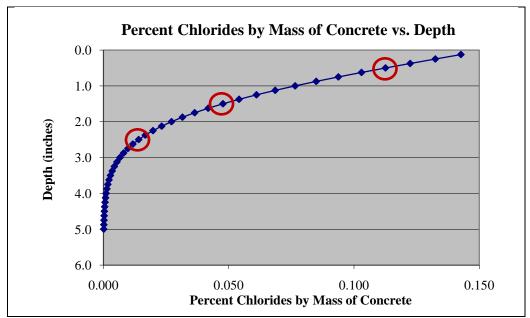
Figure 46: Calculated chloride content profile used for mixed-in chlorides

When these values were inserted into Fick's 2^{nd} Law of diffusion, a chloride content nearly 4.5 times greater than the corrosion threshold was found at a depth of 0.5", a chloride content 2.0x greater than the corrosion threshold was found a depth of 1.5" (the level of reinforcing steel in this project), and a chloride content approximately 0.5x the corrosion threshold was found a depth of 2.5". The anticipated chloride profile for a bridge deck with 10 years of exposure can be seen in Figure 46.

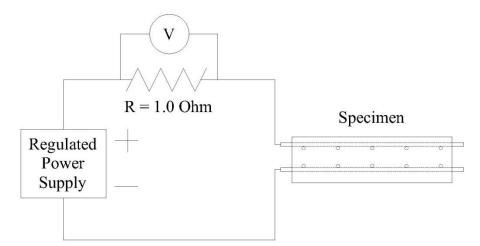
Figure 51: Corrosion cell for laboratory specimens

Even though each layer of reinforcement had electrical continuity, the two layers were not electrically connected. This forced the current to travel through the concrete. The accelerated corrosion test regime is similar to the one used for an earlier WHRP Project (No. 0092-01-06). ⁽²⁴⁾

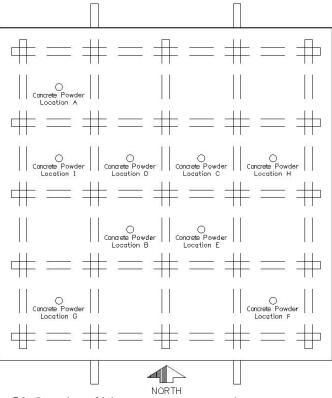
Figure 56: Location of laboratory concrete powders

After an additional 3-months of exposure to accelerated corrosion after patch repairs, chloride content of the 14 CoC specimens were evaluated at two locations per specimen at depths of $\frac{1}{4}$, $\frac{1}{2}$, $\frac{3}{4}$, 1", $1-\frac{1}{4}$ ", $1-\frac{1}{2}$ ", $1-\frac{3}{4}$ ", and 2". One location was tested inside the patched area (Location B), and one location was tested outside the patch area (Location H). Because of inconsistencies, additional testing was performed at Locations D, E, G, and I to verify the original results.

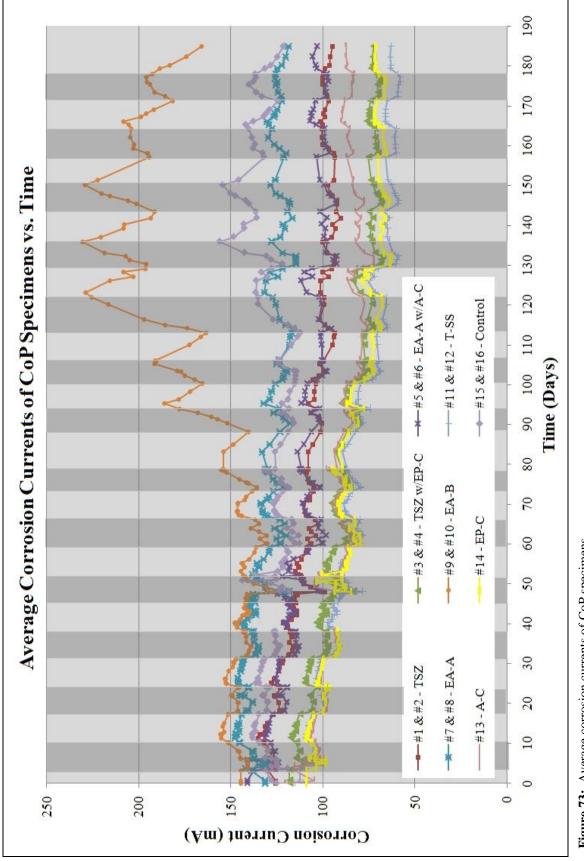
Figure 73: Average corrosion currents of CoP specimens

Based on the results of the current monitoring for the laboratory CoP specimens, it can be concluded that the tri-silane sealer (T-SS), epoxy/polyurethane coating (EP-C), and thermal sprayed zinc with epoxy/polyurethane coating (TSZ w/EP-C) were most effective.

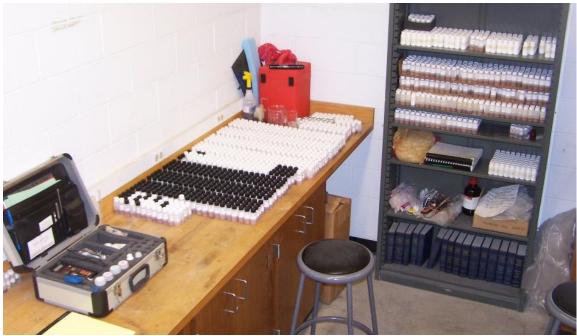
Figure 79: Tested concrete powder samples

This same approach was followed for determining the chloride content of virgin concrete, concrete with pre-mixed chlorides in the CoC specimens, concrete after 3-months exposure in CoC specimens, concrete after 6-months exposure in both CoC and CoP specimens, and the bridge decks tested in the field. In all, approximately 2,000 concrete powders were analyzed for this project (Figure 79).

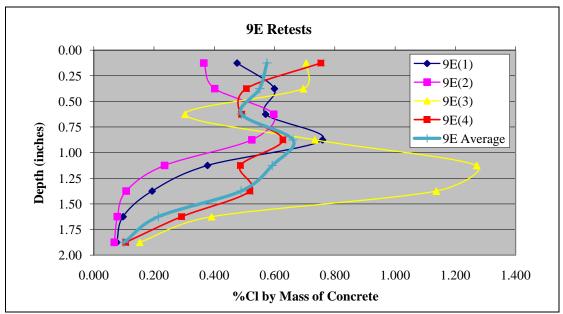
Figure 85: Chloride contents near Location 9E

Because of the variation in chloride contents at similar locations (Figure 85), we concluded that the chloride penetration in these specimens was not one-dimensional and did not conform to Fick's 2nd Law.

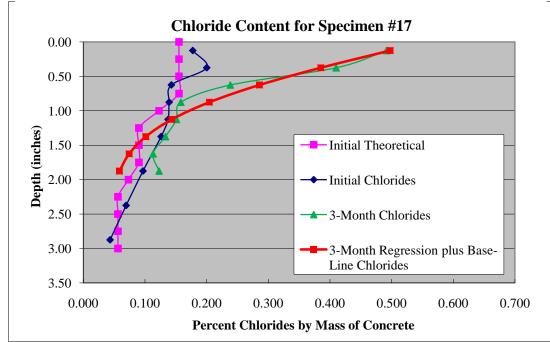
Figure 90: Comparison of initial theoretical, initial, 3-month, and 3-month regression chlorides for Specimen #17

Figure 90 shows a representative graph comparing the initial theoretical, initial, 3month, and 3-month regression plus base-line chloride levels.

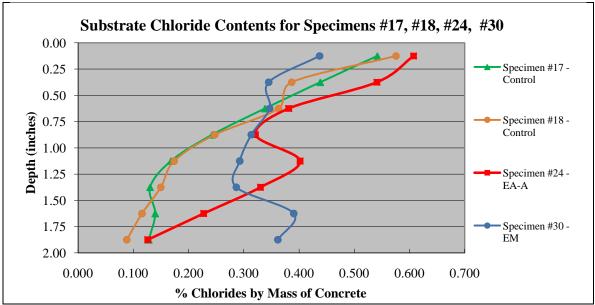
Figure 92: Comparison of substrate chloride contents of Specimens #17, #18, #24, and #30 after 6-months

For Specimens #24 (EA-A) and #30 (EM), the substrate chloride contents did not entirely agree with Fick's 2nd Law either. To verify the results, additional tests were taken at two locations. After the retests were completed, results from each increment of depth were averaged. Figure 92 displays the non-conformity of Ficks's 2nd Law in regards to the average substrate chloride contents of Specimens #24 and #30. The substrate chloride contents of the Control specimens have also been provided.

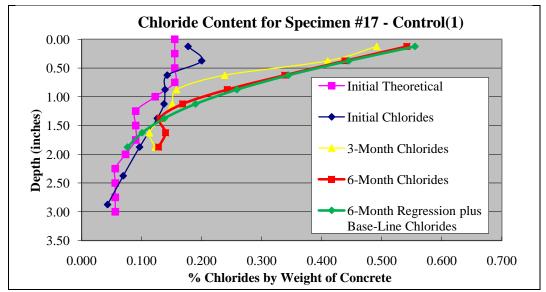
Figure 95: Comparison of initial theoretical, initial, 3-month, 6-month, and 6-month regression chlorides for Specimen #17

It should be noted, however, that the chloride contents of the substrate concrete were not used in evaluating the performance of the treatments within the patch repair materials. The chloride testing of the substrate concrete was performed merely to show that chlorides have continued to penetrate the concrete and that an environment representative of a patch repair in the field was simulated. Figure 95 shows the ingress of chlorides over the course of the 6 months of testing for the substrate concrete of a Control specimen. Chloride levels increased significantly over the course of testing. Furthermore, the actual chloride content and regression plus base-line chlorides at 6-months have excellent agreement.

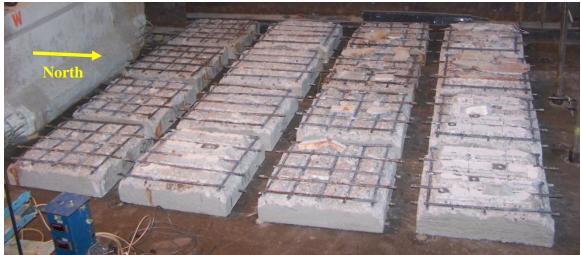
Figure 97: CoP specimens after dissection

The dissected CoP specimens are displayed in Figure 97 while Table 35 presents the individual and combined ratings for each of the CoP specimens after 6-months of accelerated corrosion testing. In Table 35, Rebar A denotes the top mat reinforcing steel on the west end of the specimens while Rebar E denotes the reinforcing steel on the east end of the specimens. Detailed condition observations of the CoP specimens can be found in Section 4.2.

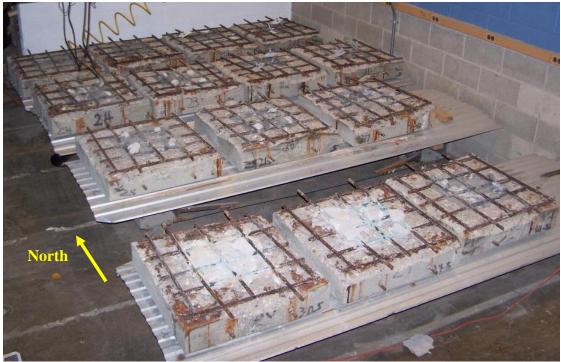
Figure 99: CoC specimens after dissection after 6-months

Figure 99 displays the dissected CoC specimens and Table 37 presents the individual grades and combined rating for each of the specimens after 6-months of exposure. In Table 37, Rebar A denotes the reinforcing steel on the west end of the specimens while Rebar E denotes the reinforcing steel on the east end of the specimens. Detailed condition observations of the specimens can be found in Section 4.3.

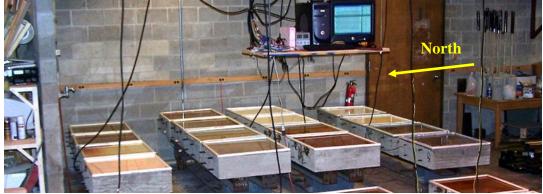
Figure 101: Condition of CoP specimens after 3-months

As seen in Figure 101, visible signs or corrosion, in the form of rust staining on the concrete surface, were present on the CoP specimens that did not contain coatings after only 3-months of exposure. After 6-months of exposure (Figure 102), a majority of the specimens, excluding those with the T-SS and TSZ w/EP-C, displayed signs of rust staining. Sections 4.2.1 through 4.2.16 display the surface condition and associated crack mapping of the CoP specimens at 0-months, 3-months, and 6-months of exposure, as well as the dissected specimens with their rebar ratings. All of the figures in the following sections are oriented with "North" towards the top of the page (Figures 103 to 230). The numbers in parentheses are representative of the specimens for each treatment.

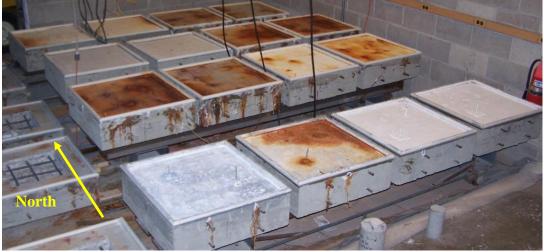
Figure 102: Condition of CoP specimens after 6-months

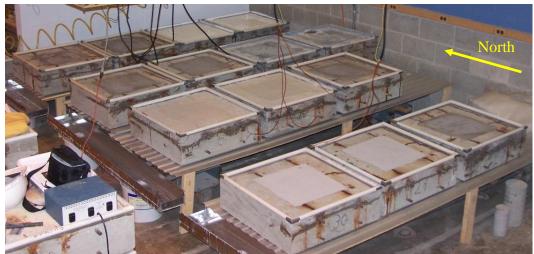
Figure 233: Condition of CoC specimens after completion of patch repairs

After the previously discussed patch repairs were completed, the CoC specimens were re-positioned (Figure 232) and the second phase of accelerated corrosion testing for the CoC specimens was commenced (Figures 233 and 234).

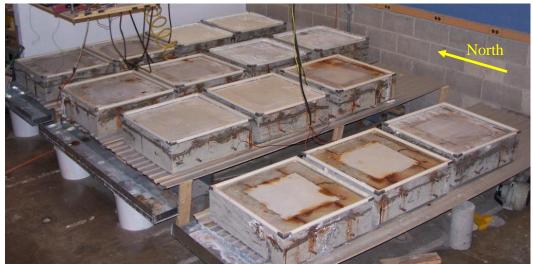
Figure 234: Condition of CoC specimens after 6-months

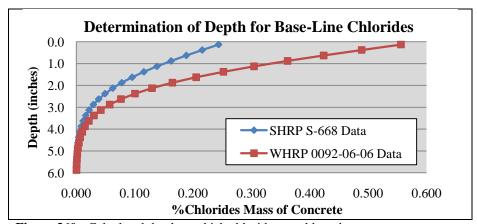
Figure 360: Calculated depth at which chlorides would not be present

By utilizing Fick's 2^{nd} Law of diffusion, the data from SHRP S-668 ⁽¹¹⁶⁾, and the data from the control bridges presented above, a determination was made as to what depth chlorides would not be present after 15 years of exposure. This age was used as it was representative of the bridge decks that were tested. Using $C_0 = 10.1$ lb/yd³ (0.258% chlorides by concrete weight) and D = 0.11 in²/yr, as shown in SHRP S-668, chloride levels reached approximately 0% at 5 inches. Using $C_0 = 23.1$ lb/yd³ (0.590% chlorides by concrete weight) and D = 0.097 in²/yr, as found by the control bridge decks in Table 50, chloride levels again reached approximately 0% at 5 inches (Figure 360).

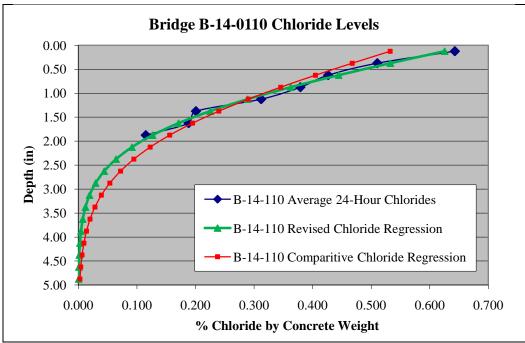
Figure 361: Bridge B-14-0110 Regression Comparison

To show how the analyses involving the "comparative chloride regression" and "relative chloride regression" related to the "raw data", Figures 361 and 362 have been provided as a comparison to Figures 358 and 359 above. The "base-line" chlorides have not been added to the regression plots. The plots show an excellent agreement between the raw data and regression curves.
