# Evaluating the Impact of Anti-Icing Solutions on Concrete Durability

WisDOT ID no. 0092-21-03

September 2023

## TECHNICAL REPORT DOCUMENTATION PAGE

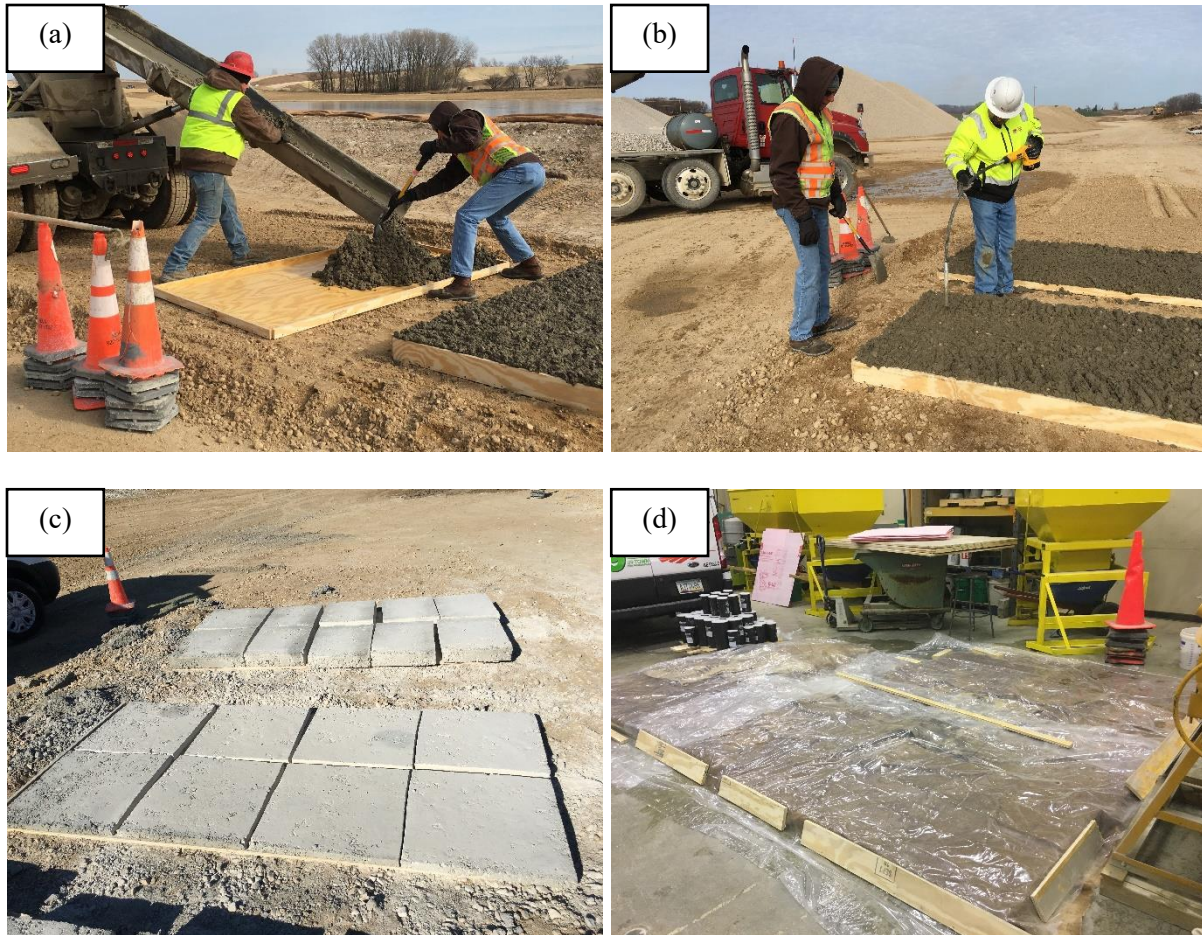
**Figure 2.1 (a) Plant-mixed concrete was poured into 4’\*8’ forms (b) consolidated and finished on site (c) sawcut into 2’\*2’ panels after 48-hour on-site curing (d) panels were transported to the lab and burlap cured for 28 days.**

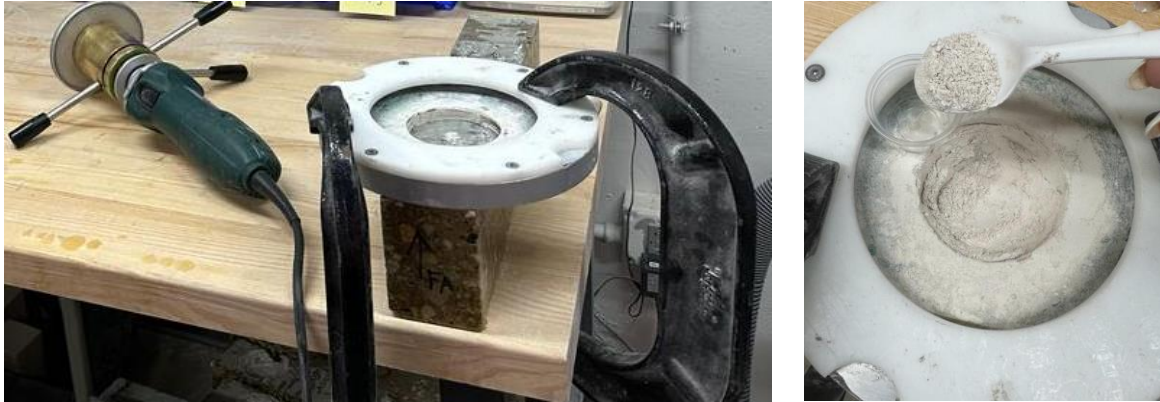
**Figure 2.3 (left) Profile grinder and CDF sample prior to collecting powder sample for chloride analysis, (right) Collecting grinded powder**

Chloride ion content was determined using acid titration according to ASTM C1152 and AASHTO T260. All the samples were ground to a powder with caution to prevent contact of the material with hands, or other source of body perspiration or contamination. As such, all sampling tools, such as spoons, clear storage container, and sieve, were washed with alcohol and dried before use. A diamond profile grinder was utilized to obtain the specimens. Per AASHTO T260, the surface layer to 1.6mm was removed, depth #1 reports average chloride content collected from depths ranging from 1.6mm to 13mm, and depth #2 from depths ranging from 13mm to 25mm. Figure 2.3 shows the setup used to extract chloride powder samples from a CDF beam. Sanitized spoons were utilized to collect the resulting powder and transfer it to the appropriately labeled container. Subsequently, a vacuum cleaner was used to ensure the complete removal of all powder from the corresponding layer before starting the subsequent layer drill process as shown in Figure 2.3.

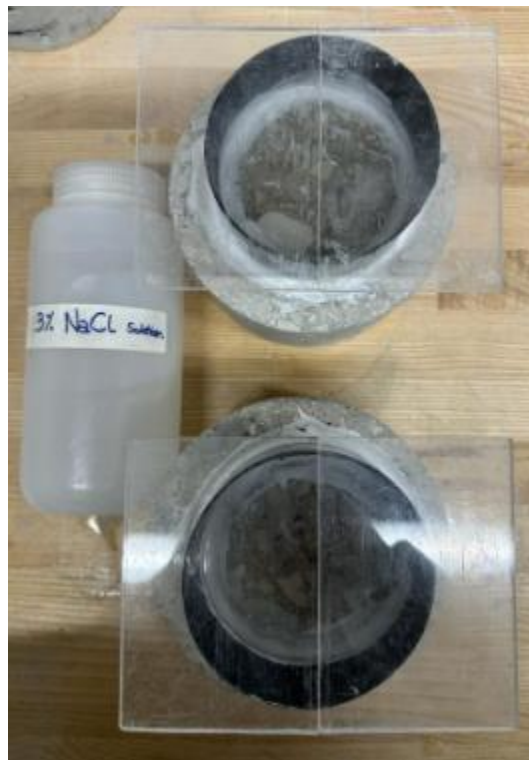
**Figure 2.4 90-day ponding arrangement**

The 90-day salt ponding test followed AASTHO T259 with analysis following AASTHO T260. Figure 2.4 shows two of the samples undergoing the 90-day ponding using the 3% NaCl solution.

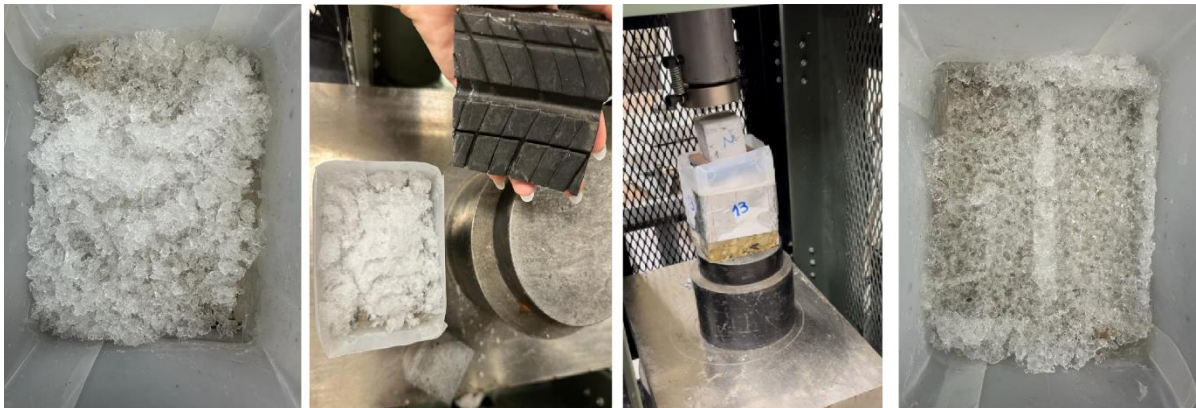
**Figure 2.5 Sample before, during, and after tire compression**

Subsequently, the samples were compacted with the layer of snow by employing a compression testing equipment configured with a car tire setup, exerting a pressure of 75 psi to simulate the vehicle action on concrete pavement. The pressure was selected using the maximum AASHTO HS-20 loading of 32 kips/axle and 120 in<sup>2</sup> rectangular contact area.

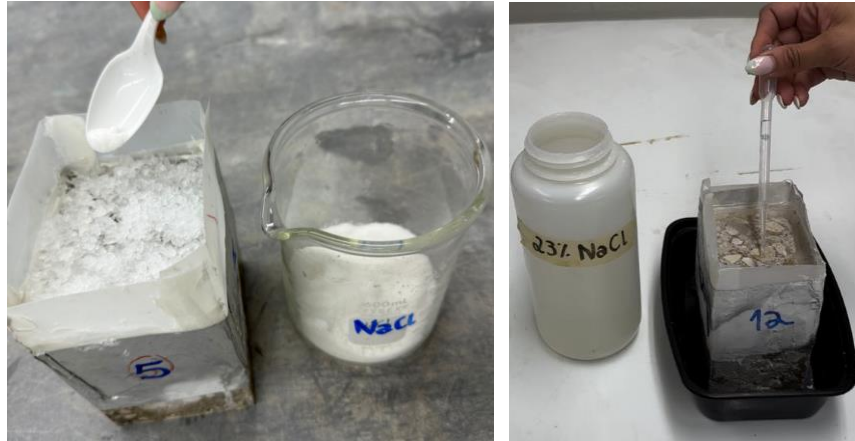
**Figure 2.6 Application of solid or liquid NaCl**

The DI samples received solid NaCl applied to the surface of the snow prior to tire compression and the AI samples received the liquid brine directly to dry concrete which was allowed to soak into the concrete in the freezer for 24 hours prior to application of snow and tire pressure as shown in Figure 2.6. The lowest effective temperature for a 23% NaCl solution is 15°F so the solution was liquid in the freezer. After compression of the snow with the tire setup, the samples were returned to the freezer for one day at a temperature of 25°F. Each sample was placed inside an individual plastic container. Afterwards, the samples were removed from the freezer and allowed to melt in the lab, ensuring they were covered with plastic to prevent evaporation, for 4 hours.

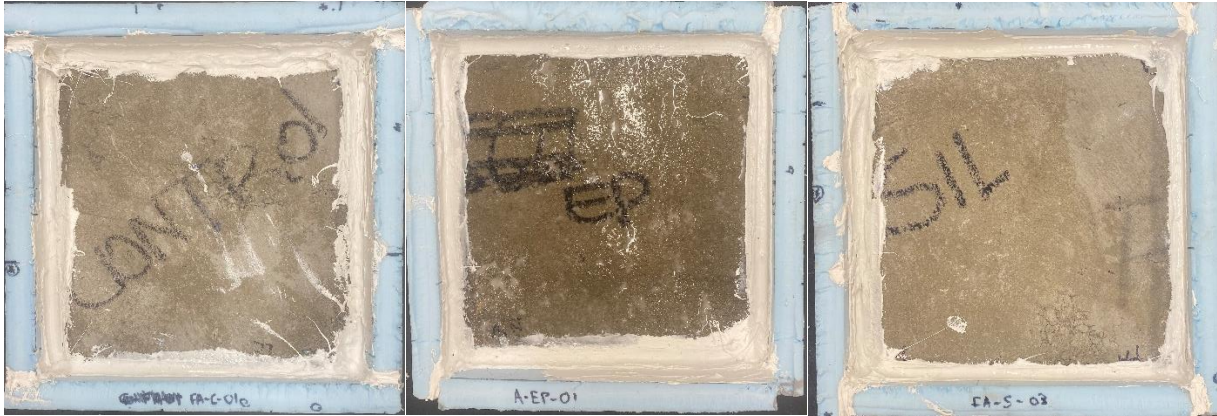
**Figure 2.8 Representative Deicer Scaling Specimens Before Testing  
(from left to right: A-FA Control, A Epoxy, A-FA Silane)**

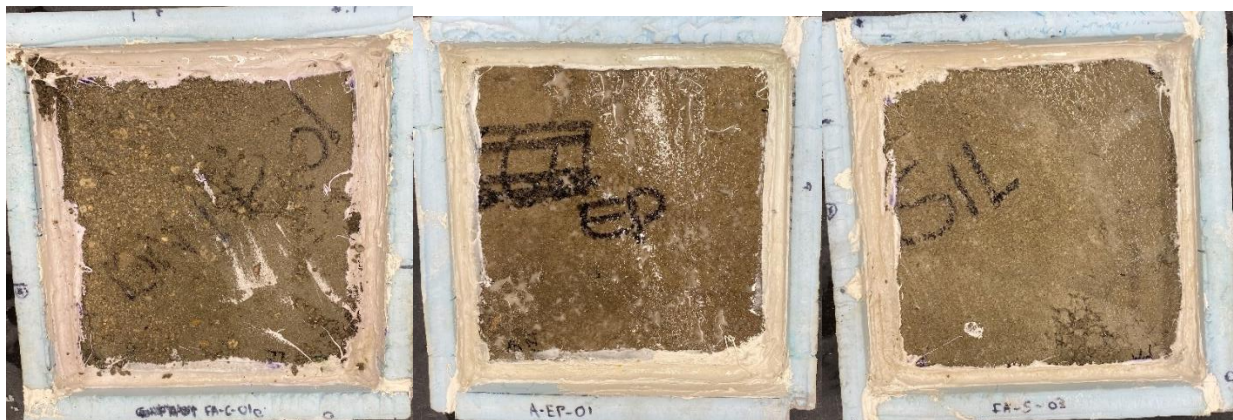
**Figure 2.9 Representative Deicer Scaling Specimens After 50 Cycles  
(from left to right: A-FA Control, A Epoxy, A-FA Silane)**

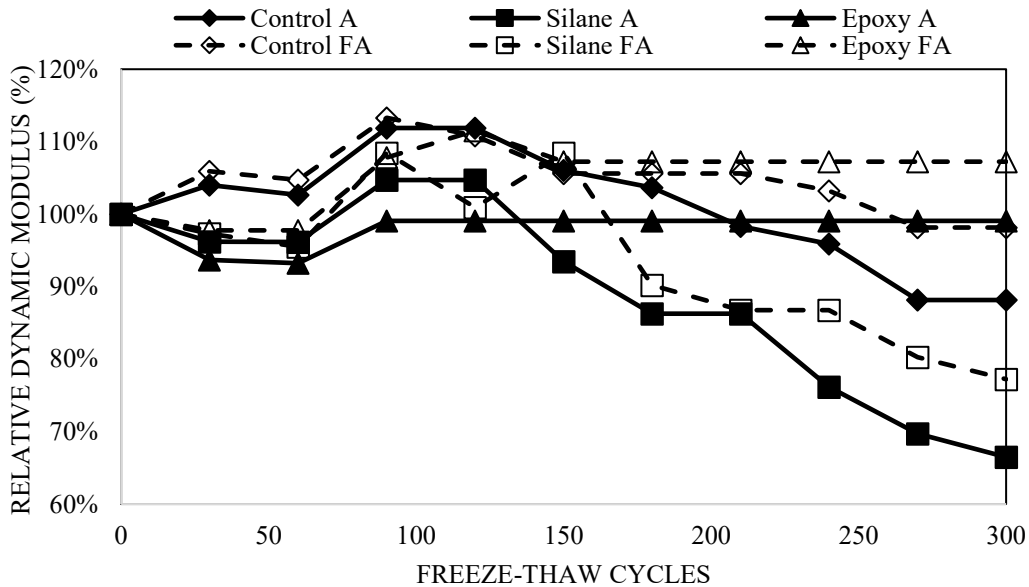
Figure 2.11 ASTM C666A Relative Dynamic Modulus

The relative mass and relative dynamic modulus results for the ASTM C666A test are shown in Figure 2.10 and Figure 2.11, respectively. ASTM C666A is conventionally used to assess the freeze-thaw (FT) resistance of plain concrete and most sensitive to coarse aggregate durability and concrete air system, although there is much debate surrounding the appropriateness of the submerged conditions, rapid freezing and thawing rate, and 300 cycles (Taylor, et al., 2021). Observing the untreated control specimens for the A and A-FA concrete with the A concrete having a durability factor of 88 and the A-FA of 98, indicating good performance for both with A-FA having better performance.

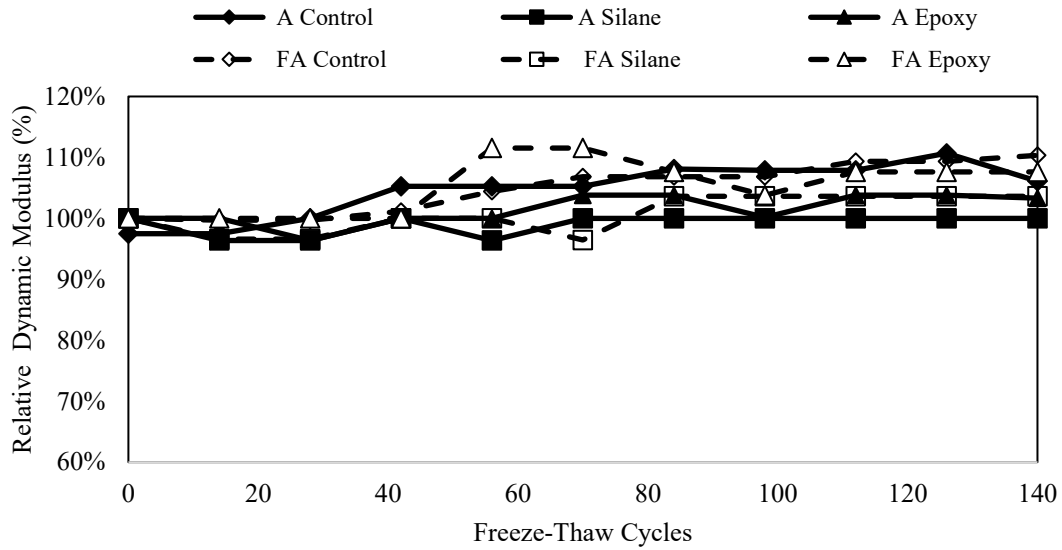
**Figure 2.13 CDF-W Relative Dynamic Modulus**

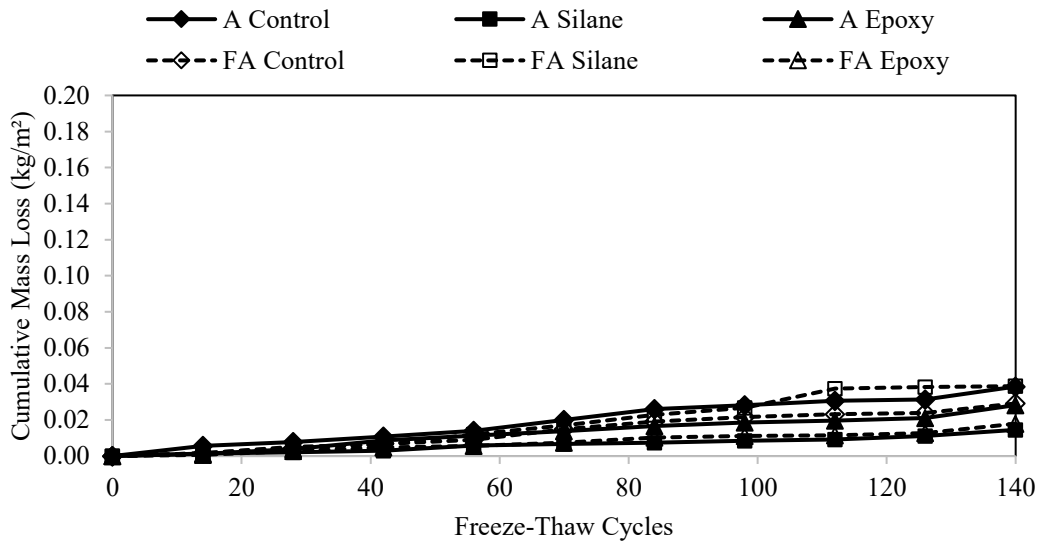
**Figure 2.14 CDF-W Cumulative Mass Loss from Scaling**

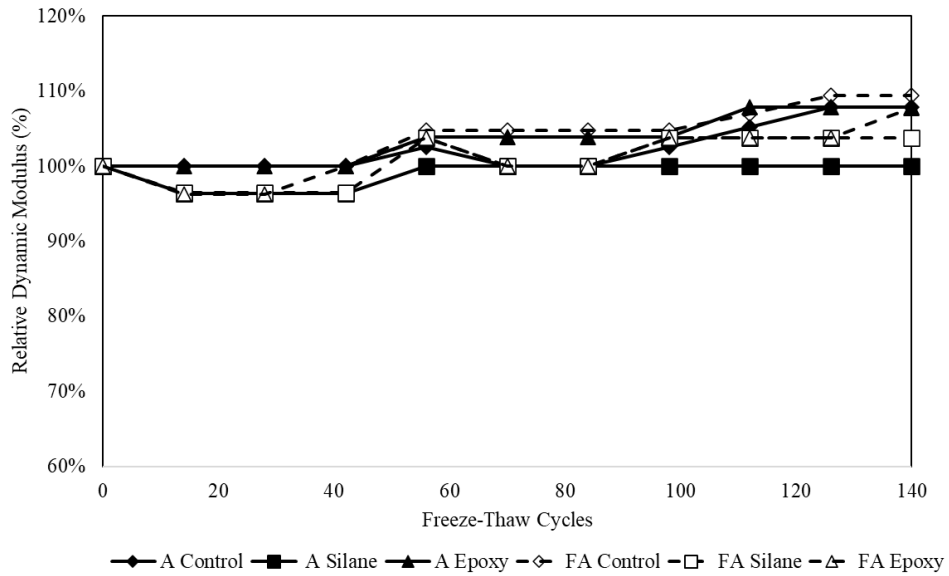
**Figure 2.15 CDF-DI Relative Dynamic Modulus**

Figure 2.15 and Figure 2.16 present the dynamic modulus and scaling results for samples where 3% NaCl was used as the freezing fluid (CDF-DI) and Figure 2.17 and Figure 2.18 for the samples receiving the 23% NaCl liquid anti-icer brine (CDF-AI). In general, all samples had good performance. It should be noted that when CDF testing uses salt treatments, the dynamic modulus will increase slightly as the test progresses as salt penetrates the specimens and either reacts to form other solid products or crystallizes. While in the short-term this provides strengthening to the concrete, the continued introduction of salt will have many negative consequences to durability. Both the CDF-DI and CDF-AI treatments had significantly higher scaling than the CDF-W, water control. The scaling from the deicer samples (CDF-DI) was roughly double that of the liquid brine anti-icing (CDF-AI) samples. This is consistent with the literature showing around 3% NaCl resulting in the most significant durability damage (Valenza & Scherer, 2006). While the samples

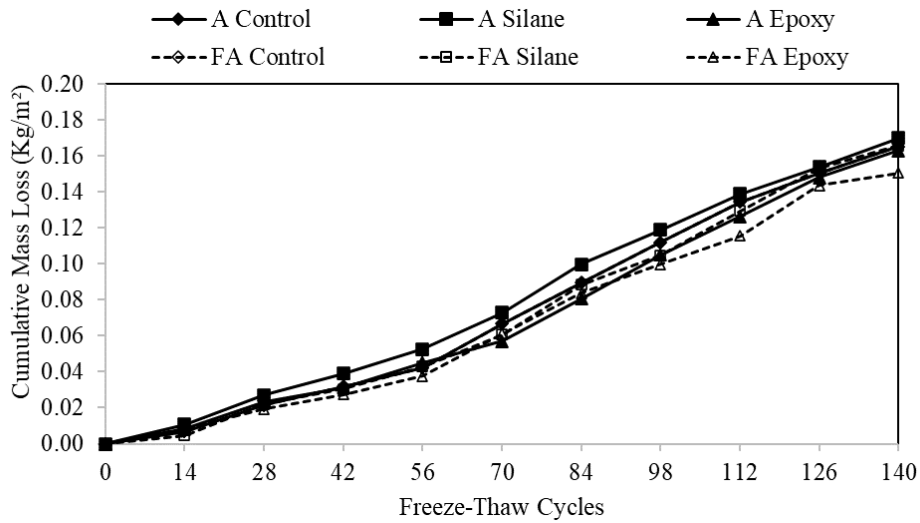
**Figure 2.16 CDF-DI Cumulative Mass Loss from Scaling**

tested in the deicing fluid had higher scaling than those tested in water, material scaled was well below the 0.80 kg/m<sup>2</sup> cutoff and consistent with the ASTM C672 data showing high resistance to scaling.

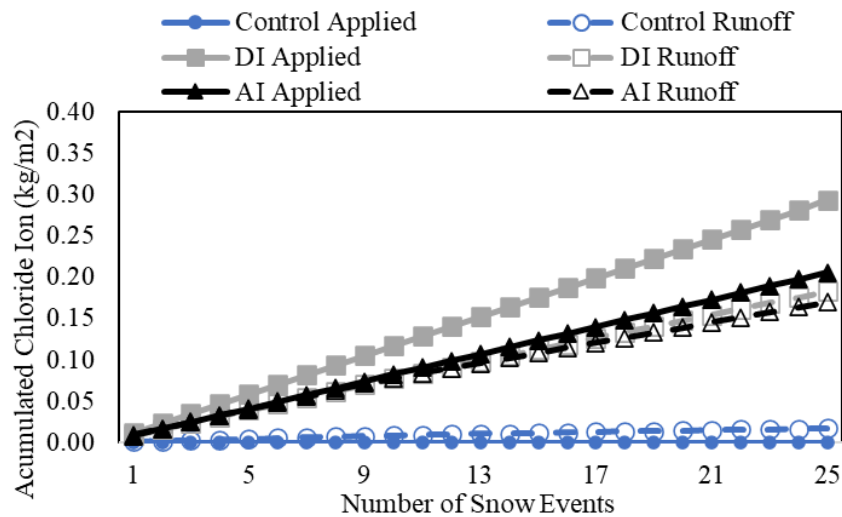
**Figure 2.19 Applied Versus Runoff Chloride Content from Simulated Tire Testing**

During testing the melt water was collected and chloride concentration measured for all conditions. For the size samples tested, the volume of runoff was similar for all samples. Figure 2.19 shows a comparison of the total chlorides applied during testing and the amount of chlorides collected in the runoff. As previously discussed and designed for in the test program, standard deicing practices using solid NaCl require more material per area than the liquid anti-icing brine protocol (i.e., 0.30 kg/m<sup>2</sup> DI applied vs. 0.20 kg/m<sup>2</sup> AI applied after 25 snow events in Figure 2.19). However, the amount of chlorides in the runoff are similar (i.e., 0.16 kg/m<sup>2</sup> DI runoff vs. 0.15 kg/m<sup>2</sup> AI runoff after 25 snow events in Figure 2.19). Therefore, more chloride retained in concrete in deicing applications than in anti-icing applications. This supports the findings presented previously where the deicing condition results in more chlorides in the concrete than the anti-icing condition.

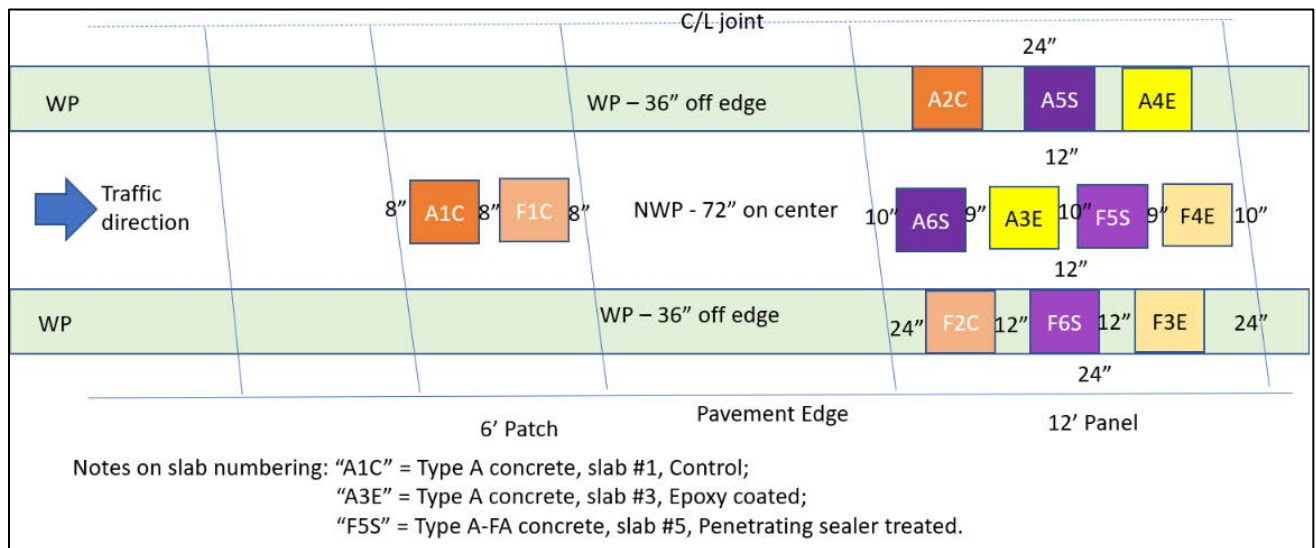
Figure 3.2 Placement of 12 concrete panels at MnROAD

This task utilized the full-scale testing facility at MnROAD. MnROAD is a pavement test track made up of various research materials and pavements owned and operated by the Minnesota Department of Transportation. Located near Albertville, MN, temperature at MnROAD is very similar to central Wisconsin. Cell 37 on the Low Volume Road has reached its end of research life (Figure 3.1), so two slabs within this cell were taken out and replaced with a concrete mix very similar to Wisconsin A-FA concrete. In addition, 12 concrete panels (2 ft \* 2 ft size) casted in the WIS 23 Corridor Project (Fond du Lac to Plymouth) were placed into the fresh concrete. Figure 3.2 shows the layout of the 12 panels. Overall, the following three factors were included in this study:

- Bare concrete: Type A, Type A-FA.
- Mitigation techniques: penetrating sealer (silane), thin polymer overlay.
- Install location: inside wheelpath, between wheelpath.

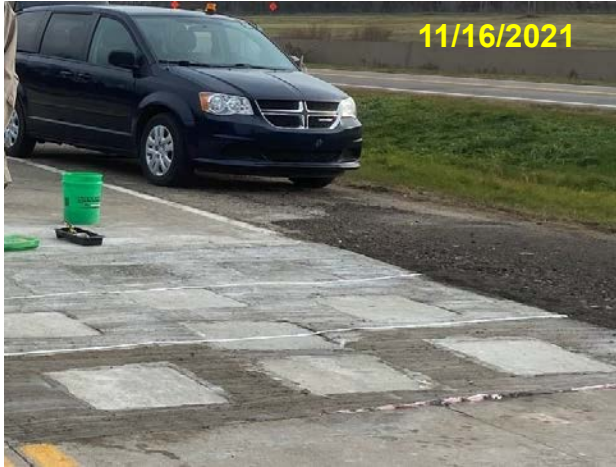
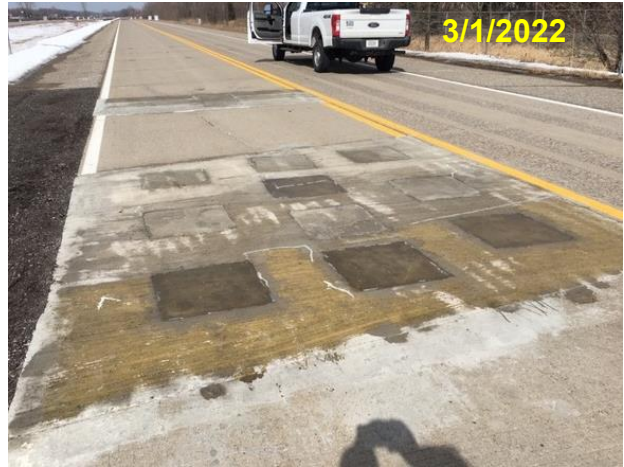
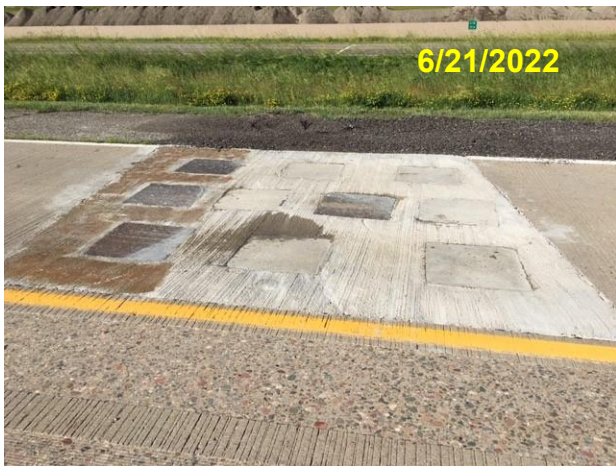
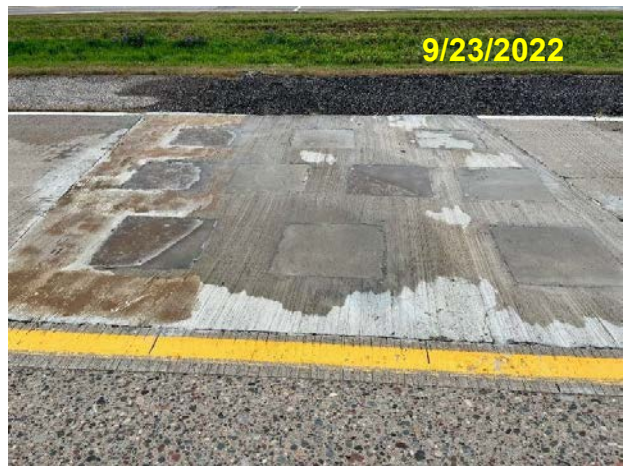
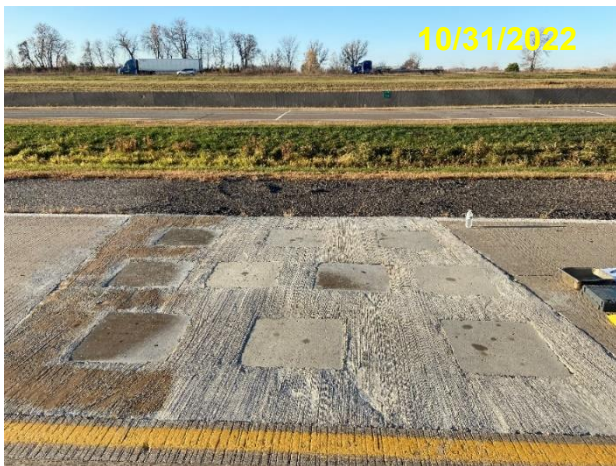
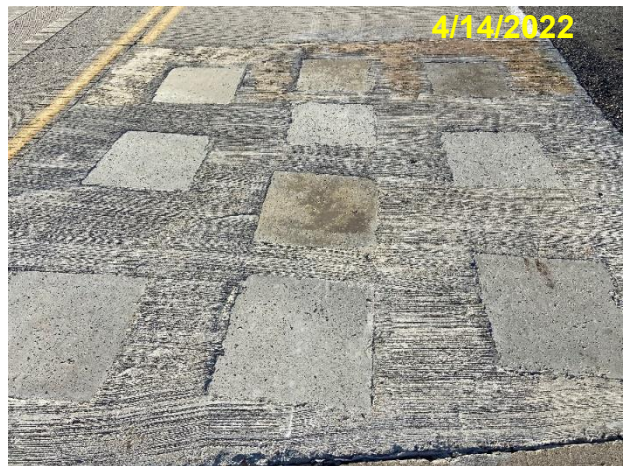
**Figure 3.4 Performance of concrete panels at MnROAD**

Figure 3.4 shows the performance during the 17-month study period. As expected, there was no visual distress on any of the panels due to the short time of study (i.e., the design life of concrete pavement is 20 years and the actual service life of concrete pavement is commonly 30~40 years).

- 1) One year after the construction (10/31/2022), the epoxy and silane coating prevented the transmission of electric current resulting the meter reading “OF”. This may be an indication of the protection from epoxy and silane. After another winter season (4/14/2023), readings were obtained on concrete with epoxy and silane coating, but readings were all higher than the control samples (without any coating). This may indicate the wear-off of the coating, as shown visually in Figure 3.4.

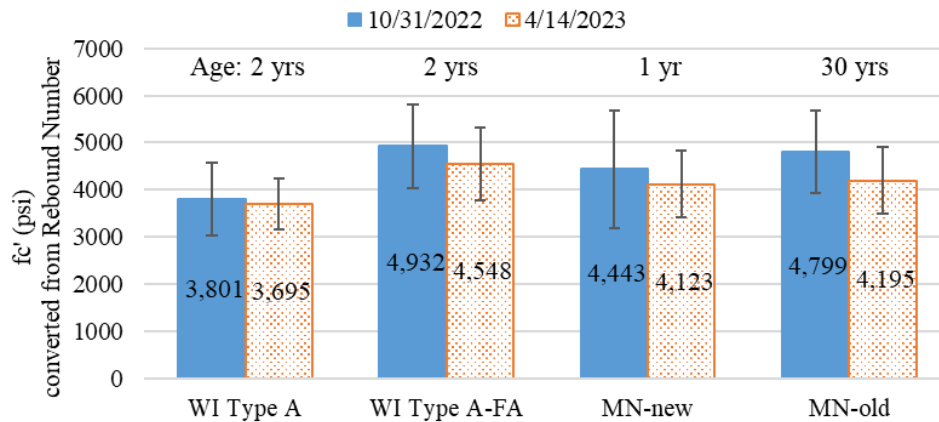
**Figure 3.5 Compressive strength converted from rebound hammer test**

- 1) WI Type A-FA concrete has 20~30% higher strength than WI Type A concrete. This agrees with the literature that fly ash increases the compressive strength.
- 2) WI Type A-FA concrete is 10% stronger than MN-new concrete. MN-new is also A-FA concrete designed to mimic the Wisconsin mix, but it was 1 year younger in age.

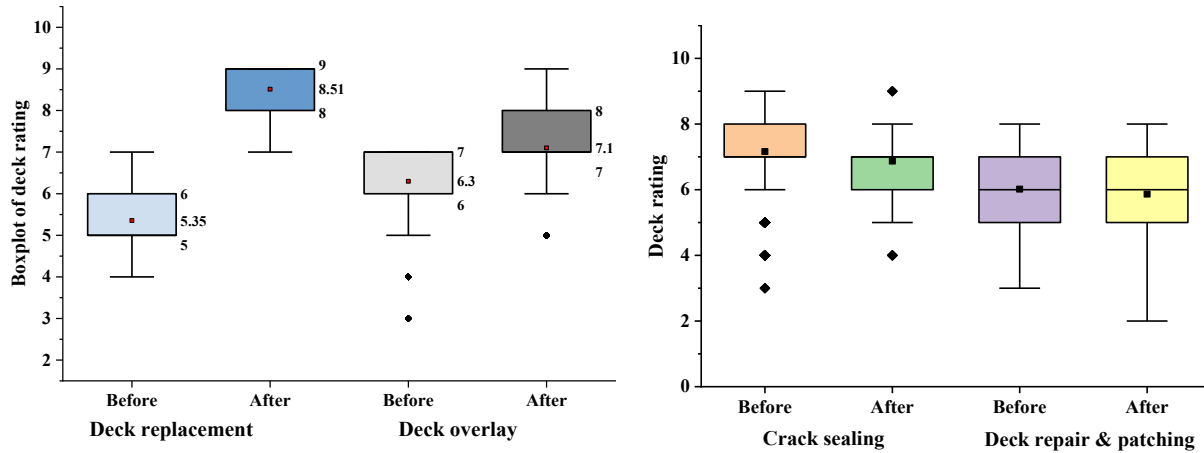
**Figure 4.3 Deck condition ratings before and after maintenance activities.**

The bridge deck ratings before and after maintenance activities were summarized in boxplots, as shown in Figure 4.3. The influences of deck replacement and overlay on deck rating were both significant. Deck replacement can efficiently recover deck condition from average rating of 5.3 to 8.5; while overlay can improve deck condition from average rating of 6.3 to 7.1. For crack sealing, deck repair & patching, no apparent improvement in deck condition ratings were noticed.

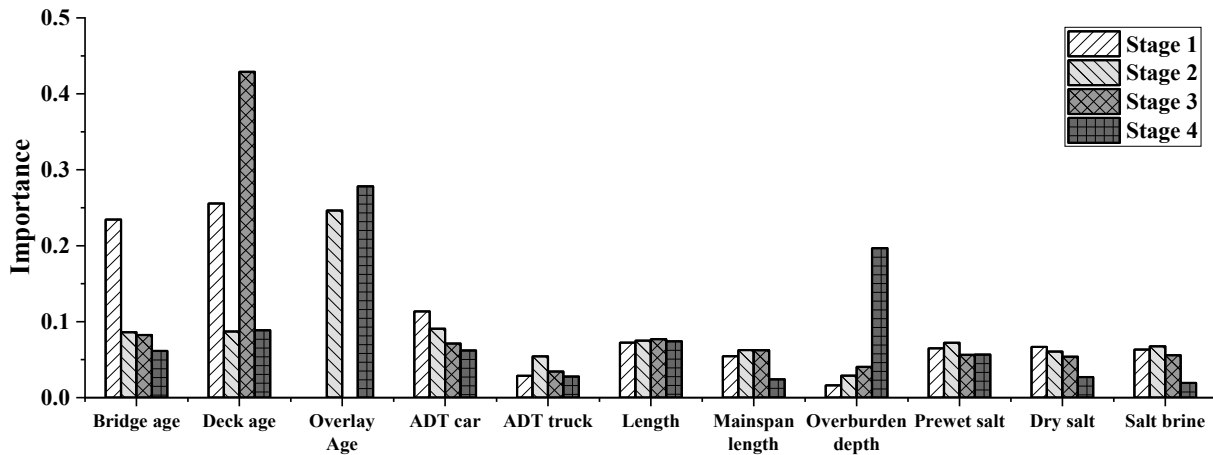
**Figure 4.7 Importance of input variables for bridge condition prediction**

Figure 4.7 shows importance of input variables from RF models. Only variables with importance values greater than 0.05 are presented. As it can be noticed that bridge age and deck age show relatively higher importance compared to other input variables. Overlay age shows significant importance only at stage 2 and 4. The average daily traffic of car (ADT car) presents the third importance rank in stage 1, 3, and 4, and shows the secondary importance in stage 2. The average daily traffic of truck (ADT truck) shows relative low importance at all stages. The importance of three types of salt usages are similar. As for other bridge deck features, deck length and main span length show higher importance among these deck features except stage 4, in which the overburden depth has higher importance. It is noted that the importance of concrete sealer is low ( $<0.05$ ), but it is included in the input variables for further analysis.

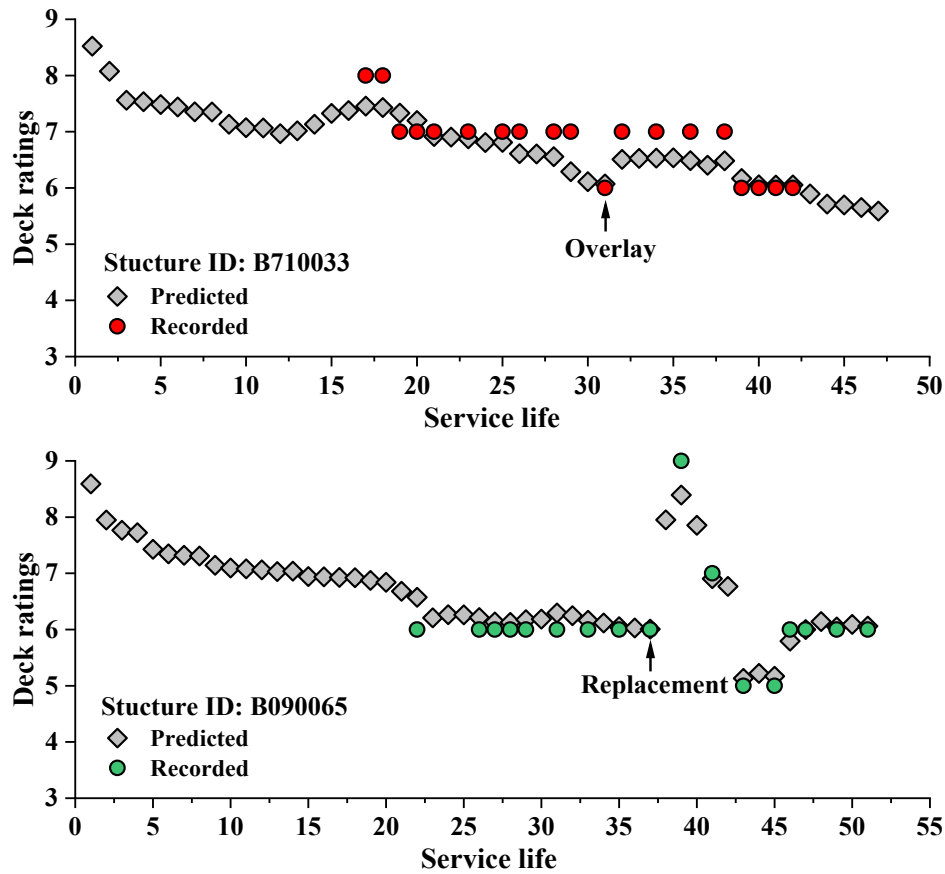
Figure 4.8. Predicted deck ratings for two selected bridges

Figure 4.8 presents two examples of predicted deck ratings for 100-year service life of bridge using the inputs of two recorded bridges in the database. The prediction model shows good capability to predict the variations of deck condition that match well with the actual data. The effects of overlay and replacement on deck condition ratings can be clearly observed.

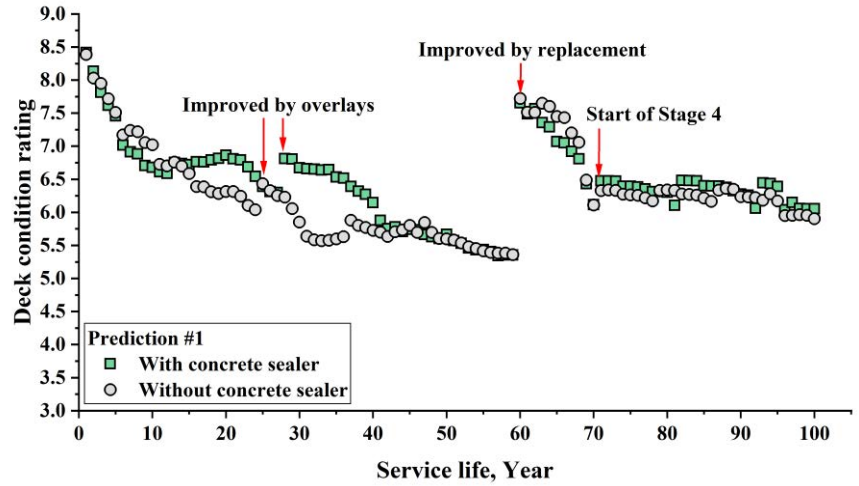
Figure 4.9 Effect of concrete sealer on deck condition ratings.

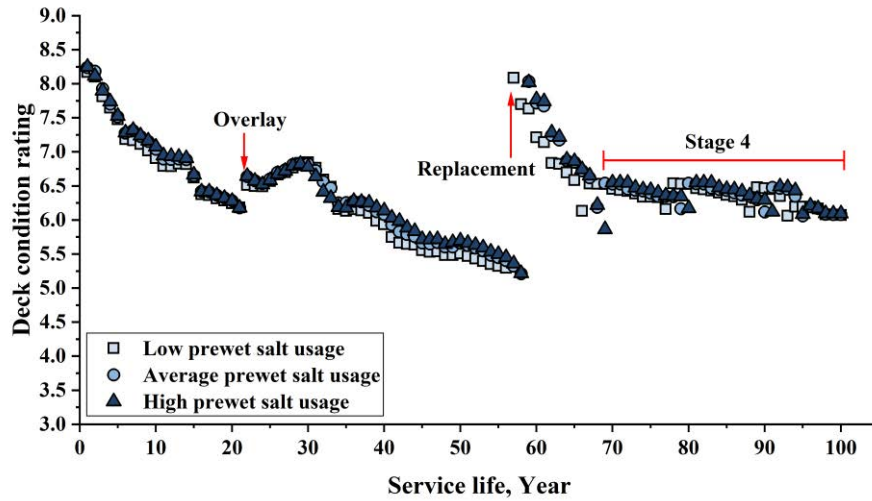
Figure 4.10 Effect of salt usage on deck condition ratings.

The effects of different types of salt usages on predicted deck ratings are shown in Figure 4.10. According to the predicted deck condition ratings, only minor differences could be observed for bridge decks with different salt usages. More usages of prewet salt and salt brine result in slightly higher deck condition ratings, while less dry salt usage presents slightly higher deck condition ratings. Although the difference is not dramatic, this finding agrees with laboratory study as discussed in Chapter 2 that anti-icing (with salt brine) created less damage than deicing (with dry salt).

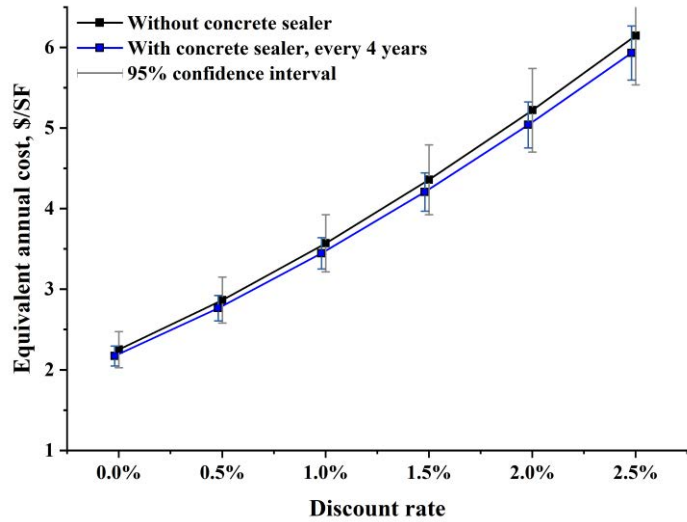
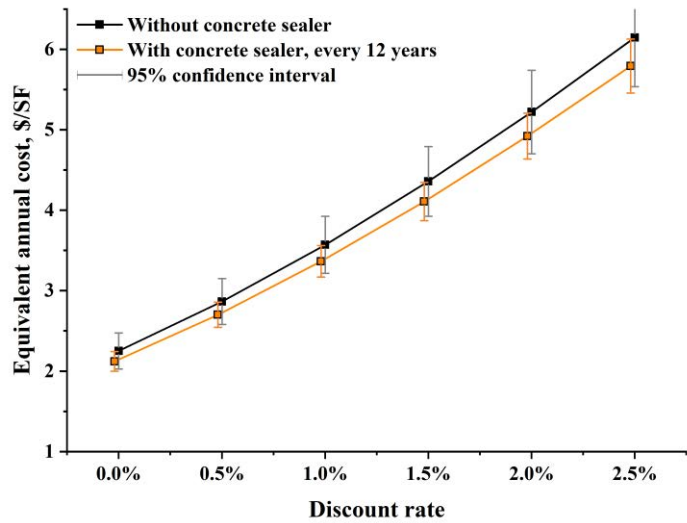
The monetary discount rate is important in LCCA to discount future costs for long-term projects. The equivalent uniform annual costs (EUACs) are calculated for all LCCA cases using different discount rates based on the range in 2023 Discount Rates for OMB Circular No. A-94. Figure 4.14 compares EUACs of bridge decks with and without concrete sealers at different scenarios. The results show that EUAC increases with the increase of discount rate. When the concrete sealer is applied every 2 years, the EUACs at all discount rates are close to those without concrete sealers. When concrete sealers are applied every 4 or 12 years, lower EUACs are observed and the difference of EUACs between the bridge decks with and without concrete sealer is enlarged as the discount rate increases.
