# Bridge Integrated Analysis and Decision Support - Phase II

WisDOT ID no. 0092-04-15

# **Bridge Integrated Analysis And Decision Support – Phase II**

## **Final Report**

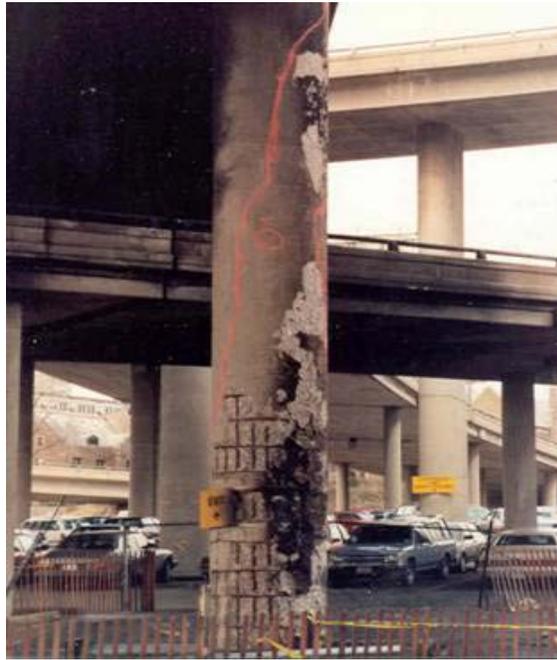
On Friday, November 27, 1992, a gasoline truck lost control over the bridge before 10:00 a.m., and dropped, through a protective concrete barrier, 33 feet onto a parking surface, where it exploded into flames and damaged several nearby vehicles [1]. The fire from the gasoline explosion resulted in heavy scaling and delamination of concrete in piers supporting the bridge (see Figure 1).

**Figure 1. Column with Scaling and Delamination Due to Fire**

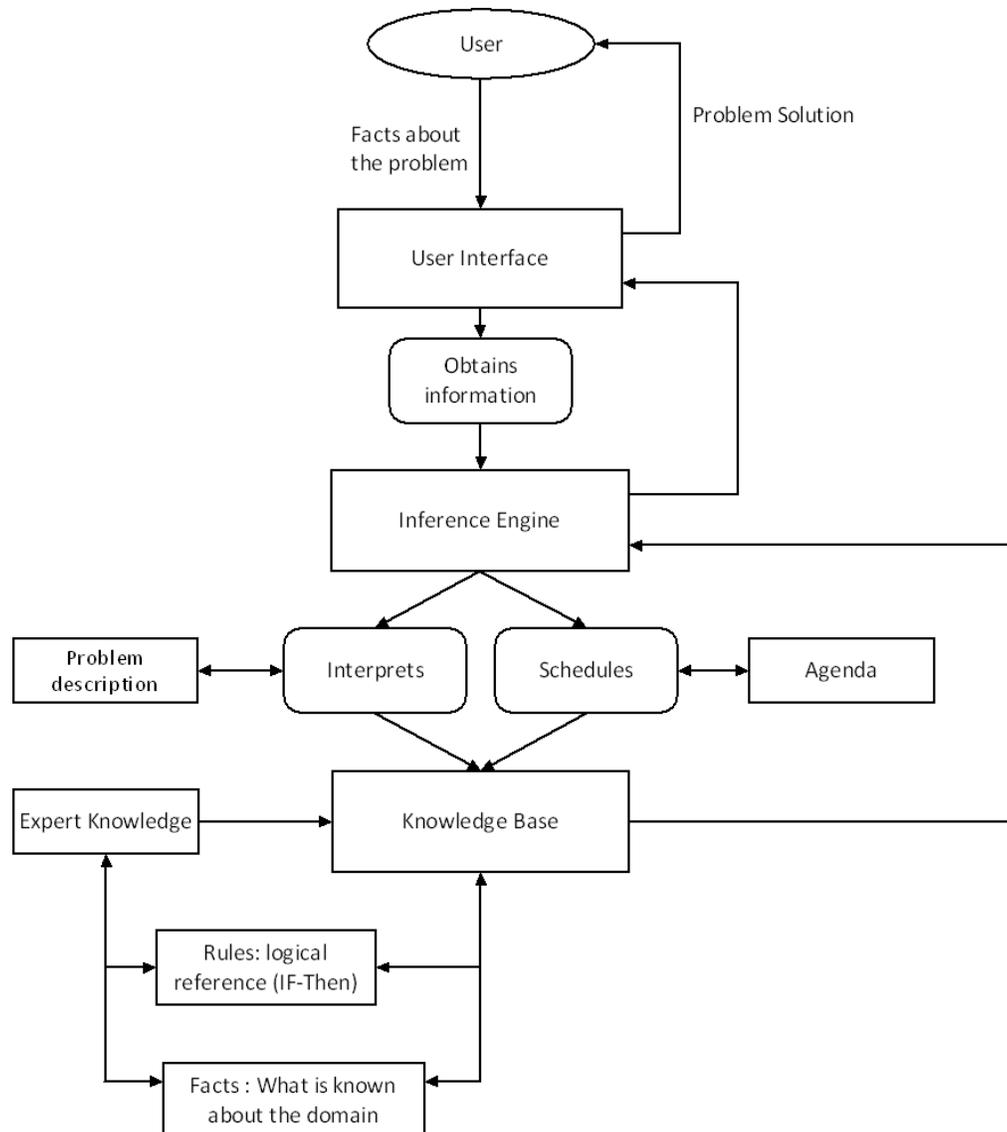
solving specific problems. The inference engine performs the process of interpreting this knowledge. The user interface provides a link between the first two components and the user. In addition to facilitating the communication between the user and the system, the user interface accepts entries, displays data and graphics, and provides other capabilities [20]. Figure 7 illustrates the interaction among the knowledge base, inference engine, and user interface in an expert system.

**Figure 7. Interaction Among An Expert System's Primary Components**

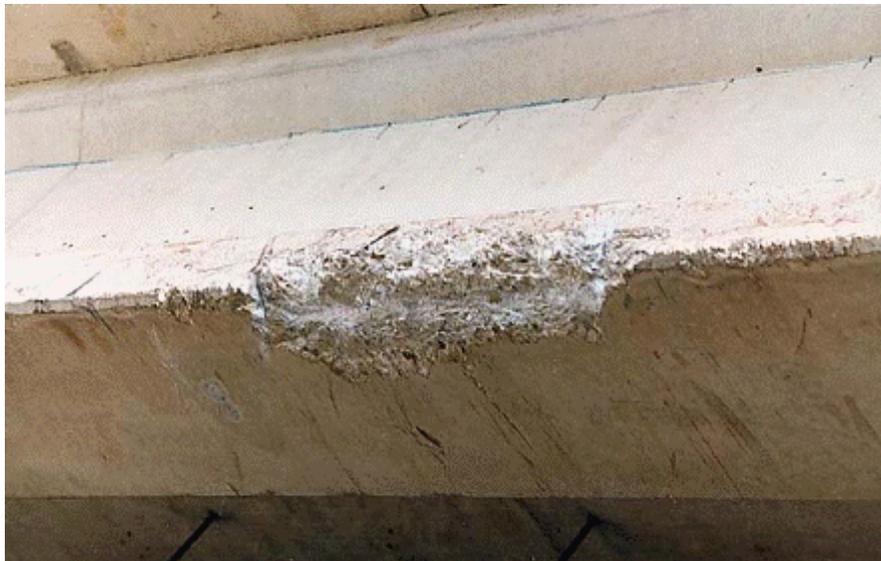
**Figure 9. Minor Damage - Shallow spalls, scrapes and minor cracking**

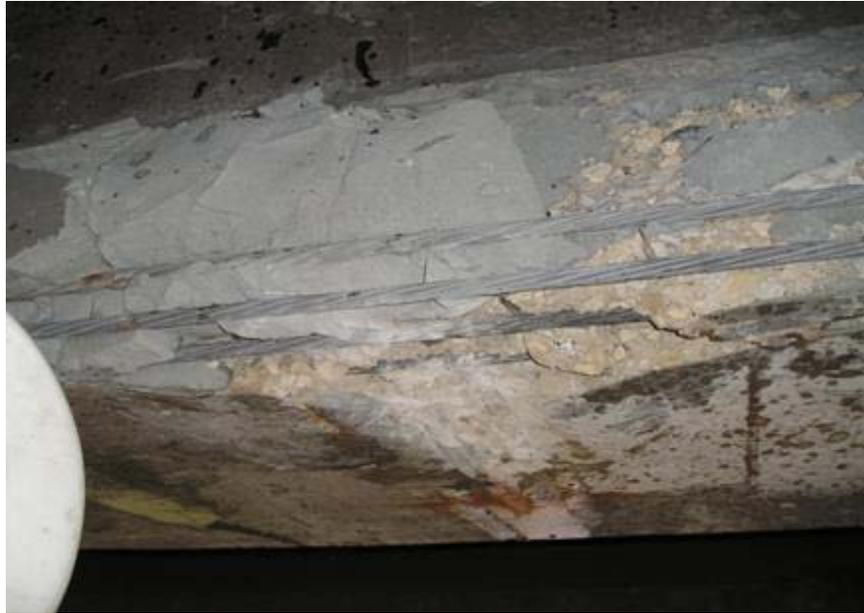
**Figure 10. Moderate Damage - Large spalls, minor loss of section and exposed strand**

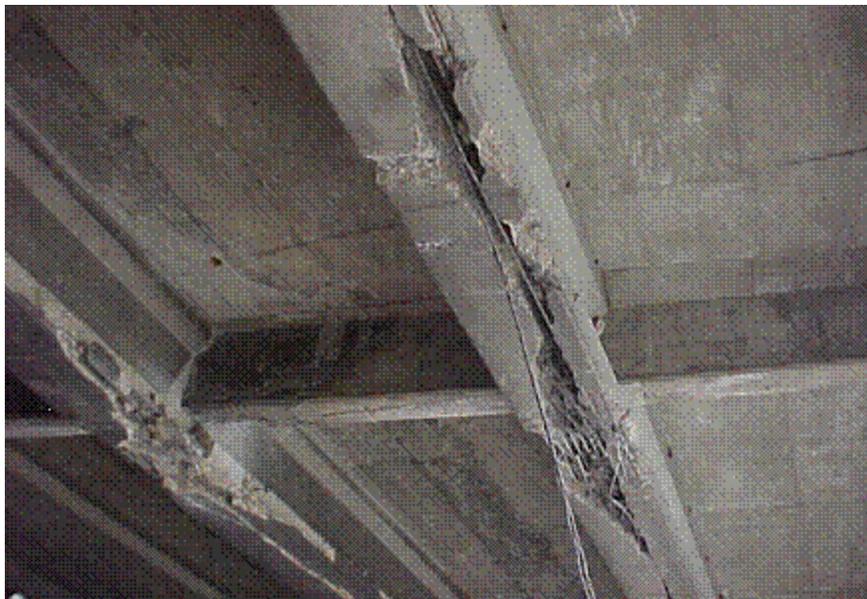
**Figure 11. Severe Damage - Severe cracking, major loss of section, and damaged strands**

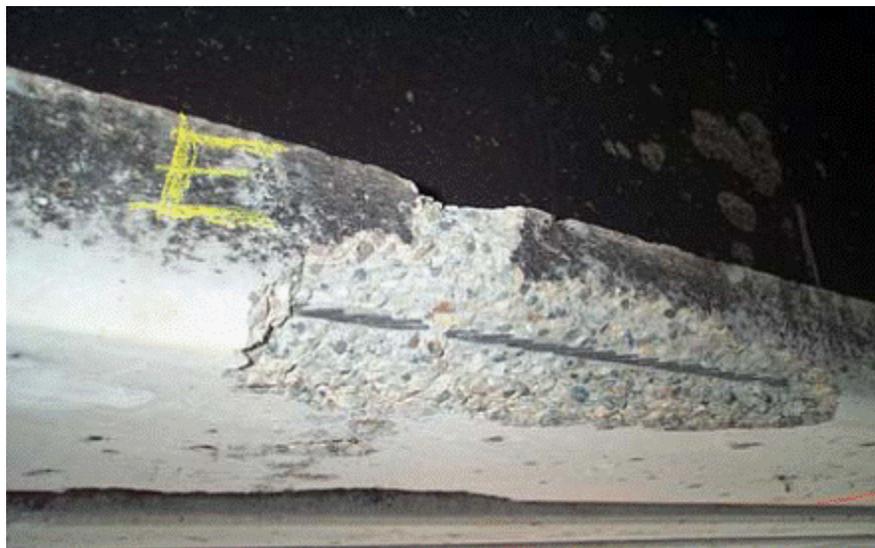
The intensity of the fire and the concrete damage level after being exposed to flames can be identified based on the resulting color. According to the Precast/Prestressed Concrete Institute (PCI), concrete that is not discolored and has been heated and then cooled did not reach temperatures above 600°F. If the concrete has turned into a pink color due to fire, it could have reached temperatures between 600°F and 1100°F. Concrete heated above 1100°F and then cooled tends to develop a whitish-gray surface; and for above 1700°F some concretes turn to a buff or yellowish color [40] (see Figure 12).

**Figure 12. Concrete Girder Damaged by Fire (Buff color)**

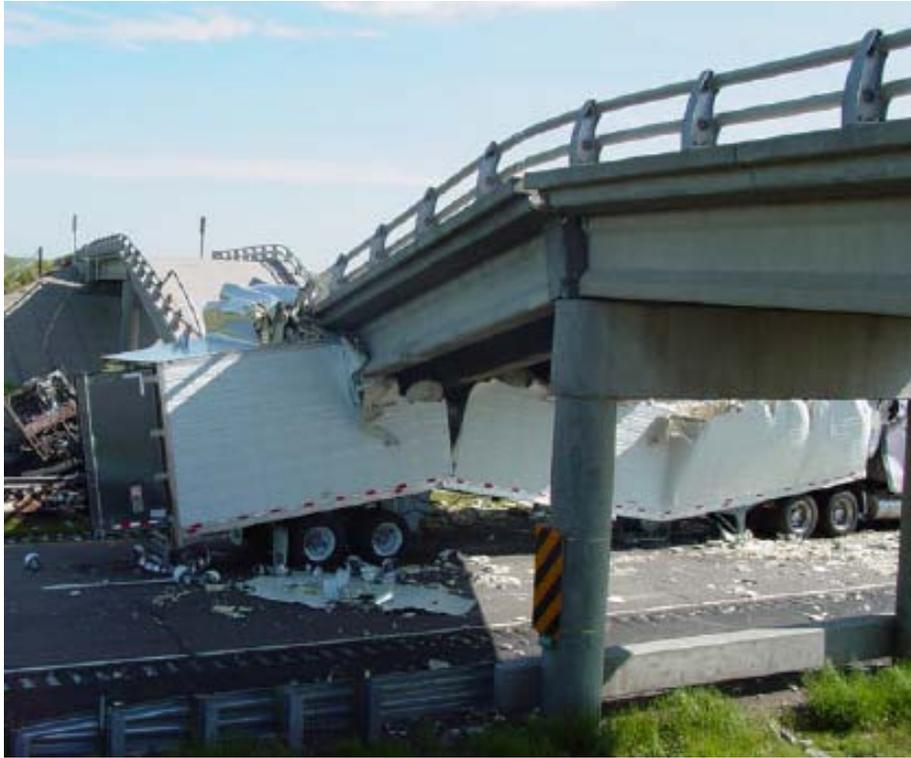
According to the WisDOT's Structure Inspection Manual [43], signs of pier impact damage include scrapes, chips, cracks, spalls, and possibly a fractured section of a pier component. In cases of severe collisions, reinforcing bars can be exposed or damaged. The WisDOT manual classifies the impact damage into three condition states based on the observed evidence on the structure. These include: Condition state 1 - that is defined as having previously repaired damage and new minor evidence of impact, Condition State 2 – with unrepaired former minimal damage including spalls and exposure of a few reinforcing steel bars, and Condition State 3 – with evidence of severe damage to cause concerns for public safety or serviceability of the member or structure (see Figure 13).

**Figure 13. Example of a Severe Impact Damage to Substructure**

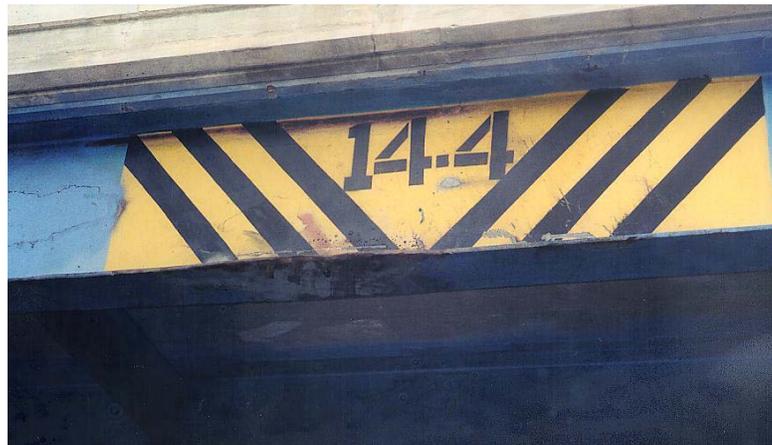
- Condition State 1: When there is previous damage that has been repaired.
- Condition State 2: When there is unrepaired previous damage and the new damage is minimal and does not cause any safety concern. Repairs may not be required. (see Figure 15).

**Figure 15. Condition State 2 for a Steel Girder Moderately Damaged by Impact (scrapes and minor distortion of the bottom flange)**

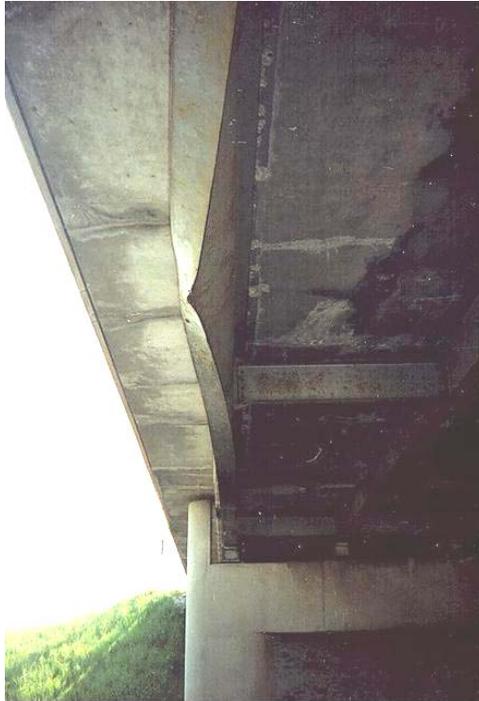
- Condition State 3: When the damage causes concerns regarding safety or bridge's serviceability. The member may have been severely damaged to the extent that it may no longer possess its original structural capacity. In such cases, an appropriate structural analysis will be warranted to determine the member's new capacity. Accordingly, appropriate repairs should be implemented for the affected structure (see Figure 16).

**Figure 16. Condition State 3 for a Steel Girder Severely Damaged by Impact (major distortion of the web and bottom flange)**

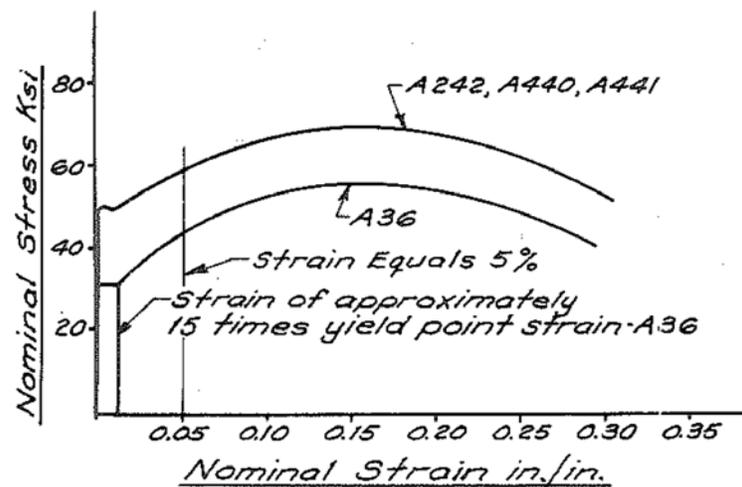
displacement, strain hardening occurs in the steel and further deformation will take place only if there is some increase in the level of the applied stress. Shanafelt and Horn [47] state that for steel strains bellow 5% from impact loads on bridge members there will be little effect on the materials properties. It must be noted however that most of the strain caused by vehicular impacts in steel bridge members would fall within 5 to 10 times the strain at the point of yield. As such, no significant degradation can be expected in the affected steel unless cracking or fracture occurs.

Figure 17. Nominal Stress Strain Diagrams for Typical Bridge Steels

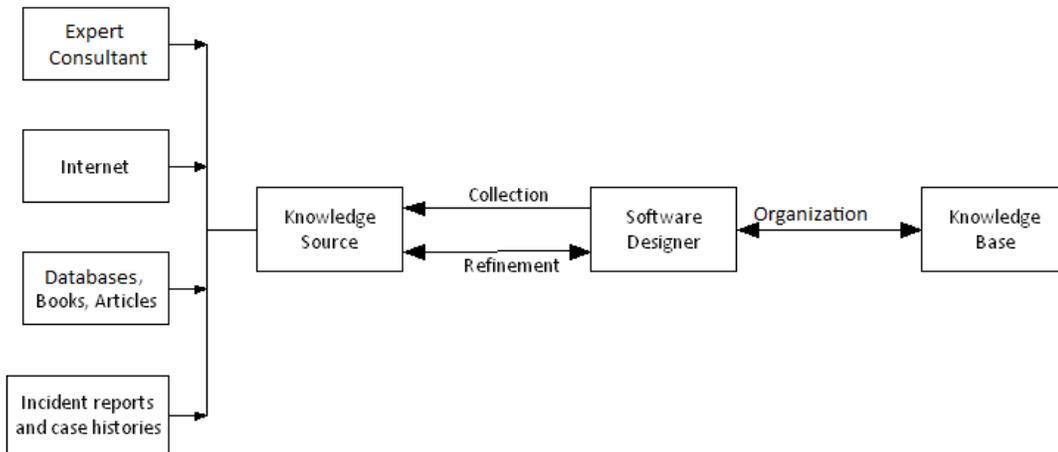
The process of refinement, representation, and elicitation of the knowledge obtained was performed manually. Interviews, case study analysis, critical incident analysis, discussion, and brainstorming were employed. These methods were applied by the research staff (software designer) to integrate the acquired knowledge into the software. Figure 18 shows the knowledge acquisition process that was followed for the development of BEES.

**Figure 18. Knowledge Acquisition Process for Developing BEES**

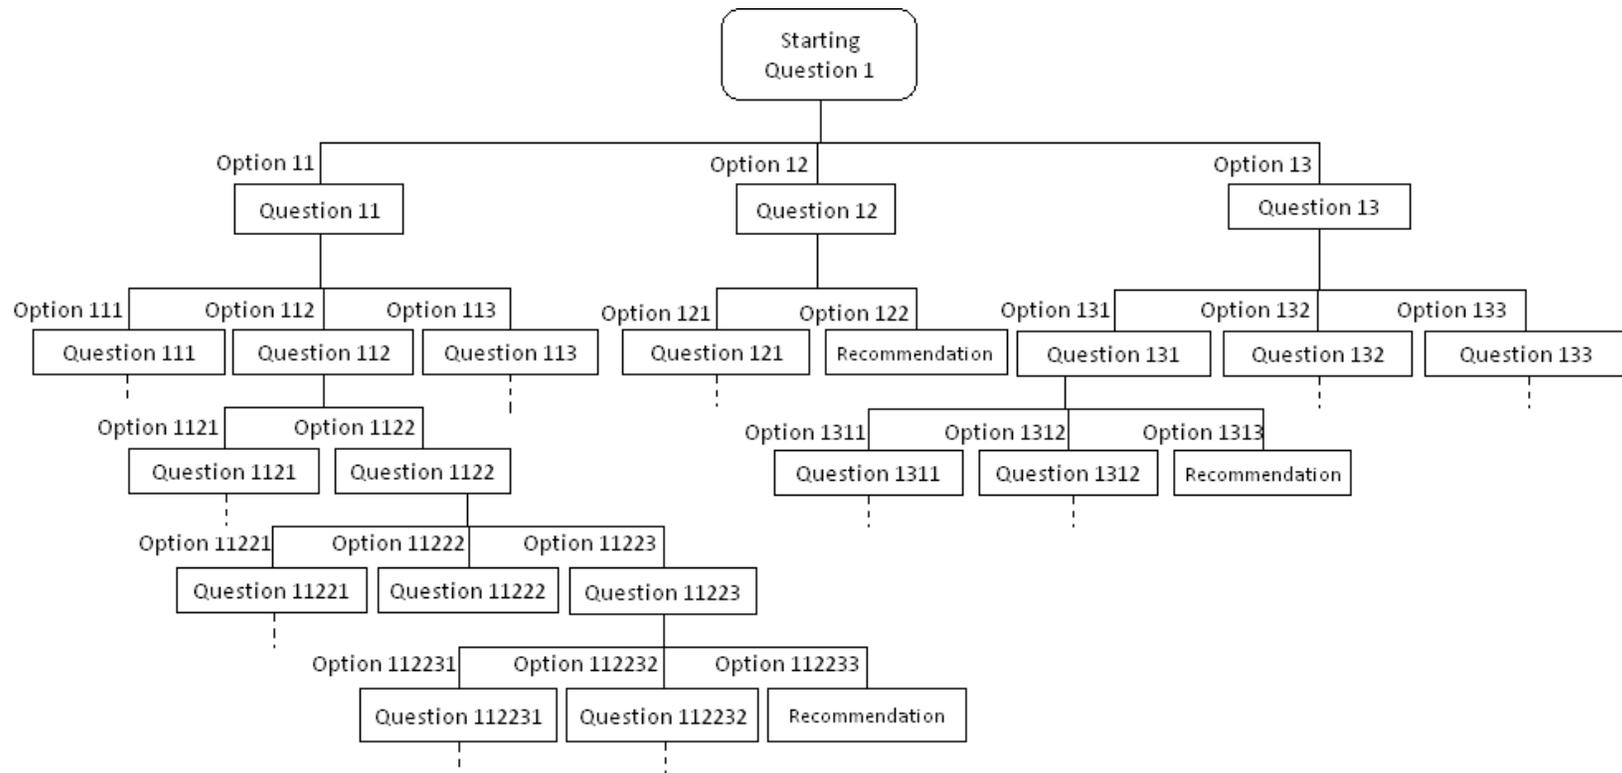
A system of rules and procedures were created in the form of a decision tree, as shown in Figure 19, to organize the collected information. The nodes of the decision tree represent the questions presented to the user while the links represent the options given for each question. The interaction between these components determines the nodes to follow and an eventual recommendation when the process is completed. The questions are organized based on following a format of hierarchy, so the most general or relevant question is considered first. When the more general questions are answered, more specific questions are asked and the final recommendation is provided at the completion of the process.

Figure 19. General Decision Tree used for Developing BEES

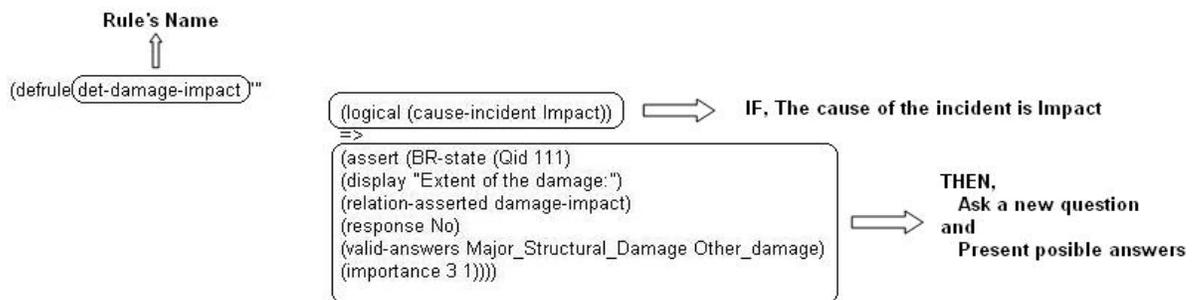
Every rule-related part of the general decision tree is created based on the information available in the BEES' knowledge base. Each of these rules consists of a precondition and an action. The precondition describes a situation in which a relevant action to be taken. Based on this principle, a production of rules was created in the form of IF-THEN pairs, i.e., IF this condition exists, THEN some action will take place. Figure 20 shows an example of a precondition and action as related to rules in BEES.

**Figure 20. An Example of Precondition and Action in BEES**

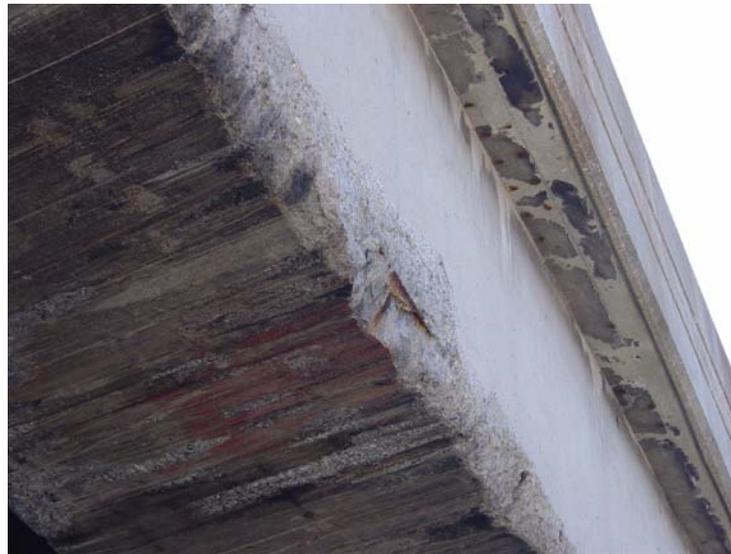
2. *Moderate damage*: If the visual inspection indicates the presence of large cracks located in the area of the impact or other critical locations, and shallow spalls and/or loss of section large enough to expose undamaged prestressed tendons then the damaged caused by the impact is classified as Moderate. A crack width between 0.1" and 0.19" for reinforced concrete girders and between 0.009" and 0.03" for prestressed concrete girders is considered as causing moderate damage [43]. It is considered here that such cracks, and moderate spalls and/or loss of section are not severe enough to be classified as causing major structural damage. Partial damage that does not comprise the safe usage of the structure is also considered as moderate (see Figure 22).

**Figure 22. Moderate Damage – RC Girder Damaged by Impact (spalls and exposure of undamaged steel bars)**

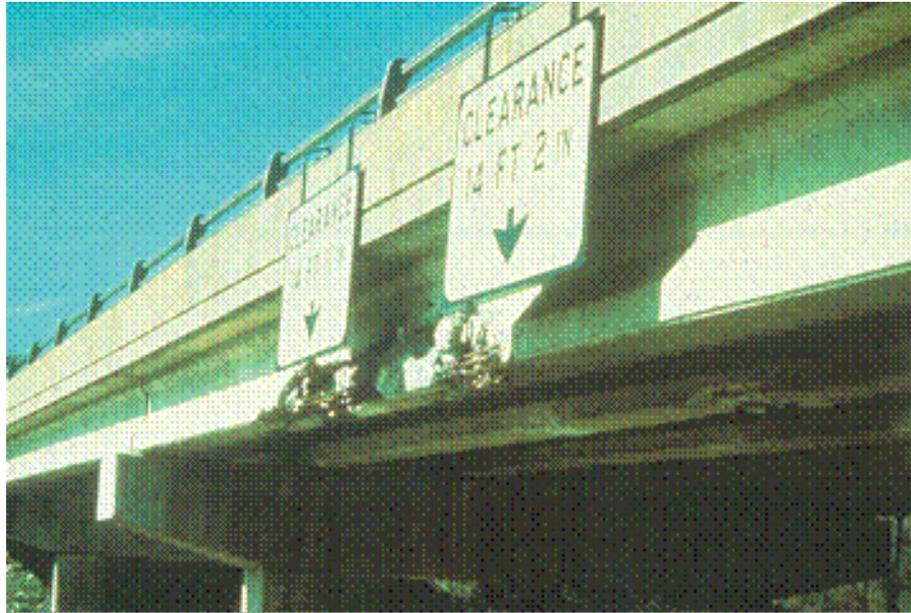
cracking, and/or girder distortion, the damage is classified as severe. Cracking is considered severe for example when it propagates from an impacted flange into the web of the girder. In cases of severe damage, a crack width will exceed 0.19" for reinforced concrete girders and 0.03" for prestressed concrete girders [43]. Due to the severity of the damage, it is considered that the structural integrity has been compromised (Figure 23).

**Figure 23. Severe Damage – PS Concrete Girder Damaged by Impact (extensive spalls and loss of section, severe cracking and multiple exposed or damaged strands)**

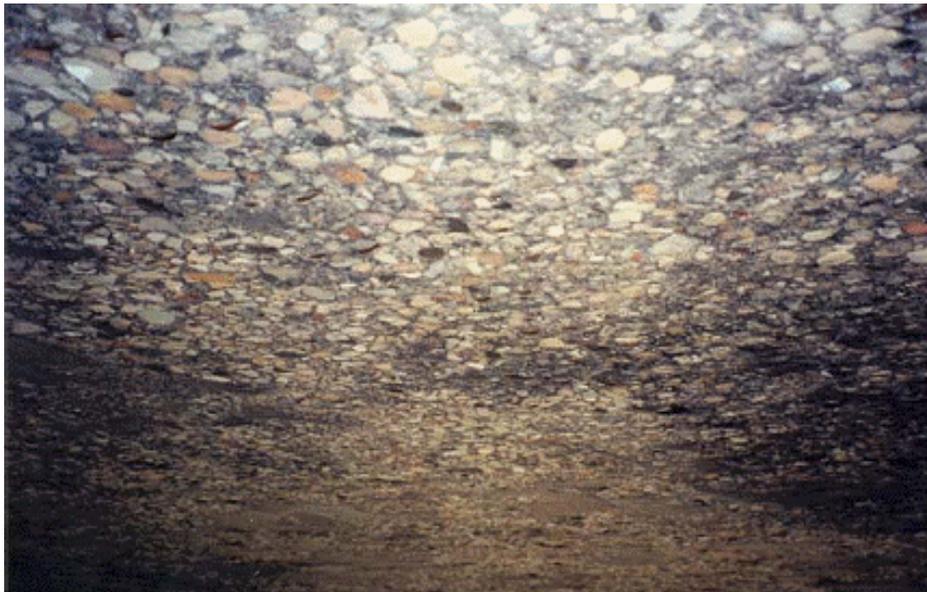
1. *Minor damage:* For fire damage to concrete girders or decks, a minor damage is defined as the presence of isolated cracks, few spalled and delaminated areas, and no exposure of reinforcing steel or prestressed strands. Under this condition, the structural integrity of the member or structure is not compromised. If scaling is evident, it will be considered minor if the cement paste loss is limited to 1/4 inch deep, and it is accompanied with only surface exposure of coarse aggregates (see Figure 24). The detrimental effects of concrete exposed to temperatures below 600°F are considered minimal, since the damage is mostly limited to the surface. Concrete below this temperature is not discolored or damaged. For the identification of the concrete color after the fire, it is necessary to remove the soot that mask the actual color.

**Figure 24. Minor Damage – Concrete Girder Damaged by Fire (minor spalling with no reinforcement exposure)**

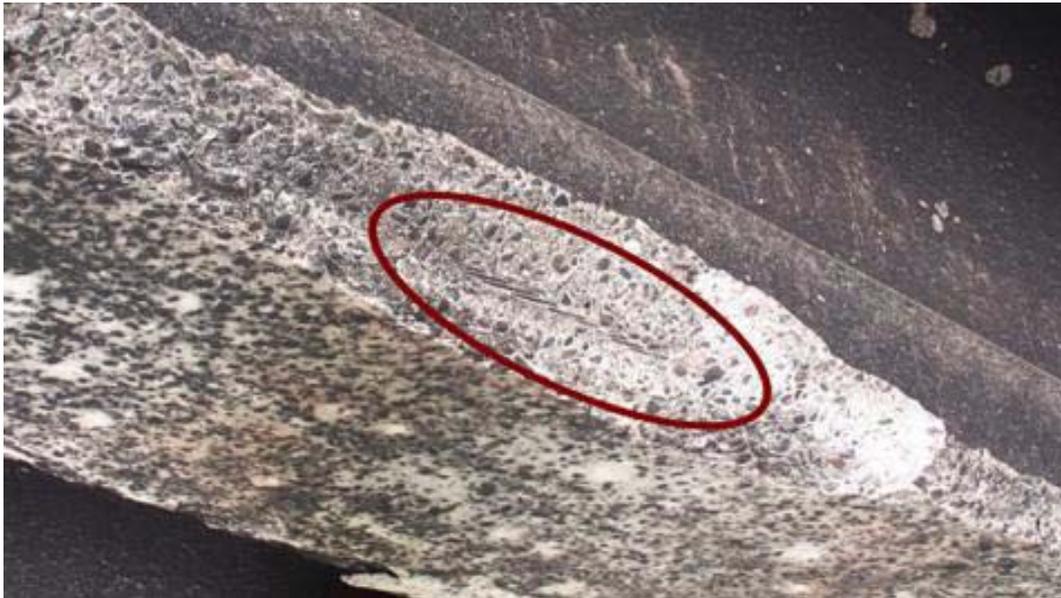
2. *Moderate damage*: Under this classification, concrete contains greater amounts of cracking, and spalled and delaminated areas as those classified under *minor damage*. Scaling is classified as moderate if there is a cement paste loss of from 1/4 inch to 1 inch deep, and the exposure of the sides of the coarse aggregates [43]. Steel may be exposed under this classification but there should be no visible signs of loss of prestressing force, member sag, or flexural cracks (see Figure 25). Concrete members exposed to temperatures between 600°F and 1700°F are somewhat permanently damaged. At these temperatures, the color of the concrete exposed directly to the flames changes. A pink coloration appears if temperatures between 600°F and 1100°F are reached due to the formation of ferrous salts. At temperatures above 1100°F and below 1700°F, concrete exhibits a white-gray coloration. At temperature exposure below 1700°F, the damage level is not considered severe enough to compromise the structural integrity of the member. Partial damage that does not comprise the safe usage of the structure is also considered as moderate

**Figure 25. Moderate Damage – PS Concrete Girder Damaged by Fire (rounded concrete edges and exposure of strands)**

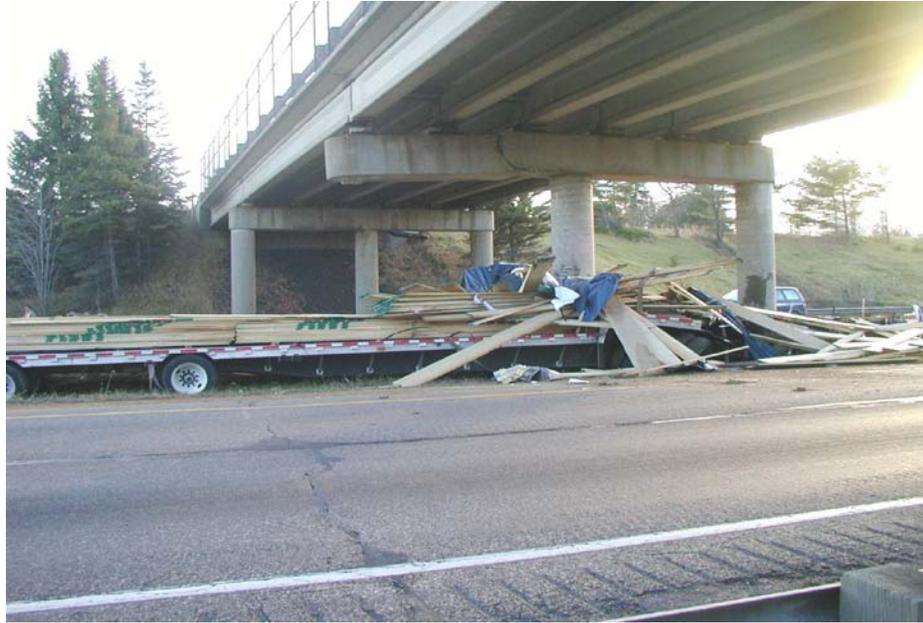
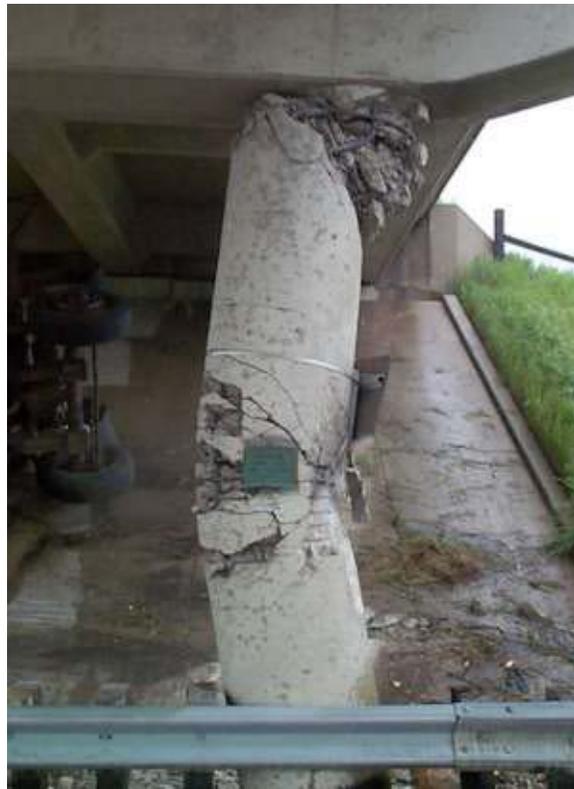
3. *Severe damage*: A severe damage is defined when the safety of the public and structural integrity have been compromised (see Figure 26 and Figure 27). Excessive flexural cracks at the base of concrete columns and horizontal or diagonal cracks at the pier-cap/column interface are signs of excessive lateral bending. This cracking pattern is considered to be a severe damage to the member. Overloads or differential substructure settlement produced by an impact can be identified with mid-height flexural cracks, as well as vertical cracks and crushed concrete [43]. The structural integrity may be compromised if one or more columns are severely damaged or severe spalling and exposure of damaged steel are evident in the affected member.

**Figure 26. Severe Damage – Concrete Substructure Damaged by Impact**

**Figure 27. Severe Damage – Concrete Substructure Damaged by Impact**

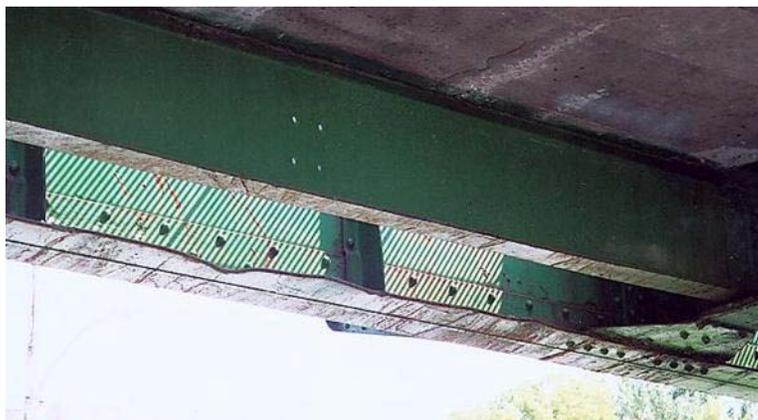
1. *Minor damage*: A minor damaged is defined if the visual inspection does not indicate any evidence of structural damage. Under this damage classification, structural members or elements may experience minor damage such as dents, scrapes, and distortions but no cracks should exist in the primary and secondary members or at the toes of butt and fillet welds in such members (see Figure 28).

**Figure 28. Minor Damage - Steel Girder Damaged by Impact (girder lower flange slightly distorted, scrapes underneath the member)**

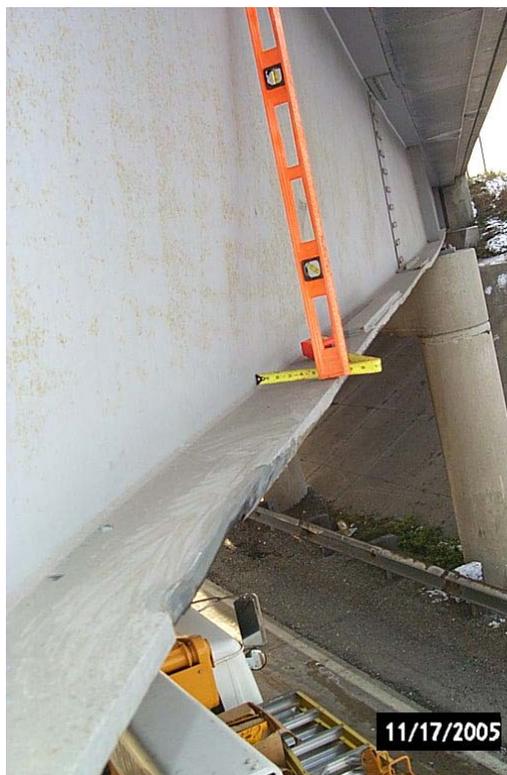
2. *Moderate damage*: Under the moderate damage classification, there may be considerable deformation, minor cracking, dents or nicks but there will be no safety concerns or diminishing effects on the structural integrity. No immediate repair will be required to keep the structure in service under the moderate damage classification. Critical areas such as welded connections and the area of primary damage must be examined for possible cracking. Evidence of peeling of paint or scaling should be considered as an indicator of unusual strain that could lead to possible cracking (see Figure 29).

**Figure 29. Moderate Damage - Steel Girder Damaged by Impact (local distortion of the bottom flange)**

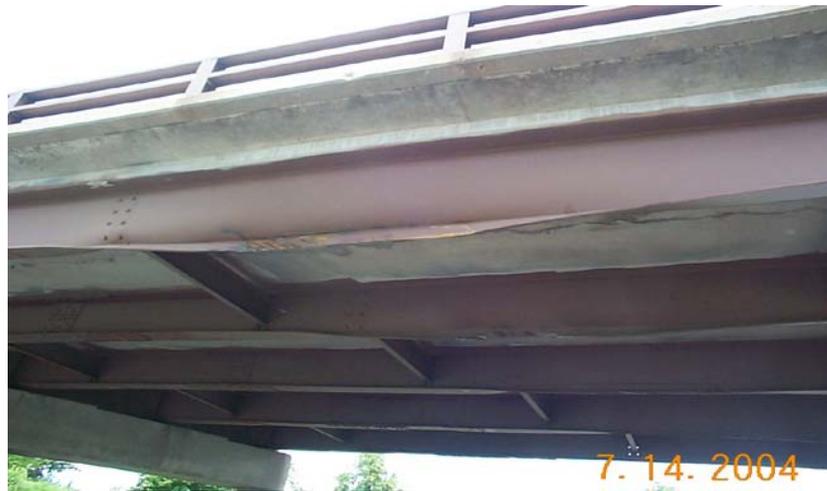
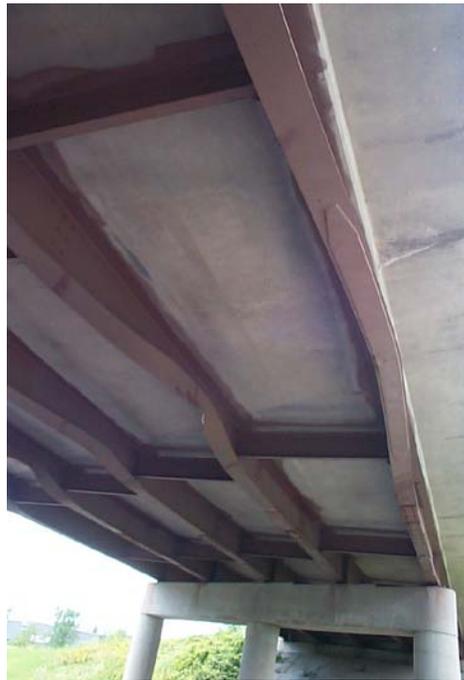
elements, or severe nicks or gouges on plate edges or member corners (see Figure 30).

**Figure 30. Severe Damage - Steel Girders Damaged by Impact (lateral and in-plane distortions of multiple girders)**

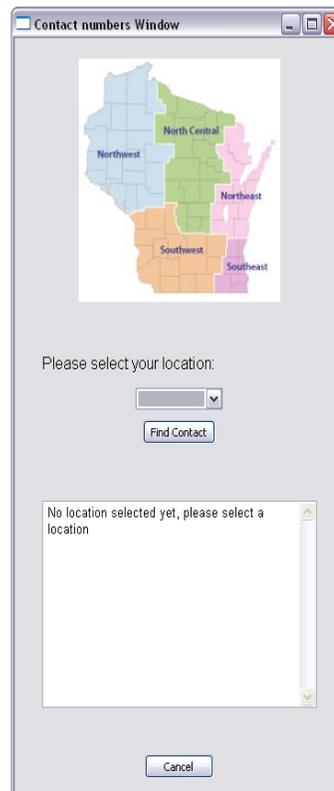
**Figure 32. Contact Information Window**

local authorities to be contacted depending on the location of the incident (see Figure 32). The WisDOT's Statewide Traffic Operations Center's (STOC) number is given as the first contact according to the WisDOT Emergency Traffic Control and Scene Management Guidelines.

1. *Contact the appropriate authorities:* In order to minimize confusion, reduce unnecessary procedures, and ensure a rapid response, the appropriate authorities have to be contacted as soon as the incident occurs. To facilitate this first emergency action, BEES provides a list of appropriate names and telephone numbers by regions. By clicking on the "contacts" button of the initial emergency procedure window, the user can find the

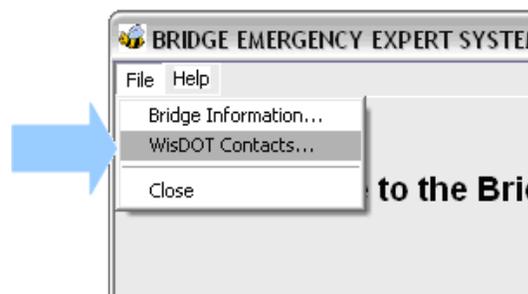
**Figure 40. Contact Search Accessed from the Menu Bar**

The main objective of this feature is to provide the user with a list of emergency contacts including names, telephone numbers, and email and office addresses. This feature can be accessed from the File menu by clicking on the “WisDOT Contacts...” option (see Figure 40). In addition, access to this feature is also available when the Initial Emergency Procedure window is used by the user (see Figure 41).

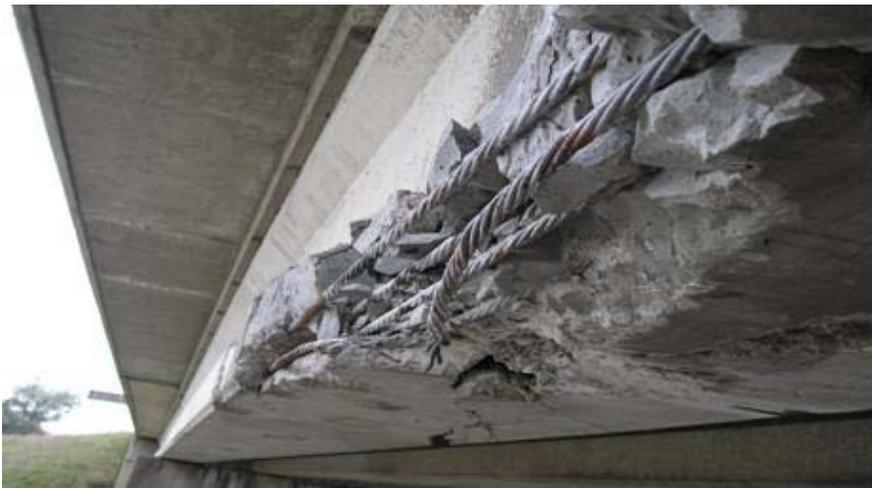
**Figure 50. Detailed View of Severely Damaged Exterior PS Concrete Girder**

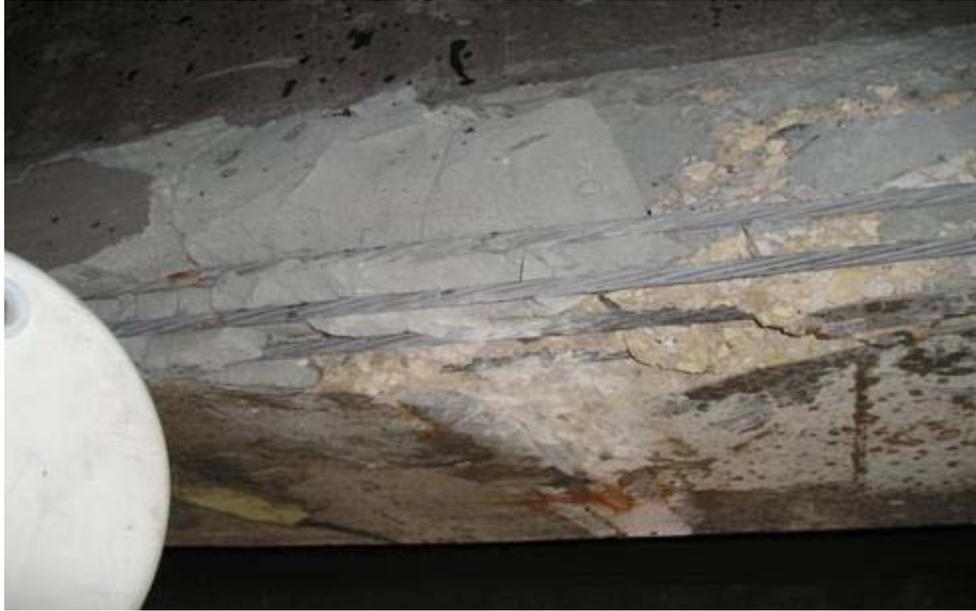
**Figure 51. Failure of Previously Repaired Locations in Girder Flanges (separated concrete patches)**

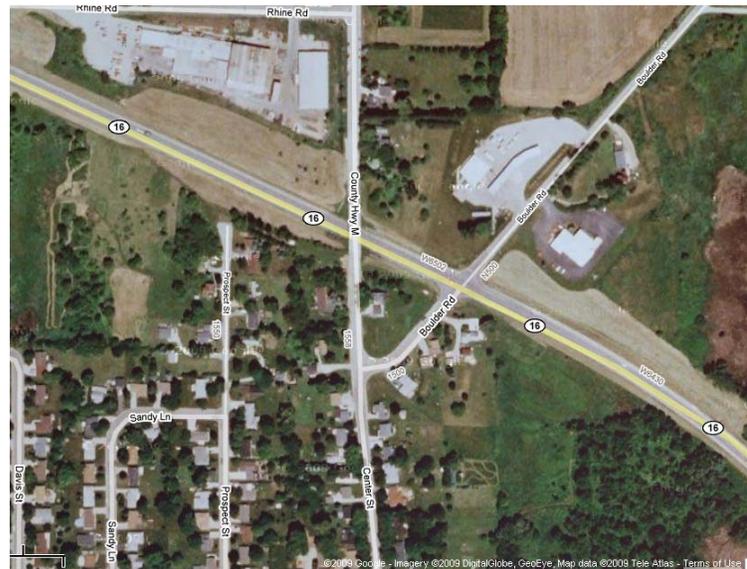
Figure 73. County Highway M Bridge Spanning over State Highway 16 (B-14-0044)

The County Highway M Bridge is located on the northern boundary of the City of Watertown, where it spans over State Highway 16 (see Figure 73). The bridge was constructed in 1960 and carries two lanes of traffic. The bridge is identified with the number is B-14-0044.

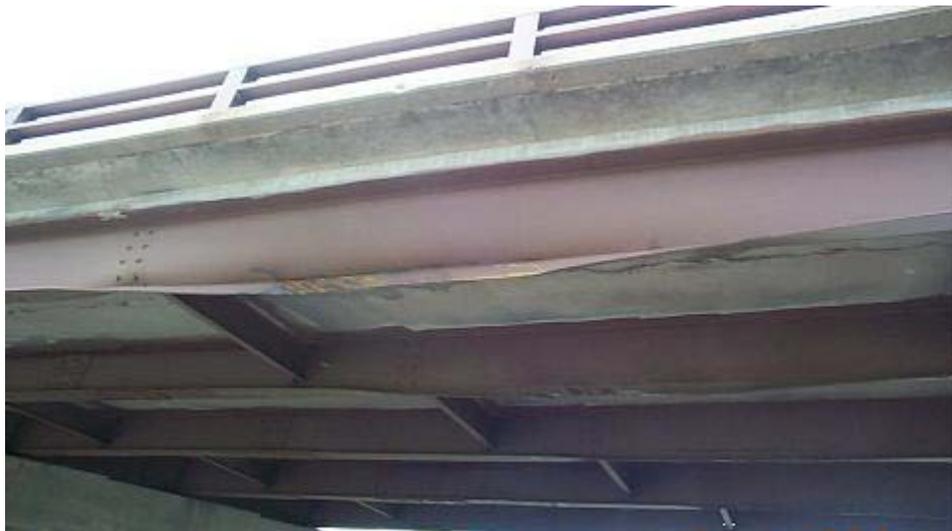
**Figure 74. Impact Damage to Steel Girders in Bridge ID # B-14-0044 (side view)**

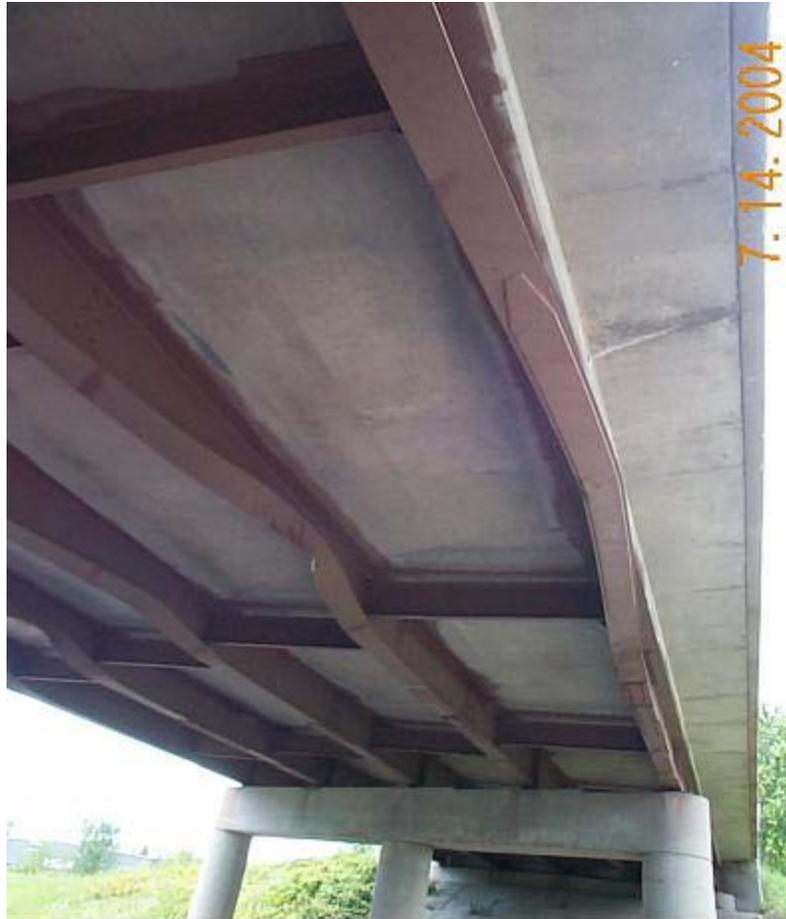
**Figure 75. Impact Damage to Steel Girders in Bridge ID # B-14-0044 (underside view)**
