Wisconsin Highway Research Program

September 2010

WHRP 10-10

1. Report Number WHRP 10-10	2. Govt. Accession No	3 Recipient's Catalog No.	
4. Title and Subtitle Performance Evaluation of Open Graded Base Course with Doweled and Non-doweled Transverse Joints on USH 18/151, STH 29, and USH 151		5. Report Date September 2010	6. Performing Organization Code Wisconsin Highway Research Program

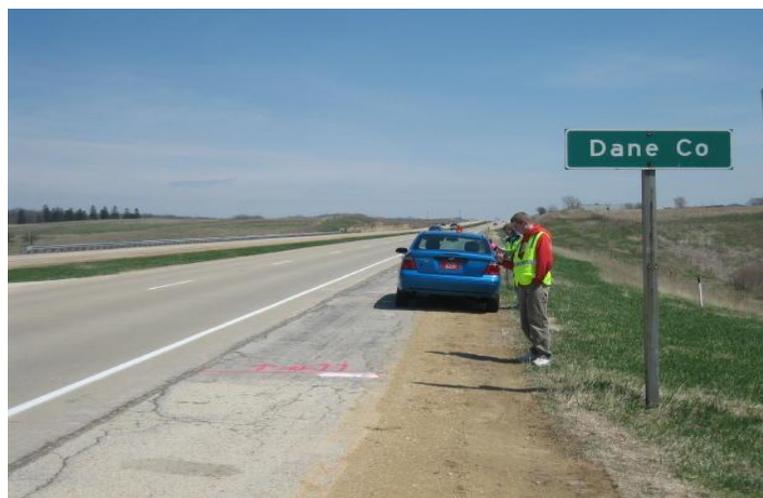
Figure 3.1 Field Verification of Test Sections on Eastbound USH 18/151

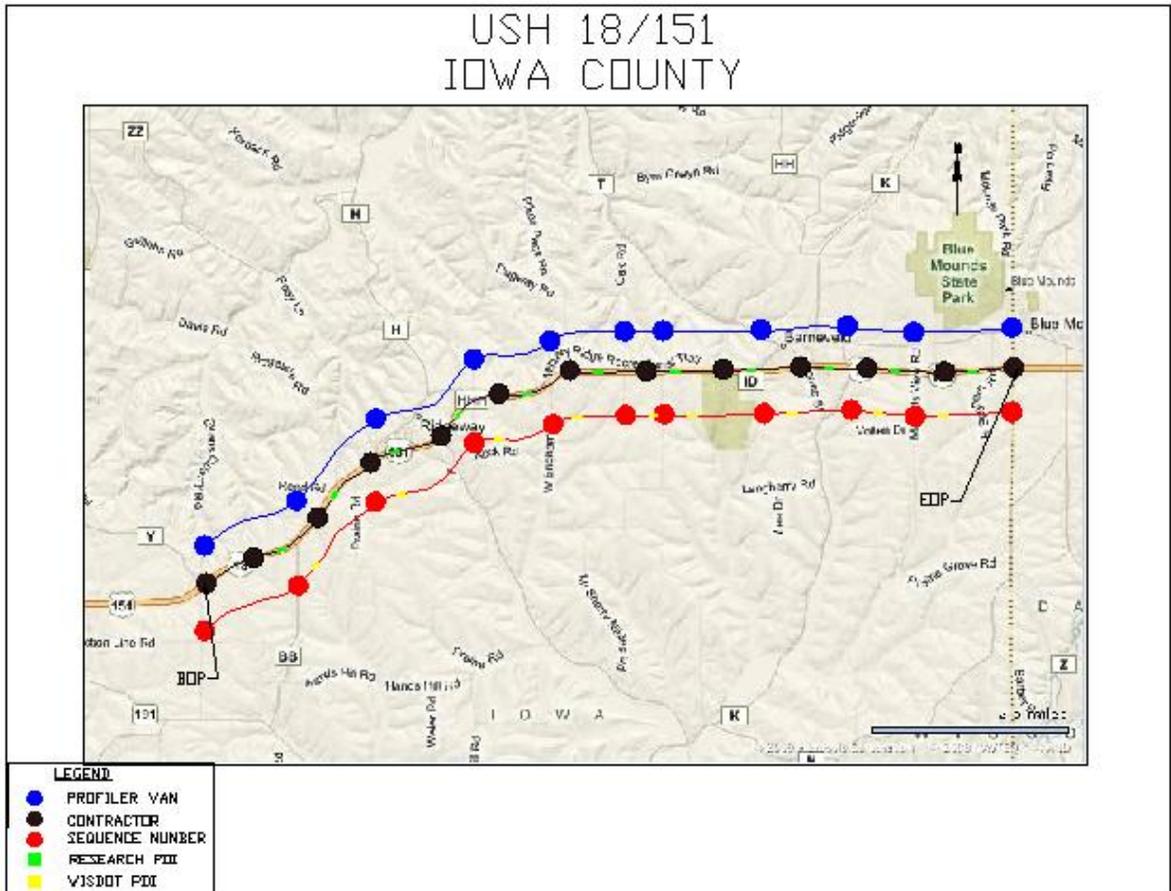
Figure 3.2 Test Sections for USH 18/151 in Iowa County

Figures 3.2 through 3.4 illustrate USH 18/151 in Iowa and Dane Counties. These figures indicate a disagreement between the construction butt joints (Contractor) and RP locations. Many of the construction joints were found between intersections, while the RP descriptors generally originated and terminated at intersections.

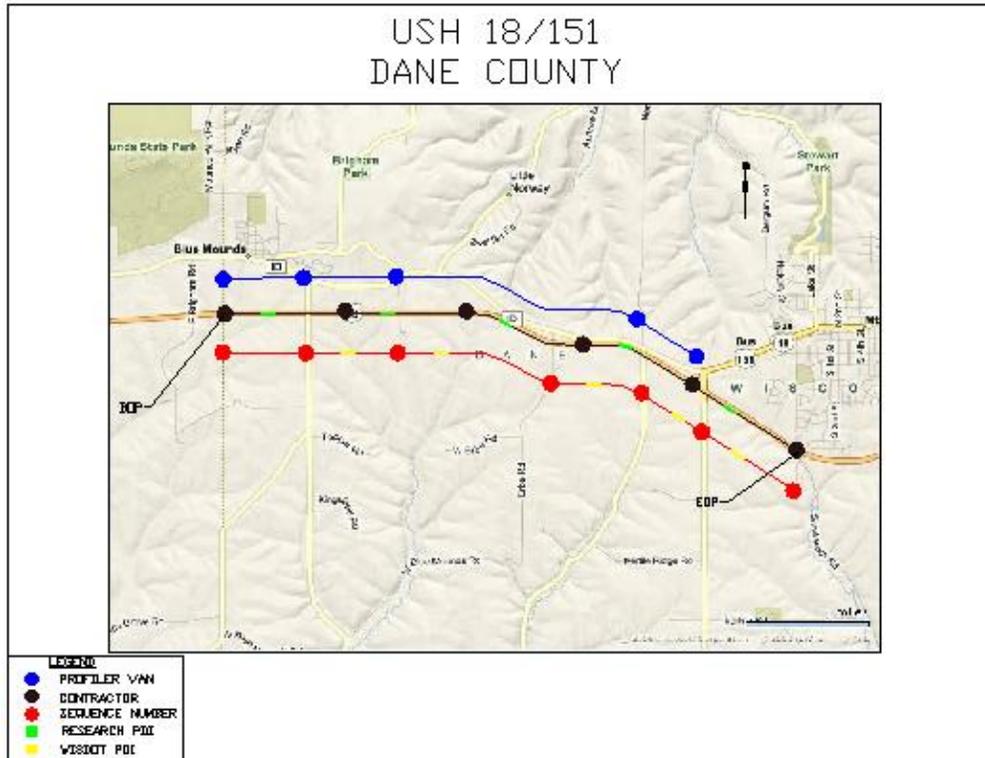
Figure 3.3 Test Sections for USH 18/151 in Dane County

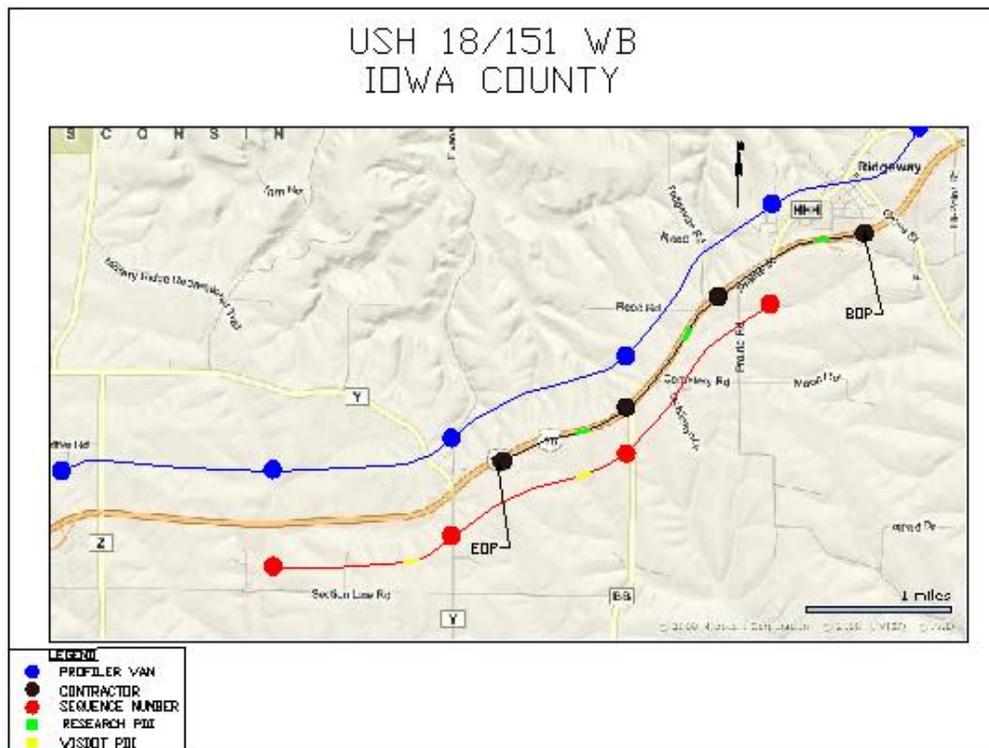
Figure 3.4 Test Sections for USH 18/151 Westbound in Iowa County

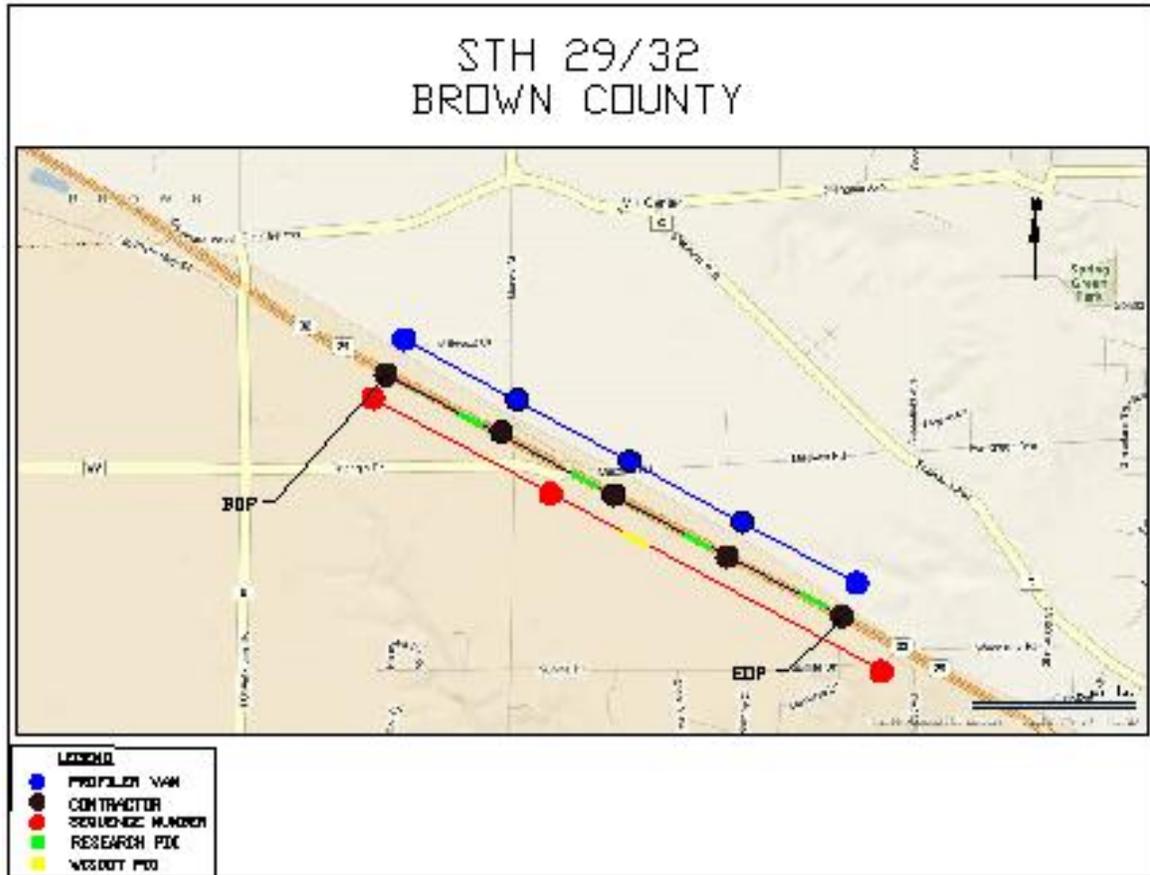
In Figure 3.5, the STH 29/32 project indicates a general agreement between the construction butt joints and the RP and Sequence Number termini. Figure 3.6 illustrates the USH 151 project in Columbia and Dane Counties.

Figure 3.5 Test Sections on STH 29/32 in Brown County

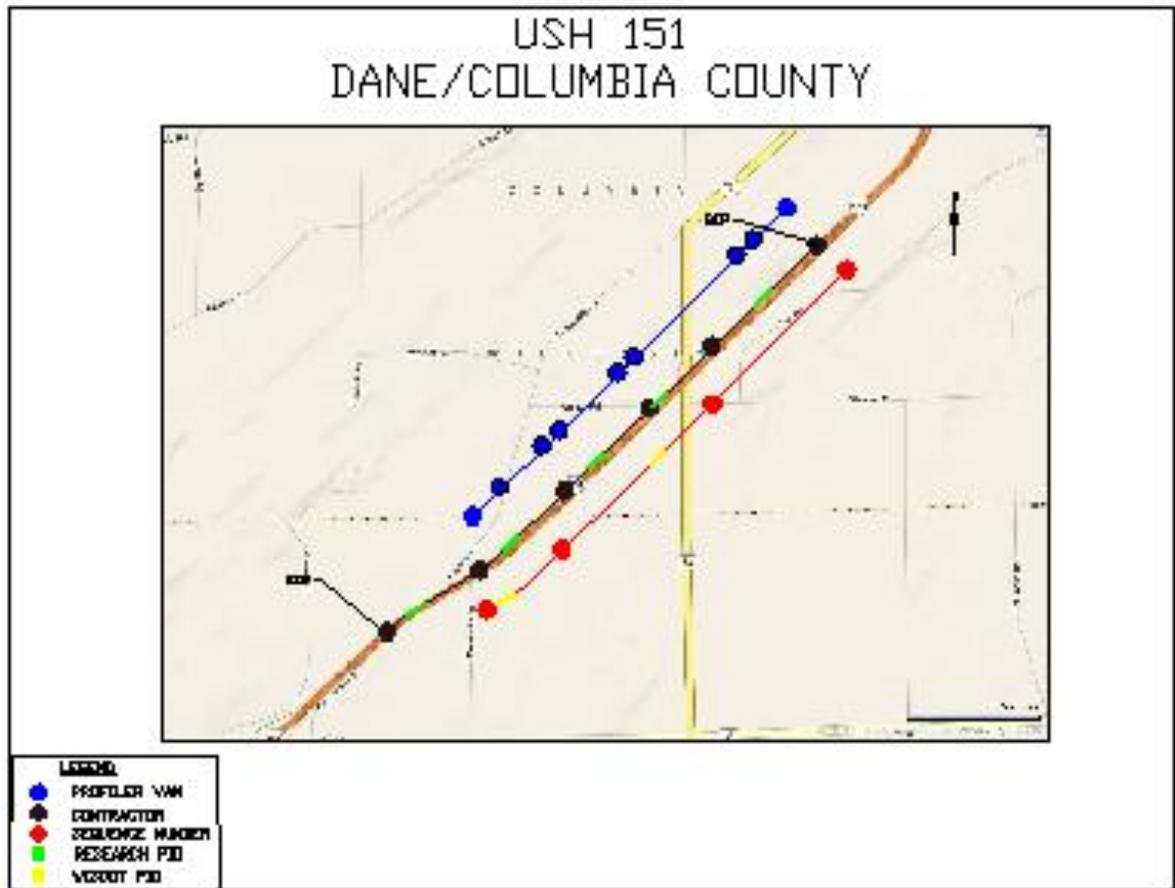
Figure 3.6 Test Sections for USH 151 Dane and Columbia Counties

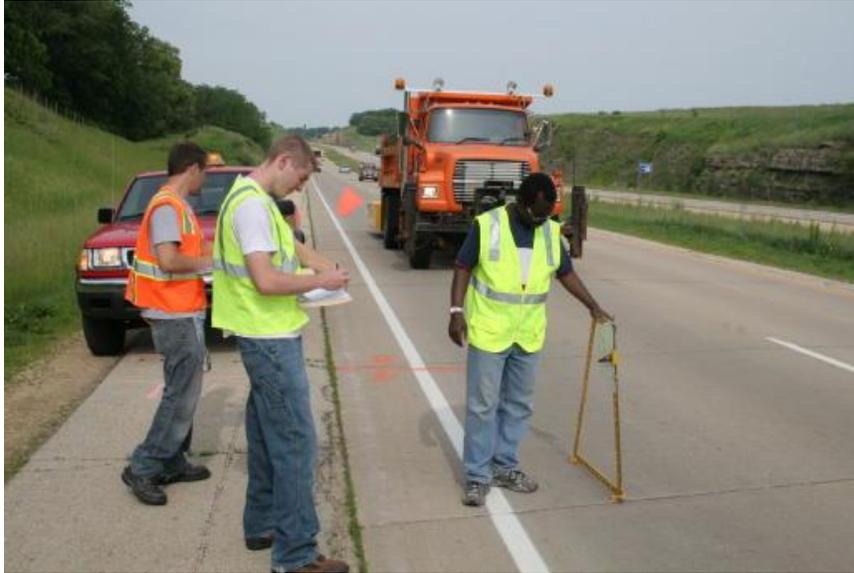
Figure 4.1 Transverse Joint Fault Measurement on USH 18/151

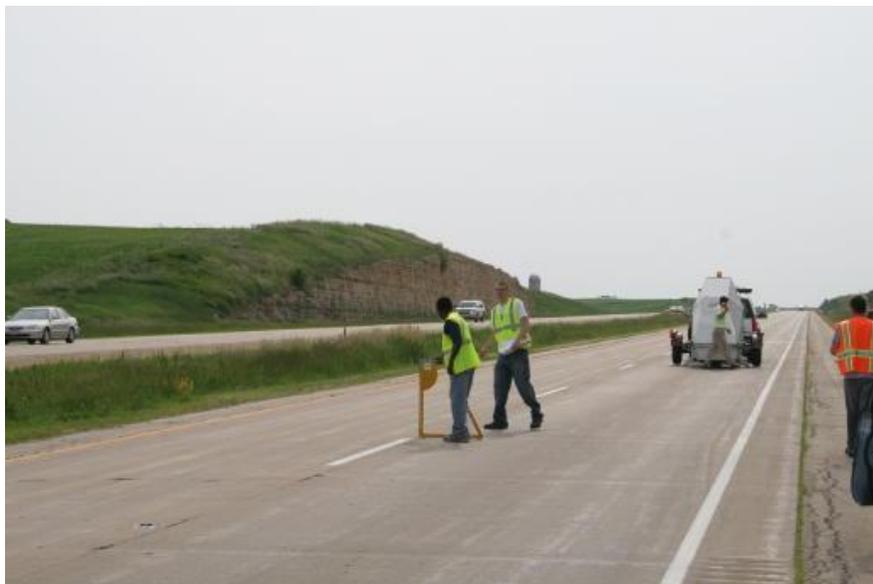
Figure 4.2 Longitudinal Fault Measurement on USH 18/151

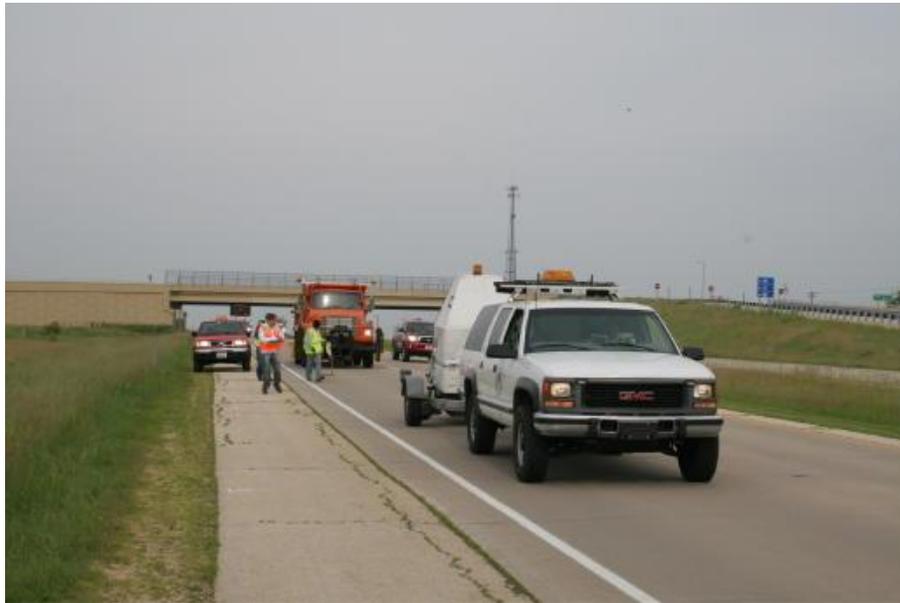
Falling Weight Deflectometer (FWD) testing was performed using WisDOT's Kuab 2-m FWD. FWD testing was utilized to provide fundamental measures of transverse joint load transfer capacity, subgrade strength and uniformity of slab support. A traditional two-layer analysis procedure, using FWD deflections measured at various load levels, was used to determine the in-place stiffness of the constructed pavement (all layers combined) and the dynamic k value of the subgrade. Effective PCC slab thicknesses were estimated based on assumed pavement moduli values based on the PCC pavement deflection analysis procedure outlined in the 1998 supplement to the AASHTO guide. Namely, an AREA-based solution was employed to estimate the pavement's radius of relative stiffness, with corrections applied to account for in-place slab dimensions (length and width). Figure 4.3 illustrates FWD testing on the USH 18/151 project.

Figure 4.3 FWD Testing on USH 18/151 at Barneveld Interchange

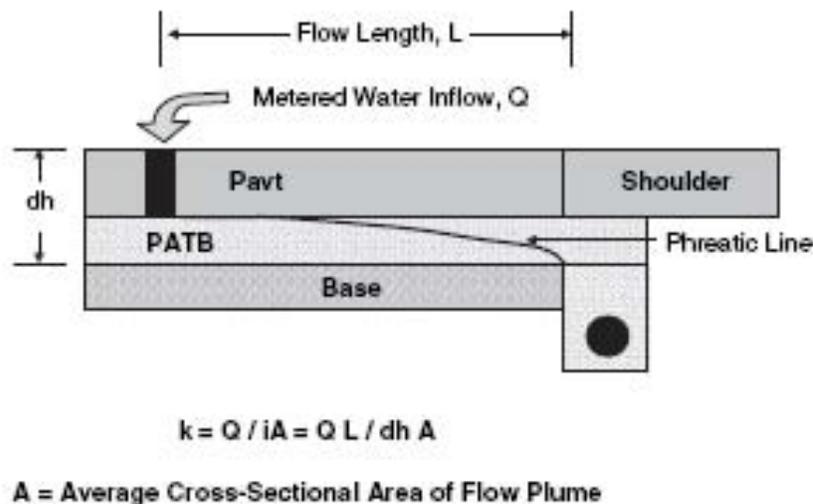
Figure 4.4 Measurement of In-Place Permeability

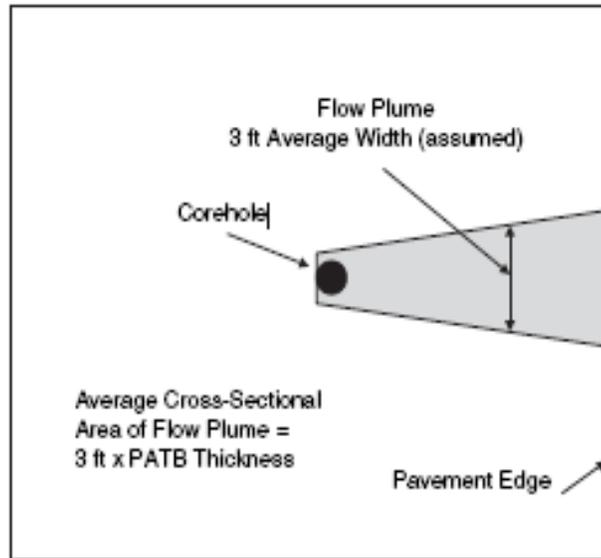
Figure 4.5 Illustration of plume of water from core hole to pavement edge

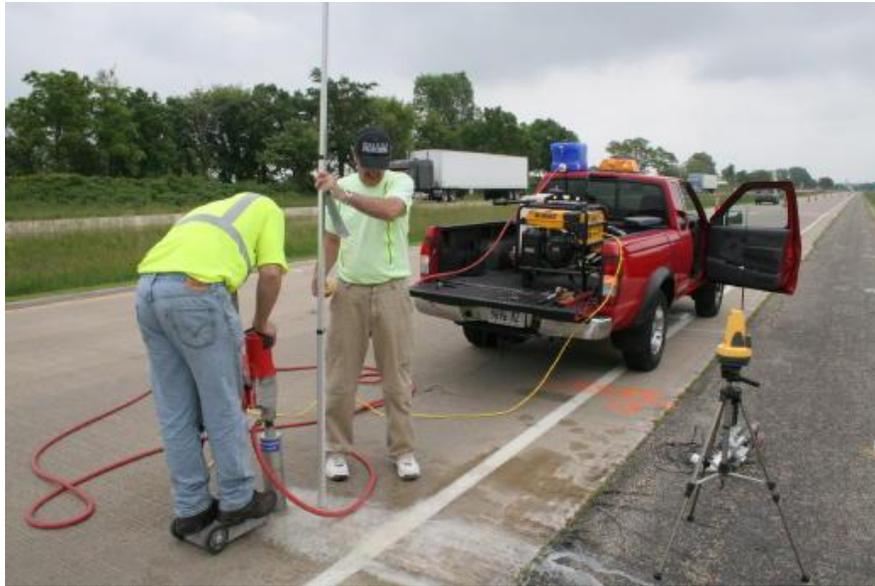
Figure 4.6 Drilling Corehole and Recording Elevations (USH 18/151)

Permeability and drainage capacity were measured within each of the OGBC test sections. Full-depth cores were cut through the PCC pavement, then water from a county highway truck was pumped into the drainage layer to allow subsurface flow towards the longitudinal collector edgedrain pipe and ultimately out the transverse edgedrain outlet. (FWD testing preceded water permeability testing so that the flow of water in the pavement base did not alter the FWD reading). A flow meter measured and displayed the rate of water inflow, in gallons per minute, and the total volume of infiltrated water, in gallons. Inflow rates ranged from 0 to 8 gallons per minute. The permeability of the drainage layer, in feet per day, was then estimated using standard permeability and flow calculations. Target permeability from the FDM is recommended at 1,000 feet per day (WisDOT 2008). In several test sections, no water flow was observed after 100 gallons of water were added to the corehole. If water was observed at the outlet, tracer dye was added at the corehole to then measure the time to flow through the drainage system. Figures 4.6 through 4.12 capture permeability testing.

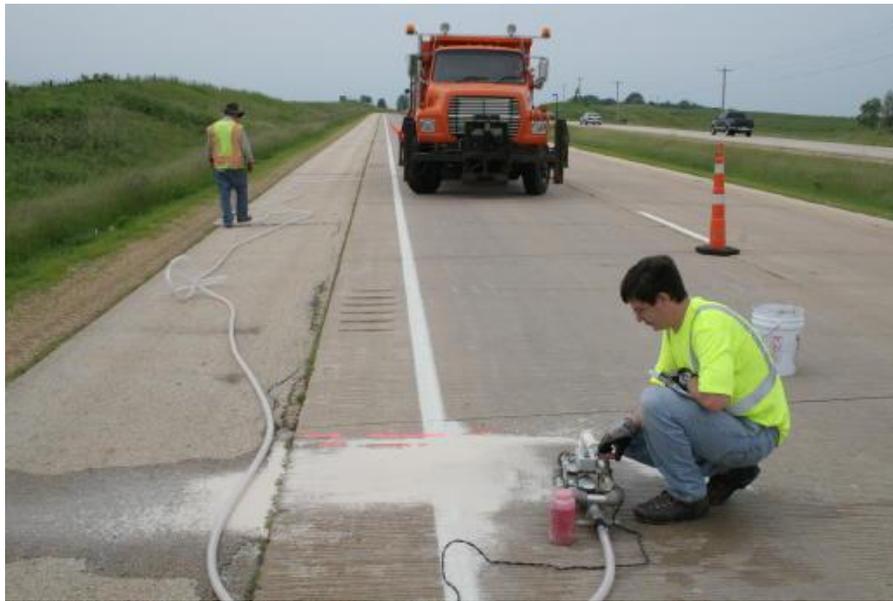
Figure 4.7 Water Inflow at Corehole and Recording Rate and Total Volume (USH 18/151)

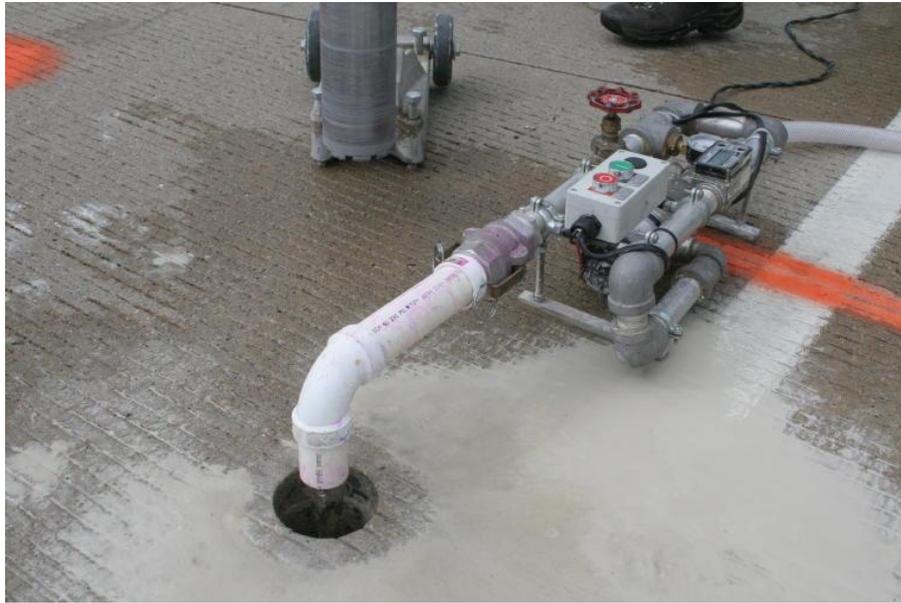
Figure 4.8 Water Flow Meter (USH 18/151)

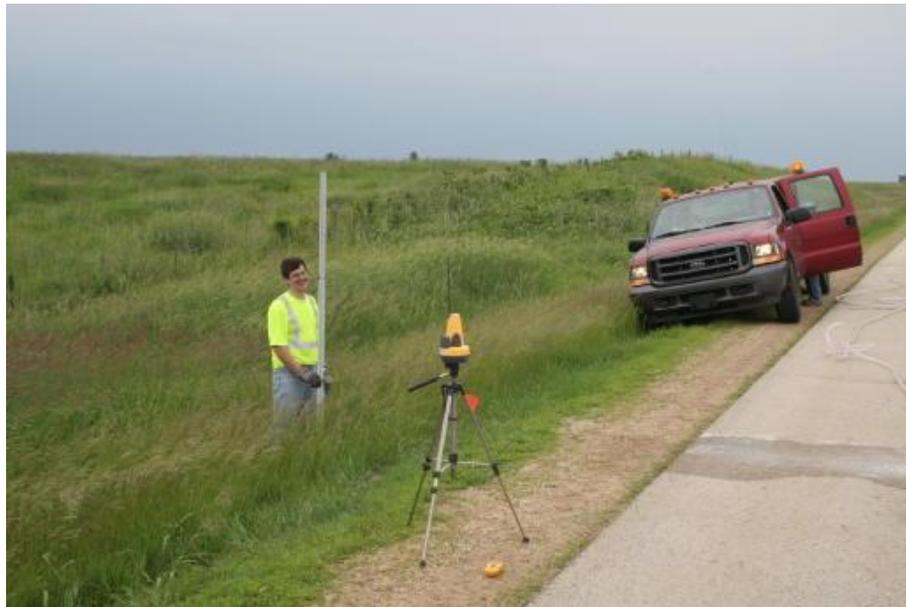
Figure 4.9 Recording Elevation at Outflow Drainpipe (USH 18/151)

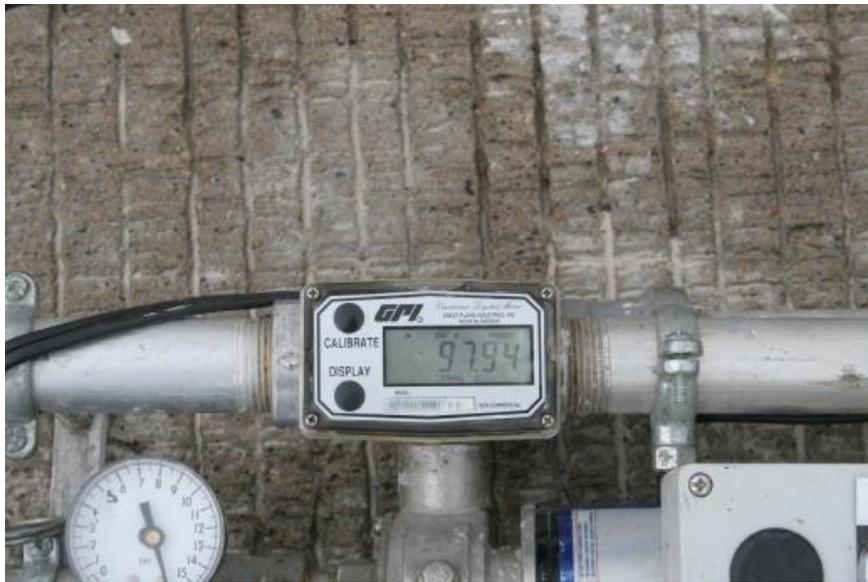
Figure 4.10 Flow Meter measuring 97.94 Gallons of Water into Corehole (STH 29)

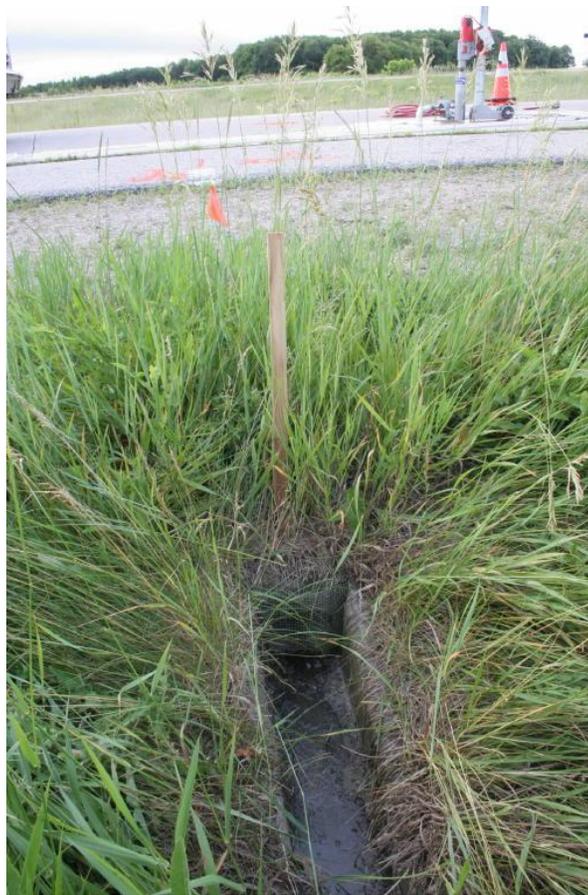
Figure 4.11 Water flowing out Edgedrain Pipe and Apron Endwall (STH 29)

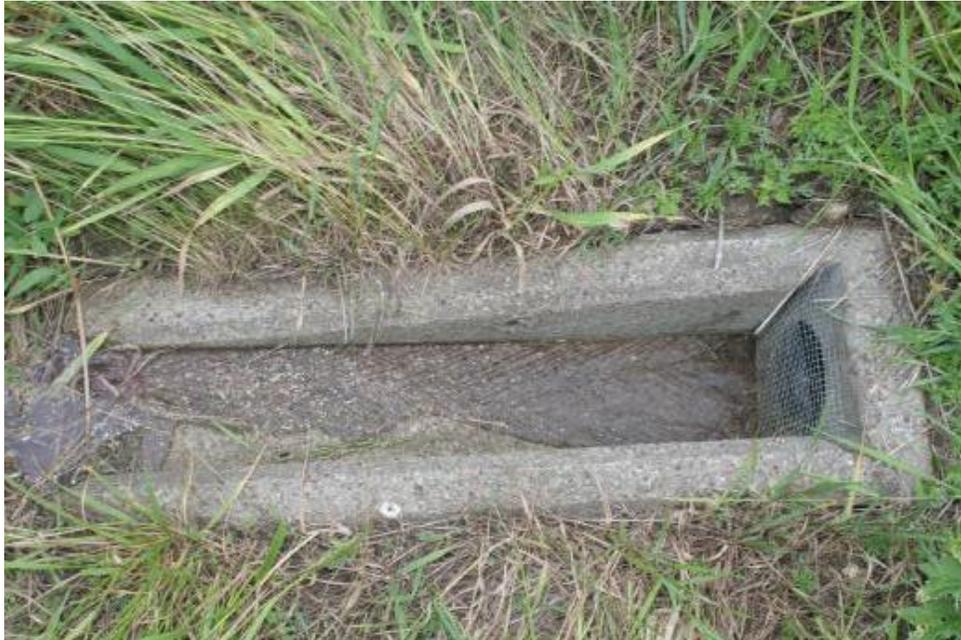
Figure 4.12 Water with Tracer Dye flowing out Edgeline Pipe and Apron Endwall (STH 29)

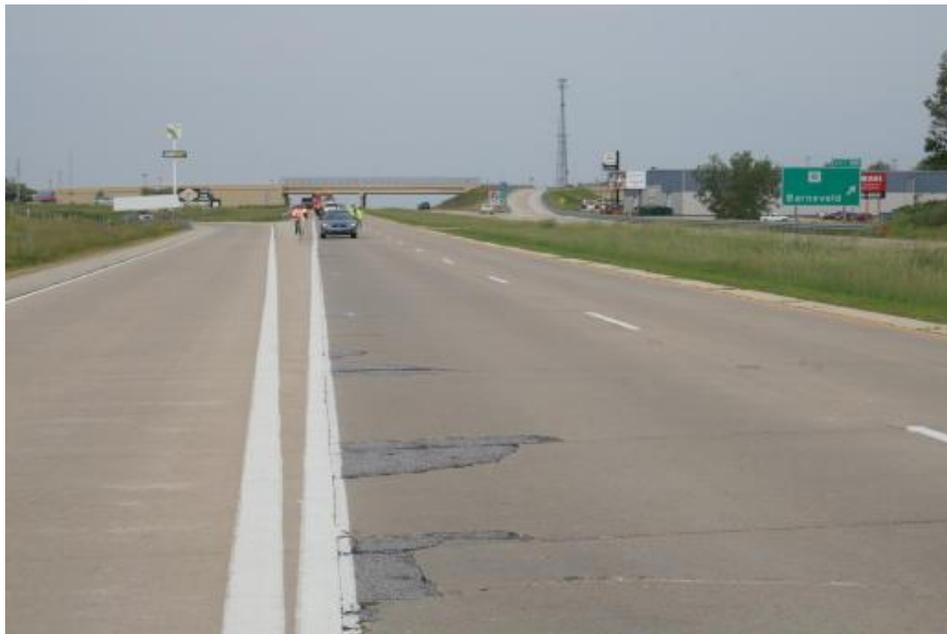
Measured performance data from the three highway segments are shown in Tables 5.2 through 5.4. The third TIC section on USH 18/151 was omitted from the analysis since patching and distressed joints/cracks appeared to be the result of a removed right-side longitudinal pipe when a new eastbound entry ramp was constructed in 2004. Figure 5.1 illustrates the extent of patching in this TIC section adjacent to the new on-ramp.

Figure 5.1 Patching in TIC Section Adjacent to New On-Ramp

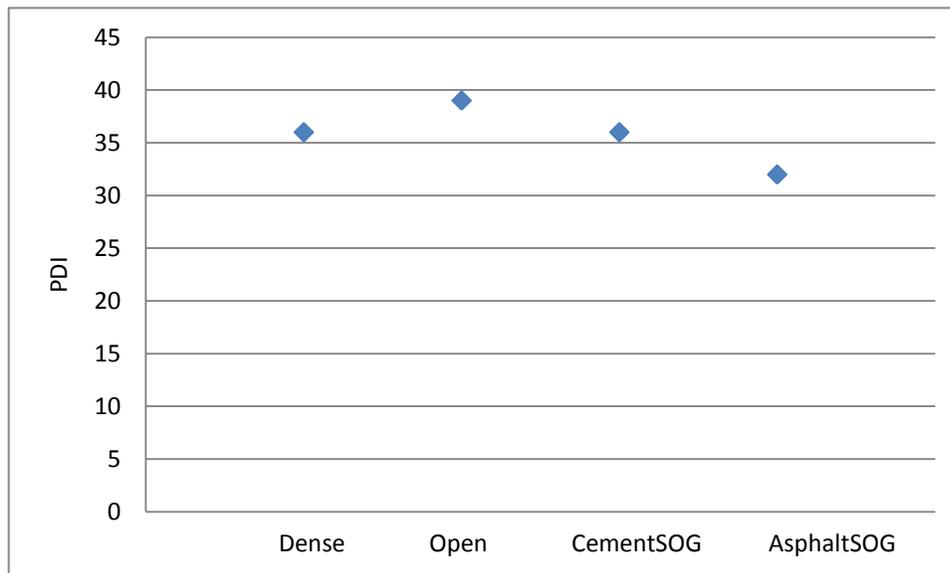
The plot for doweled, unsealed JPCP in Figure 5.2 illustrates nearly the same performance among the different bases for doweled concrete pavement. Except for skewed transverse joints, the dense-graded base section (#14) is considered the standard, having a 6-inch thick dense-graded crushed aggregate base, and unsealed doweled transverse joints. Distresses common to all segments included slight to moderate distressed joints/cracks and slight transverse faulting. PDI scores were highest for open-graded base and lowest for the asphalt-stabilized open-graded (ASOG) base. ASOG had no slab breakup or surface distresses, however it measured a greater severity of distressed joints and cracks (moderate rating compared to others with a slight rating).

Figure 5.2 PDI variation for Unsealed Doweled Transverse Joints on USH 18/151

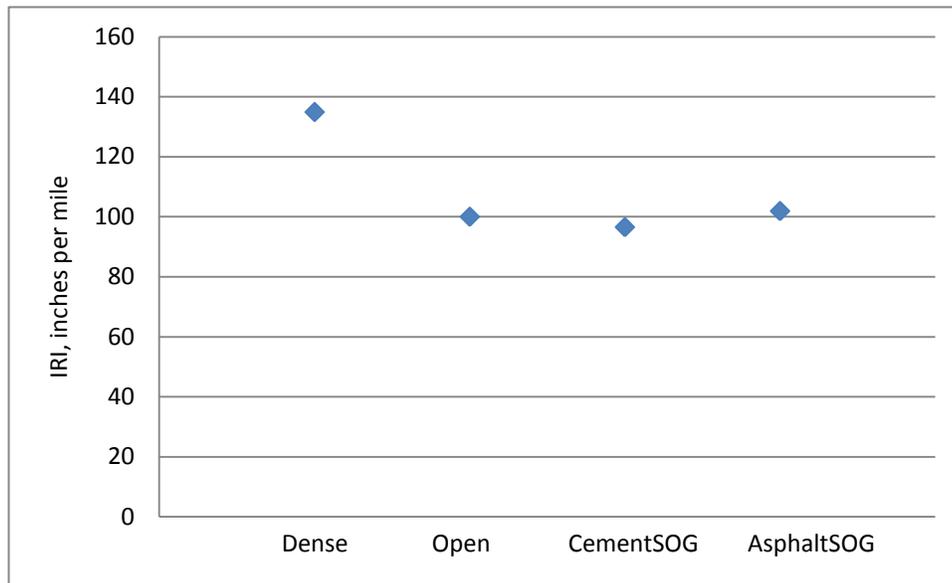
Figure 5.3 compares the IRI (inches per mile) with the same four sections, where values ranged from 97 to 135 inches per mile. Overall, this is considered good ride performance and within the normal range of what is expected for a rural PCC pavement nearing its first maintenance cycle. The dense-graded base section (#14) had the roughest ride when compared to all open-graded doweled sections. There was little difference among the open-graded sections, with a measured IRI approximately 100 inches per mile. Thus, based on the analysis of these two plots, asphalt-stabilized open graded base had the lowest measured distresses, while the open-graded bases had a lower surface roughness but higher measured distresses.

Figure 5.3 IRI variation for Unsealed Doweled Transverse Joints on USH 18/151

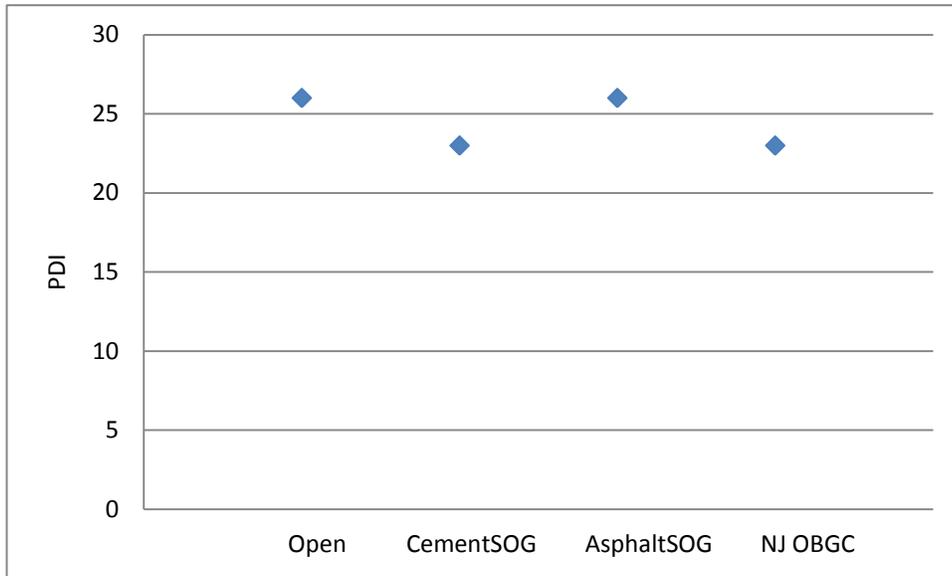
Similar plots were prepared for the test sections on USH 151, where all test sections were constructed with permeable base; no mainline dense-graded control sections were constructed for comparative purposes. Sections were doweled 10-inch thick PCC, unsealed skewed transverse joints, paved over a 4-inch upper permeable base and 4-inch lower dense base. Drainage pipe was 6-inch diameter, unlike USH 18/151 with 4-inch pipe diameter. Figure 5.4 illustrates nearly the same performance among the different bases, where PDI scores were very similar for the four sections, ranging from 23 to 26. Slight distressed joints/cracks were common to all segments. The higher PDI scores were attributed to the untreated OGBC base having 10% of slab area with slab breakup and surface distresses, and asphalt-stabilized OGBC having slight transverse faulting. However, faulting data from the WisDOT performance van measured 0.01 inches for all sections except New Jersey OGBC with a recorded value of zero.

Figure 5.4 PDI variation for Unsealed Doweled Transverse Joints on USH 151

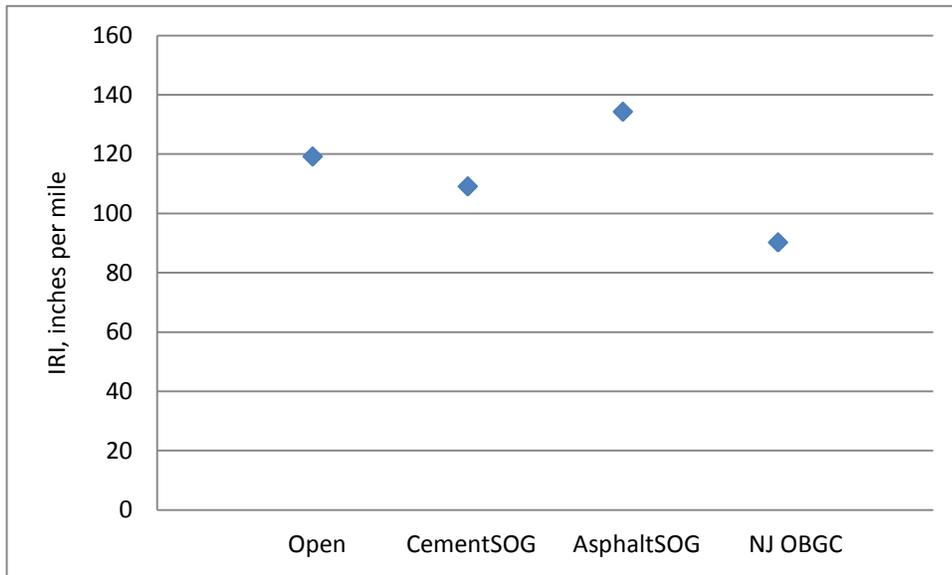
IRI was plotted for the same four sections in Figure 5.5. The New Jersey open-graded base had the smoothest ride when compared to other open-graded sections. ASOG base had the roughest ride, and unstabilized OGBC and CSOG bases had intermediate values. Overall, the finer-graded New Jersey base had less composite distresses and a smoother ride. The more coarse OGBC Gradation #1 is no longer specified for drainable PCC pavement bases.

Figure 5.5 IRI variation for Unsealed Doweled Transverse Joints on USH 151

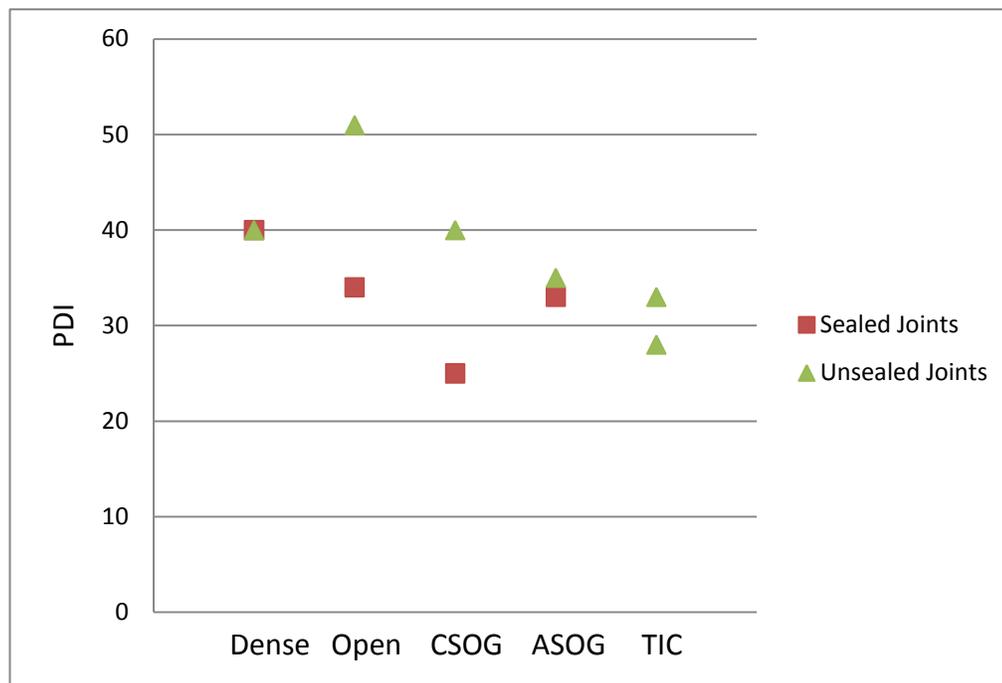
Figure 5.6 plots the PDI against base type on non-doweled USH 18/151 sections. When using the median value for the sealed and unsealed PDI scores, it can be concluded that cement-stabilized, asphalt-stabilized, and TIC drains had the least amount of distress. Dense-graded and unstabilized OGBC had the highest composite measure of pavement distress. Sealed joints produced a better performing pavement than unsealed joints. All TIC sections were unsealed.

Figure 5.6 PDI variation for Base Type on Non-doweled Sections on USH 18/151

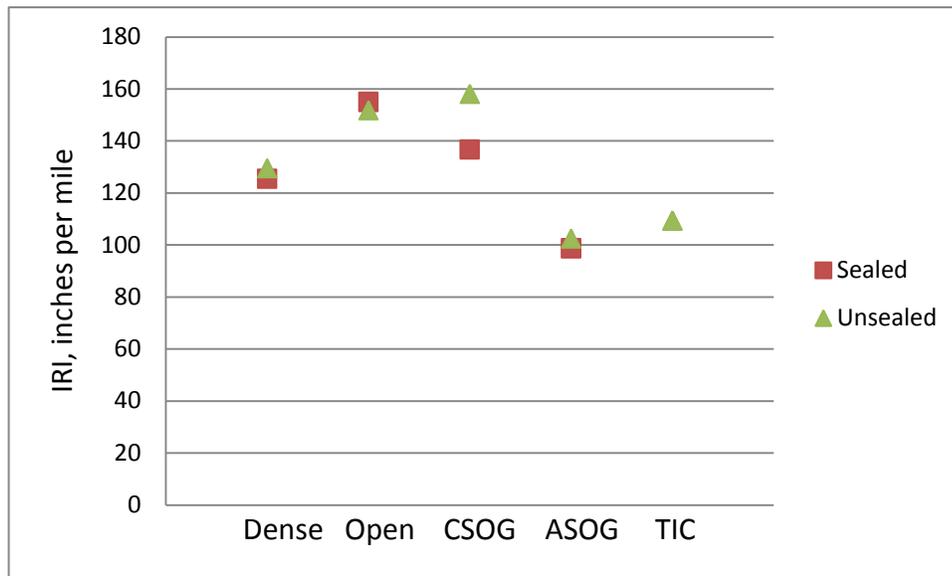
Similarly, ride was plotted against the same sections (see Figure 5.7). Asphalt-stabilized open base and TIC drains had the smoothest ride, while untreated and CSOG had the rougher ride. Sealant did not appear to have a consistent effect on ride. Based on this analysis of non-doweled sections, ASOG base and TIC drains had better distress-based performance and ride than the other non-doweled sections.

Figure 5.7 IRI variation for effect of Base Type on Non-doweled Sections on USH 18/151

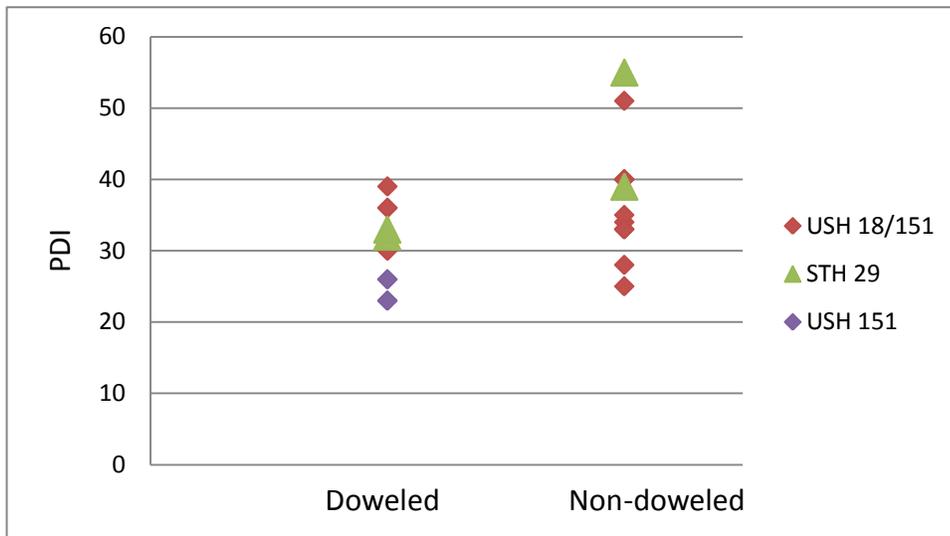
Since 1988, doweled JPCP pavements have been exclusively specified as a WisDOT PCC pavement standard. This study presented a valuable opportunity to understand their effect on performance and ride quality. Figure 5.8 combines the data from the three projects and plots the PDI against doweled and non-doweled pavement. This plot suggests that non-doweled pavement generally has a higher distress level than doweled; however, with the two highest non-doweled values removed, the difference is less pronounced.

Figure 5.8 PDI variation with Transverse Joint Dowel Treatment (all segments)

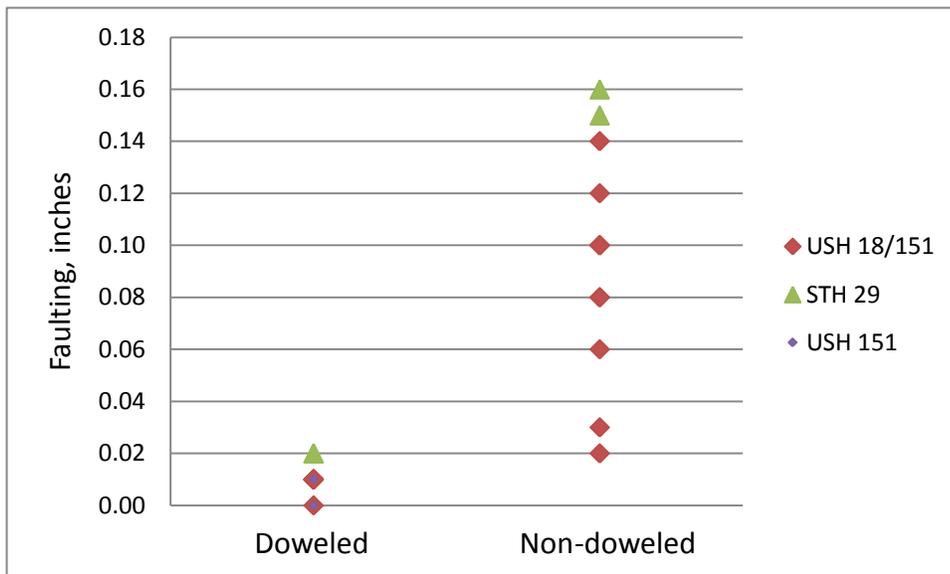
Since the composite PDI inherently limits the ability to assess individual distresses, they were reviewed individually to assess their contribution. As would be expected, transverse faulting impacted the PDI scores. The extent of transverse faulting was equal among all test sections; however, the severity was higher for non-doweled joints with about half of those sections rated a level 2 (¼ to ½ inch). Figure 5.9 illustrates this relationship using actual data from the WisDOT performance Van. Clearly, faulting was higher on the non-doweled sections, yielding values greater than or equal to 0.02 inches. All doweled sections were either at or less than 0.02 inches.

Figure 5.9 Faulting variation with Transverse Joint Dowel Treatment (all segments)

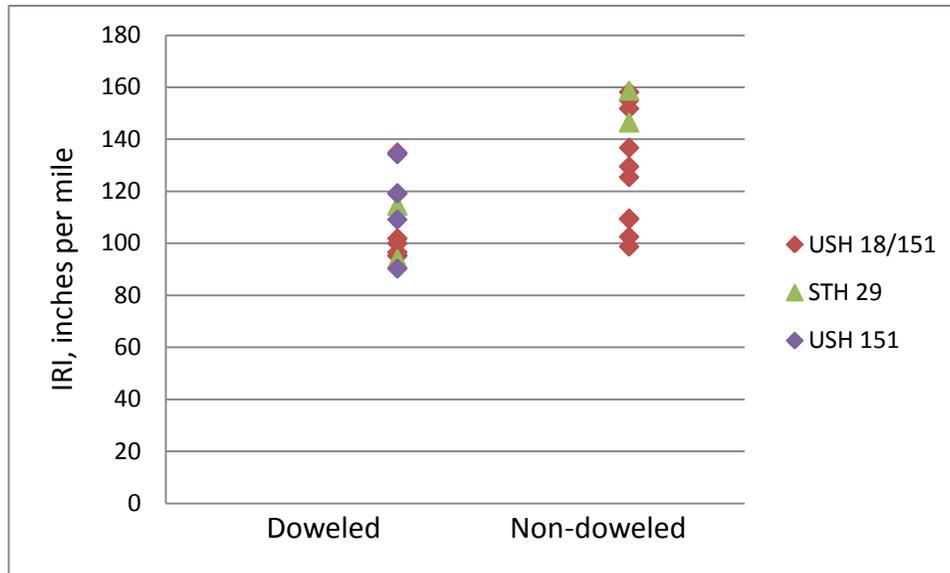
Transverse faulting affects ride quality, and Figure 5.10 confirms this relationship where IRI was generally higher on non-doweled pavements, but many doweled sections had an equal roughness to non-doweled sections.

Figure 5.10 IRI variation with Transverse Joint Dowel Treatment (all segments)

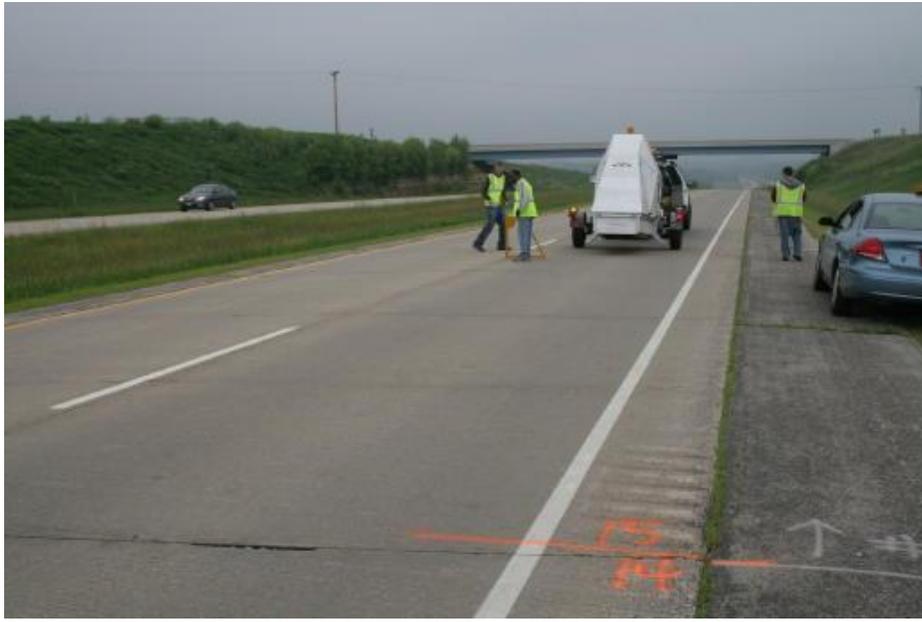
The effect of sealant was further investigated by comparing adjacent sealed and unsealed sections on doweled USH 18/151 dense graded sections, and a combination of doweled and non-doweled sections on STH 29. First, the two sections on USH 18/151 were analyzed. These adjacent sections both had doweled JPCP with 6-inch thick dense graded base, with the only difference being Section #14 without sealant (WisDOT standard) and Section #15 with sealant. Traffic levels were assumed equal, however the 528-foot PDI segment was just beyond an exit ramp for STH 78 on the west side of Mount Horeb (Figure 5.11).

Figure 5.11 Location of USH 18/151 Test Section east of STH 78 Exit Ramp

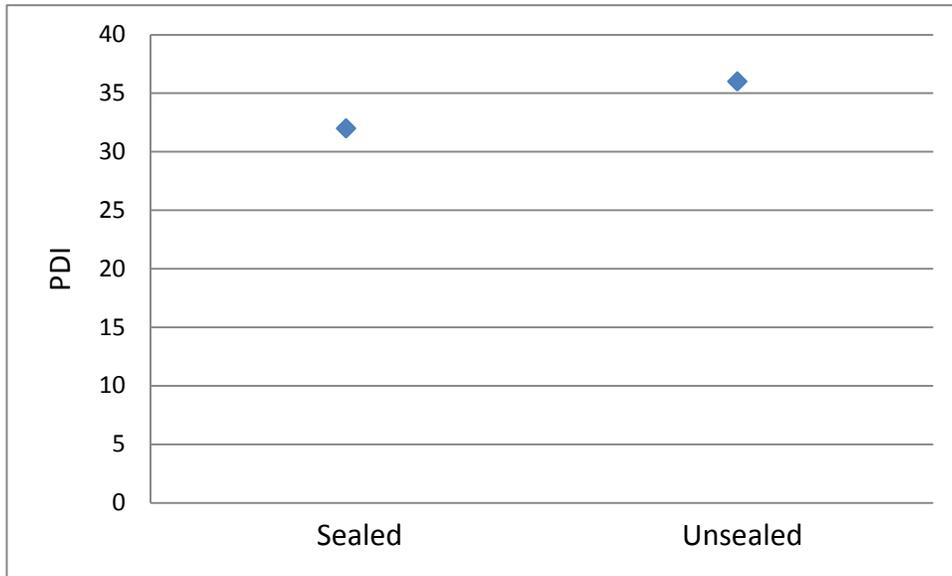
Figure 5.12 illustrates the PDI for the two dense-graded doweled JPCP segments on USH 18/151 where the sealed section slightly outperformed the unsealed section. Both sections had identical extent and severity levels for slab breakup, distressed joints/cracks, surface distress, longitudinal distress, and transverse faulting; all were lowest severity rating, and all except distressed joints/cracks were lowest extent. The distress that produced the higher PDI for the unsealed section was patching, where 1 to 3 patches (extent=1) in good condition (severity=1) increased the PDI from 32 to 36. In Figure 5.13, the sealed section had a lower roughness than the unsealed section. Based on these two plots, sealed doweled joints yielded a better performing pavement than unsealed doweled joints.

Figure 5.12 PDI for Sealed/Unsealed Doweled Joints on Dense Base (USH 18/151)

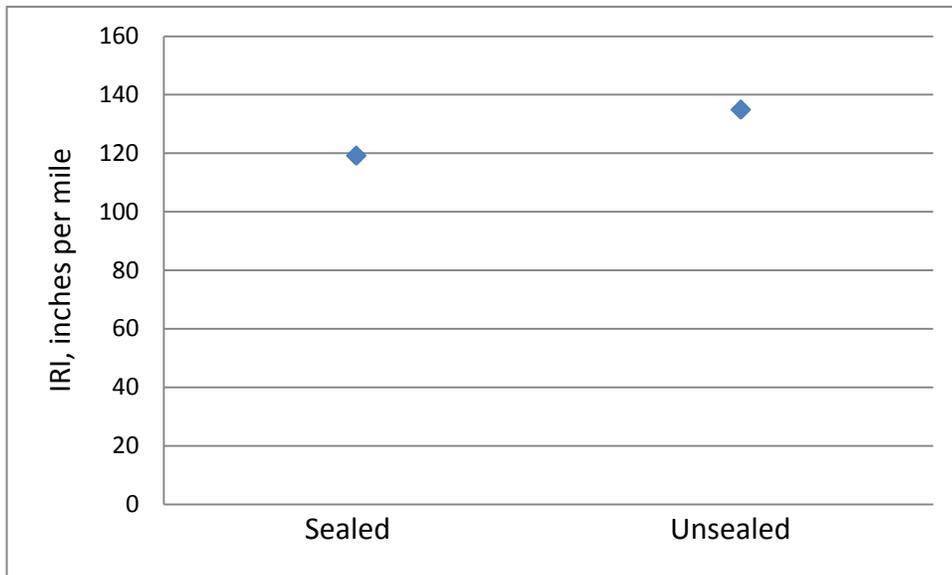
Figure 5.13 IRI for Sealed/Unsealed Doweled Joints on Dense Base (USH 18/151)

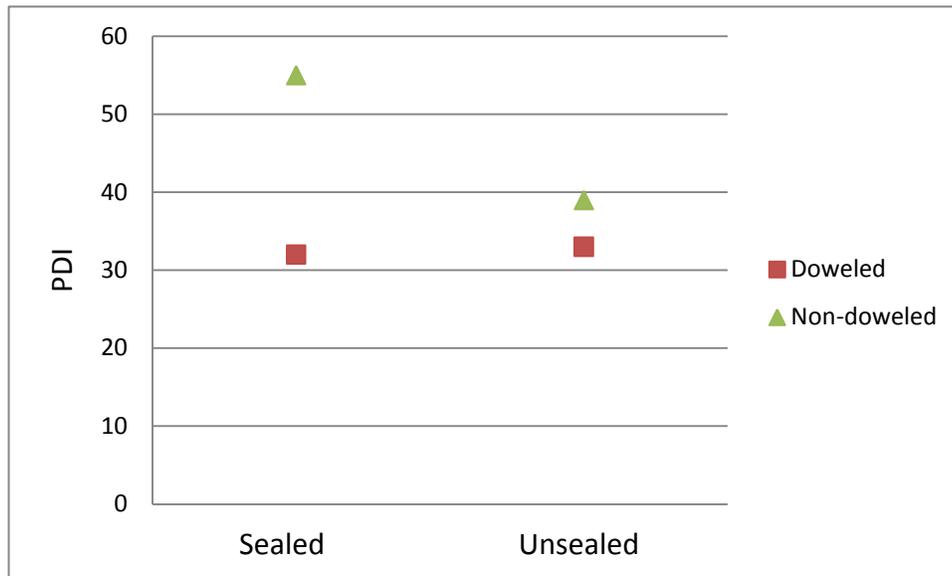
STH 29 had 10-inch thick PCC with a combination of both doweled/non-doweled joints and sealed/unsealed joints, and a uniform unstabilized open-graded base course. Figure 5.14 shows that the unsealed sections for doweled/non-doweled joints performed better than the median PDI for the sealed sections. This finding is contrary to USH 18/151. The sealed doweled pavement did perform a little better than the non-doweled section, but the opposite occurred on the non-doweled sections. Figure 5.15 for IRI performance found that sealed doweled joints had a smoother ride than the other combinations. Sealed/non-

Figure 5.14 PDI for Sealed/Unsealed Doweled/Non-Doweled Joints on STH 29
