Wisconsin Highway Research Program

September 2010

WHRP 10-10

1. Report Number WHRP 10-10	2. Govt. Accession No	3 Recipient's Catalog No.	
4. Title and Subtitle Performance Evaluation of Open Graded Base Course with Doweled and Non-doweled Transverse Joints on USH 18/151, STH 29, and USH 151		5. Report Date September 2010	6. Performing Organization Code Wisconsin Highway Research Program

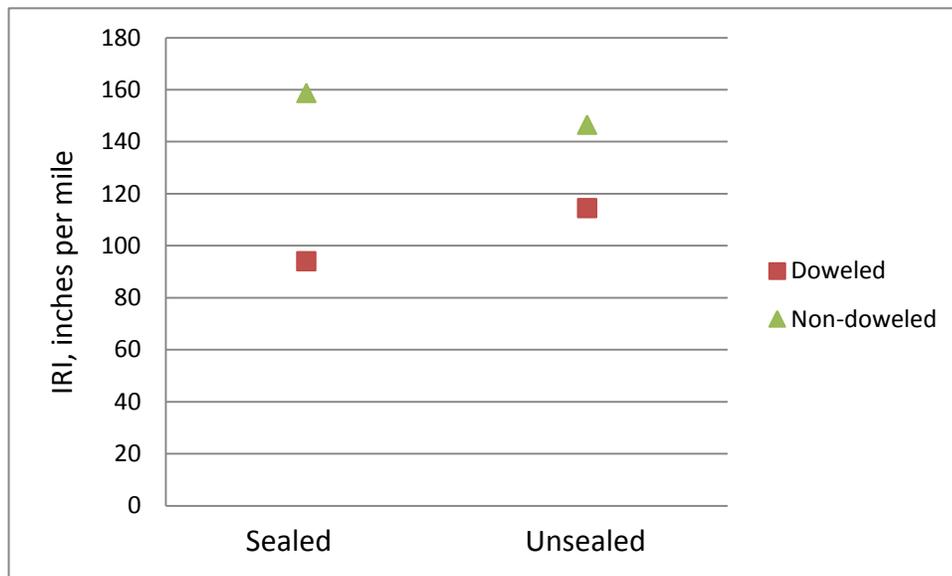
doweled joints produced the roughest ride, and as expected, non-doweled joints, whether sealed or unsealed, had the highest IRI values.

Figure 5.15 IRI for Sealed/Unsealed Doweled/Non-Doweled Joints on STH 29

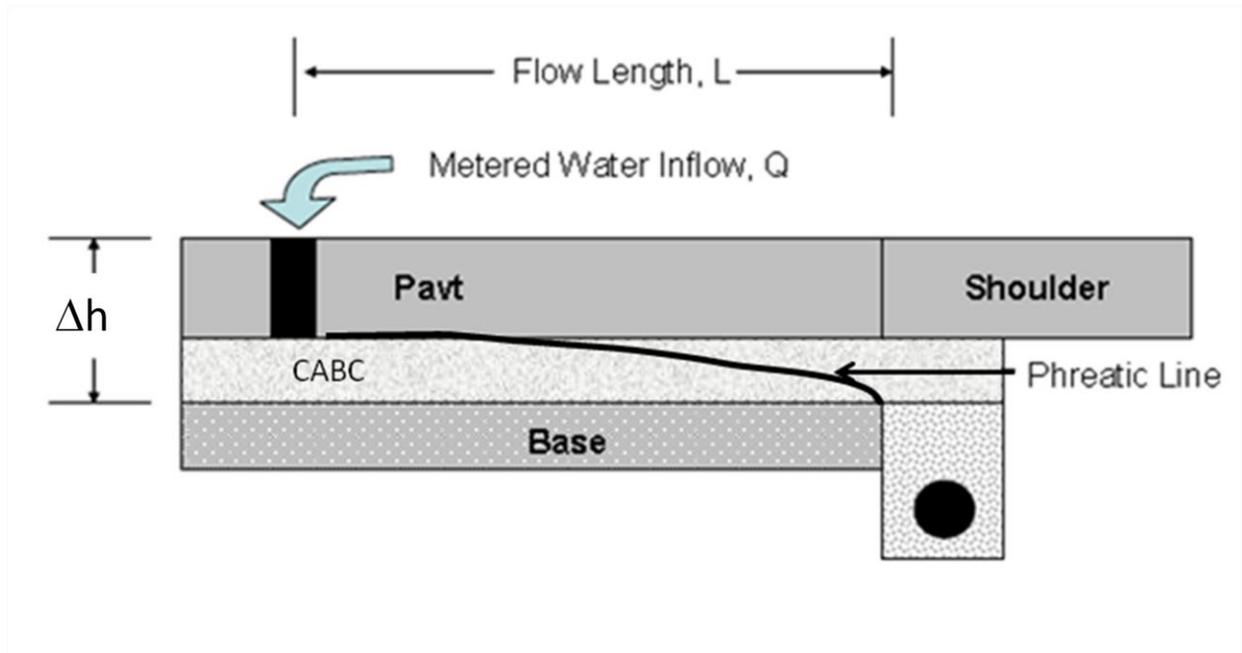
Clear water was allowed to flow into the base until it was observed flowing out of the downstream outlet, as illustrated in Figure 6.1. Once free-flow through the drainage system was established, a tracer dye was added to the inflowing water. A stopwatch was used to measure the time to when outflow was first observed, the time to when tracer dye outflow was observed, and the time when inflow was stopped. In many cases no water was observed flowing out of the downstream outlet after 20 minutes. In these cases, drainage testing was terminated and no tracer dye was introduced.

Figure 6.1 Flow Conditions During Permeability Testing

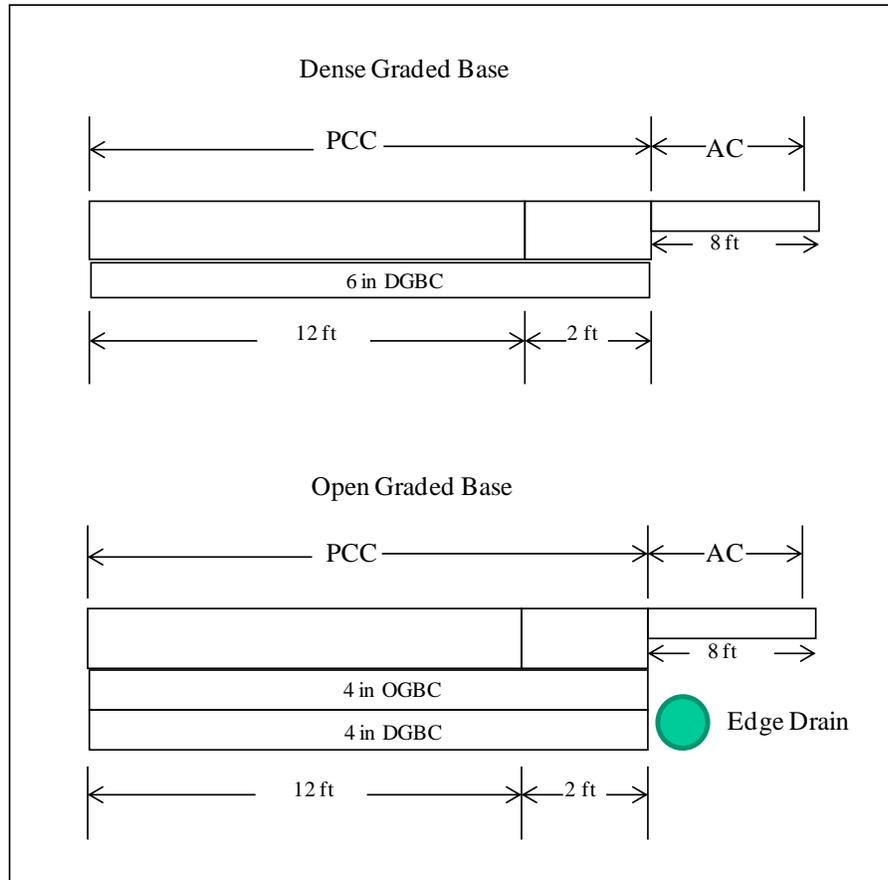
Primary differences among projects included USH 18/151 having a 9-inch thick PCC pavement, while both STH 29 and USH 151 having a 10-inch thick PCC pavement. Based upon an investigation in the MEDPG software calibration project, a majority of drainable PCC pavements in the state are 10 inches thick. Thus, a 10-inch thick pavement was selected for LCCA; however, any pavement thickness must be designed for traffic loading and base support. PCC pavement width was specified at 26 feet, with two 12-foot driving lanes and an integral 2-foot shoulder. The composite shoulder consists of a 2-foot extension of the PCC plus 8-foot wide asphaltic concrete (AC) surface, where the outer slab of the roadway is 14 feet with the striped pavement edge marked 12 feet from the centerline to indicate the limits of the travel lane.

Figure 7.1 Pavement Cross Sections for LCCA

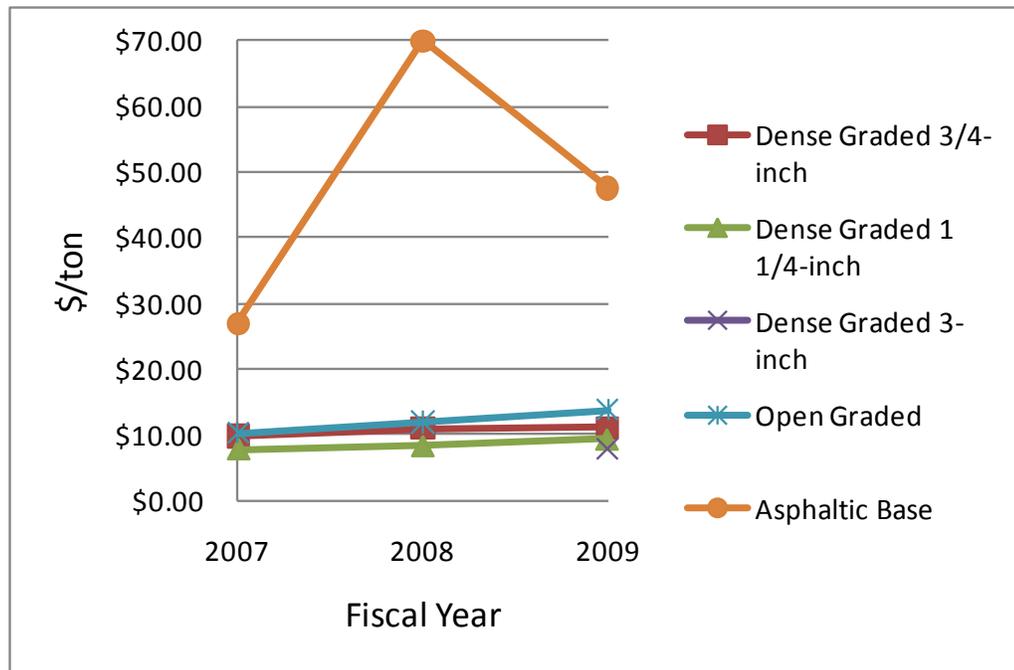
Figure 7.2 illustrates the trends in aggregate bases (dense, open, and asphaltic) from 2007 to 2009. All untreated aggregate bases had a consistent upward trend, and it was reasonable to adopt the most recent 2009 price for LCCA. The 3/4-inch NMAAS was adopted for dense-graded aggregate base consistent with current practice, and a smaller NMAAS provides improved grade control for the pavement base, a feature critical for high-quality ride PCC pavement. Open-graded base specified in Section 310 is used on standard permeable base concrete pavements. The percentage passing the #4 sieve ranges from 15 to 45%. Wisconsin Gradation #1 was constructed on the USH 151 test sections in this study, where the percentage passing the #4 sieve was limited to 0 to 10%, yielding a theoretical permeability of 10,000 feet per day (Rutkowski 1998). USH 151 had an actual Gradation #1 passing the #4 sieve of 3%. One section constructed on USH 151 had New Jersey OGBC with a passing #4 of 49% (specification range of 40 to 55%) and theoretical permeability of 3,000 feet per day. Neither the Gradation #1 or New Jersey OGBC are currently specified, thus, the most reasonable approach for LCCA is to use the current Section 310 prices. Conversions used, consistent with WisDOT policy, were 2 tons/CY for dense-graded base and 1.75 tons/CY of open-graded base.

Figure 7.2 Unit Prices for Aggregate Base

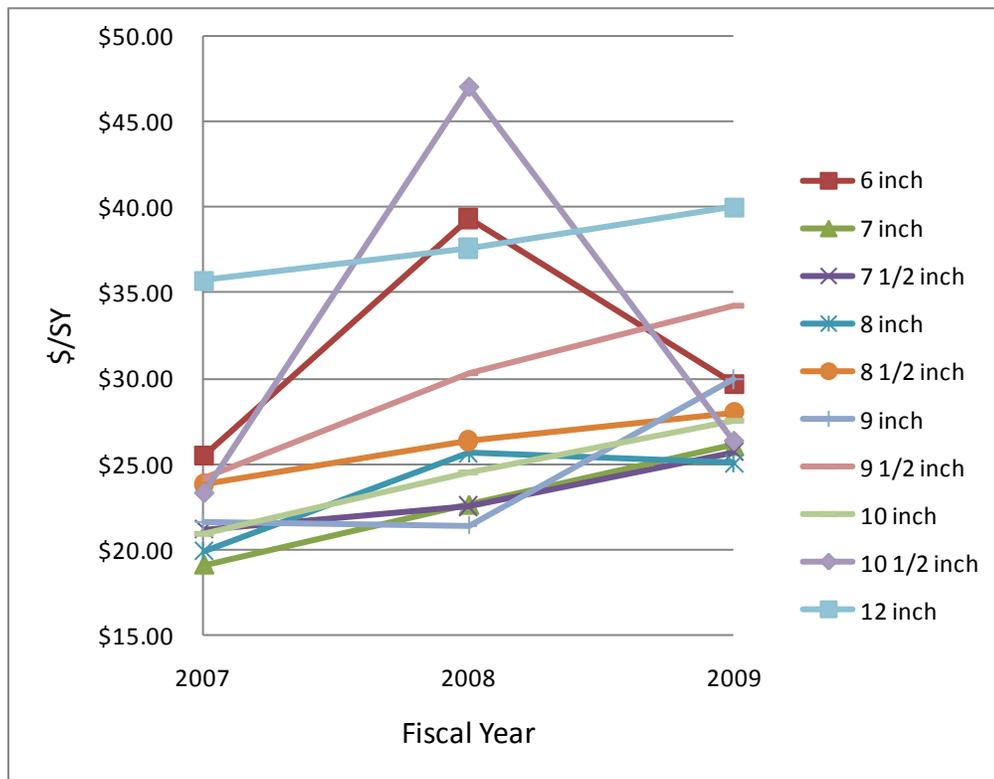
A plot of \$/SY for PCC pavement thickness by year was prepared to illustrate the cost trends (Figure 7.3) to assess whether thickness and year had a relative impact. Upward cost trends were observed for 7, 8½, 9, 9½, 10, and 12-inch thick PCC pavements, while 6, 8, and 10½-inch had a general decrease from 2008 to 2009. Overall, pavement costs have generally increased the past few years. As noted earlier, the 10-inch thick pavement was selected for the LCCA.

Figure 7.3 Unit Prices for Concrete Pavement Thickness

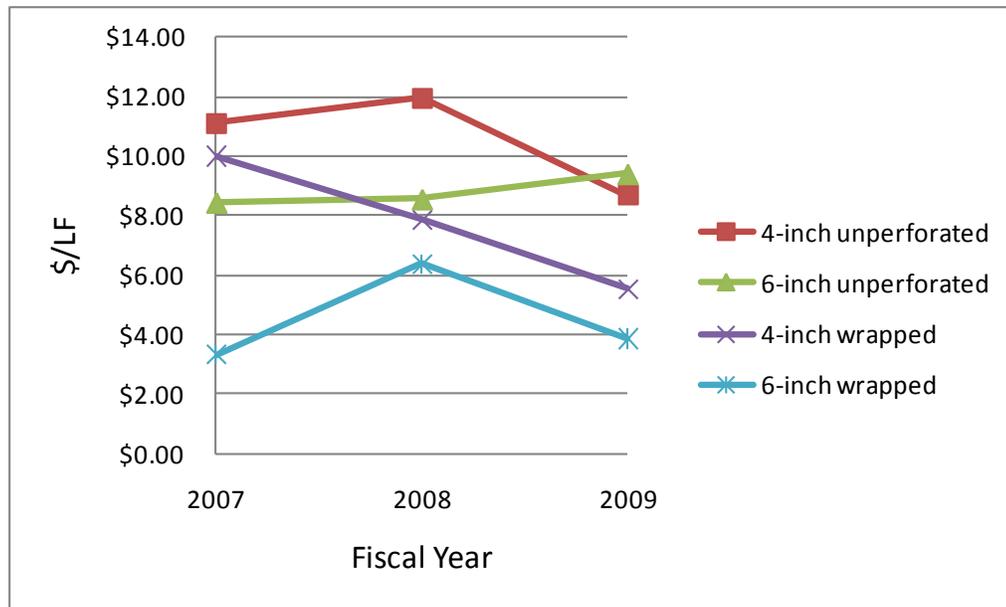
Drainage pipe unit prices were then analyzed by plotting the data in Figure 7.4. Both the 4-inch and 6-inch prices were plotted since a 4-inch perforated pipe underdrain was installed on USH 18/151, and 6-inch perforated pipe on STH 29 and USH 151. As mentioned earlier, the 6-inch pipe has been selected for LCCA. The prices show a general spike in 2008, for 4-inch unperforated and 6-inch wrapped, consistent with the spike in oil prices, since polyvinyl chloride drainage pipe (AASHTO M 278) is a petroleum-based product. The 6-inch perforated had an increasing trend, while 4-inch wrapped had a decreasing trend.

Figure 7.4 Unit Prices for Underdrain Pipe

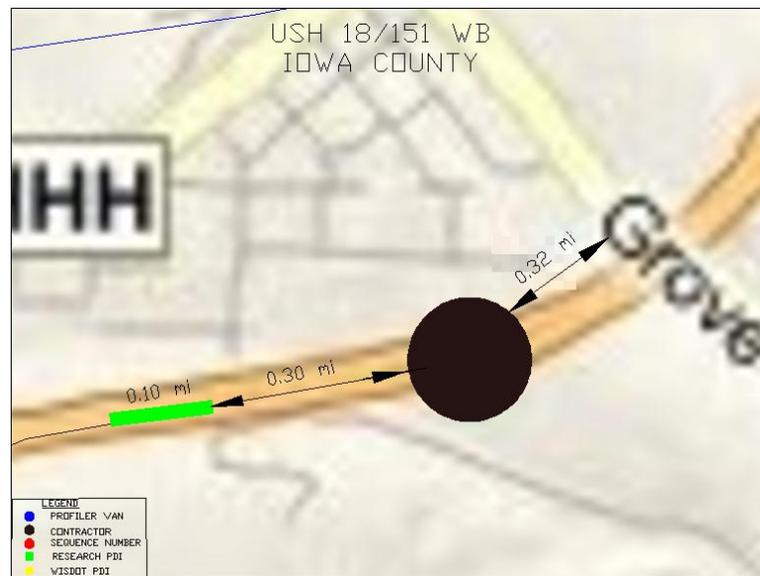
An example of adjusting the performance data to the Research PDI is provided in Figure A.1. This example is provided for Section 3 located in the west bound lane of USH 18/151, which begins 0.32 miles west of CTH 'H' (Grove Street) overpass. The butt joint is located here and the research PDI starts 0.3 miles from this point and runs 0.1 miles west along USH 18/151.

Figure A.1 Locating Research PDI for Section 3 in Westbound USH 18/151

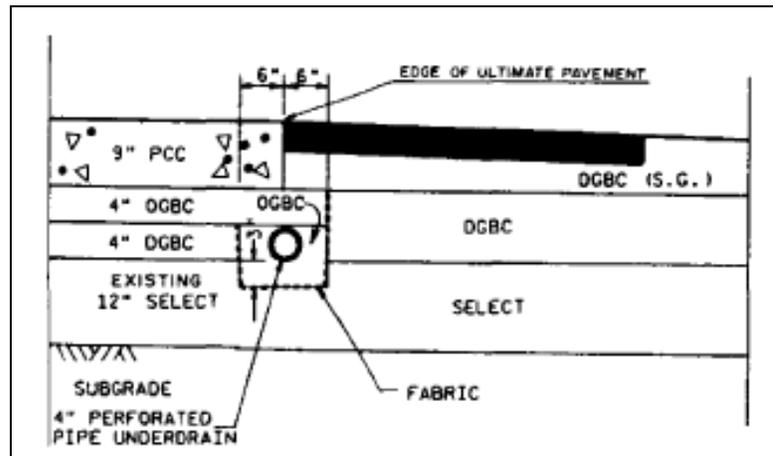
Figure B.1 USH 18/151 Sections 1 and 2 with Non-Stabilized OGBC

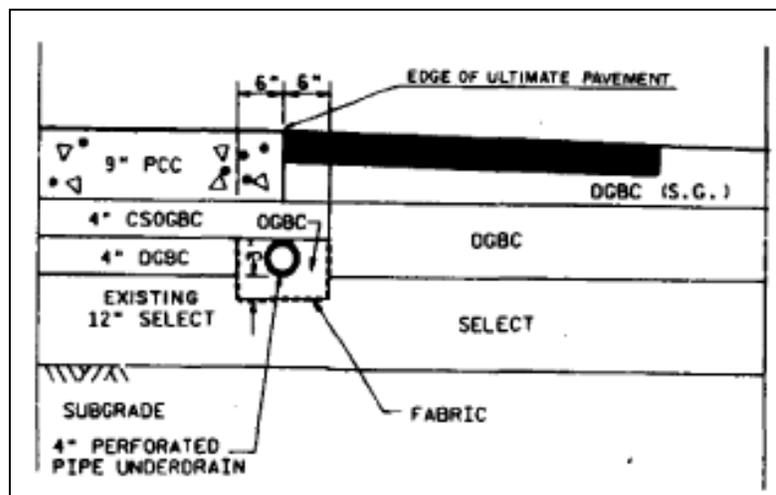
Figure B.2 USH 18/151 Sections 3, 4, and 11 with Cement-Stabilized OGBC

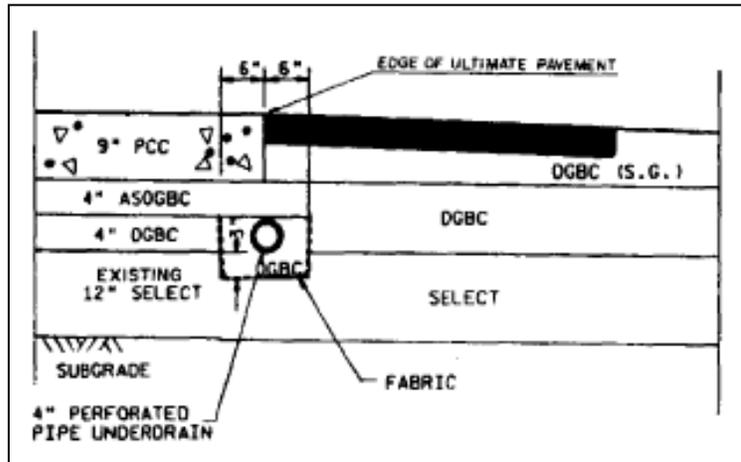
Figure B.3 USH 18/151 Sections 5, 6, and 12 with Asphalt-Stabilized OGBC

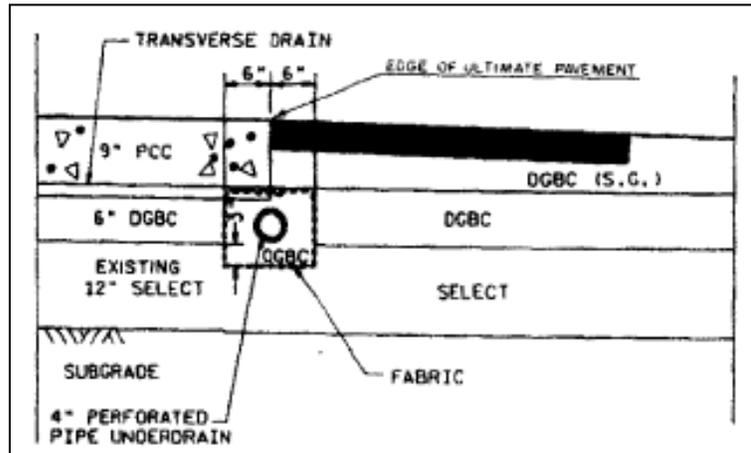
Figure B.4 USH 18/151 Sections 7 and 10 with TIC Drain

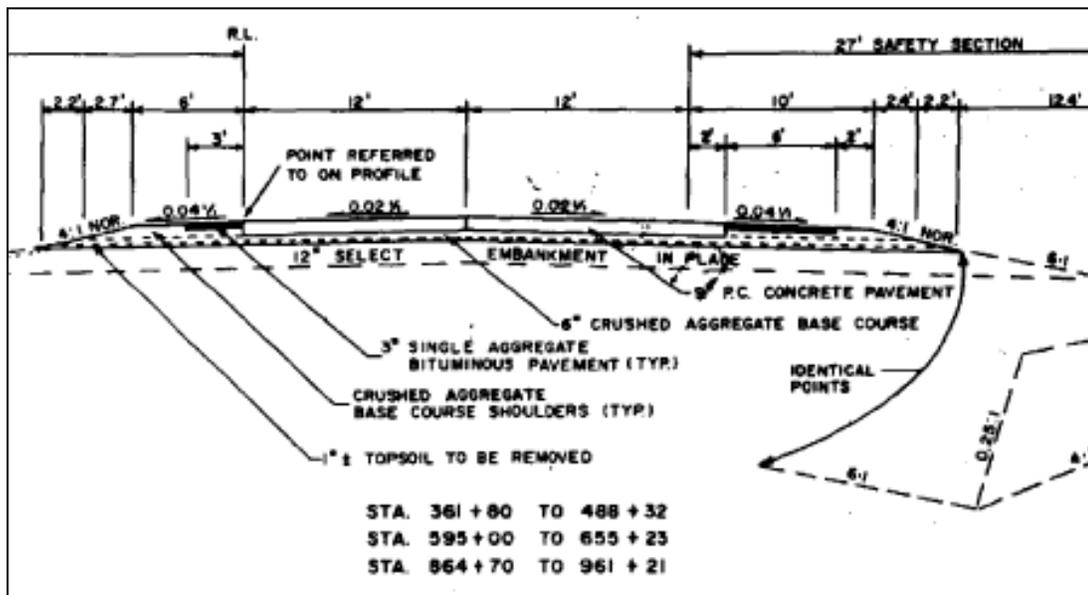
Figure B.5 USH 18/151 Sections 8, 9, 14 and 15 with Dense Graded Base Course

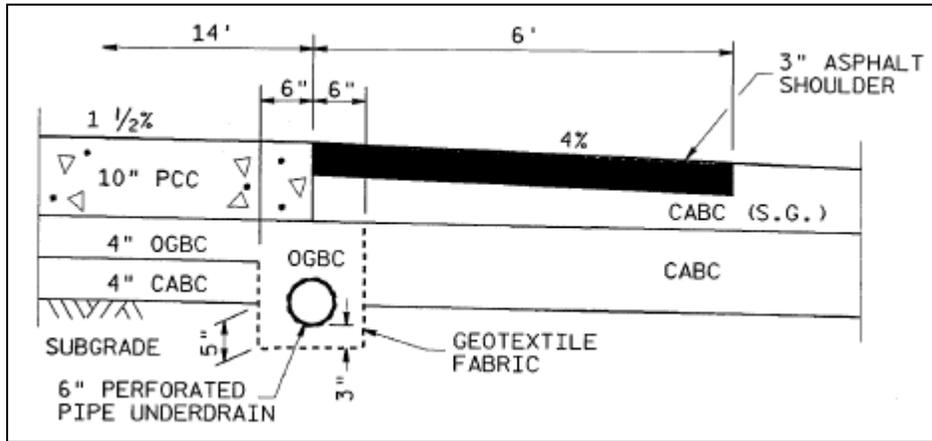
Figure B.6 STH 29 Sections 1 through 4 with Non-Stabilized OGBC

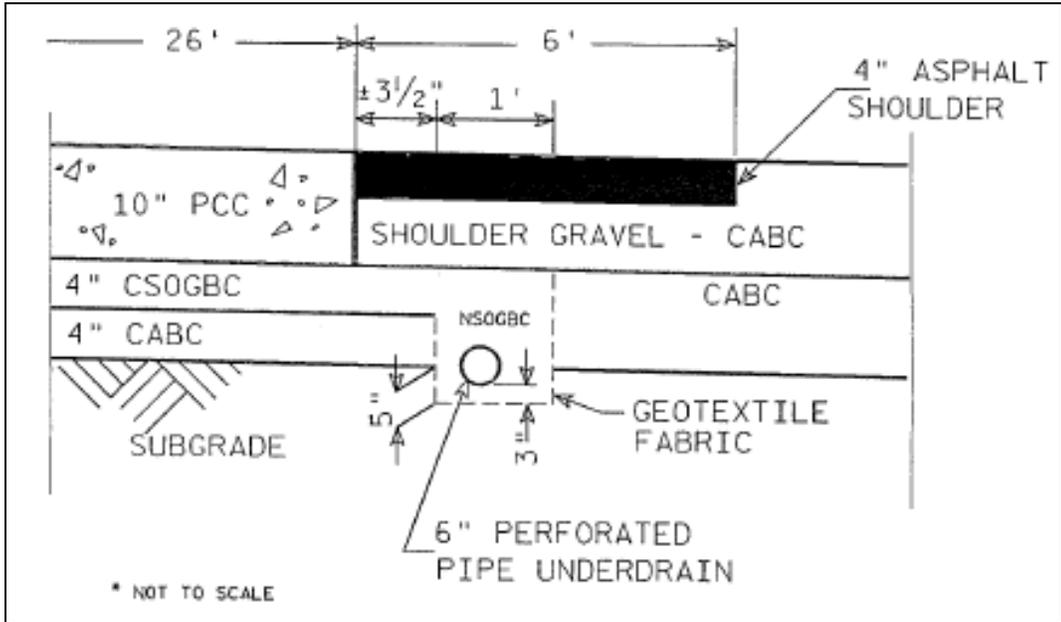
Figure B.7 USH 151 Section 1 with Cement-Stabilized OGBC

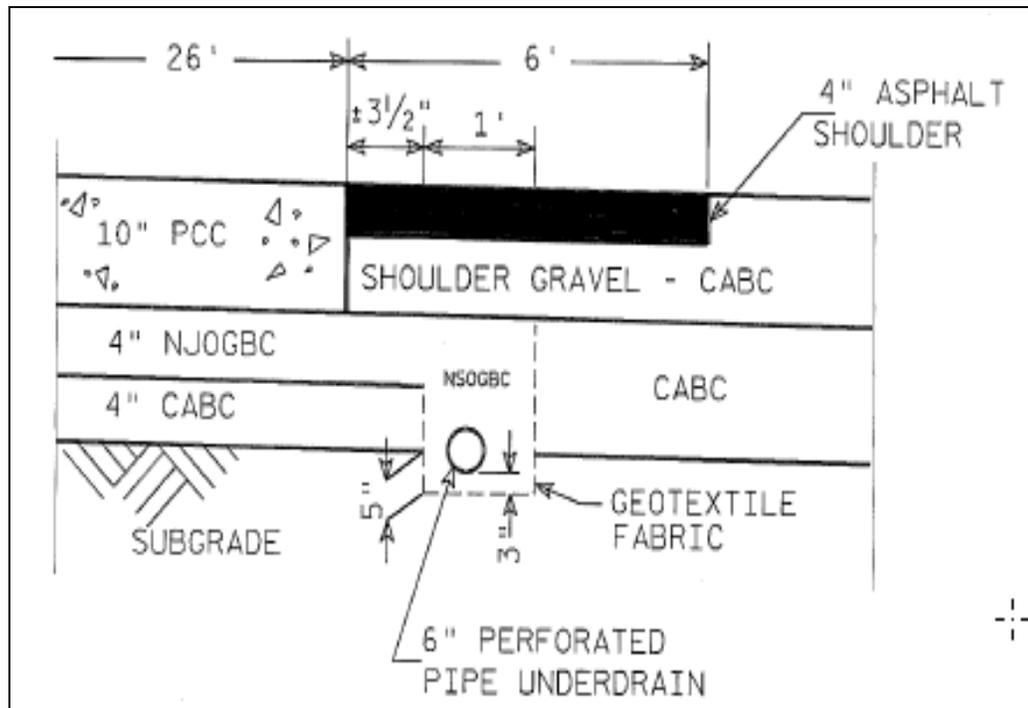
Figure B.8 USH 151 Section 2 with New Jersey Non-Stabilized OGBC

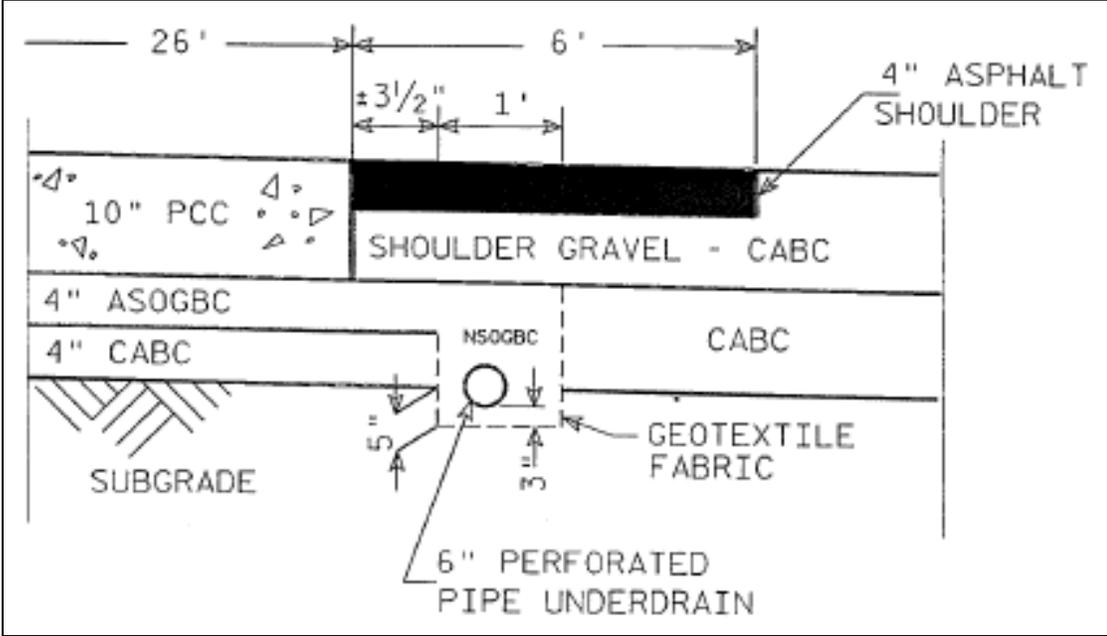
Figure B.9 USH 151 Section 3 with Asphalt-Stabilized OGBC

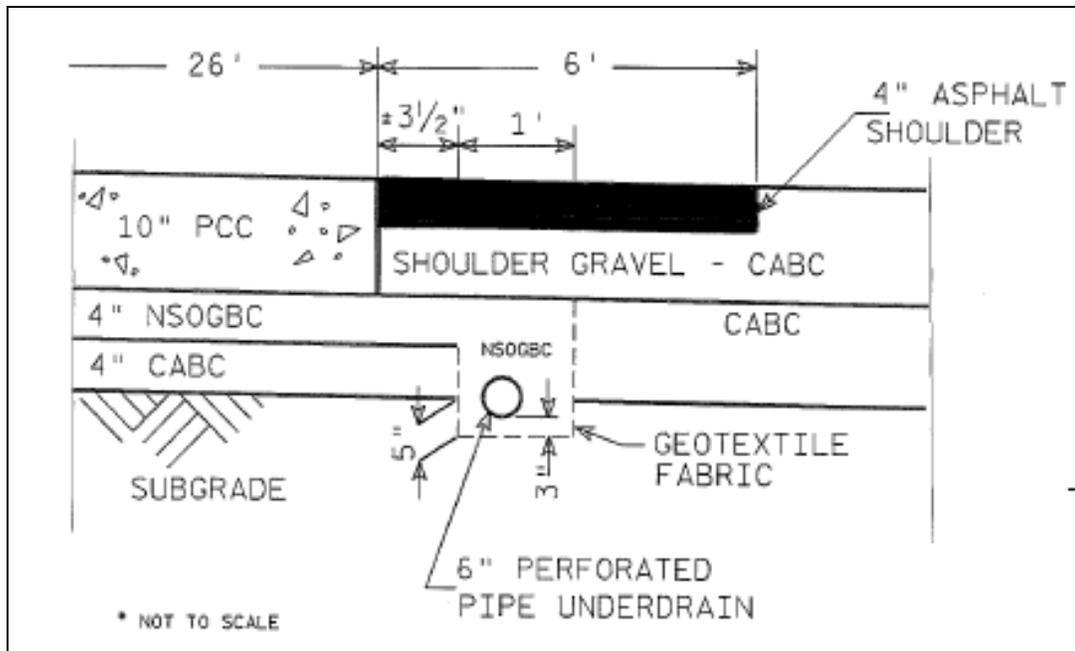
Figure B.10 USH 151 Section 4 with Non-Stabilized OGBC
