Field Study of Air Content Stability in the Slipform Paving Process

WisDOT ID no. 0092-11-06

January 2013

Field Study of Air Content Stability in the Slipform Paving Process Final Report

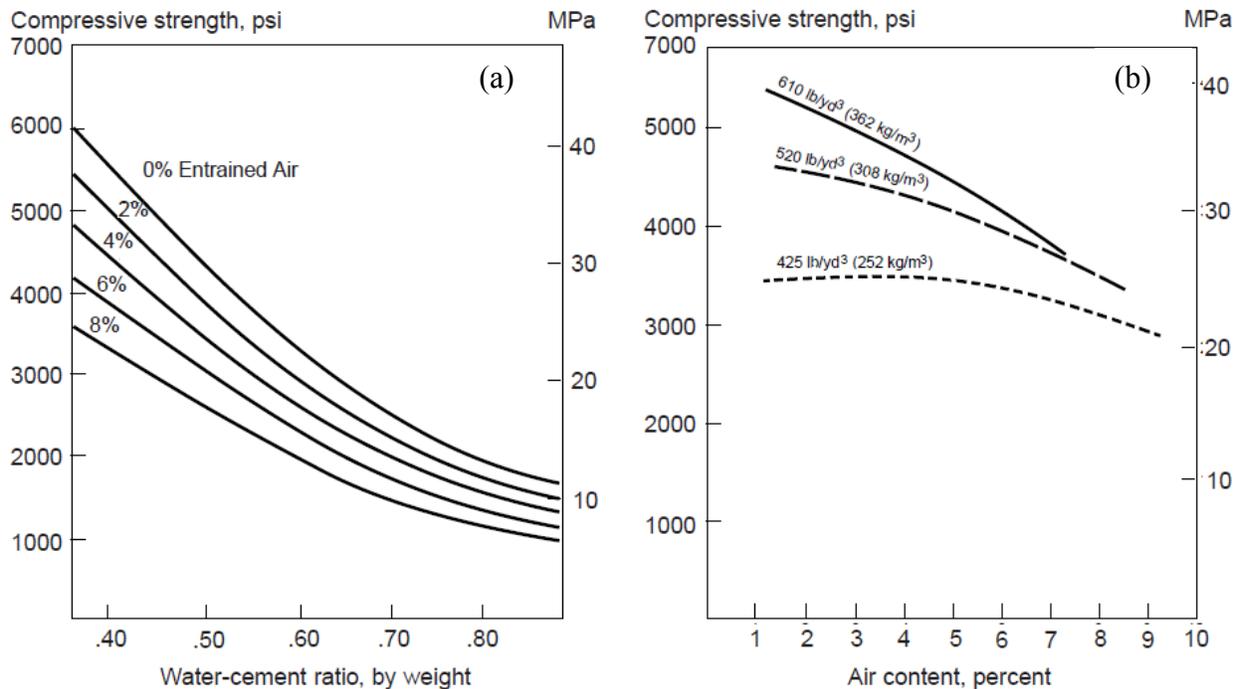
Typical relationships between compressive strength and w/cm for various air contents is shown in figure 1(a). Figure 1(b) shows the typical relationships between compressive strength and air content for concretes with different cement contents.

Figure 1. Relationships between compressive strength, w/cm , and air content (Walker and Bloem 1955, Bloem 1950).

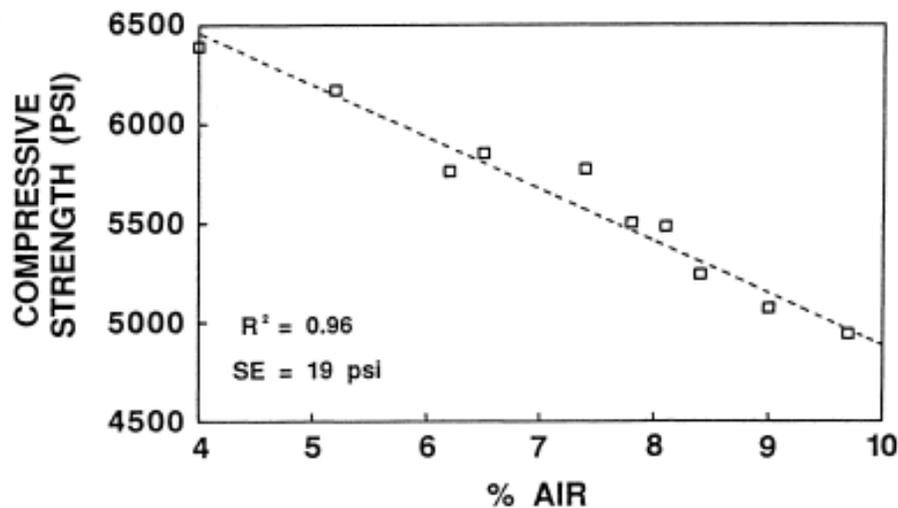
Ozyildirim (1990) conducted a laboratory study to evaluate the impact of air content on the compressive strength of concretes with cementitious materials content of over 600 lbs/yd³ and a maximum w/cm of 0.45. Ten batches were tested for fresh properties (air content, slump, and unit weight). Six batches used Vinsol resin-based AEAs and the remaining four batches used synthetic AEAs. The relationship between the air content measured by a Type A pressure meter (according to ASTM C231) and the 28-day compressive strength measured using 4x8 inch cylinders is shown in figure 2.

Figure 2. Relationship between compressive strength. and air content (Ozyildirim 1990).

Most agencies set their maximum air content values in the range of 8 to 10 percent, with WisDOT's upper value set at 8.5 percent. Using the relationship from the chart above, it is observed that a nearly 25 percent loss of strength is associated with an increase in air content from 4 to 10 percent.

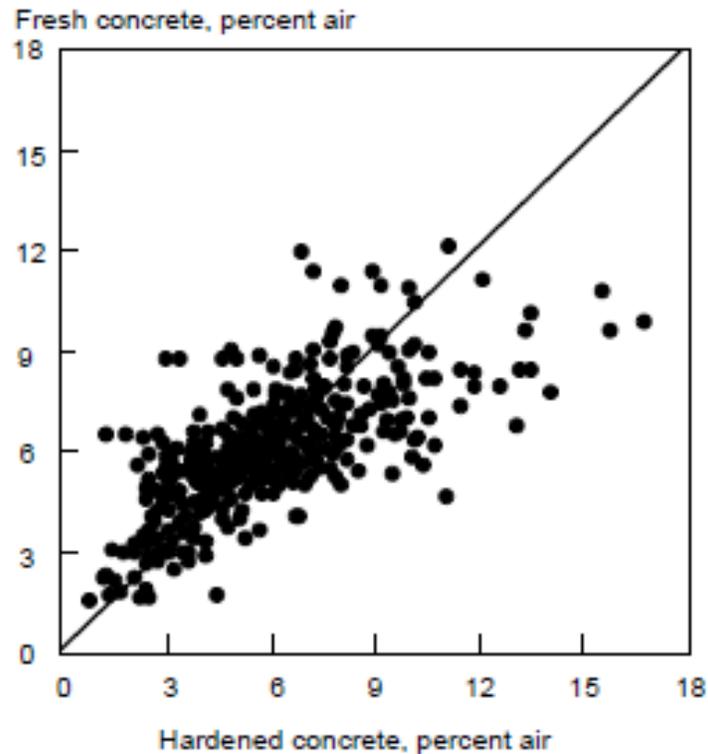
A scatter plot showing the relationship between fresh and hardened air contents is shown in figure 3 (Nagi and Whiting 1994).

Figure 3. Relationship between fresh and hardened air contents (Nagi and Whiting 1994).

The study conducted by Nagi and Whiting (1994) used 400 separate comparisons from various laboratory and field studies. The mean air content for both fresh and hardened concrete was about 6 percent. The mean absolute difference was found to be around 1.3 percent. Overall, the typical absolute difference between the fresh and hardened air contents is within 2 percent, not taking into consideration the unusual observations where the fresh and hardened concrete air contents are considerably different.

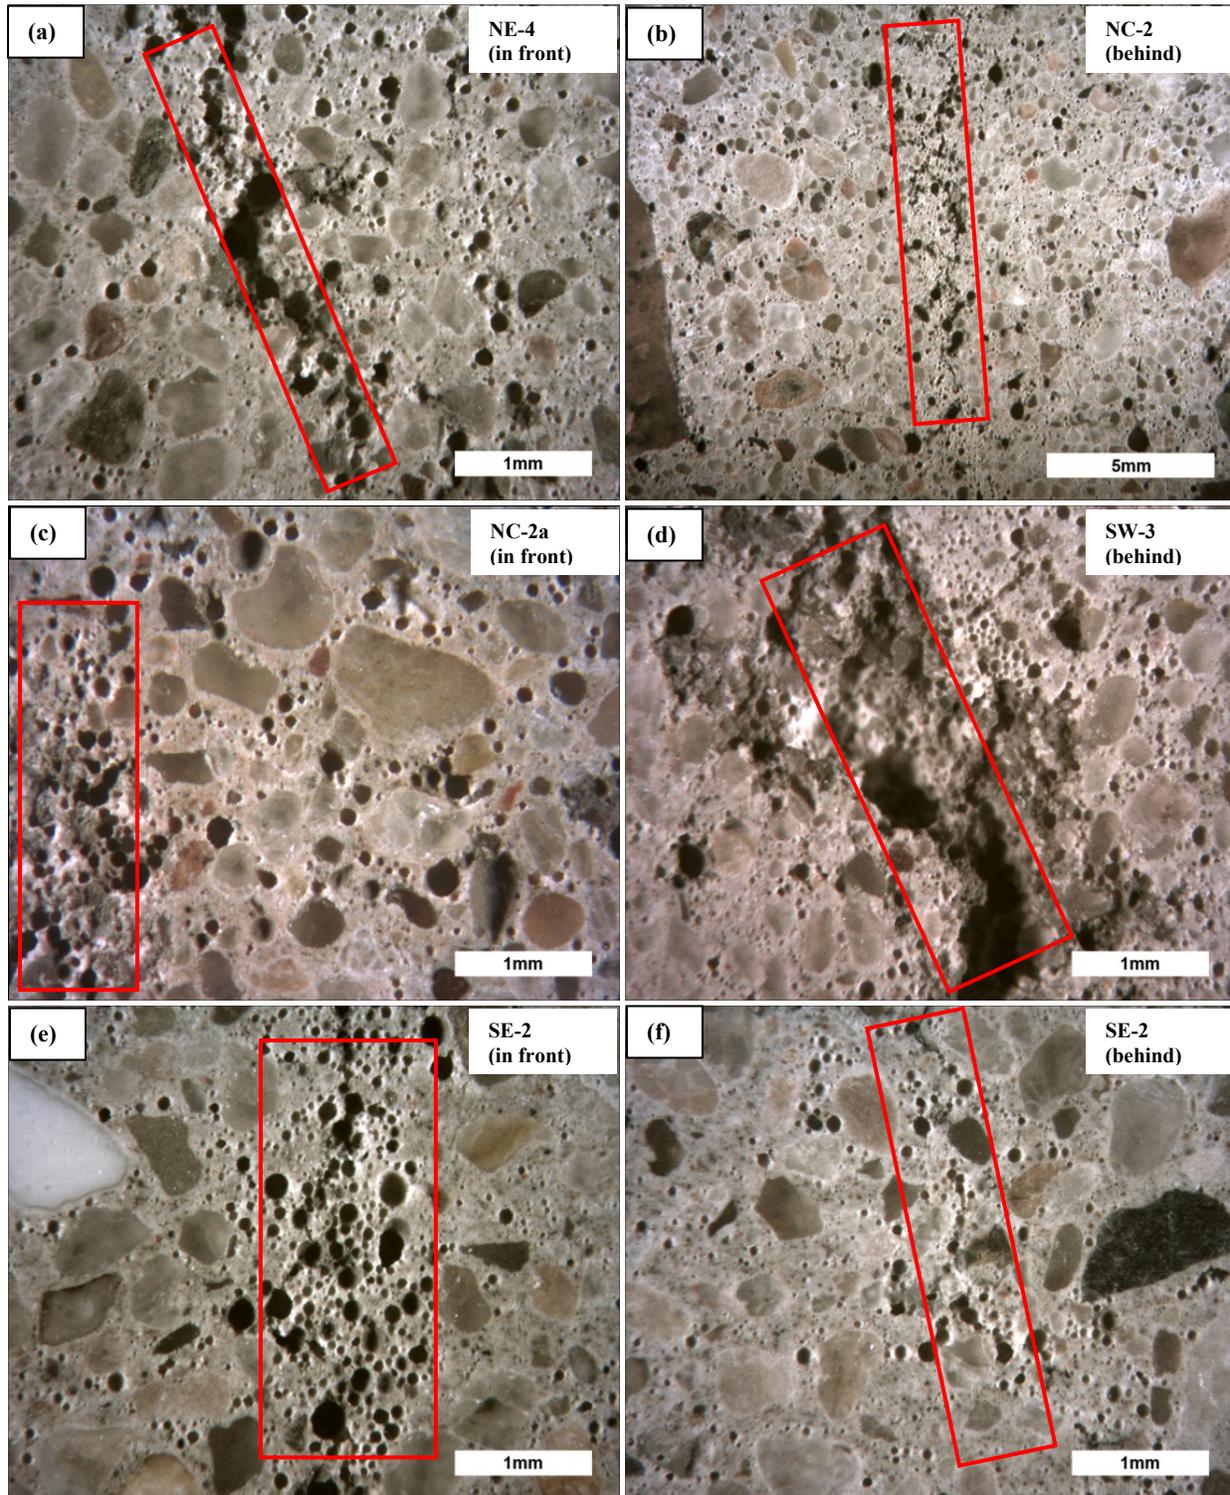
Figure 7. Micrographs of field-cast cylinder specimens exhibiting segregation due to internal vibration.

- The method used to consolidate the cylindrical specimens (as well as the concrete used in the determination of fresh concrete air content) clearly impacted the fabric of most of the concrete, creating segregation, clustering of air voids around the aggregates, and coalescence of air voids within the paste. This affected at least one cylindrical specimen from every project. In 9 of the 12 projects, the cylinders cast using concrete from in front of and behind the paver were affected. It is therefore recommended that other methods of consolidation (like rodding or the use of a mobile table vibrator) be considered for preparing specimens for air content determination. It should also be noted that 4 by 8 inch cylinders were used in this project and more energy is expected to be trapped and applied to the concrete during consolidation in the smaller specimens. WisDOT typically uses 6 by 12 inch cylinders for strength testing.

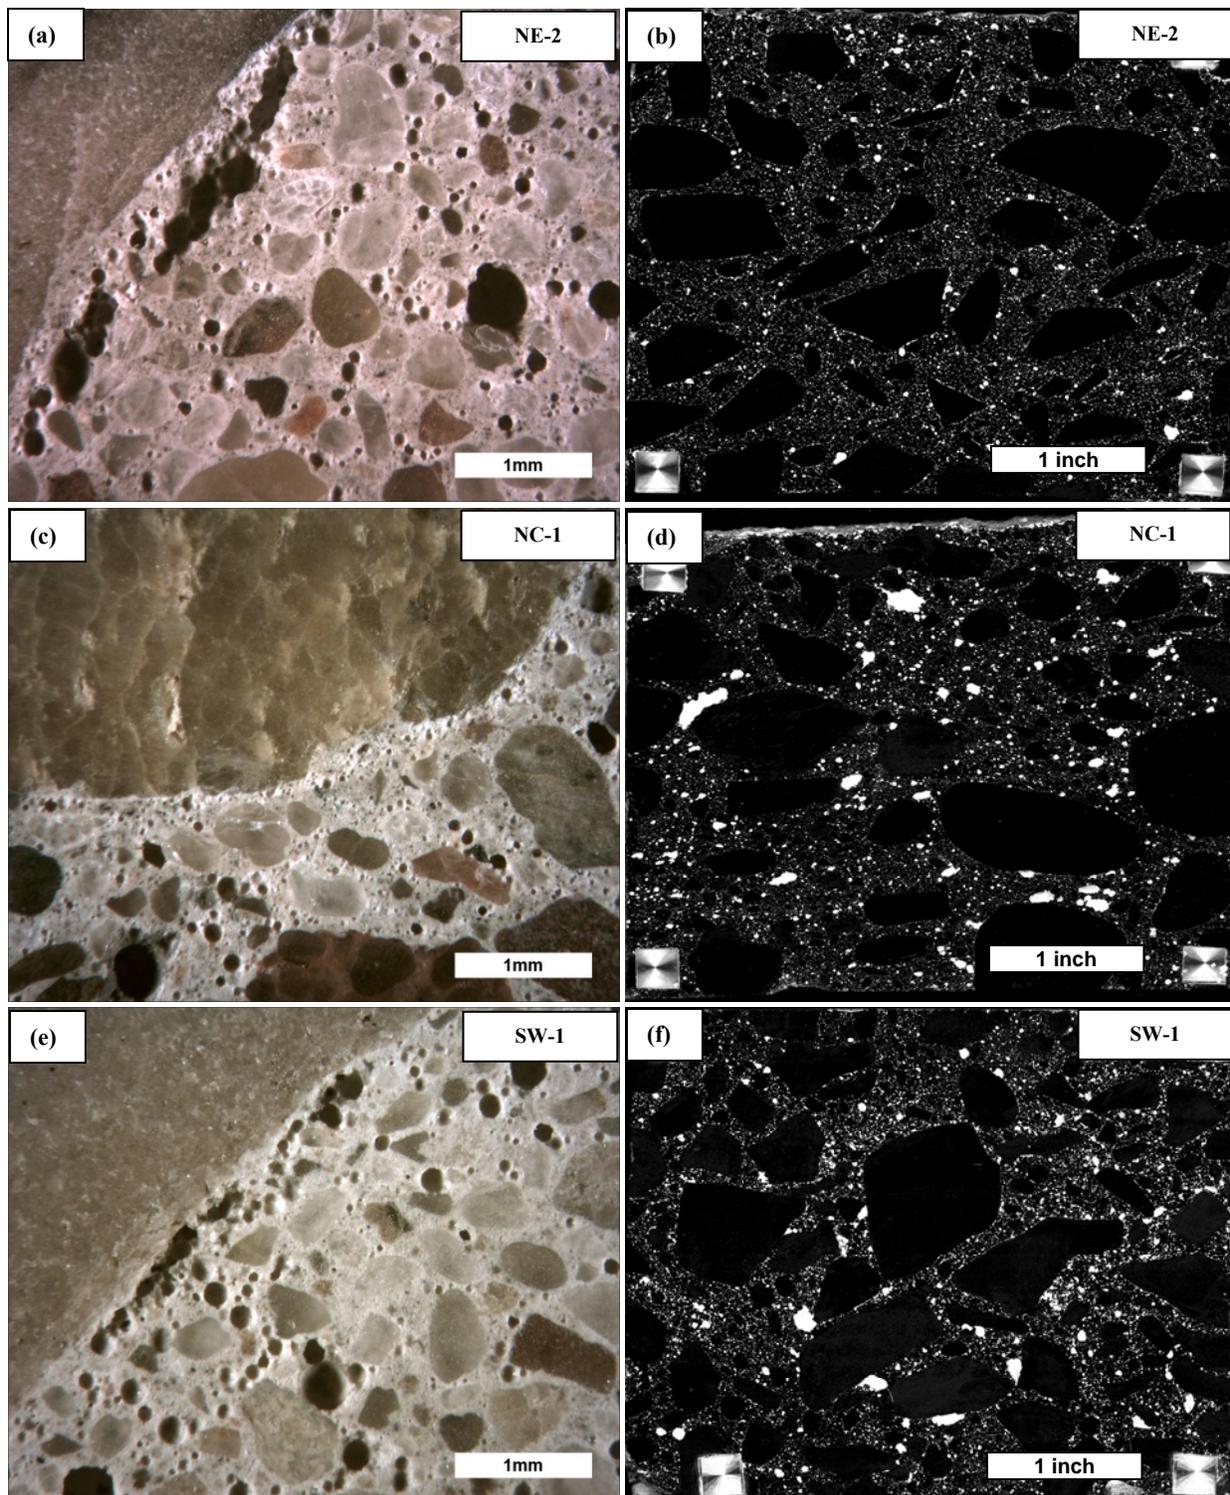
Interestingly, issues with the air-void system were also observed in some of the extracted cores. Figures 8 (a) through (f) show micrographs and scanned images of several extracted core specimens (from projects NE-2, NC-1, and SW-1) that exhibited accumulation of air voids around the aggregates. Figures 9 (a) through (f) show micrographs and scanned images of extracted core specimens (from projects: NE-4, NC-2, and SW-3) that were unusually porous with significant coalescence of entrained air voids. As these core specimens represent the concrete as-placed, there is some concern regarding the uniformity of the air-void system in newly constructed pavements.

Figure 8. Micrographs and scanned images of core specimens exhibiting accumulation of air voids around aggregates.

- Either air void clustering or coalescence was observed in the cores extracted from half the projects (i.e., 6 of the 12 projects) indicating that this phenomena might be widespread. Of the six projects having air void clustering and coalescence, the average total hardened air content of the as-placed concrete was 8.7 percent (versus 7.3 percent for those projects in which air void clustering and coalescence was not observed). Although there is variability in these data, it appears that the opportunity for irregularities in the air void system increases as air content increases.

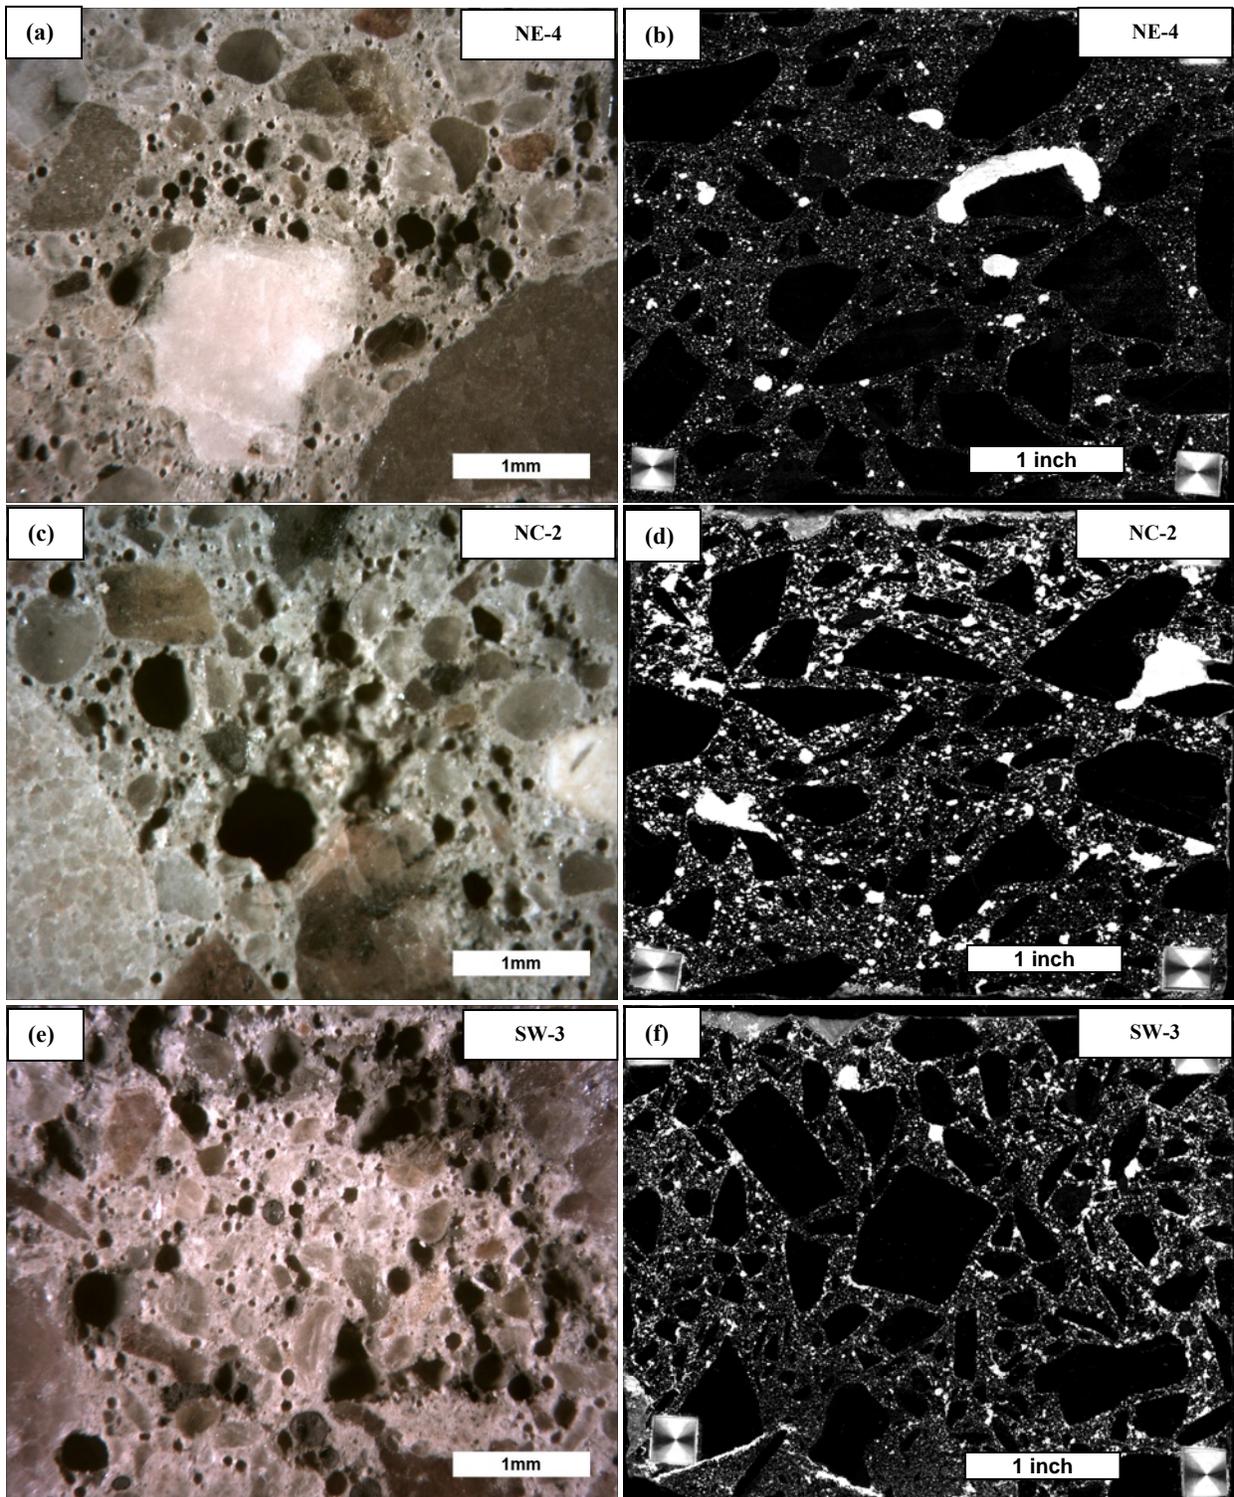
Figure 9. Micrographs and scanned images of unusually porous core specimens exhibiting coalescence of entrained air voids.

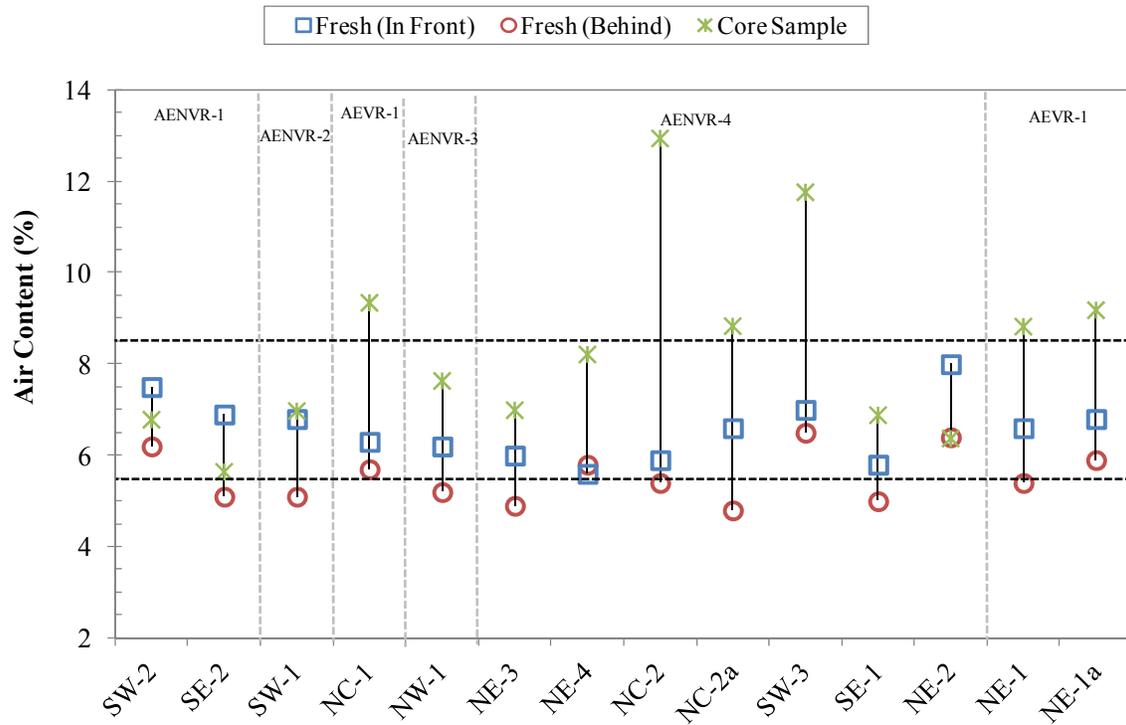
Figures 16 through 21 summarize the air content measured in the fresh concrete, field-cast cylinders, and the core samples extracted from the pavement. The horizontal dashed lines in each plot show WisDOT's current specification for air content of fresh concrete measured in front of the paver (5.5 to 8.5 percent). These figures clearly show the trends discussed above, as well as the project-to-project variation.

Figure 16. Comparison of fresh and hardened concrete (cores) air contents (Automated Method).

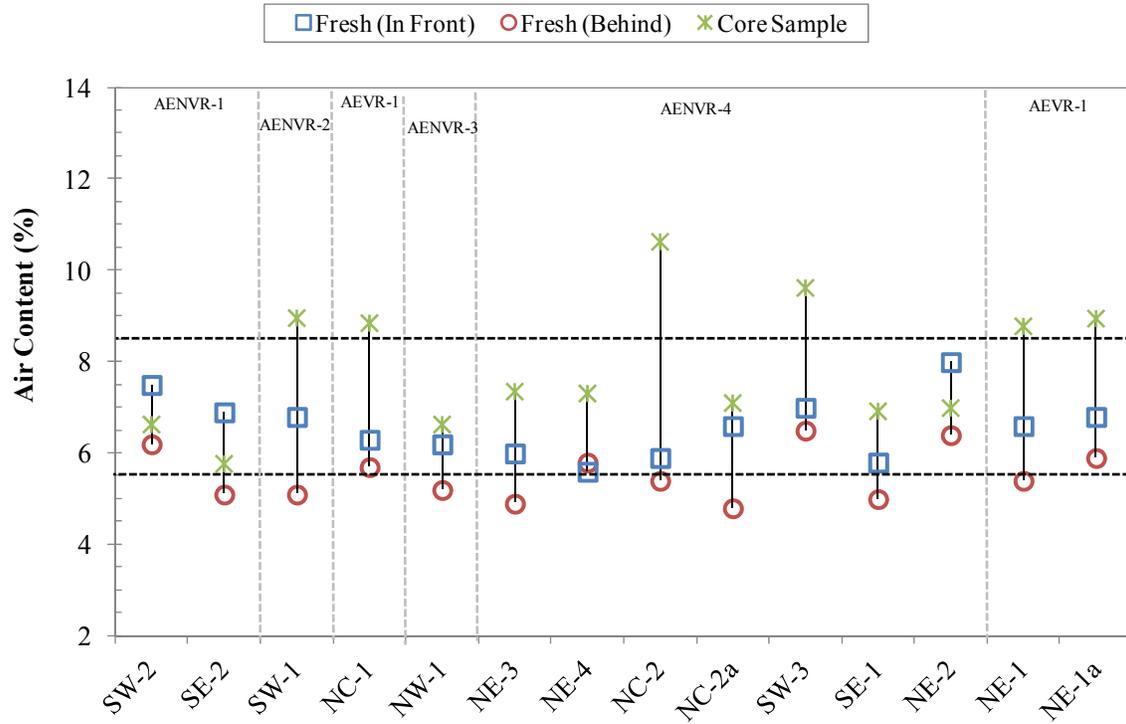
Figure 17. Comparison of fresh and hardened concrete (cores) air contents (ASTM C457 Manual Method).

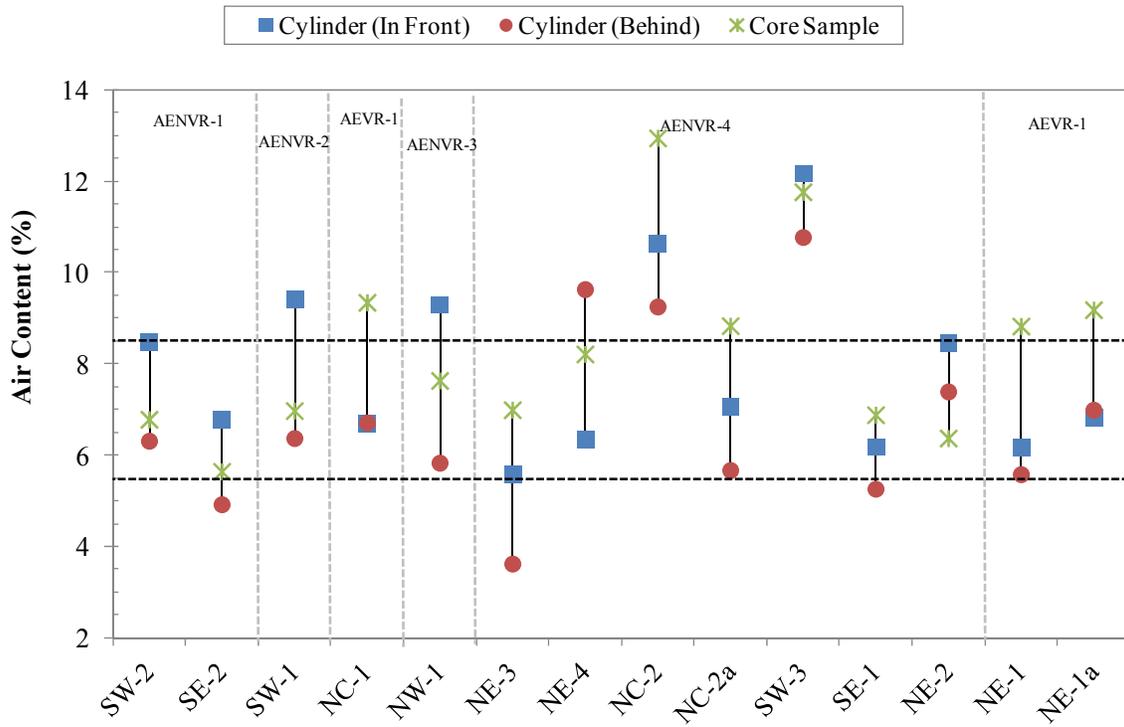
Figure 18. Comparison of air contents in cylinders and cores (Automated Method).

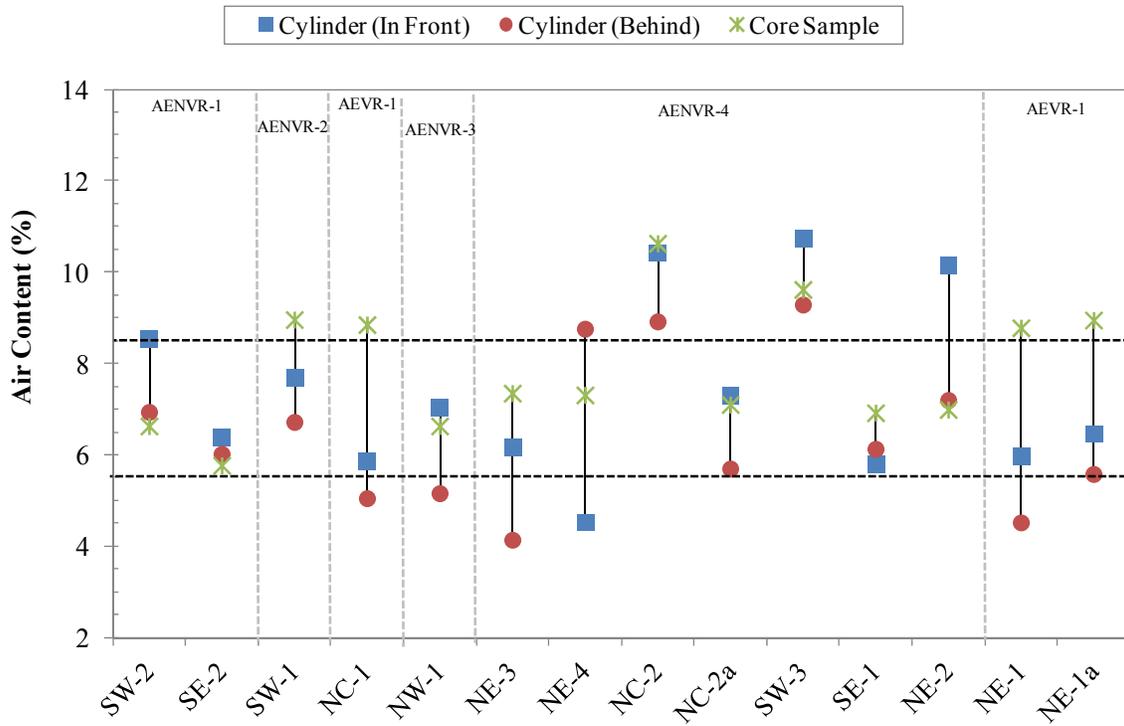
Figure 19. Comparison of air contents in cylinders and cores (ASTM C457 Manual Method).

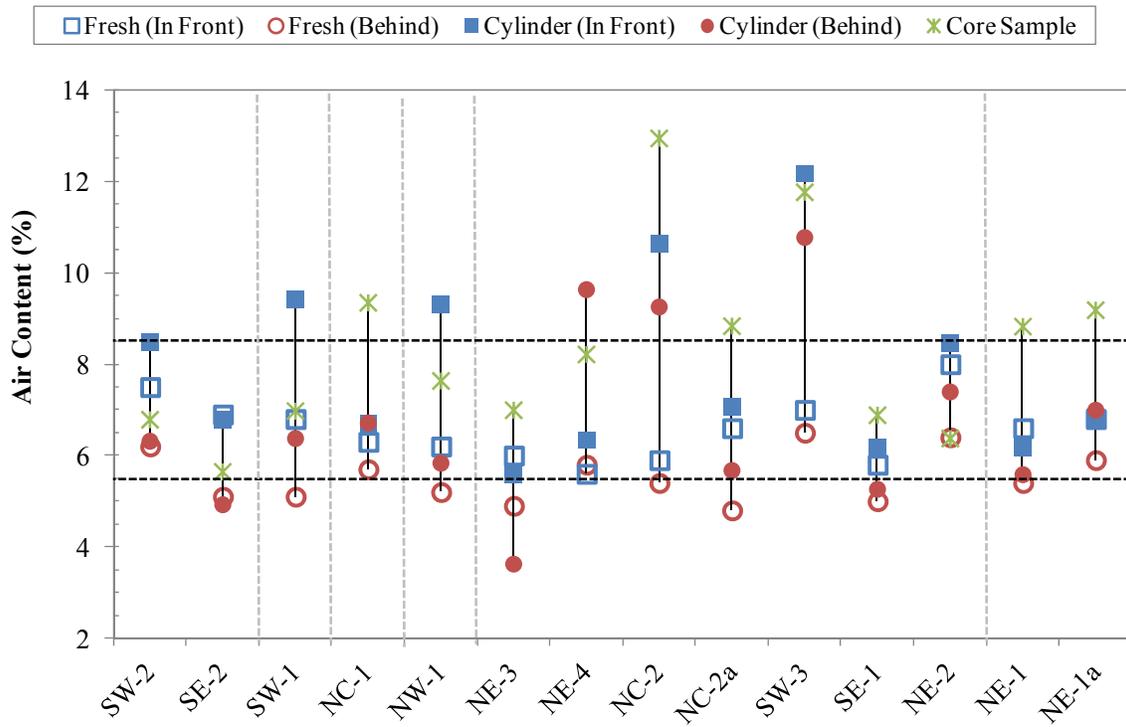
Figure 20. Summary of air contents measured in the field and laboratory (Automated Method).

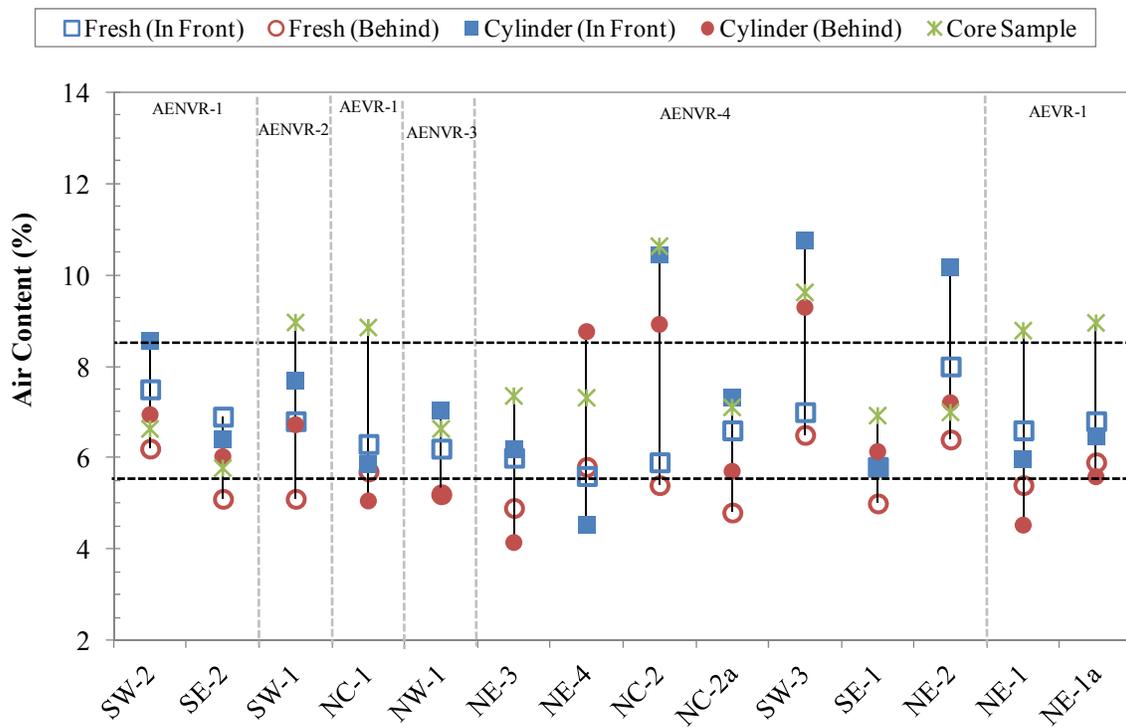
Figure 21. Summary of air contents measured in the field and laboratory (ASTM C457 Manual Method).

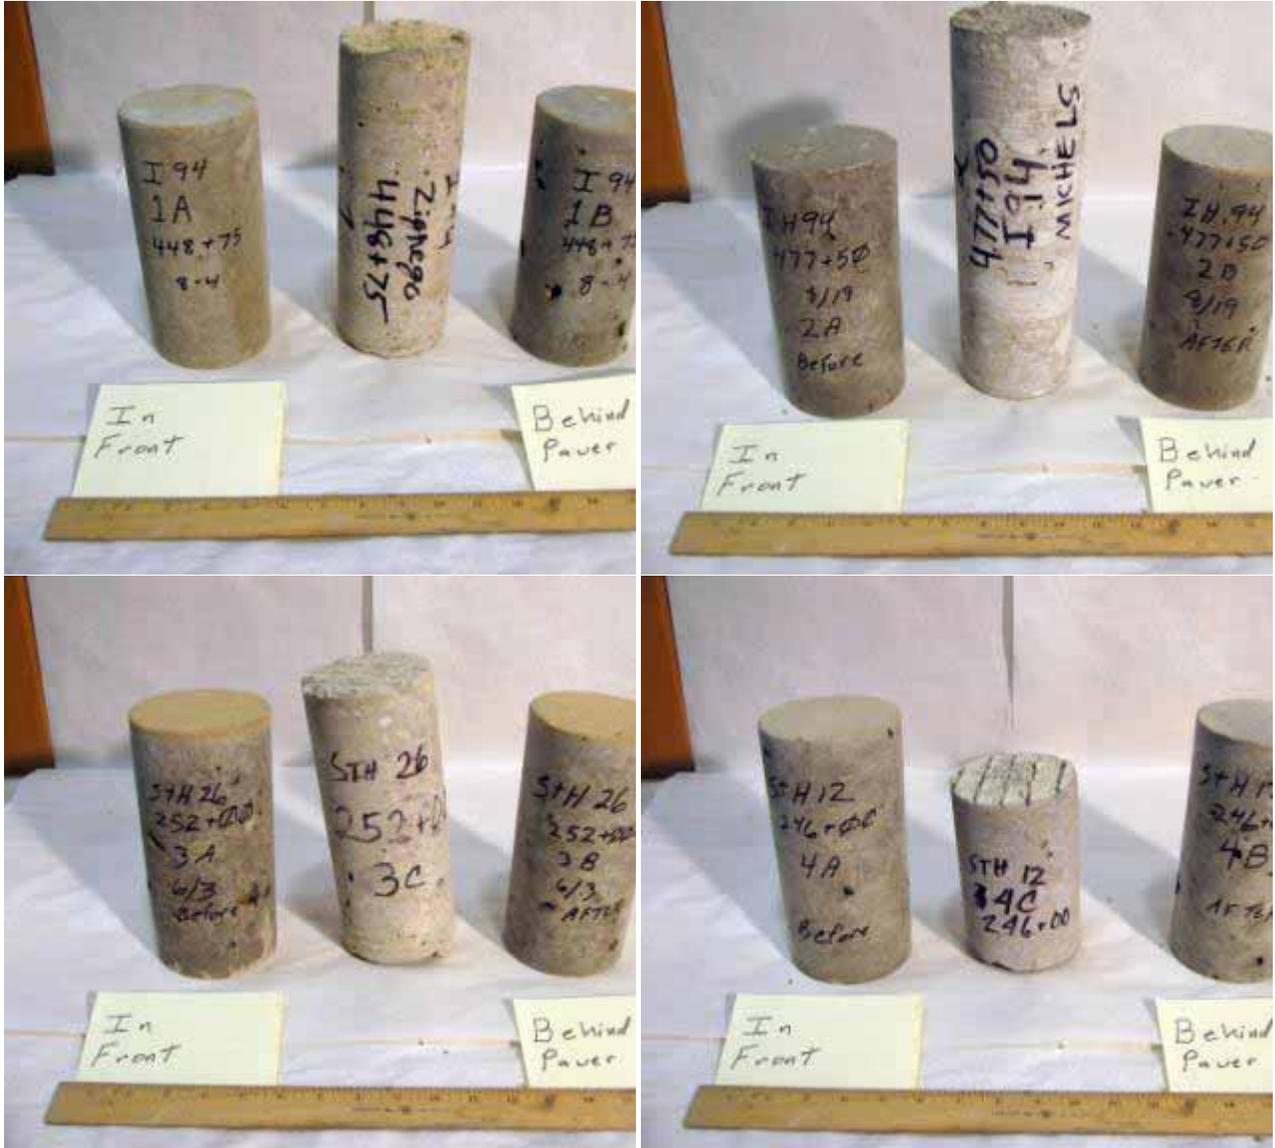
Figure 1: Images of specimens received. Clockwise from top, left: SW-1; SE-1; SW-3; SW-2.

These conflicting results are likely the product of sample collection methods. Vibrator trails are present evident in many of the cylinder specimens, including cylindrical specimens created from concrete collected after the slipform paver had passed. Concrete in these specimens has therefore been worked and compacted multiple times. It is reasonable to expect that air content would decline with such treatment. Collection of fresh concrete samples after the slipform paver is likely to be the single greatest challenge faced by researchers conducting this sort of investigation.

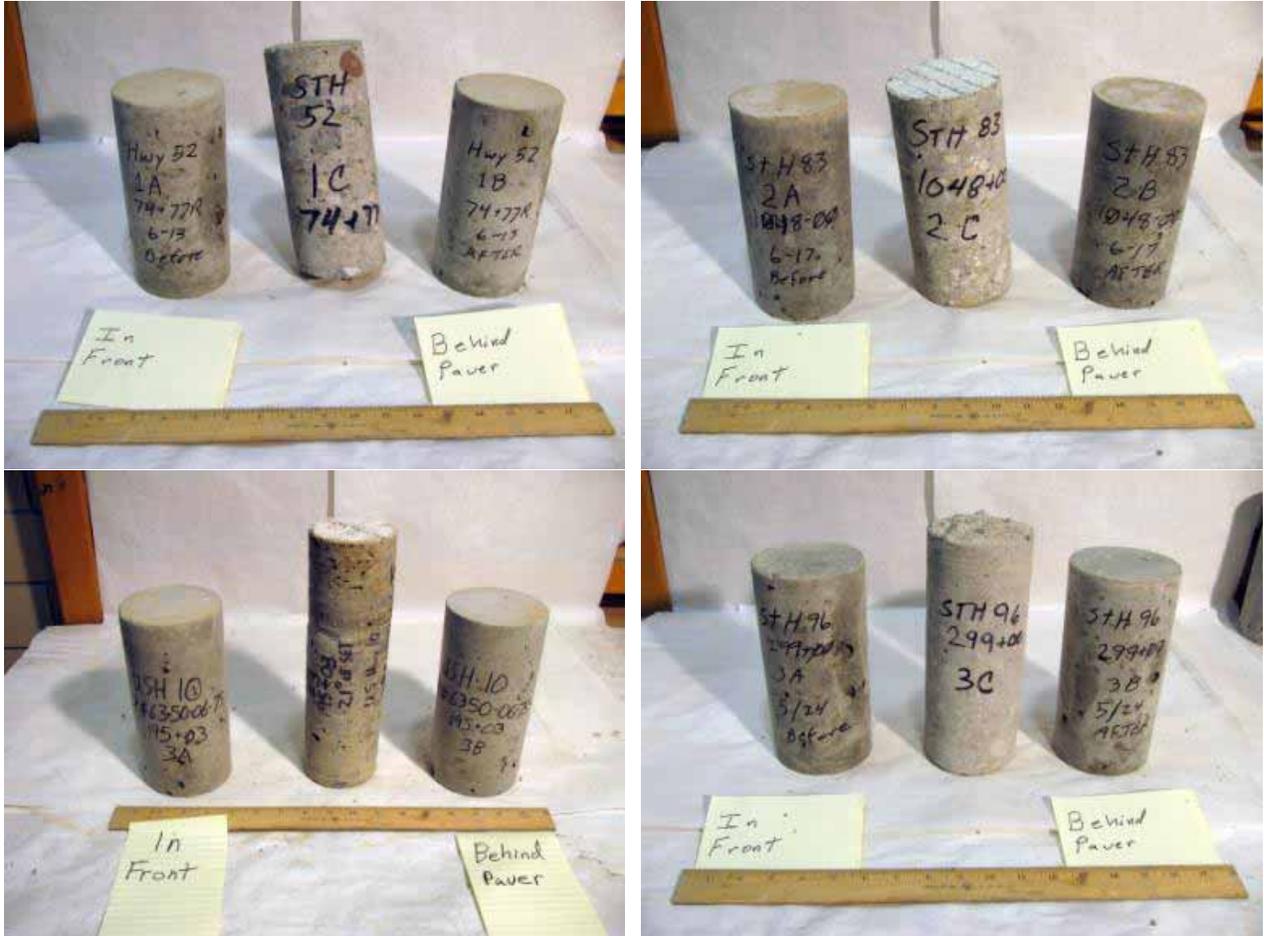
Figure 2: Images of specimens received. Clockwise from top, left: NC-1; SE-2; NE-2; NC-2.

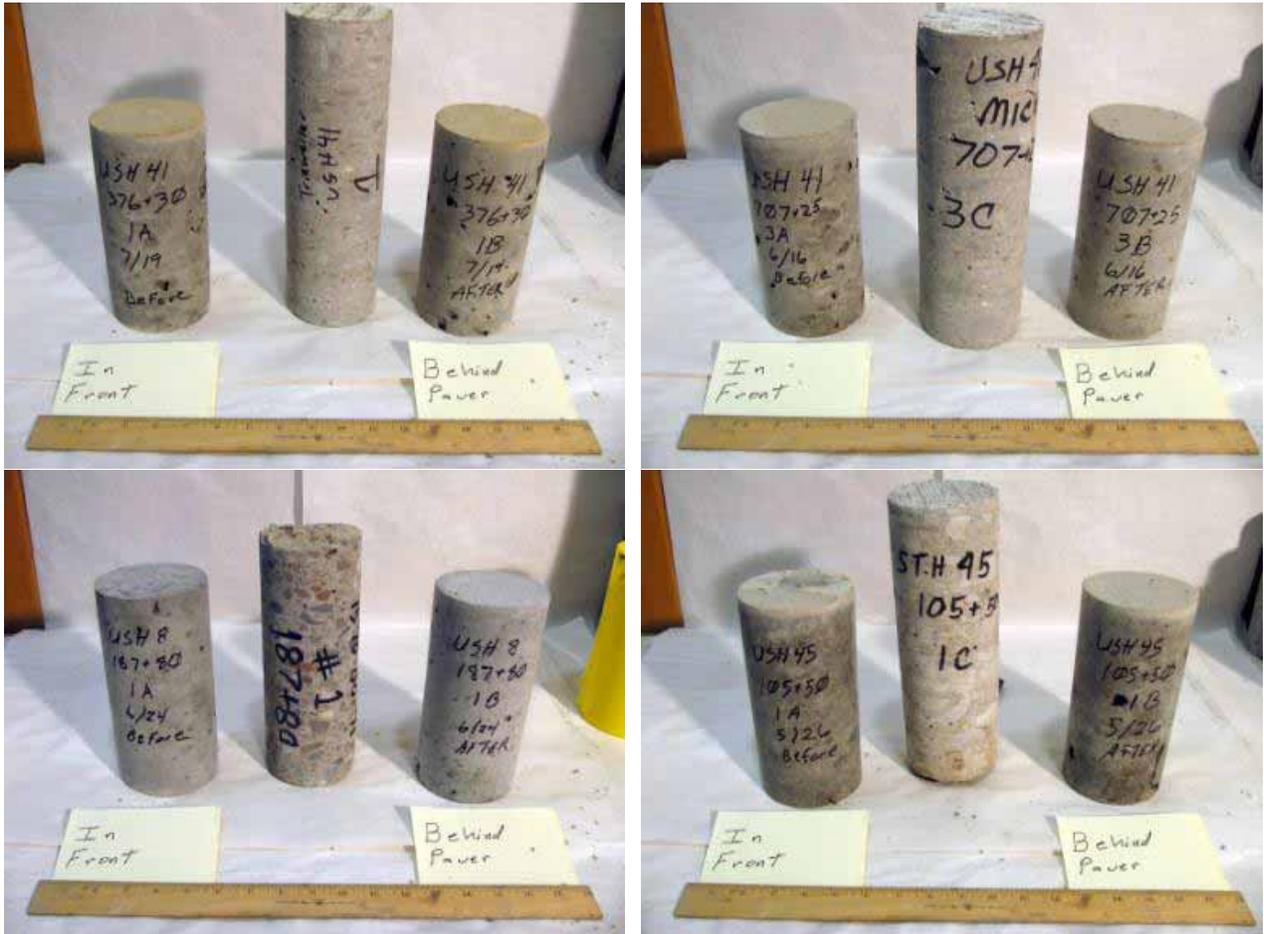
Figure 3: Images of specimens received. Clockwise from top, left: NE-4; NE-3; NE-1; NW-1.

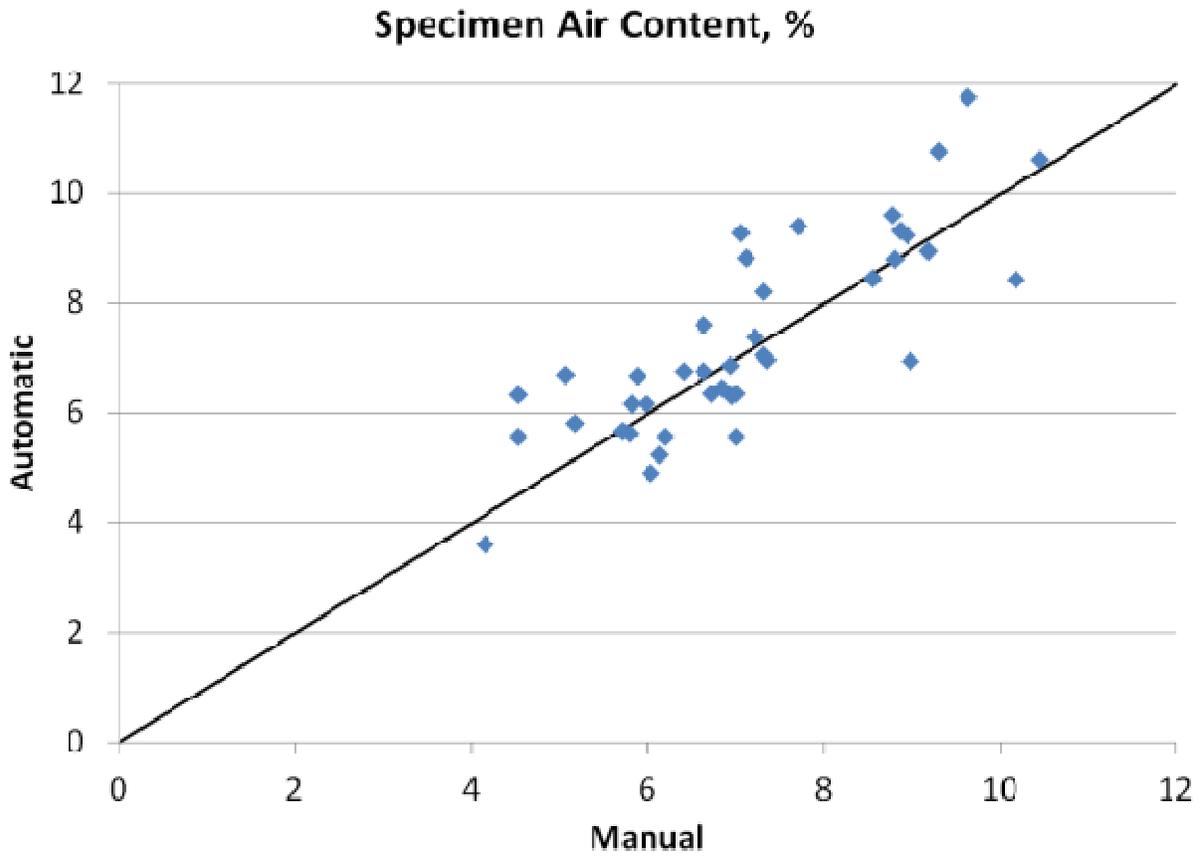
Figure 89: Comparison of air content determined manually and automatically for each specimen (cylinder or core).

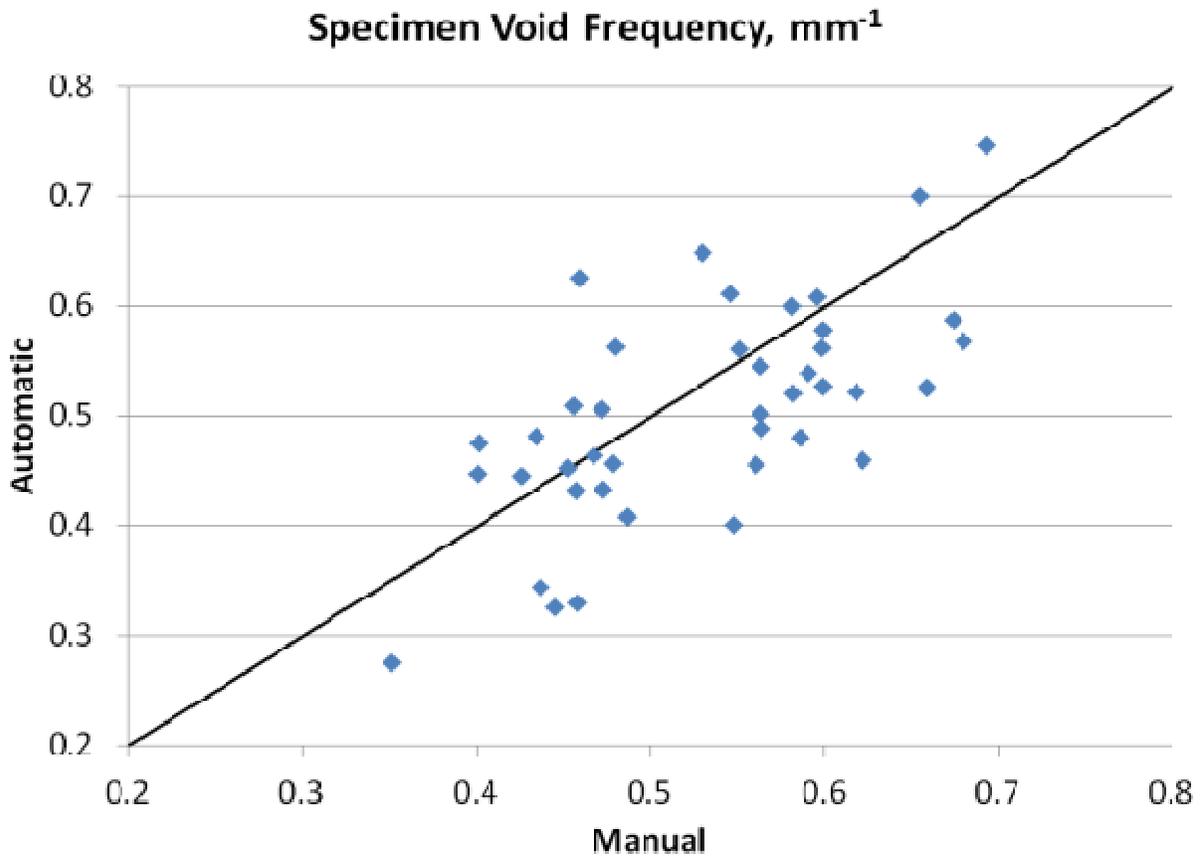
Figure 90: Comparison of void frequency determined manually and automatically for each specimen (cylinder or core).

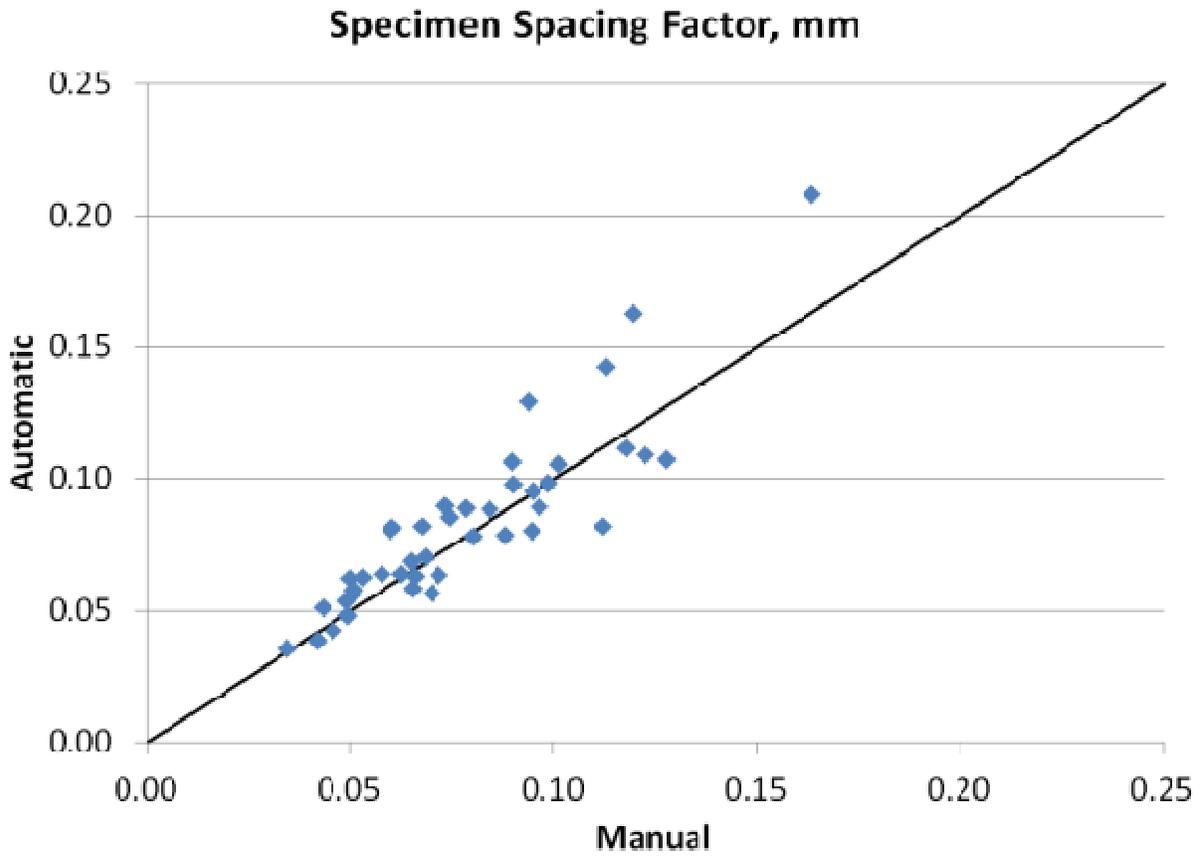
Figure 91: Comparison of spacing factor determined manually and automatically for each specimen (cylinder or core).

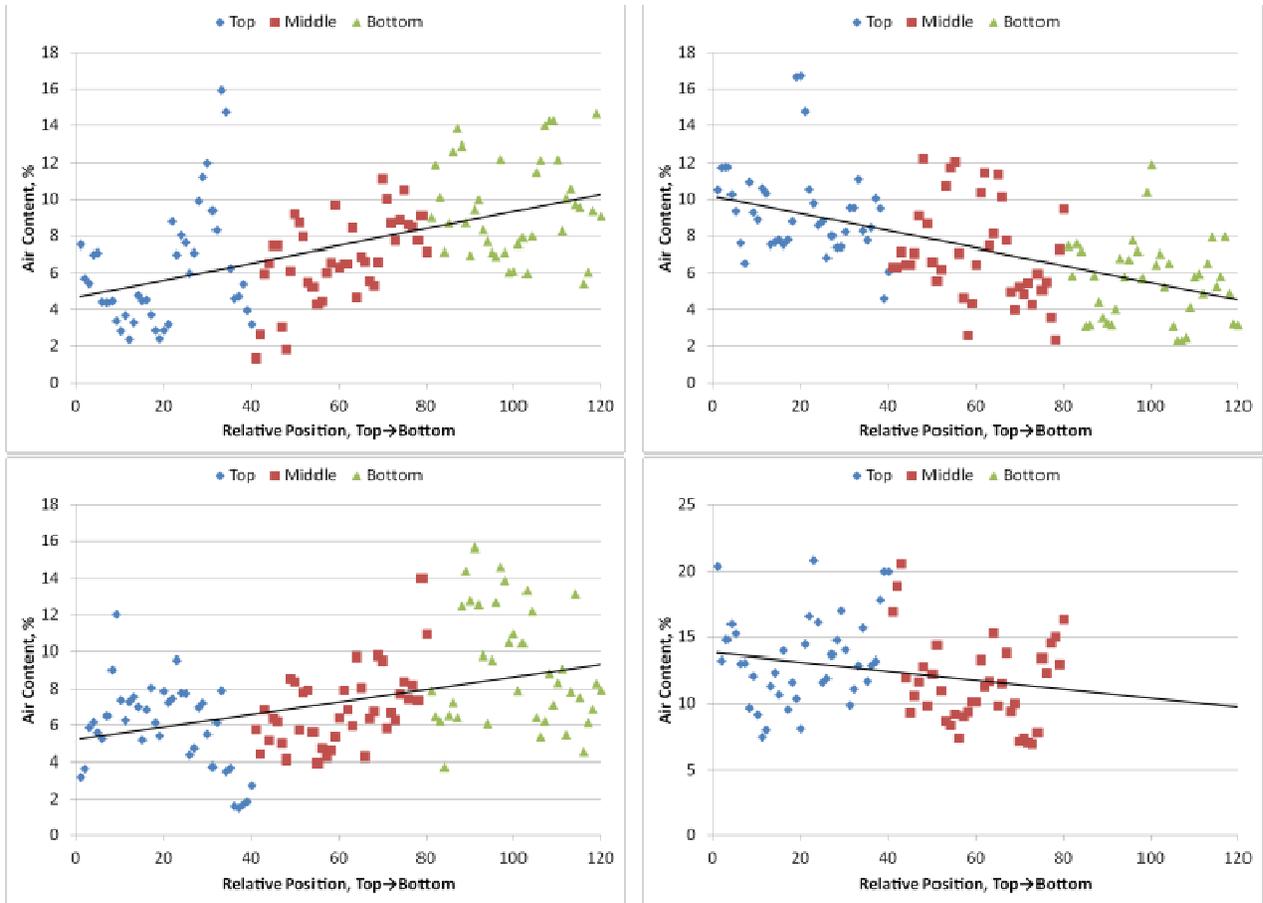
Figure 92: Plots of air content by relative depth in cores. Clockwise from top, left: SW-1C; SE-1C; SW-3C; SW-2C.

Table 6 shows the variation of the average air content in the cores by depth. Significant variations in the air content by depth were observed in some of the core samples. Some samples exhibited increasing air contents with depth, some show decreasing air contents with depth, and some show no apparent difference. These results suggest that some mixtures may have been more difficult to consolidate than others. It should be noted that the air content values by depth provide reasonable estimates that can be used for comparative purposes.
