Field Study of Air Content Stability in the Slipform Paving Process

WisDOT ID no. 0092-11-06

January 2013

Field Study of Air Content Stability in the Slipform Paving Process Final Report

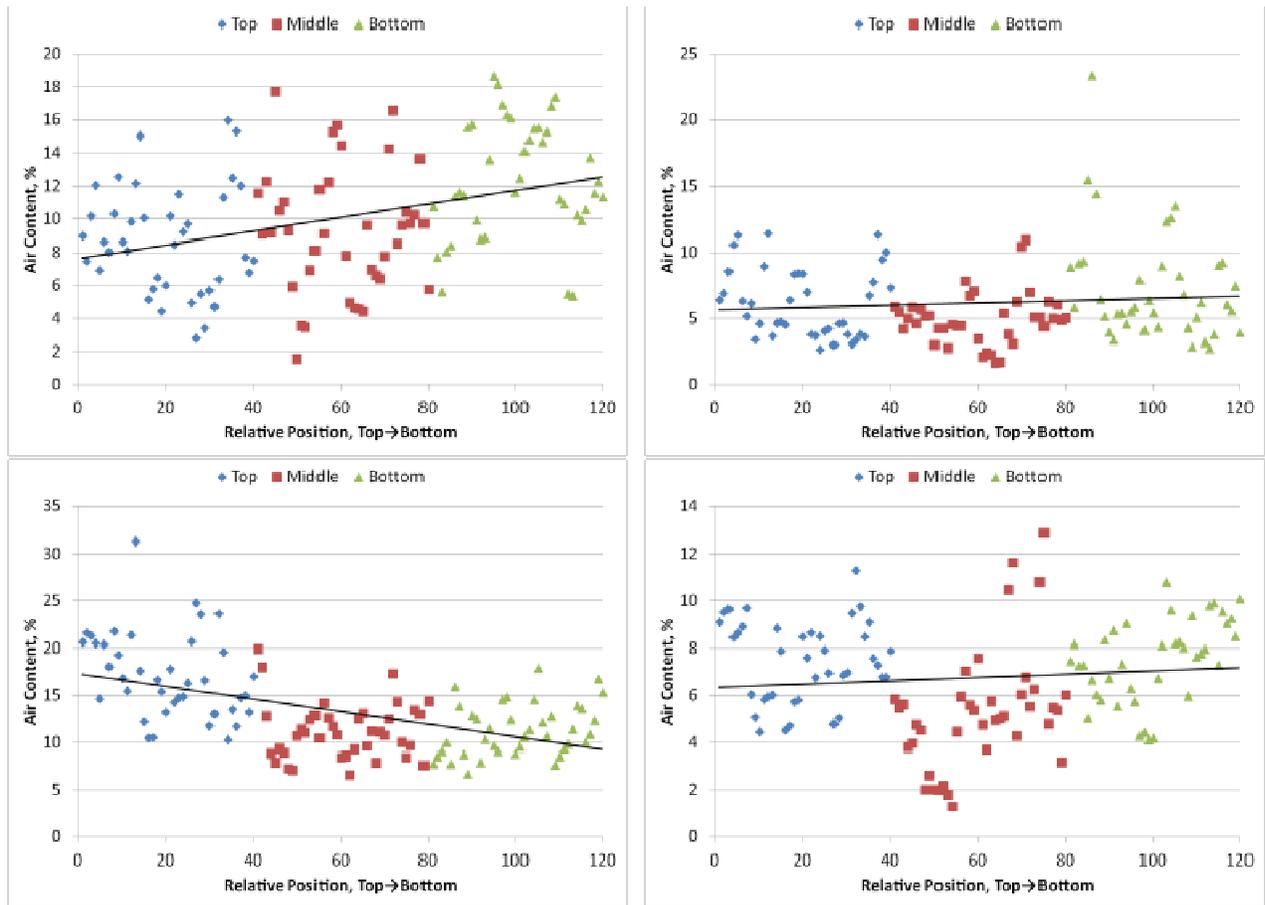
Figure 93: Plots of air content by relative depth in cores. Clockwise from top, left: NC-1C; SE-2C; NE-2C; NC-2C.

Table 6 shows the variation of the average air content in the cores by depth. Significant variations in the air content by depth were observed in some of the core samples. Some samples exhibited increasing air contents with depth, some show decreasing air contents with depth, and some show no apparent difference. These results suggest that some mixtures may have been more difficult to consolidate than others. It should be noted that the air content values by depth provide reasonable estimates that can be used for comparative purposes.

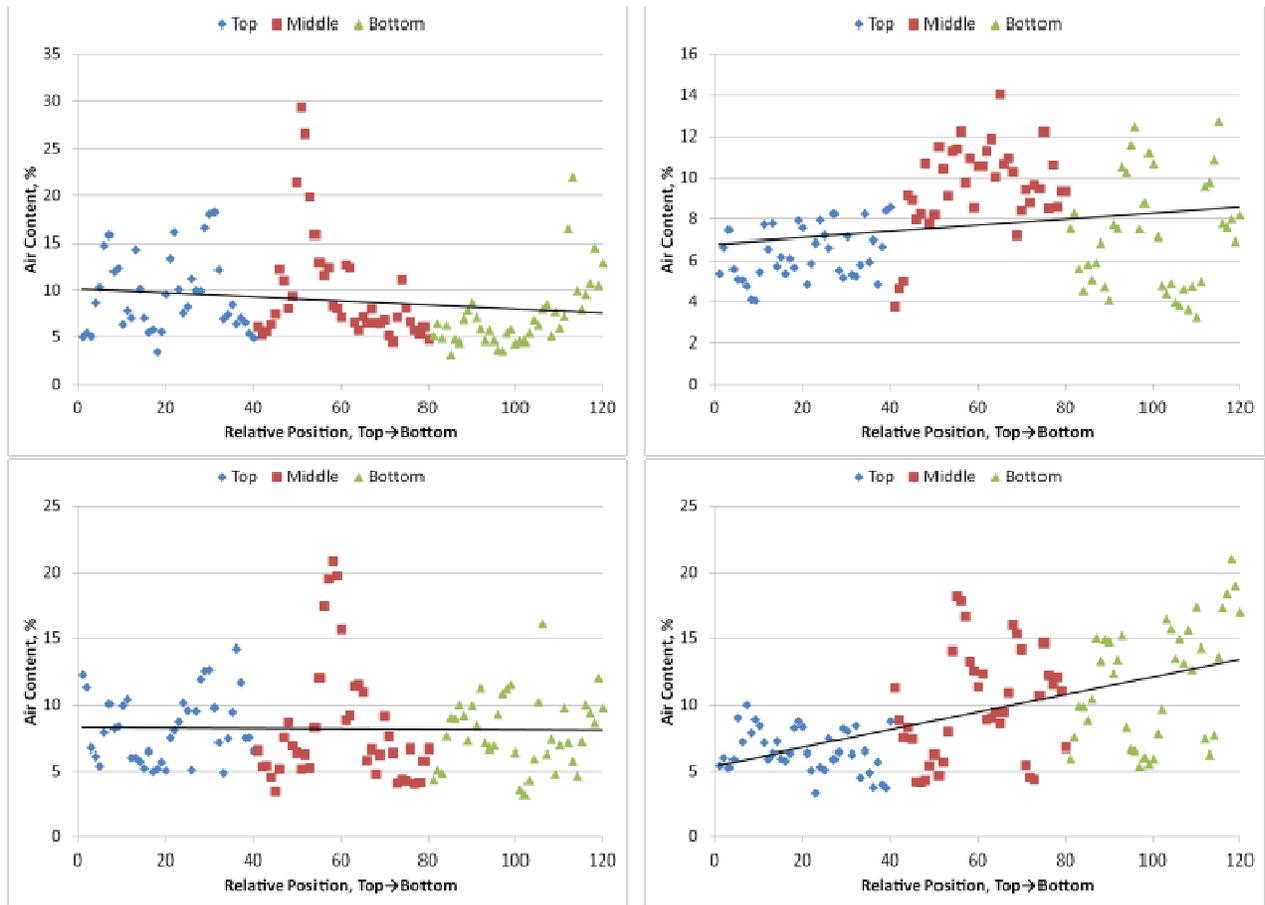
Figure 94: Plots of air content by relative depth in cores. Clockwise from top, left: NE-4C; NE-3C; NE-1C; NW-1C.

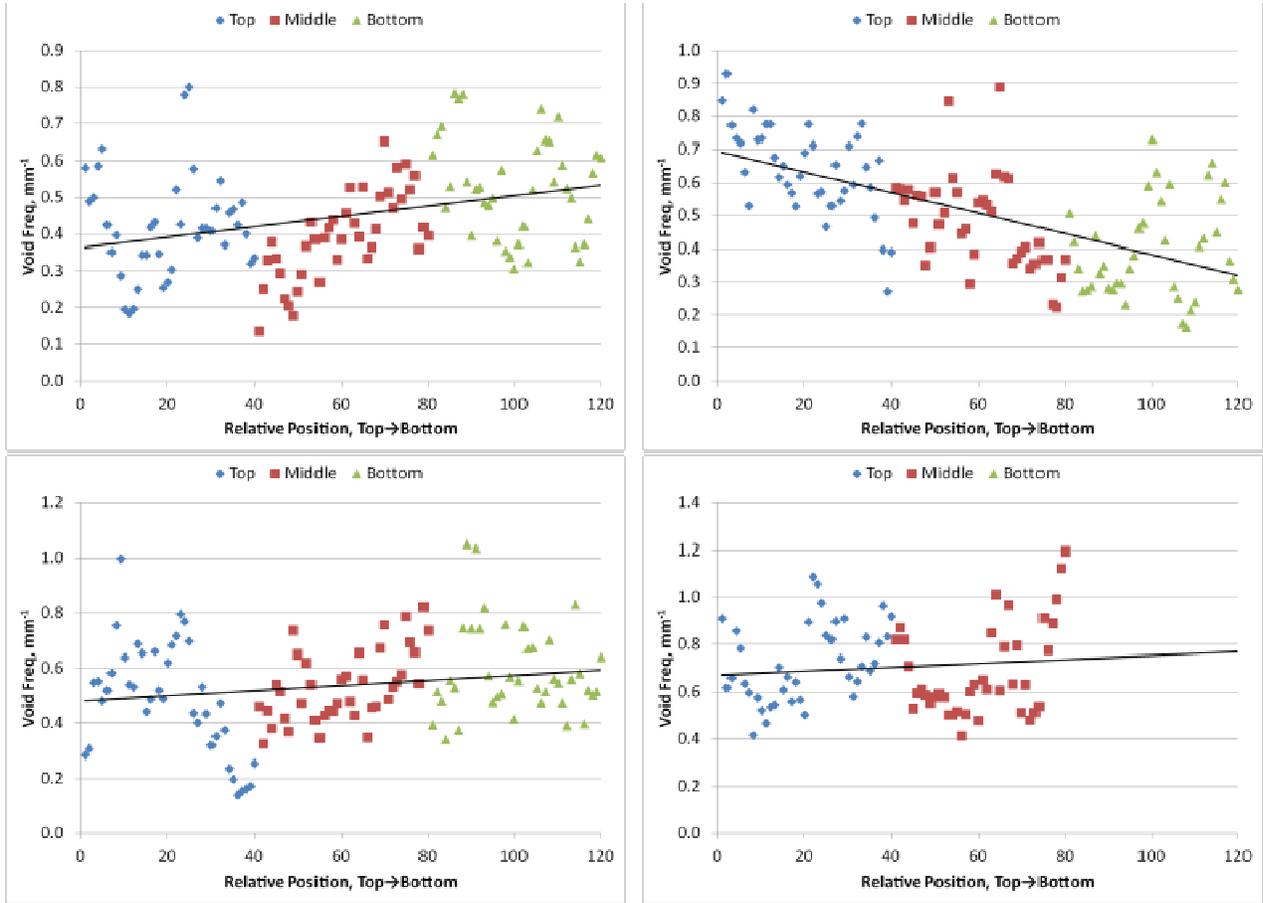
Figure 96: Plots of void frequency by relative depth in cores. Clockwise from top, left: SW-1C; SE-1C; SW-3C; SW-2C.

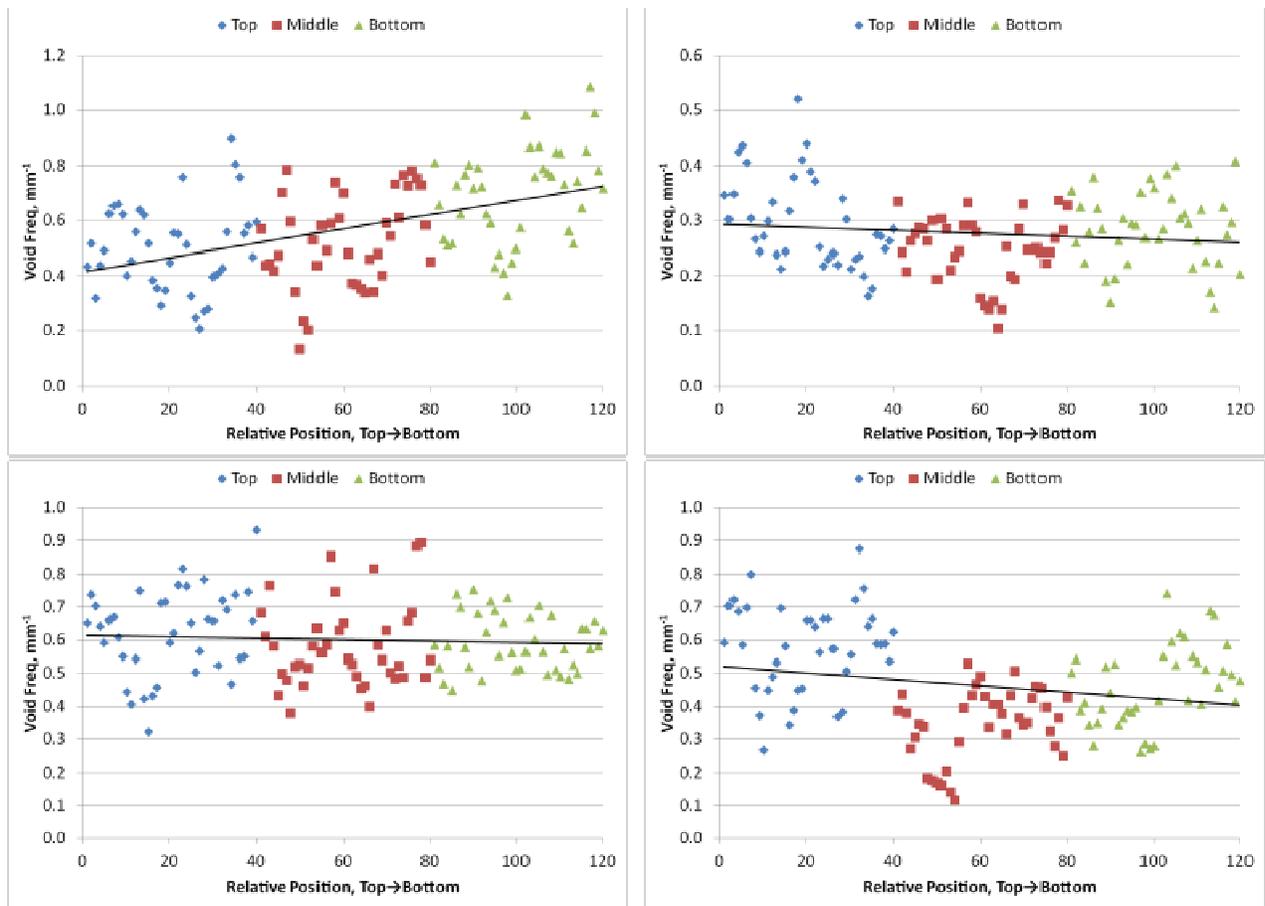
Figure 97: Plots of void frequency by relative depth in cores. Clockwise from top, left: NC-1C; SE-2C; NE-2C; NC-2C.

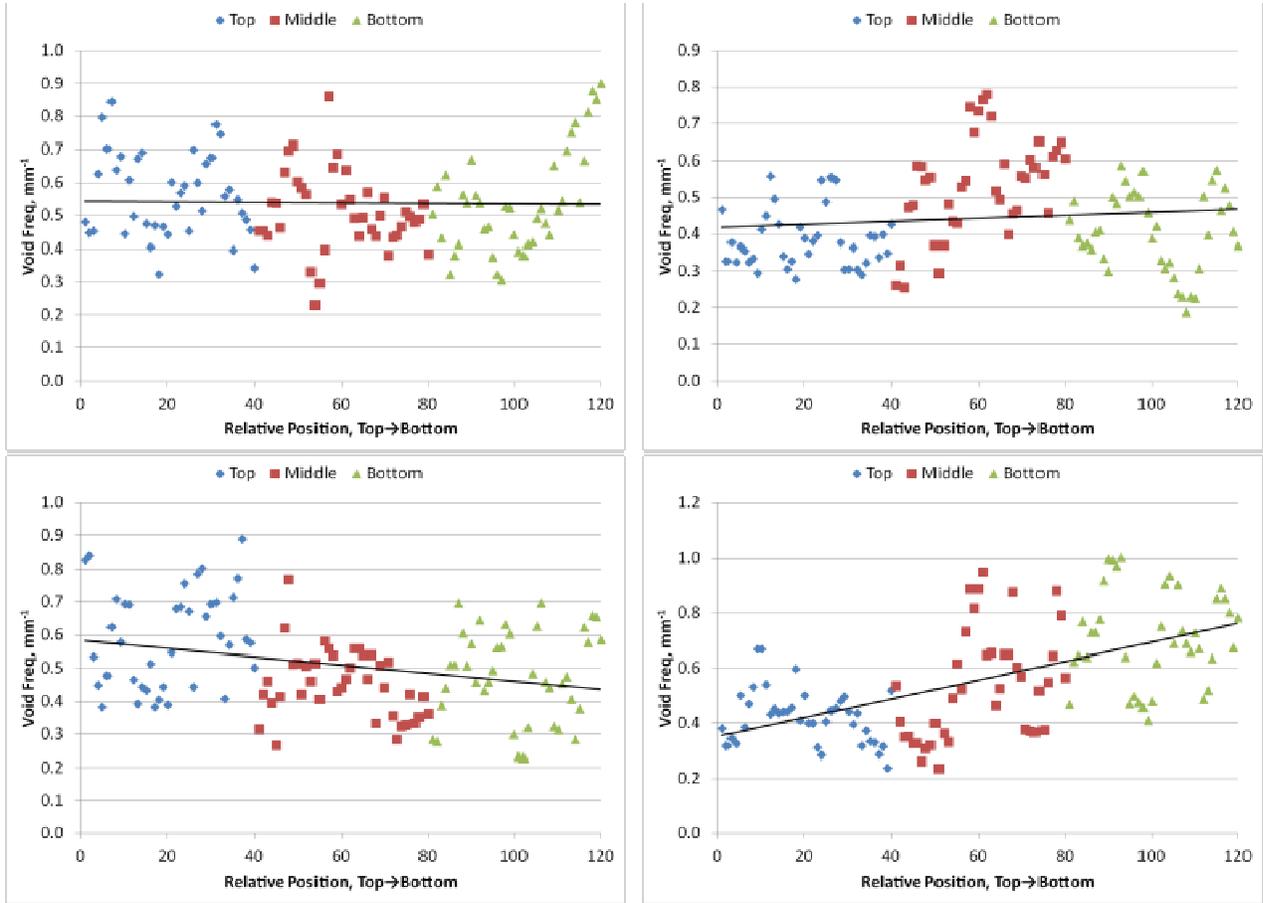
Figure 98: Plots of void frequency by relative depth in cores. Clockwise from top, left: NE-4C; NE-3C; NE-1C; NW-1C.

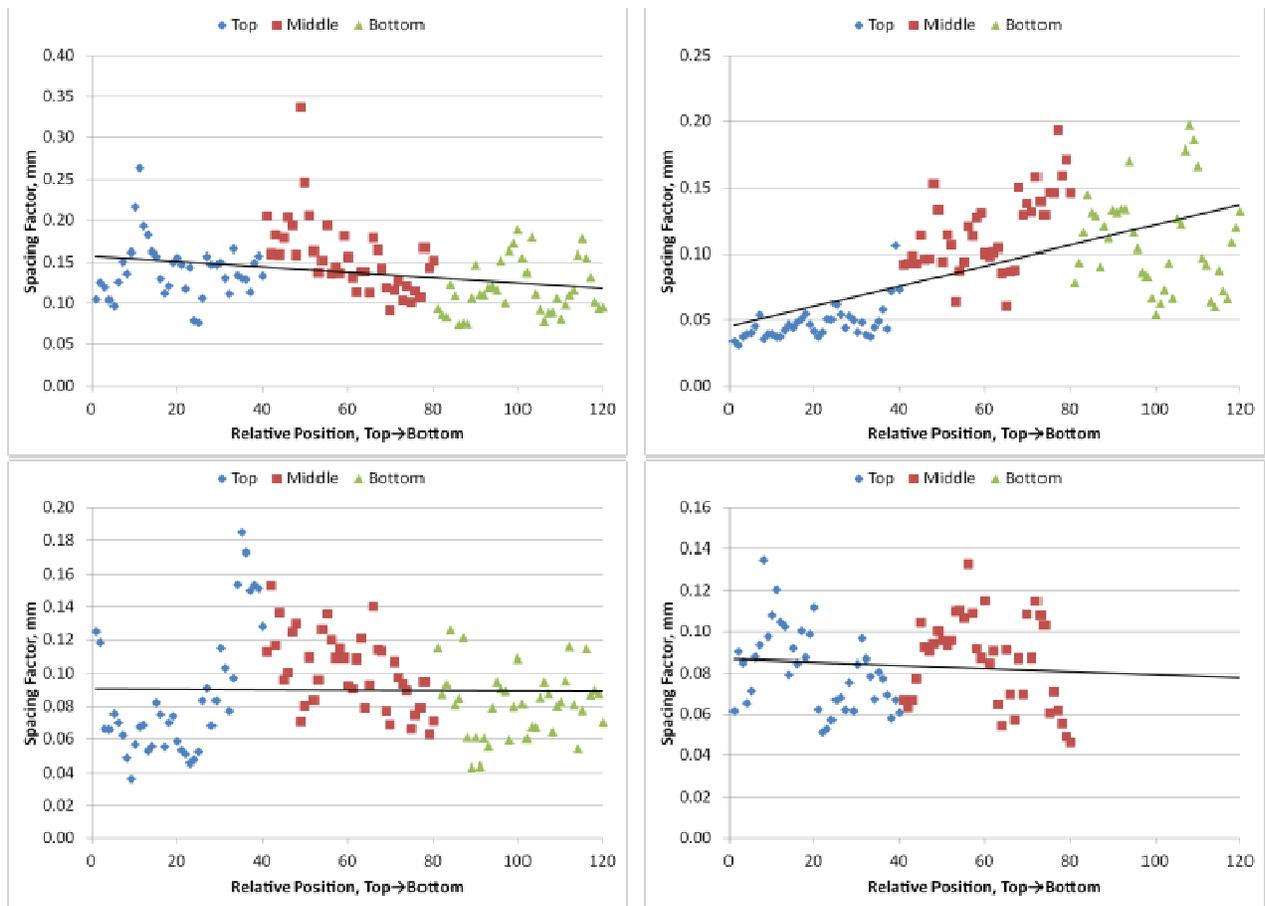
Figure 100: Plots of spacing factor by relative depth in cores. Clockwise from top, left: SW-1C; SE-1C; SW-3C; SW-2C.

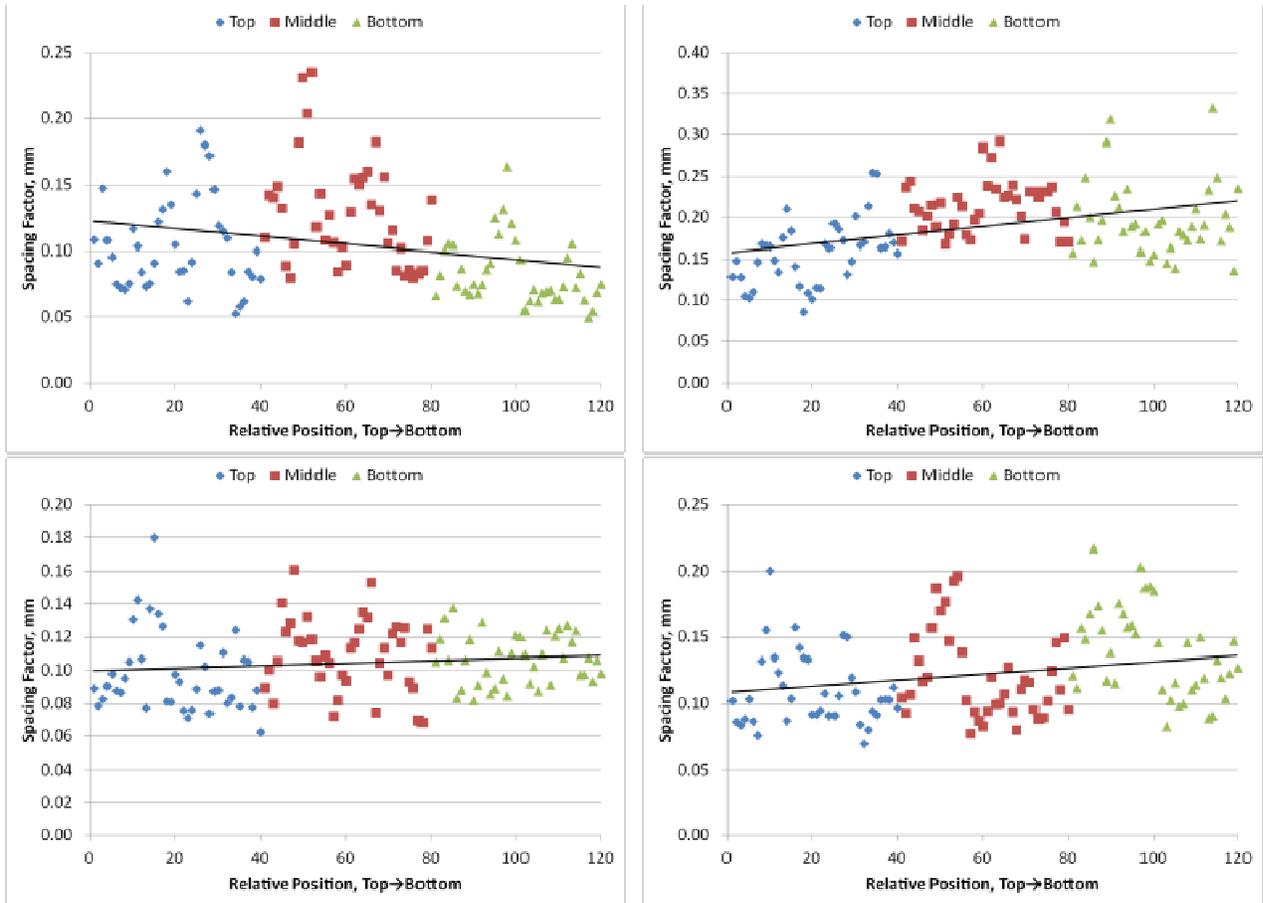
Figure 101: Plots of spacing factor by relative depth in cores. Clockwise from top, left: NC-1C; SE-2C; NE-2C; NC-2C.

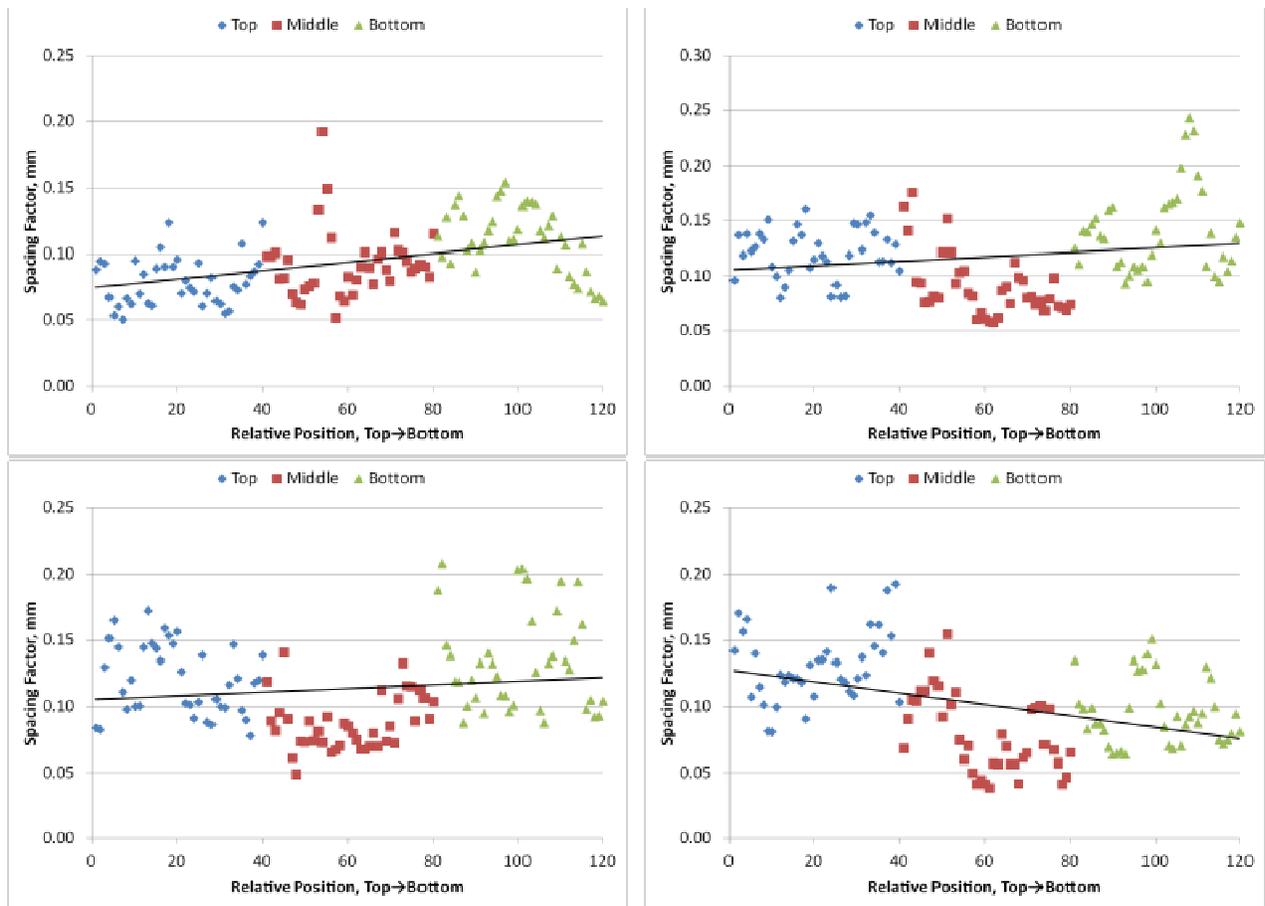
Figure 102: Plots of spacing factor by relative depth in cores. Clockwise from top, left: NE-4C; NE-3C; NE-1C; NW-1C.
