Report Number: WI-03-08

EVALUATION OF MMFX 2 STEEL  
CORROSION-RESISTANT DOWEL BARS  
IN JOINTED PLAIN CONCRETE PAVEMENT

FINAL REPORT

August 2008

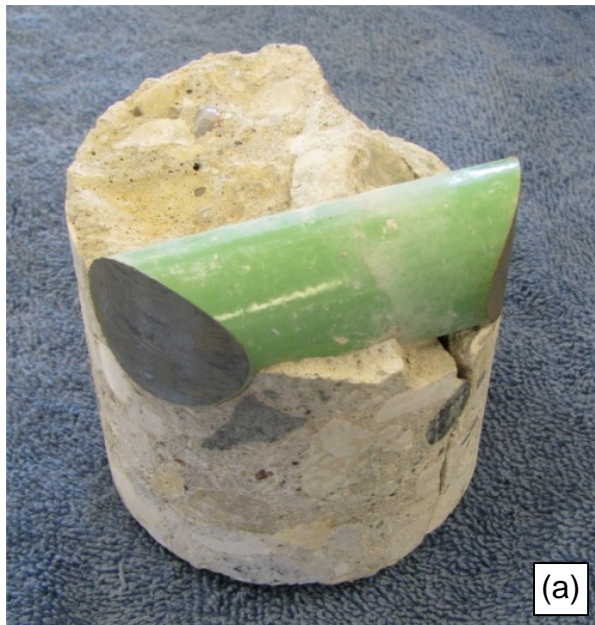
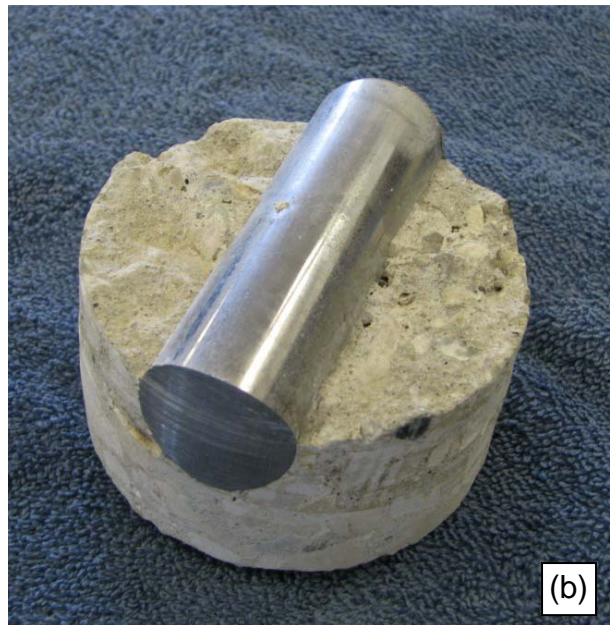
**Figure 5.** Epoxy-coated steel (a) and MMFX 2 steel (b) dowel bar cores removed after five years in service.

Cores were immediately inspected for signs of corrosion. None of the six cores taken exhibited any corrosion on the dowel bar. Two of the cored dowel bars are shown in Figure 5. For the two cores

removed from the control section, the epoxy coating remained intact and did not exhibit any signs of blistering or other defects on the surface that would indicate corrosion was taking place in the steel. The four MMFX 2 steel dowel bars were also corrosion-free.

The absence of corrosion on all cored dowel bars indicates that epoxy-coated steel and MMFX 2 steel both resisted corrosion for the five-year period of this study. However, the duration of the test period was not long enough to draw a conclusion on which material exhibits greater in-service corrosion resistance for the life of a concrete pavement.

An additional observation is worth noting. Cores were stored indoors under ambient conditions after removal from the pavement. During the first six months after removal, the exposed steel surfaces of the epoxy-coated dowels began to corrode, while the exposed MMFX 2 steel remained free of corrosion. While in-service conclusions cannot be drawn from this observation, the MMFX 2 steel provided protection against corrosion when exposed to ambient conditions, while the carbon steel corroded when its protective epoxy coating was disrupted.

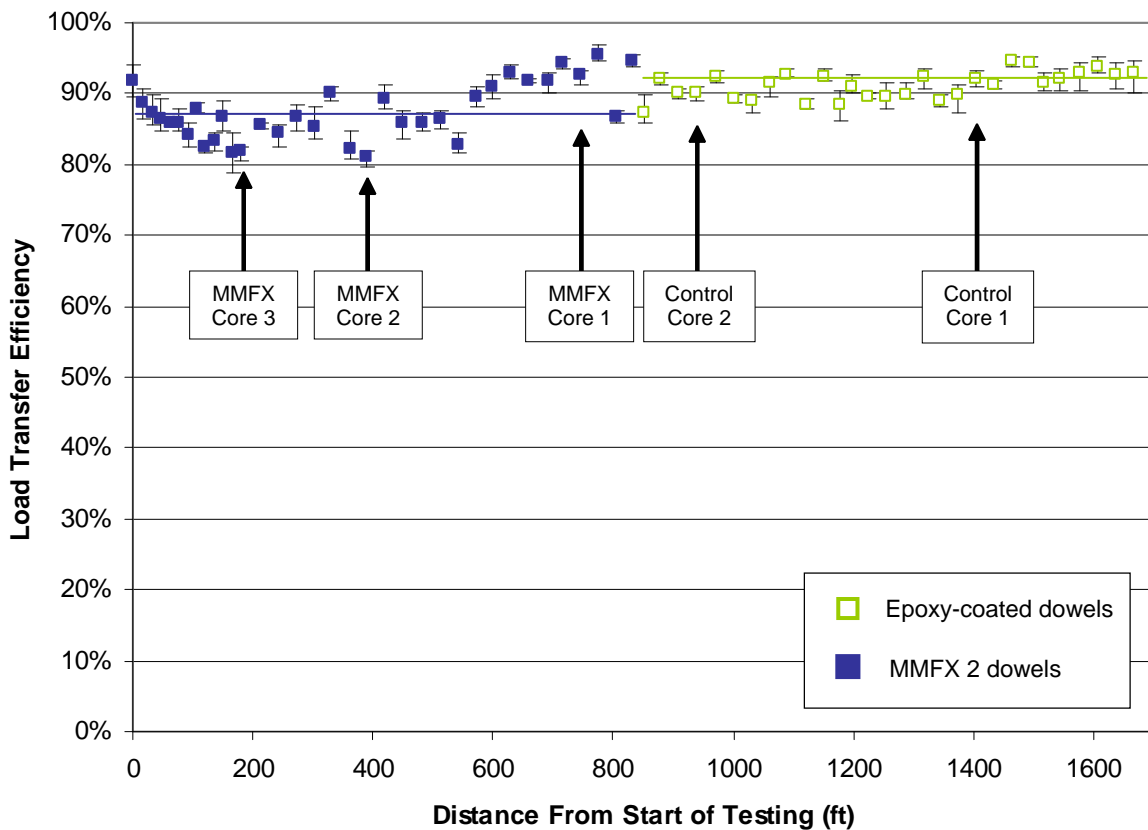
**Figure 7.** Load transfer efficiency data for epoxy-coated and MMFX 2 steel dowel bars.

The median LTE values were 92 percent and 87 percent for joints constructed with epoxy-coated and MMFX 2 steel dowel bars, respectively. Both values are well over the 70 percent LTE level that is recommended for effective load transfer in doweled JPCP. [6] LTE values measured in the MMFX 2 steel test section were slightly more variable than those in the epoxy-coated steel section; the coefficients of variation for MMFX 2 and epoxy-coated steel dowel bars were 4.6 and 2.1 percent, respectively. Overall, both dowel bar types provided adequate load transfer, and the relatively small variations in LTE might be related to construction issues rather than material differences.
