WIS 35 CORRIDOR STUDY

WISDOT ID: 5221-09-00

PURPOSE & NEED

Multimodal

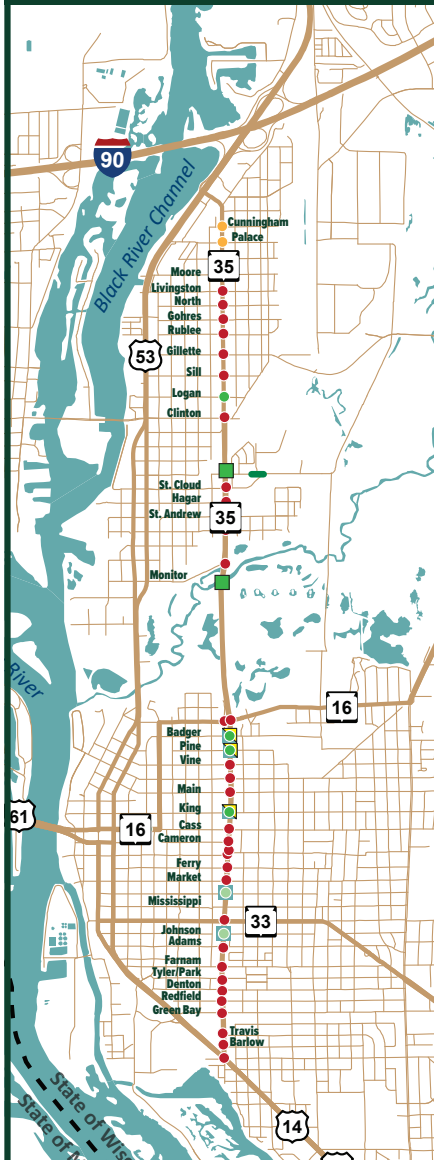
Pedestrian Crossing Level of Traffic Stress

- Ped. Crossing LTS***
- Very Low Stress
 - Low Stress
 - Moderate Stress
 - High Stress
- Enhanced Ped. Crossing**
- Grade Separated
 - Median Refuge
 - RRFB
 - RRFB & Median Refuge
- *LTS (Level of Traffic Stress) is a quantitative method for evaluating bicycle and pedestrian facilities.
