Study Needs: Roadway Geometrics

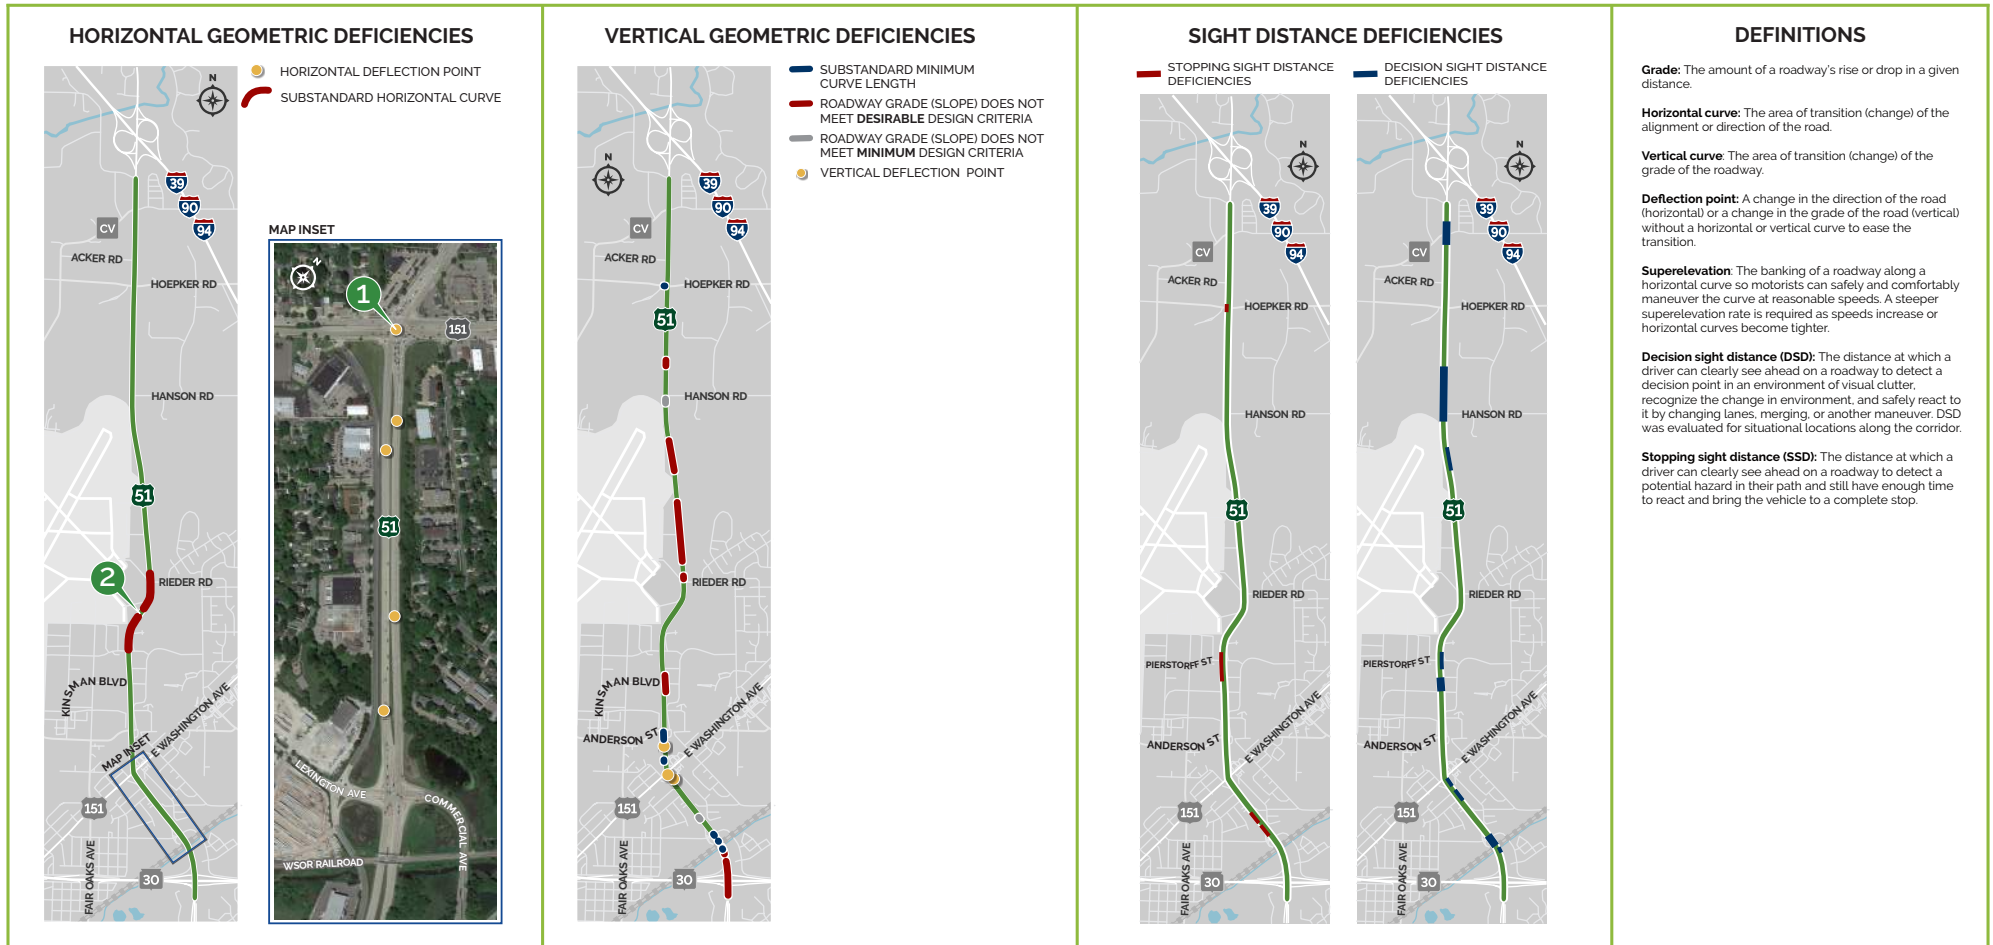
Roadway and geometric deficiencies can lead to safety and operational concerns. Two locations on the US 51 corridor with recorded crashes that appear to be associated with roadway geometrics are ① the intersection skew of the north leg of the intersection at US 51 and US 151/East Washington Avenue and ② the two horizontal curves north of Pierstorff Street.
