Implementation and Field Evaluation of Pretensioned Concrete Girder End Crack Control

Michael Oliva
Emre Kizilarslan
University of Wisconsin - Madison

WisDOT ID no. 0092-15-01

May 2016

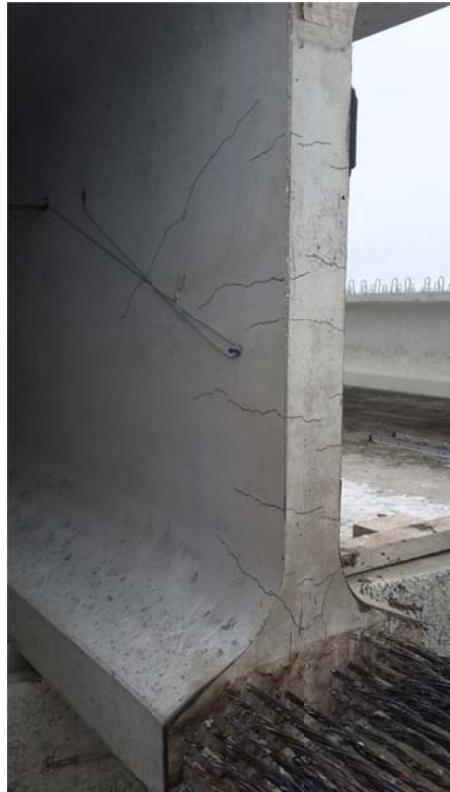
Figure 1-1. Cracks at the end of a Wisconsin 72W girder.

pretensioned girders in the end zones. As girders are built deeper with more prestress force, the cracks tend to be larger (2) as in Figure 1-1.

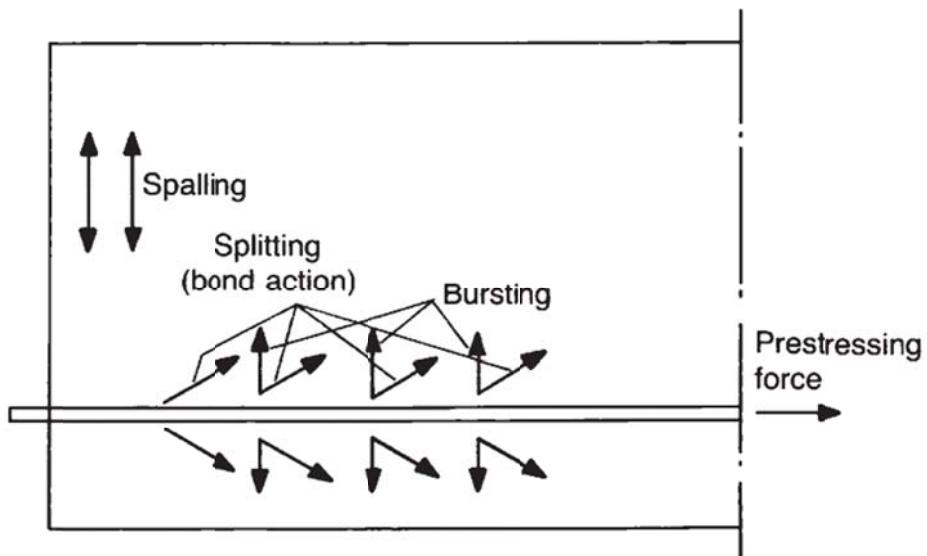
- Bursting is estimated to occur due to spreading forces over the cross-section,
- Spalling is identified to ensue in the case of thin webs.
- Splitting takes place along the transmission length as a result of the effect of internal pressure exerted by the prestressing steel during shortening (wedging effect).

Figure 2-1. Three mechanism in FIB 2010 model code in anchorage zone (4).

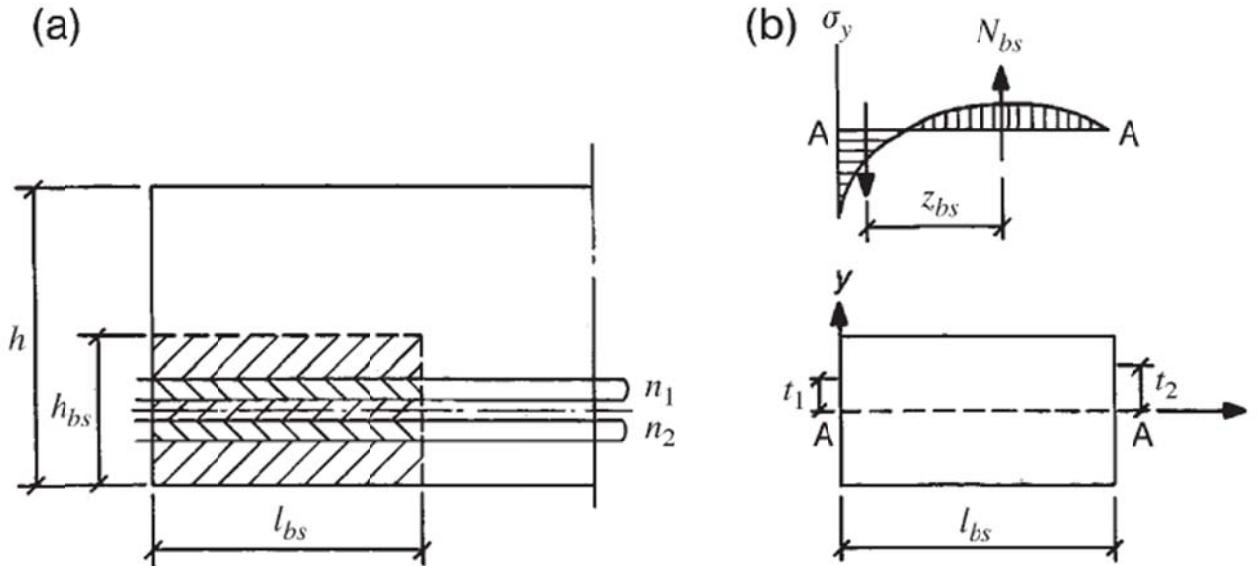
To calculate the bursting force, the FIB code uses the symmetric prism analogy in Figure 2-2. The calculation is based on a virtual prismatic element, defined in order to describe the bursting forces. The prism is shown in Figure 2-2(a) (shaded area). The calculation of length of the prism (l_{bs}), the internal lever arm for the bursting force (z_{bs}), the bursting force (N_{bs}), and the maximum bursting stress (σ_{bs}) can be found in the code.

Figure 2-2. The prism analogy for calculation of the bursting force (4).

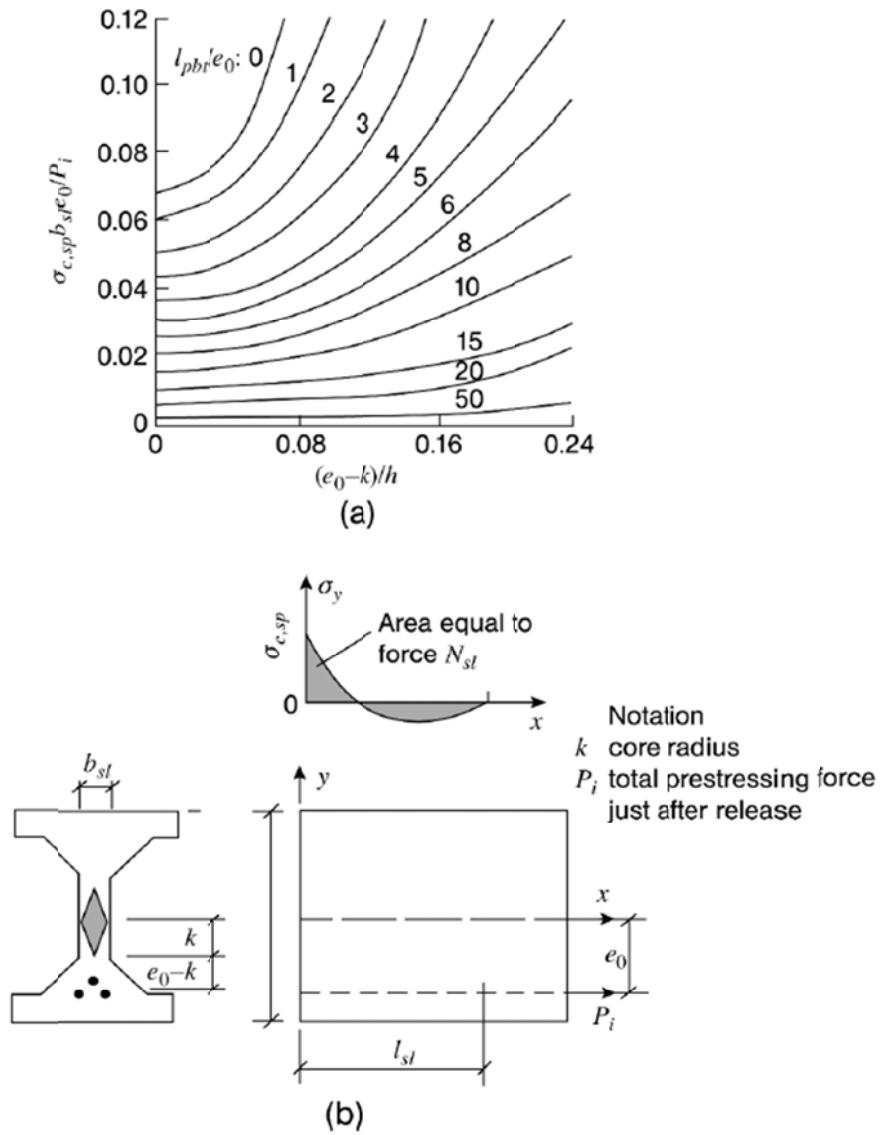
The FIB code gives a chart shown in Figure 2-3 (a) for the calculation of the spalling stress as a function of eccentricity and transmission length. This is based on linear elastic analysis for members with h smaller than 400mm (15.7 in.). If maximum bursting stress (σ_{spl}) is smaller than the design axial strength of concrete (f_{ctd}), no spalling reinforcement is necessary.

Figure 2-3. Maximum spalling stresses (4).

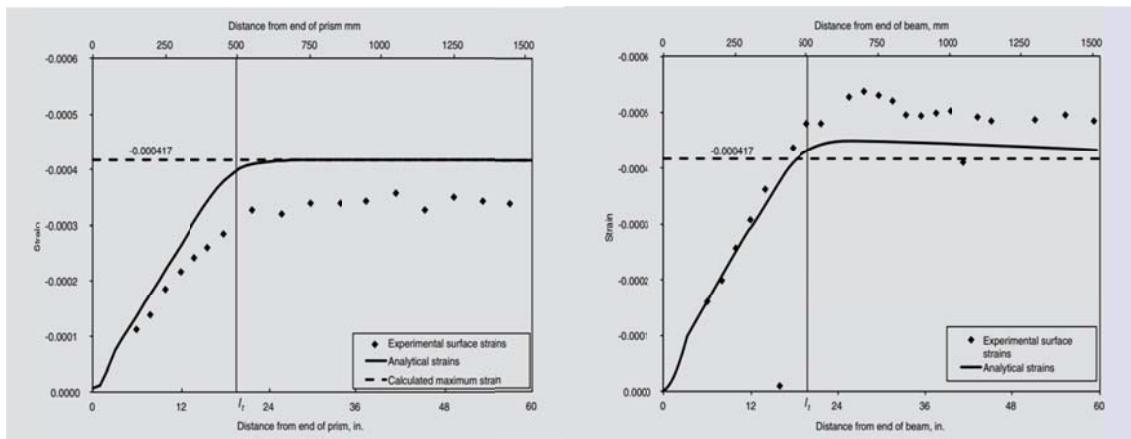
Figure 2-8 shows the comparison of experimental concrete surface strains and analytical concrete strains for one prism and one typical T beam model. The maximum errors are 20% for prisms and approximately 40% for T beams. Even though the comparison has errors, the authors used linear elastic behavior without justification. They also made a conclusion that the comparisons confirm the practicality and accuracy of the models. The T beams are heavily pre-stressed and show some cracks around strands, so the results of beams having only 3 strands cannot be modelled with linear elastic material property and might not represent the case with larger amount of strands in deep girders.

Figure 2-8. Comparison of experimental concrete surface strains and analytical concrete strains for a prism (left) and a typical T beam model (right) (7).

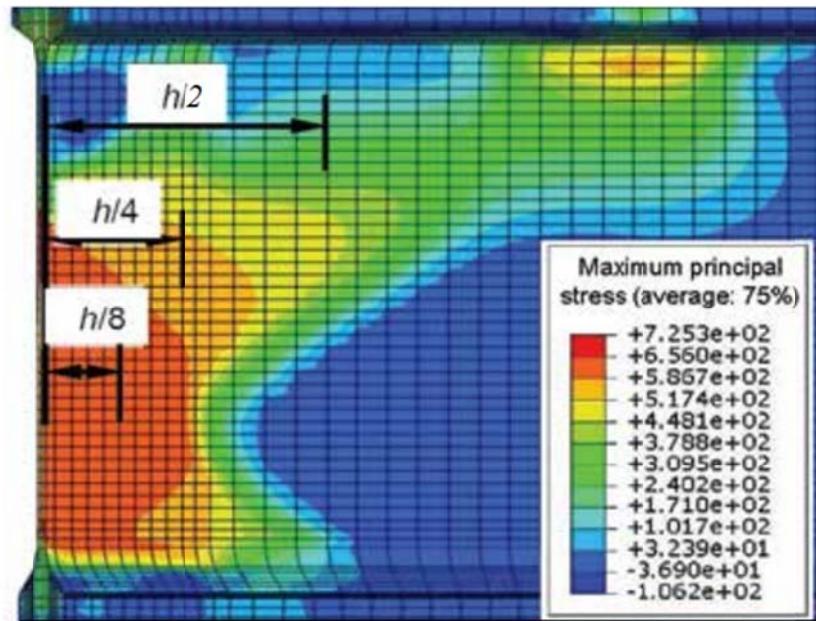
From the finite element analysis results with all girders, the authors observed that the stress distribution showed that the requirement of distributing the end zone reinforcement within a distance equal to $h/4$ from the girder end was needed, as noted in the AASHTO Specifications. However, the stress distribution shows that a relatively high stress concentration extends beyond $h/4$ to about $h/2$ (Figure 2-11), where no end zone reinforcement is needed according to the AASHTO LRFD specifications recommendation. They suggested the findings of Tuan et al. (12) that put 50% of the end zone reinforcement within $h/8$ and the remainder of the end zone reinforcement between $h/8$ and $h/2$ from the end. Also, the finite element analysis predicted the correct location of highest tensile stress, which was observed at the web and bottom flange interface but at a lower height than that suggested by the Gergely-Sozen (10) procedure.

Figure 2-11. Principal stress distribution in concrete along anchorage zone (9).

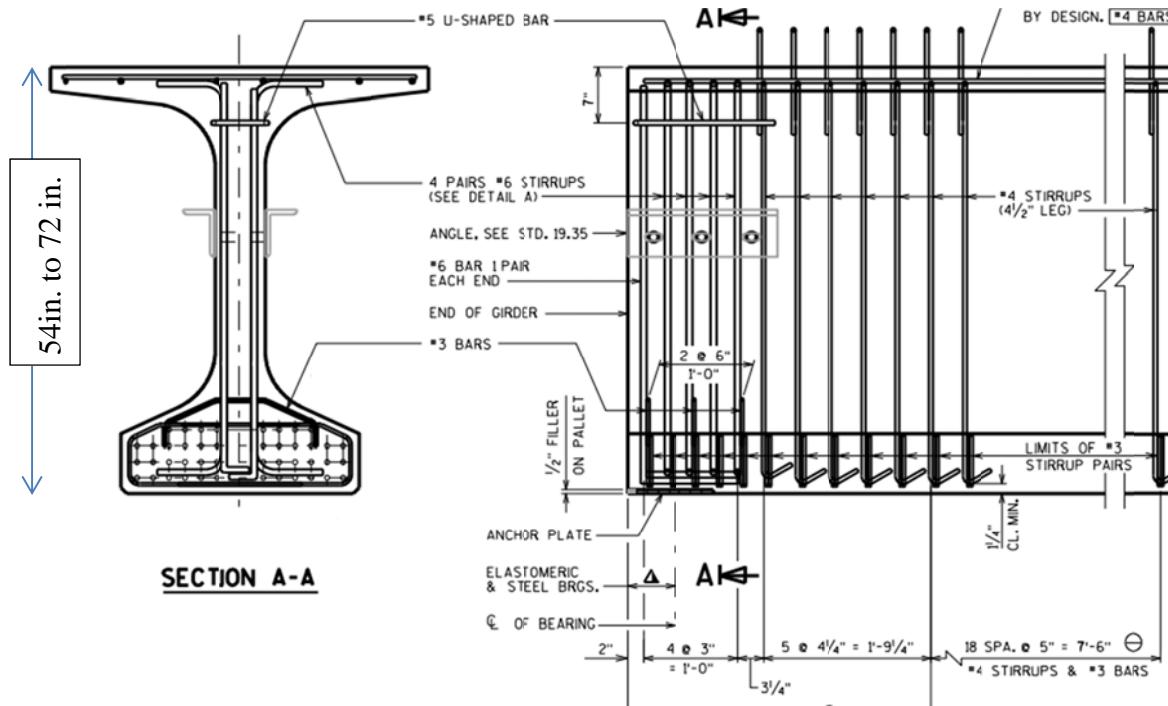
These girders also have the same general pattern for end zone reinforcement as in Figure 3-2, though in different quantities, since the top and bottom flange dimensions are the same. The only change in different girders is the length of web steel reinforcing bar. They are adjusted to fit in depths of girders. Additionally, there are five #4 U reinforcing bars along the web going 7ft inside of the 82W girder only. All mild reinforcement bars are ASTM A706, Grade 60 steel. The strands are 0.6in in diameter, and have 270 ksi ultimate strength with low relaxation. All bridge girder strands are uncoated, per American Association of State Transportation and Highway Official (AASHTO) requirements (3), and particularly subject to corrosion and deterioration if exposed to corrosive conditions by concrete cracks. The girders also have bottom steel stirrups that are epoxy coated to control corrosion. All other details are provided in the Standard Details of the WisDOT Bridge Manual (14). However, these details can be changed according to each project's needs.

Figure 3-2. The end details of girders.

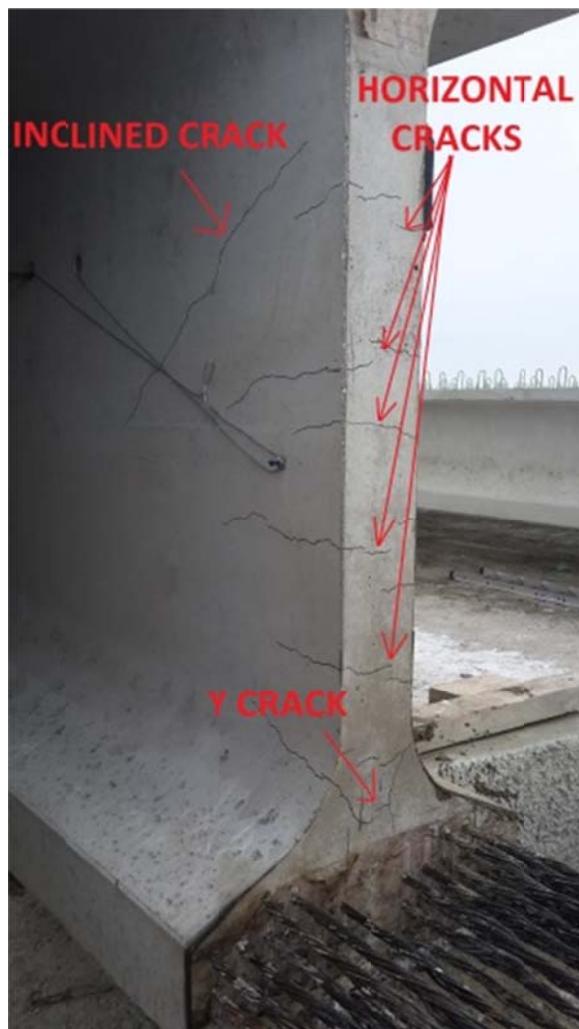
According to their directions and locations; the girder cracks of concern in this study can be categorized in three groups: inclined cracks, horizontal web cracks, and Y-cracks (1) (Figure 3-3).

Figure 3-3. Inclined, Horizontal Web, and Y cracks shown on 72W girder.

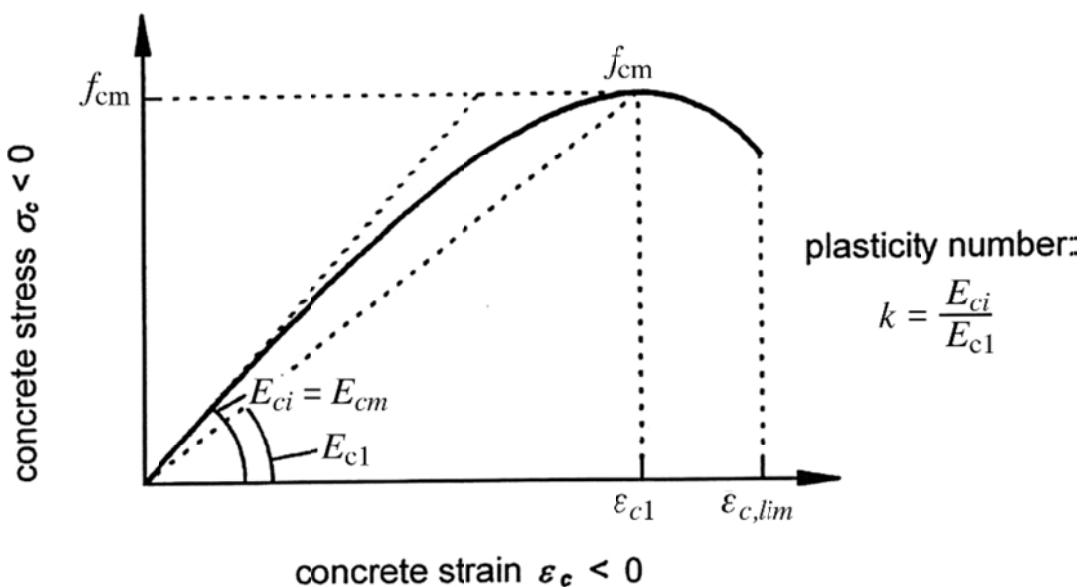
In the end, the compressive behavior is as shown in Figure 4-2:

Figure 4-2. The graph of plastic constitutive behavior of concrete in compression.

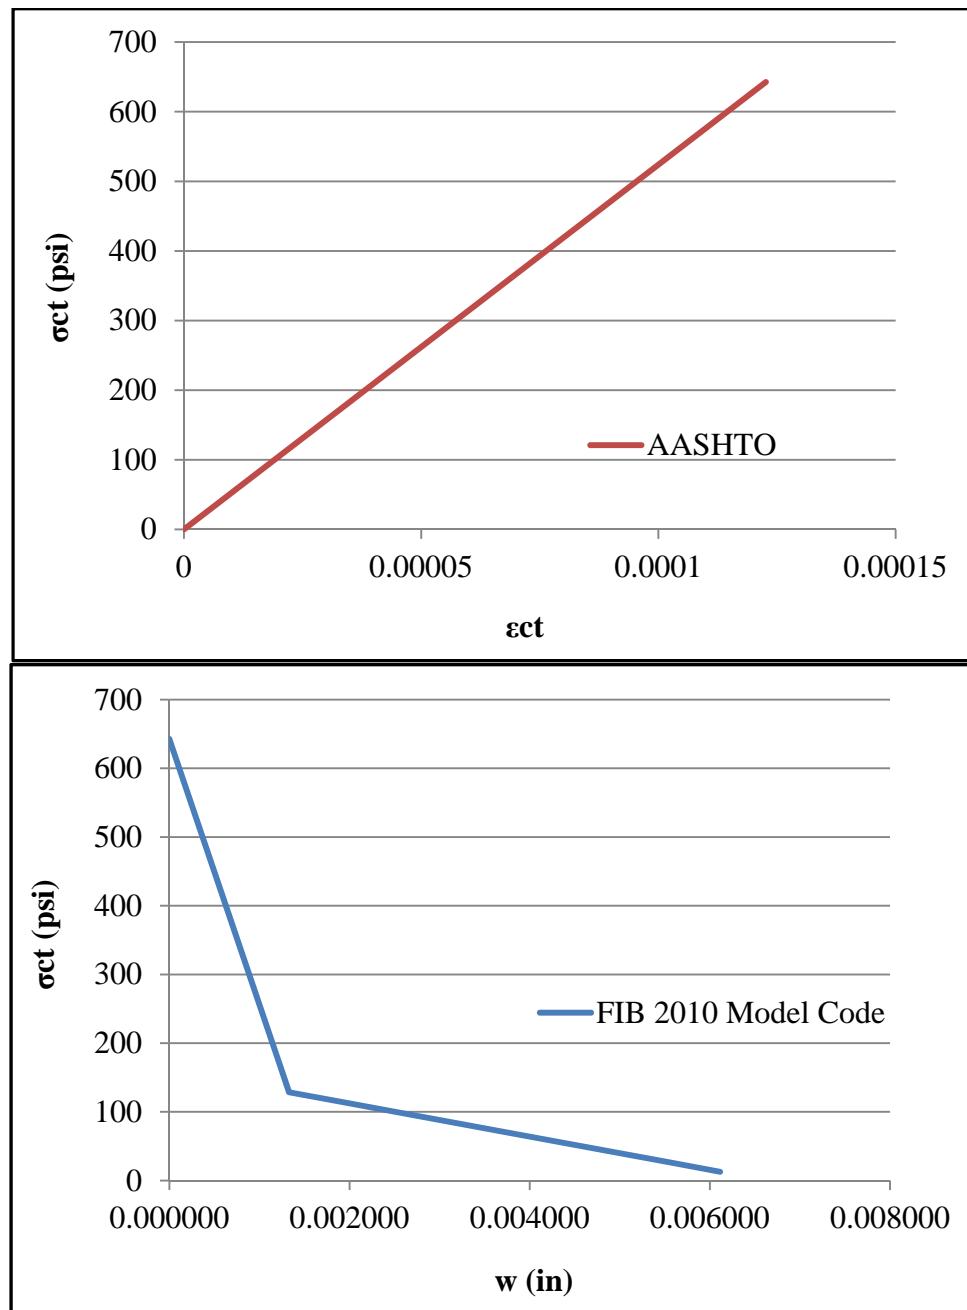
Figure 4-5 shows the graphs of pre-cracking and post-cracking concrete behaviors of the 72W girder having an initial 7800psi compressive strength at de-tensioning. Please refer to the Appendix to see the details of the calculation.

Figure 4-5. Tension Model Used in Abaqus: top = before cracking, bottom = post cracking.
(initial behavior depends on strain, ϵ ; post cracking depends on crack width, w)

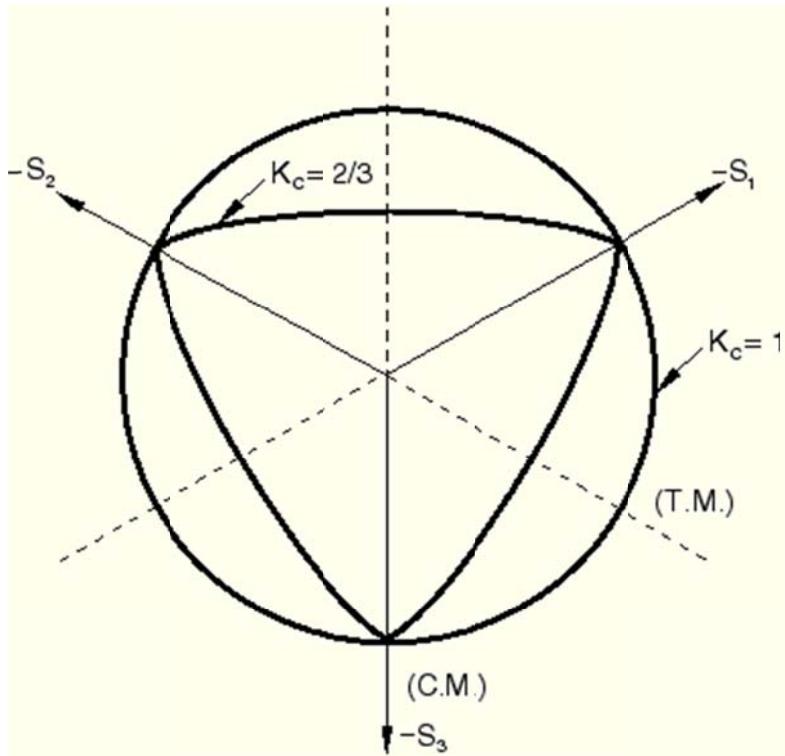
K is the ratio of the second stress invariant on the tensile meridian to that on the compression meridian. It should be in between 0.5 and 1.0, and a default value was used, which is 2/3 (Figure 4-6) (14).

Figure 4-6. Yield surface in the deviatoric plane corresponding to different values of K

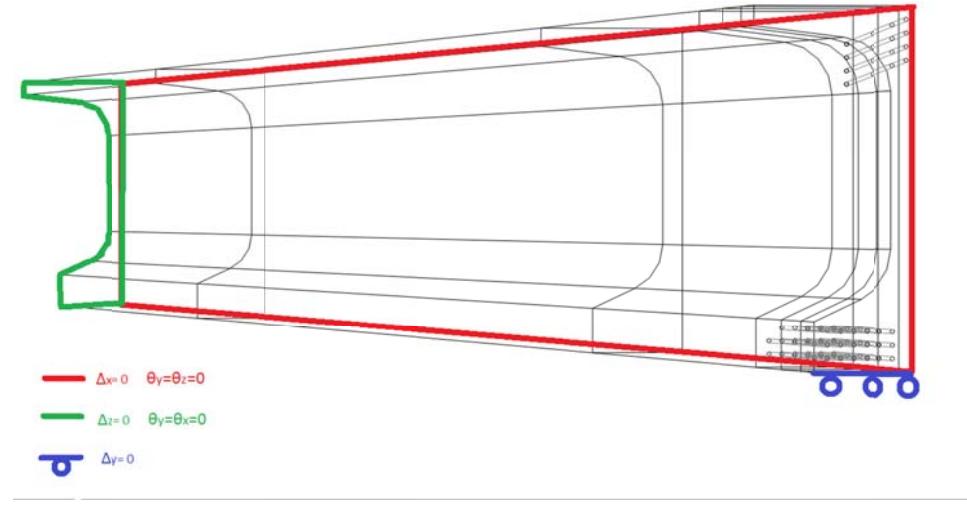
direction to zero, which should be the case because the three dimensional concrete elements do not have rotational degree of freedoms.

Figure 4-7. Boundary Conditions of models, mid-span section is at left, end at right.

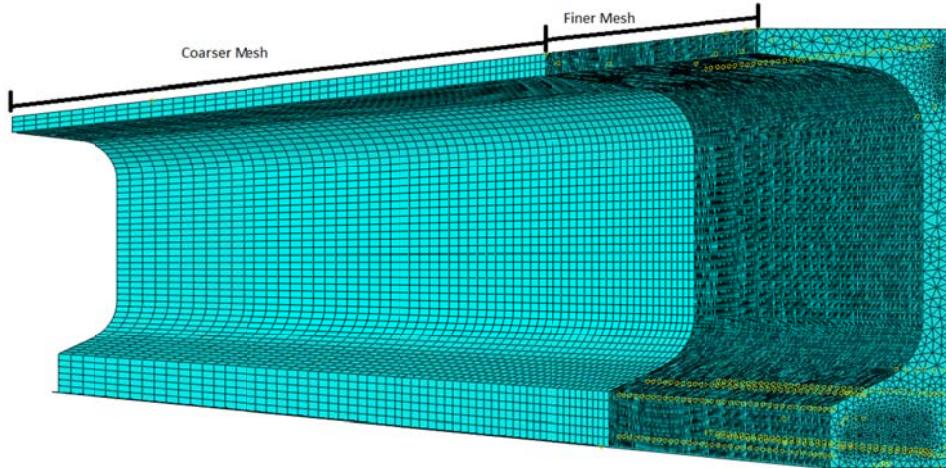
Using nonlinear material properties considerably increases the computational time. Even though a finer mesh will give more accurate results, it is not reasonable due to the large time requirements associated with computation. Therefore, a finer mesh was utilized only for the area of interest, i.e. the nonlinear girder end zone, in order to get reasonable results. However, in the linear zone the element sizes were gradually increased up to mid-span as visible in Figure 4-13.

Figure 4-13. Mesh example of 54W girder.

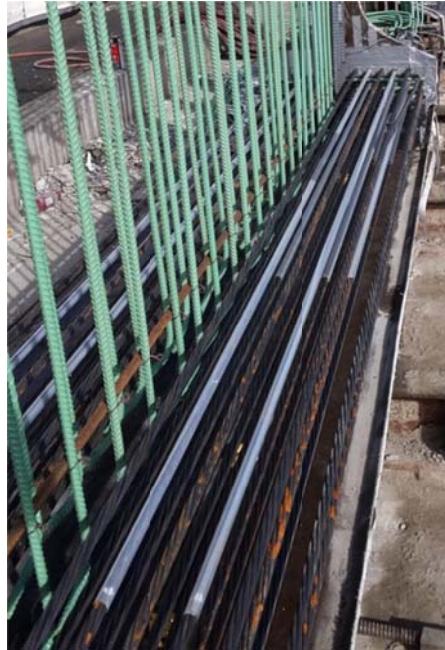
Figure 5-5. Plastic shield around strand for de-bonding.

The debonding is achieved by just placing plastic sheathing around strands as in Figure 5-5. Even though this type of debonding is assumed to debond the strand from the concrete, there may be some transfer due friction but it is small compared to the force transferred by bonding, therefore, this was ignored.

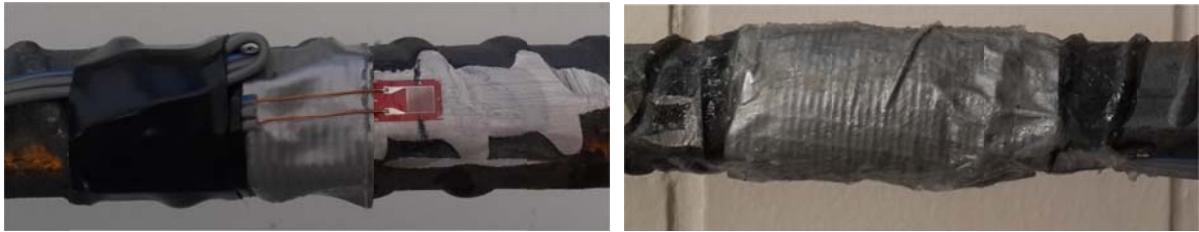
Figure 5-7. Strain Gauge on re-bar (left), and after water-proof (right).

damage during casting, moisture proof and cushioning protection was applied around them (Figure 5-7).

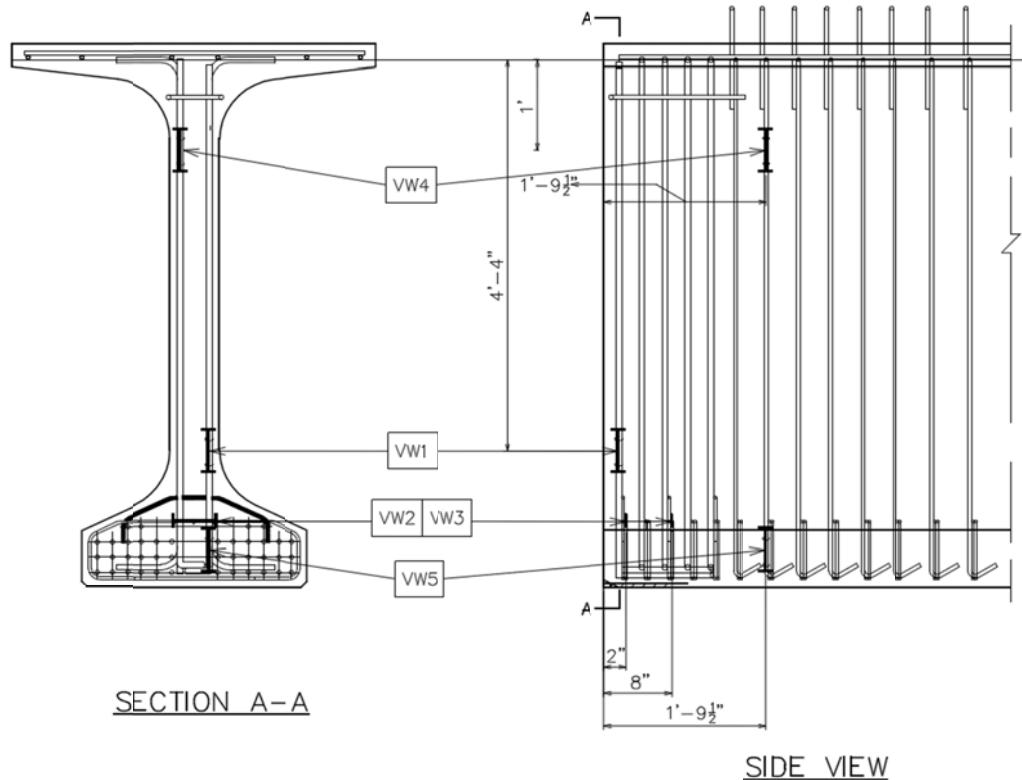
The other gauge type used was 2" and 6" length Geokon Model 4202 vibrating wire gauges (27). These type of gauges were placed across the expected location of cracks (from analyses) so that strains in concrete during cracking could be observed. Locations and orientation can be seen in Figure 5-10.

Figure 5-10. Vibrating Wire Gauge Locations.

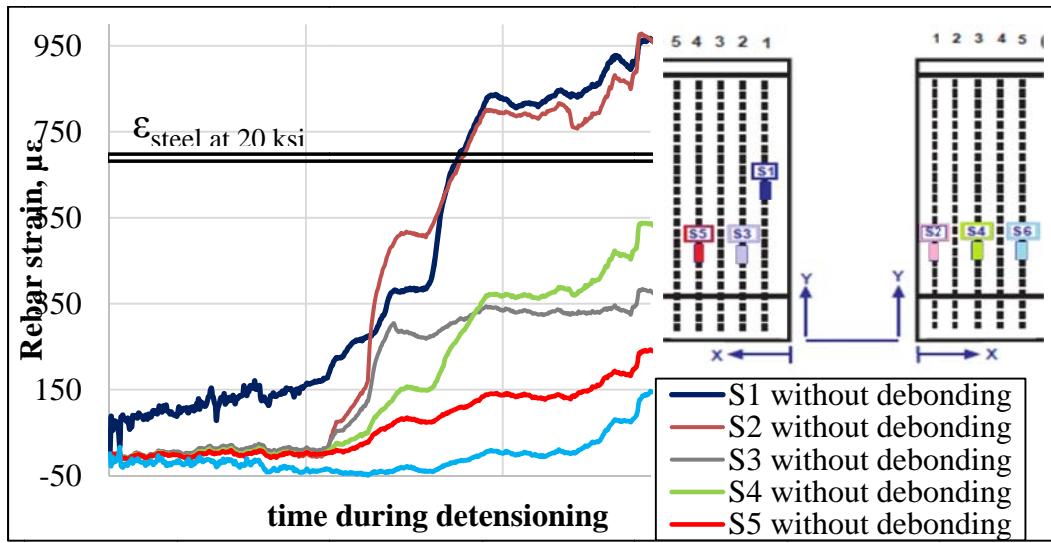
In the plots, the effect of de-bonding can be seen. In bonded girders, all the tension strain values are approximately 200 micro strain larger than in the de-bonded girder because

Figure 5-15. Bonded girder: Strain change of reinforcing bars in horizontal web crack region, most are 20" up from bottom (gauges, S2, S3, S4, S5 and S6).
(Tension positive, compression negative)

4. The standard girder end design details that show five #6 sets of vertical web bars at the girder ends could be changed to show three sets since the strain results showed that the additional bars further from the girder end have low strains and are ineffective in crack control. (*see Figures 5.15&16, page 75, and Figures 6.15-17, page117*)

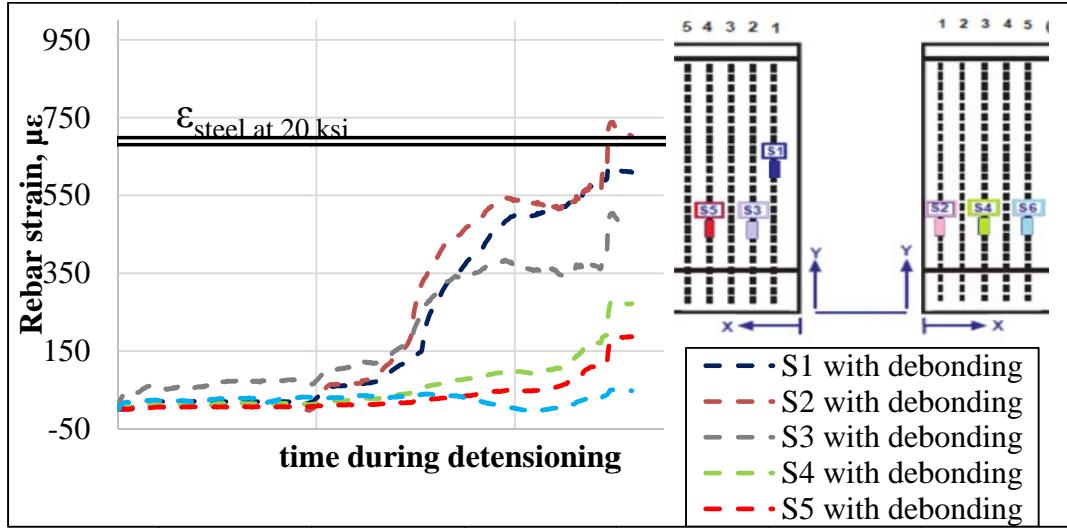
Figure 5-16. Debonded girder: Strain change of reinforcing bars in horizontal web crack region, most are 20" up from bottom (gauges S2, S3, S4, S5 and S6).
(Tension positive, compression negative)

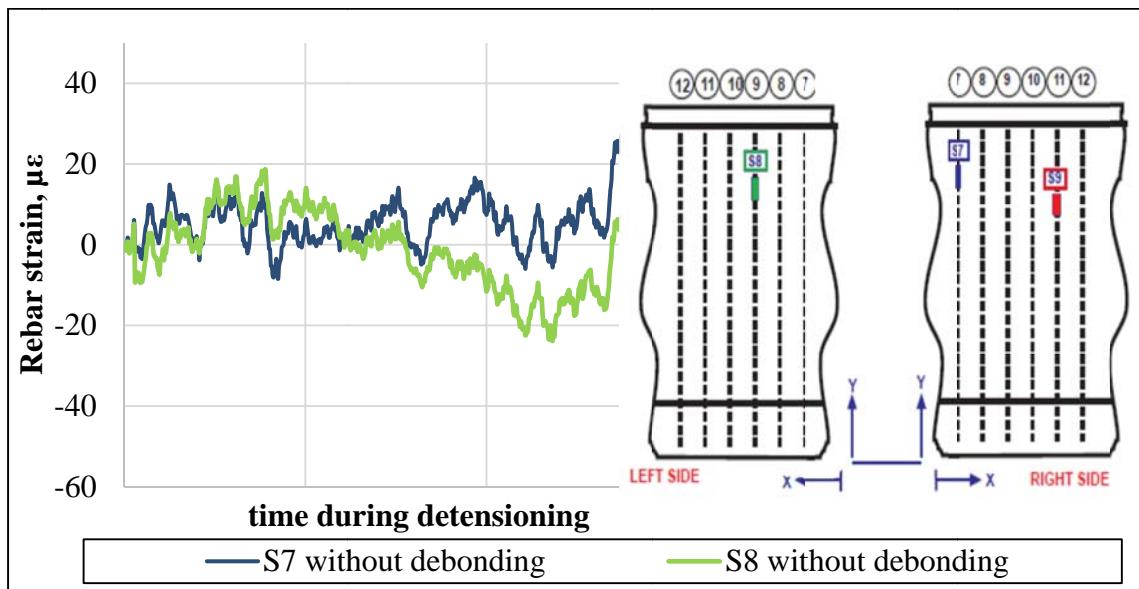
These gauges were placed very close to the draped strands hoping to cross the inclined cracks. All the values in Figures 5-17&18, however, are less than 60 $\mu\epsilon$. Therefore, it seems that the locations of the cracks were mis-predicted. In the de-bonded girders, the data showed that all gauges are primarily in compression so de-bonding prevented this region from cracking. On the other hand, data from the bonded girder shows that both tension and compression strains were present. Tensile strains may have caused cracks around that region. Note that the strain gauge S9 in the bonded girder must have been damaged during casting of concrete with subsequent poor operation and the data is omitted in Figure 5-17.

Figure 5-17. Bonded girder: Strain change of reinforcing bars in inclined crack region, close to top of girder (gauges S7, and S8). (*Tension positive, compression negative*)

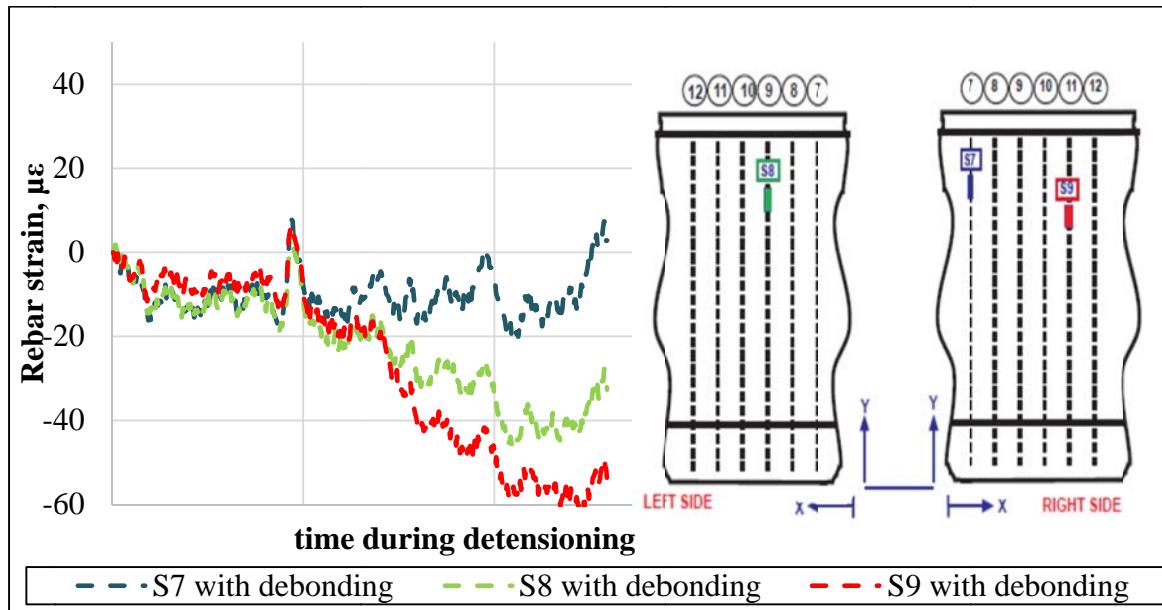
Figure 5-18. Debonded girder: Strain change of reinforcing bars in inclined crack region, close to top of girder (gauges S7, S8, and S9). (*Tension positive, compression negative*)

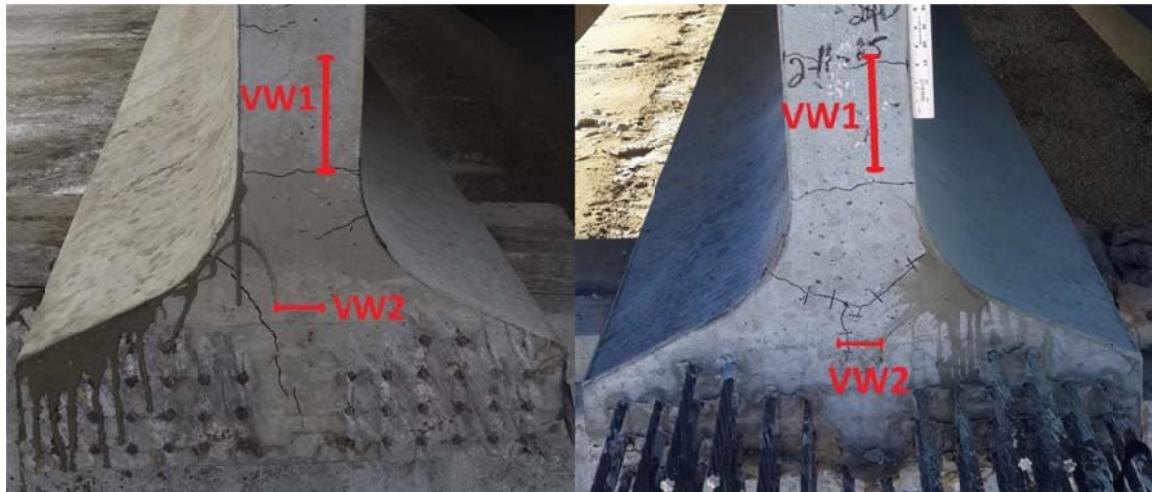
Figure 5-23. Location of vibrating wire gauges VW1 and VW2 in both bonded (left) and de-bonded (right) girders.

The bonded girder, however, gave higher concrete strains than the de-bonded girder at locations other than VW2 (Y crack region). The strains in the horizontal VW2 gauge increased by $300\mu\epsilon$ in both girders between de-tensioning and erection but the strain of that gauge in the de-bonded girder is 33% higher than in the bonded girder. The reason may be that the VW2 gauge in the de-bonded girder crossed a Y crack but the crack did not pass through the gauge in the bonded girder as illustrated in the end view of Figure 5-23. Though VW2 results were small in the bonded girder, the Y crack was actually larger but the gauge missed the Y crack location as is clear in the figure.

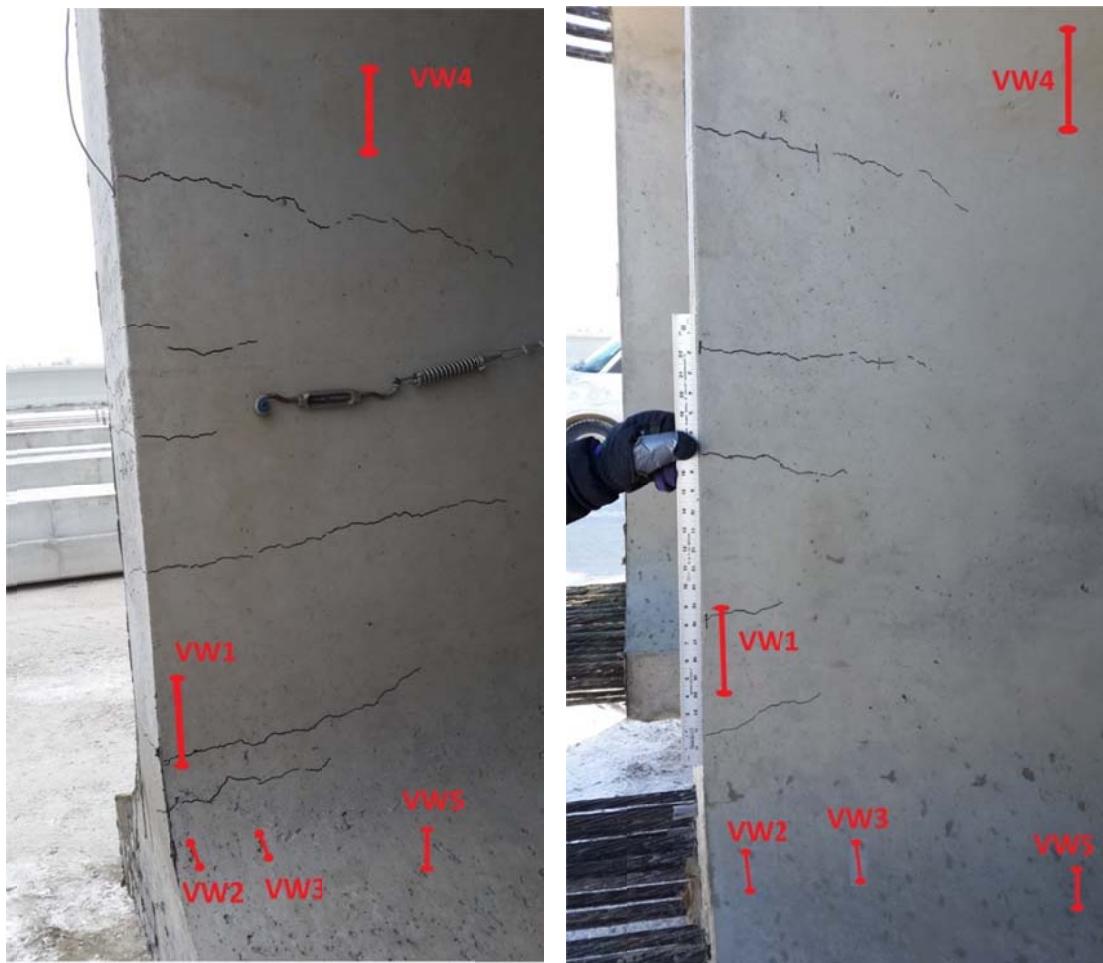
Figure 5-24. Location of vibrating wire gauges in bonded (left) and de-bonded (right) girders.

Figure 5-24 shows a side view of the general location of vibrating wire gauges in each girder. This indicates how close the gauges were placed to crack regions. Figure 5-24 shows that the VW1, VW2, and VW3 gauges in the bonded girder either crossed or were near to cracks; and VW1 and VW2 in the de-bonded girder were close to cracks. The results in Table 5-4 also seem to agree in some cases with these observations.

Another observation is that as in Figure 5-24; VW1, VW2, and VW3 were either near to or crossed cracks. In the comparison, strains from both the model and test data results are over the assumed cracking limit for the concrete holding those gauges. As such, the

In Figure 5-24, VW1, and VW2 passed through cracks. Therefore, strains from both predicted and measured results are over the cracking limit. The prediction of crack locations was quite accurate.

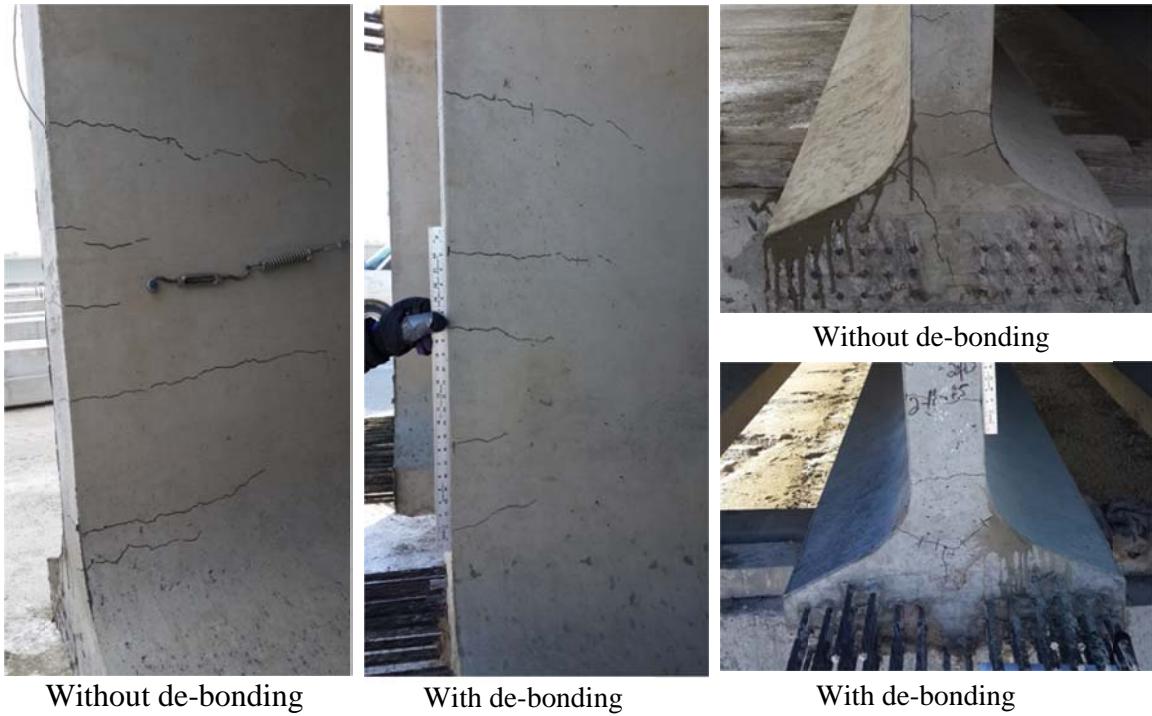
Figure 5-25. Cracks at the ends of bonded and de-bonded girders.

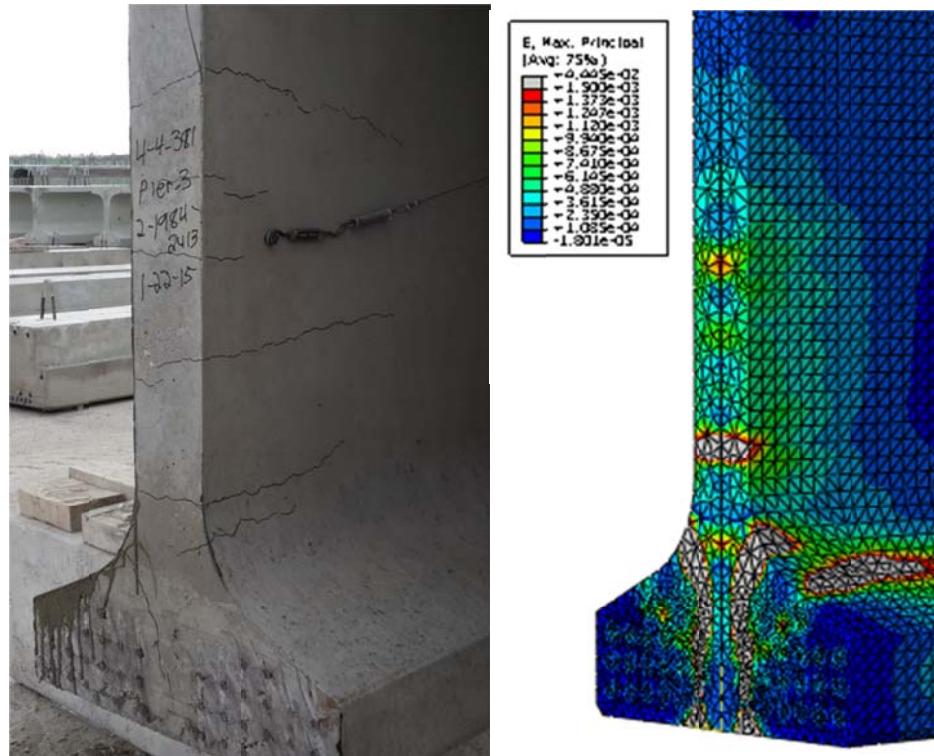
Figure 5-29. The comparison of actual girder end cracking with Abaqus model strains for bonded girder. (*tension is negative*)

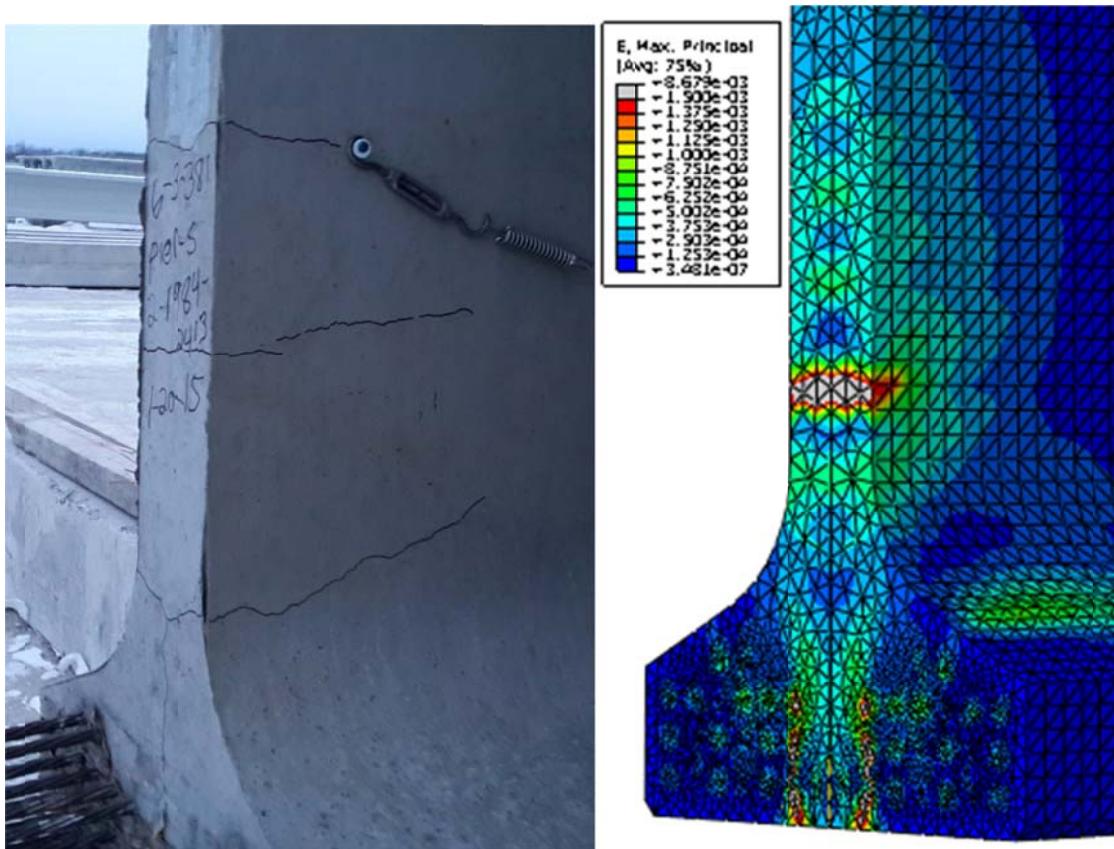
Figure 5-32. The comparison of actual girder end cracking with Abaqus model strains for the de-bonded girder.

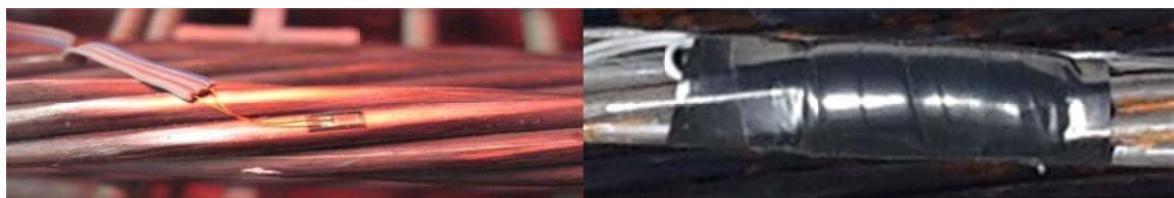
Figure 6-8. At the left, strain gauge on strand and at the right, the gauge after protection.

Foil Strain Gauges on Strands: Three gauges were put on the surface of one strand per girder. The purpose of these gauges is to estimate the prestress transfer length of strands. They are manufactured by Tokyo Sokki Kenkyujo (27). These gauges were 1mm (0.04in) in length and were longitudinally glued on one of the seven strand wires as in Figure 6-8. After gluing, a protection coating was applied. They were first covered with microcrystalline wax, then Butyl rubber, and finally duct tape was used to provide some mechanical protection. The coating covered 2 inches of the strand length.

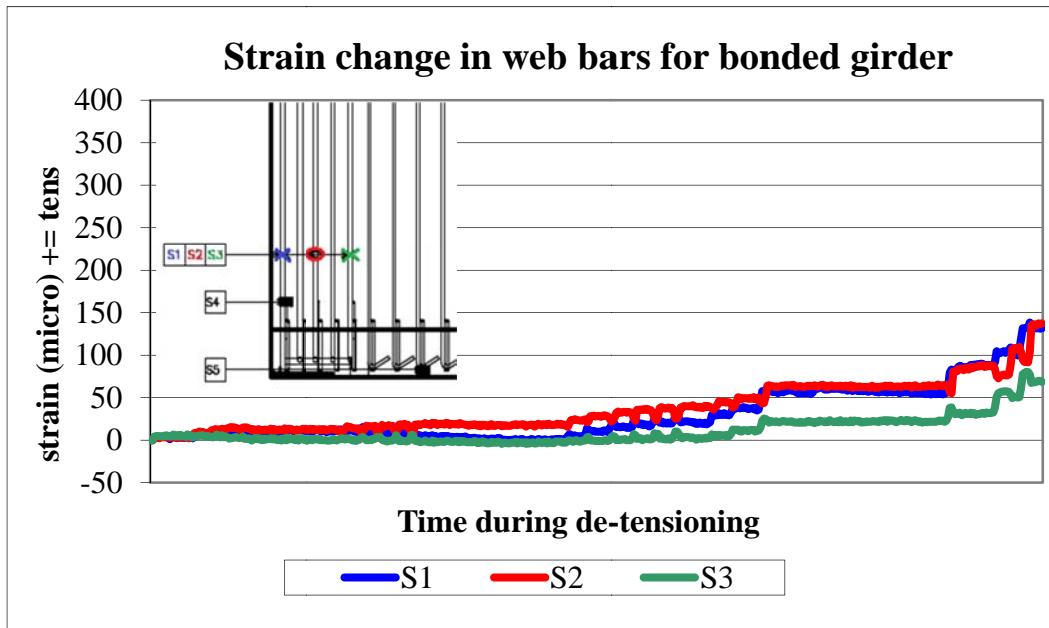
Figure 6-15. The test results of web bar strain gauges S1, S2, and S3 for bonded girder (*positive is tension*).

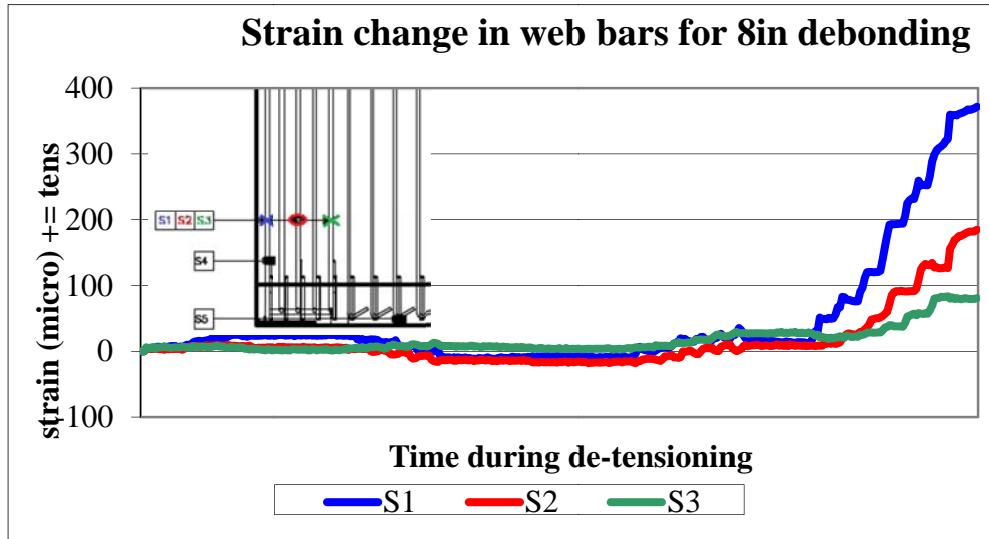
Figure 6-17. The test results of web bar gauges S1, S2, and S3 for debonded 8in. girder.
(positive is tension)

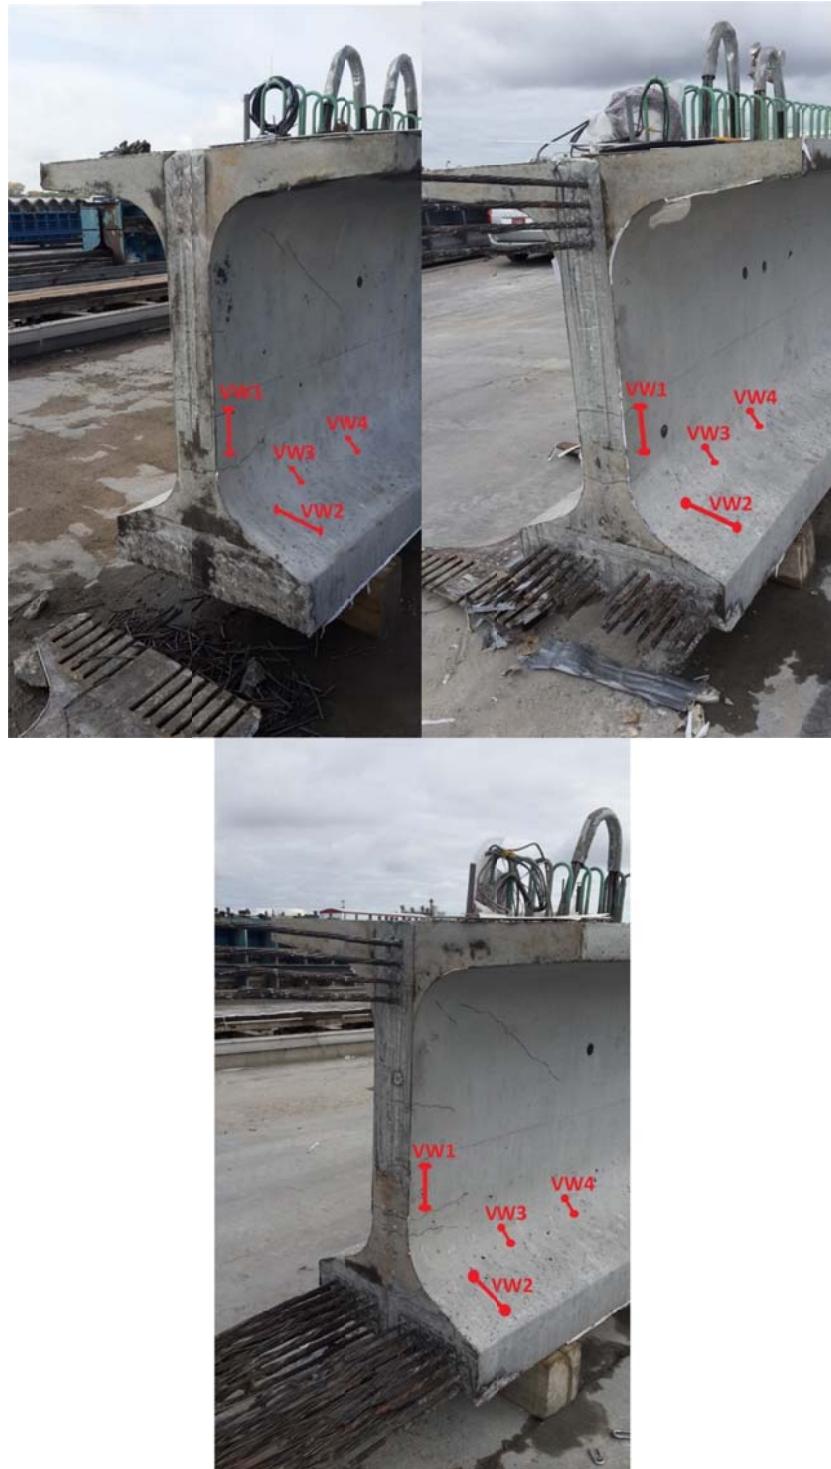
Figure 6-25. The location of vibrating wire gauges in bonded (top left), 38% debonded (top right), and the girder that is debonded 8 in. from end (bottom).

Concrete is a heterogeneous mixture of an aggregate, sand, cement and water. However, the distribution of these components are not even throughout the body depending on many factors like casting position of concrete member, vibration, etc. so locating cracks by modelling concrete bodies is a challenging job. As mentioned before, the location of all gauges were positioned inside the concrete according where high strains were predicted by Abaqus models with nonlinear material properties. Figure 6-25 shows the general location of vibrating wire gauges in each girder. This is made to see how close the gauges were placed to the visible cracks.

It seems that except for the vibrating wire gauge labelled as VW1, cracks did not cross the other vibrating wire gauges. The VW 1 gages were very near to, or possibly crossing a crack.
