Implementation and Field Evaluation of Pretensioned Concrete Girder End Crack Control

Michael Oliva
Emre Kizilarslan
University of Wisconsin - Madison

WisDOT ID no. 0092-15-01

May 2016

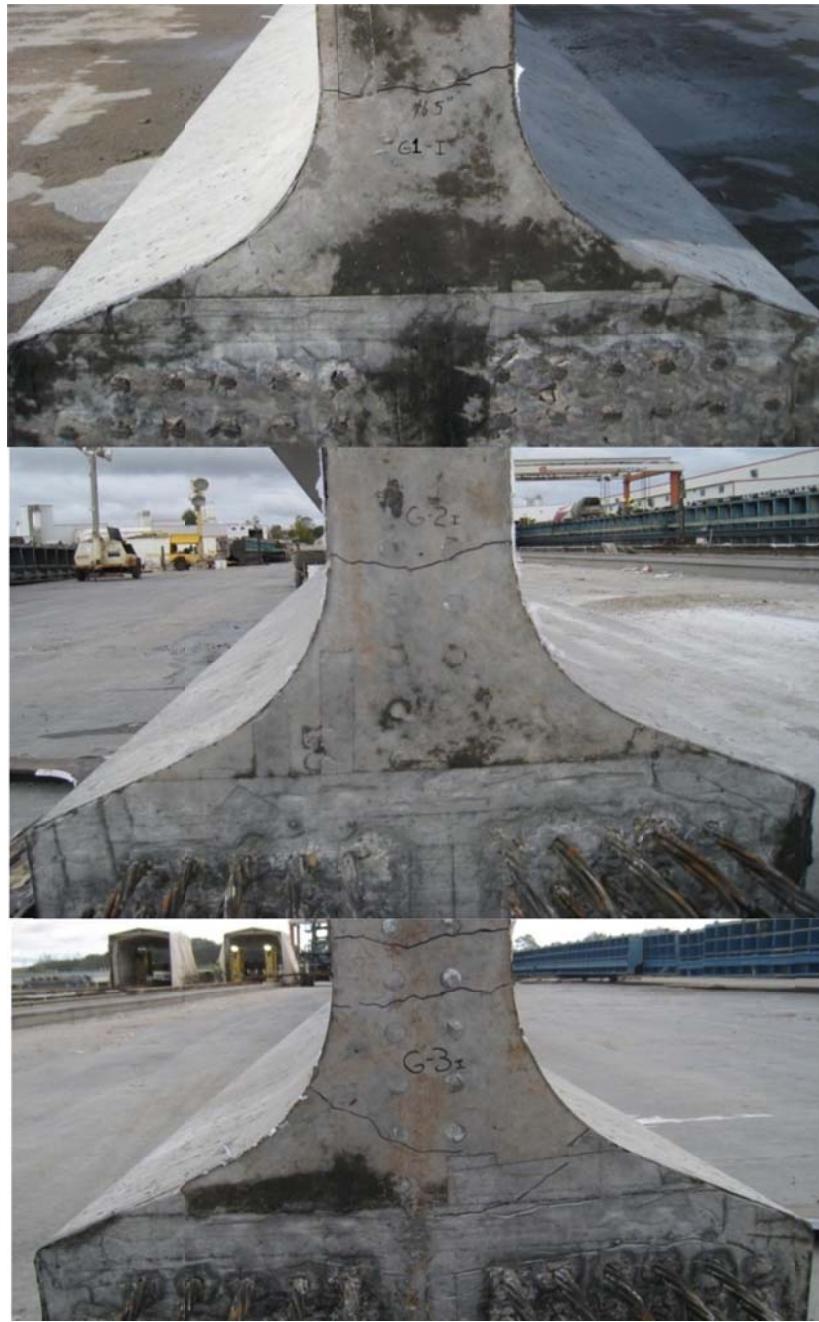
Figure 6-26. Close-up picture of bottom flange for bonded (top), 38% de-bonded (middle), and 8in. debonded (bottom) girders.

Right after de-tensioning, it was observed that Y cracks in the instrumented ends did not develop or show a vertical leg through the bottom flange as in Figure 6-26. While the 8 inch debonded beam showed the start of top legs of a Y crack, the VW2 gage was parallel to the cracks and would not provide any measurement. The VW3&4 gages might have crossed the cracks if the cracks extended far enough in from the end of the girder.

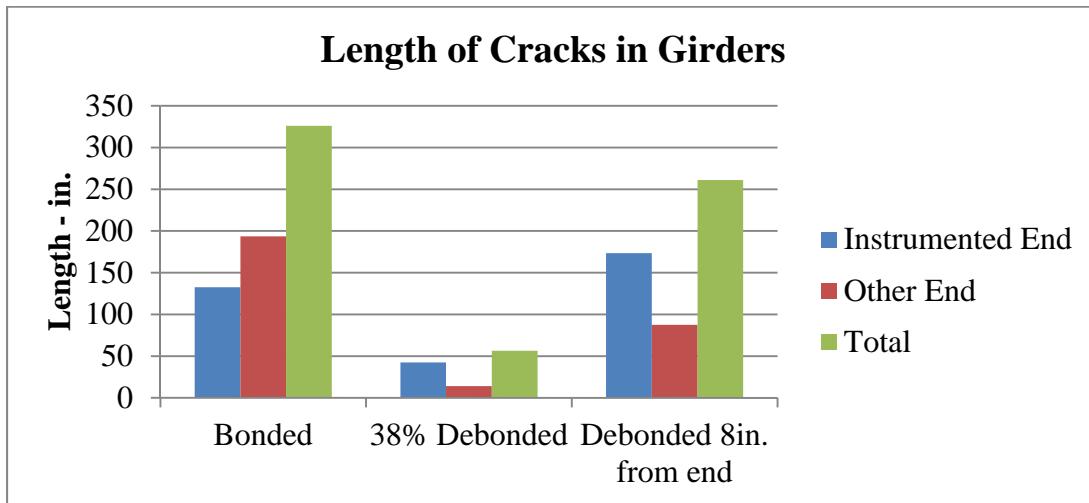
Figure 6-28. Total crack lengths of girders.

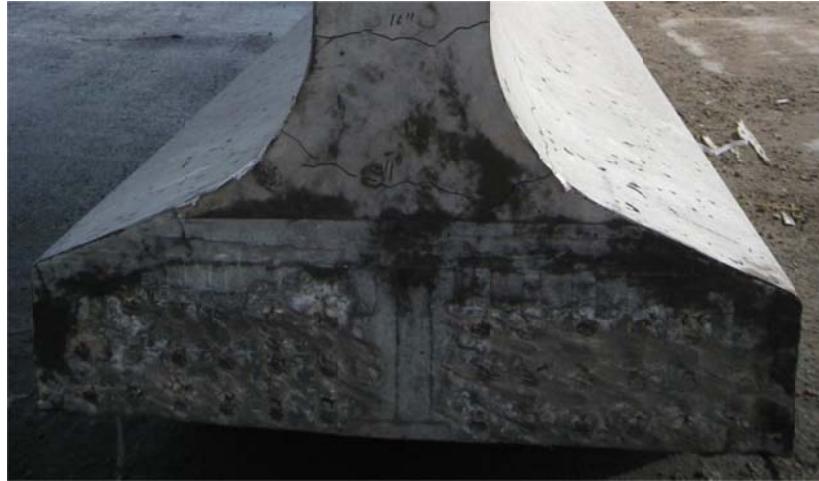
Figure 6-30. Other end of normal girder which was in the middle of the bed.

It is possible that the layout of the girders in the bed affected the end cracking. Looking at the other end of the normal girder, as in Figure 6-30, the top horizontal legs of a Y crack were apparent just as in the 8 inch debonded girder.

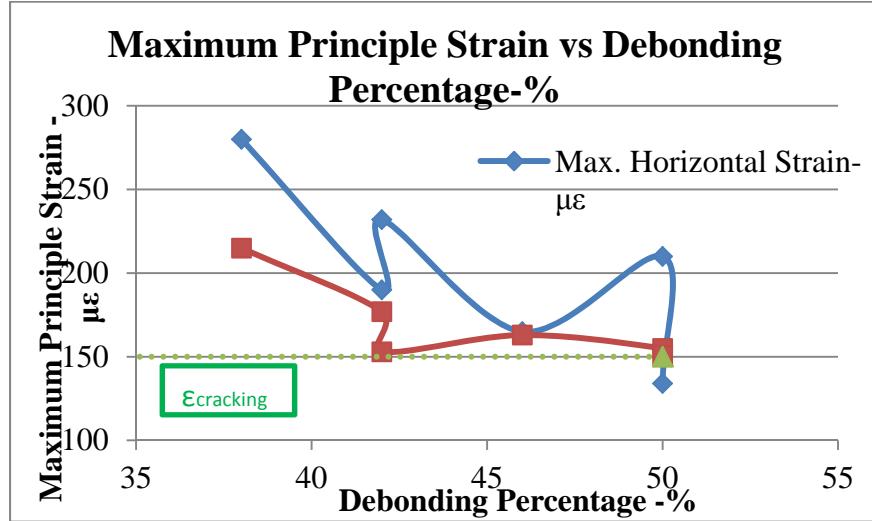
Figure 8-3. Maximum principle strain at horizontal and Y crack region from each girder.
(Note: A fully bonded strand pattern resulted in maximum horizontal and Y-crack strains of 1243 and 2734 $\mu\epsilon$ respectively.)

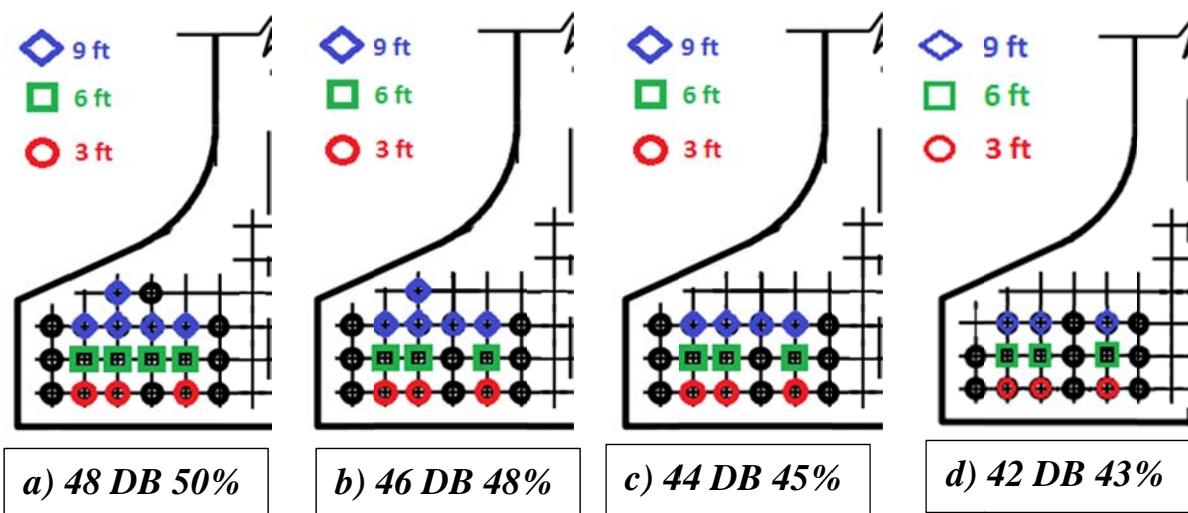
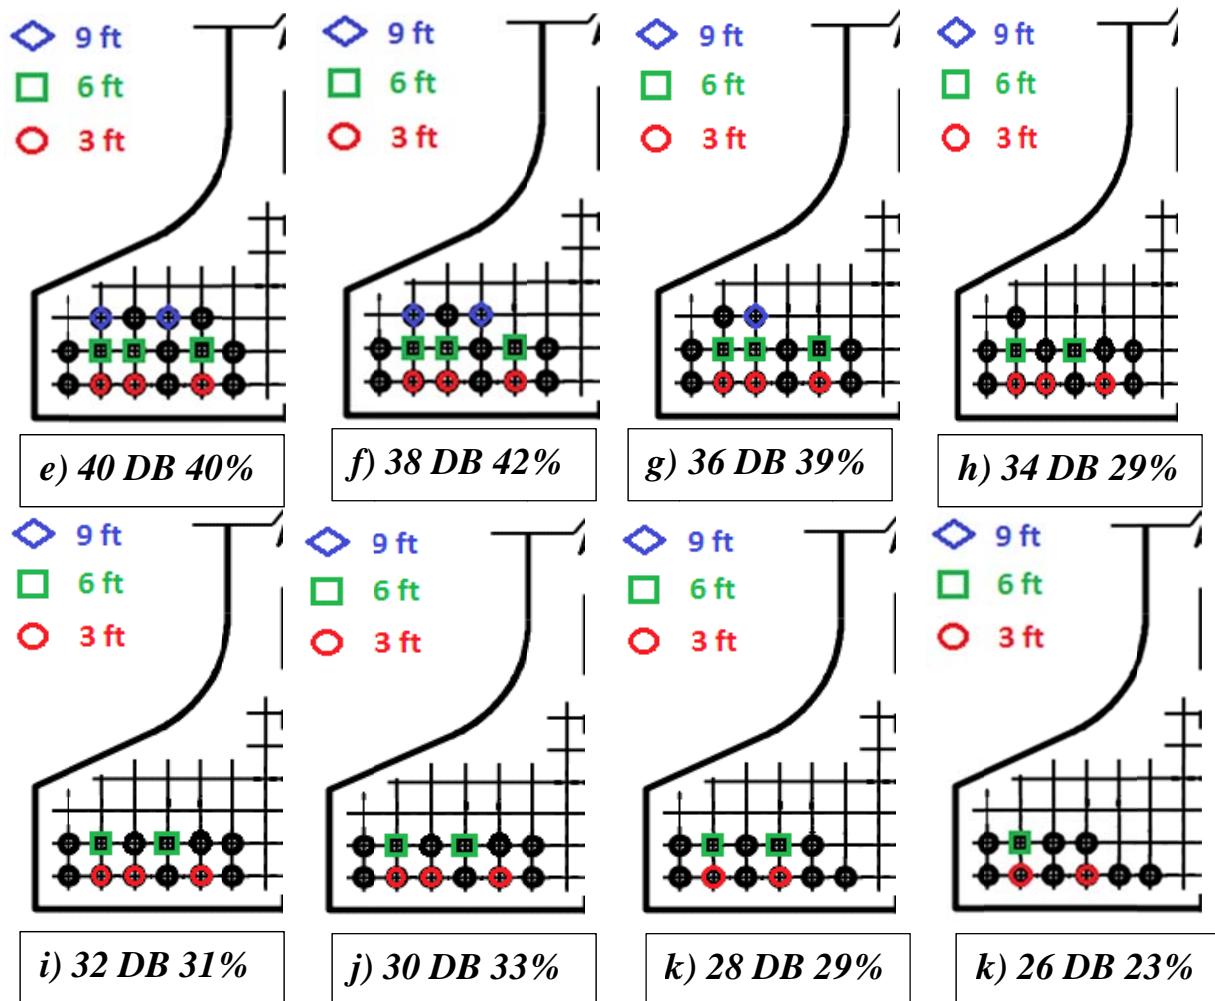
Figure 8-4. Recommended debonding patterns for 72W and 54W girders with different number of strands.

Bottom flange Y cracking, that is detrimental to durability, can be eliminated by debonding the appropriate number of strands. When high amounts of prestressing are used, more than 26 strands, the AASHTO limit of 25% debonding is insufficient in eliminating flange cracking. Other states, such as Texas, build girders with as much as 50% debonding without detrimental bond effects. When a 72W girder has a full complement of 48 strands, debonding of 42% to 50% of the strands is necessary to eliminate flange cracking. A complete summary of the number of strands to debond, and best strand patterns, has been developed and they are provided as recommended designs in Chapter 8, and specifically in Table 8-1 (p173) and Figure 8-4.
