Evaluation of Recycled Base Aggregates

WisDOT ID 0092-17-01

July 2019

WISCONSIN HIGHWAY RESEARCH PROGRAM

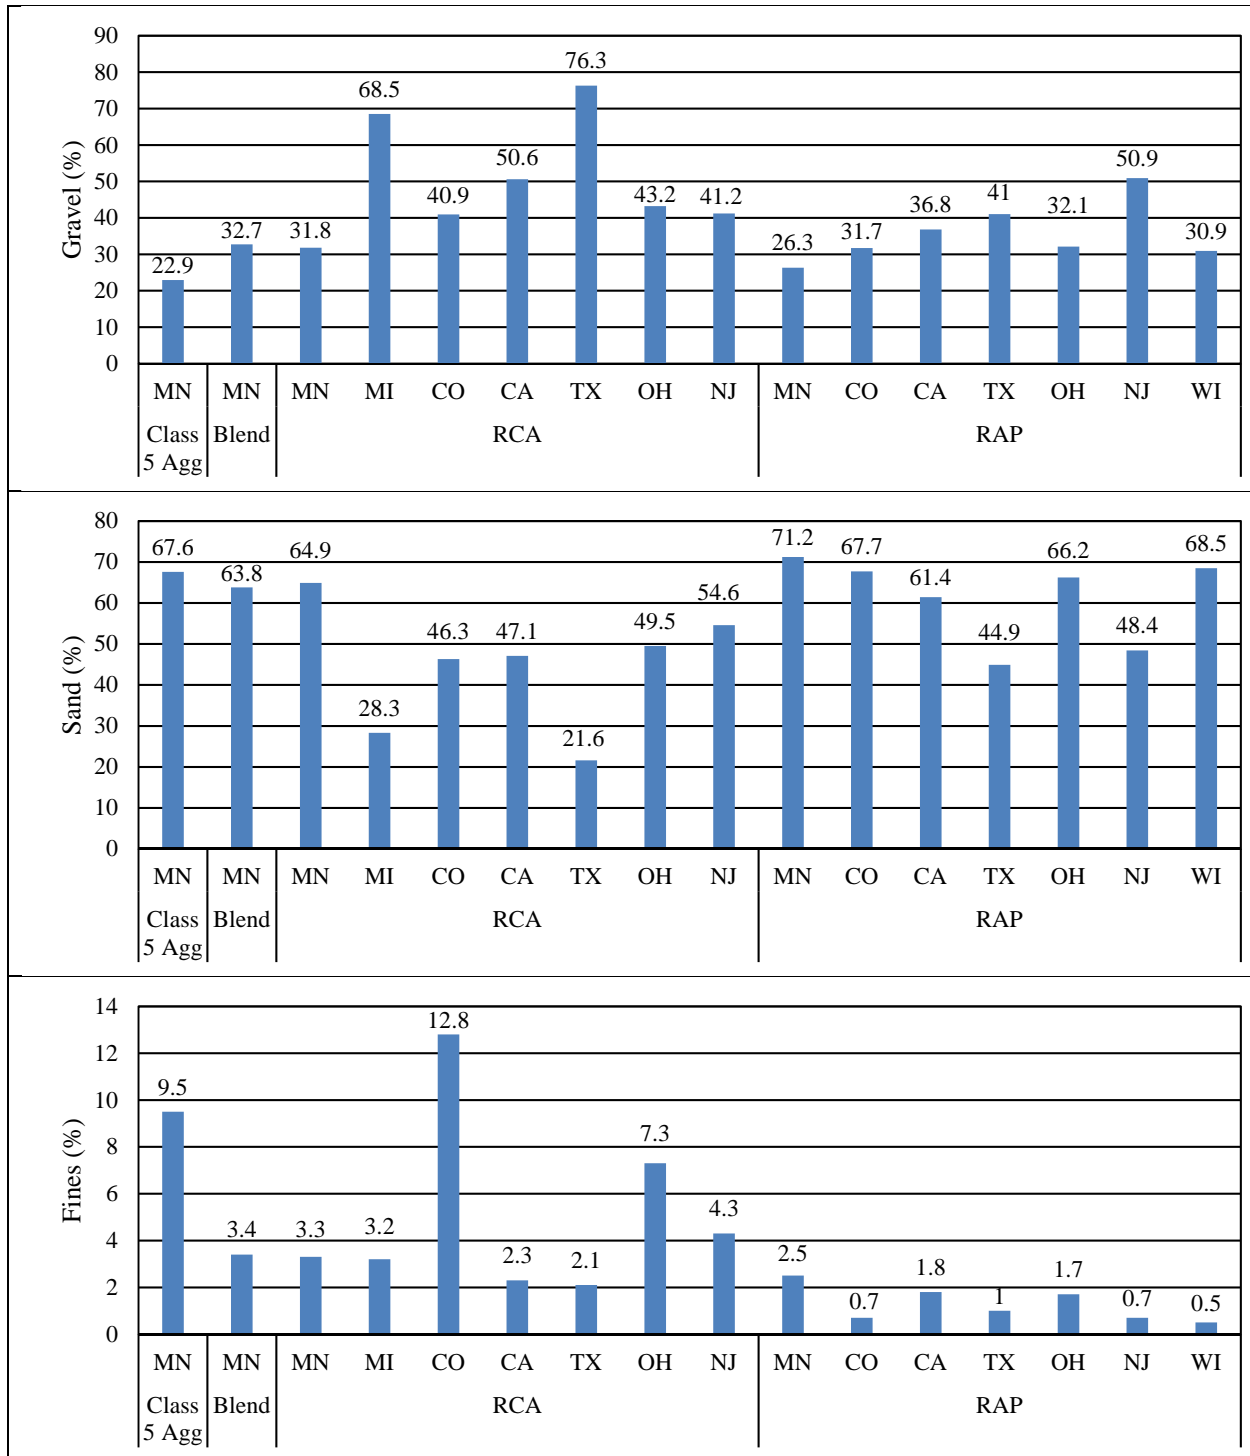
Figure 2.2: Gradation of RCA and RAP materials from different resources compared with MnDOT class 5 and blend aggregate (data obtained from Edil et al., 2012).

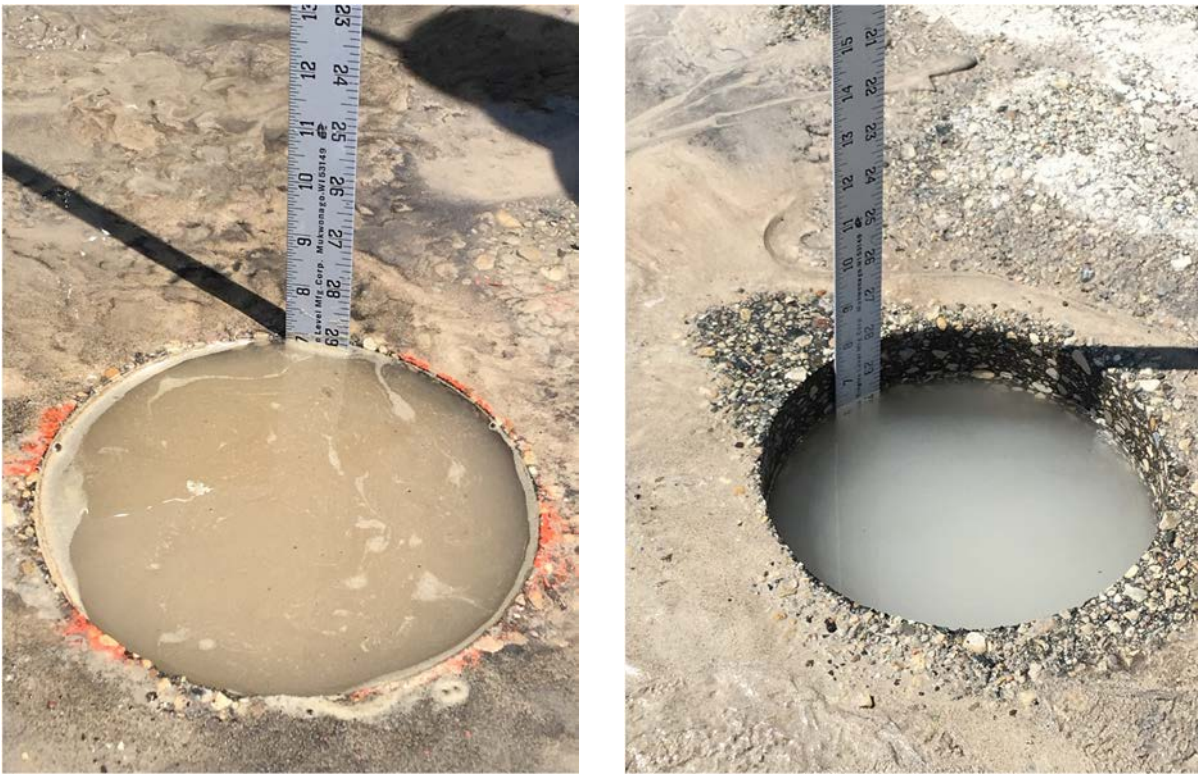
Figure 3.5: Field drainability test conducted on the investigated aggregate base layers.

Once the pavement surface core was removed, the hole in the HMA surface was filled with water and left for a period of about 10 to 45 minutes to stabilize, depending on the rate of water level decrease. Thereafter, the hole is refilled again with water to the top of the pavement surface and the level of water was recorded with time for a period ranging from few minutes to one hour. The research team attempted to use the core-hole permeameter (CHP) device in accordance with ASTM D6391: Standard Test Method for Field Measurement of Hydraulic Conductivity Using Borehole Infiltration. However, the time limitations of highway lane closures and the need to conduct DCP testing, aggregates sampling, FWD and GPR, refilling the hole with HMA, and traffic control made such attempts very difficult to execute. The research team instead filled the HMA hole with water as described earlier and observed and recorded the decrease in water level with time, as depicted in Figure 3.5.

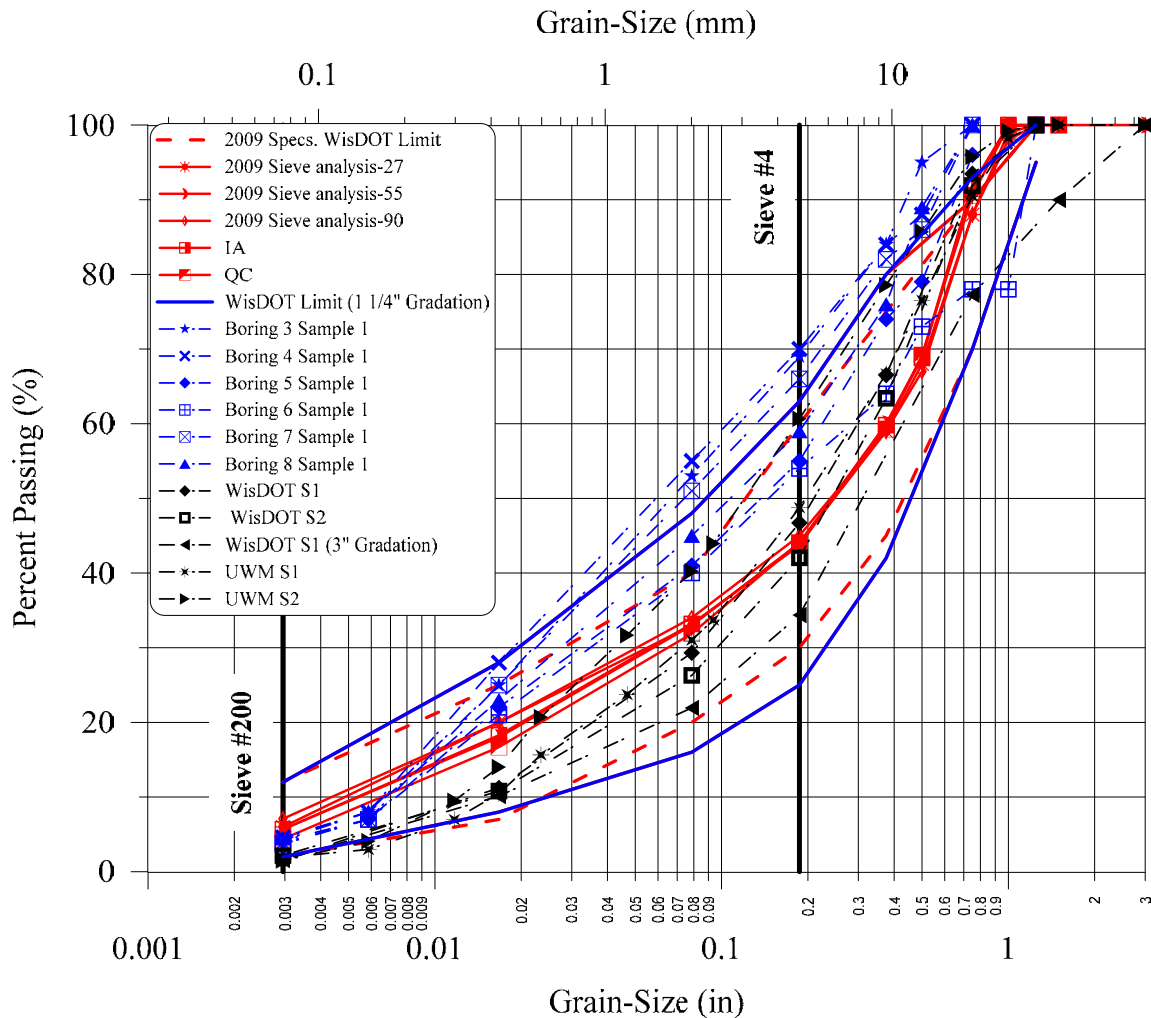
Figure 4.10: Particle size distribution of the investigated RCA base course material at STH 78 with data from 2009 and 2018.

Figure 4.10 depicts the particle size distribution plots of the RCA base material from tests conducted in 2009 (by WisDOT and contractors) and in 2018 (by WisDOT and the research team). The figure also depicts the current and the 2009 WisDOT specification limits for dense graded base.

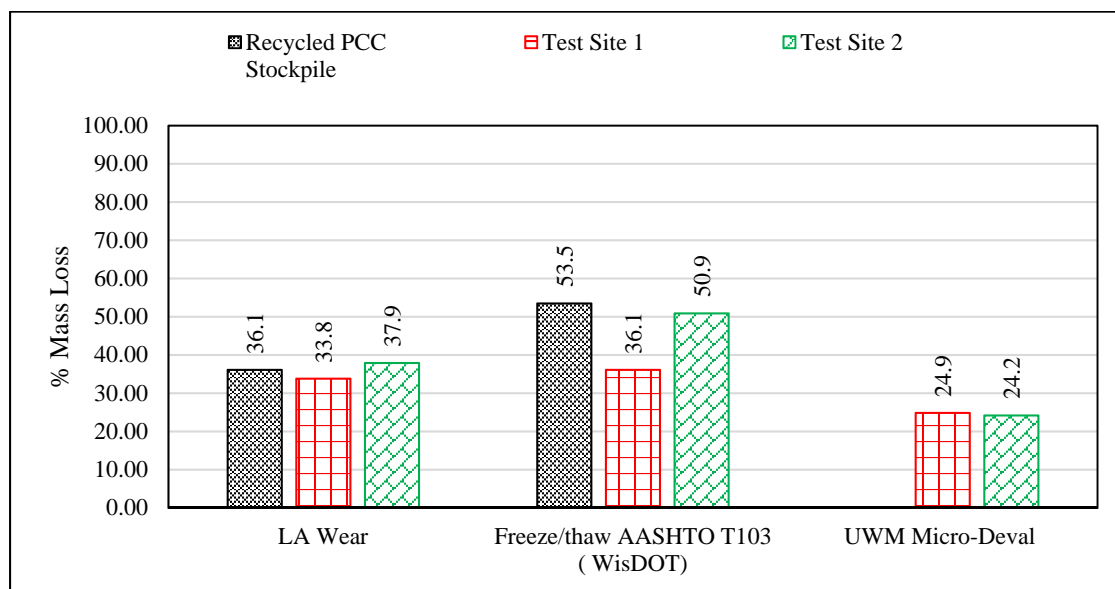
Figure 4.12: Mass loss of the RCA base material at STH 78.

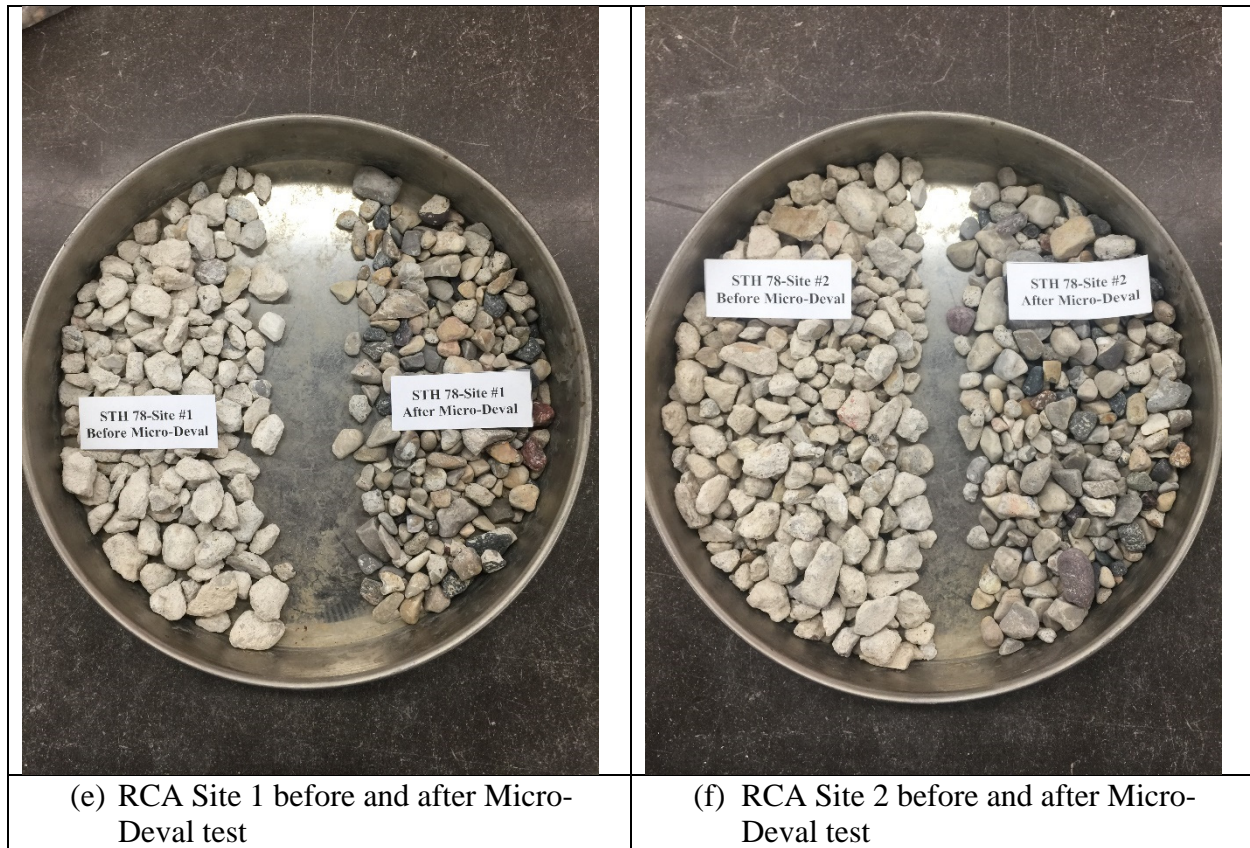
Figure 4.13 (Cont.): Pictures of the RCA base material from STH 78 before and after Micro-Deval abrasion test.

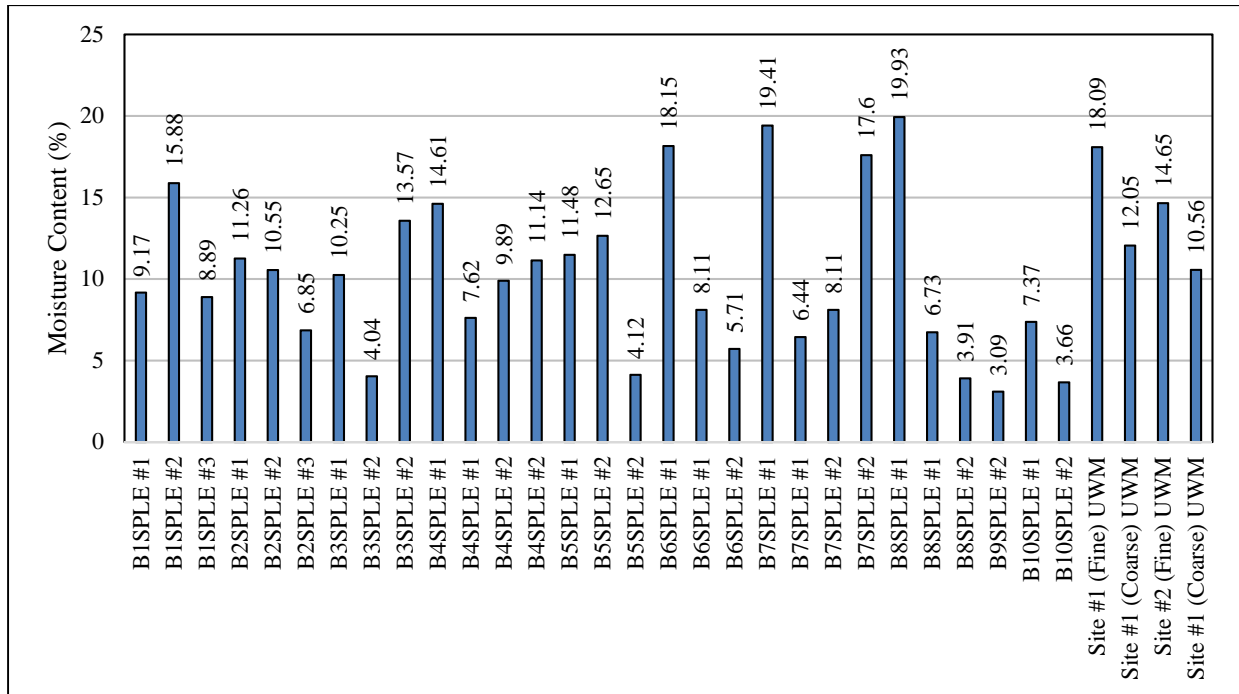
Figure 4.14: Moisture content of the investigated RCA base course layer of STH 78 at several locations.

The poor performance of the STH 78 pavement in terms of pavement condition and ride quality is presented and discussed in detail in Chapter 7 based on the field measurements of pavement performance indicators by WisDOT and the research team. Such performance could be attributed in part to the poor performance of the RCA base layer materials where the field moisture content values were relatively high ranging from 3.66 to 19.93% with an average of 10.47% (Figure 4.14). The higher than normal absorption characteristics and sand size fraction increase the chance to retain moisture resulting in pavement surface heave/movement due to freeze thaw effect.

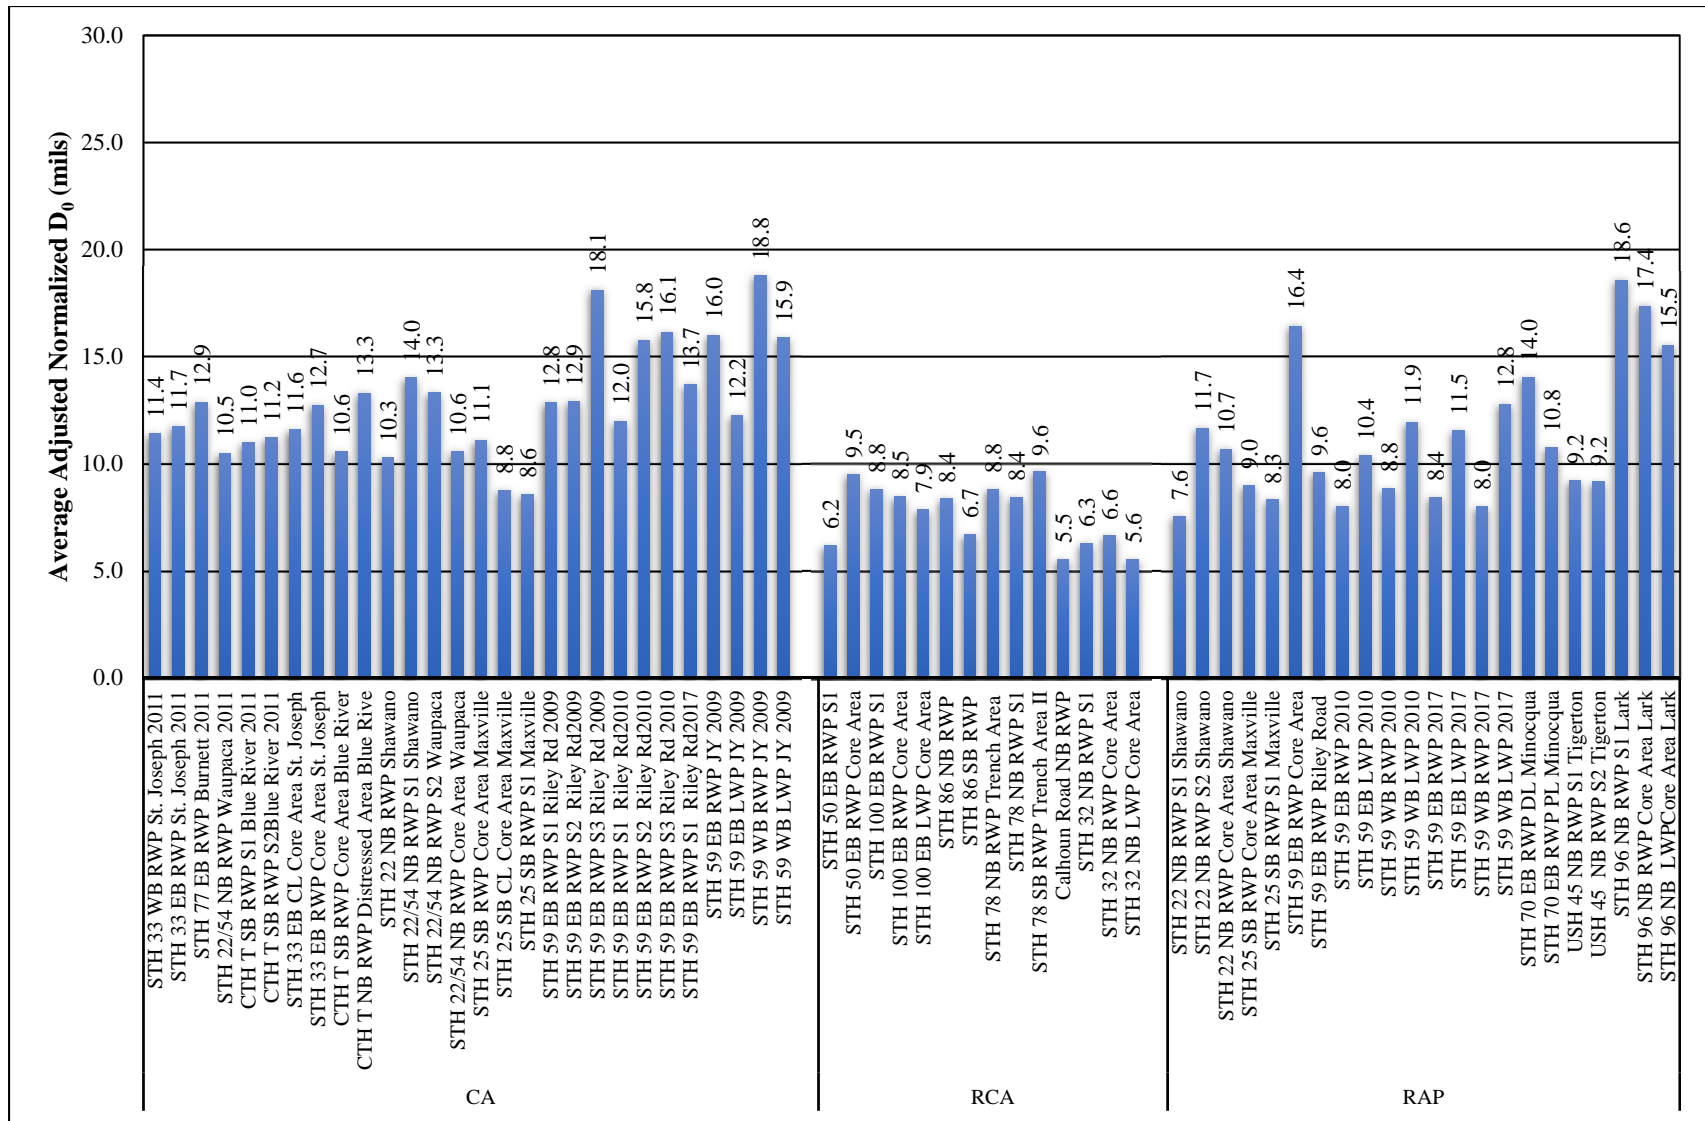
Figure 5.9: Average adjusted deflection under loading plate (D_0) normalized to 9,000 lb load for the investigated HMA pavement test sections with crushed aggregate, recycled concrete aggregate, and reclaimed asphalt pavement base layers.

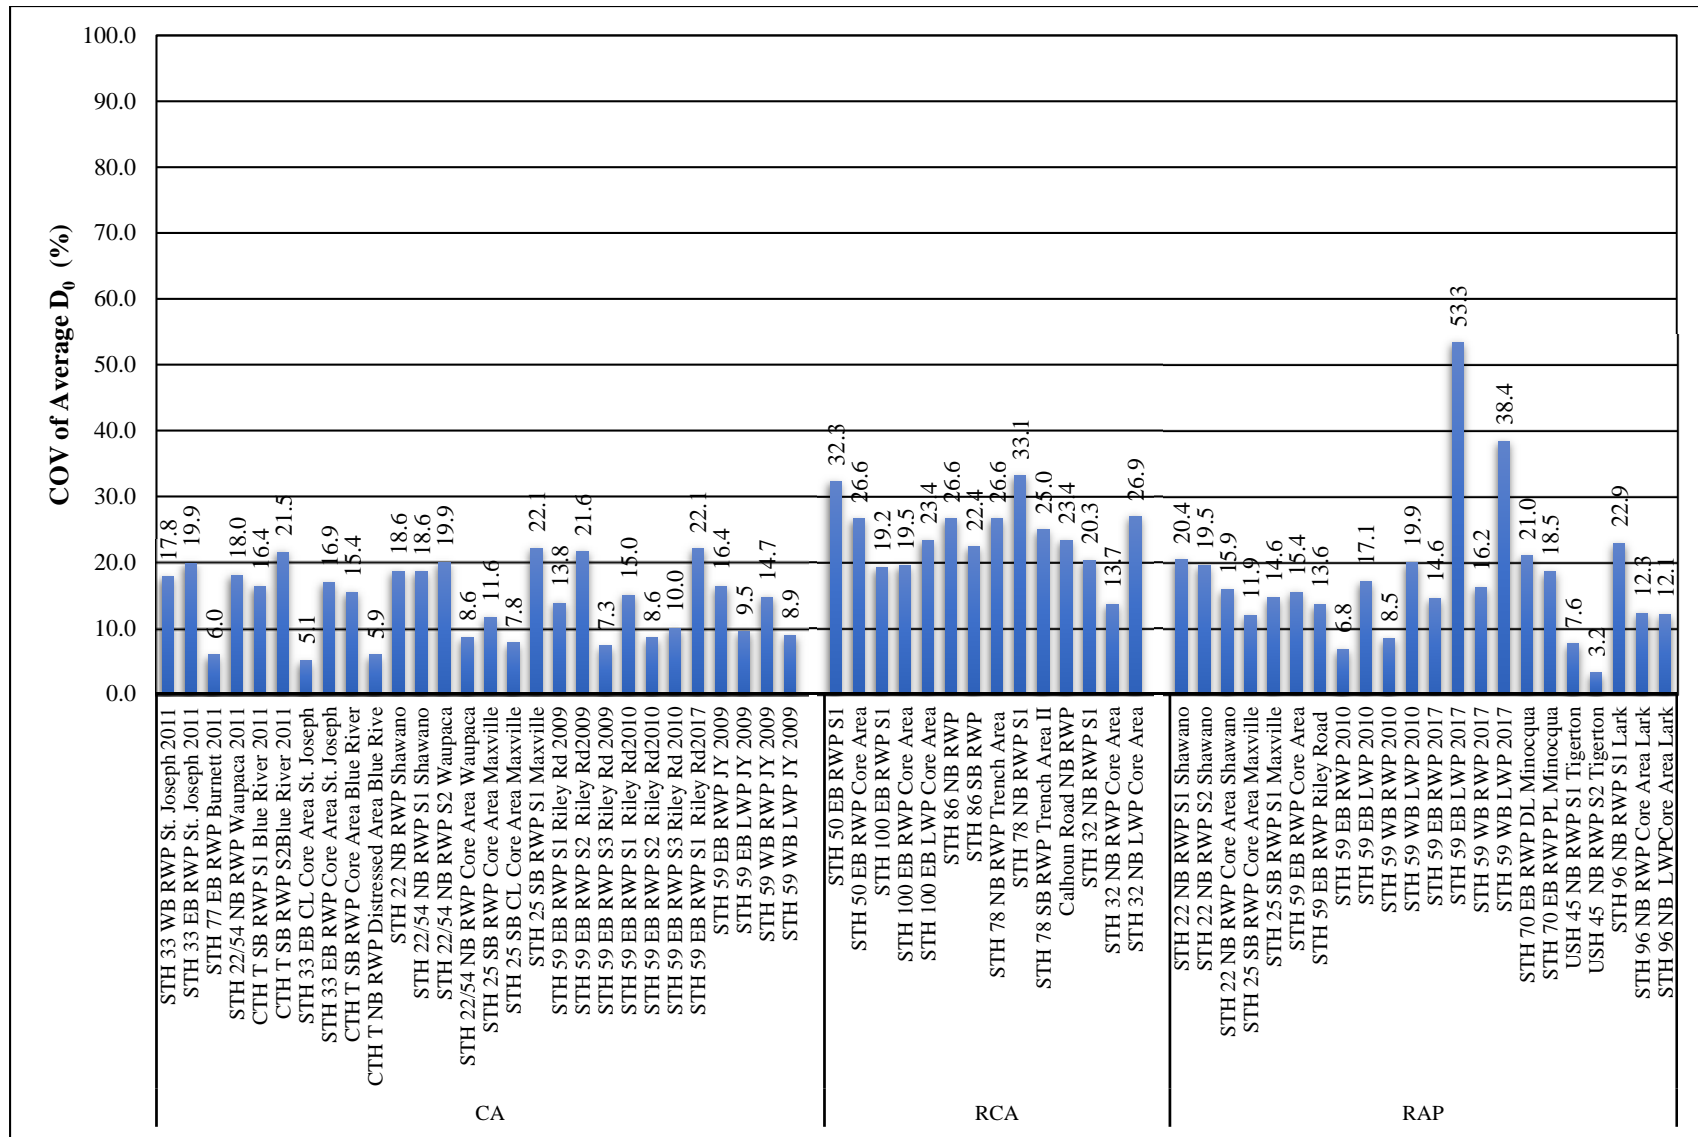
Figure 5.10: Coefficient of variation of back-calculated HMA layer modulus for the investigated pavement test sections with crushed aggregate, recycled concrete aggregate, and reclaimed asphalt pavement base layers.

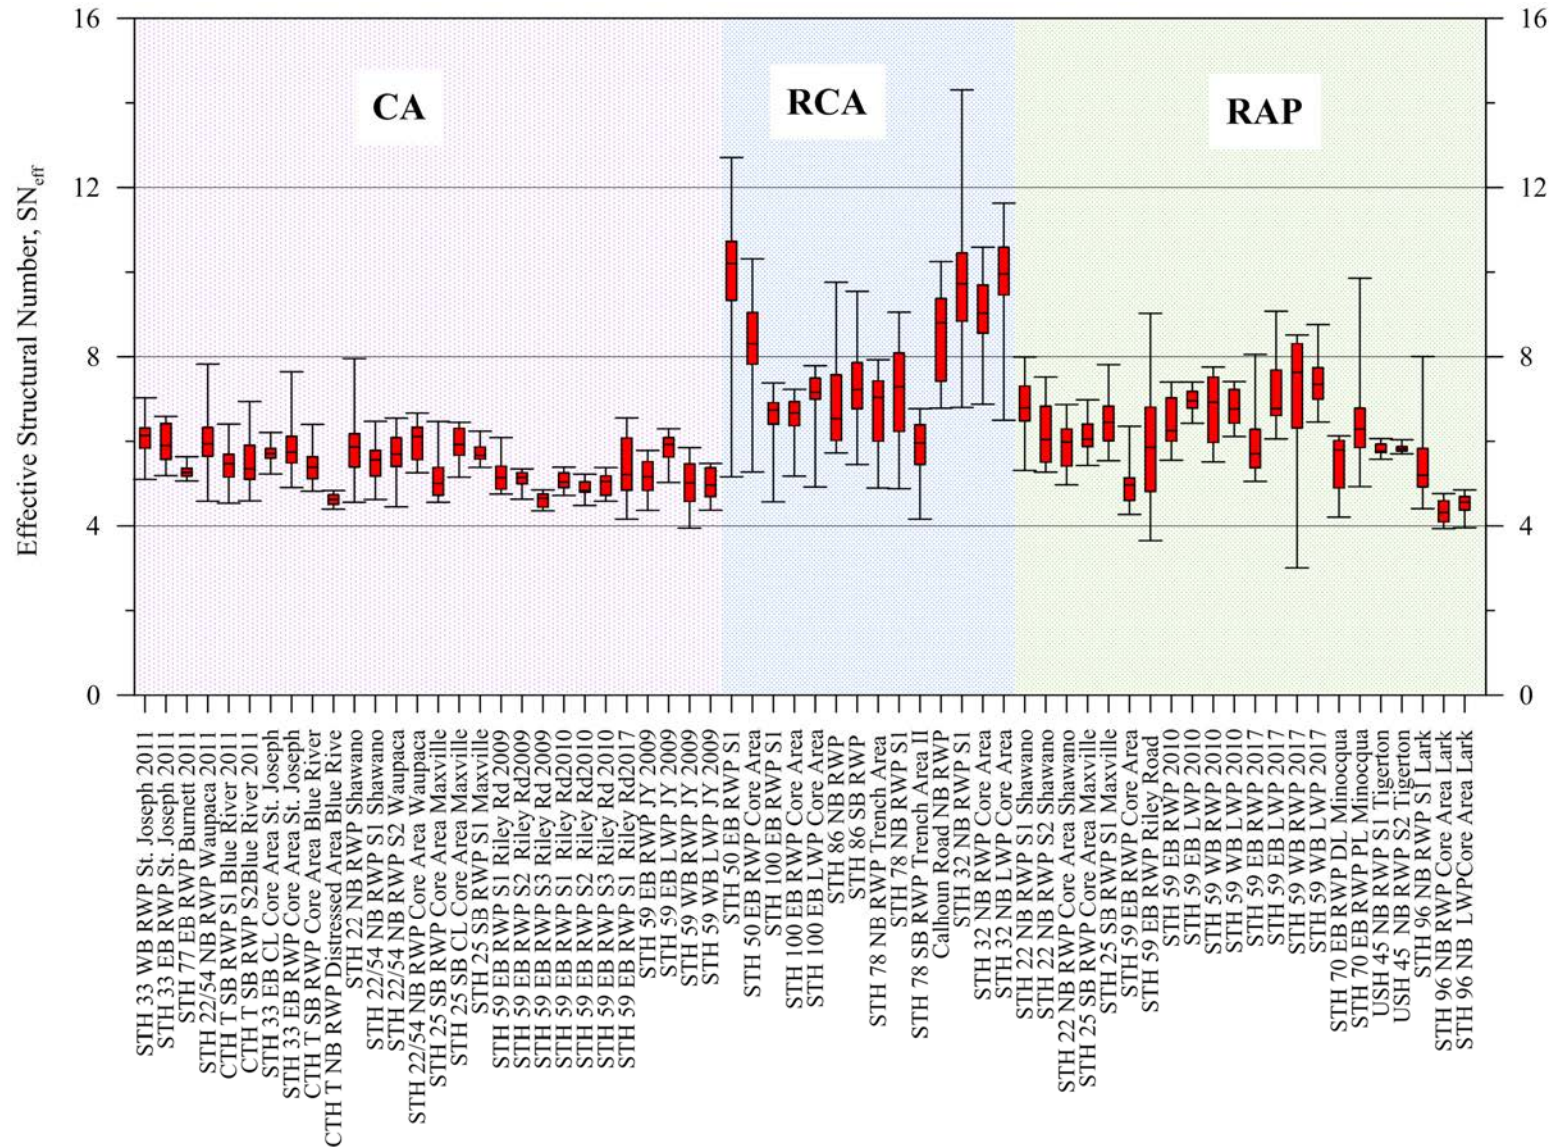
Figure 5.11: Box-Whisker plot of the effective structural number for the investigated pavement test sections with crushed aggregate, recycled concrete aggregate, and reclaimed asphalt pavement base layers.

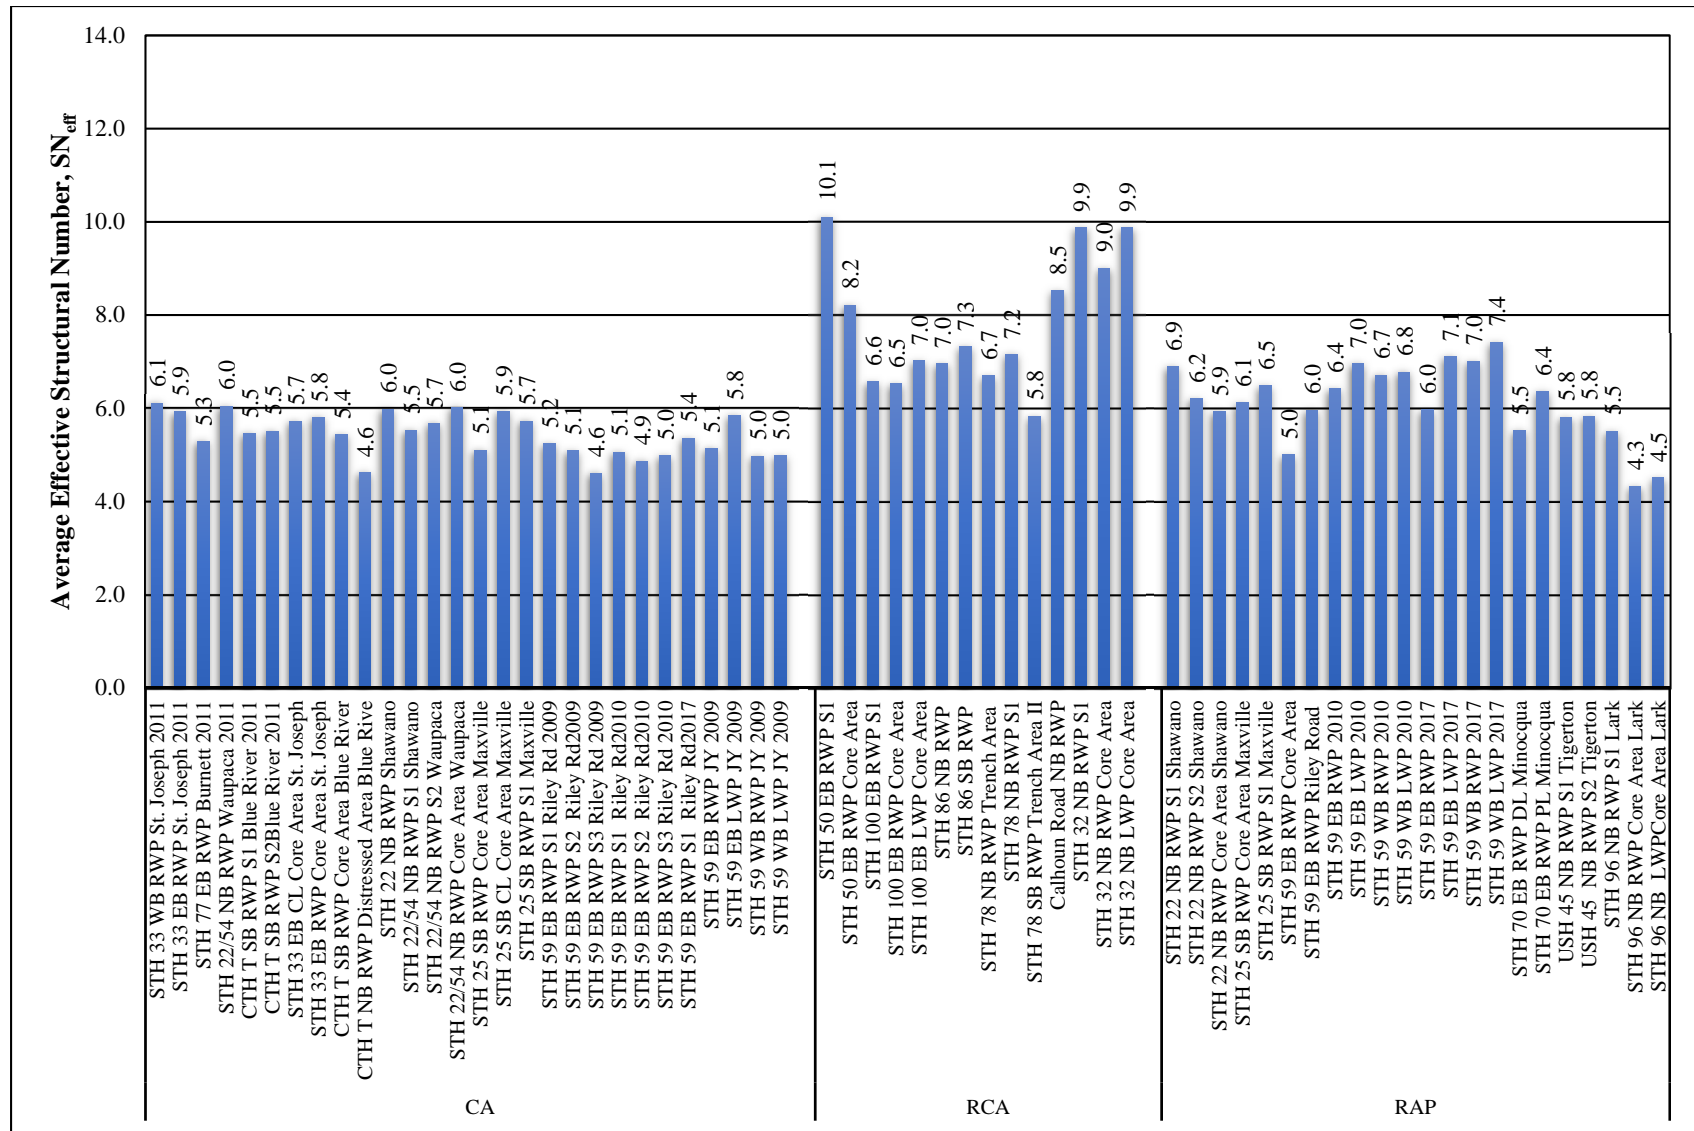
Figure 5.12: Average effective structural number for the investigated HMA pavement test sections with crushed aggregate, recycled concrete aggregate, and reclaimed asphalt pavement base layers.

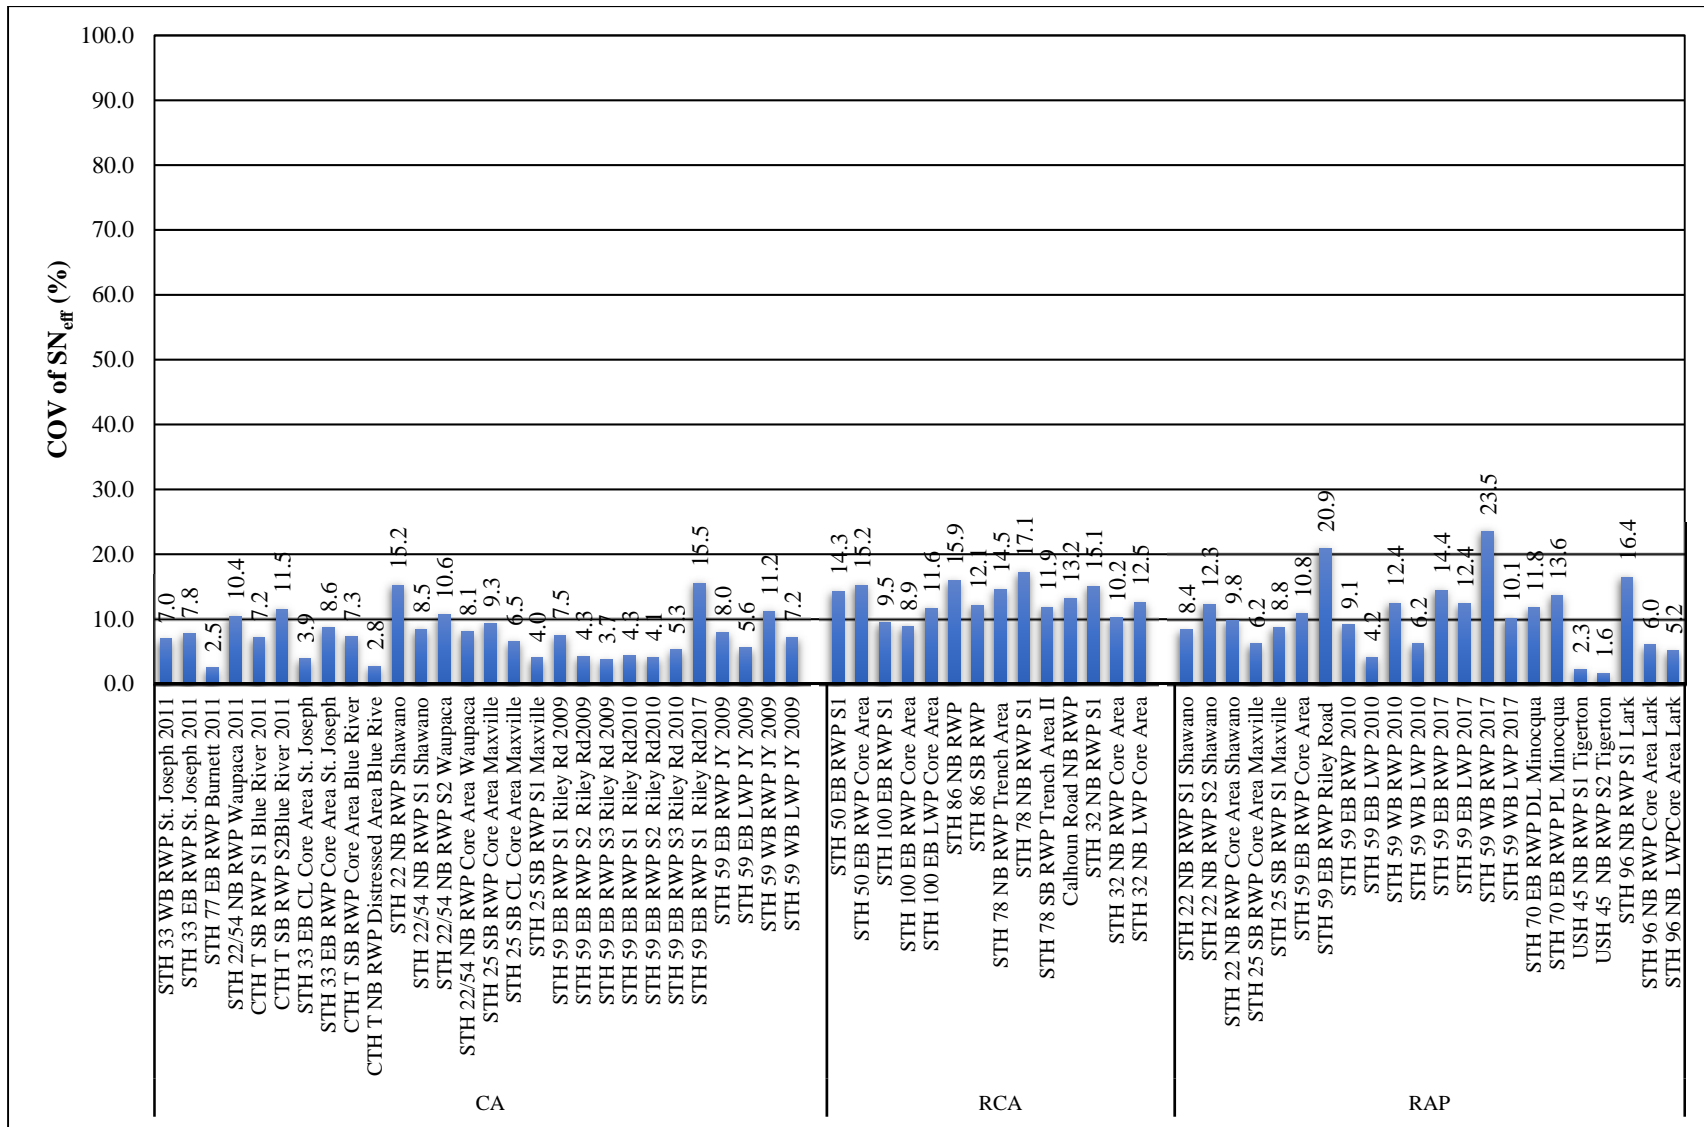
Figure 5.13: Coefficient of variation of effective structural number for the investigated pavement test sections with crushed aggregate, recycled concrete aggregate, and reclaimed asphalt pavement base layers.

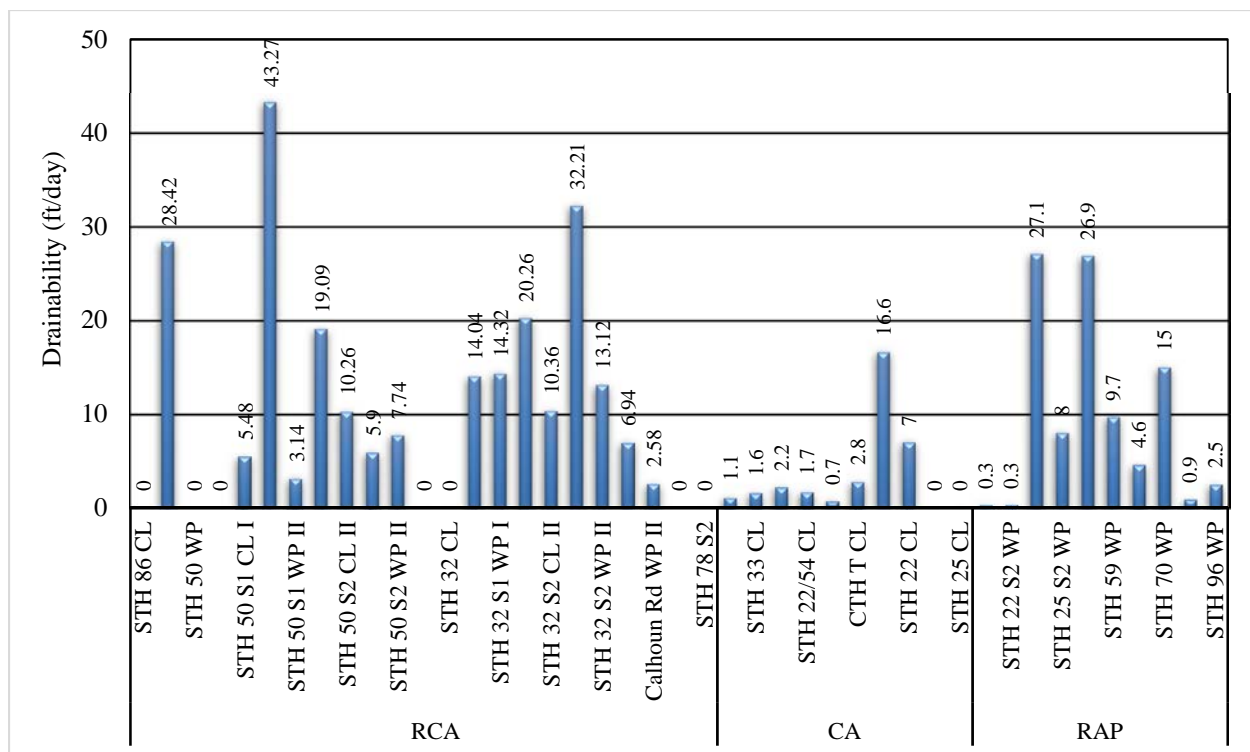
Figure 5.24: Field drainability of the investigated RCA, CA, and RAP base course layers.

The field drainability test results are influenced by many factors including the thickness of the base layer, particle size distribution of base materials, amount of fines, density of base materials, properties of the subbase layers, subgrade type and properties, the climatic conditions, seasonal variations in moisture within pavement layers and subgrade, pavement geometry/slopes, drainage infrastructure around the pavement, etc. Therefore, the comparison and evaluation of the drainability of base layers is more complicated than presented herein.

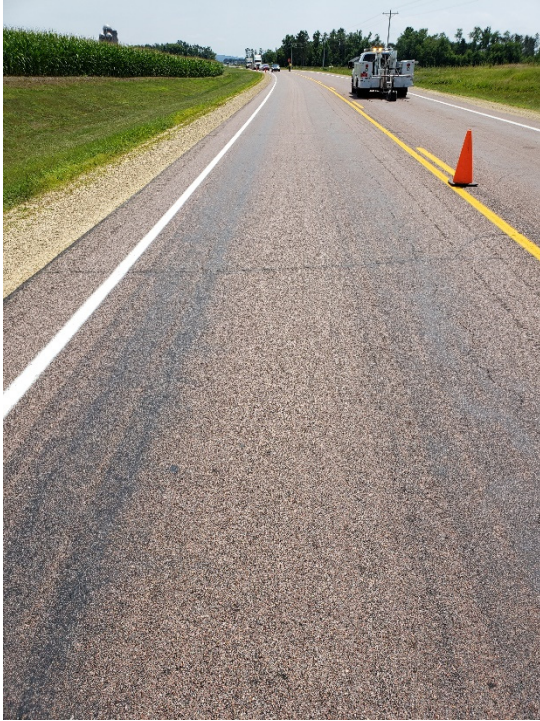
(a) Bleeding and fatigue cracking – STH 25

Figure 5.26: Pavement surface distress observed on pavements with CA base layers.

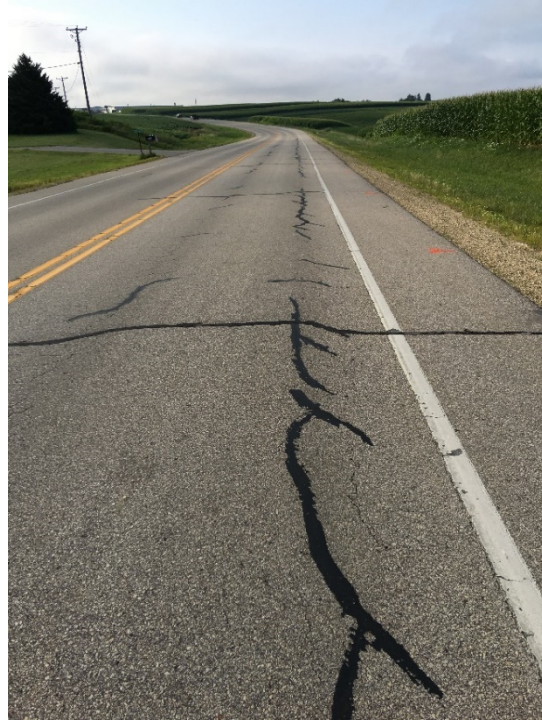
(b) Fatigue and transverse cracking – STH 33

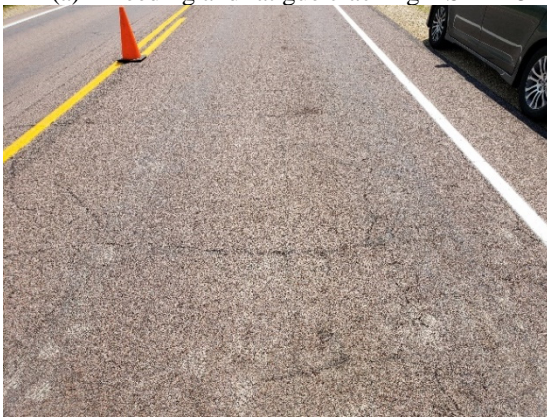
(c) Fatigue cracking – STH 25

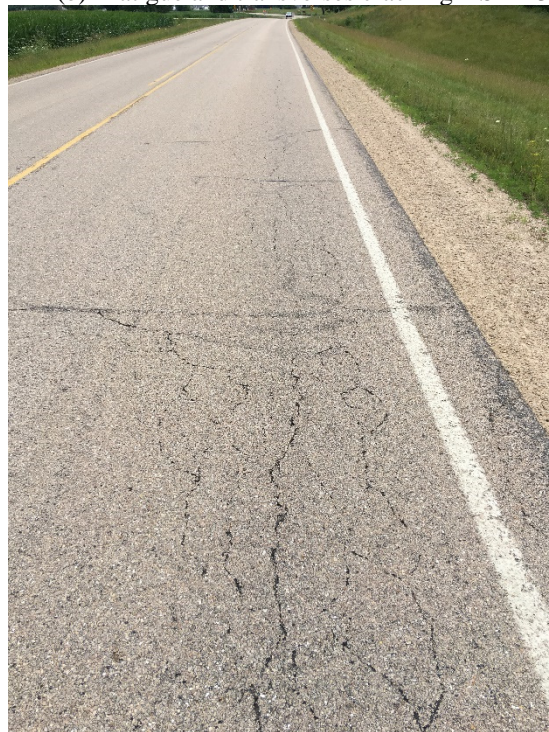
(e) Fatigue cracking – CTH T

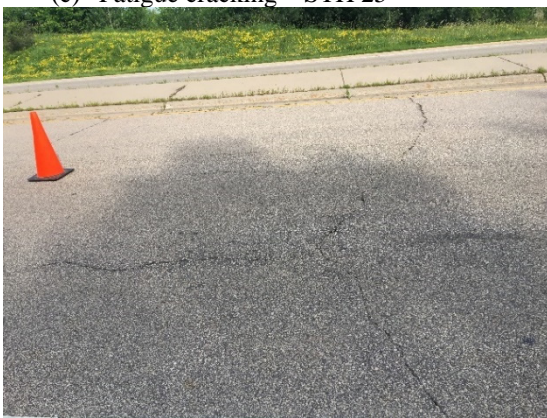
(d) Transverse and Longitudinal cracking – STH 22

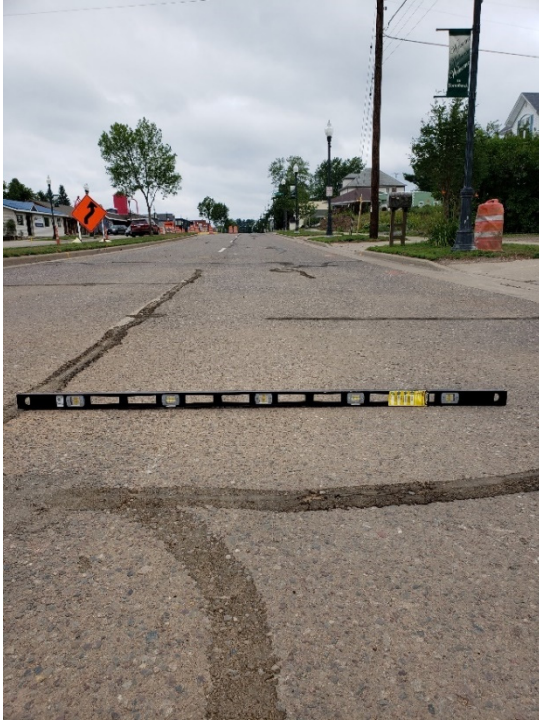
(a) Rutting – STH 86

Figure 5.27: Pavement surface distress observed on pavements with RCA base layers.

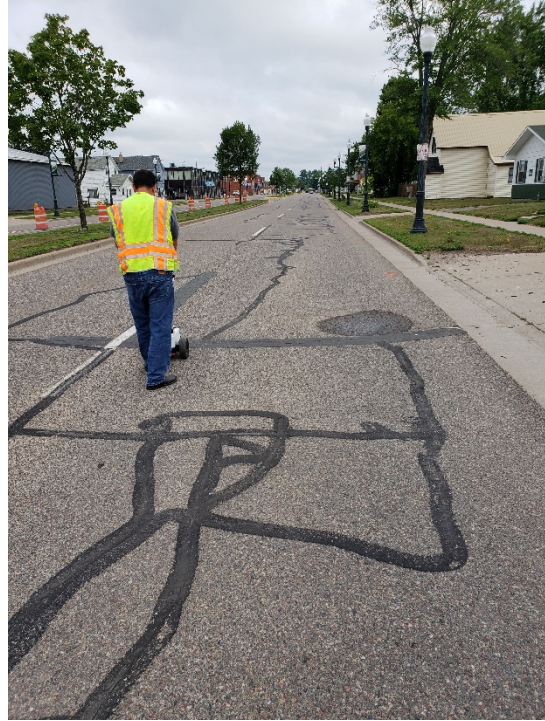
(b) Longitudinal and transverse cracking – STH 86

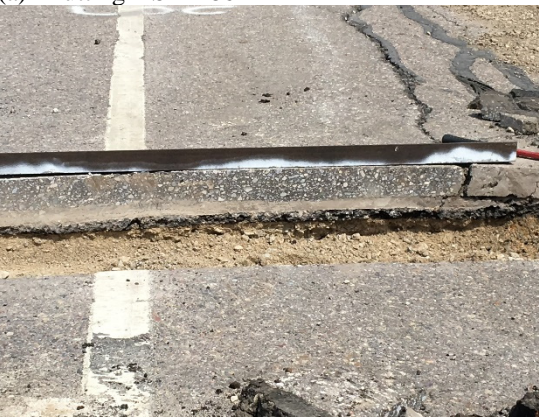
(c) Edge heave– STH 78

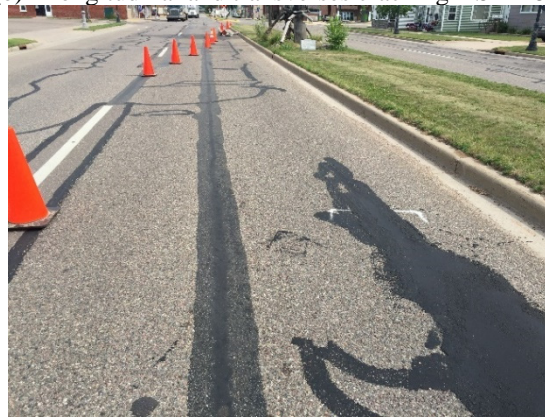
(d) Longitudinal and transverse cracking – STH 86

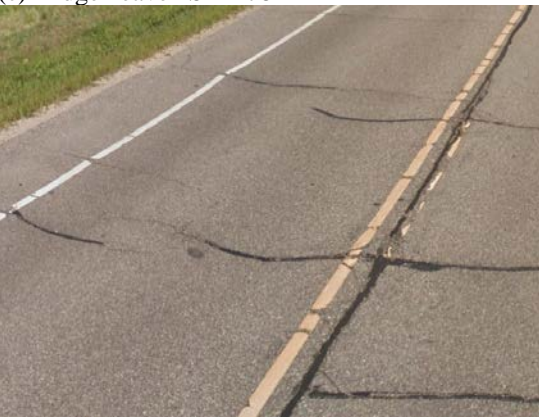
(e) Longitudinal and transverse cracking – STH 78

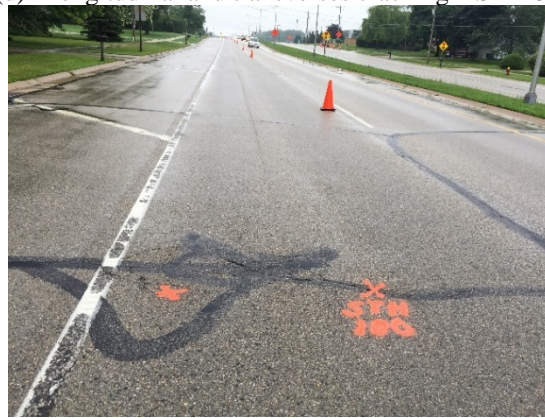
(f) Longitudinal and transverse cracking – STH 100

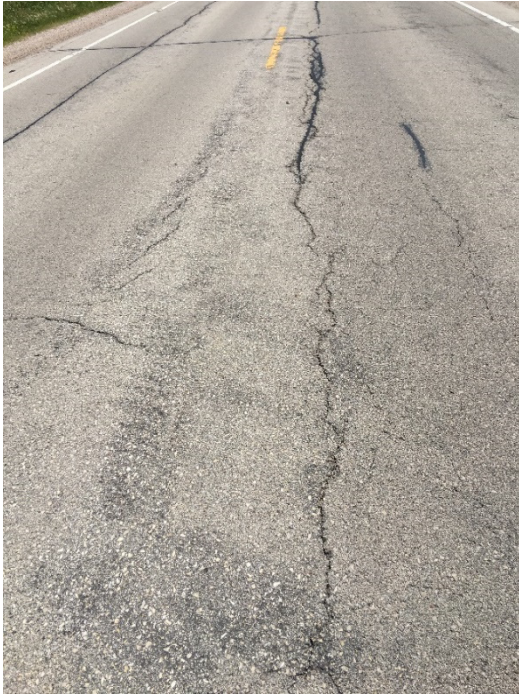
(a) Fatigue cracking – STH 96

Figure 5.28: Pavement surface distress observed on pavements with RAP base layers.

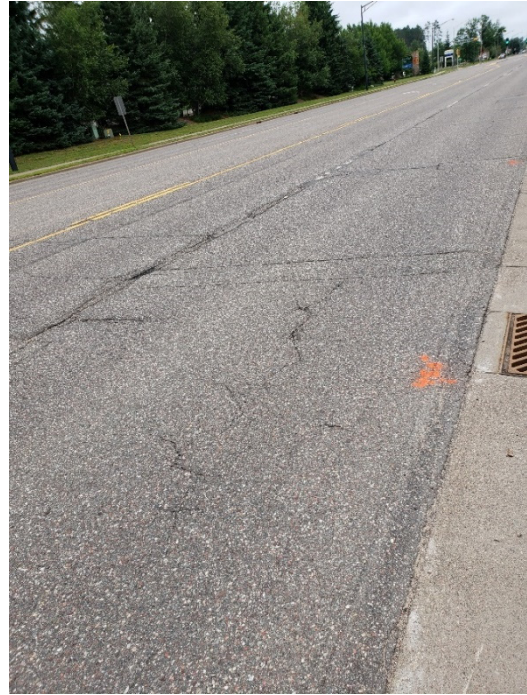
(b) Fatigue cracking STH 70

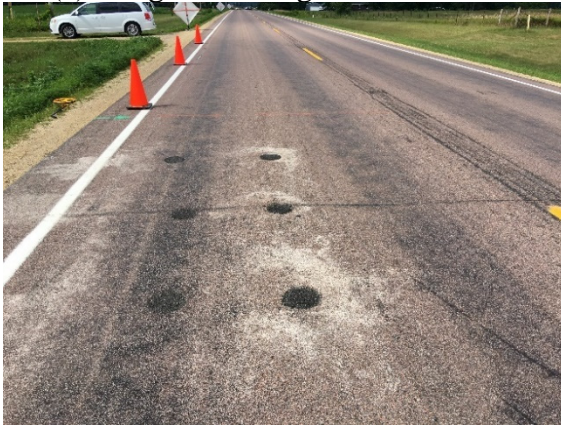
(c) Bleeding – STH 25

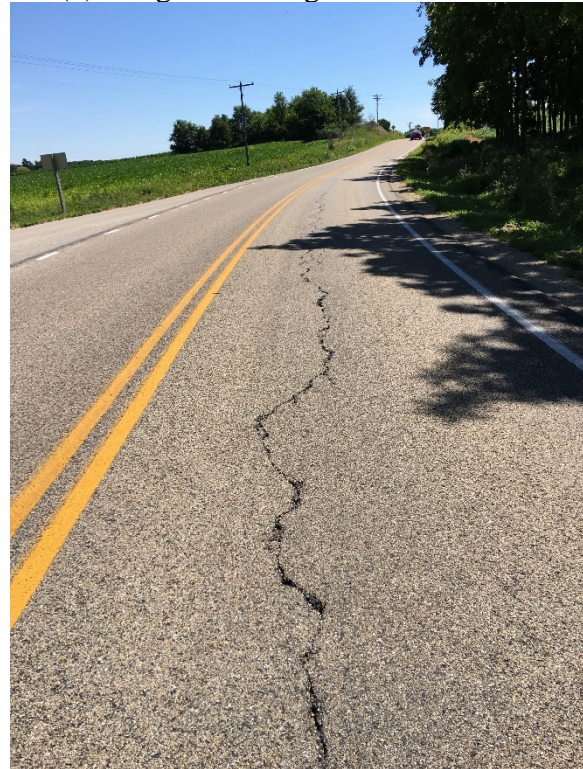
(d) Longitudinal cracking – STH 59
