Evaluation of Recycled Base Aggregates

WisDOT ID 0092-17-01

July 2019

WISCONSIN HIGHWAY RESEARCH PROGRAM

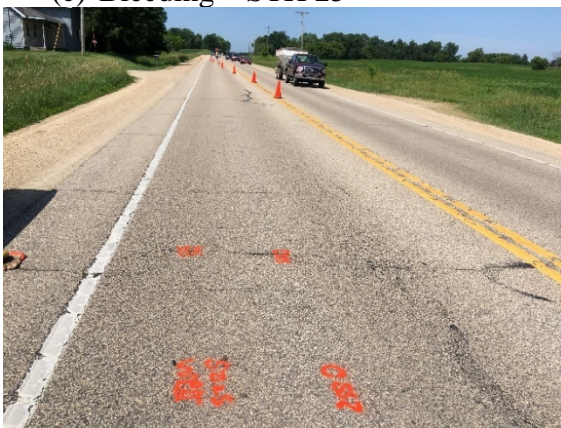
(e) Fatigue and transverse cracking – STH 22

Figure 5.28: Pavement surface distress observed on pavements with RAP base layers.

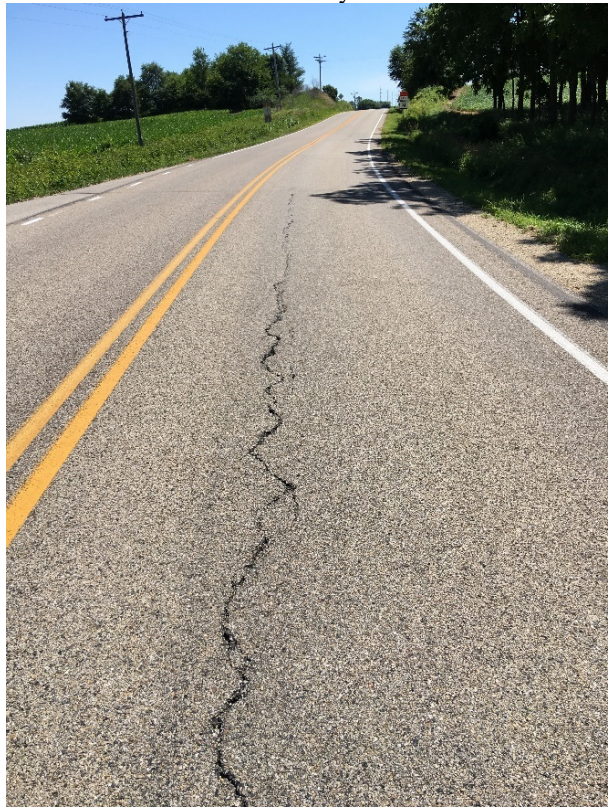
(e) Longitudinal cracking in RAP base layer section in 2018

Figure 6.1: STH 59 pavement sections with RAP and CA base layers in 2009 before reconstruction and in 2011 and 2018 after reconstruction.

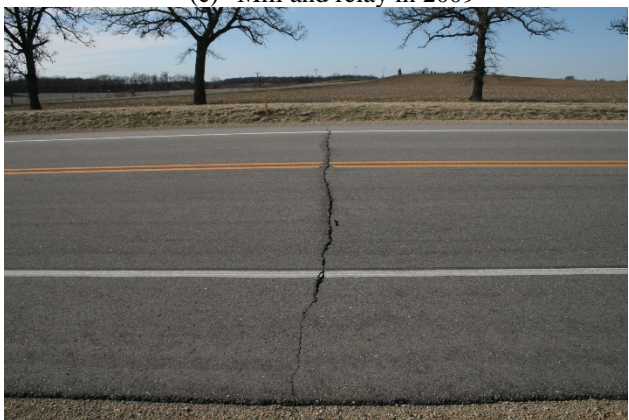
(d) Transvers cracking in 2011 in pavement section II with CA base layer section

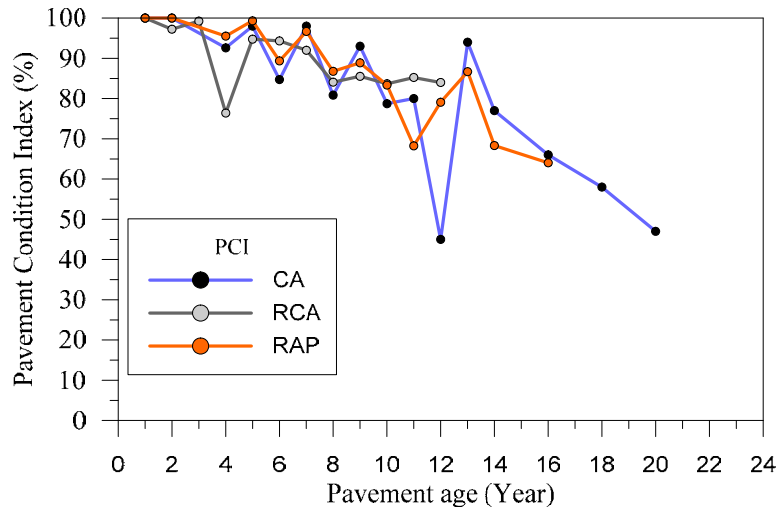
Figure 6.25: Comparison of the investigated pavement performance based on the type of base layer (average PCI for all pavement sections vs. pavement age).
